APPENDIX E: PUBLIC SITE WALKTHROUGH RATING CRITERIA & FIELD ASSESSMENT FORMS

WETLAND MITIGATION RATING CRITERIA & FIELD SITE ASSESSMENT FORMS

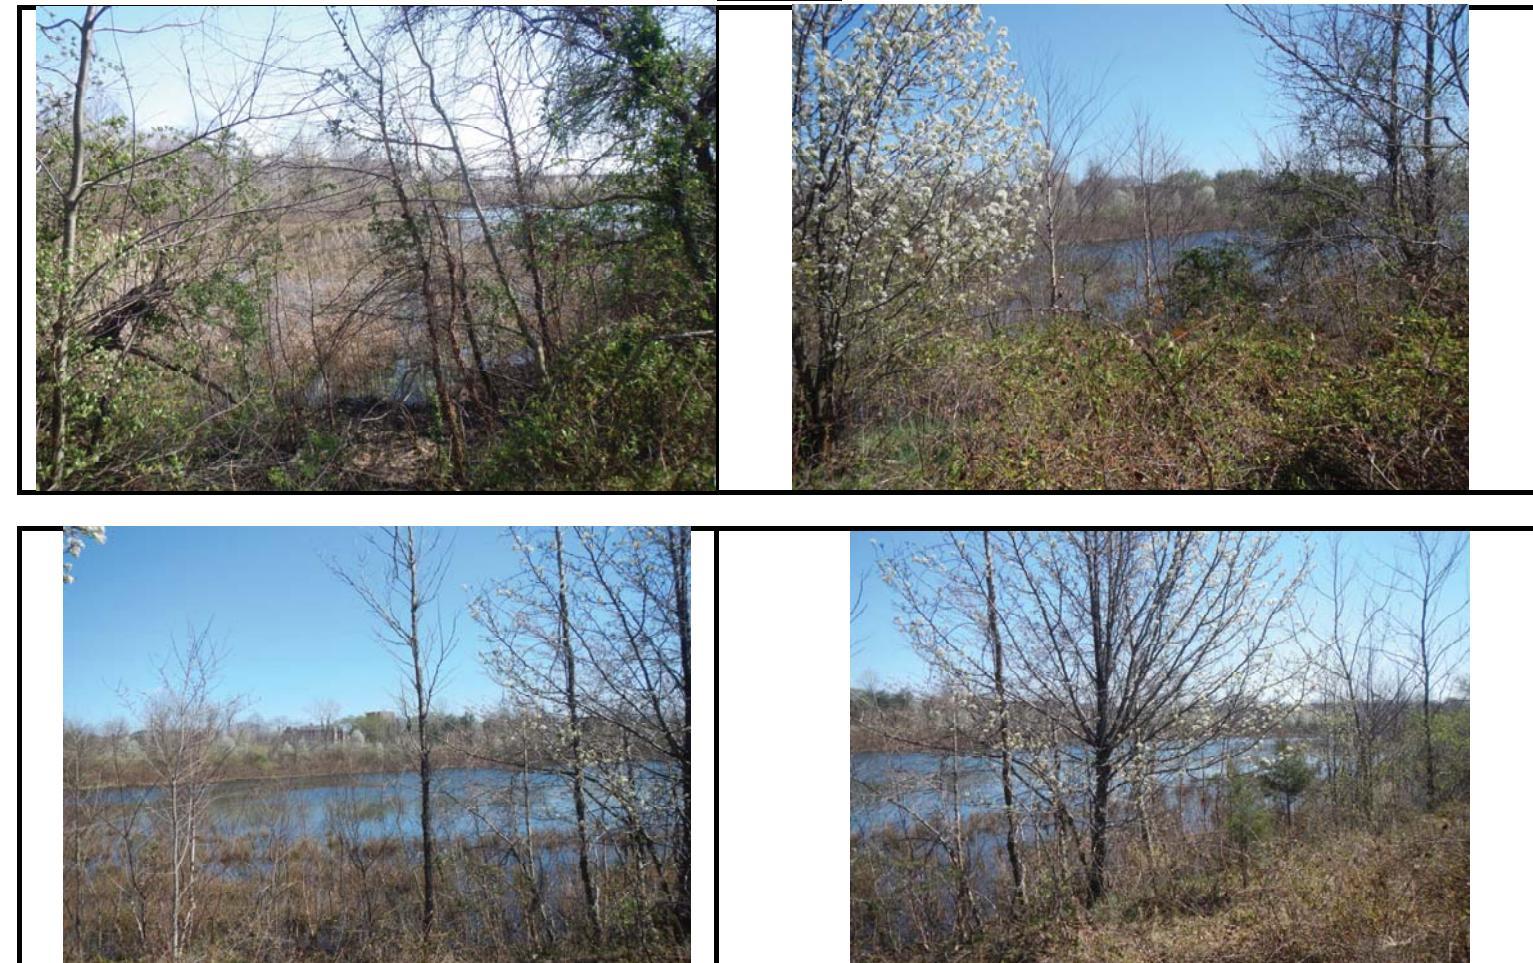
Is site currently a wetl	land?	Yes	Was site formerly a wetland?	
Condition: See photos			Condition: Site consists of open water man made pond with fring	e wetland
		Mitis	ation Site Rating	
Criteria		Score	ICriteria	Score
Soils		10	Vegetation	5
10 - Greater than 50%	hydric soil	10	10 - Herbaceous cover	5
5 - 10% to 50% hydric	soil		5 - Scrub-shrub cover	
1 - Less than 10% hvdr	ic soil		1 - Mostly forested	
Describe:			Describe:	
Water - permanently inundated with fringe wetland			Surrounded by scrub shrub - river birch, bradford pear, red maple	and sycamore
·····, ·				, ,
Hydrology		10	Land Use	10
10 - Abuts wetland or s	stream	-	10 - Agricultural or Open Space	-
5 - Adjacent to wetland	d or stream		5 - Mariginal Pasture	
1 - No connection to w	vetland or stream		1 - Old field	
Describe:			Describe:	
Majority of site is oper	n water surrounded by PEM frir	nge.	Surrounded by agricultural land and scrub shrub.

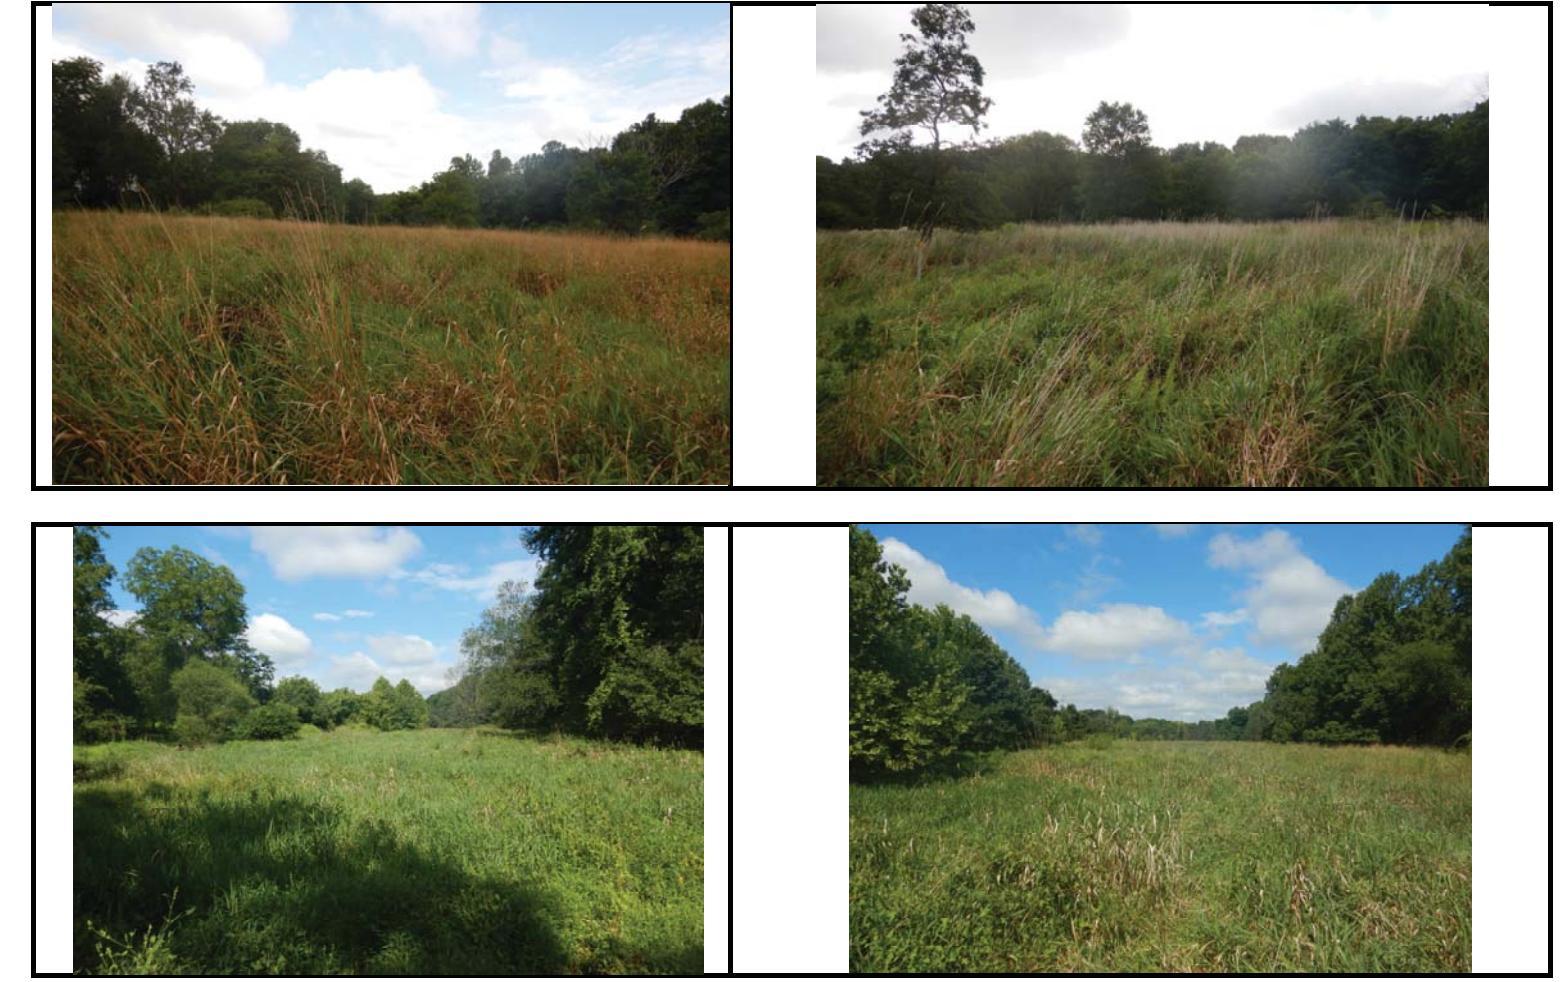
DTC analias procent?	(ovaloin holow)		Idi Field Observations	
the species present? (explain below)			Evidence of disturbance? (explain below)	
			was site formerly a wetland?	
Condition: Entire site i	Condition: Entire site in Crabbs Branch 100-year FEMA floodplain		Condition: High quality seep wetland at north western end of site.	
dominated by reed car	nary wetlands with scattered	trees.		
		N/i+i	action Site Bating	
Criteria		Score	ICriteria	Score
Soils		10	Vegetation	10
10 Greater than 50%	hydric soil	10	10 Horbasoous covor	10
5 - 10% to 50% hydric	soil		5 - Scrub-shrub cover	
1 - Less than 10% hydr	ic soil		1 - Mostly forested	
Describe:			Describe:	
Entire site located in m	nanned hydric soils Hydric so	hils verified in the	Majority of site is reed capary floodplain with scattered trees	
field	apped flyane solis. Flyane se	Jis vernied in the	Wajonty of site is recu canary hoodplain with scattered trees.

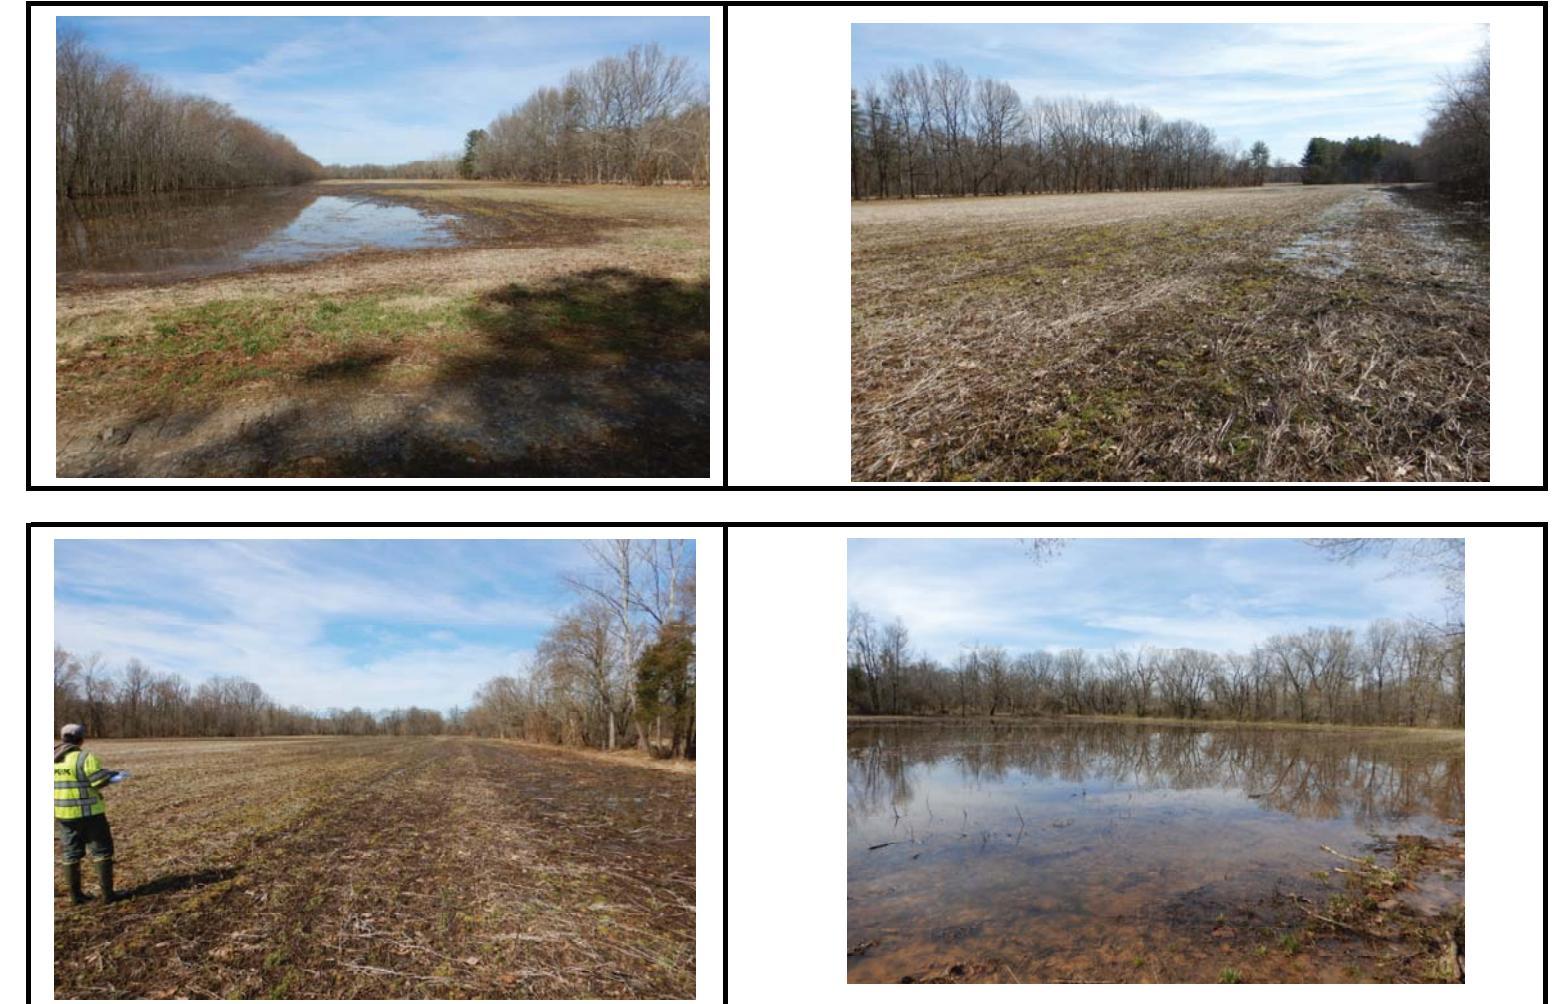
1 - Less than 10% hydric soll					
Describe:	d and have been at the instance of the		Describe:		
100% of site is mapped	d as hydric solis. No hydric soli	indicators	Active farm field - Remnant soy beans throughout site. No wet ve	g observed.	
observed during site w	valk, likely due to active farmin	g of field.			
Hydrology		10	Land Use	10	
10 - Abuts wetland or	stream		10 - Agricultural or Open Space		
5 - Adjacent to wetlan	d or stream		5 - Marginal Pasture		
1 - No connection to w	vetland or stream		1 - Old field		
Describe:			Describe:		
PFO wetland abutting	southeast corner of site. Exten	sive open water	Active farm field - Remnant soy beans throughout site. No wet ve	g observed.	
areas within site.					
100-Year Floodplain		5	Habitat Value	10	
10 - Yes (active eviden	ice of flooding)		10 - Contiguous to wetland/upland forest > 100 ac		
5-Yes (mapped but no	o evidence of active flooding)		5 - Contiguous to wetland/upland forest 25-100 ac

aepressions.		10		10	
Estimated cut to wetla	anu nyurology	10	Ounces Present	10	
TO - Less than 2			10 - NO UTILITIES ON SITE		
J-Delween 3 - 5 1 - greater than 5'			1 - Utilities within notential creation area		
Describe:					
Groundwater observe	d 14" below ground surface in	non-saturated	No evidence of utilities observed within or adjacent to the site.		
areas.					
			T	05	
			I otal Score out of 100	95

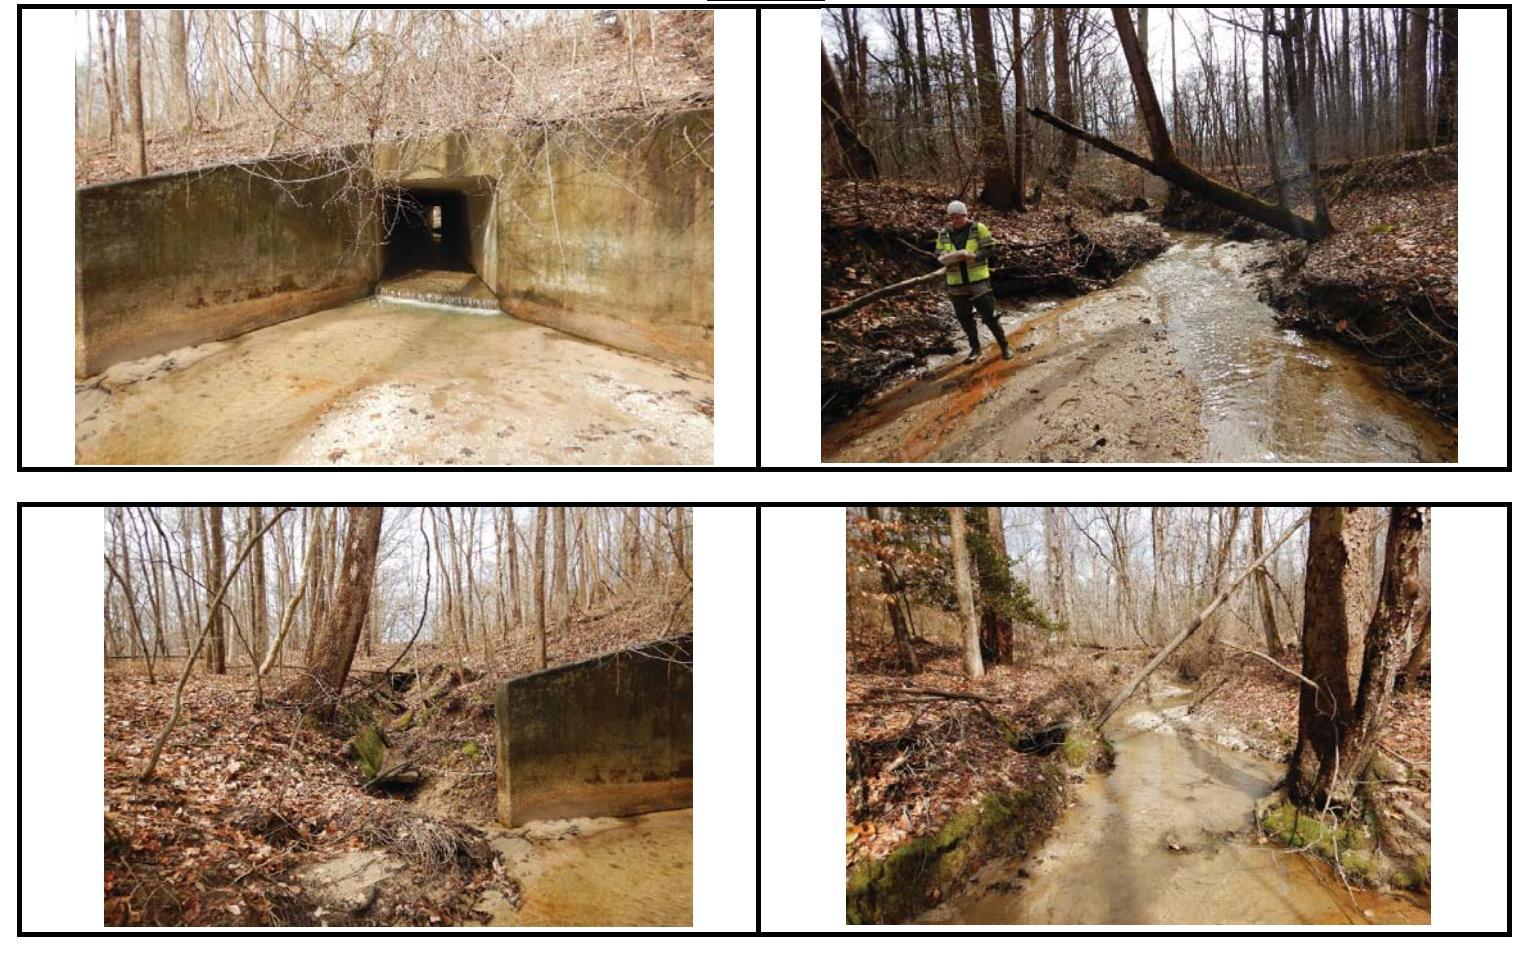
Deteriorating concrete on culvert
