I-495 & I-270 Managed Lanes Study

# **CA-5 (UNNAMED TRIBUTARY TO GREAT SENECA CREEK) STREAM RESTORATION MITIGATION**

**Semi-Final Design Report**

**April 2022**

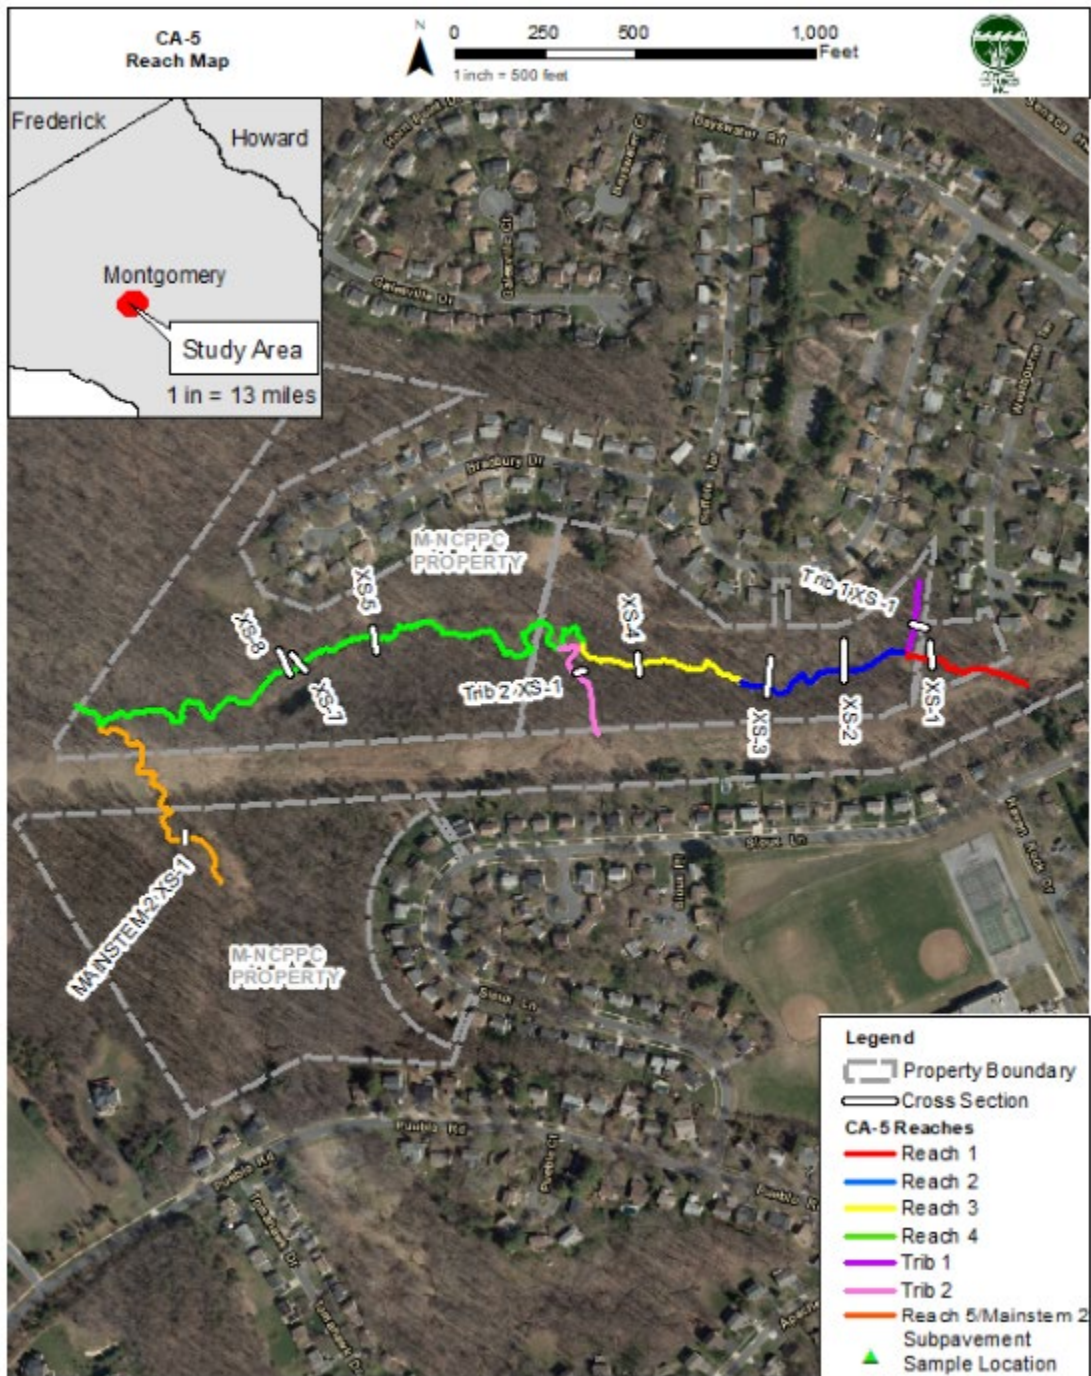
Figure 7. Reach Map

Reach 3 begins downstream of the exposed bedrock and sewer protection and is characterized by higher, more severely eroded banks. The slope and sinuosity remain fairly consistent from Reach 2 to Reach 3, but the entrenchment increases significantly in Reach 3. There is less bedrock control through Reach 3 and no exposed sewer crossings, leading to a more consistent riffle/pool sequence through this reach. Reach 3 contains mostly gravel and sand, with some larger cobble deposits that appear to be coming from a lens of loose material exposed in the eroded banks. Due to the high eroded banks, there is an increased presence of down trees and woody debris in the channel through this reach. Reach 3 ends where the valley slope flattens out again, the banks get slightly lower, and the channel sinuosity increase. The slope of Reach 3 is 2.3%, with a high entrenchment ratio and moderate to high width/depth ratio that led to an F4b Rosgen stream classification.

Reach 4 begins just upstream of the second tributary, where the valley and channel slopes flatten out and the channel increases in sinuosity. The reach has several tortuous meander bends with highly eroded banks and large deposits of sediment on the inner meander bend. It appears that the majority of sediment from the wetland headcut at Reach 2, the loose bank material in Reach 3, and the erosion and headcutting in the second tributary are settling out in Reach 4. There does not appear to be a significant source of sediment supply upstream of the study area, so most of the sediment load appears to be coming from within the site. Reach 4 also has down trees and woody debris throughout the reach due to the eroded outer meander bends. The reach is mostly sand and gravel with some cobble and bedrock outcrops. There is one sewer crossing at the upstream end of Reach 4, but no casing is exposed. A 15" RCP outlets on the right bank of Reach 4 approximately halfway down the reach. On the left floodplain near the 15" RCP there is an old man-made pond. No records could be found of the pond as a stormwater facility, so it may be an old farm pond. The pond outlets to the channel through a rock weir. Reach 4 ends where CA-5 joins with the Mainstem 2, another unnamed tributary to Great Seneca Creek. The slope of Reach 4 is 1.7%, with a moderate entrenchment ratio, moderate width/depth ratio, and moderate sinuosity that led to a B4c Rosgen stream classification.

The Mainstem 2 /Reach 5 (WC6) is an additional unnamed perennial tributary to Mainstem 1 (WC7) that contains a drainage area of approximately 0.43 square miles and contains perennial flow. This section contains approximately 766 linear feet of existing stream. A stormwater management (SWM) facility is located upstream of the proposed work area. Tight meanders are noted throughout the reach with undercut banks and active erosion along the outer meander banks. Localized bank erosion appears to be the main source of fine sediments that are minimal throughout the reach. Significant sediment deposition is noted upstream of the SWM facility that is preventing the transport of sediment downstream. Additionally, the SWM facility significantly reduces the storm discharges in the tributary. The tributary begins in a forested area before traversing through a cleared Right of Way owned by Potomac Electric Power Company (PEPCO.) The tributary enters a wooded corridor before joining Reach 4 of Mainstem 1 tributary. Woody material is present in the channel, particularly through the PEPCO ROW where existing brush along the streambanks is extending into the channel creating debris jams. Mainstem 2 tributary contains short steep riffles that average a length of 11.4 linear feet and a slope of 4.3%. The overall channel slope is 0.97%. The Mainstem 2 has a moderate entrenchment ratio, a low width to depth ratio, and moderate sinuosity that led to a B4c Rosgen stream classification.

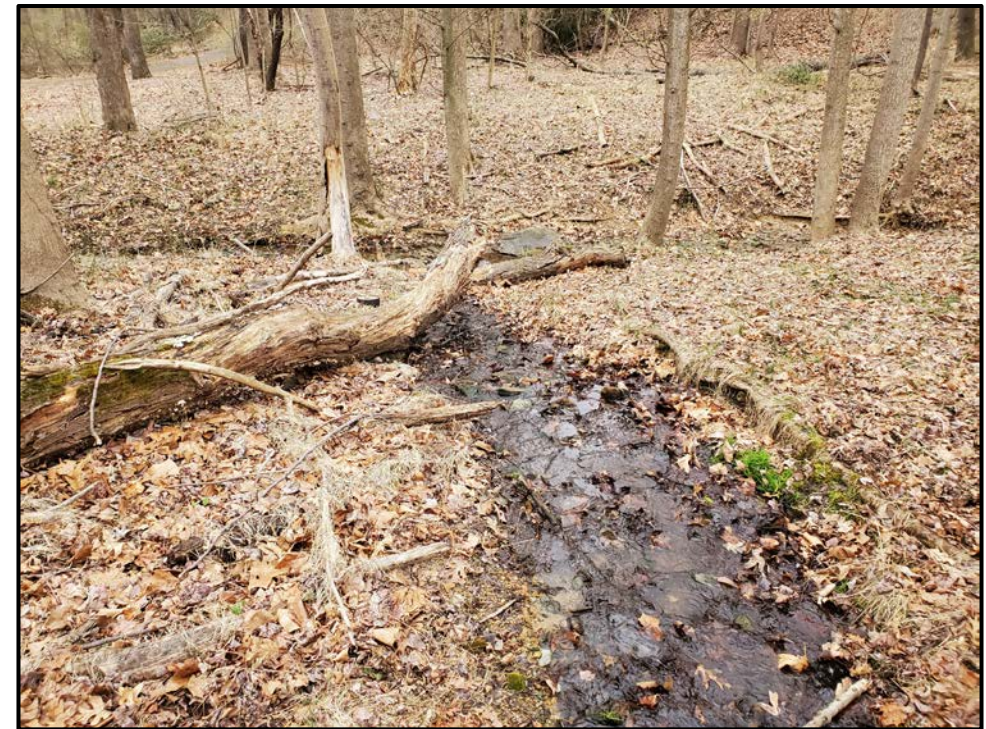
CA-5 Photo Point 103 Downstream at Groundwater  
Seep
