WETLAND AND FLOODPLAIN STATEMENT OF FINDINGS

Wetland and Floodplain Statement of Findings

Replacement and Widening of the American Legion Bridge, Phase 1 South, I-495 & I-270

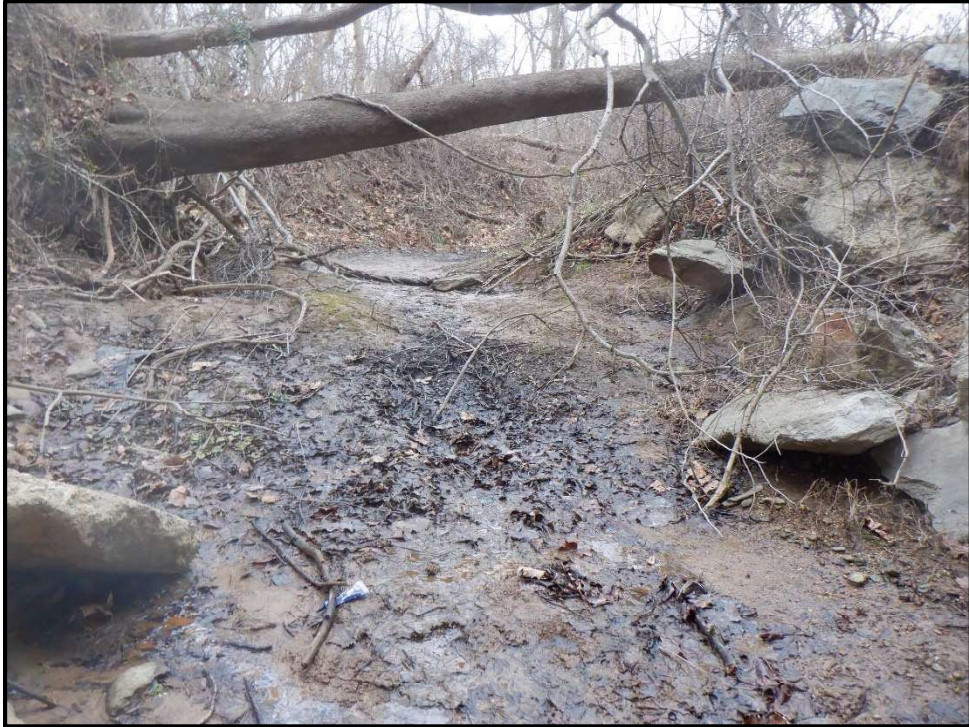
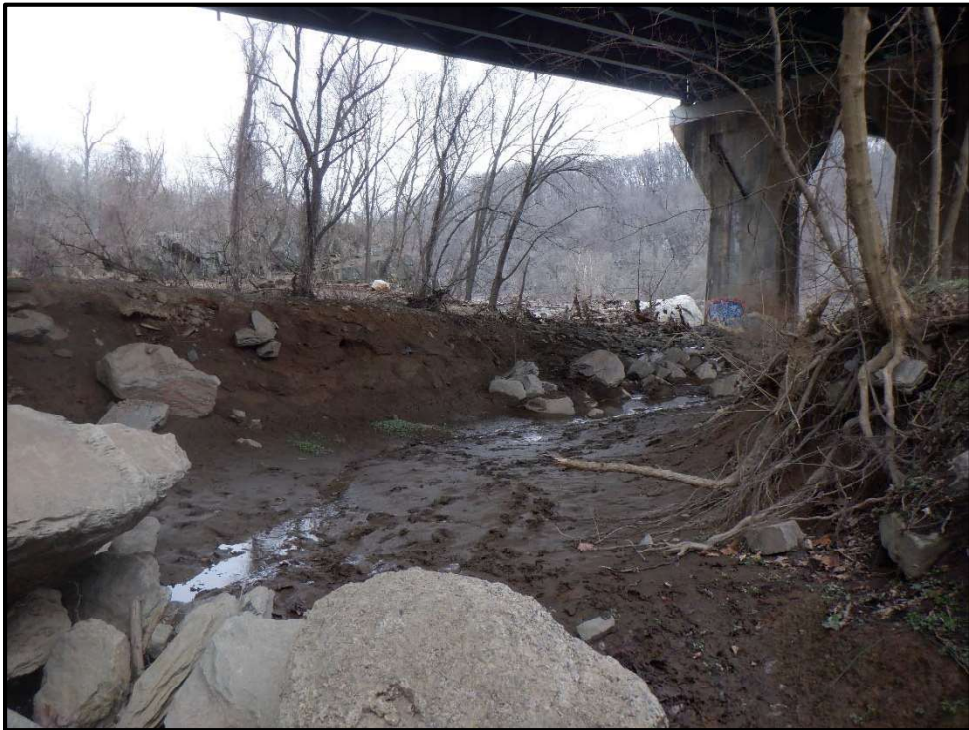
Waters 22NN – Intermittent

During a qualitative assessment of the aquatic community at Stream 22NN, no fish were observed, but many pouch snails (Family Physidae) and aquatic worms (Subclass Oligochaeta) were collected. Pouch snails and aquatic worms are both considered pollution-tolerant organisms.

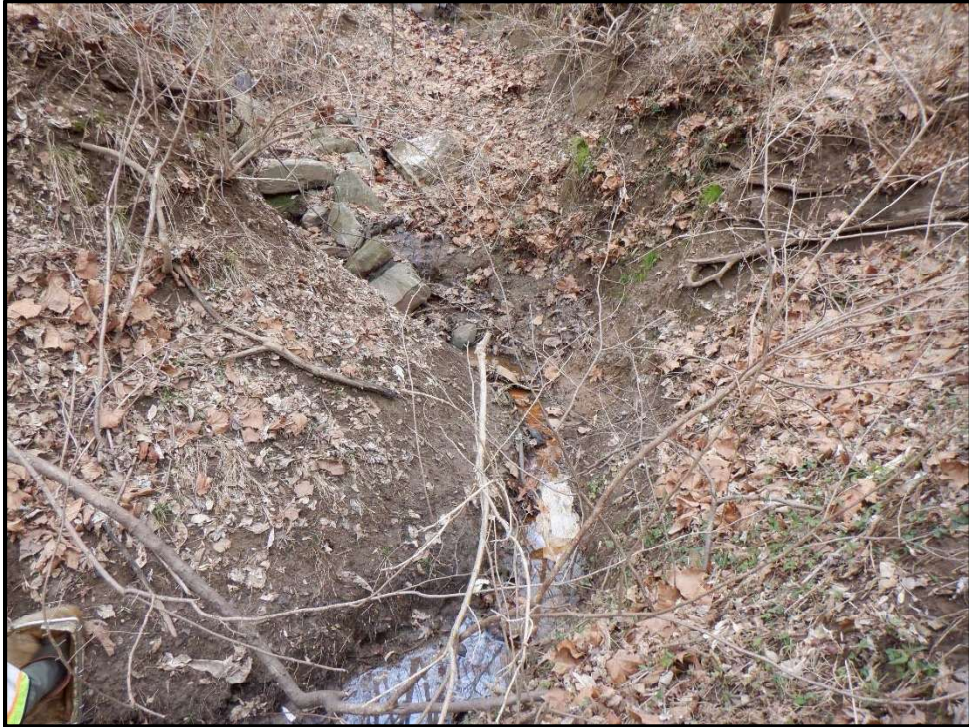
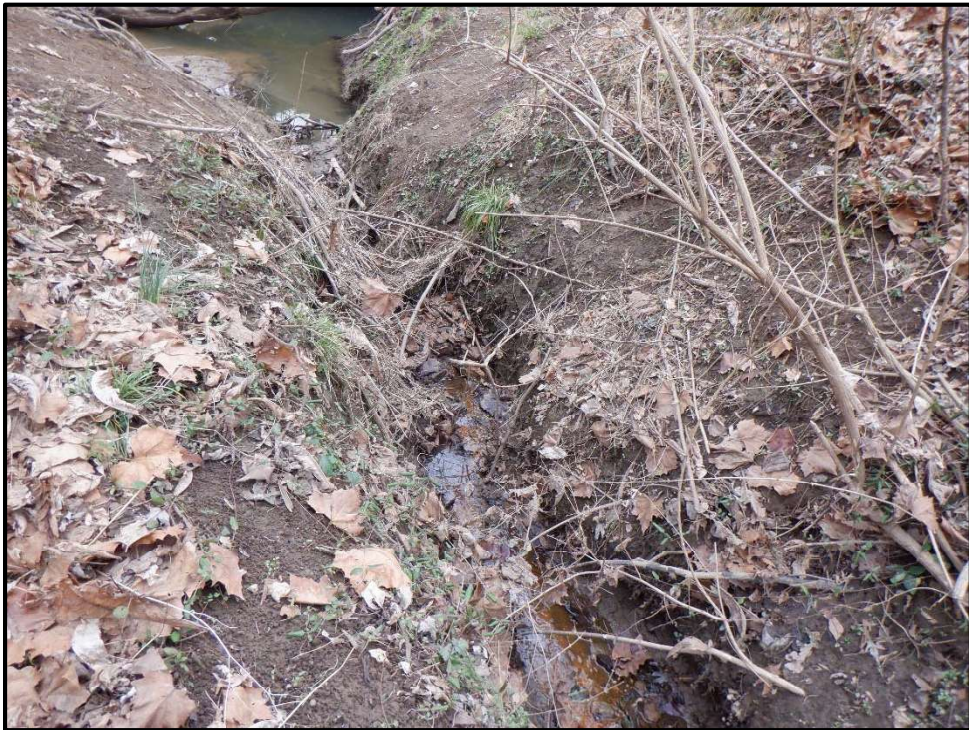
Waters 22QQ – Intermittent

During a qualitative assessment of the aquatic community at Stream 22QQ, no fish were observed, but aquatic worms (Subclass Oligochaeta) were collected. Aquatic worms are pollution-tolerant organisms.

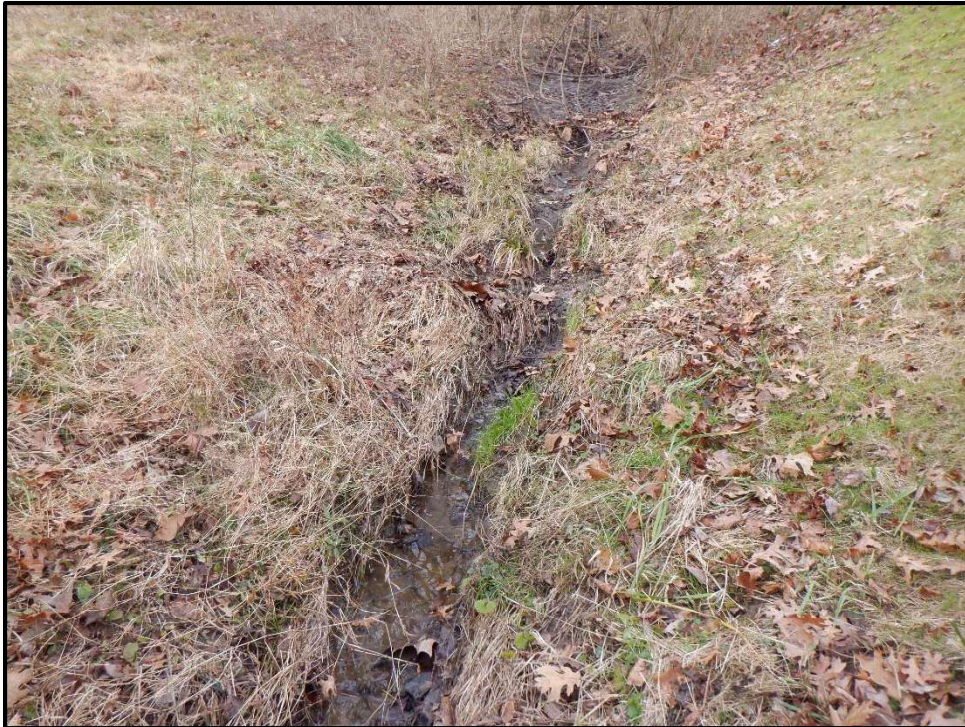
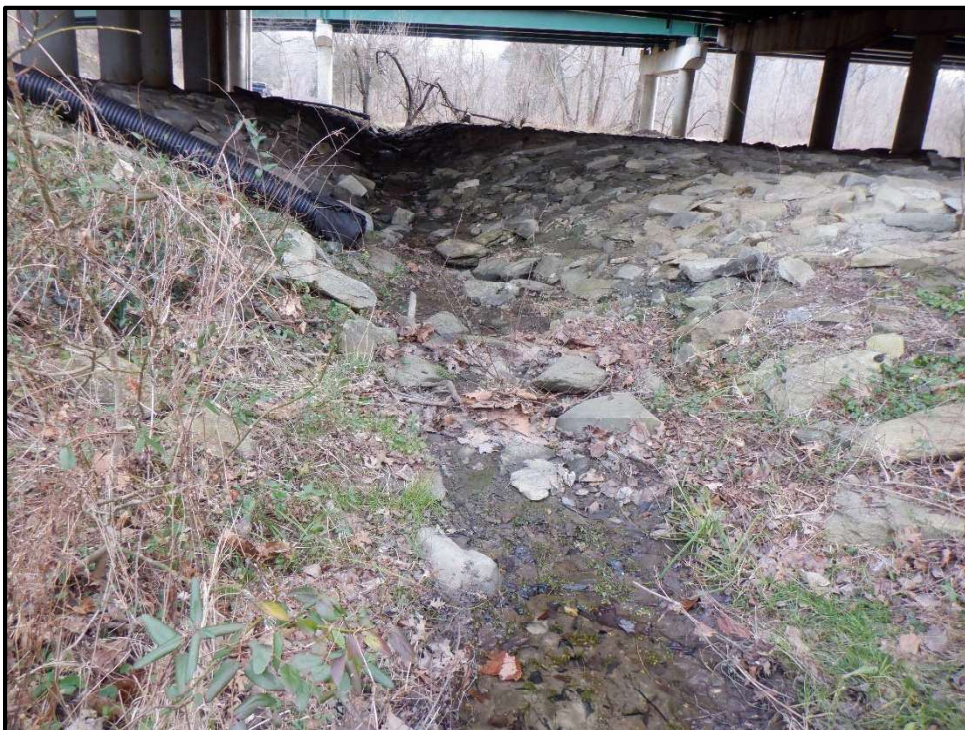
Waters 22V – Intermittent

Based on the assessment of fish and macroinvertebrate habitat using EPA’s Rapid Bioassessment Protocols for low gradient streams, the epifaunal substrate/available cover at 22V is poor, with less than 10 percent available habitat. Overall, the benthic macroinvertebrate habitat is deficient. For fish, there is no habitat present. Riffles are lacking with little variety and no flow diversity, while pools are mostly small-shallow with no root mat or submerged vegetation.

Vegetation is providing very little shade for the stream, as it is bordered by mowed grass and young regenerating woody species. The bridge provides 100 percent of shade for the portion flowing underneath. Stream 22V receives sediment and pollutant runoff from the adjacent roadways. No odor was present at the time of the survey, however cloudiness caused by fine sediments was present in the standing water and trash was observed along the banks.

During a qualitative assessment of the aquatic community at Stream 22V, no fish were observed, but many pouch snails (Family Physidae) and some aquatic sowbugs (Family Asellidae) were collected from the standing water. Pouch snails and aquatic sowbugs are both considered pollution-tolerant organisms.

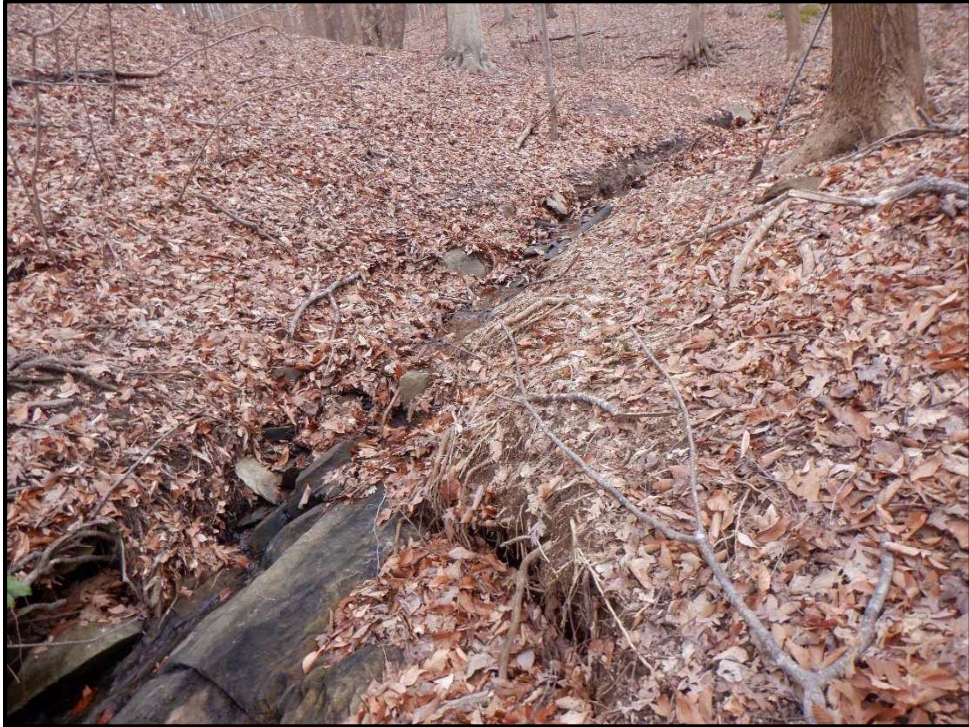
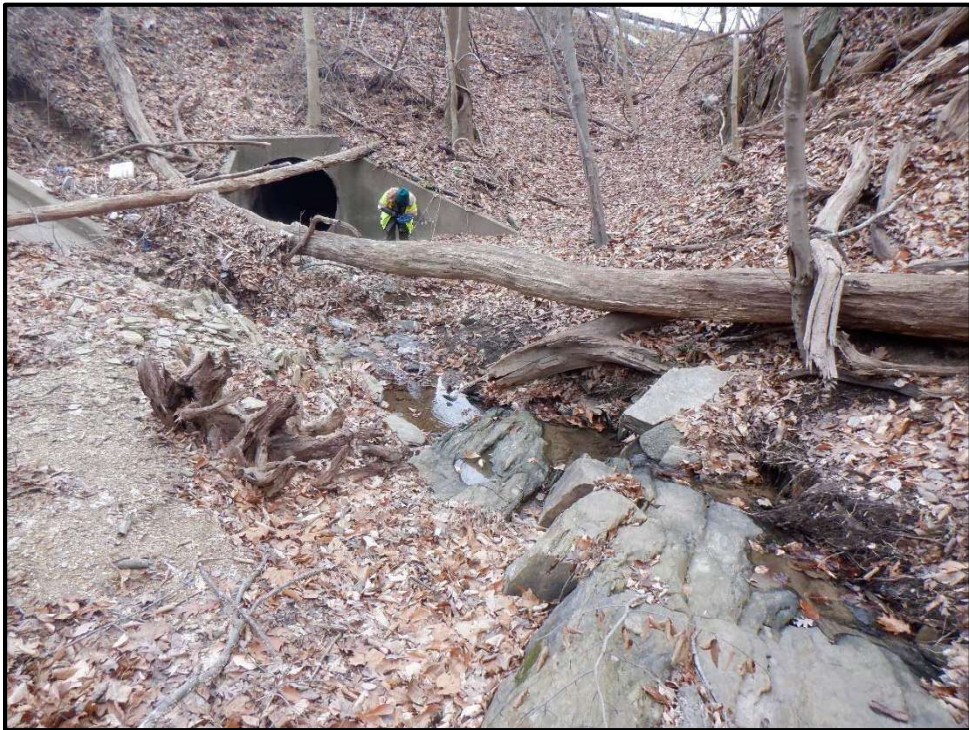
Waters 22WW – Intermittent

Substrate of the riffles consists of cobble, gravel and bedrock and is roughly 25 percent embedded. Pools are mostly shallow with gravel substrate, but some root mat habitat is available. Leaf packs observed were transient and unlikely to be suitable habitat. Shallow-fast and shallow-slow were the only two depth regimes present at Stream 22WW. Roughly 5 percent of the bottom of the streambed is affected by

During a qualitative assessment of the aquatic community at Stream 22WW, aquatic worms (Subclass Oligochaeta), net-spinning caddisflies (Family Hydropsychidae), stoneflies (Order Plecoptera) and aquatic sowbugs (Family Asellidae) were collected in the stream. Aquatic worms and aquatic sowbugs are considered pollution-tolerant groups of organisms; net-spinning caddisflies are moderately pollution-sensitive; and stoneflies are pollutant-sensitive organisms. As Stream 22WW is a small intermittent channel, it is unlikely to be providing fish habitat, and none were observed during the time of the survey.

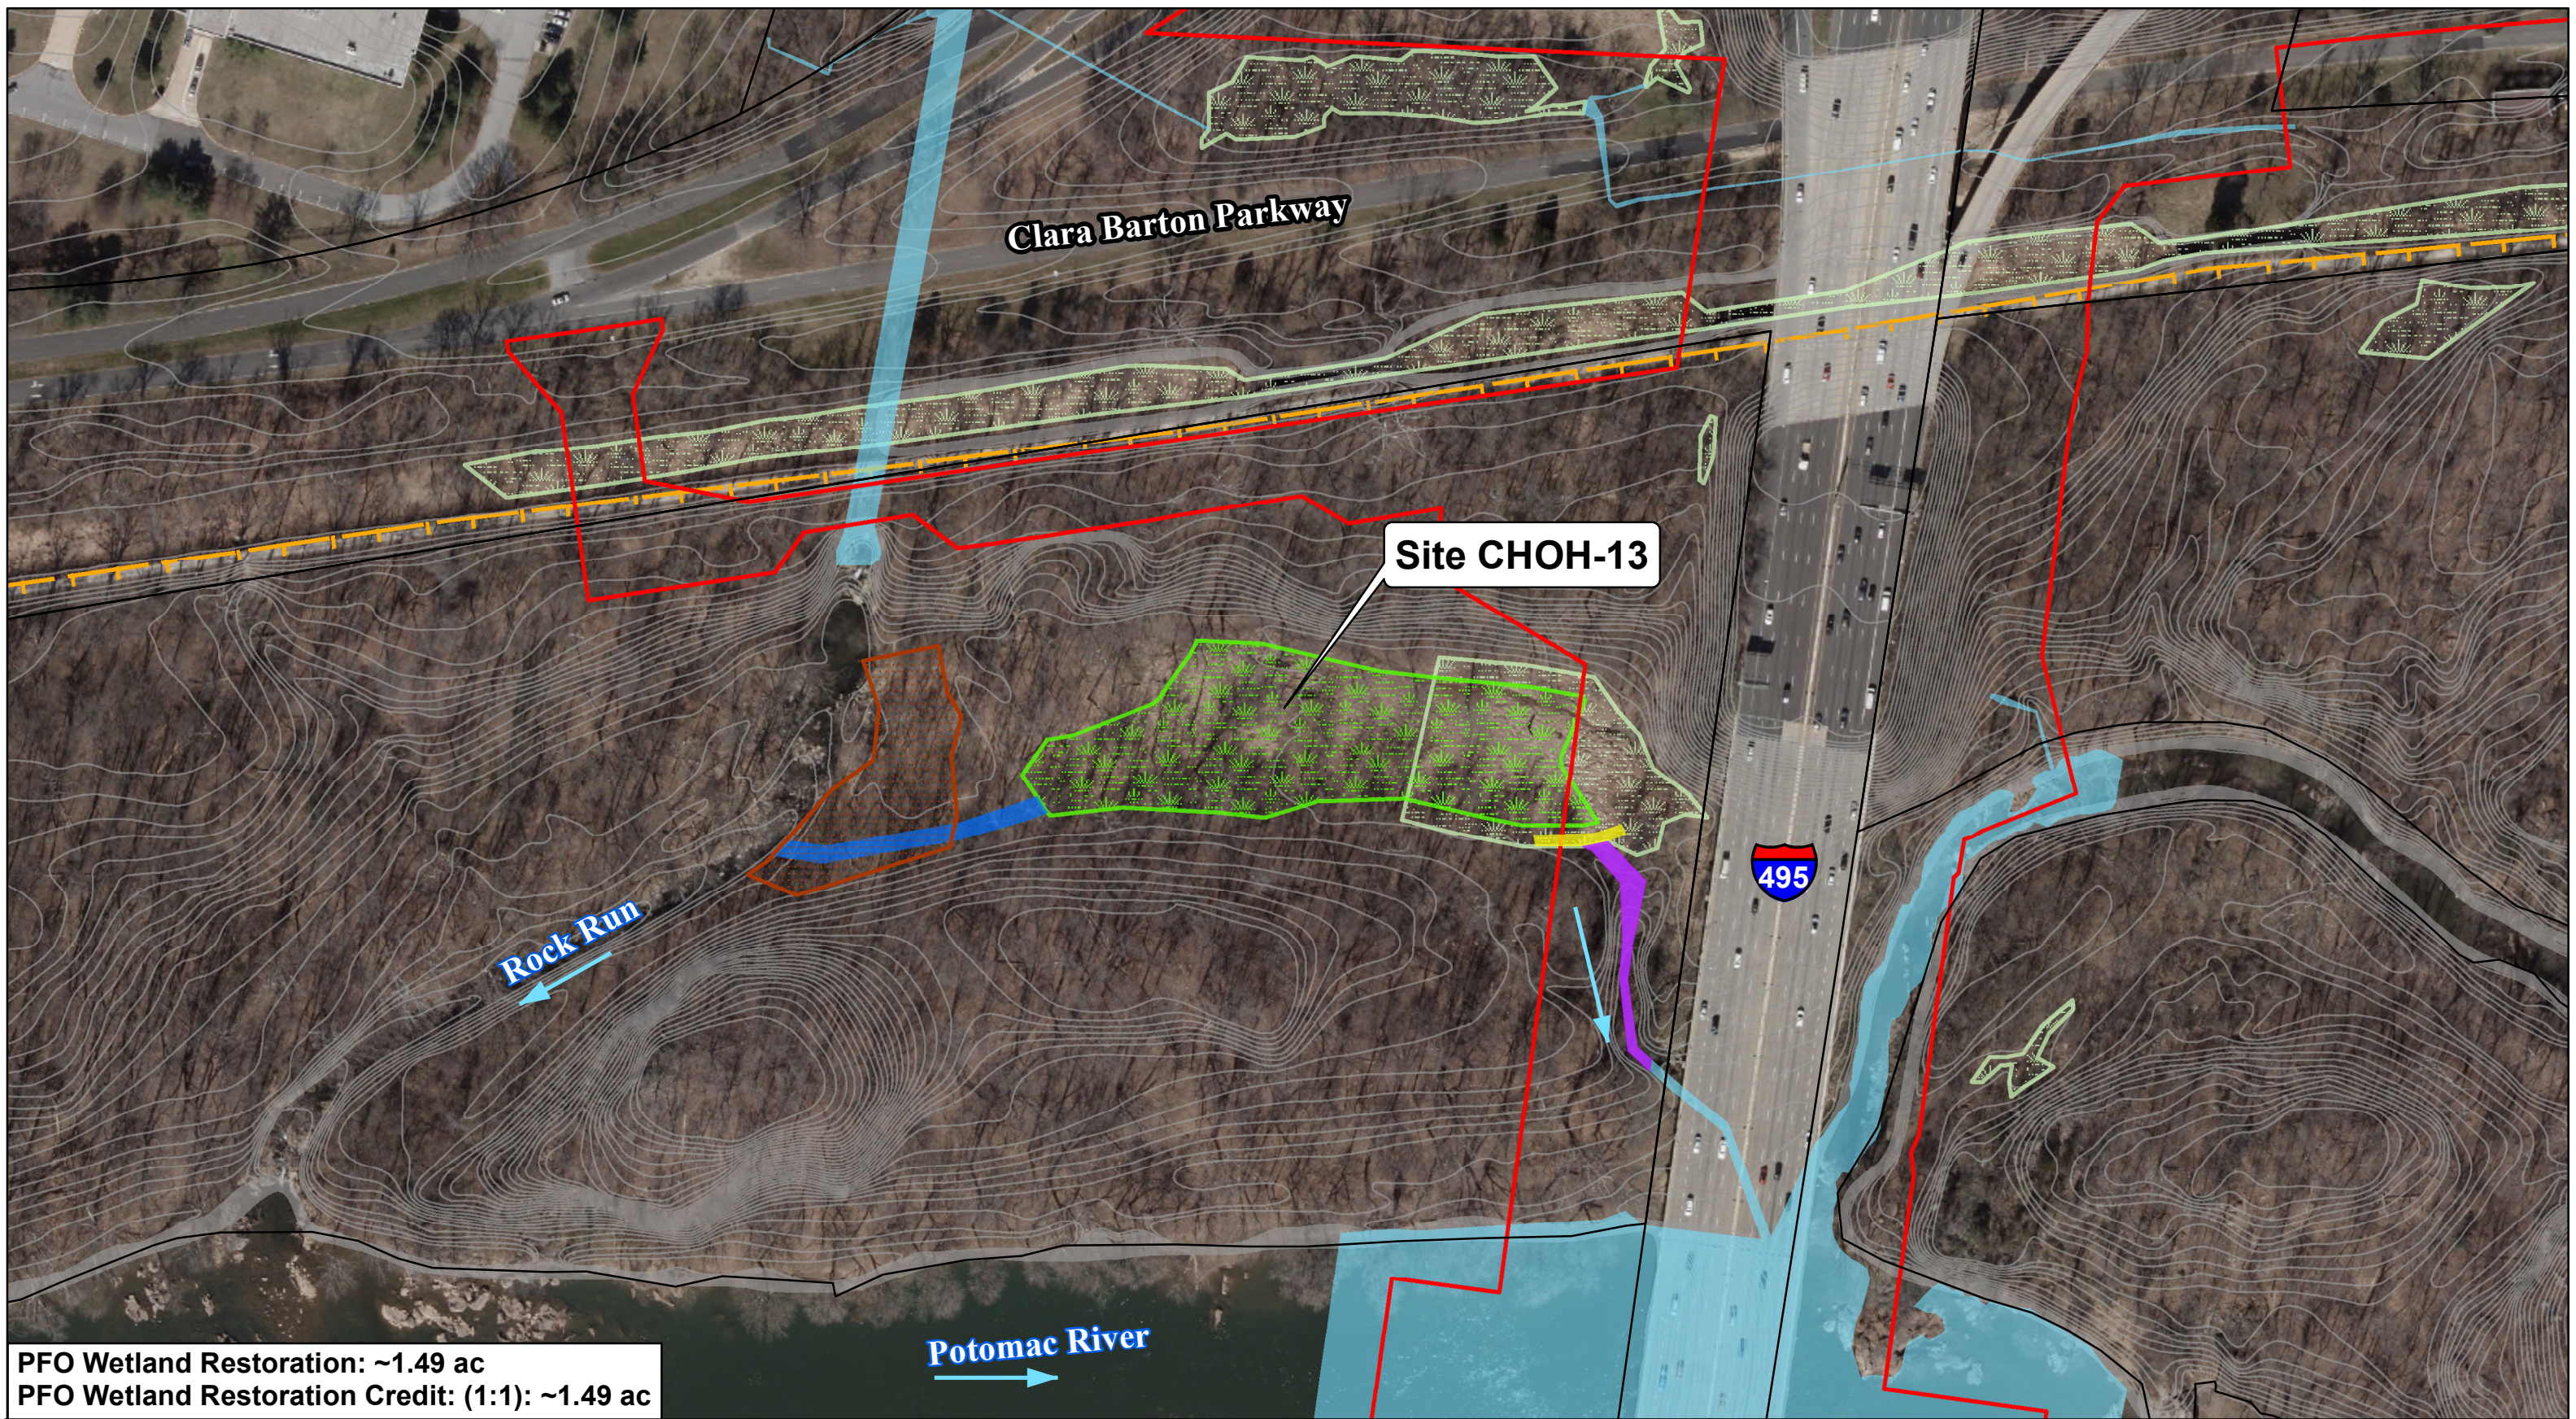
I-495 & I-270 Managed Lanes Study
NPS Wetland Mitigation
Concept Design Plan
Site CHOH-13

PFO Wetland Restoration: ~1.49 ac
PFO Wetland Restoration Credit: (1:1): ~1.49 ac

Parcel Boundaries	Delineated Streams	PFO Wetland Restoration
Phase 1 South LOD	Delineated Wetlands	Channel Fill
100 Year FEMA Floodplain	Sub-Surface Bedrock	Groundwater Dam & Micro-berm
2' Contours	Outlet Channel
