I-495 & I-270 Managed Lanes Study

# **APPENDIX D**

## **Compensatory Stormwater Mitigation Plan**

### **June 2022**

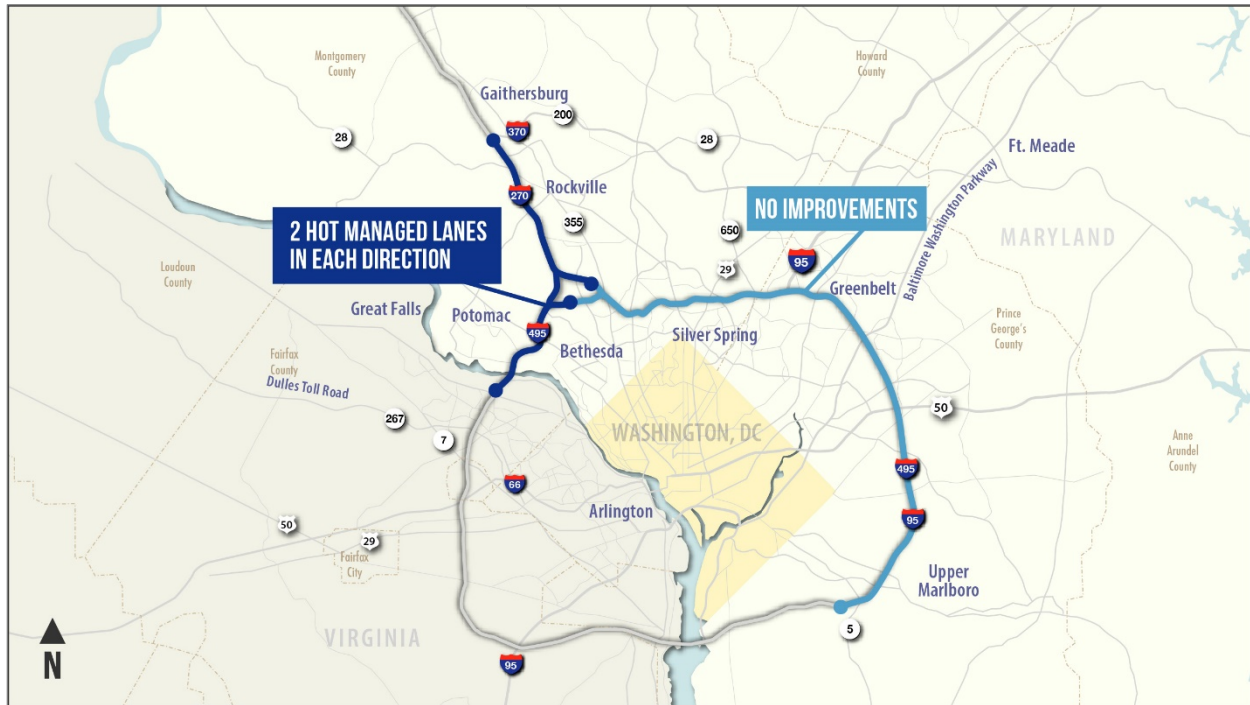
**Figure 1-1: I-495 & I-270 Preferred Alternative Limits**

The Federal Highway Administration (FHWA), as the Lead Federal Agency, and the Maryland Department of Transportation State Highway Administration (MDOT SHA), as the Local Project Sponsor, are preparing an Environmental Impact Statement (EIS) in accordance with the National Environmental Policy Act (NEPA) for the Public-Private Partnership (P3) I-495 & I-270 Managed Lanes Study (MLS). The MLS is evaluating potential transportation improvements to portions of the I-495 and I-270 corridors within Montgomery County and Prince George's County, Maryland and Fairfax County, Virginia. The MLS extends along I-495 from south of the George Washington Memorial Parkway in Virginia to just west of Maryland 5, I-270 East and West Spurs in their entirety, and along I-270 from its intersection with the I-270 East and West Spurs to its intersection with I-370. FHWA and MDOT SHA identified the Preferred Alternative: Alternative 9 – Phase 1 South and documented this decision in the Supplemental Draft Environmental Impact Statement (SDEIS) published on October 1, 2021. The Preferred Alternative focuses on building a new American Legion Bridge and delivering two high-occupancy toll (HOT) managed lanes in each direction on I-495 from the George Washington Memorial Parkway in Virginia to west of MD 187 on I-495, and on I-270 from I-495 to north of I-370 and on the I-270 east and west spurs (**Figure 1-1**).

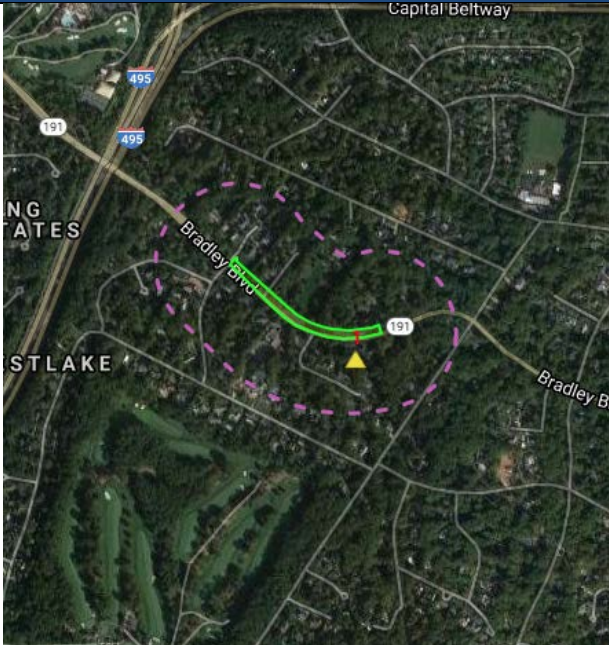
LOD ID: WAS-1805	Site Rank: Low	<b>Figure Location:</b>

Quadrant:	NW	
Watershed:	WAS	
Street Address/Nearest Cross Streets	North side of Bradley Boulevard (MD 191), southeast of Redwood Avenue	
City	Bethesda	
County	Montgomery	
Type of property	ROW	
<b>Ranking Rationale Site Summary</b>		
<p>The LOD is located along the north side of Bradley Boulevard (MD 191), southeast of Redwood Avenue, in Bethesda, Maryland. Residential properties surround the LOD in all directions. A golf course is located further to the south. I-495 is further to the west. Based on a review of historical imagery, the area surrounding area was primarily agricultural land and residential properties prior to 1937. Residential development continued in all directions of the LOD through 2005, when the surrounding area was observed similar to its current configuration. The Lay Women’s Association, approximately 95 feet to the south, was listed as having a minor air permit. Based on the type of environmental listing impacts to the LOD are unlikely.</p>

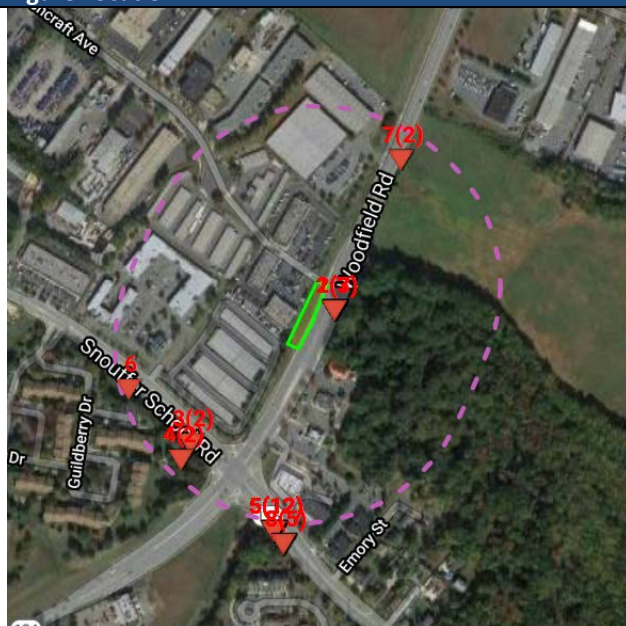
<b>Quadrant:</b>	NW	
<b>Watershed:</b>	WAS	
<b>Street Address/Nearest Cross Streets</b>	East side Woodfield Road (MD 124) between Snouffer School Road and Lindbergh Drive	
<b>City</b>	Gaithersburg	
<b>County</b>	Montgomery	
<b>Type of property</b>	ROW	
<b>Ranking Rationale Site Summary</b>		
<p>The LOD is located along the west side of Woodfield Road (MD 124) between Snouffer School Road and Lindbergh Drive, in Gaithersburg, Maryland. The surrounding area is a mix of commercial and residential developments. Commercial and residential development is observed to begin prior to 1993. The surrounding area is in its current configuration by 2005. A shopping center adjacent to the LOD had a dry-cleaning facility approximately 150 feet southeast (potentially crossgradient) of the LOD, that historically utilized chlorinated solvents in their dry-cleaning operations. Based on a review of investigation summary reports and analytical soil and groundwater data provided by MDE through a PIA request, soil and groundwater in the immediate vicinity of the LOD is not believed to be impacted by the former dry-cleaner. The shopping center also had two former 550-gallon heating oil USTs that were excavated and removed from the site in 2005 and 2007. No impacts were identified with the UST removed in 2005; however, analytical data showed detected concentrations of TPH-DRO at 85 mg/kg, two feet below the grade of the UST (approximately 7 feet bgs) that was removed in 2007. Both USTs received closure from MDE. Based on this information, residual concentrations of petroleum constituents could be encountered within the limits of the LOD based on the proximity of the former USTs. Thus, further investigation may be warranted prior to any intrusive groundwork to determine whether or not impacted material is present within the boundaries of the LOD.</p>

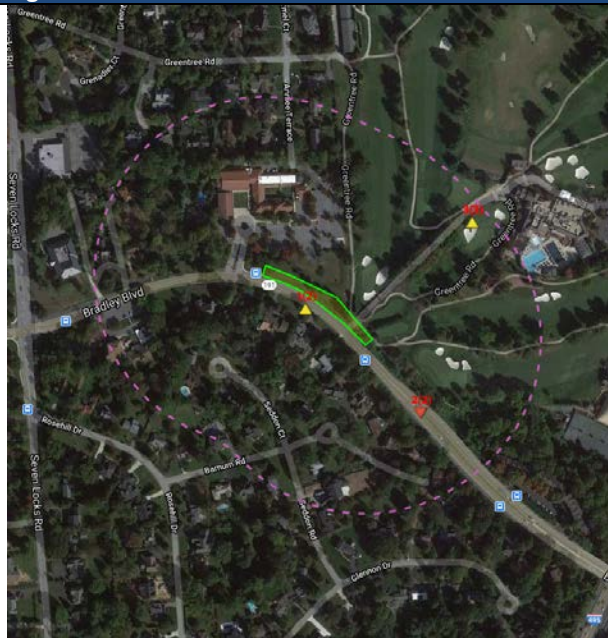
<b>Quadrant:</b>	NW	
<b>Watershed:</b>	WAS	
<b>Street Address/Nearest Cross Streets</b>	North side of Bradley Boulevard (MD 191), east of Seven Locks Road	
<b>City</b>	Bethesda	
<b>County</b>	Montgomery	
<b>Type of property</b>	ROW/Private	
<b>Ranking Rationale Site Summary</b>		
<p>The LOD is located along north side of Bradley Boulevard (MD 191), east of Seven Locks Road, in Bethesda, Maryland. The LOD is located south of the Bethesda Country Club and St George Orthodox Church, east of the intersection of the Bradley Boulevard and Seven Locks Road. The area is considered suburban. The LOD lies along the southern boundary of Bethesda Country Club that is listed as a delisted SHWS due to the potential that irritant gases were tested on a small area of the property around WWI. Regulators determined that no testing was required and no further action was warranted. Several USTs have been removed from the site, approximately 975 feet to the north. Thus, impacts to the LOD are unlikely.</p>

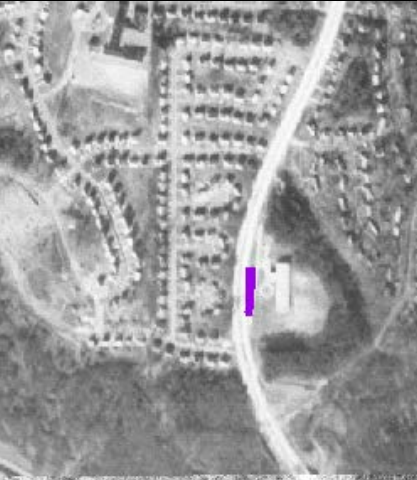
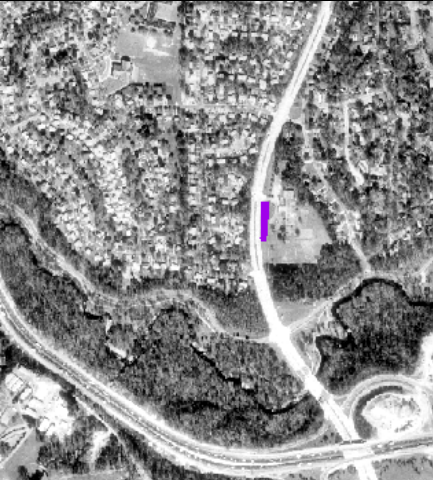
HISTORICAL IMAGES OF IMPORTANCE		
Year: 1908	Year: 1959	Year: 1988

HISTORICAL IMAGES SUMMARY		
Date Range	Property Use	Source
1908	Vacant land, adjacent to Connecticut Avenue	Topo
1959	Vacant land, adjacent to recently constructed residential homes, as well as the school directly to the west	Aerial
1988	Surrounding area is developed in its current configuration	Aerial

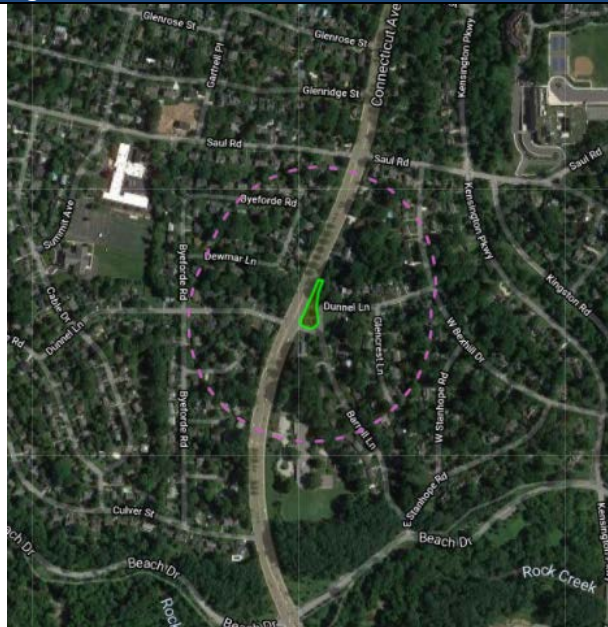
Quadrant: NW	NW	
Watershed: WAS	WAS	
Street Address/Nearest Cross Streets	East side of Connecticut Avenue, west of Dunnel Lane	
City	Kensington	
County	Montgomery	
Type of property	ROW	
<b>Ranking Rationale Site Summary</b>		
The LOD is located along the east side of Connecticut Avenue, west of Dunnel Lane, in Kensington, Maryland. Residential properties abut the LOD in all directions. Based on historical imagery, residential development began prior to 1959 and continue through approximately 1988, when the surrounding area was observed to be developed in its current configuration. No records of concern in the vicinity of the LOD were identified during the environmental review.

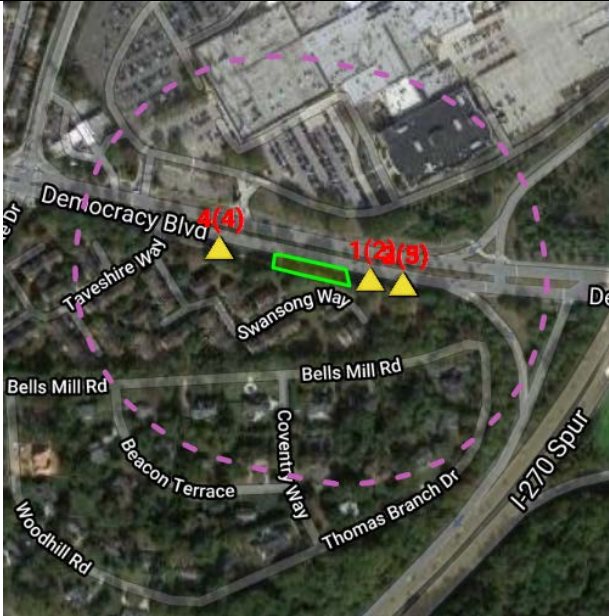
Watershed:	WAS	
Street Address/Nearest Cross Streets	South side of Democracy Boulevard between I-270 and Westlake Drive	
City	Bethesda	
County	Montgomery	
Type of property	ROW	
Ranking Rationale Site Summary		
<p>The LOD is located along the south side of Democracy Boulevard, between I-270 and Westlake Drive, in Bethesda, Maryland. The surrounding area is a mix of commercial and residential buildings. Residential and commercial development is observed to begin prior to 1959 and continued through 1998, when the surrounding area was observed to be developed in its current configuration. The LOD is located to the south across Democracy Boulevard from an indoor shopping center where there has been two OCP closed cases and several former USTs on site. Although the addresses of the sites list the stores as 200 feet from the LOD, they both measure approximately 900 feet from the LOD and therefore are of low concern. Two additional sites are listed as RCRA SQG and RCRA CESQG with no known compliance violations. Thus, impacts to the LOD are unlikely.</p>

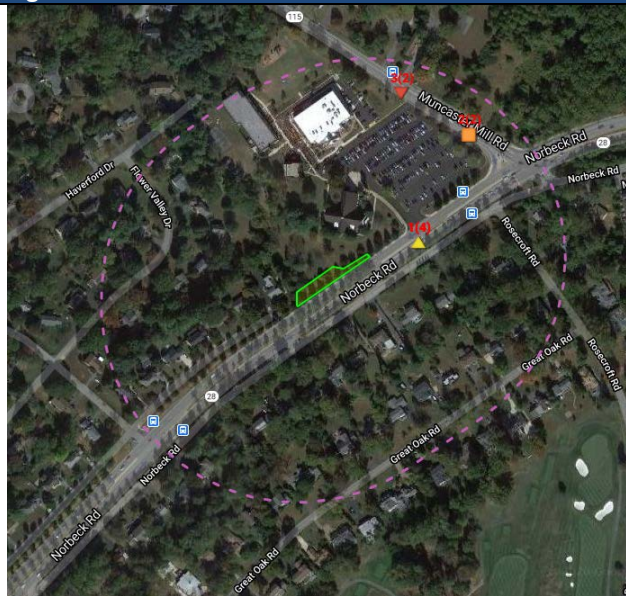
Quadrant:	NW	
Watershed:	WAS	
Street Address/Nearest Cross Streets	North side of Norbeck Road (MD 28), west of Muncaster Mill Road (MD 115)	
City	Rockville	
County	Montgomery	
Type of property	ROW	
<b>Ranking Rationale Site Summary</b>		
<p>The LOD is a located along the north side of Norbeck Road (MD 28), west of Muncaster Mill Road (MD 115), in Rockville, Maryland. The LOD has remained vacant land since the 1950s; however, it is possible that a driveway associated with a rural residential dwelling formerly transected a portion of the LOD based on an aerial photograph from 1971. The LOD appeared to be in its current configuration by 1988. The surrounding area is primarily residential with St. Patrick’s Catholic Church to the north. The surrounding residential development is observed to begin in the 1950s. Development of the church to the north is observed to begin in 1971. The area is observed to be in its current configuration by 2013. Three sites within a 0.125-mile radius of the LOD were identified with closed OCP cases and removed heating oil USTs; however, all of these are located greater than 400 feet from the LOD and are believed to be hydraulically downgradient/ crossgradient of the LOD. Thus, impacts to the LOD are unlikely.</p>

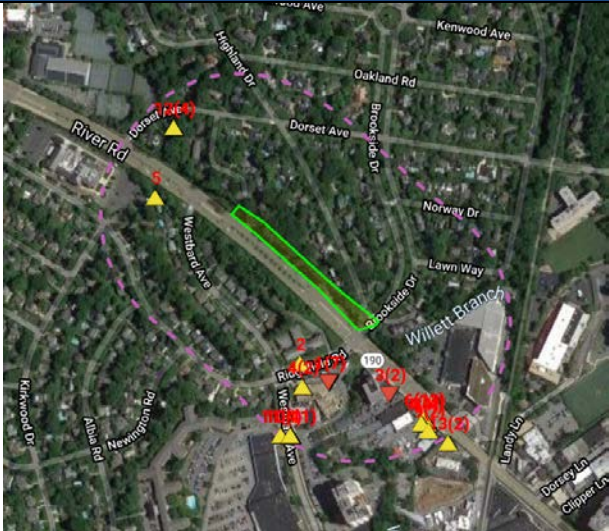
Quadrant:	NW	
Watershed:	WAS	
Street Address/Nearest Cross Streets	East side of River Road, north of Brookside Drive	
City	Chevy Chase	
County	Montgomery	
Type of property	ROW	
Ranking Rationale Site Summary		
<p>The LOD is located along the east side of River Road (MD 190), immediately north of Brookside Drive, in Chevy Chase, Maryland. The surrounding area is a mix of commercial and residential developments. Commercial and residential development began prior to 1960, and is observed in its current configuration by 1963. Numerous sites listed on one or more environmental database were identified in the surrounding area. The most significant is a large redevelopment project occurring to the south/southwest, which encompasses multiple properties listed on either the DRYCLEANERS, UST, OCP, SHWS, VCP, LRP and/or RCRA Generator databases. Multiple Phase I and Phase II investigations associated with this large redevelopment project included an area covering a retirement center, located approximately 260 feet west of the southern portion of the LOD, along with a professional building to the southwest that includes a dry cleaner, two gas stations, and a large shopping center further to the southwest. The project entered into the MDE VCP program in 2014. Environmental investigations have detected petroleum and chlorinated constituents in soil and groundwater samples above MDE cleanup standards. The impacted areas are located to the south/southwest of the LOD, which is hydraulically crossgradient based on groundwater flow direction. Further, the investigations have determined the soil and groundwater in the vicinity of the Westwood Retirement Center, located directly west of the LOD, have not been impacted. Based on this, impacts to the LOD from these facility appears unlikely. The remaining facilities, which included four dry cleaners, two gas stations, and illicit spills/releases, are located between 260 feet and 615 feet from the LOD, and are believed to either be hydraulically downgradient of the LOD, or upgradient, but hydraulically disconnected from the LOD by a stream. Thus, impacts to the LOD from these remaining facilities is unlikely.</p>

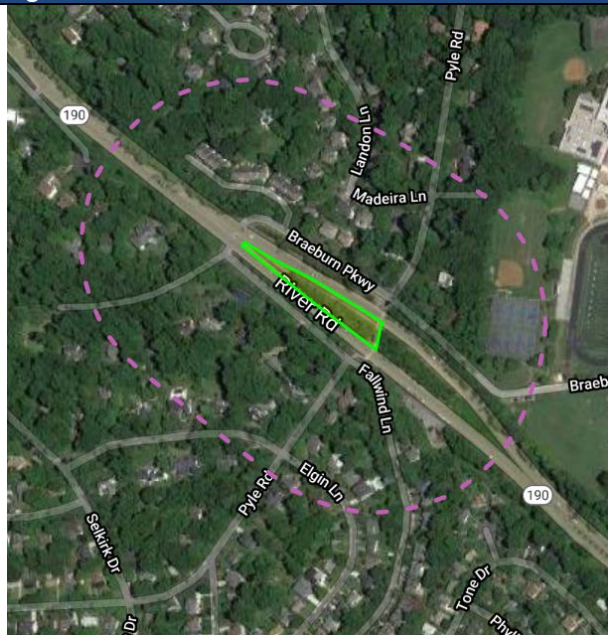
Quadrant:	NW	
Watershed:	WAS	
Street Address/Nearest Cross Streets	Median between River Road (MD 190), south of Braeburn Parkway	
City	Bethesda	
County	Montgomery	
Type of property	ROW	
<b>Ranking Rationale Site Summary</b>		
The LOD is located along the central of River Road (MD 190), south of Braeburn Parkway, in Bethesda, Maryland. The surrounding area is primarily residential. Residential development is observed to begin prior to 1960 and continued through 1981, when the surrounding area is observed to be developed in its current configuration. No records of concern in the vicinity of the LOD were identified during the environmental review.

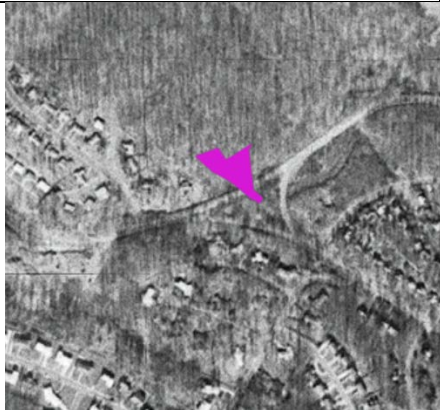
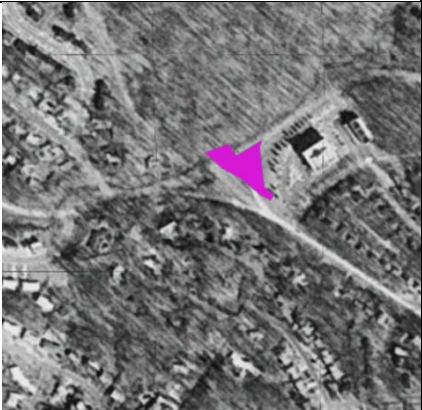
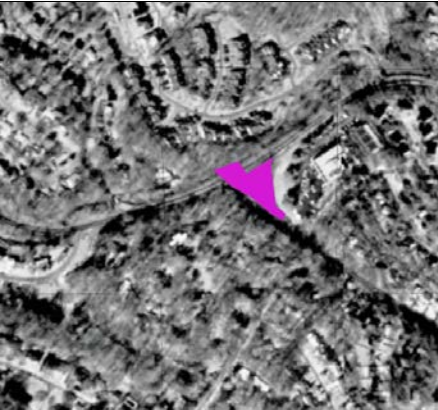
HISTORICAL IMAGES OF IMPORTANCE		
Year: 1960	Year: 1971	Year: 1994

HISTORICAL IMAGES SUMMARY		
Date Range	Property Use	Source
1960	Forested land is observed to the north, while residential development is observed to the south of the LOD.	Aerial
1971	A large commercial structure is present east of the LOD.	Aerial
1994	Additional residential development is observed to the north of the LOD. The surrounding area is observed to be in developed in its current configuration.	Aerial

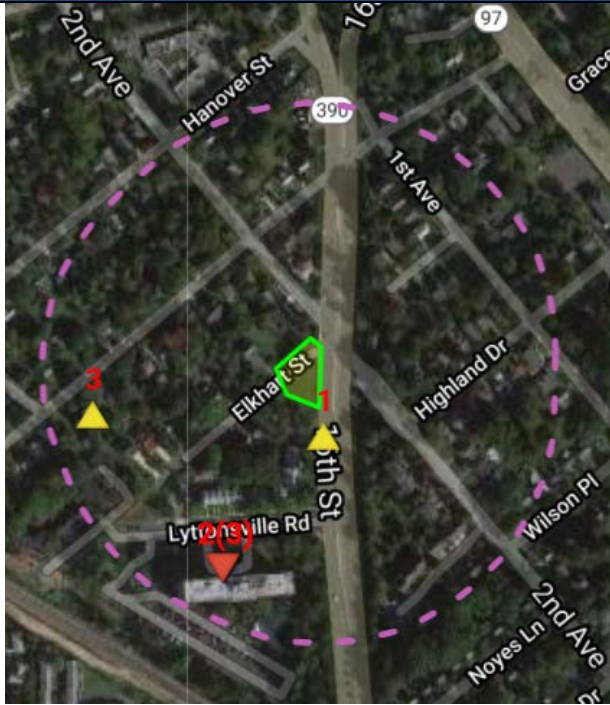
<b>Quadrant:</b>	NW	
<b>Watershed:</b>	WAS	
<b>Street Address/Nearest Cross Streets</b>	Intersection of Elkhart Street and 16 <sup>th</sup> Street (MD 390)	
<b>City</b>	Silver Spring	
<b>County</b>	Montgomery	
<b>Type of property</b>	ROW	
<b>Ranking Rationale Site Summary</b>		
<p>The LOD is located on the west side of the intersection of 16<sup>th</sup> Street, and Elkhart Street (MD 390), in Silver Spring, MD. Elkhart Street traverses the northwestern portion of the LOD. The remainder of the LOD consists mostly of grass and is surrounded by residential development. The surrounding area has been developed since at least the 1930s. Additional commercial development was observed to the south in the 1960s. By the 1980s, the surrounding area was observed to be developed similar to its current configuration. There were three sites identified within the environmental database search. Based on a review of available information the sites are not believed to have impacted the LOD based on their proximity to the LOD and/ or type of environmental database listing associated with them.</p>

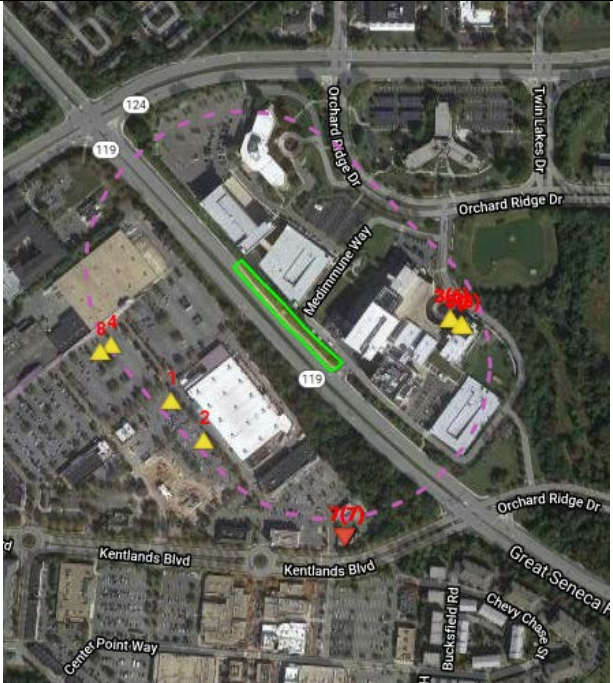
<b>LOD ID: WAS-4067</b>	<b>Site Rank: Low</b>	<b>Figure Location:</b>

<b>Quadrant:</b>	NW	
<b>Watershed:</b>	WAS	
<b>Street Address/Nearest Cross Streets</b>	Great Seneca Highway (MD 199), south of Quince Orchard Road (MD 124)	
<b>City</b>	Gaithersburg	
<b>County</b>	Montgomery	
<b>Type of property</b>	ROW	
<b>Ranking Rationale Site Summary</b>		
<p>The LOD is located along the east side of Great Seneca Highway (MD 199), south of Quince Orchard Road (MD 124), in Gaithersburg, Maryland. The LOD is surrounded by commercial development. Based on review of historical aerial and topographic maps the Great Seneca Highway and commercial development was observed in the 1993 aerial photograph with the LOD and surrounding area similar to their current configuration by 2005. Four environmental database listings were identified in the immediate area of the LOD. The Lowe's is crossgradient 555 feet to the west, a RCRA LQG is located abutting the LOD to the west, and a gas station is located approximately 660 feet downgradient. A biotechnology facility is located approximately 70 feet northeast of the LOD that currently has fourteen ASTs ranging in size between 50 to 20,000-gallons that hold #2 heating oil, used oil, and lubricating oil. Based on available information provided by MDE through a PIA request, there have been no substantial releases reported with the ASTs onsite. Thus, impacts to the LOD are unlikely.</p>

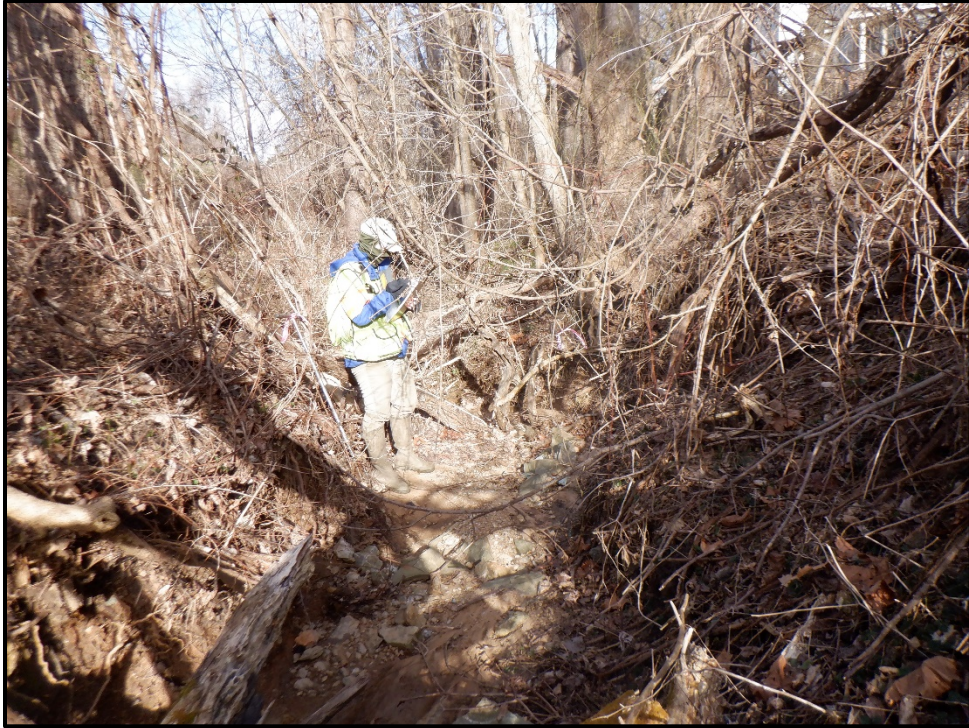
### Sub-Segment 31

Waterway 31000 – Intermittent

FEATURE ID	CLASSIFICATION	ASSOCIATED SWM LOD	DOMINANT VEGETATION (WETLANDS)	CHANNEL - APPROXIMATE WIDTHS/DEPTHS	COVER TYPE ON LEFT AND RIGHT BANKS (WATERWAYS)
SUB-SEGMENT 31					
31000	Intermittent	WAS-4641	-	Silt, cobble, gravel Width: 3 ft Depth: 0.5-1 in	Right: forest/maintained lawn Left: forest/emergent vegetation
SUB-SEGMENT 32					
32L	Perennial	WAS-3622	-	Sand, cobble, gravel, bedrock Width: 15 ft Depth: 2 ft	Right: forest Left: rock/riprap
32M	Perennial	WAS-3622	-	Silt, muck Width: 3 ft Depth: 4 in	Right: Herbaceous vegetation Left: scrub-shrub

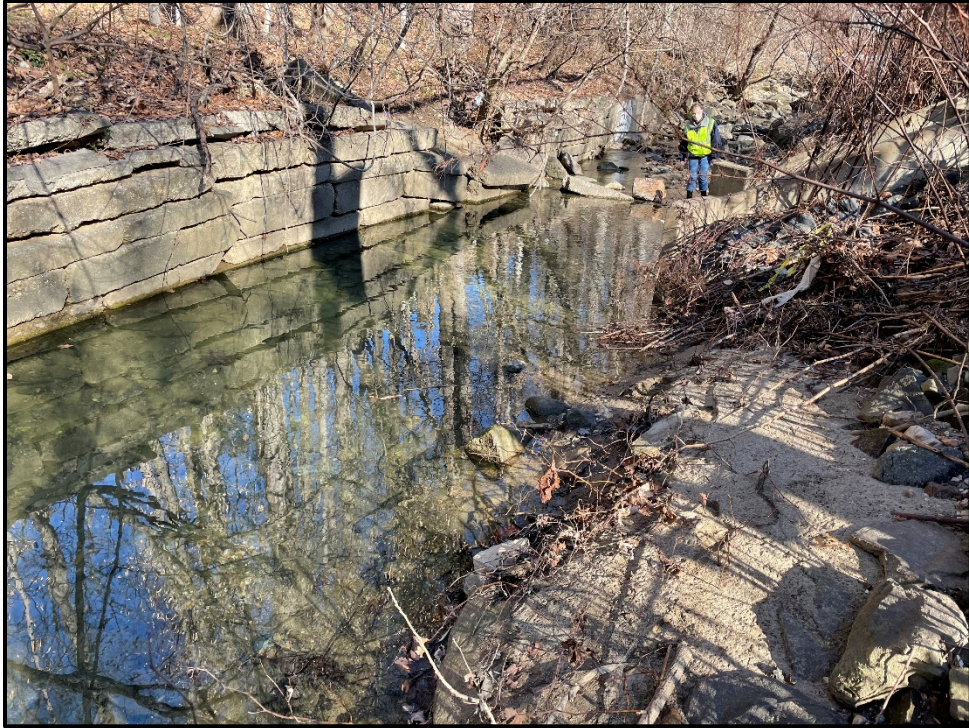
## Sub-Segment 32

Waterway 32L – Perennial

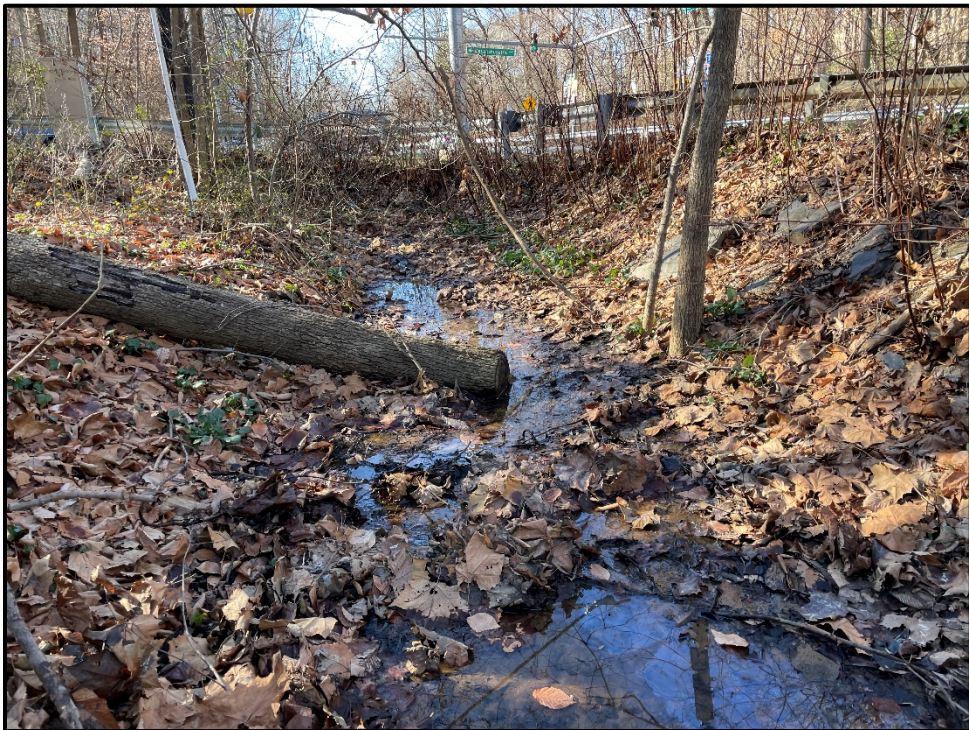
Waterway 32M – Perennial

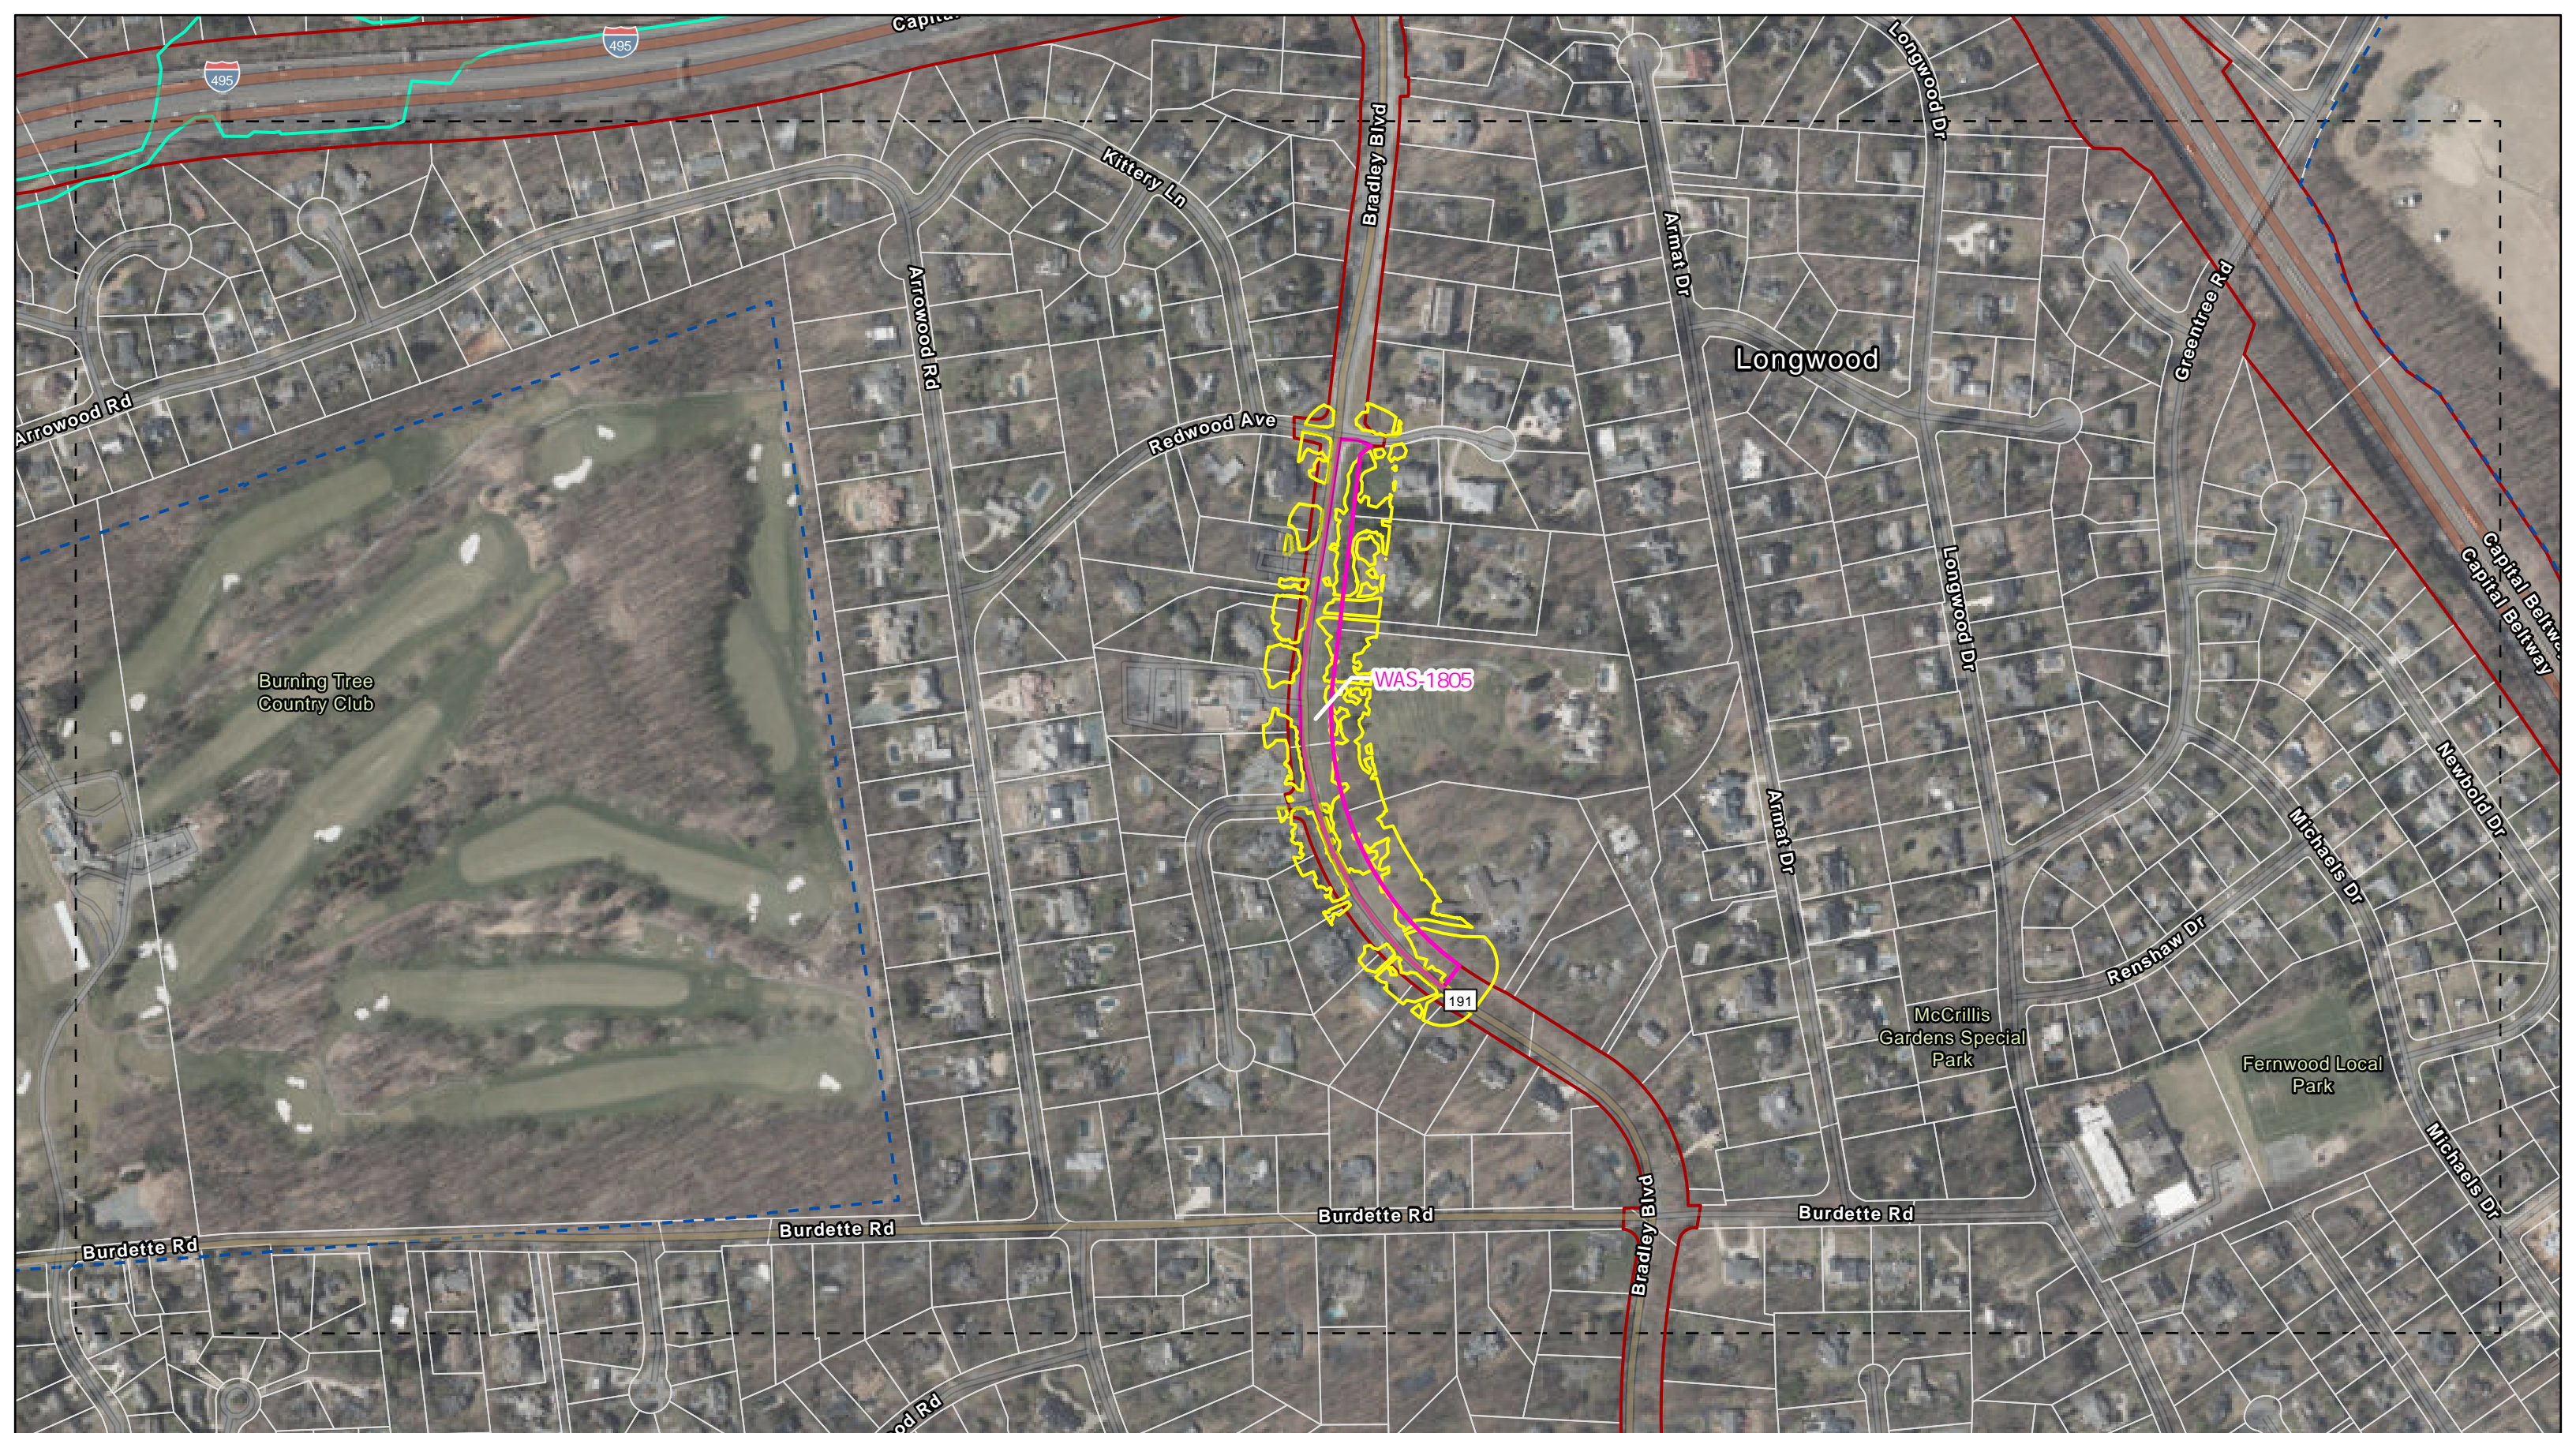
Environmental Impact Mapping

Compensatory Stormwater Mitigation
