I-495 & I-270 Managed Lanes Study

FINAL CULTURAL RESOURCES TECHNICAL REPORT

**Volume 4: Phase I Archaeological Investigation
For the I-495 & I-270 Managed Lanes Study,
Montgomery and Prince George's County, Maryland
and Fairfax County, Virginia**

**Maryland Department of Transportation State Highway Administration
Archaeological Report Number 543**

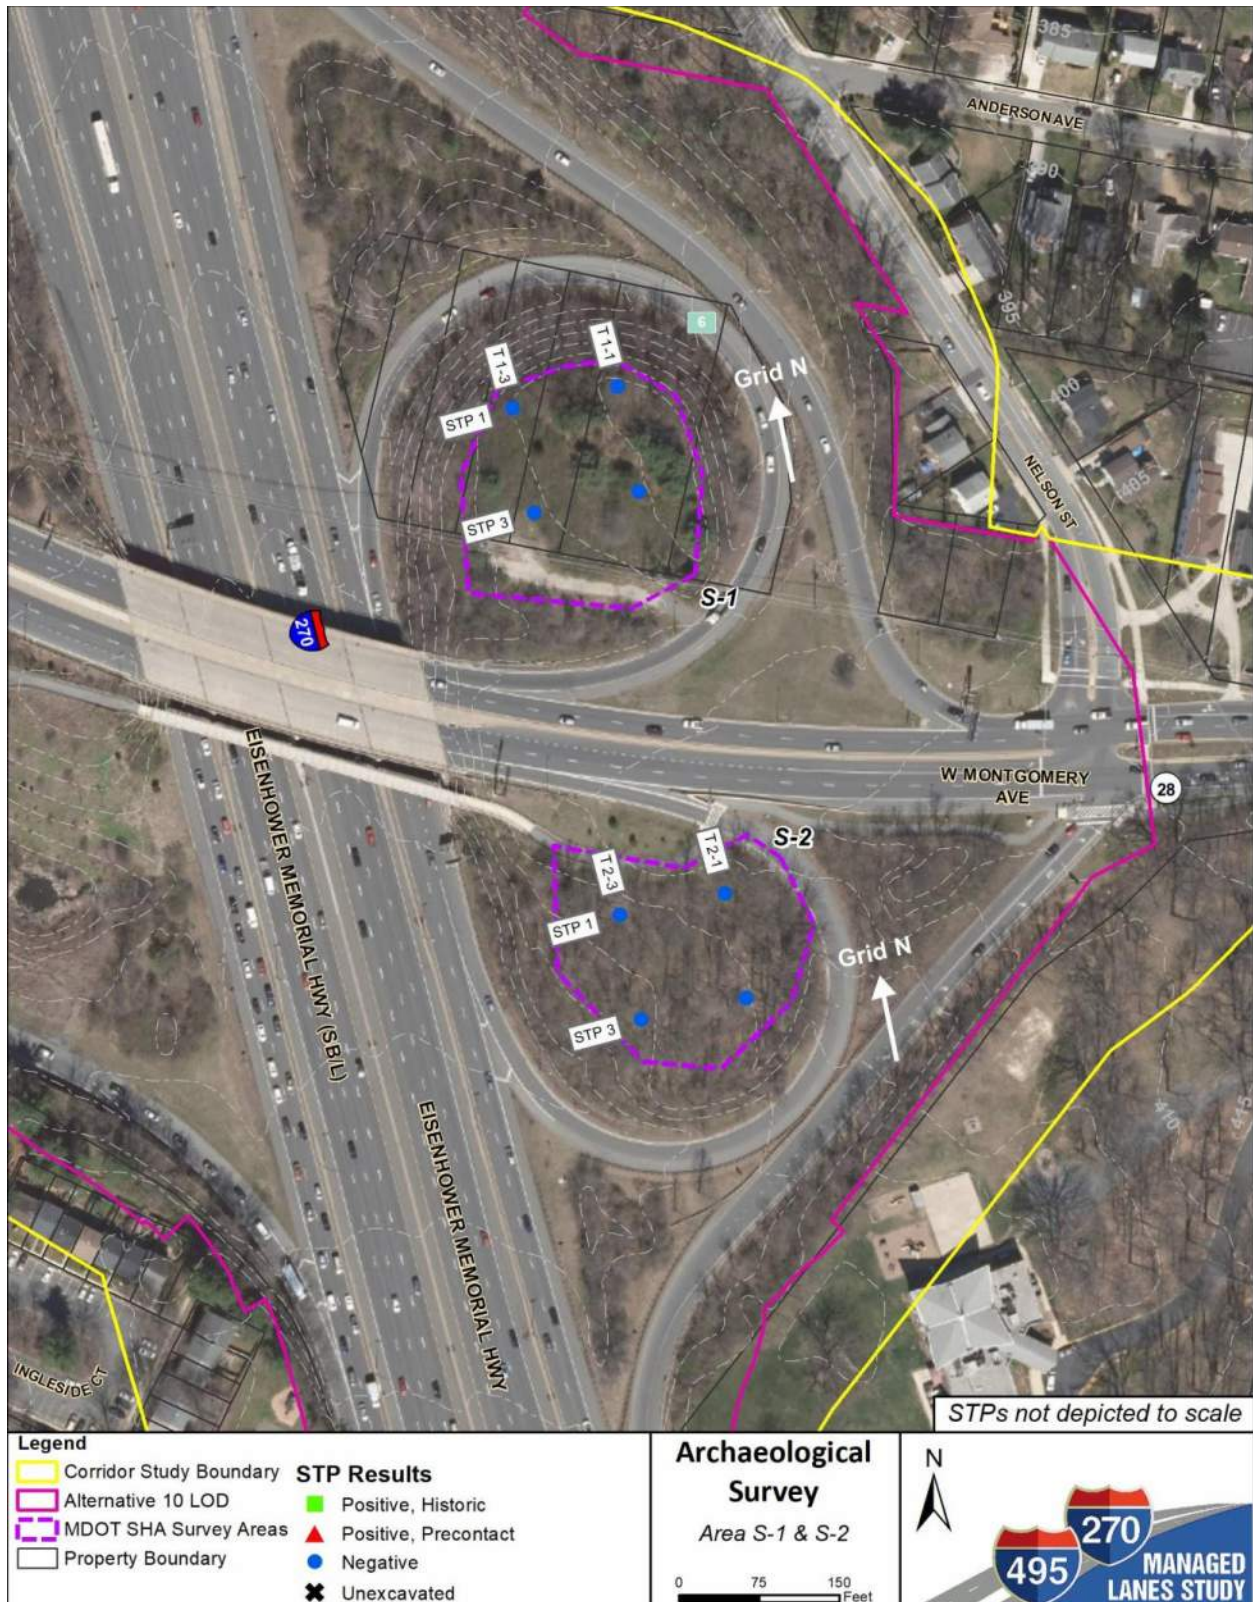
Figure 4. Results of the Phase I Survey in Area S-1 and Area S-2

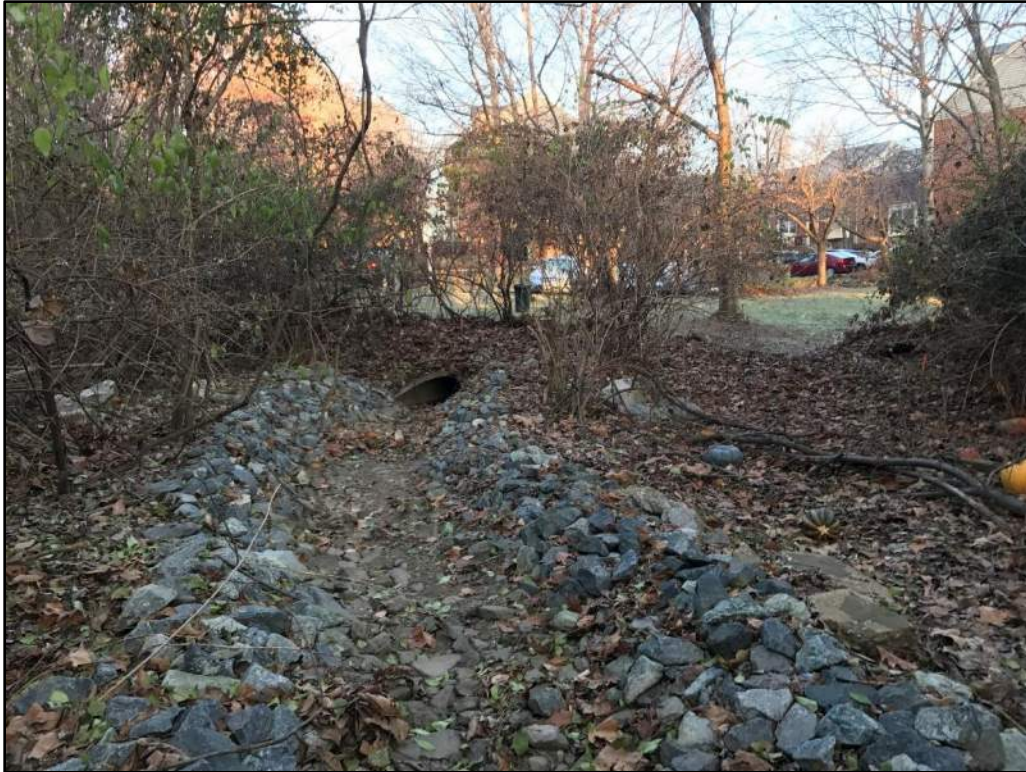
Figure 24. Improved rip-rap drainage feature in Area S-10, facing northeast

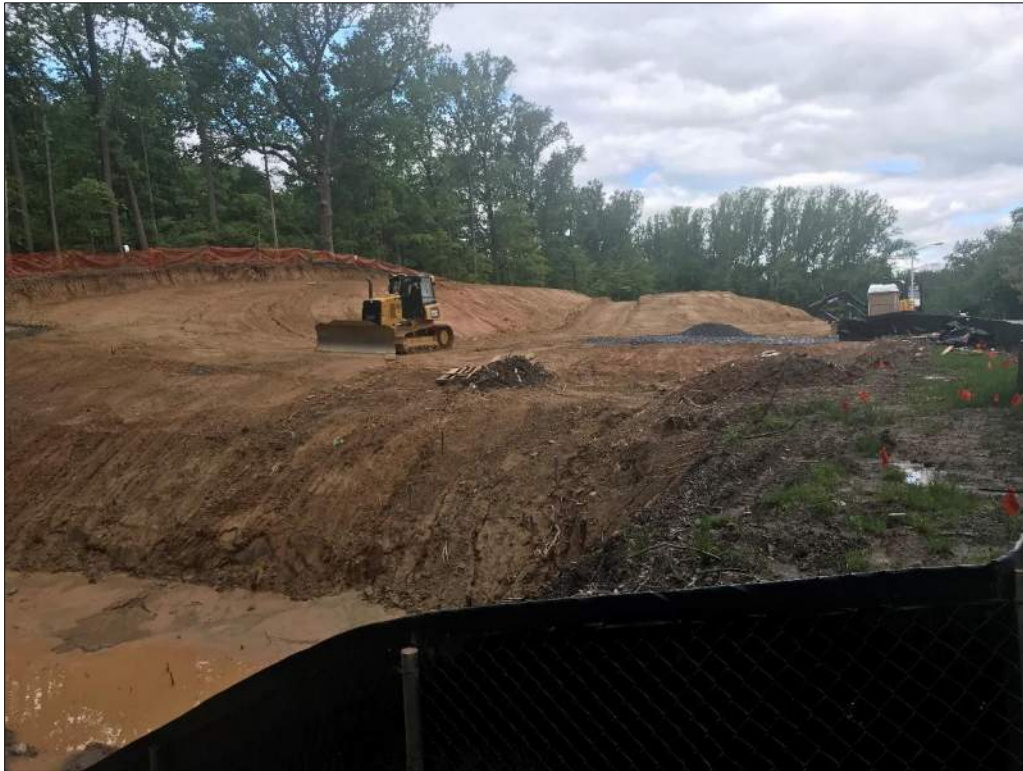
Figure 25. Cut portion of Area S-10 in May 2019, facing northwest

Area S-10 begins roughly where Grosvenor Lane crosses I-270 and continues 4,240 ft (1,292 m) along I-270, ranging in width from 95 ft (30 m) to 180 ft (55 m). Area S-10 occupies 56 privately-owned parcels of which access was secured for 50 parcels, comprising 4.37 acres. The area was largely wooded with moderate undergrowth, however during the survey a tree removal crew began work in the central flat area, preventing the archaeological crew from continuing testing in this area. The tree removal crew was part of a larger effort to prepare this area for residential development, and it became clear these efforts would significantly impact the integrity of soils in this area. Pedestrian reconnaissance showed that the equipment used to remove the area's trees had already disturbed up to 0.5 ft of the area's topsoil. A subsequent visit to the site showed that the landform had been cut and graded (**Figure 25**).

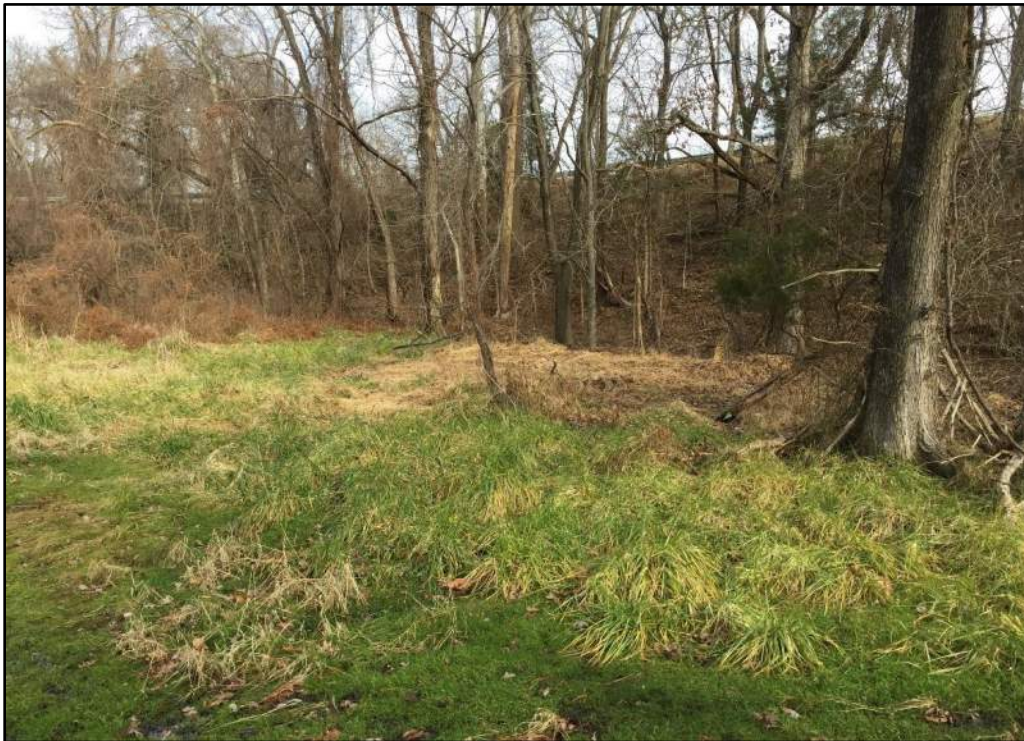
Figure 27. Base of berm carrying I-495 to the American Legion Bridge in the eastern portion of Area S-12, facing northeast

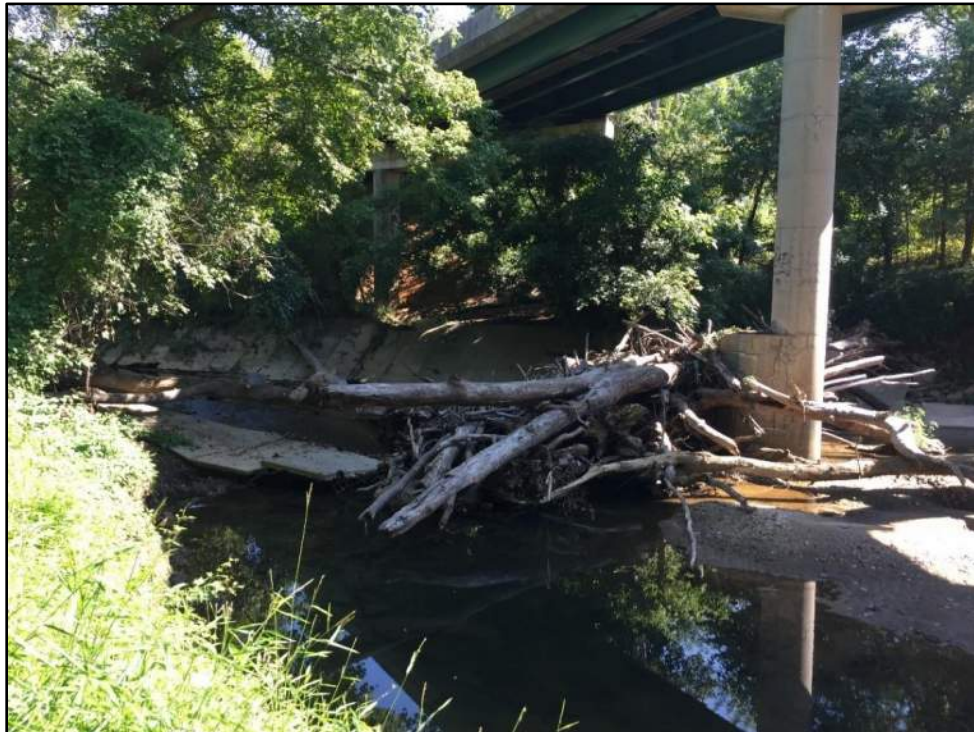
Figure 56. Concrete armoring on the Cabin John stream bank, with I-495 bridge visible in top right, facing northeast

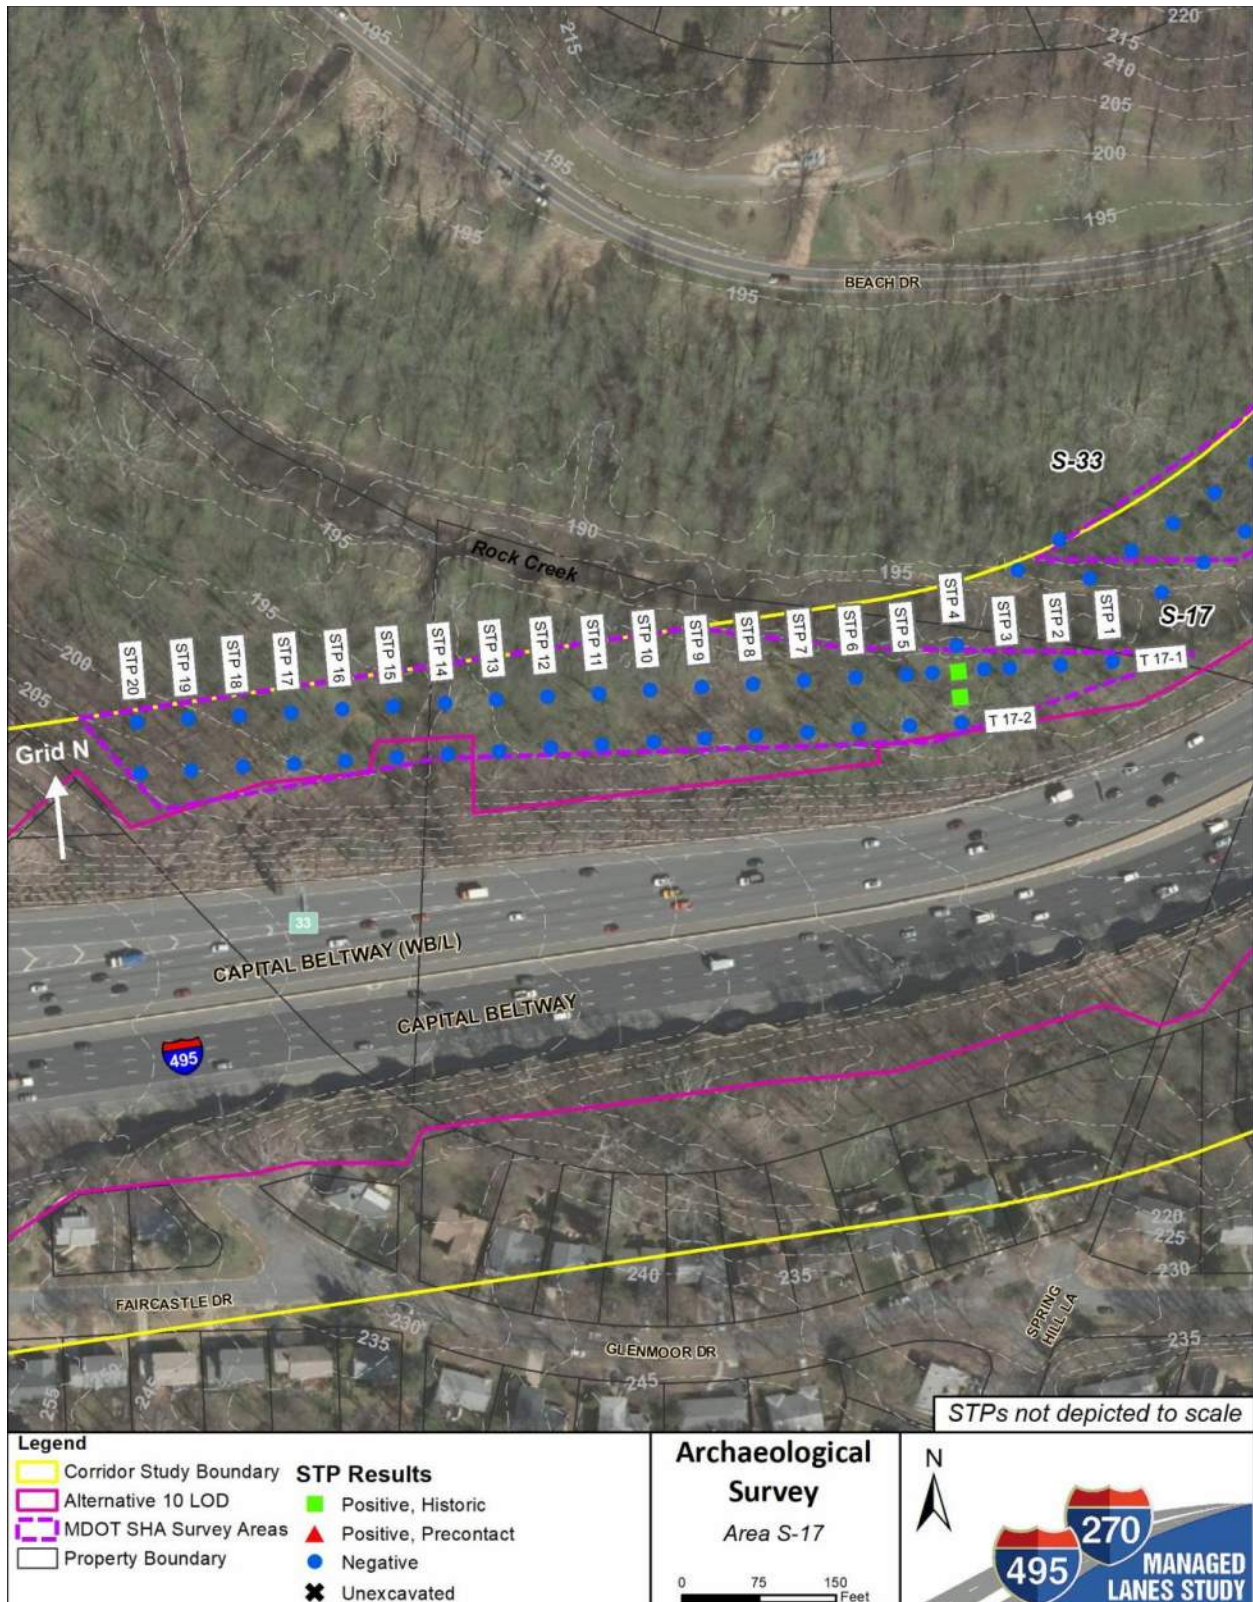
Figure 74. Results of the Phase I survey in Area S-17

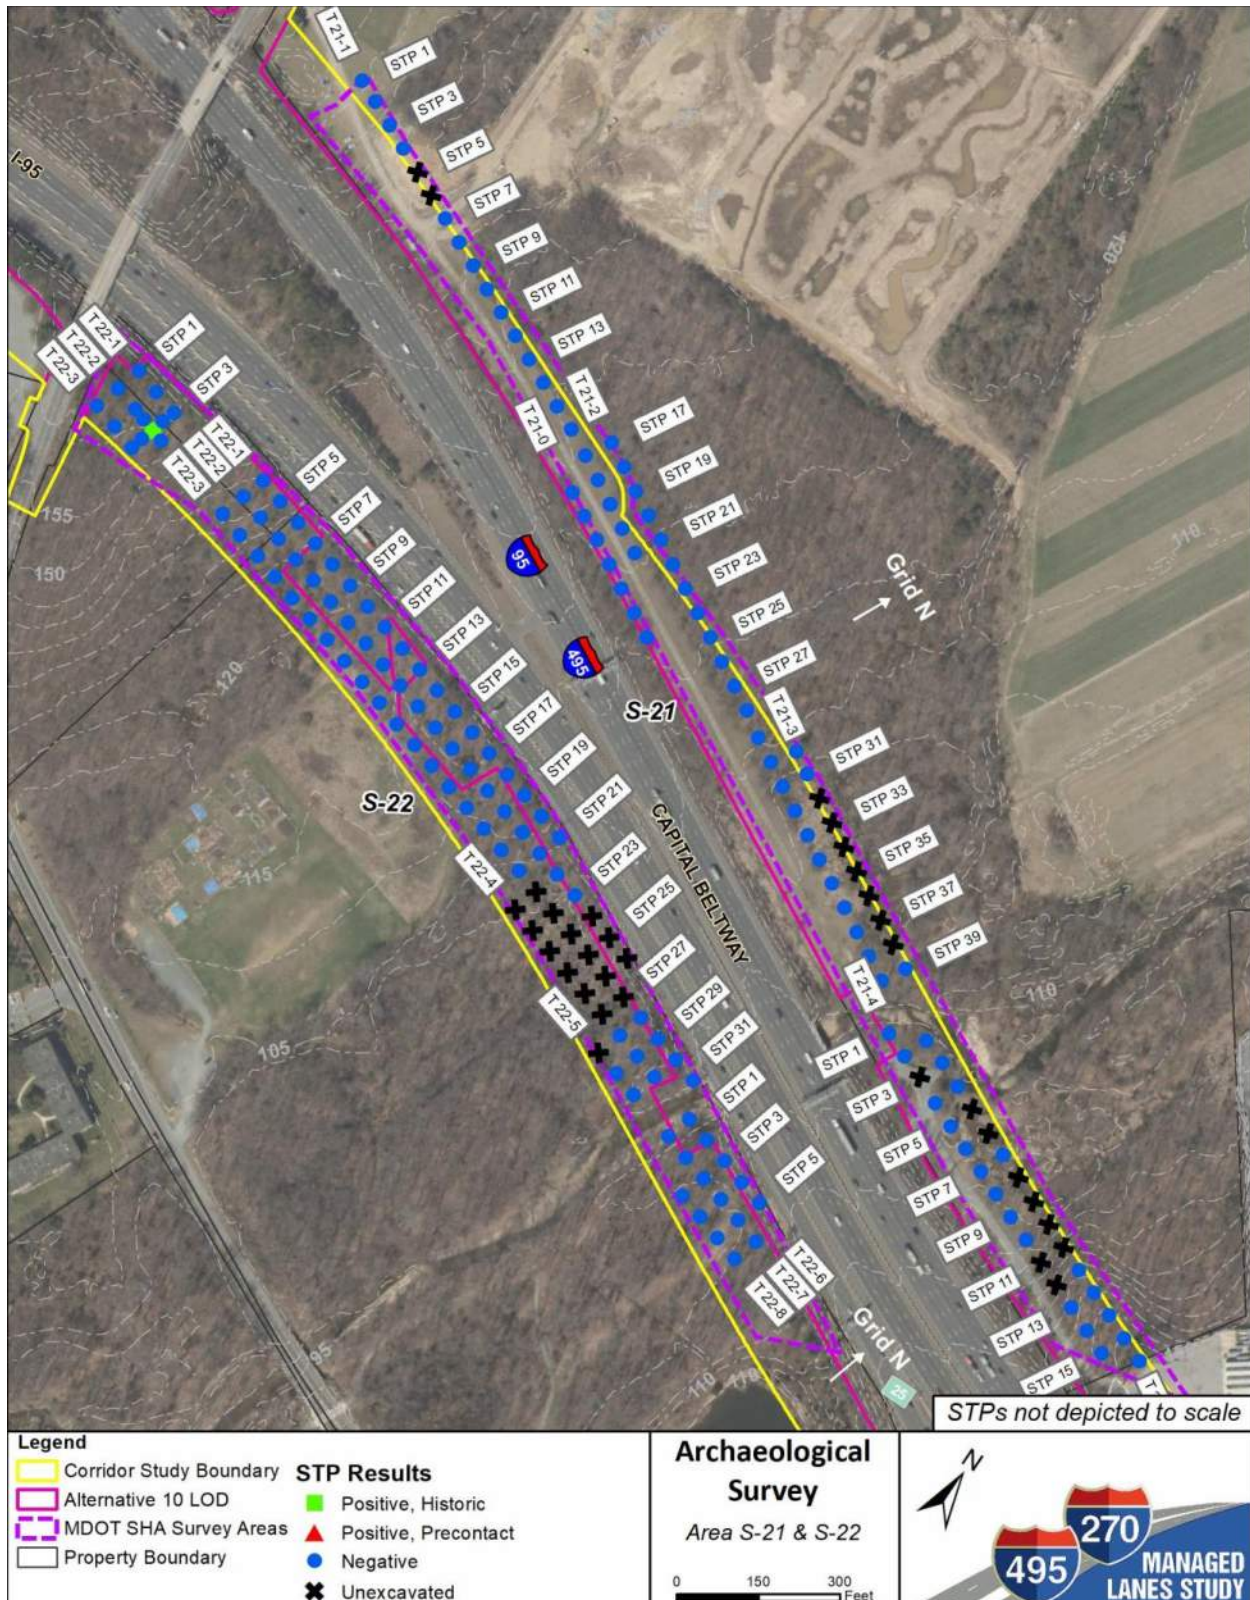
Figure 81. Results of the Phase I survey in Area S-21 and S-22

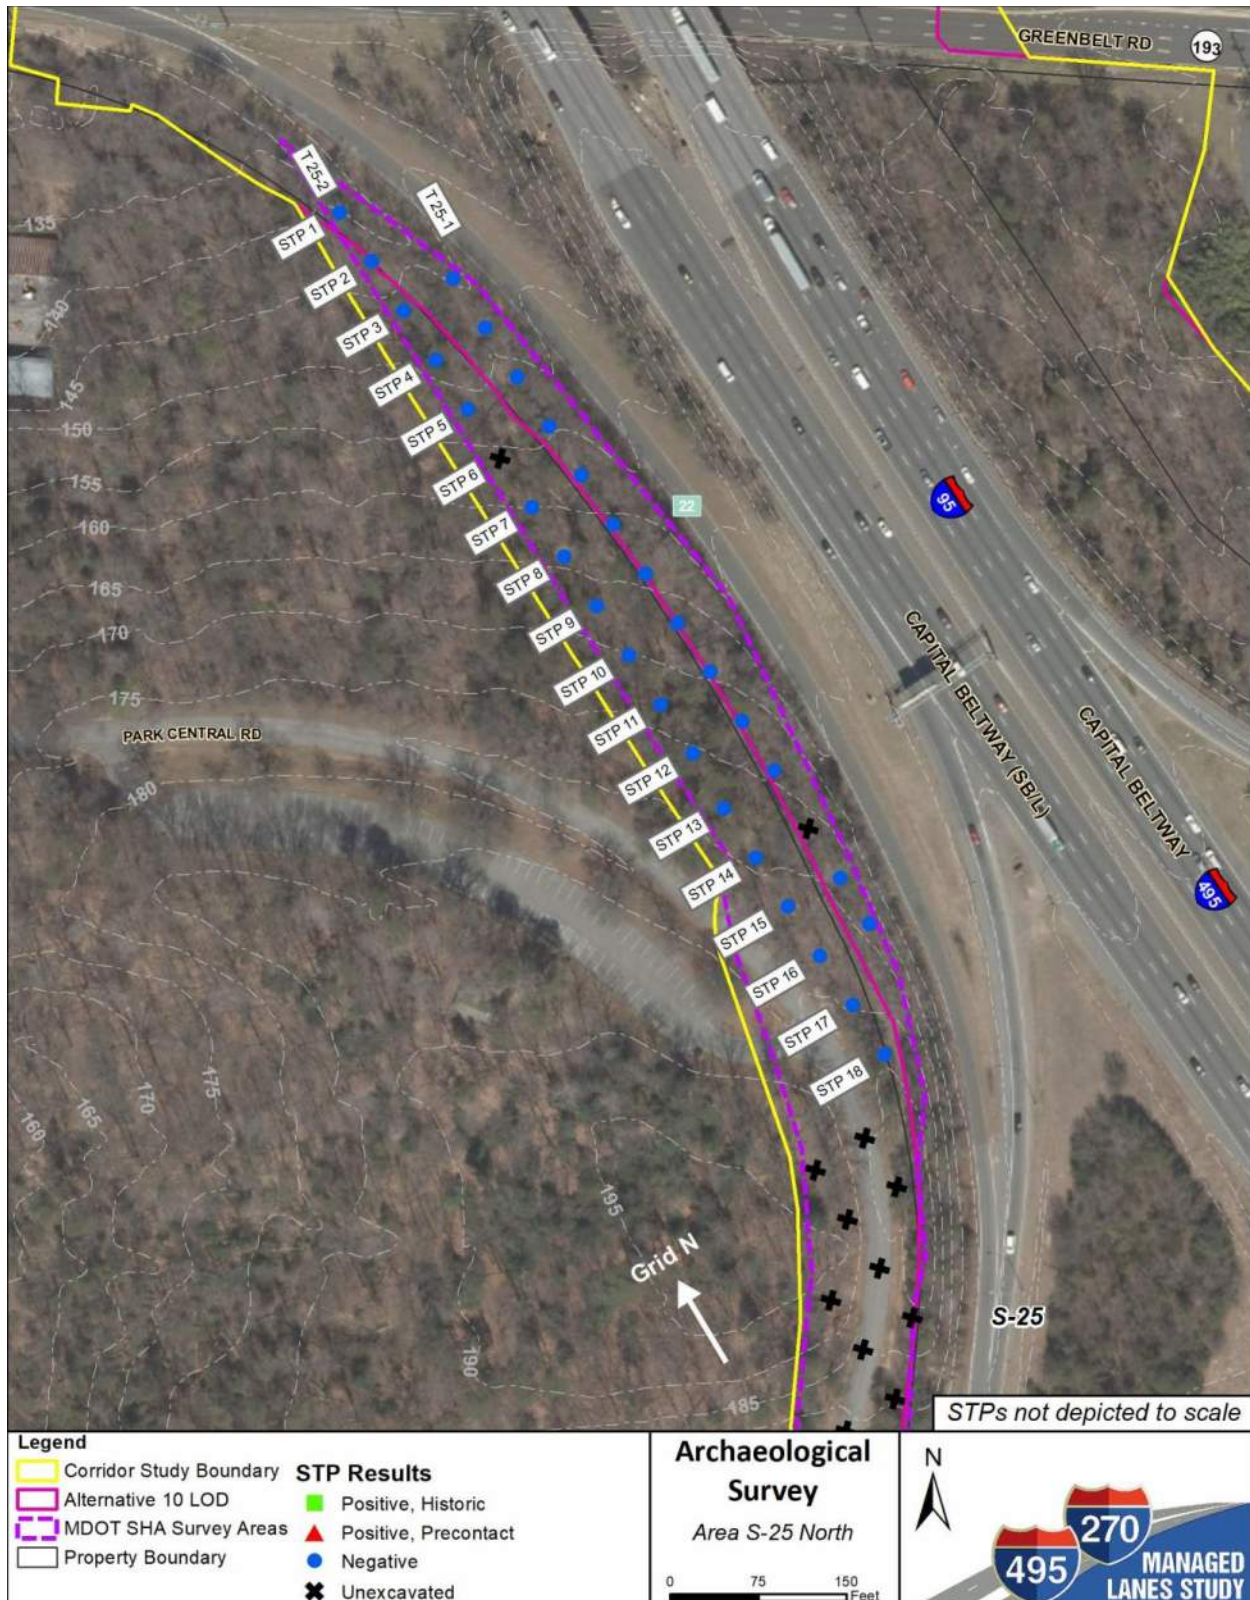
Figure 82. Results of the Phase I survey in Area S-25 North

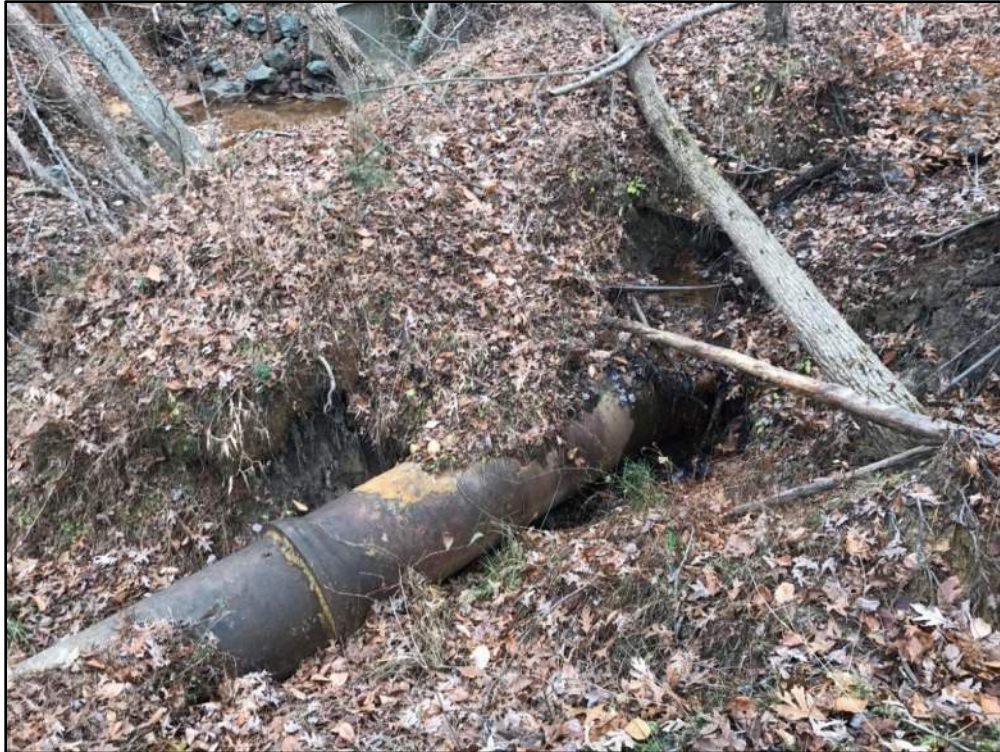
Figure 85. Cast iron pipe running through trench in Area S-26, facing southwest

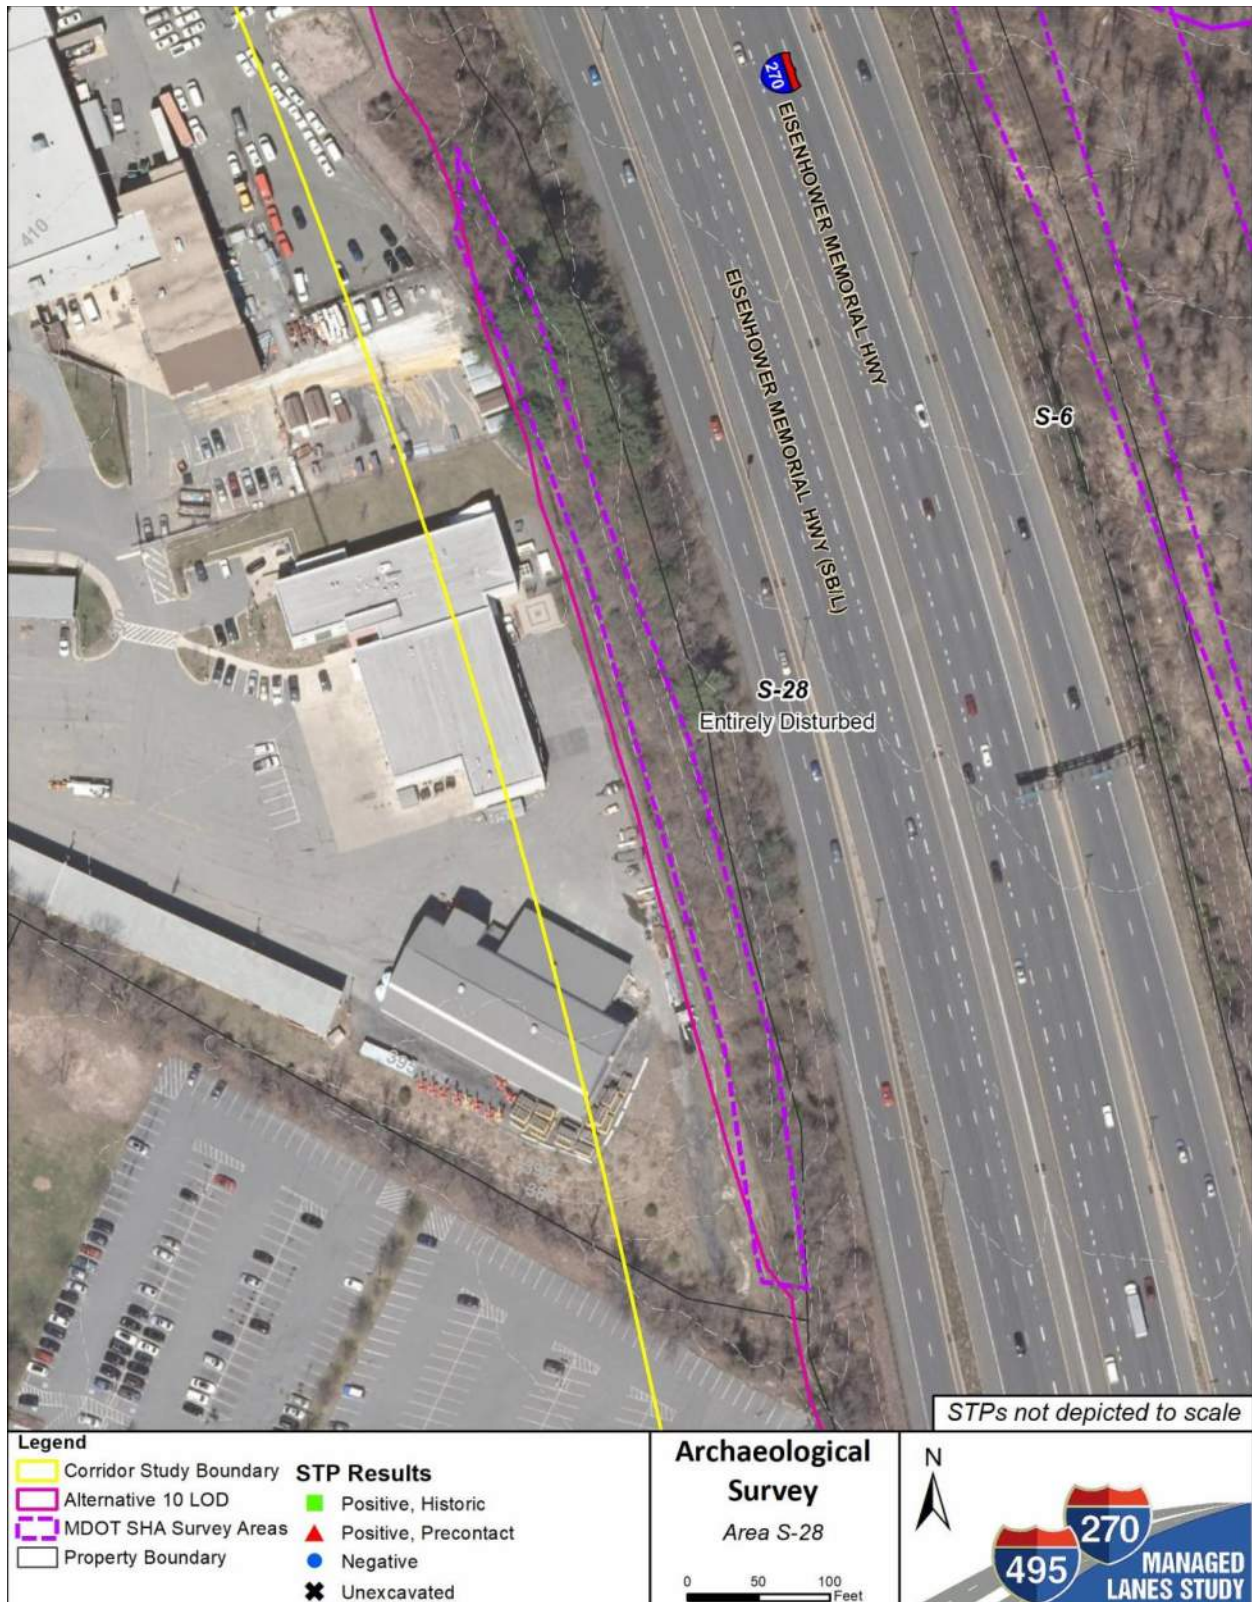
Figure 90. Results of the Phase I survey in Area S-28

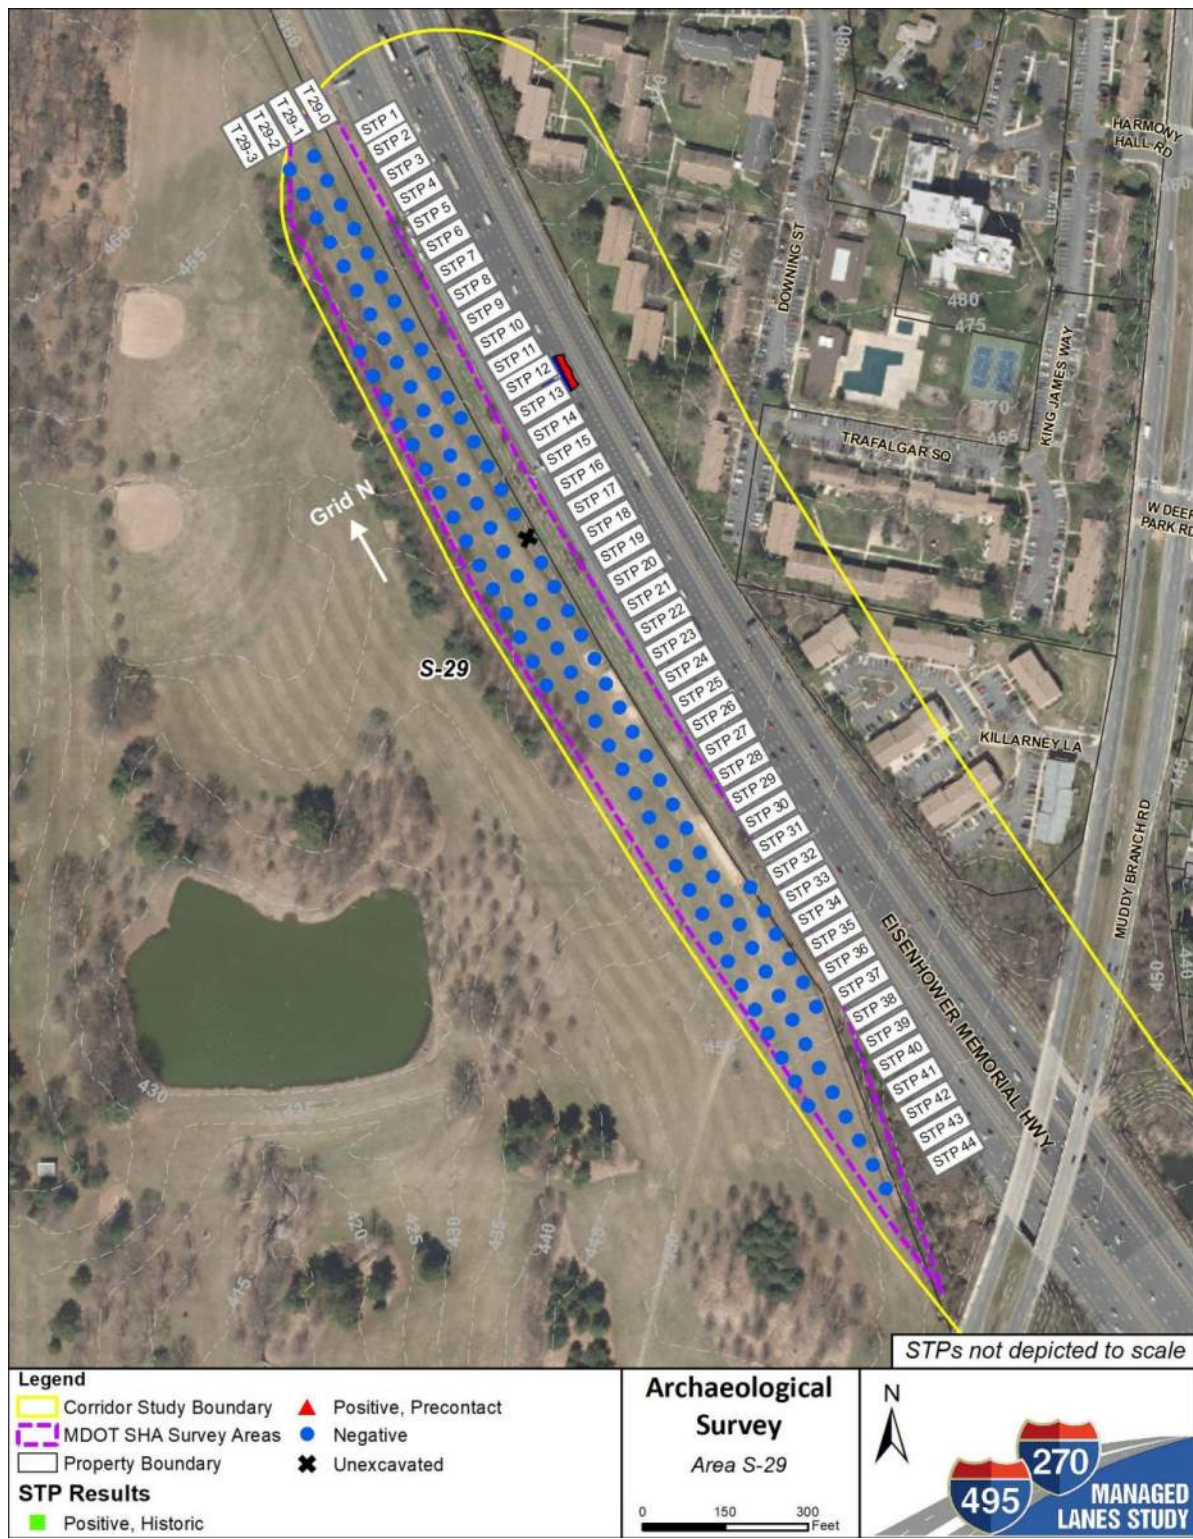
Figure 93. Results of the Phase I survey in Area S-29

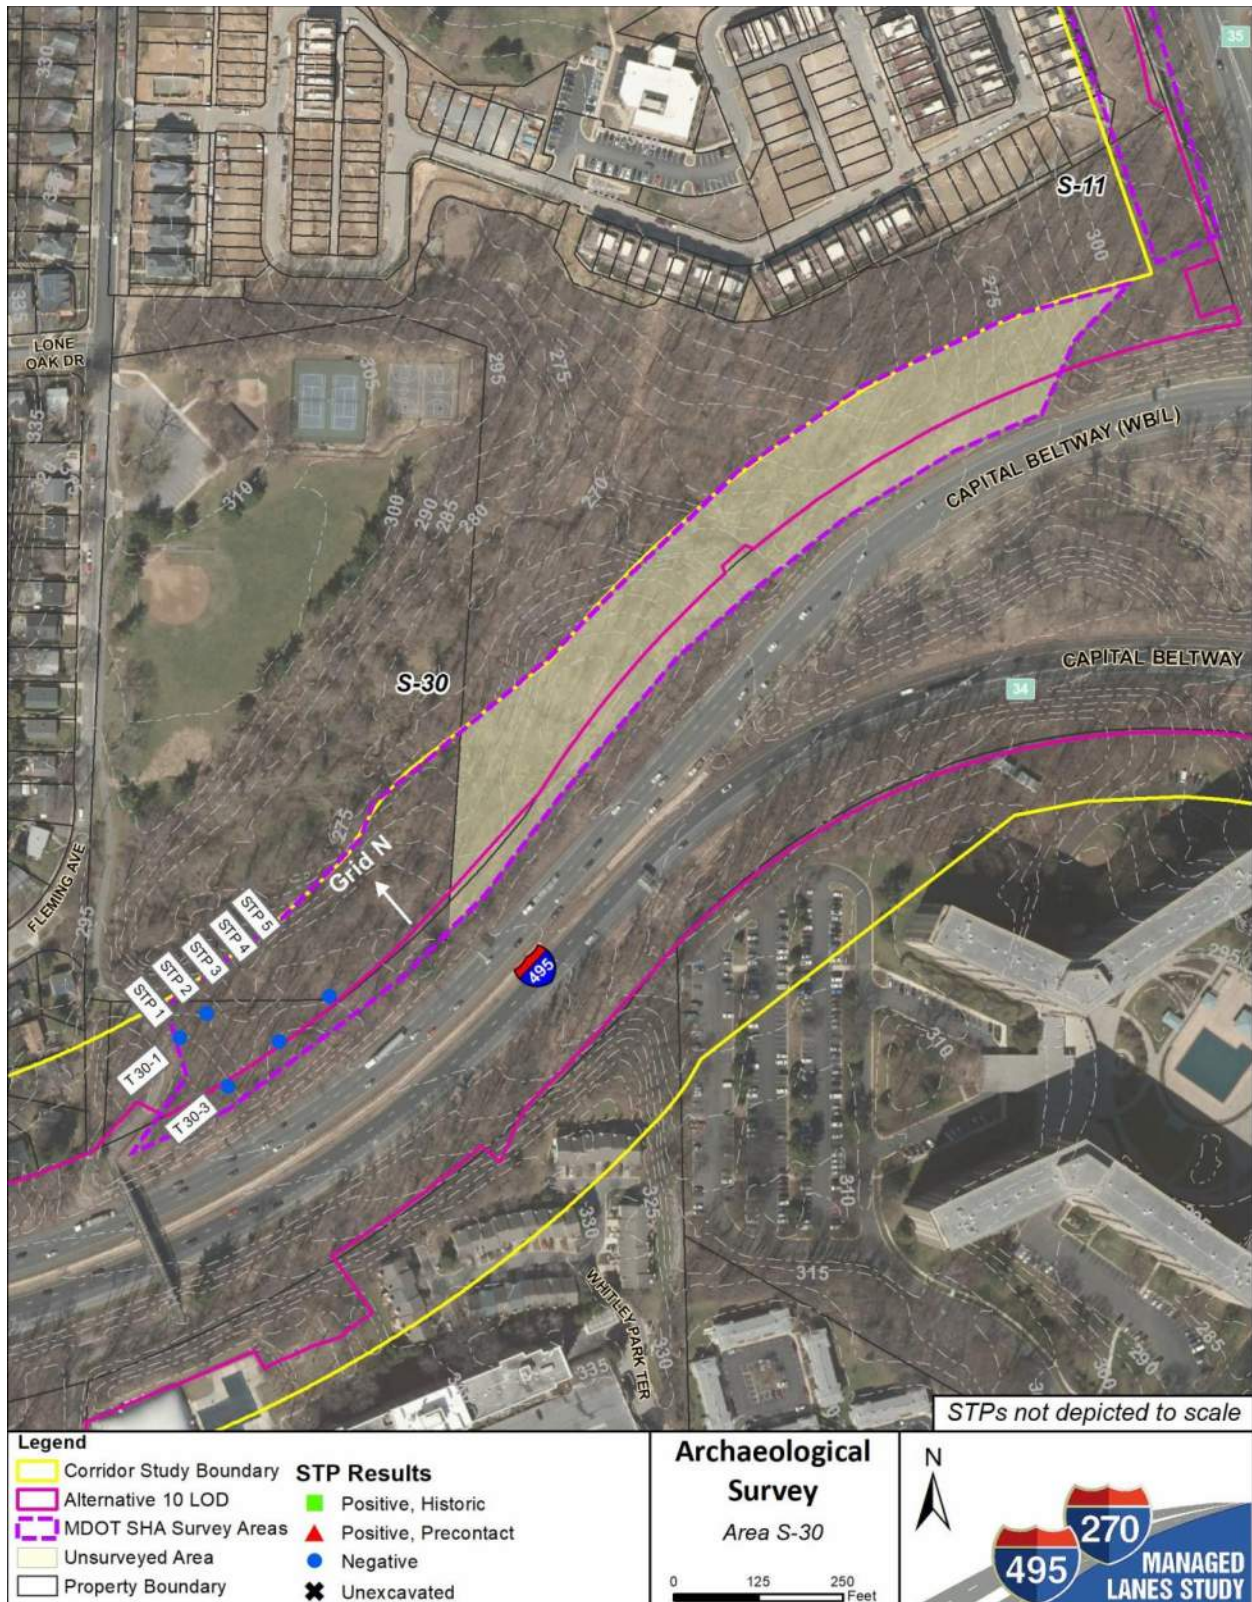
Figure 94. Results of the Phase I survey in Area S-30

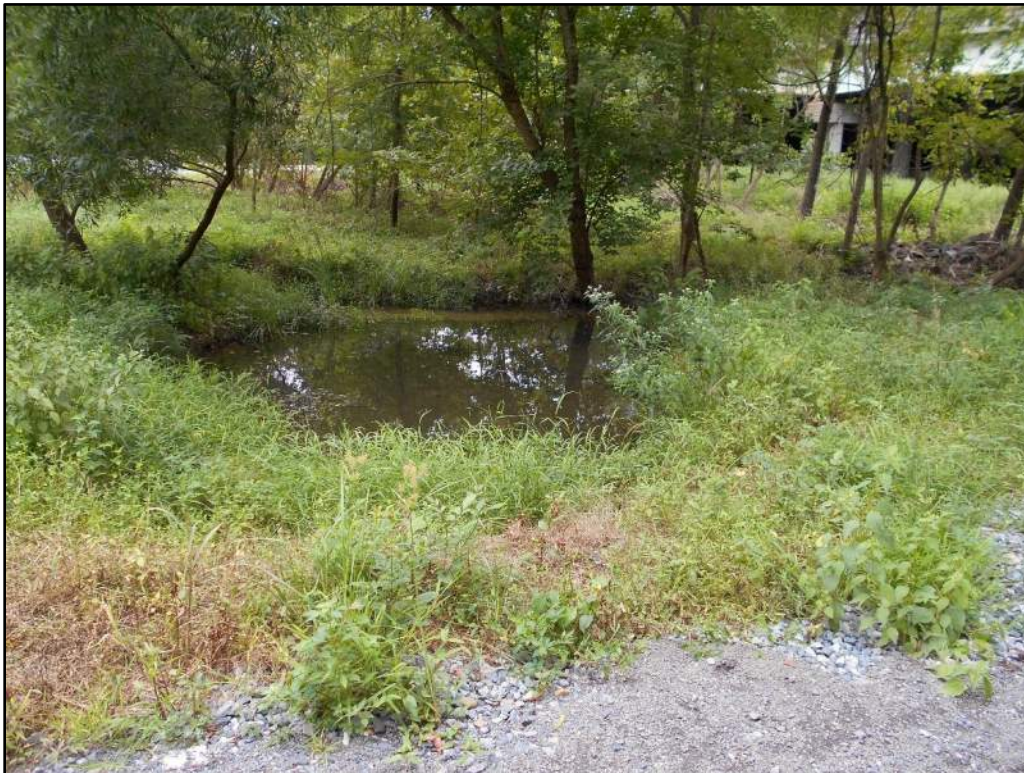
Figure 97. Water retention pond in northeastern portion of Area S-35, showing gravel drive in foreground, facing northeast

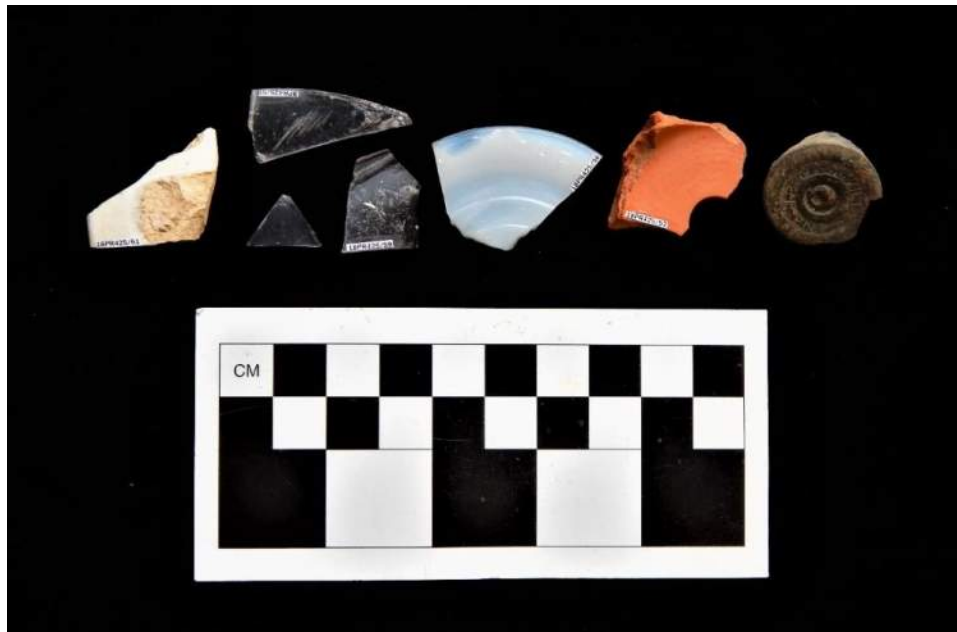
Figure 107. Artifacts from 18PR425, including nineteenth-century ironstone, amethyst bottle glass, a milk glass canning lid fragment, part of a terra cotta flower pot, and a shotgun shell

Left to right: 19th century ironstone plain, amethyst bottle glass fragment (top), amethyst bottle glass fragment (bottom), amethyst bottle glass fragment (bottom), milk glass canning lid liner, terra cotta garden ceramic, and shotgun shell.

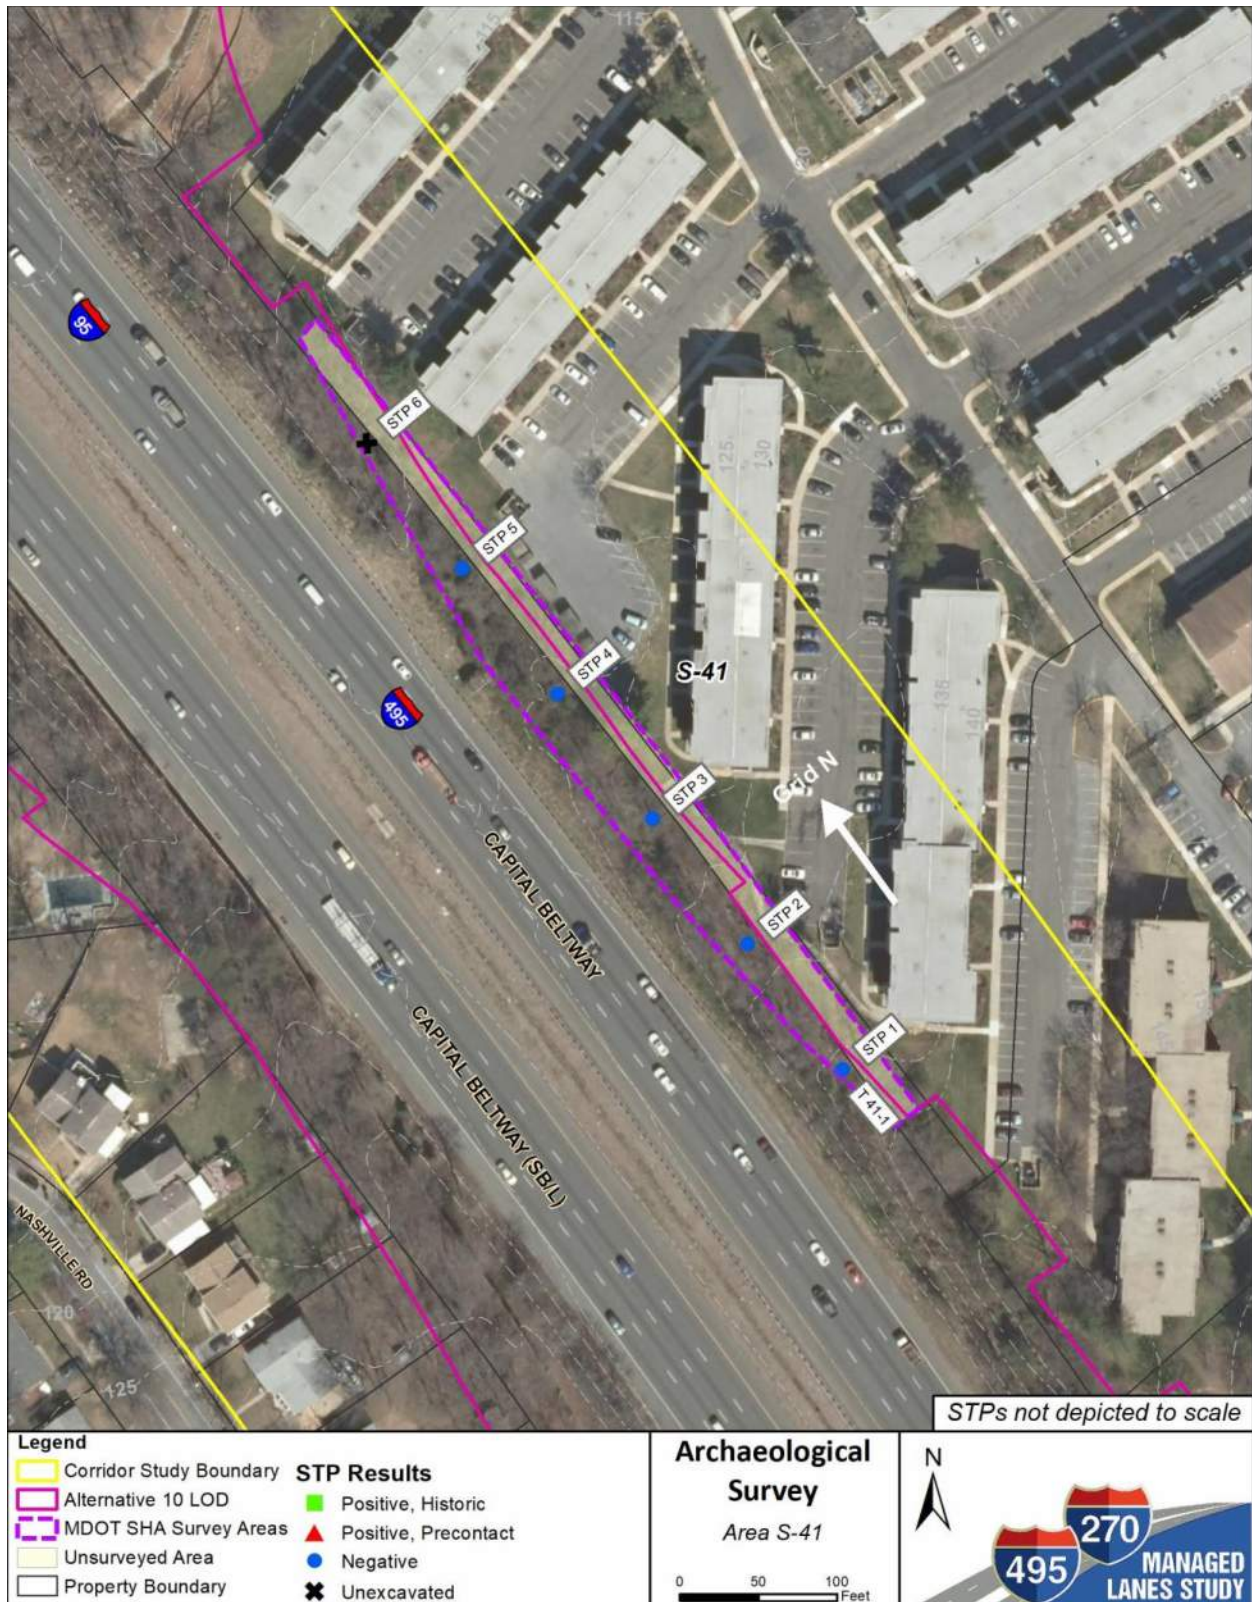
Figure 108. Results of the Phase I survey in Area S-41
