I-495 & I-270 Managed Lanes Study

FINAL CULTURAL RESOURCES TECHNICAL REPORT

**Volume 4: Phase I Archaeological Investigation
For the I-495 & I-270 Managed Lanes Study,
Montgomery and Prince George's County, Maryland
and Fairfax County, Virginia**

**Maryland Department of Transportation State Highway Administration
Archaeological Report Number 543**

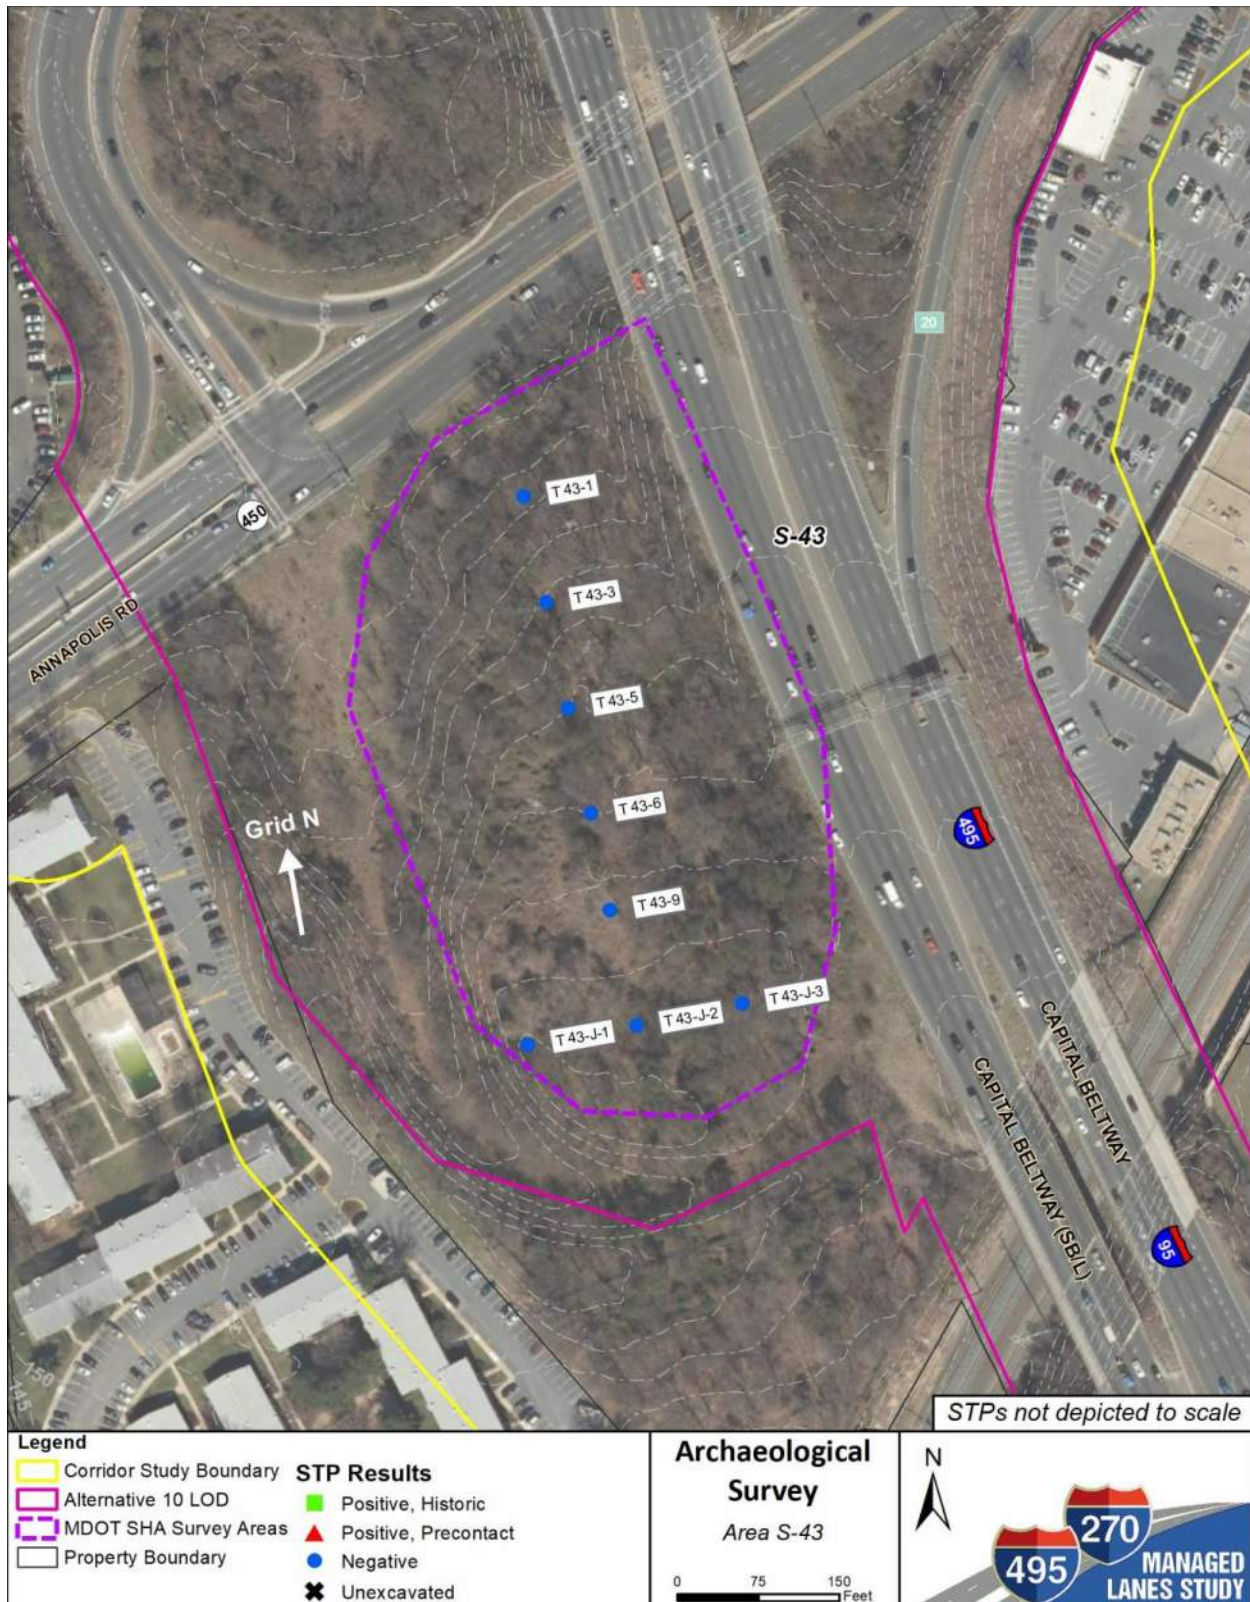
Figure 109. Results of the Phase I survey in Area S-43

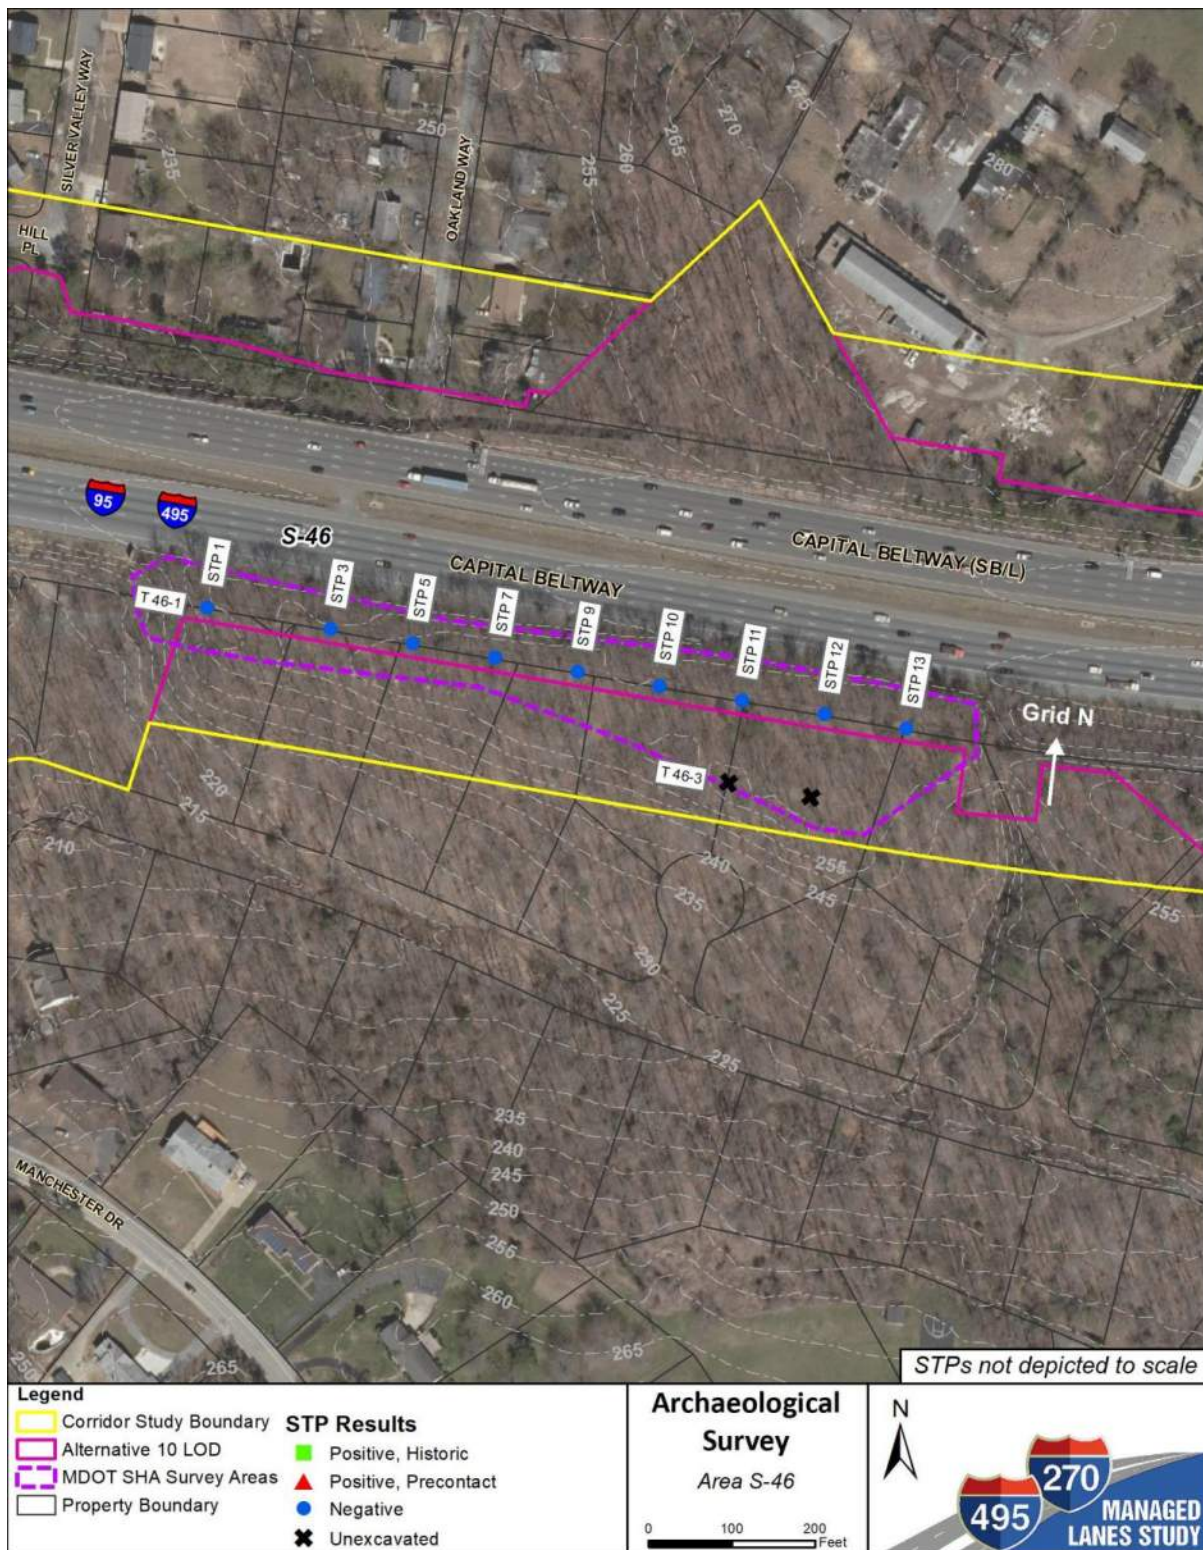
Figure 112. Results of the Phase I survey in Area S-46

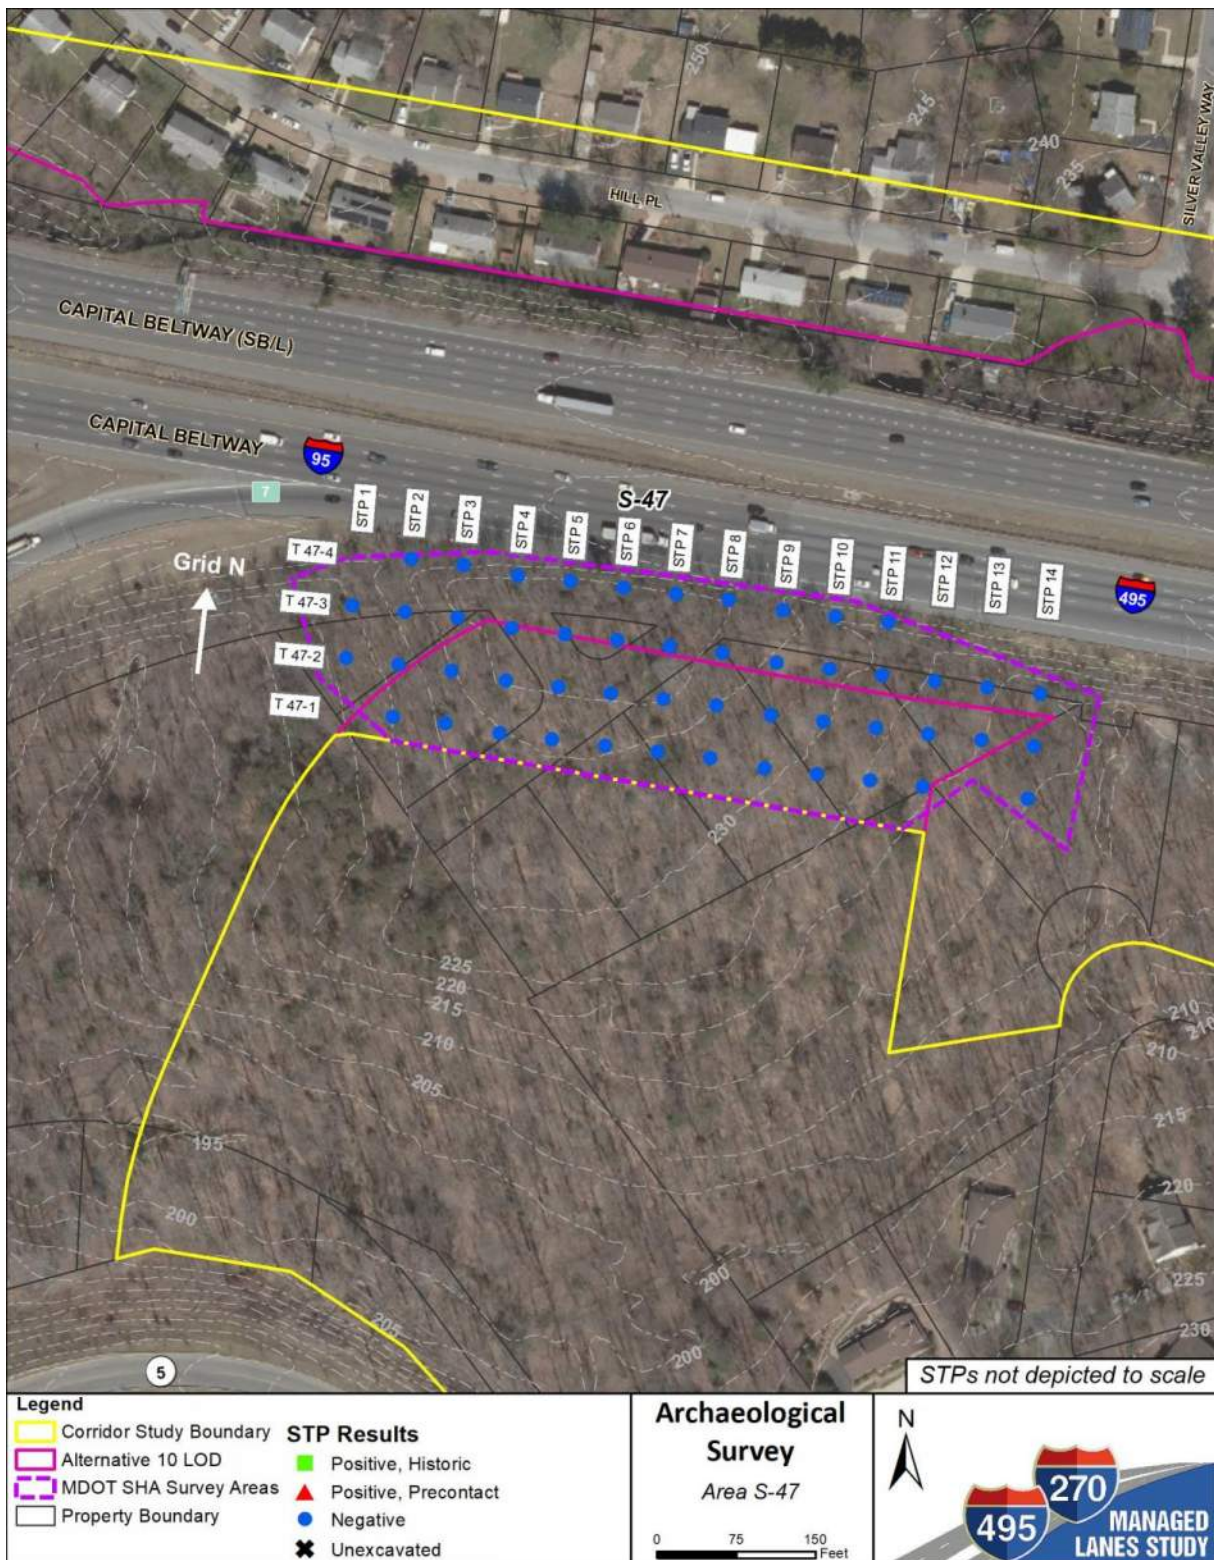
Figure 113. Results of the Phase I survey in Area S-47

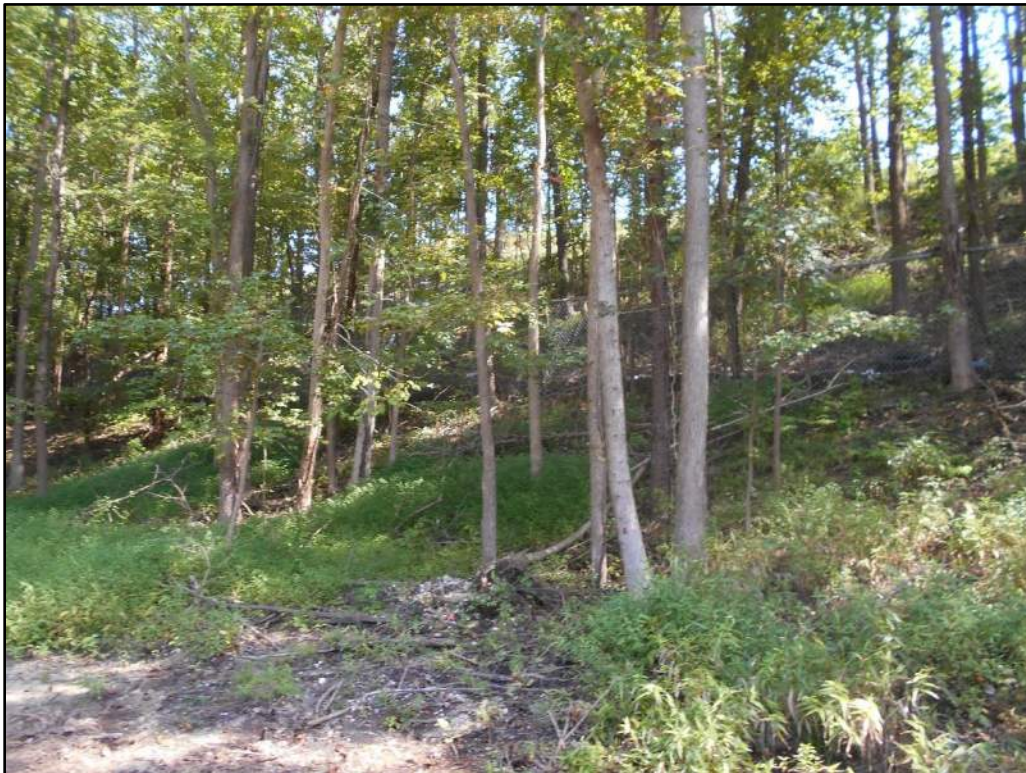
Figure 115. Disturbed slopes leading up to I-495 along the southern edge of Area S-48, facing southeast

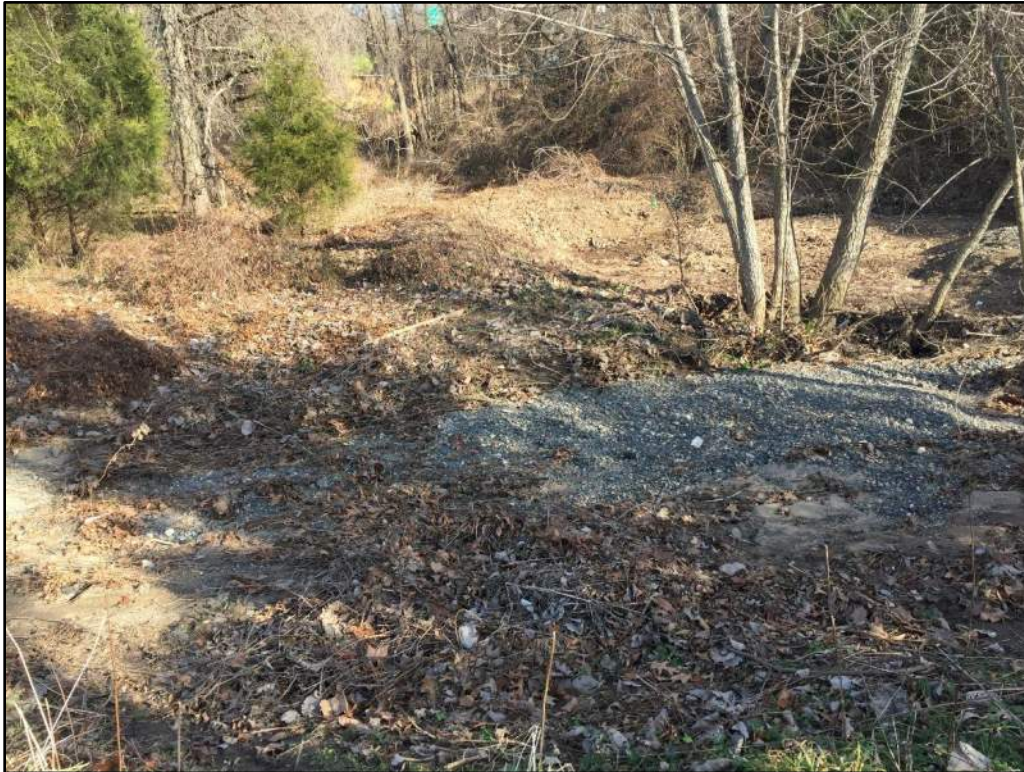
Figure 116. Gravel fill within the Sligo Creek floodplain at the base of the I-495 embankment, facing southeast

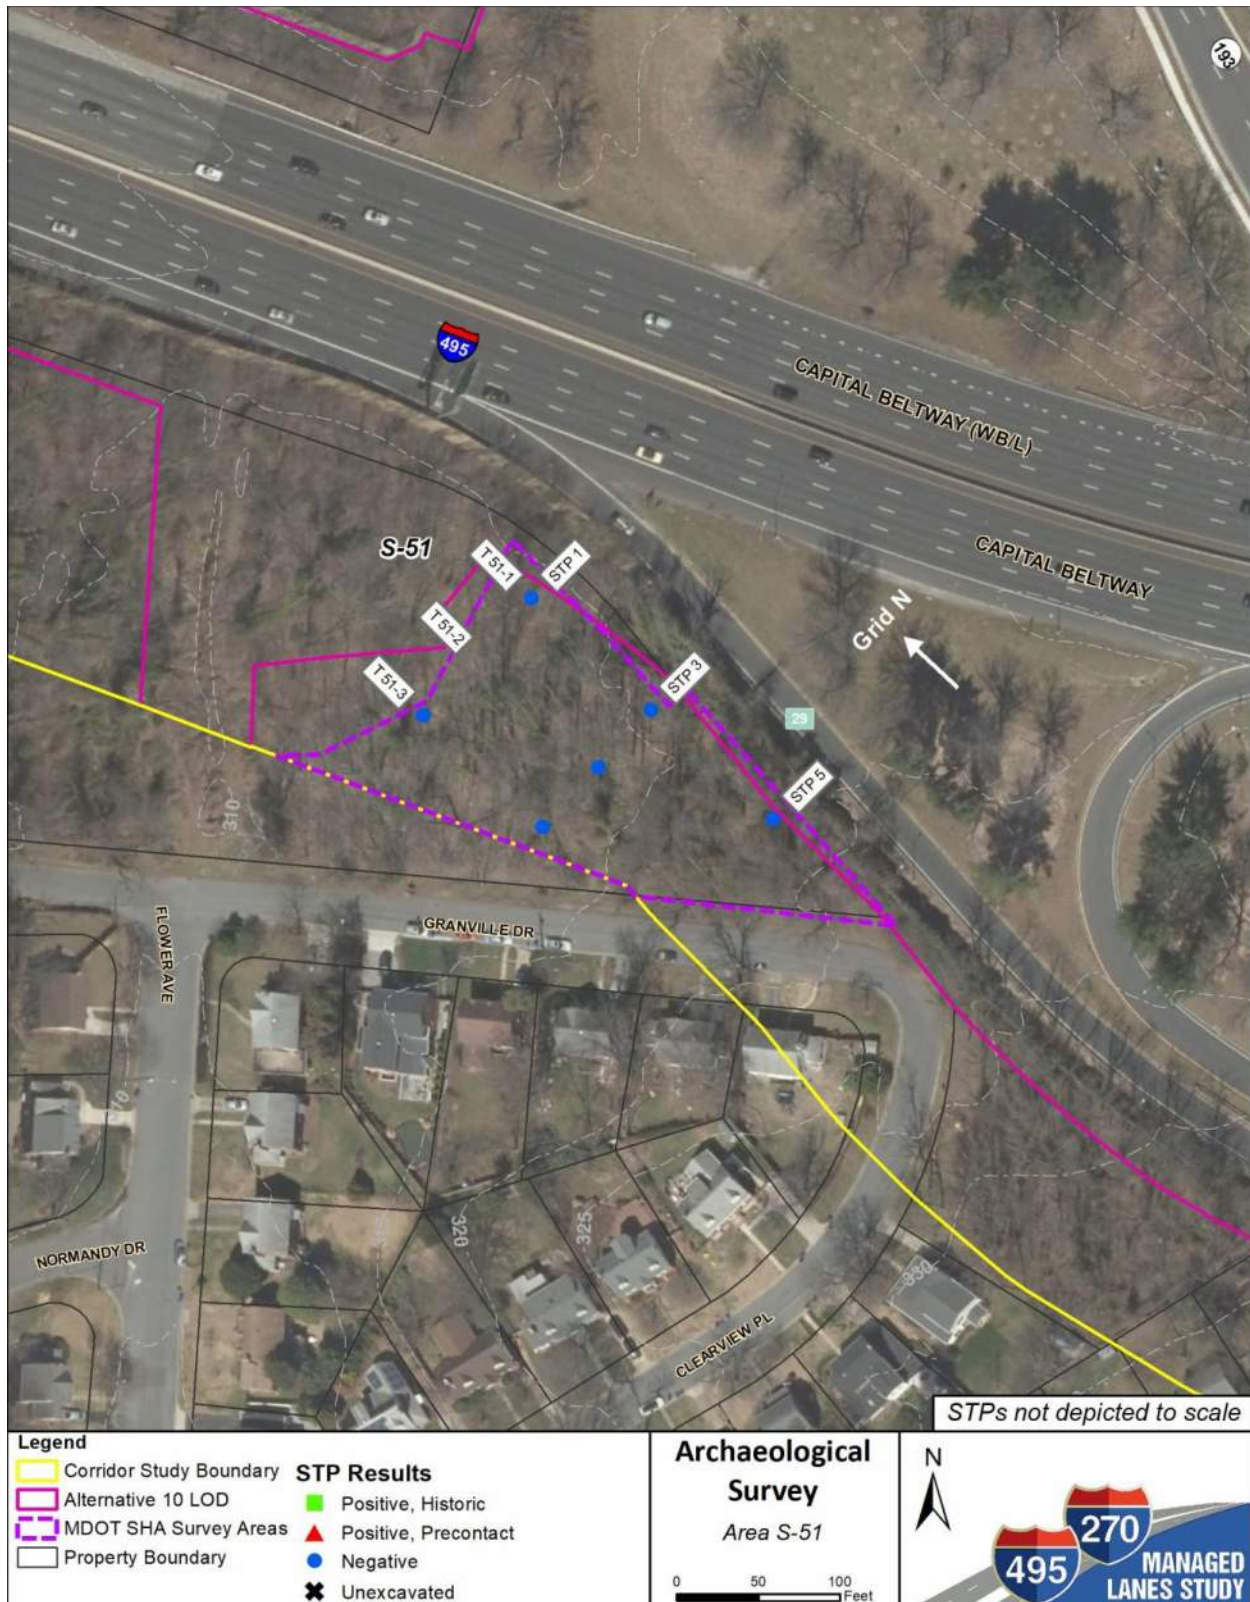
Figure 117. Results of the Phase I survey in Area S-51

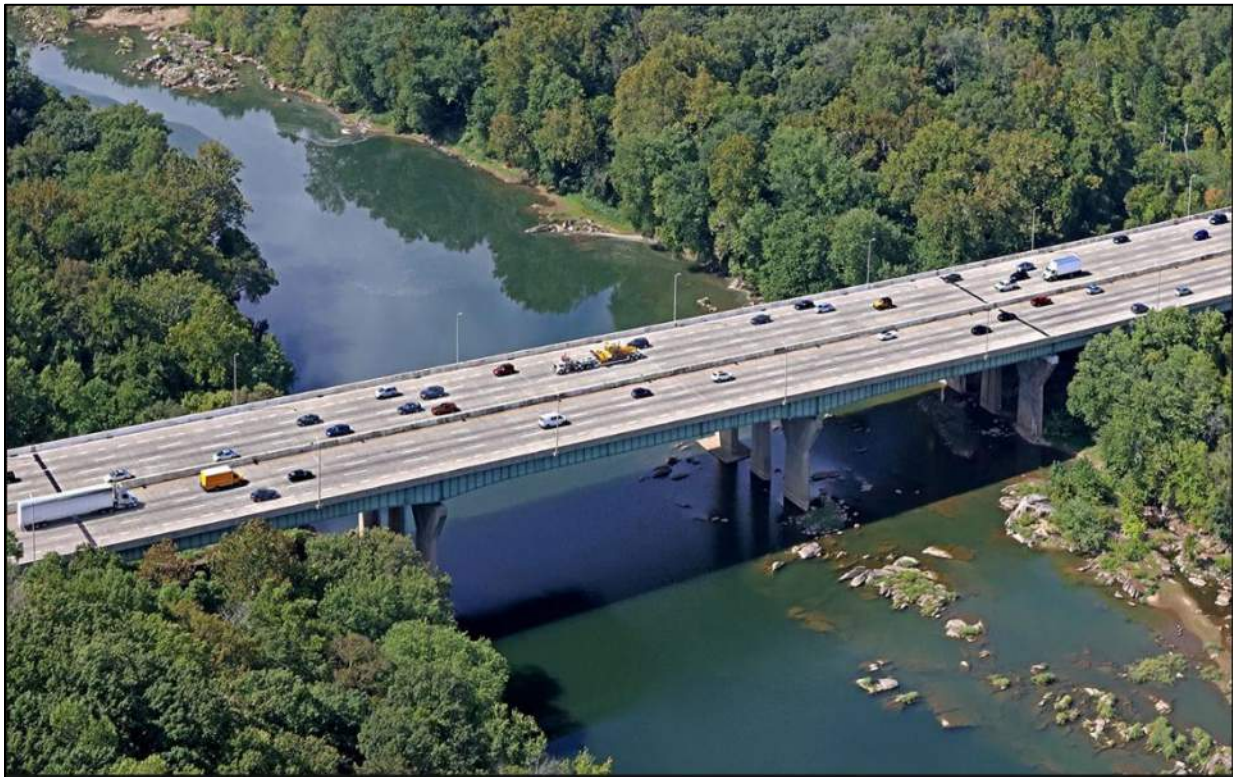
Figure 119. American Legion Bridge showing rock outcrops that occur along the north (Maryland) shoreline (upper and right portions of image) at low water level.

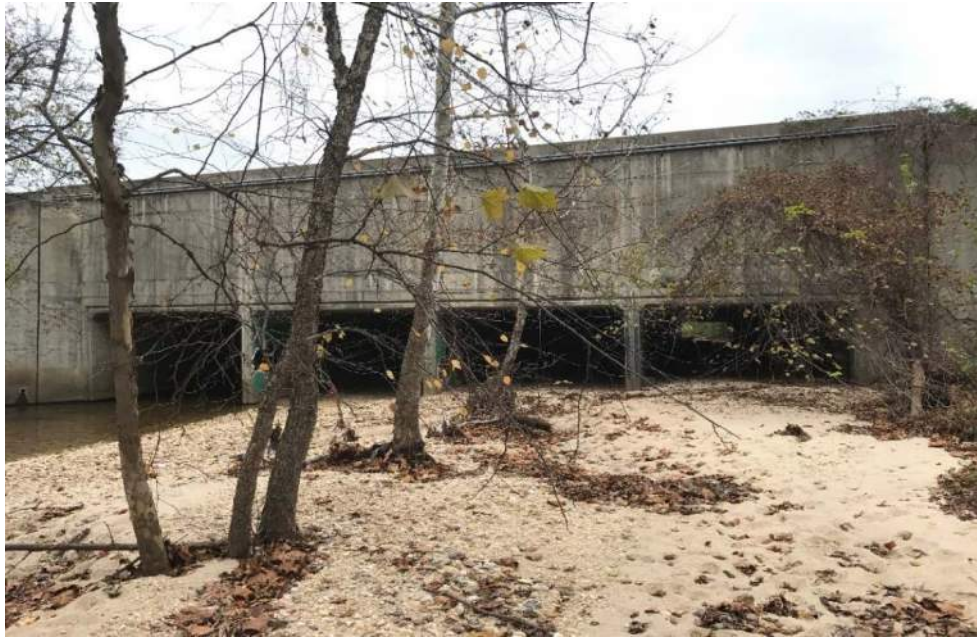
Photo Number:S-22-16

Showing: Fence-line extending along the base of I-495 berm. Wetland conditions prevented further extension of Transect 1, and the excavation of Transect 2-4.
