I-495 & I-270 Managed Lanes Study

Cultural Resources Technical Report Volume 8:

PHASE I ARCHAEOLOGICAL SURVEY OF THE RFP-4 CABIN BRANCH, RFP-6 MILL SWAMP, AND AN-6 AND AN-7 PAINT BRANCH STREAM MITIGATION SITES FOR THE I-495/I-270 MANAGED LANES STUDY ANNE ARUNDEL, CHARLES, AND PRINCE GEORGE'S COUNTIES, MARYLAND

Maryland Department of Transportation State Highway Administration
Archaeological Report Number 561

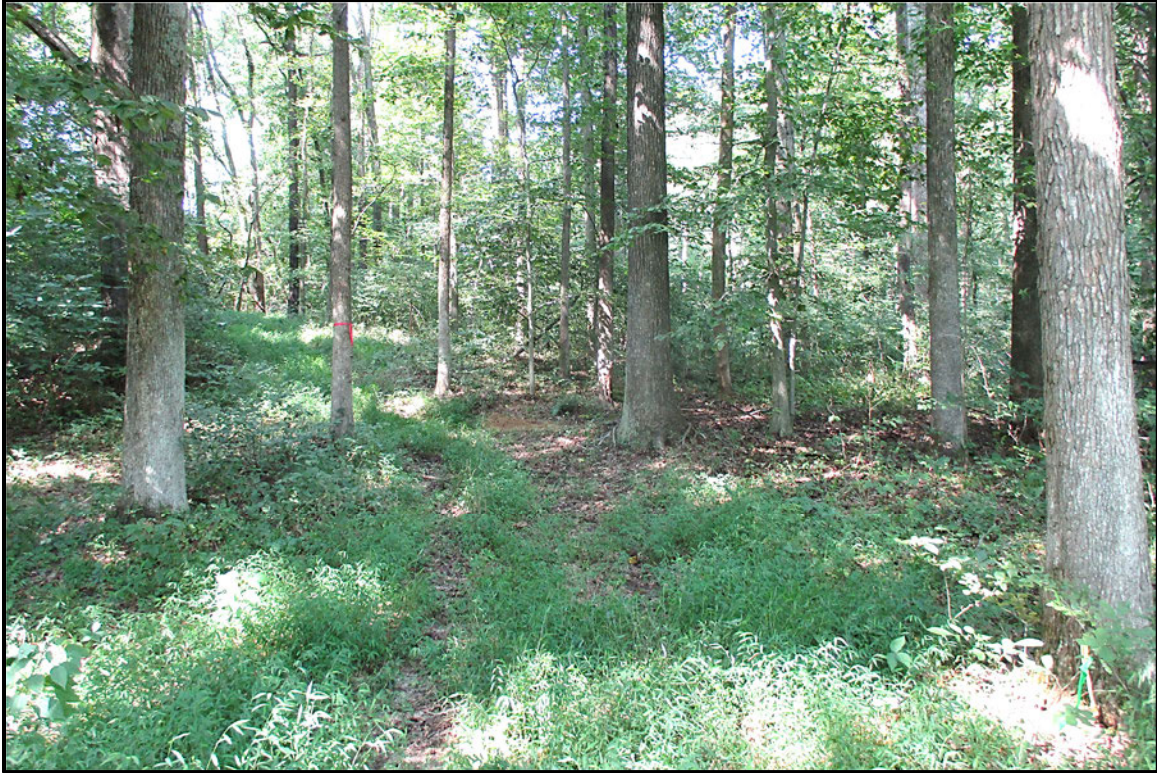
Figure 5.8. View of Resource 18ANX520-1, Facing North.

Resource 18ANX520-1 is an isolated artifact associated with an ephemeral pre-contact period use of this area. The artifact was recovered from the plowzone, and given the slope in this area (10–15%), it is possible that it eroded down from the higher elevation landform located to the northwest. Based on the isolated nature of the artifact and its recovery from the Ap horizon, the artifact does not have the ability to provide information important in history. No further archaeological investigation of this area is recommended for the project as scoped.

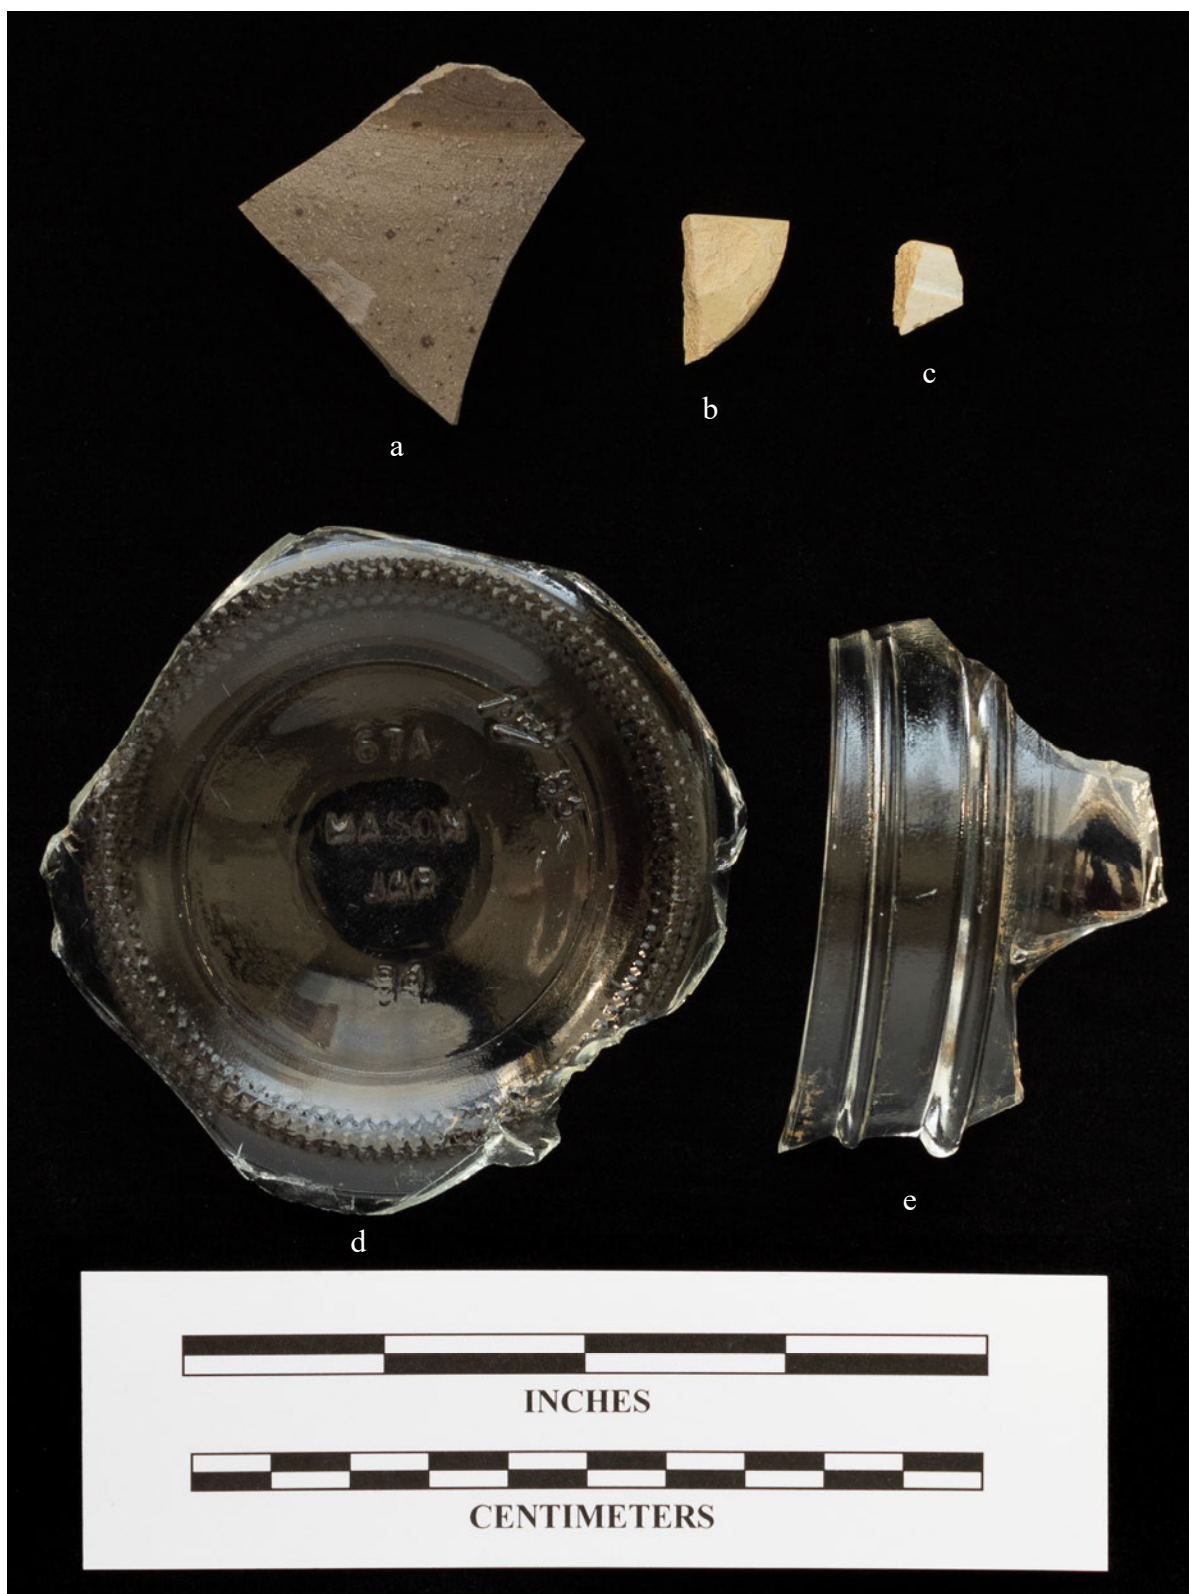
Site 18AN1696 is represented by a small collection of 19th through 20th century artifacts found within the upper and lower A horizons, primarily within a gully/eroded area. The site extends outside the project LOD (the same as the archaeology survey area in this area) to the south, and the artifacts found within the LOD are likely associated with the historic occupation located well outside the LOD. Although artifacts were found in an apparent buried A horizon, this likely represents an older plowzone and there is no indication of vertical sorting by time period. No evidence of cultural features or intact substantial or patterned artifact deposits was observed within the project LOD. The house, the barn, and the area immediately surrounding them (all located outside the project LOD) may contain cultural deposits that would provide information about historic occupation in this area, but the portion of the site located within the project LOD does not represent an intact substantial or significant archaeological resource, and site 18AN1696 as represented within the project LOD does not have the ability to yield further information regarding historic period occupation of this area. No additional archaeological investigation is recommended for site 18AN1696 in association with this project as currently scoped.

Figure 5.23. Historic Artifacts from Site 18AN1696. a) undecorated gray salt glazed stoneware body sherd; b) undecorated yellowware rim; c) undecorated whiteware rim; d) glass machine made canning jar base; e) glass machine made canning jar continuous thread rim

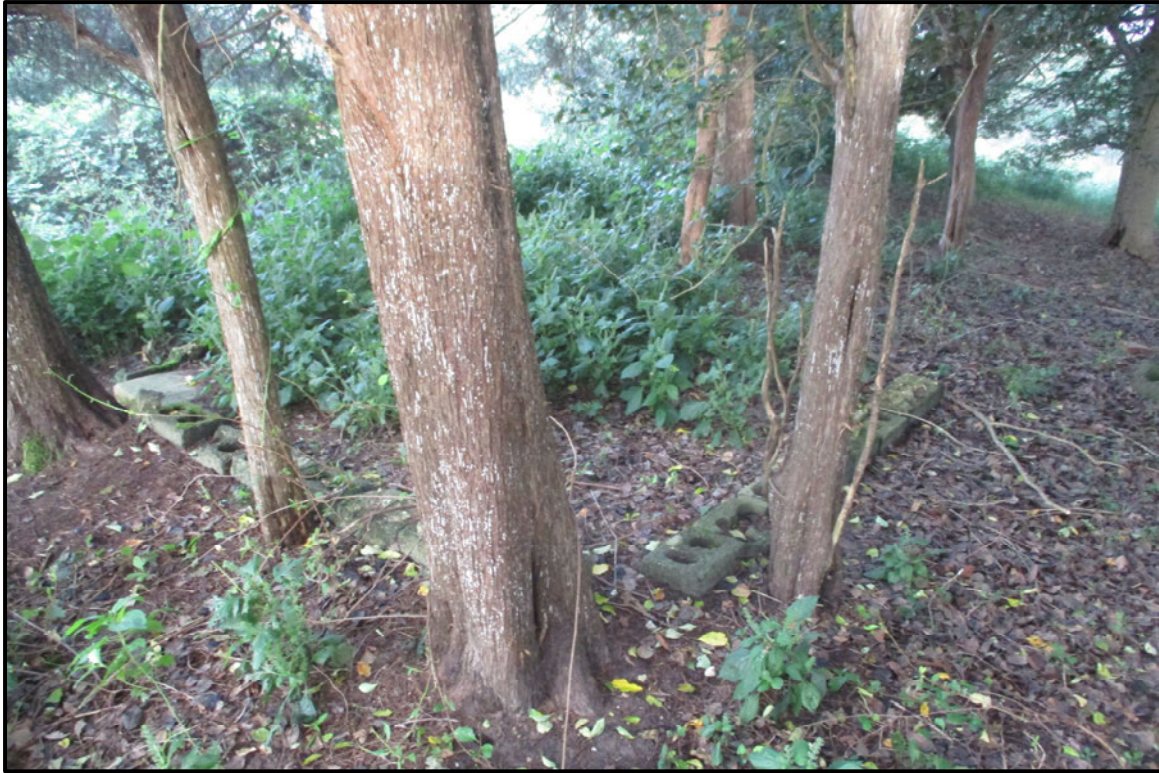
The remains of a concrete slab and cinder block foundation was identified in the wooded area between shovel tests 148 and 149, and shovel tests 150–152 were excavated near outbuildings within the backyard of a dwelling located approximately 70 ft north of the transect (Figure 6.14). A structure is depicted near the location of 18CH971 on early 20th century USGS (1913, 1923) topographic maps. A structure with outbuildings is depicted near the location of 18CH971 on the USGS 1944 Mount Vernon, VA topographic map, and the same structure is mapped at that location through the 1983 edition, at which point subsequent editions depict no structures in the vicinity. The dwelling and multiple outbuildings are visible on aerial photographs dating from 1957 through 2019, and the dwelling was still standing during the fieldwork in October 2020. All of these structures are located at least 100 ft outside the project LOD.

Figure 6.14. View of Foundation Remains at Site 18CH971, Facing Southwest.

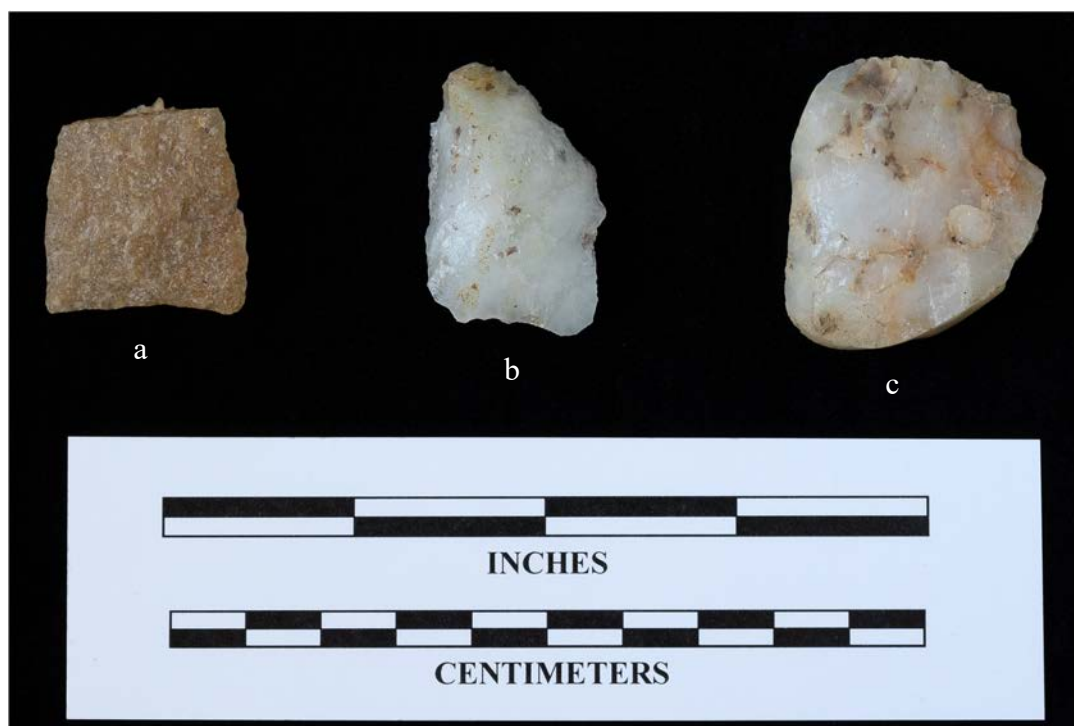
Figure 6.15. Representative Pre-Contact Artifacts from Site 18CH971. a) quartzite lanceolate PPK fragment; c) quartz early stage biface; e) quartz retouched flake

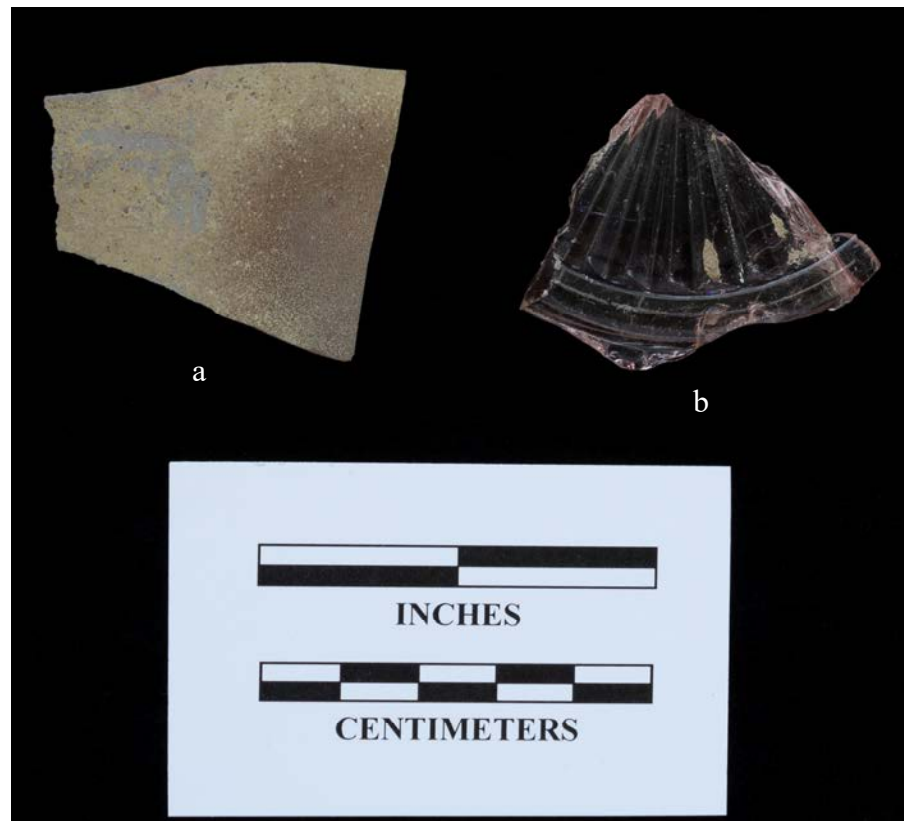
Table 6.1). One small brick fragment was observed in shovel test 148, but not collected. The stoneware sherd represents a hollowware container and exhibits an unwashed interior (Figure 6.16a). Salt glazed stoneware is associated with early 18th to 20th century manufacture (Ketchum 1991). The glassware fragment is pale pink and is Depression-era (1920s–1950s) glass (Figure 6.16b). One of the glass container fragments is 7-Up green in color, suggesting mid-20th century manufacture (SHA 2020); the other three are small fragments of colorless glass. The stoneware sherd was recovered from the ridge toe, but all of the other historic period artifacts were recovered from the higher elevation portion of the landform to the east—closer to the standing structures and the former structure locations as shown on historic mapping. Collectively, the historic period artifacts are likely associated with an early to mid-20th century occupation.

Figure 6.16. Representative Historic Artifacts from Site 18CH971. a) gray salt glazed stoneware; b) pale pink press molded Depression era glassware base

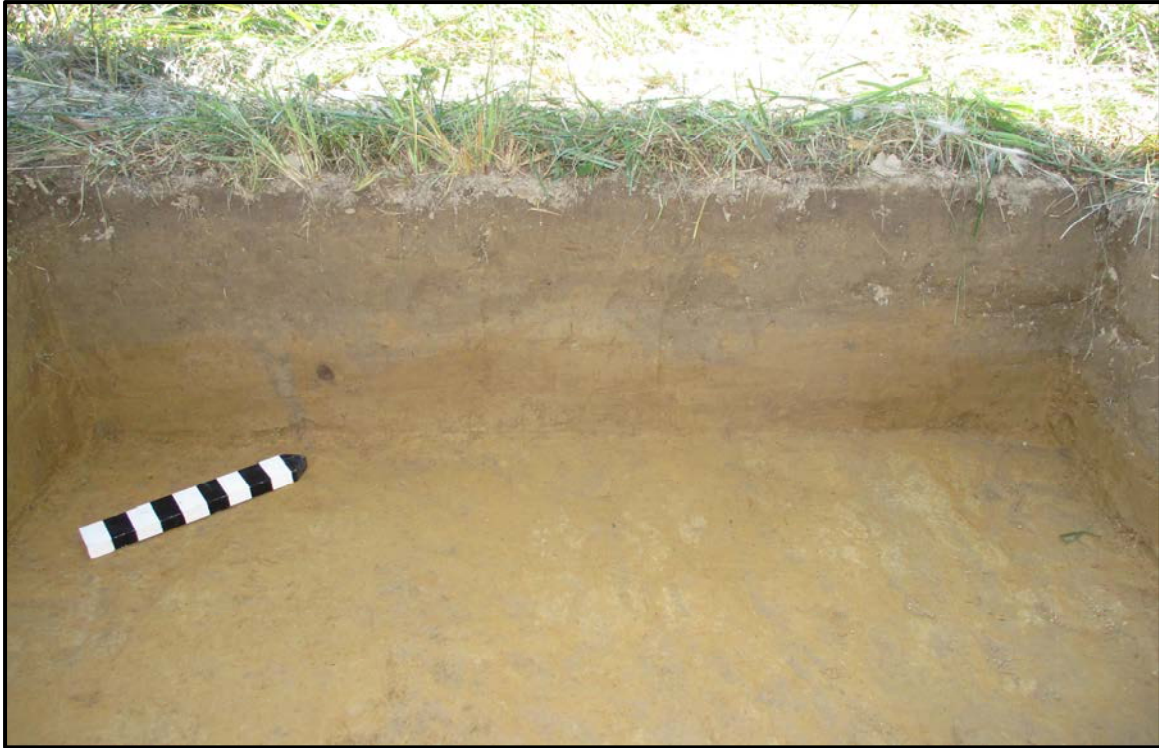
Figure 6.24. View of Test Unit 1 West Wall Profile at Site 18CH972.

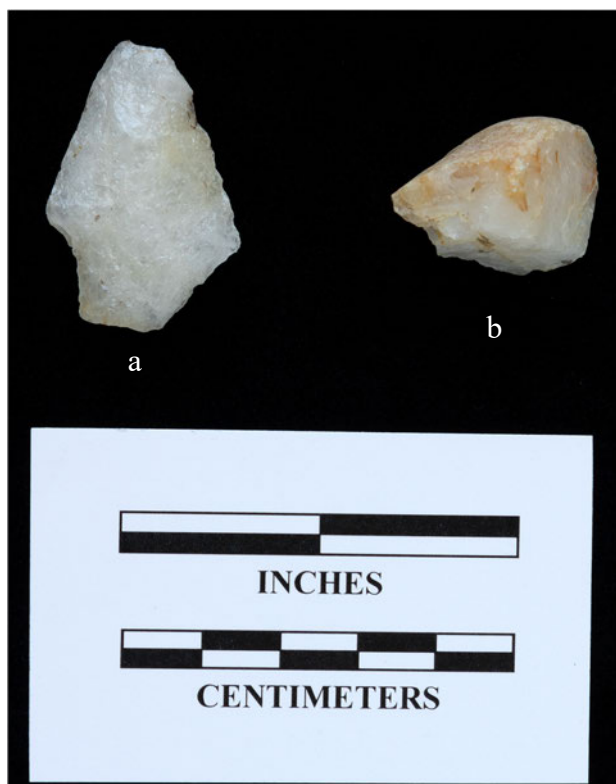
Figure 6.25. Pre-Contact Artifacts from Site 18CH972.
a) quartz Calvert PPK; b) quartz bipolar core

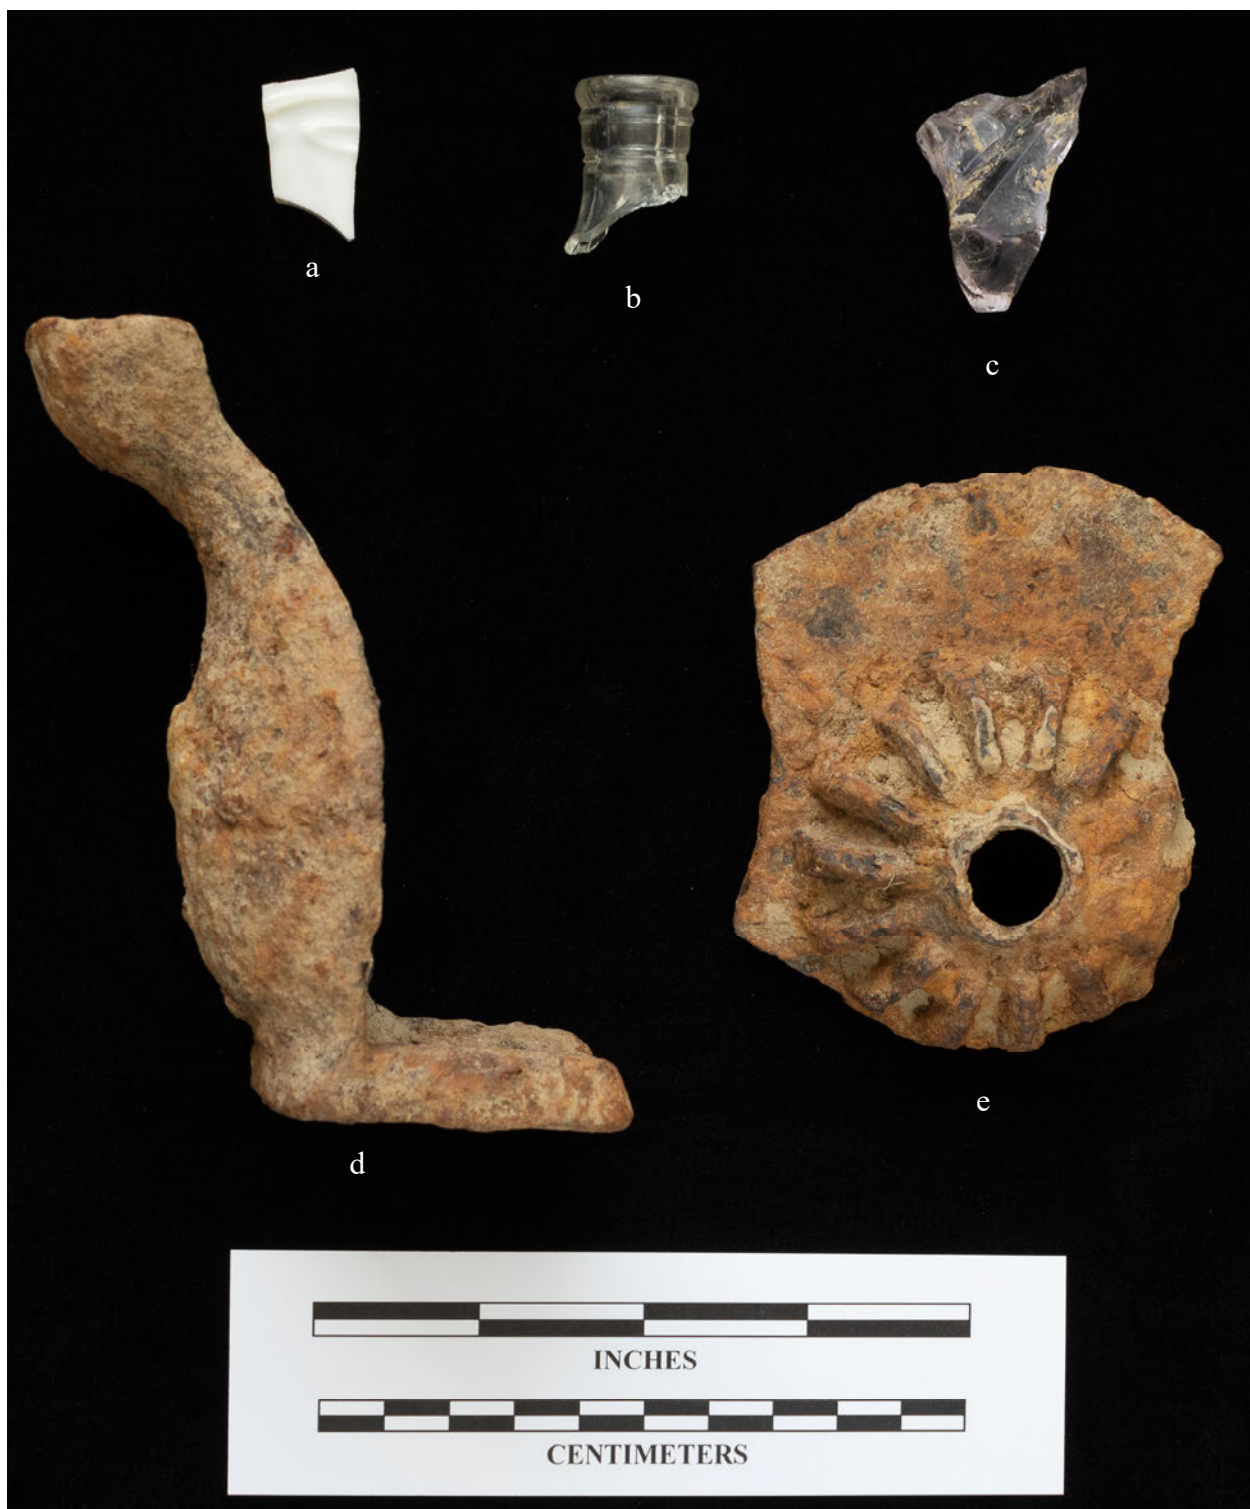
The historic period component dates to the late 19th to 20th century and is likely associated with a structure that was located in this area until about 1923, but also likely contains artifacts distributed across the field during later uses of the site area for agricultural purposes. All of the pre-contact and historic artifacts were recovered from the plowzone and there are no discrete distributions of any types of artifact classes. Site 18CH972 appears to lack the integrity, clarity, and substantial deposits or cultural features that would allow it to provide substantive information regarding local pre-contact or historic period occupations. Site 18CH972 is recommended not eligible for the NRHP, and no further investigation of the site is recommended for this project as currently scoped.

Figure 6.26. Representative Historic Artifacts from Site 18CH972. a) molded porcelain body sherd; b) colorless bottle neck/rim; c) amethyst tinted press molded glassware; d) cast iron stove leg; e) unidentified cast iron object

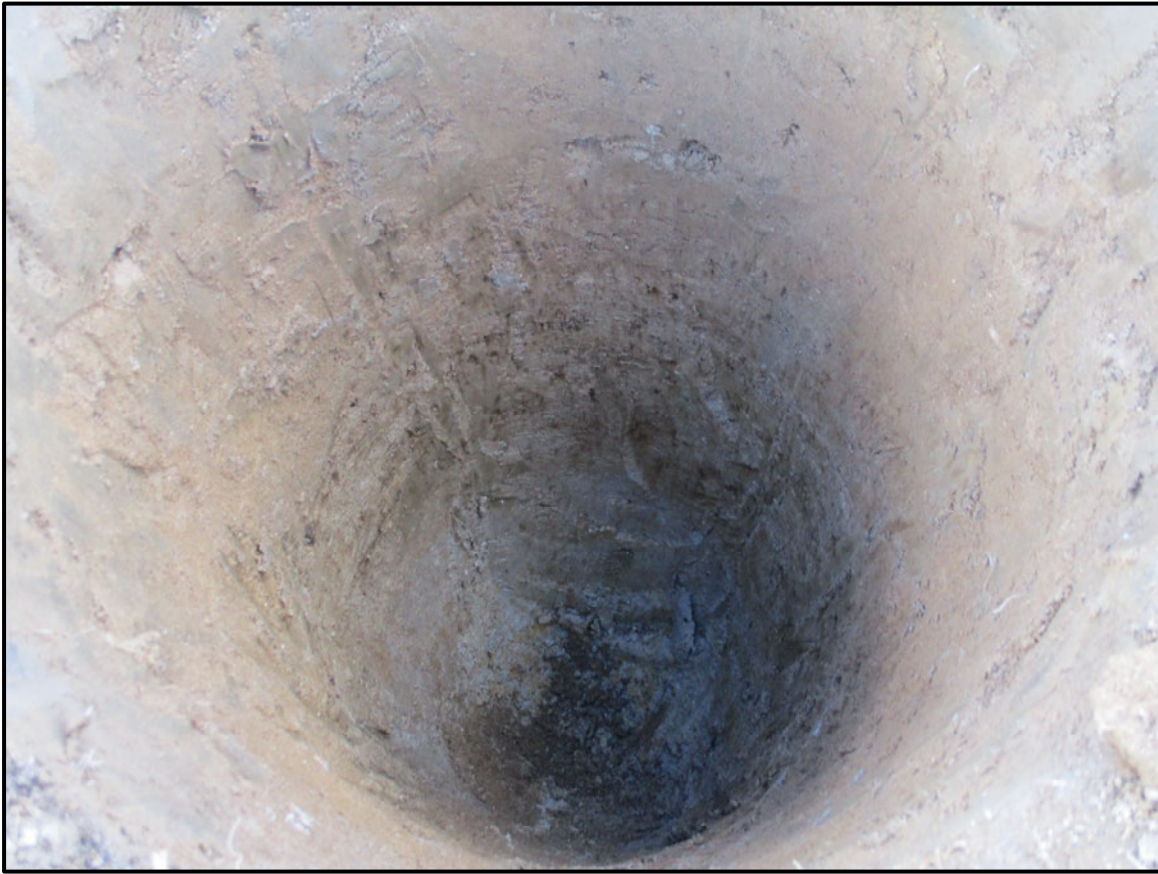
(10YR 5/4) sandy clay, and Stratum IV was a Btg horizon (2.7–3.1+ fbs) of gleyed light brownish gray (10YR 6/2) silty clay with strong brown (7.5YR 5/6) silty clay mineral staining (Figure 7.8).

Figure 7.8. View of Shovel Test 3.15 Profile in Paint Branch East.

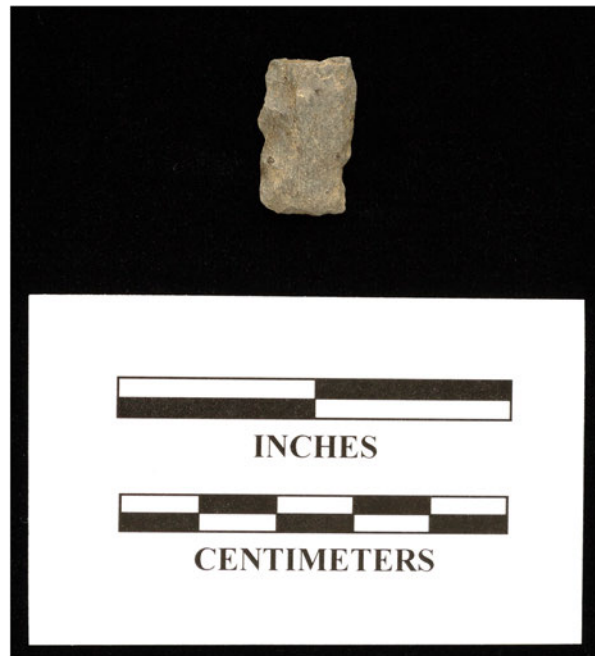
Figure 7.12. Biface Fragment from Site 18PR1191.

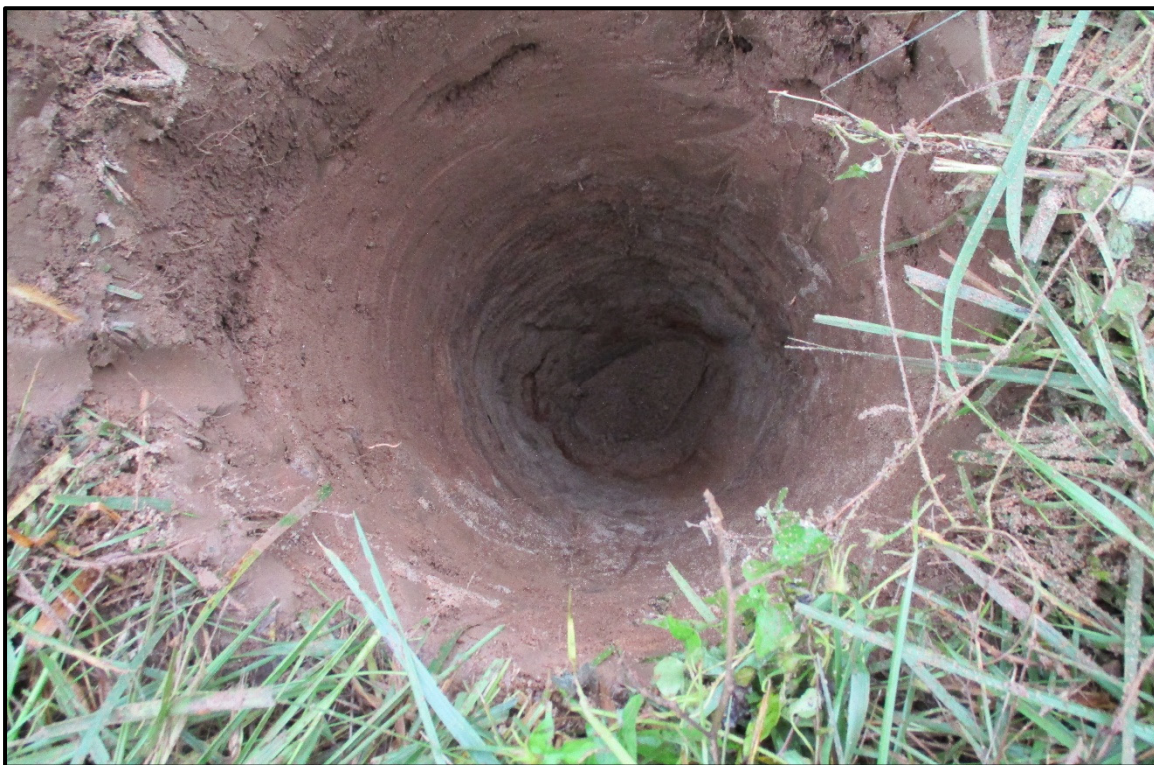
Figure 7.15. View of Shovel Test 1.5 in Paint Branch West (note bottom portion is auger only).

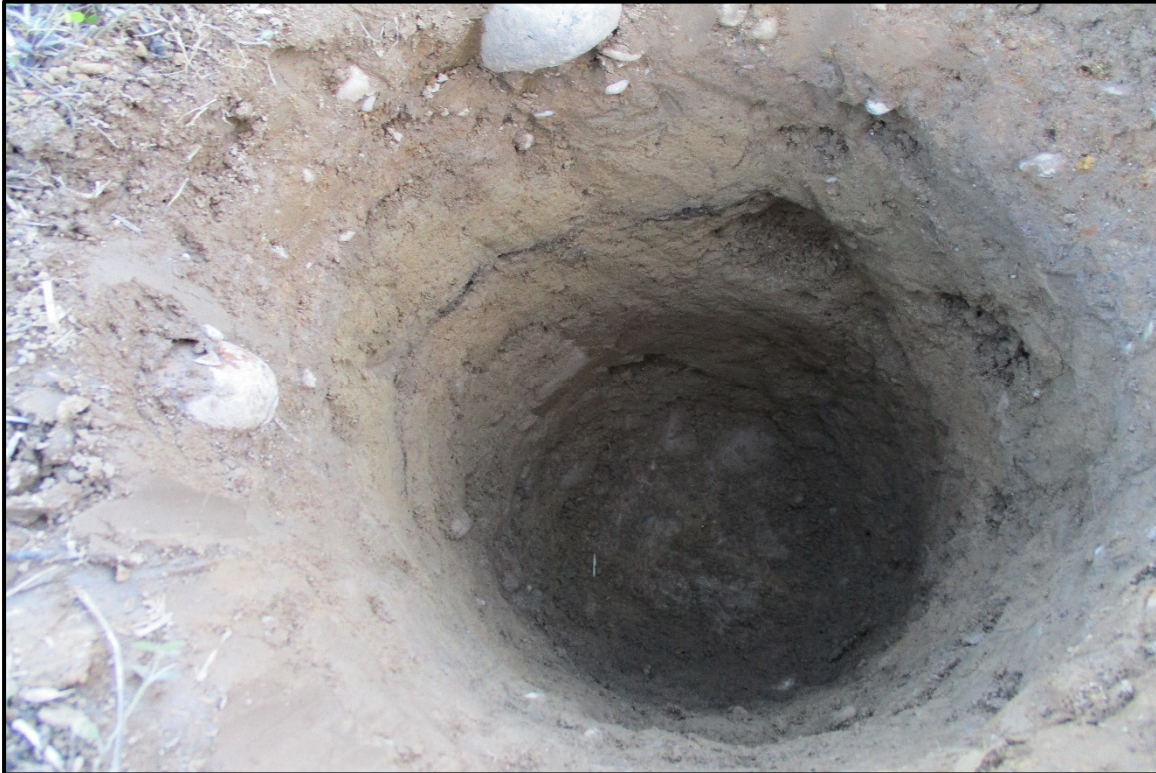
Figure 7.25. View of Dark Lens in N500 E500 at Site 18PR111, Facing North.

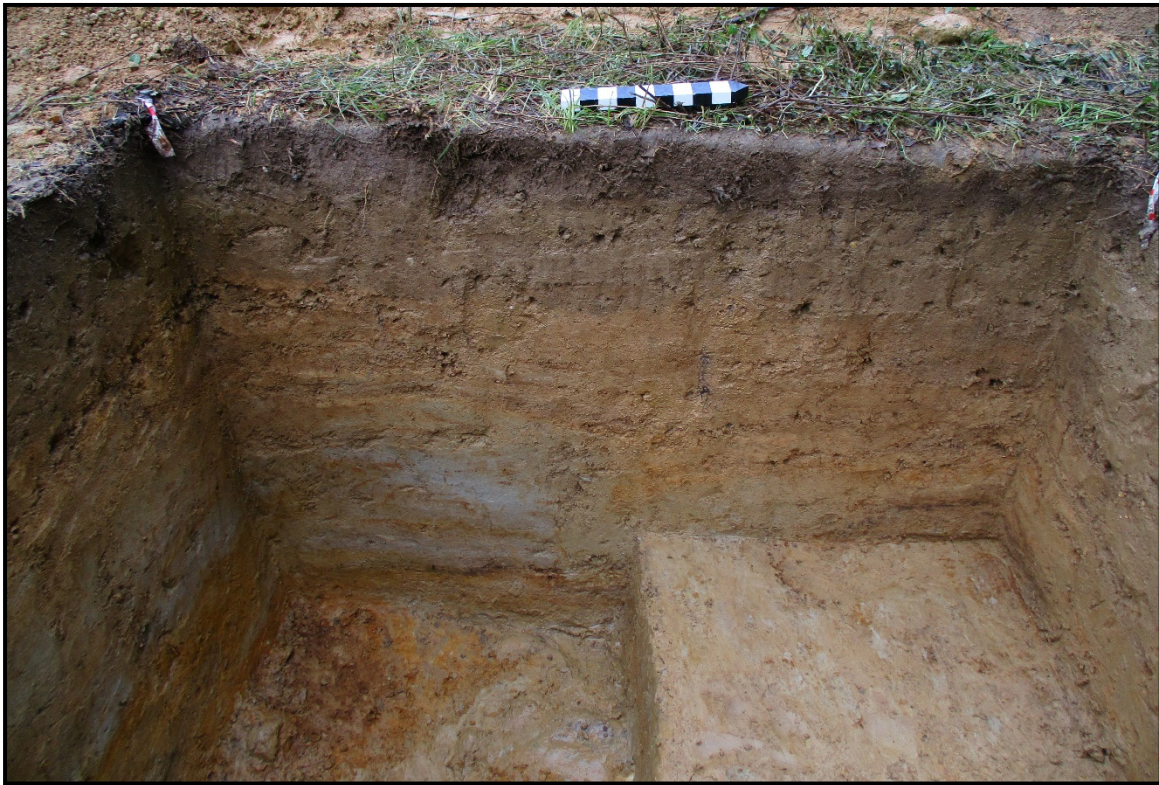
Figure 7.40. View of West Wall Profile of Test Unit 1 at Site 18PR113, Facing West.

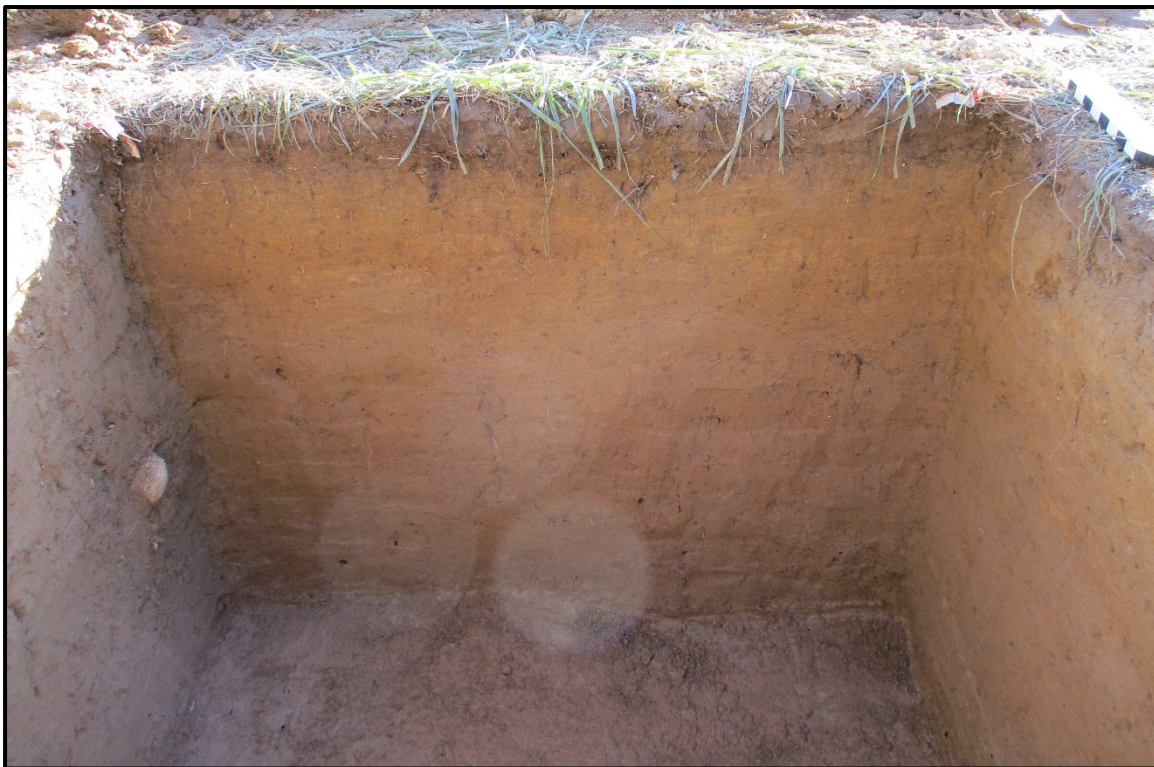
Figure 7.41. View of South Wall Profile of Test Unit 2 at Site 18PR113, Facing South.

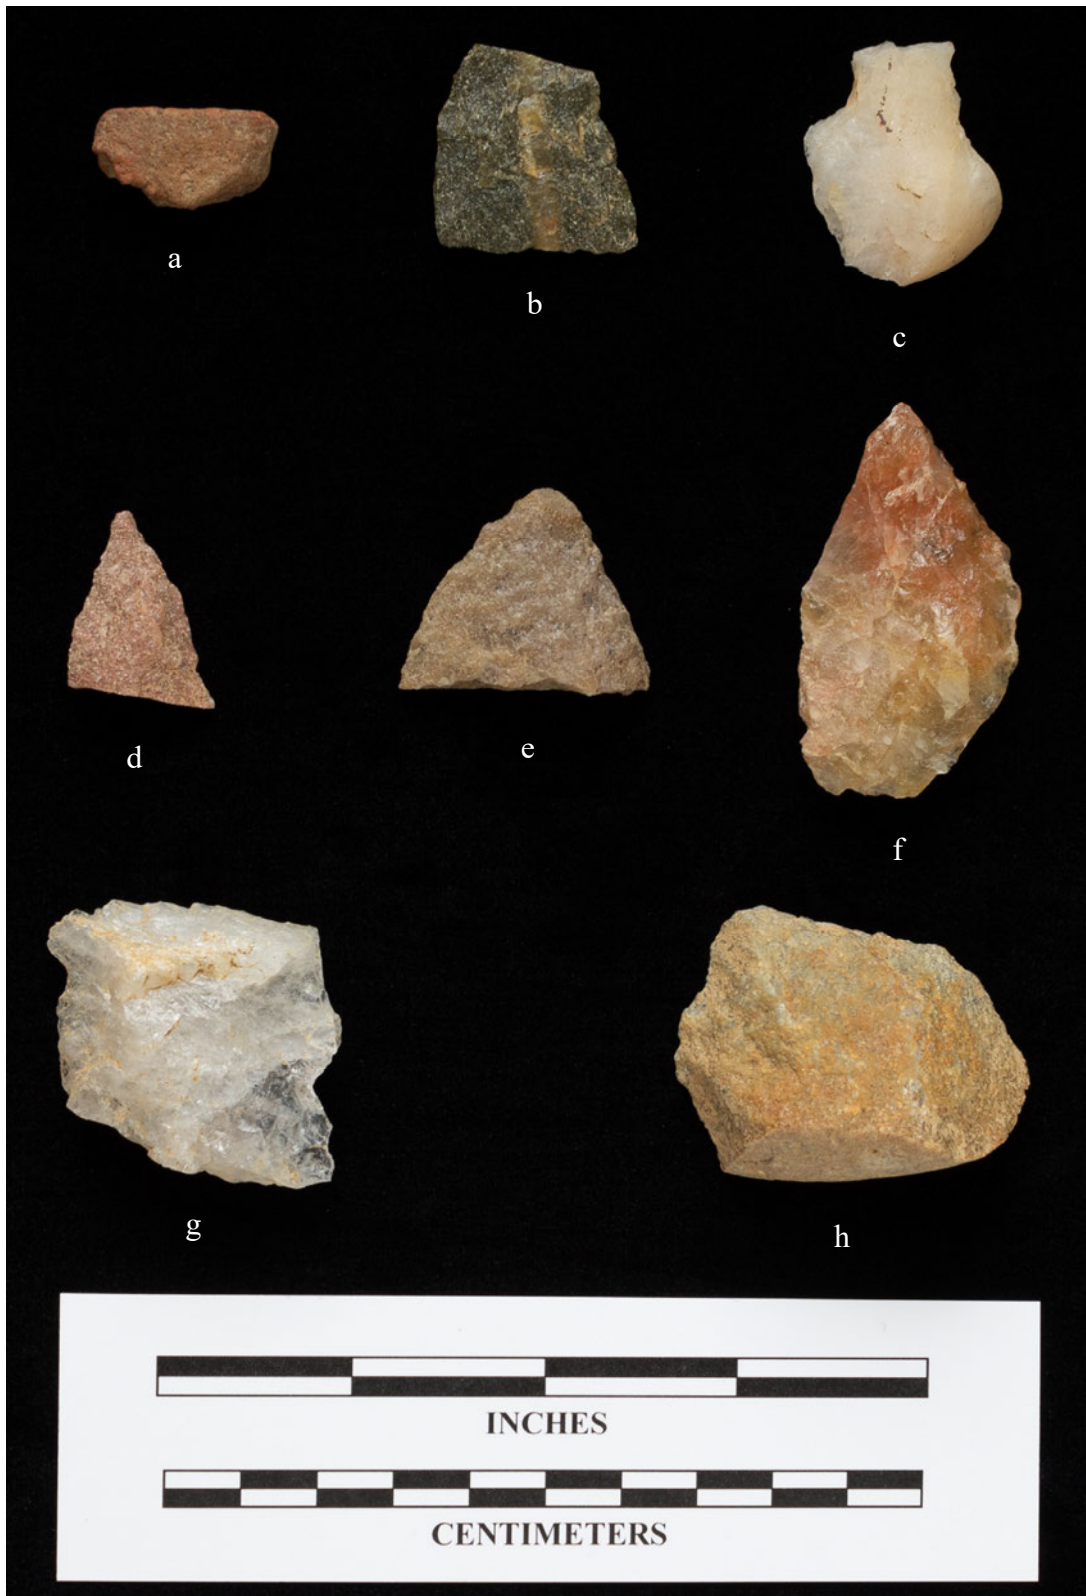
Figure 7.42. Representative Pre-Contact Ceramic and Flaked Stone Tools from Site 18PR113. a) unclassified plain sherd; b) quartzite small triangular PPK base; c) quartz graver; d) quartzite late stage biface; e) quartzite late stage biface; f) quartz mid stage biface; g) quartz retouched flake; h) quartzite retouched flake

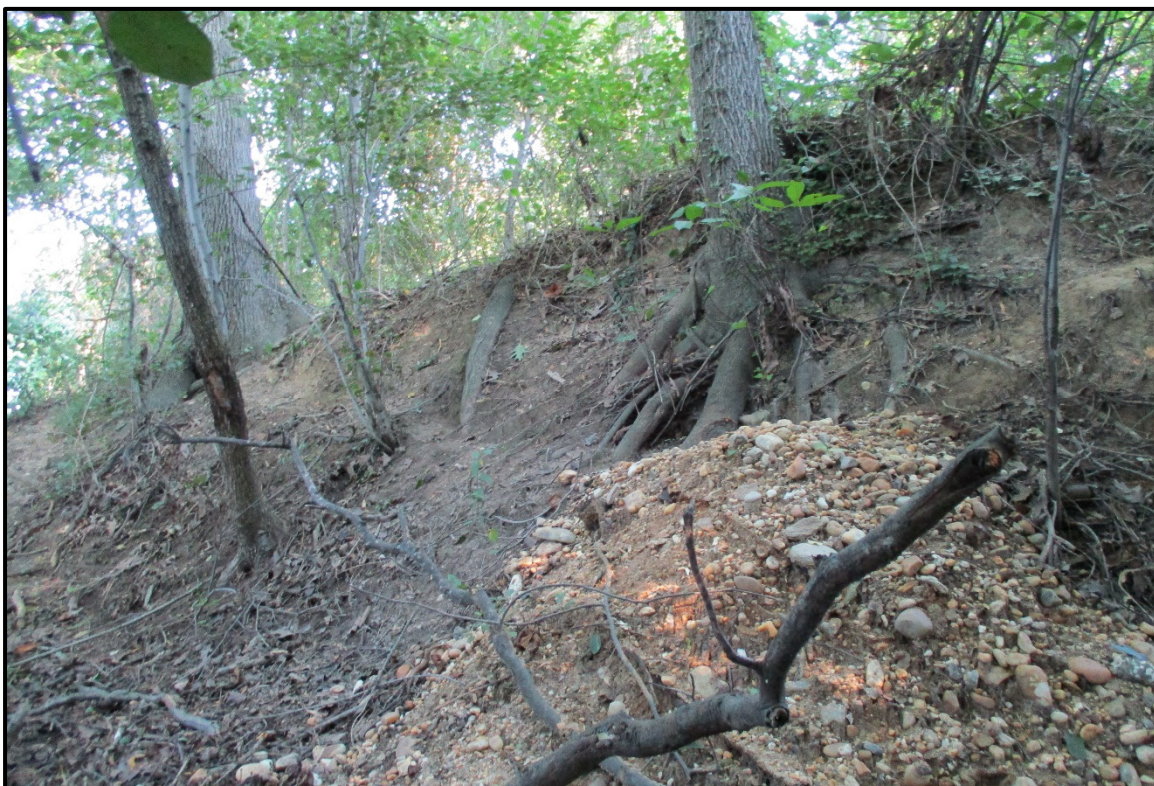
Figure 7.49. View of Eroding Gravel and Cobbles at Site 18PR1190, Facing Northwest.

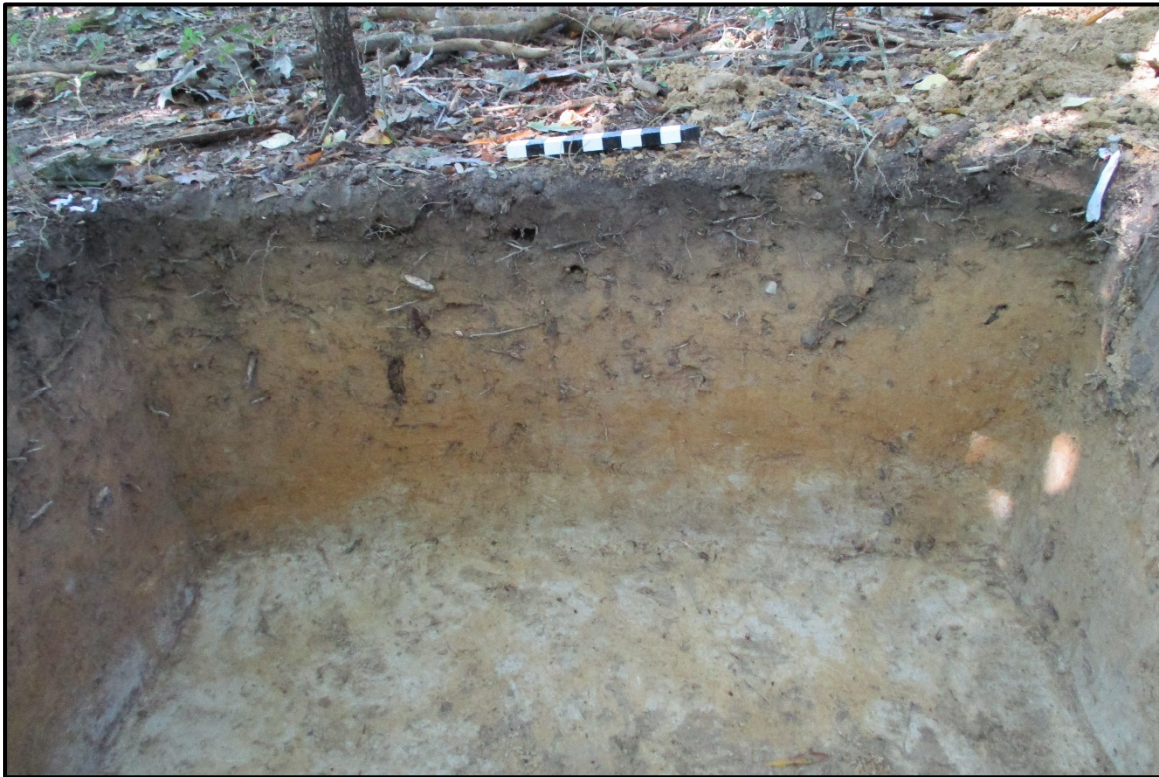
Figure 7.50. View of West Wall Profile of Test Unit 1 at Site 18PR1190, Facing West.

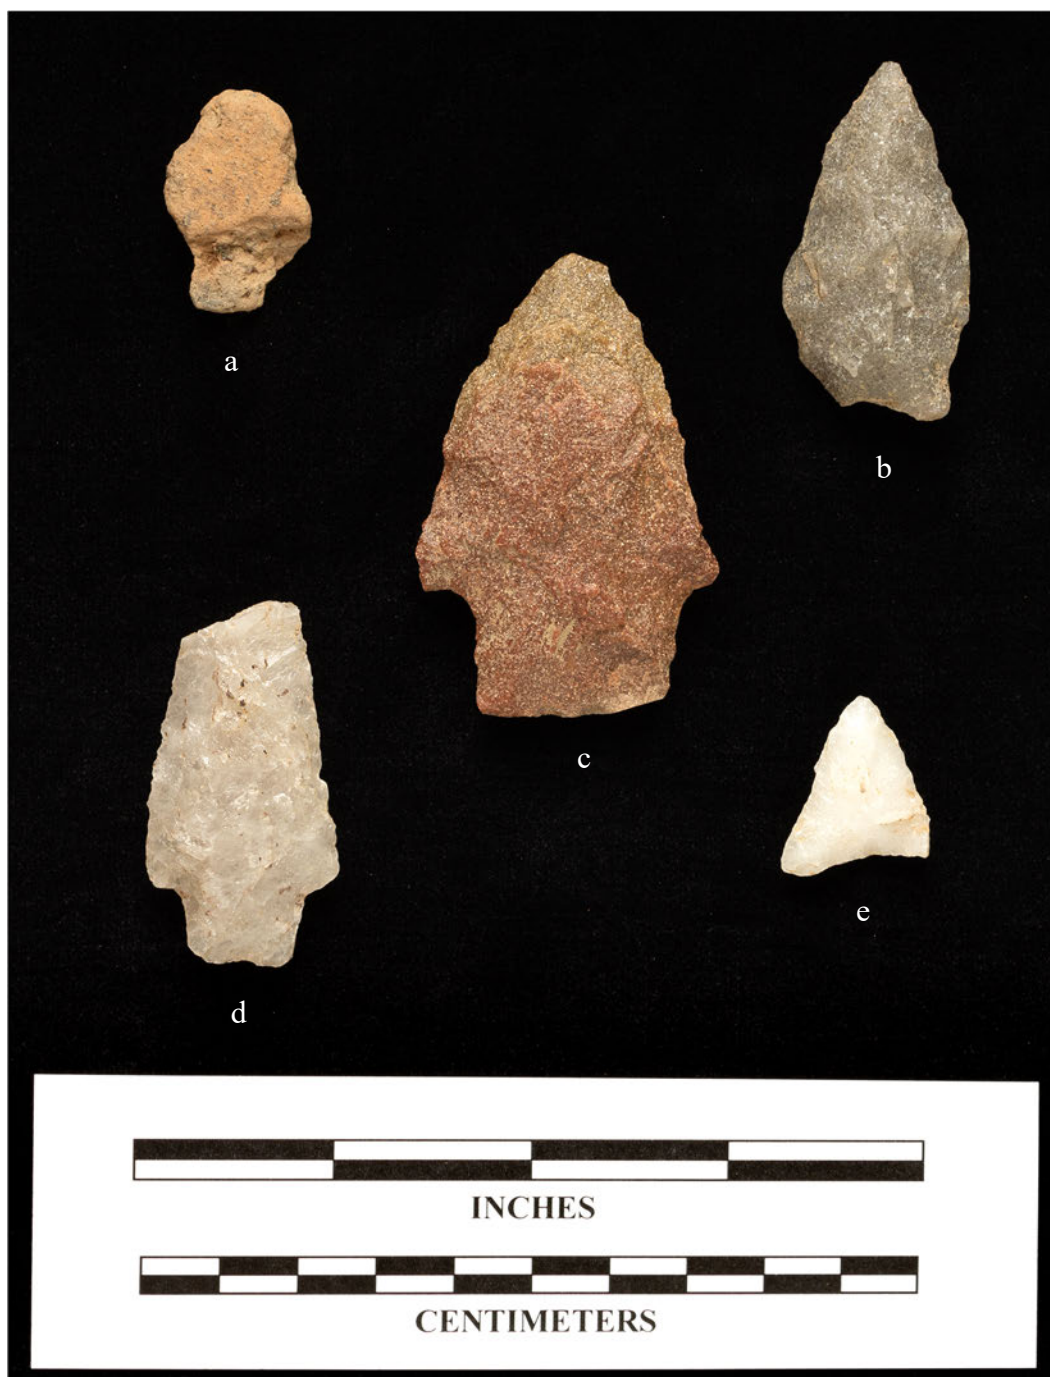
Figure 7.51. Pre-Contact Ceramic and Tools from Site 18PR1190. a) unclassified sherd; b) quartzite Orient Fishtail PPK; c) quartzite Savannah River PPK; d) quartz Savannah River PPK; e) quartz triangular PPK

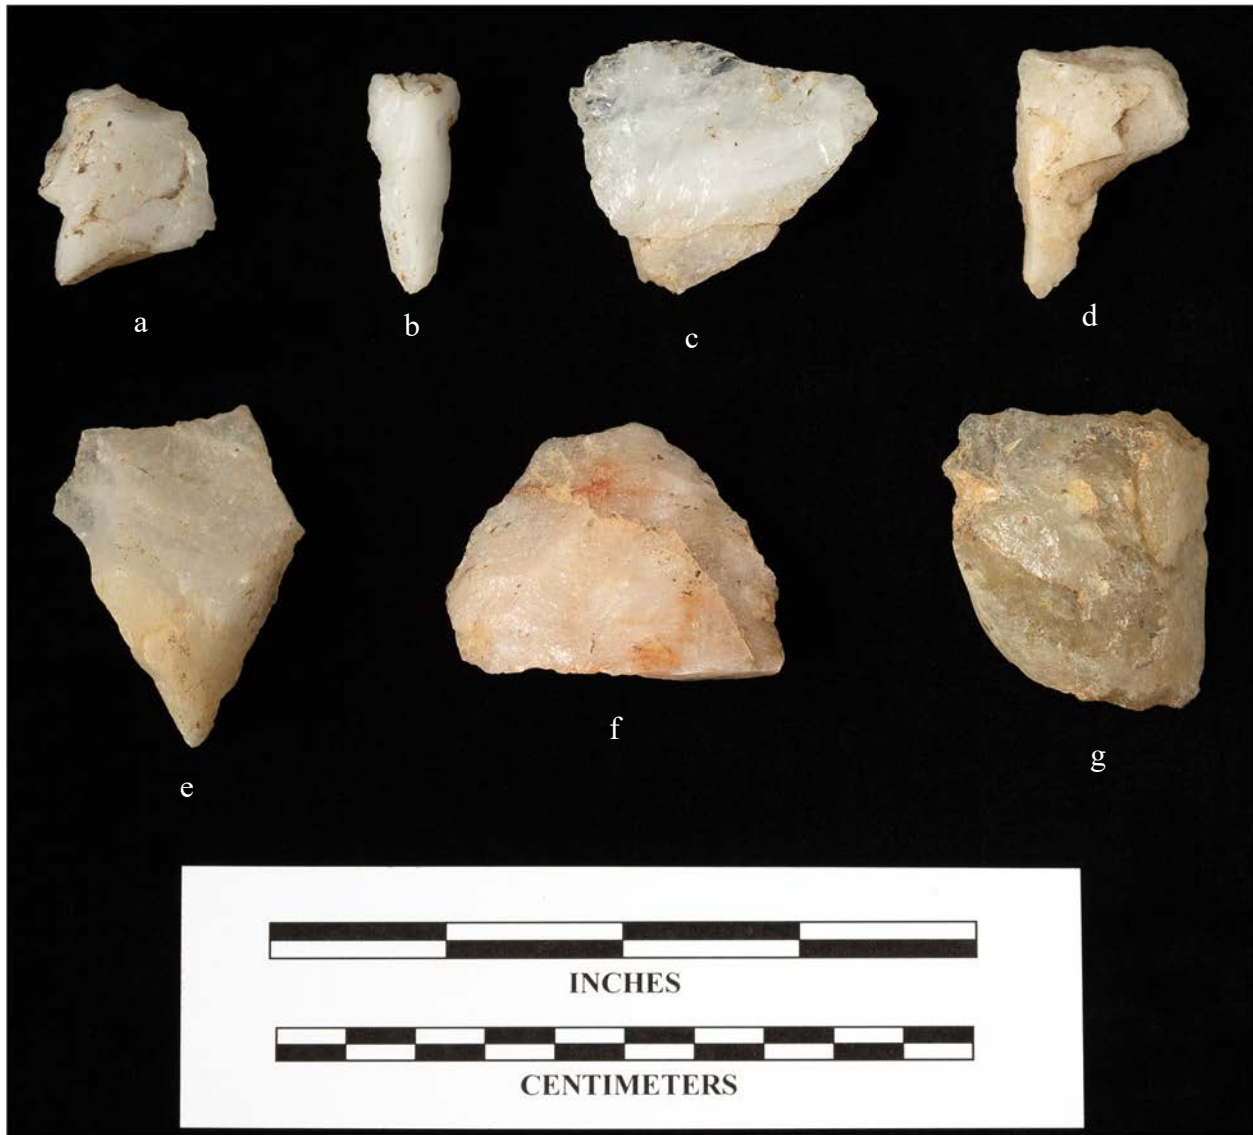
Figure 7.53. Utilized and Retouched Flakes from Site 18PR1190. a–d, g) quartz retouched flake; e) quartz utilized flake; f) quartzite retouched flake
