I-495 & I-270 Managed Lanes Study

Cultural Resources Technical Report Volume 8:

PHASE I ARCHAEOLOGICAL SURVEY OF THE RFP-4 CABIN BRANCH, RFP-6 MILL SWAMP, AND AN-6 AND AN-7 PAINT BRANCH STREAM MITIGATION SITES FOR THE I-495/I-270 MANAGED LANES STUDY ANNE ARUNDEL, CHARLES, AND PRINCE GEORGE'S COUNTIES, MARYLAND

Maryland Department of Transportation State Highway Administration
Archaeological Report Number 561

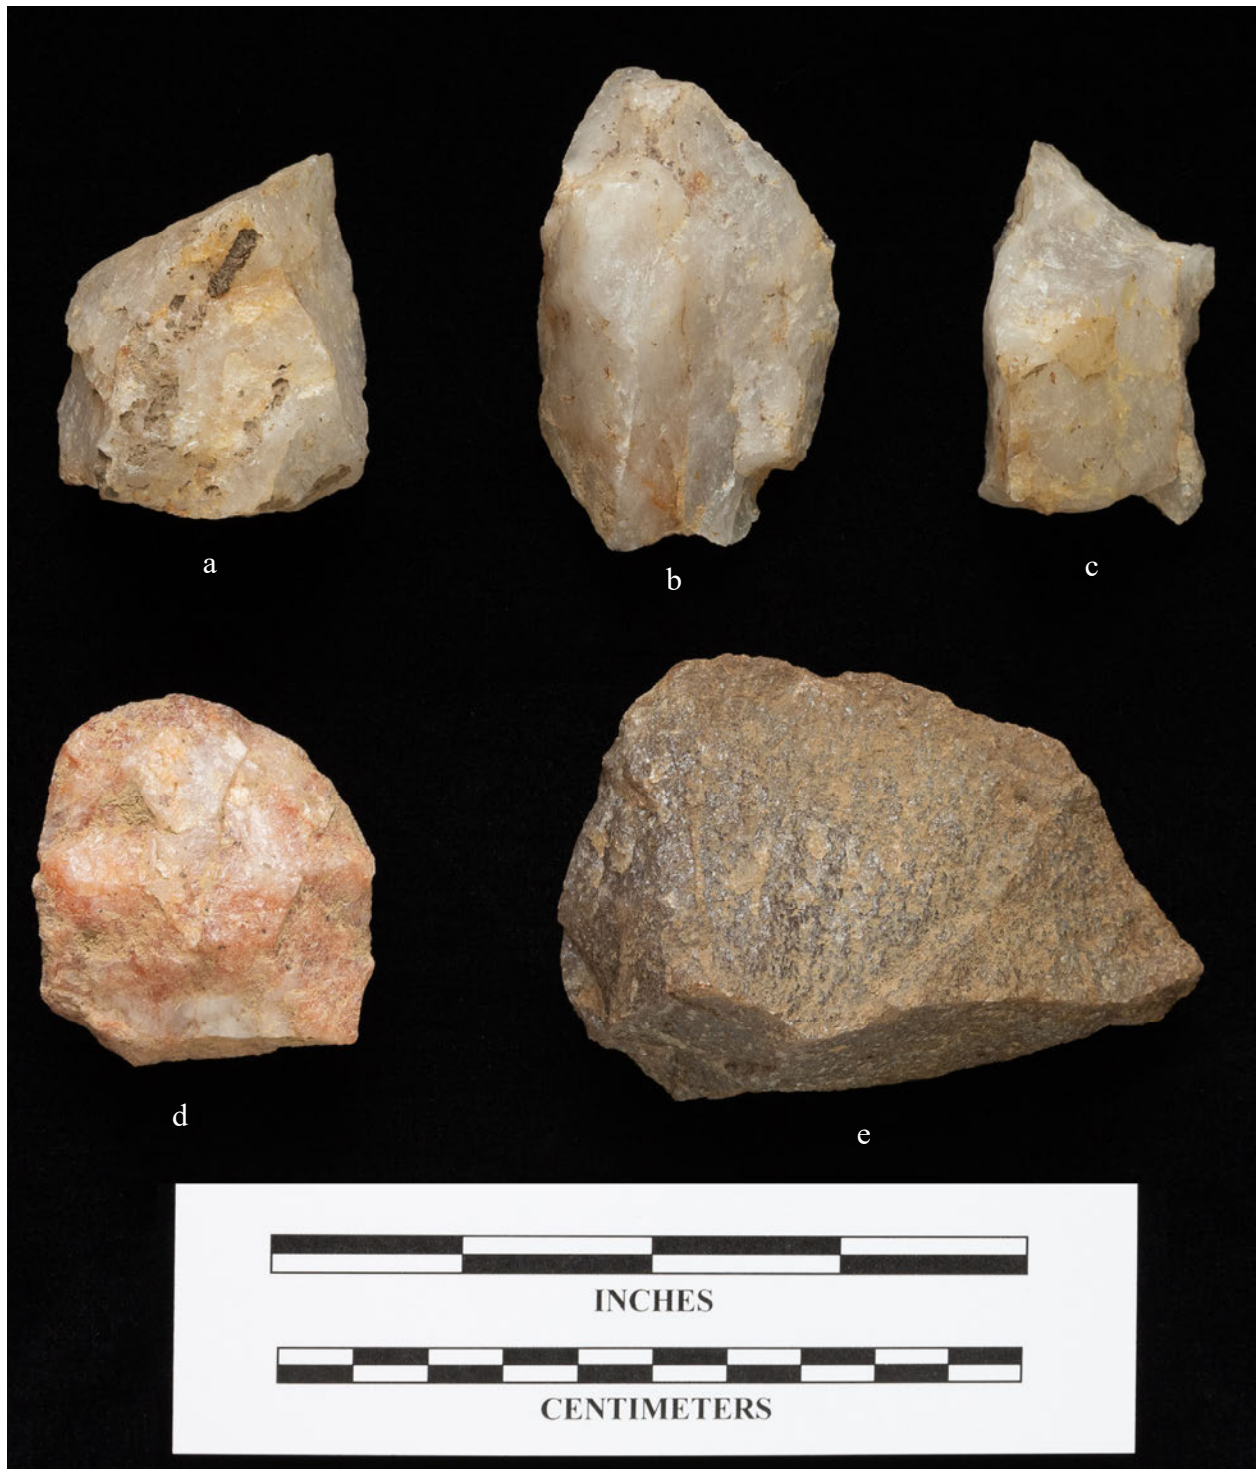
Figure 7.54. Representative Large Cores from Site 18PR1190. a, b) quartz amorphous core; c) quartz core fragment; d) quartzite exhausted core; e) quartzite core fragment

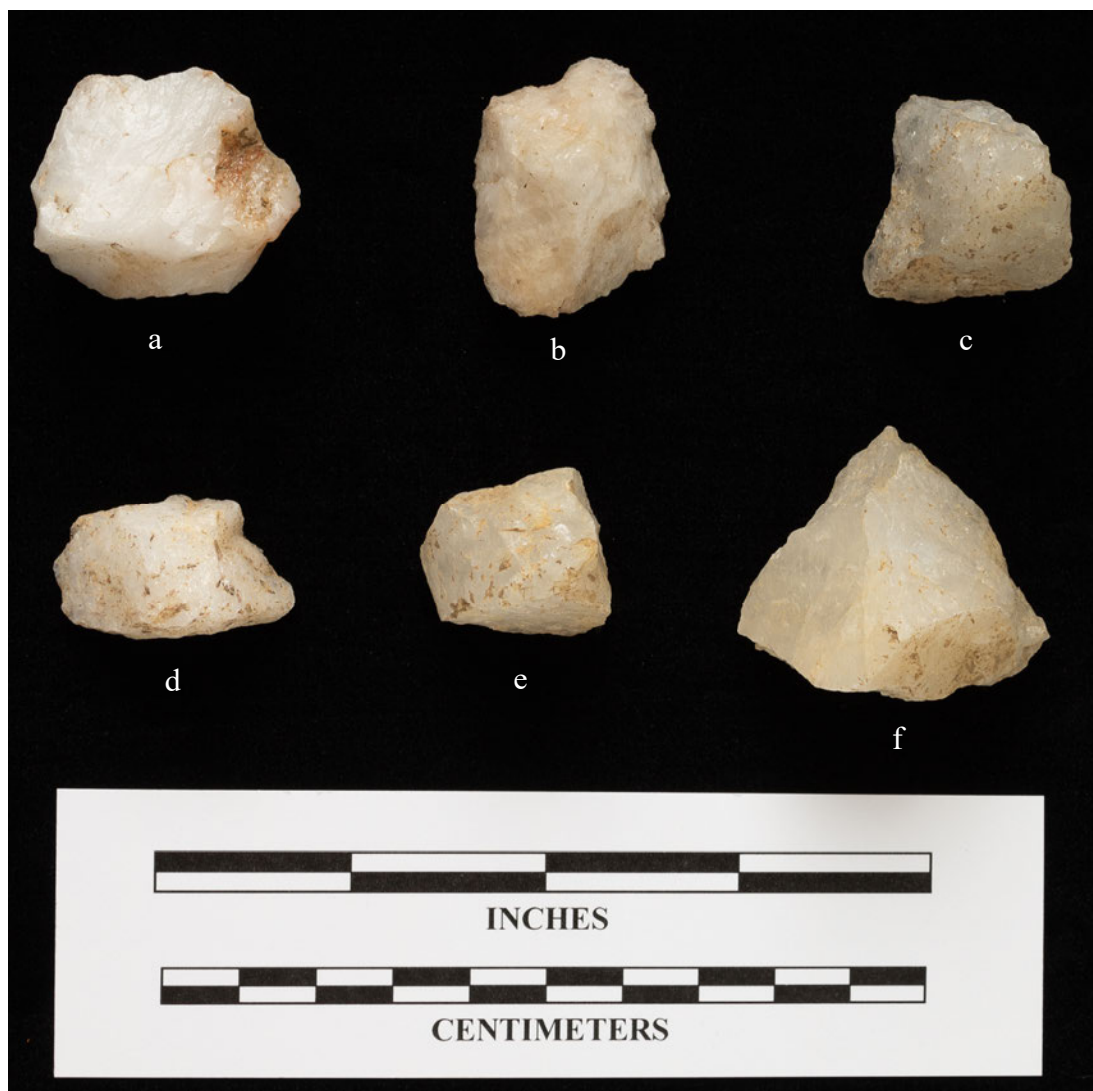
Figure 7.55. Representative Small Cores from Site 18PR1190. a, f) quartz core fragment; b) quartzite exhausted core; c) quartz bipolar core; d, e) quartz exhausted core

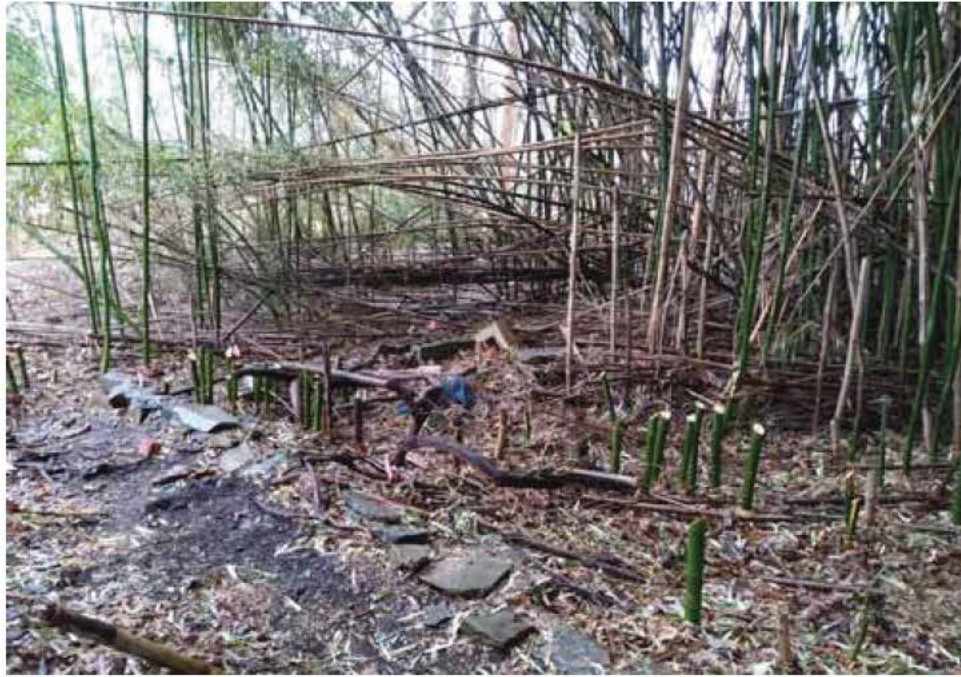
Figure 14: Exposed foundation of Moses Hall surrounded by bamboo, facing southeast (March 2020).

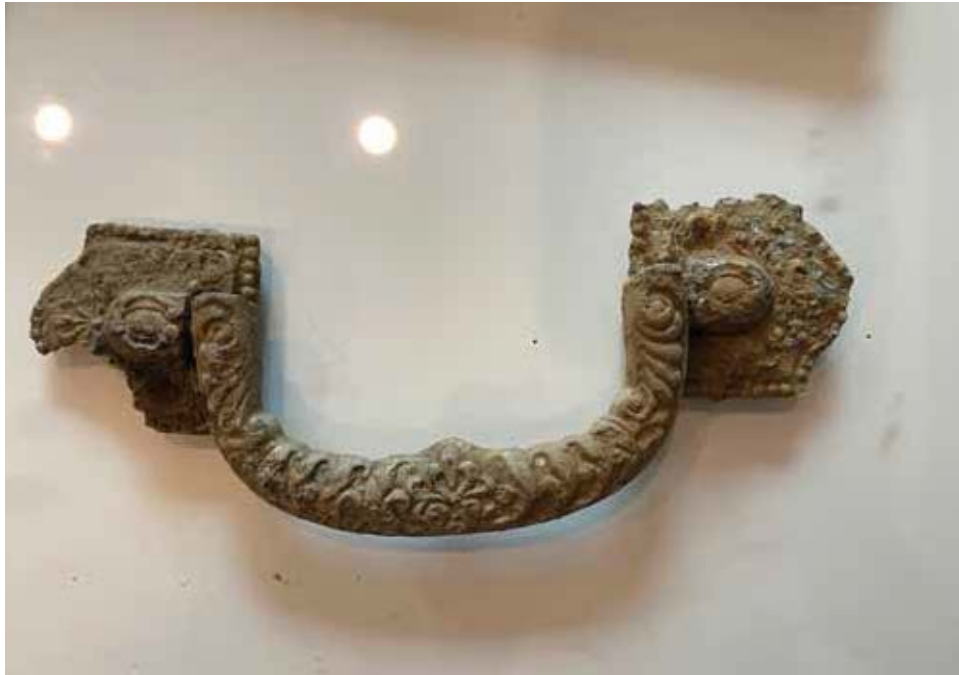
Figure 55: Metal bail-type burial container handle recovered from ground surface in Morningstar Cemetery (Front). Credit: Courtesy of the photographer, Charlotte Troup Leighton.

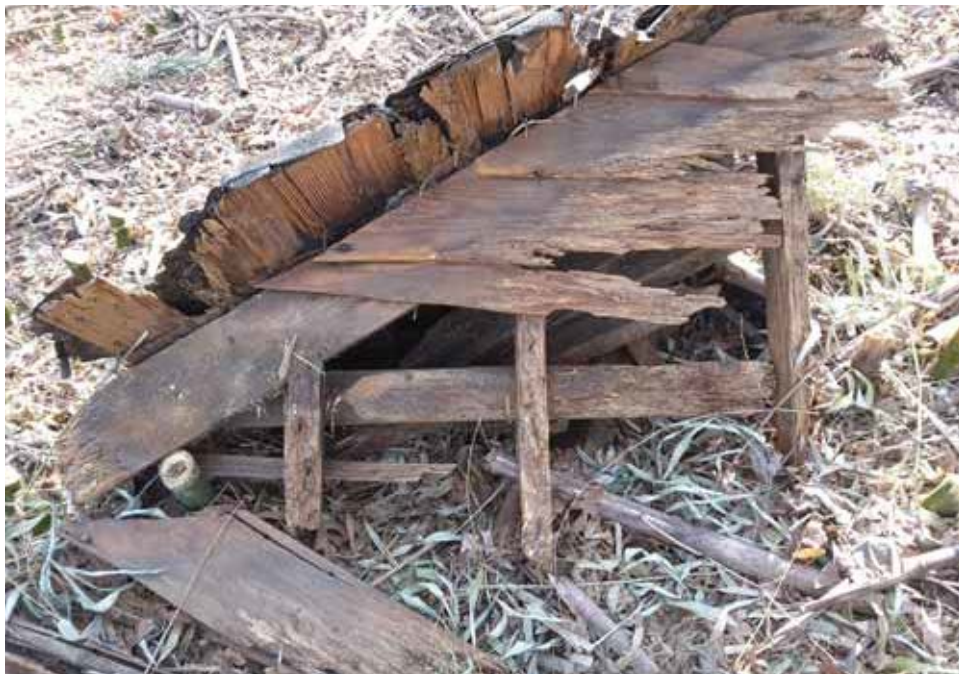
Figure 59: Close-up of a roof section, showing asphalt shingles (January 2021).
