I-495 & I-270 Managed Lanes Study

CA-5 STREAM RESTORATION DRAFT PHASE II MITIGATION PLAN

April 2022

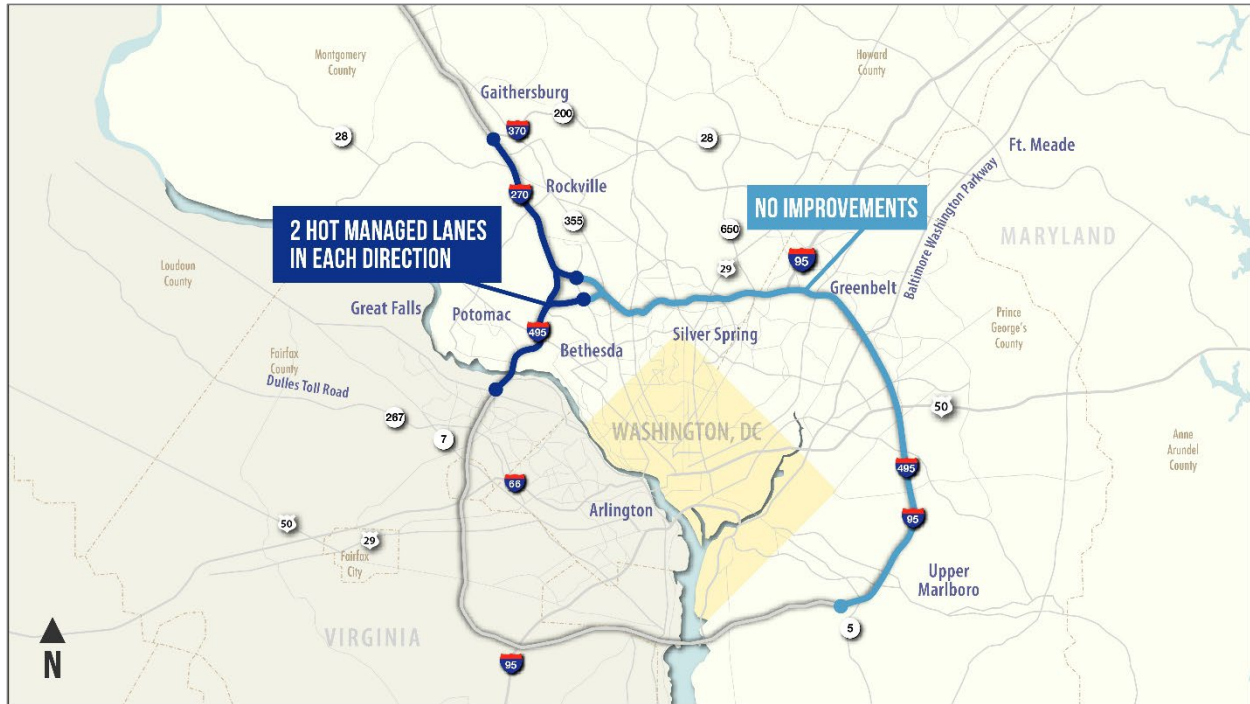
Figure 1 : I-495 & I-270 Managed Lanes Study Corridors – Preferred Alternative

370, including the east and west I-270 spurs in Montgomery and Prince George's Counties, Maryland (shown in both dark and light blue in **Figure 1**).

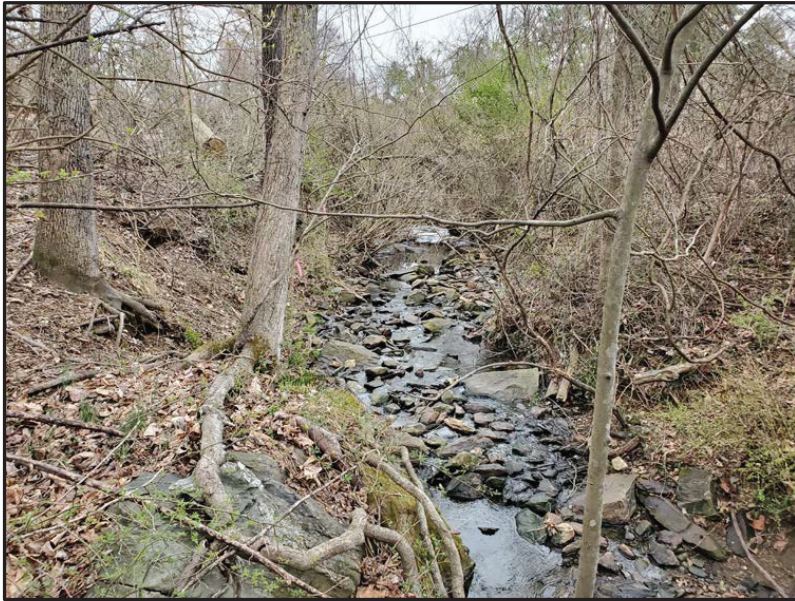
CA-5 Photo Point 1 Upstream; Long Pro Start

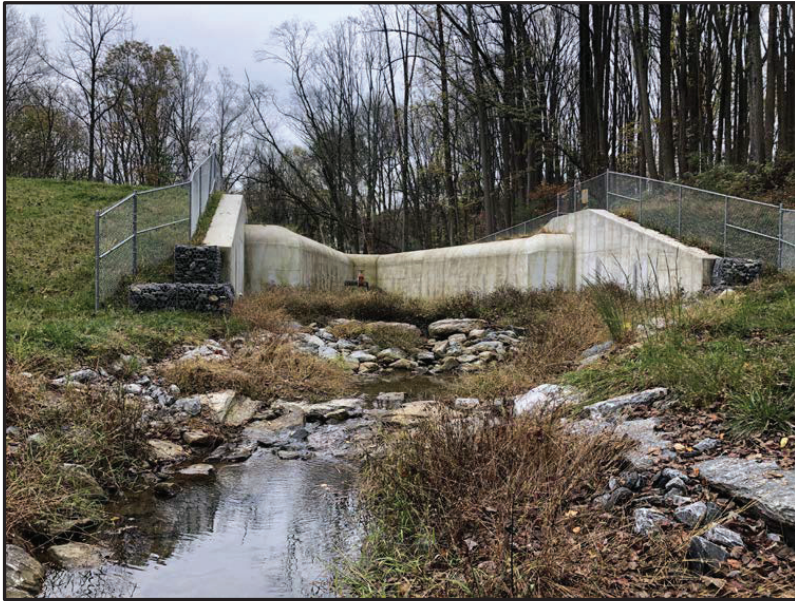
- CA-5 Photo Point 33 Upstream Main Channel

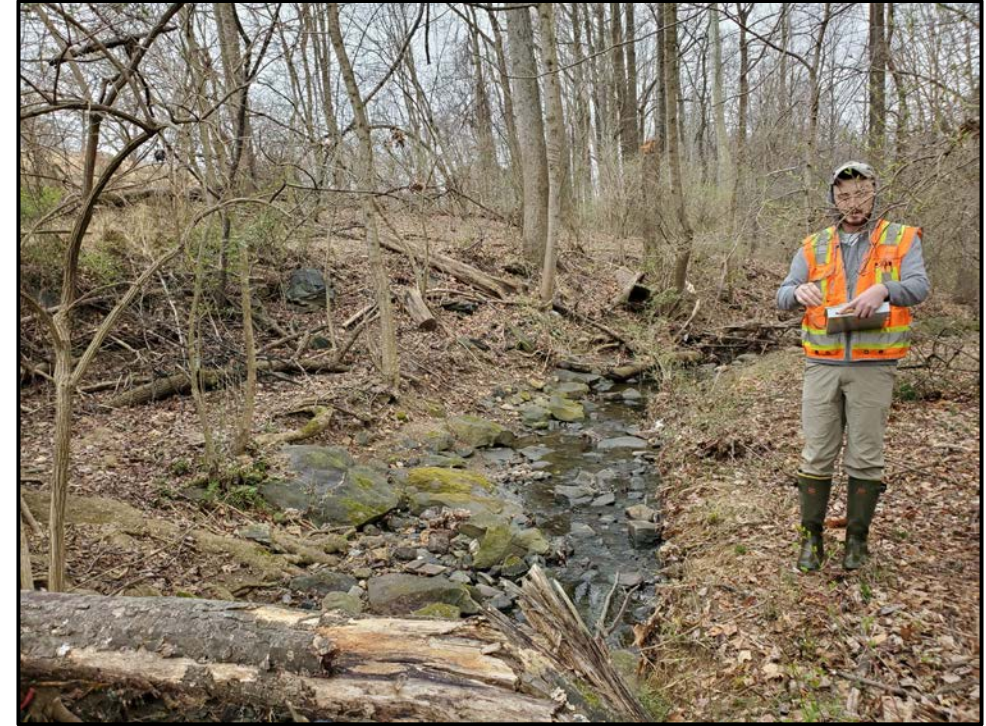
CA-5 Photo Point 1 Upstream; Long Pro Start

CA-5 Photo Point 1 Downstream

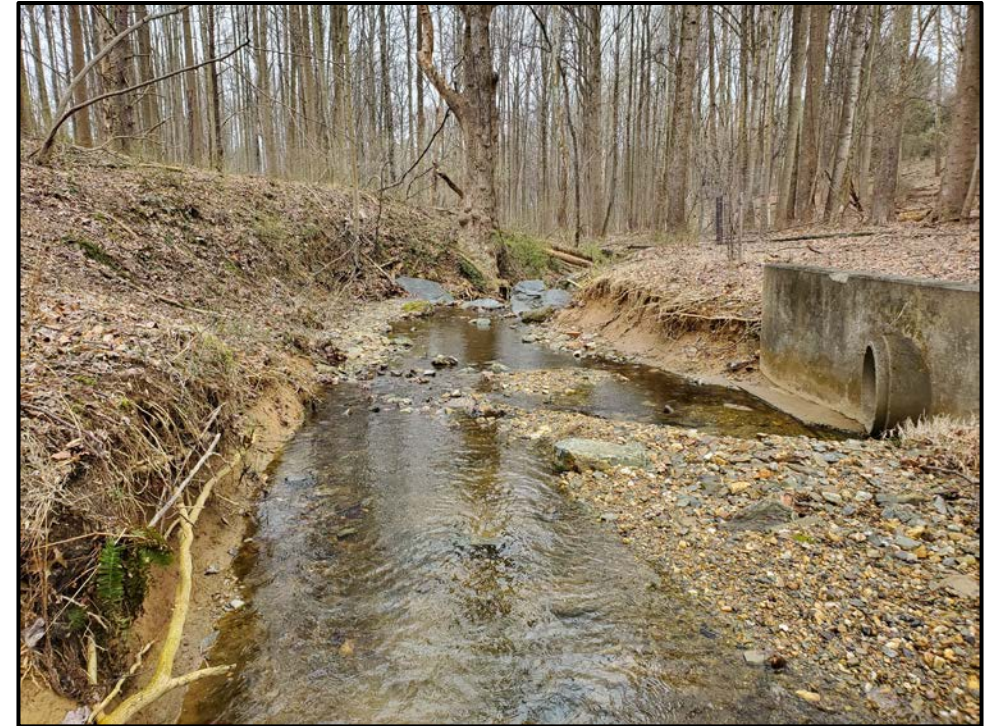
CA-5 Photo Point 10 Upstream at Confluence with Headcut Trib

CA-5 Photo Point 10 Downstream at Confluence with Headcut Trib

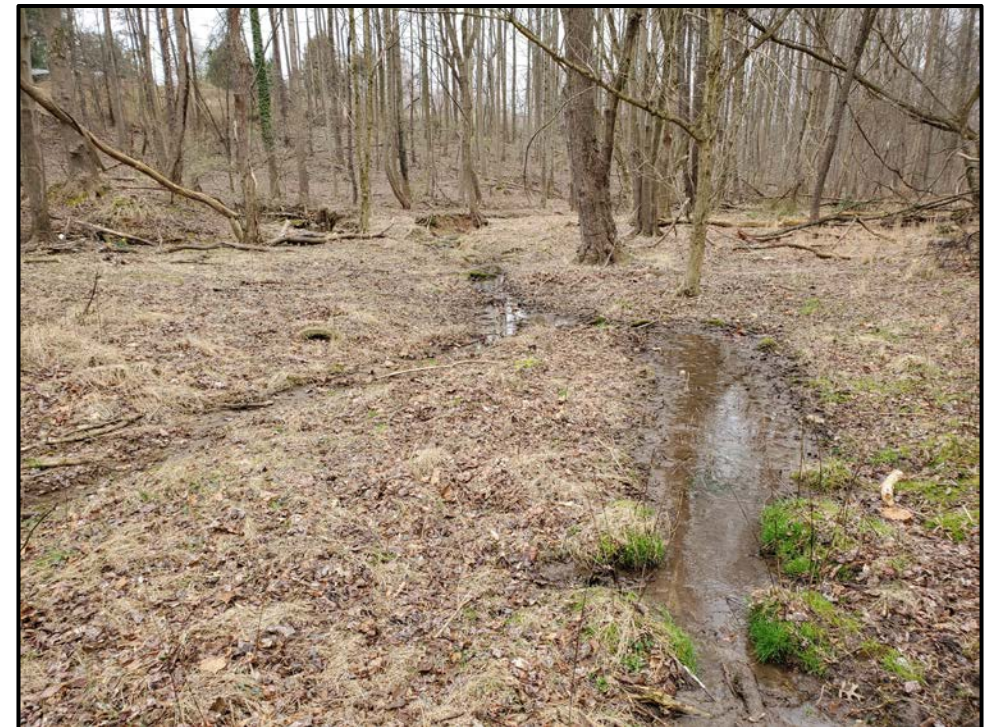
CA-5 Photo Point 201 Upstream at Groundwater
Seep Headcut

CA-5 Photo Point 201 Downstream at Groundwater
Seep Headcut

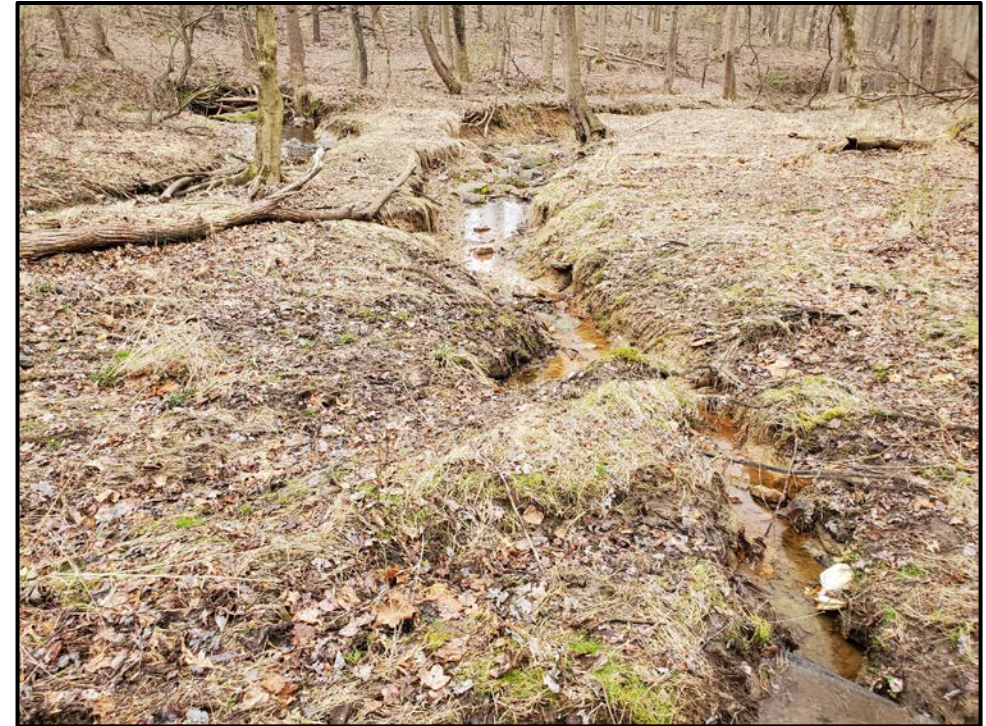
CA-5 Photo Point 202 Upstream Start of Headcut

CA-5 Photo Point 202 Downstream Start of Headcut
