APPENDIX K: PUBLIC PHASE I MITIGATION DESIGN PLANS

**I-495 & I-270 Managed Lanes Study
Wetland & Stream Mitigation - Crabbs Branch
Site AN-1**

I-495 & I-270 Managed Lanes Study
Phase I Mitigation Design Plan
Wetland/Stream Site AN-1
Crabbs Branch

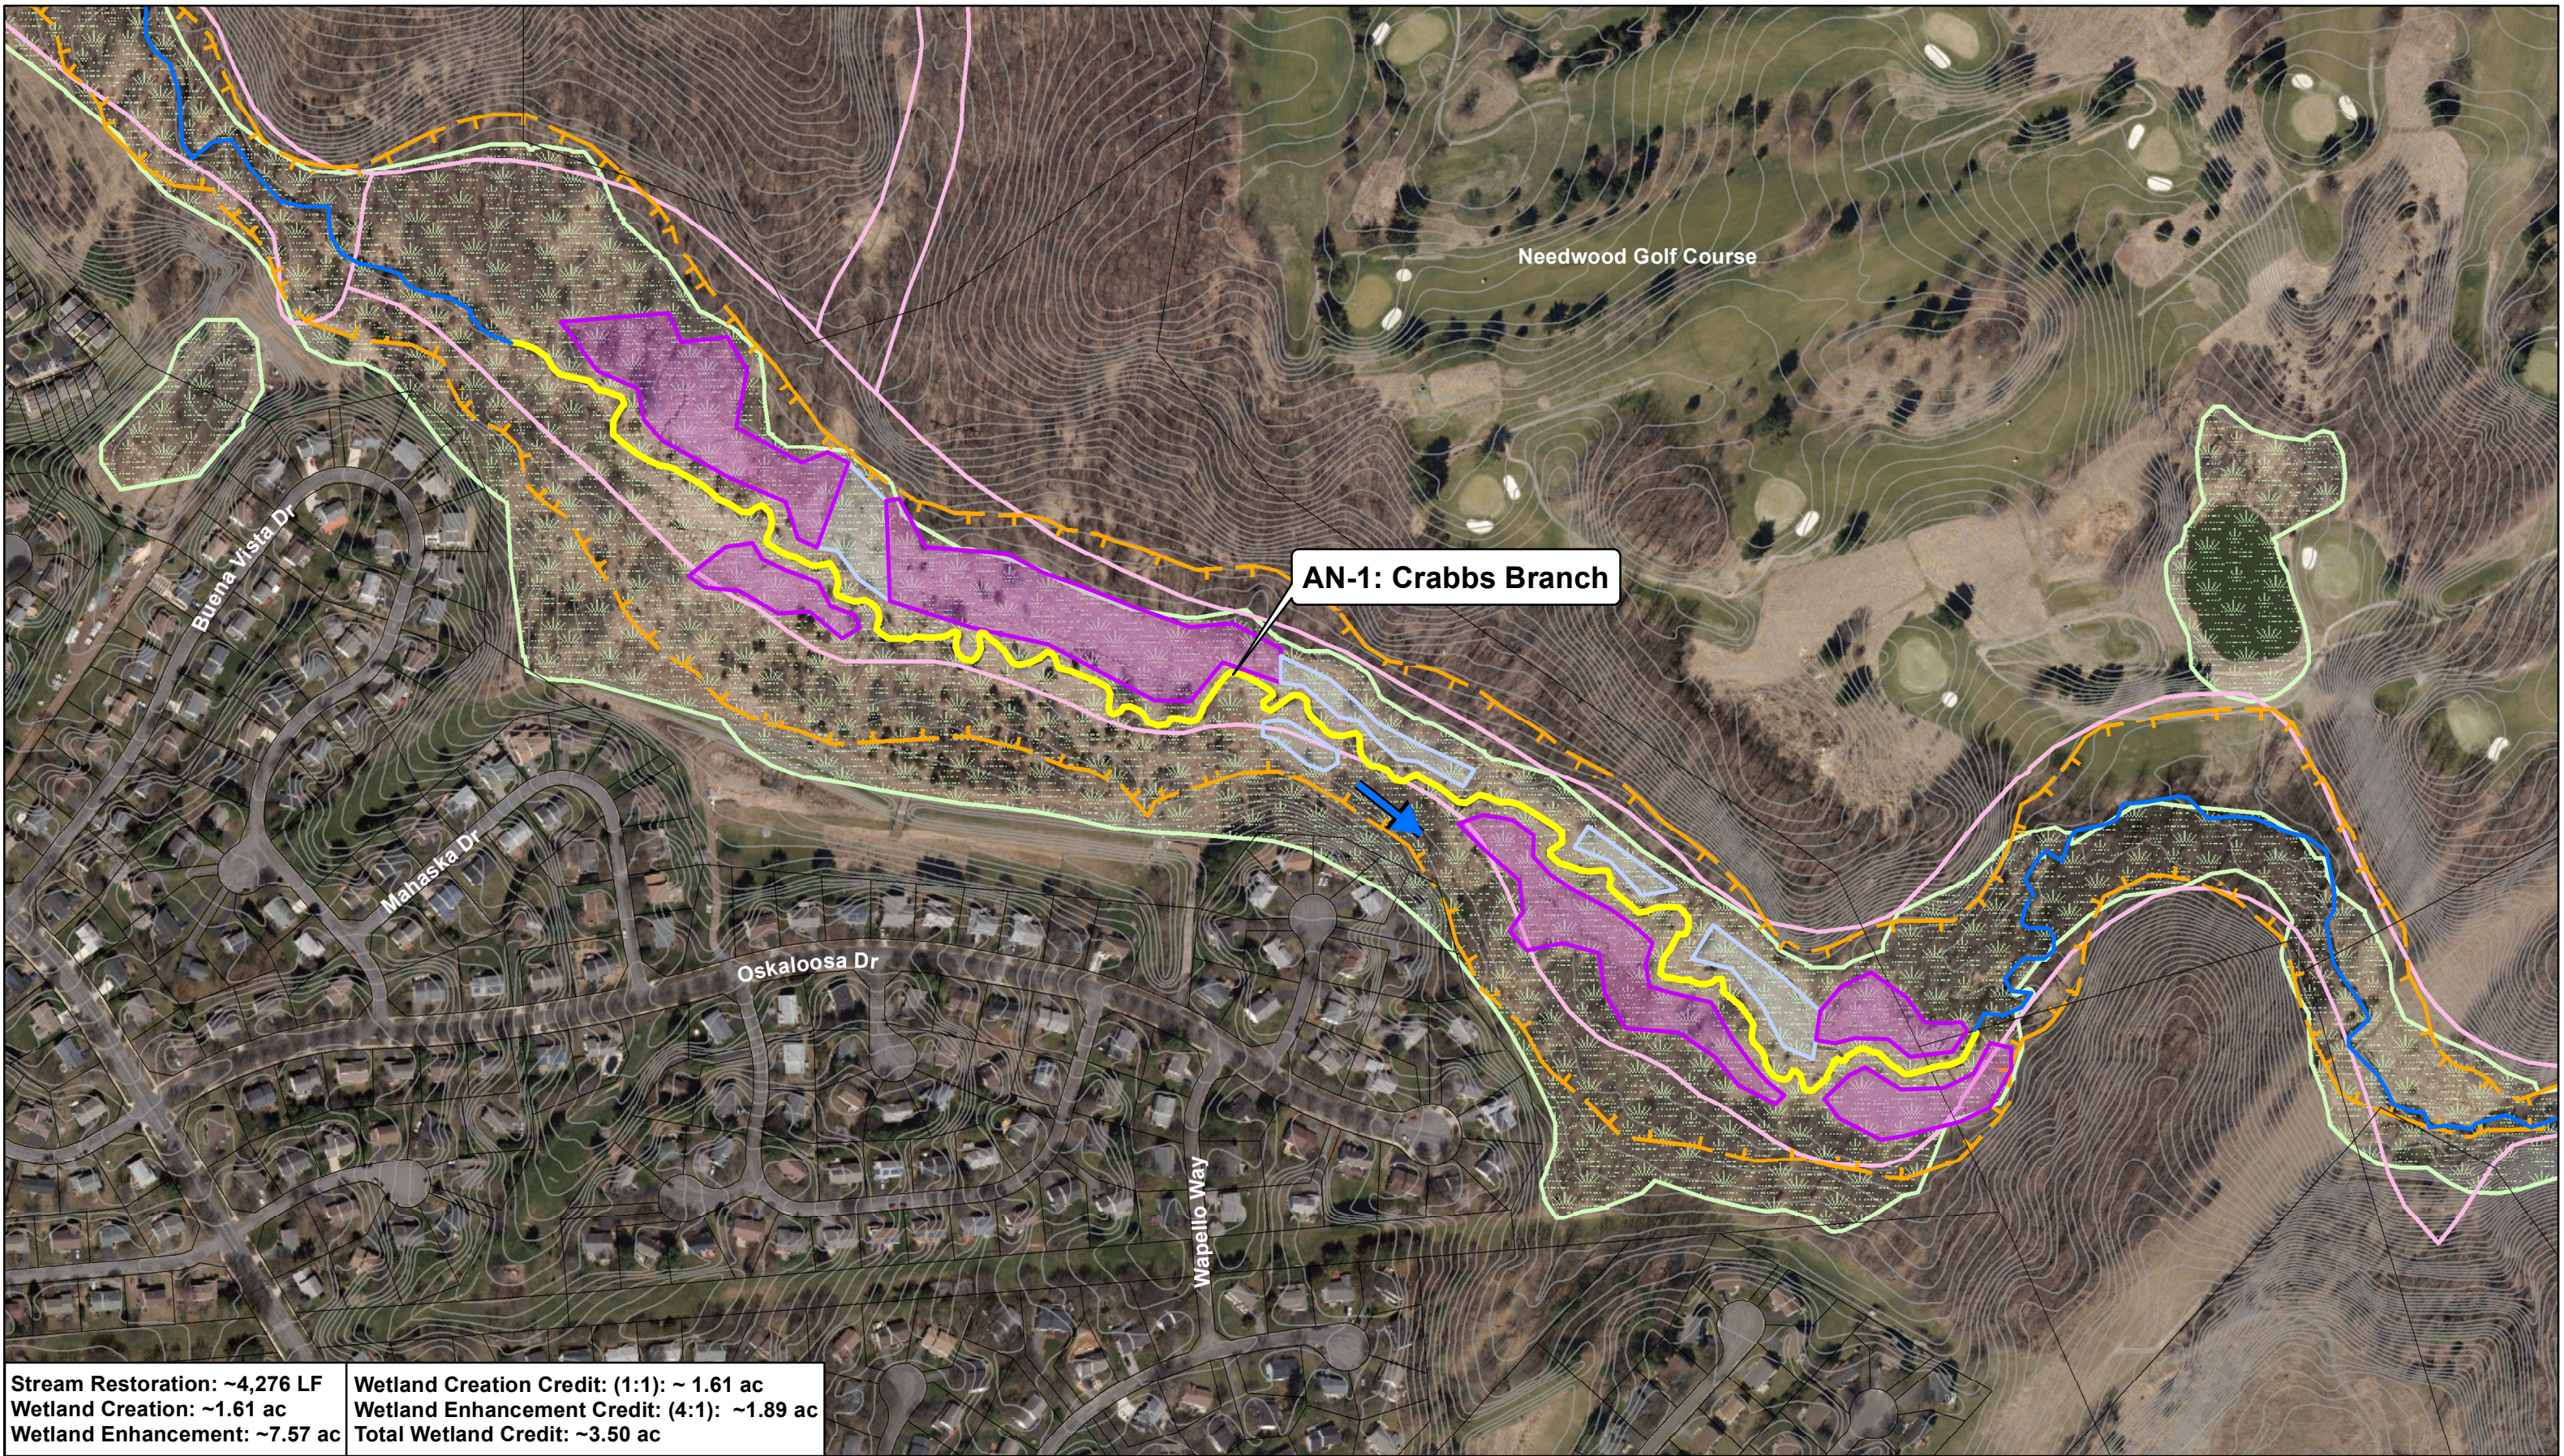
- Improve floodplain connection by lowering the floodplain in the downstream reach to provide more-frequent floodplain access to mitigate damage from erosive flood flows.
- Grade back and vegetate vertical banks to reduce erosion and instream sedimentation
- Installation of instream structures to provide channel stability and habitat diversity
- Minor floodplain grading to expand existing wetlands and restore groundwater hydrology
- Restore forested floodplain habitat by invasive species treatment and planting native trees and shrubs

Stream Site	Streams	Parcel Boundaries
Wetland Creation	NWI/DNR Wetlands	Hydric Soils
Wetland Enhancement	FEMA Floodplain	2' Contours

AN-1 is a stream and wetland restoration site located along Crabbs Branch, just east of the intersection of Redland Road and Crabbs Branch Way. The site was recommended by M-NCPPC and consists of an incised channel surrounded by a mid-successional forest in the upper reach and an open meadow with scattered trees in the lower reach. The stream is highly unstable with torturous meanders and severe erosion along 3-8 foot tall vertical banks. The hydrology and morphology of the site have been influenced by anthropogenic influences such as the upstream online Crabbs Branch Regional Stormwater Pond, residential development encroachment on the floodplain, and buried infrastructure that crosses the channel. The lower floodplain consists of wetlands dominated by invasive reed canary grass that is preventing forest regeneration. There is potential access at the upstream end of the site off of Crabbs Branch Way and through an HOA road off of Oskaloosa Drive at the downstream end of the site.

- Stream Restoration – Approximately 4,276 linear feet
- Wetland Restoration – Approximately 1.61 acres of Creation (~1.61 acres credit) & 7.57 acres of Enhancement (~1.89 acres credit)

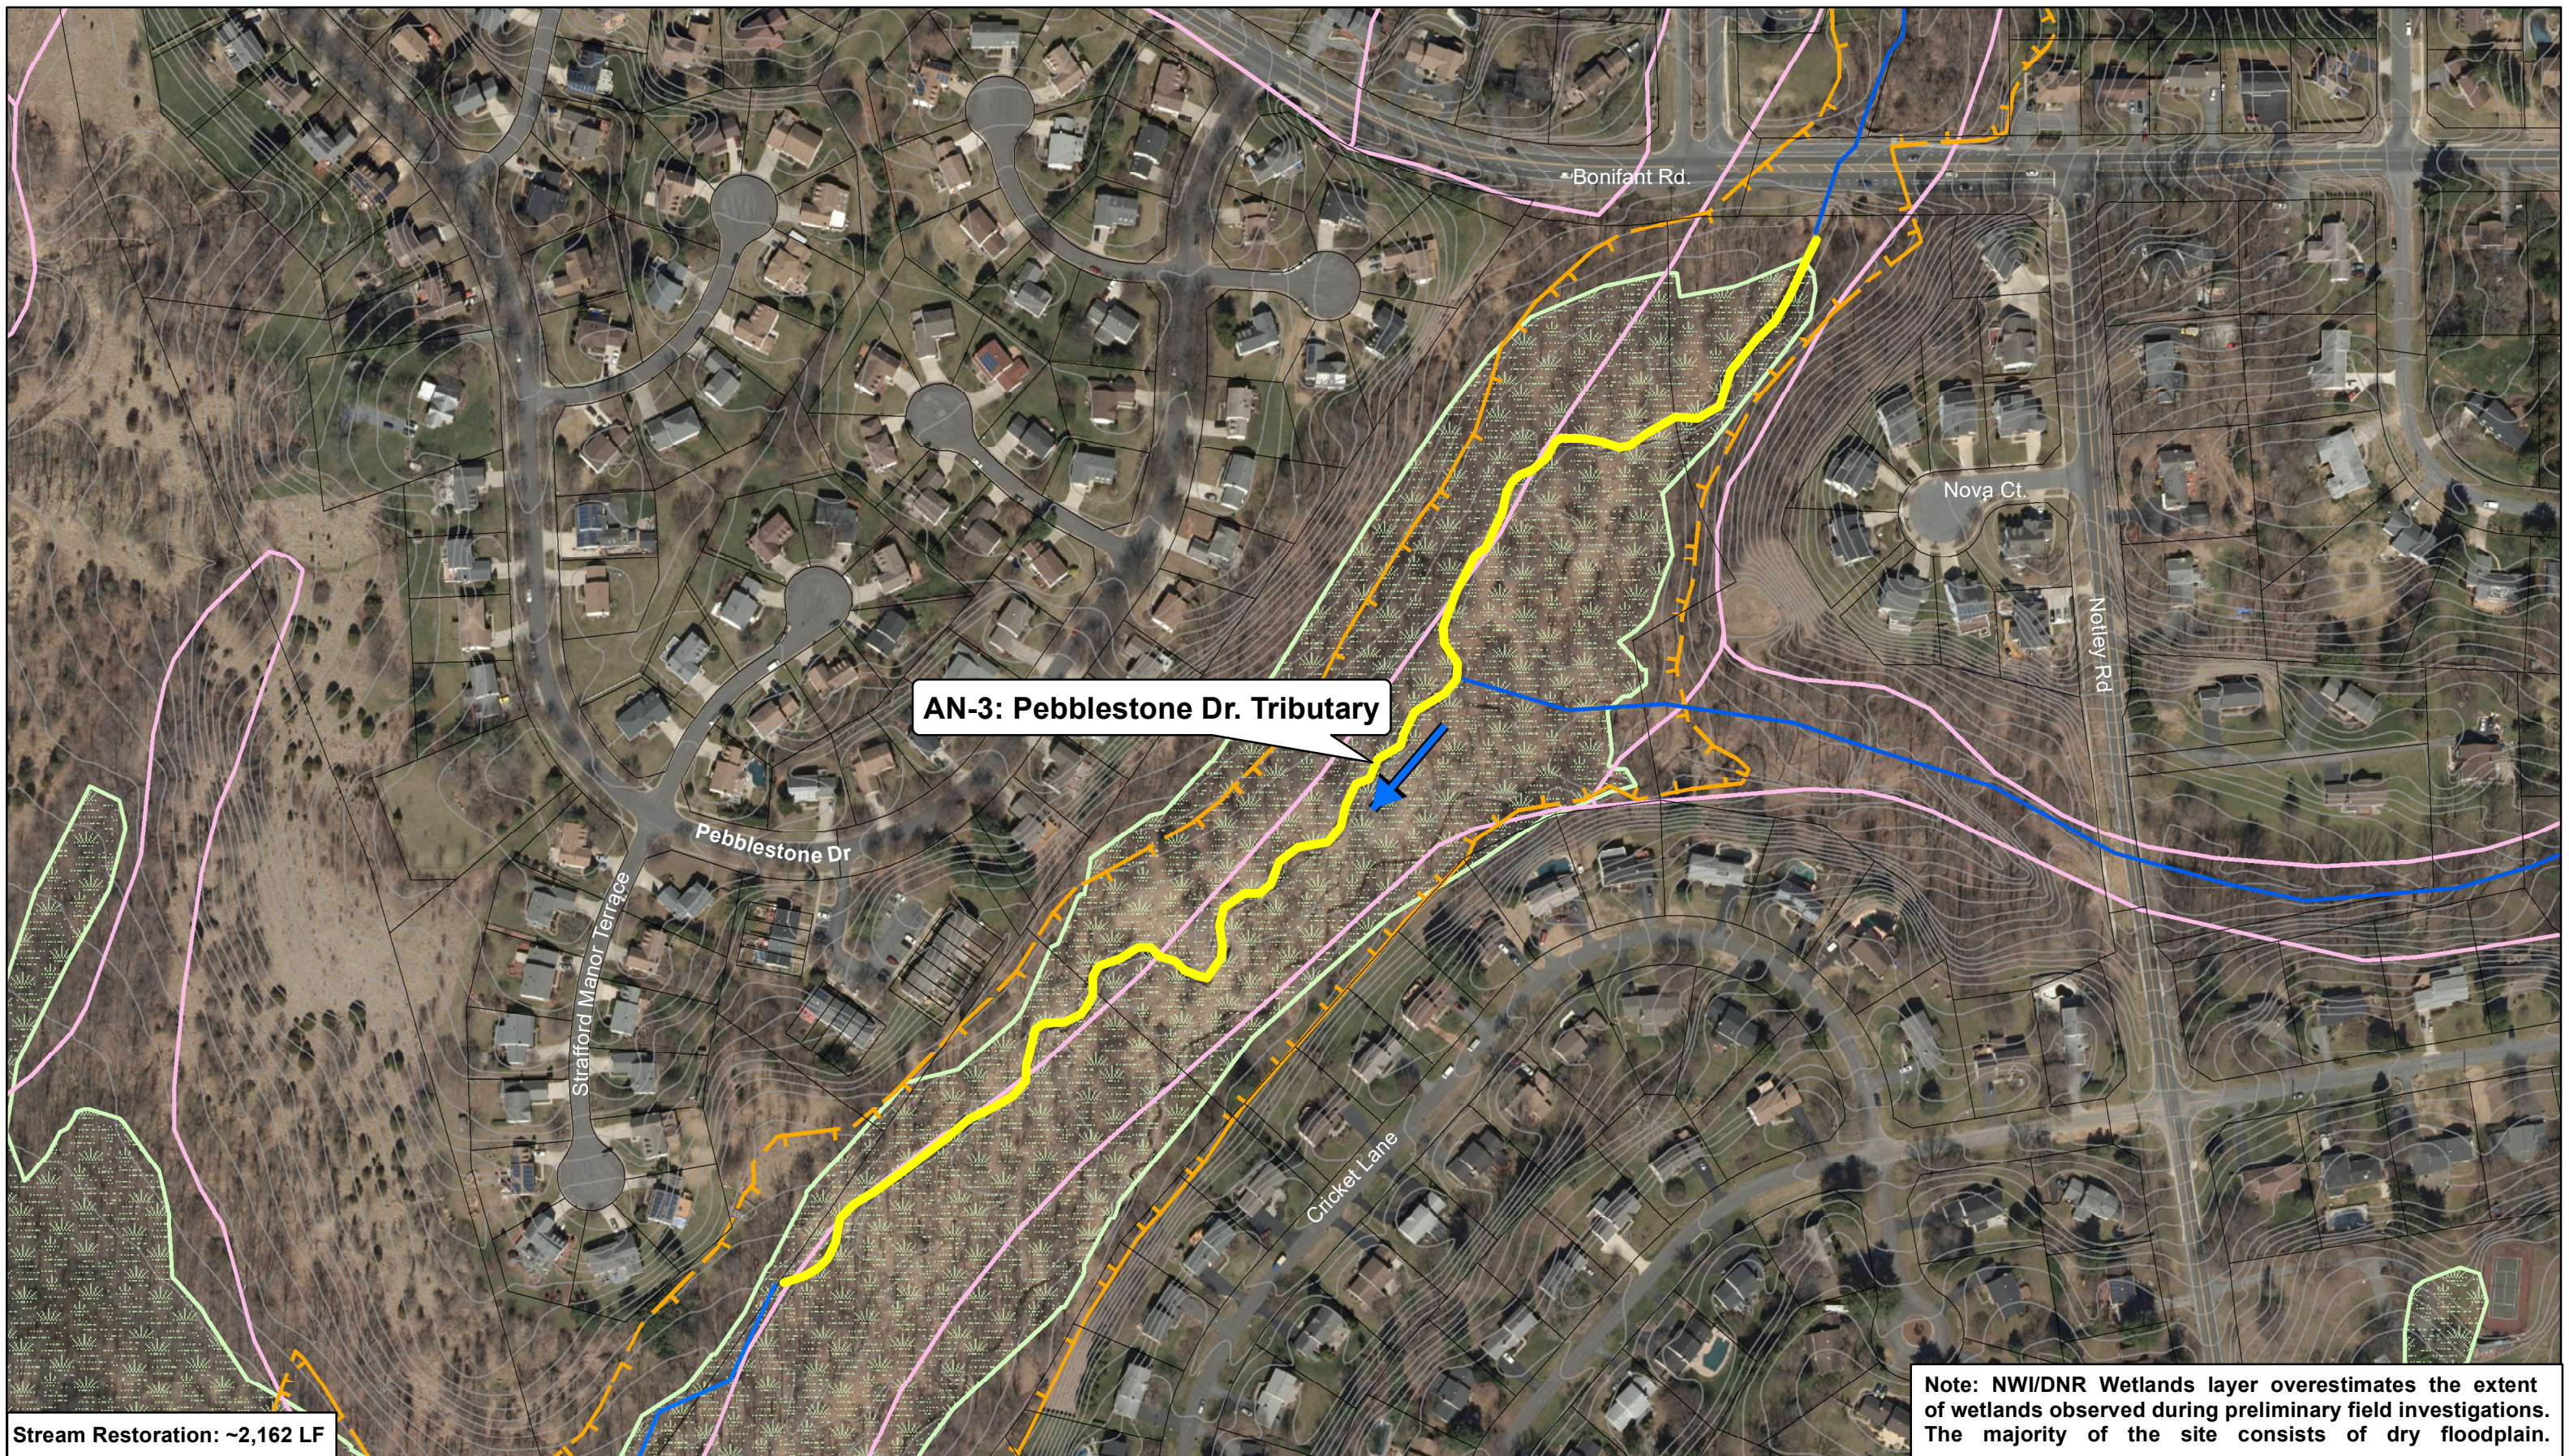
I-495 & I-270 Managed Lanes Study
Phase I Mitigation Design Plan
Stream Site AN-3
Pebblestone Dr. Tributary

- Grade and vegetate vertical banks to reduce erosion and instream sedimentation
- Install instream structures to reduce channel incision and improve fish and benthic habitat
- Improve floodplain connection by raising the stream bed and/or creating floodplain benches to provide more-frequent floodplain access to mitigate damage from erosive flood flows
- Provide fish passage over existing rip-rap by raising the stream bed to allow access to 0.59 miles of potential upstream habitat
- Installation of instream structures to protect exposed utilities
- Riparian habitat enhancements by invasive species treatment and seeding/planting native species
- Improve plan and profile of existing stream to enhance stream functions

Stream Restoration: ~2,162 LF

AN-3 is a stream restoration site located along an unnamed tributary to Northwest Branch, just east of Pebble Stone Drive. The site was recommended by M-NCPPC and consists of a deeply incised channel surrounded by a mid-successional forest with extensive herbaceous invasives. The majority of the reach is highly unstable with severe erosion along 3-8 foot tall vertical banks and extensive deposition bars within the channel. A 1-2 foot tall fish blockage over rip-rap and an exposed sewer line were observed at the upstream and downstream ends of the site. There is potential access, which would require minimal tree impacts, through open canopy areas dominated by invasives and along an old route that was used for a previous ICC stream restoration project (NW-4) located within the same stream valley.

- Stream restoration – Approximately 2,162 linear feet

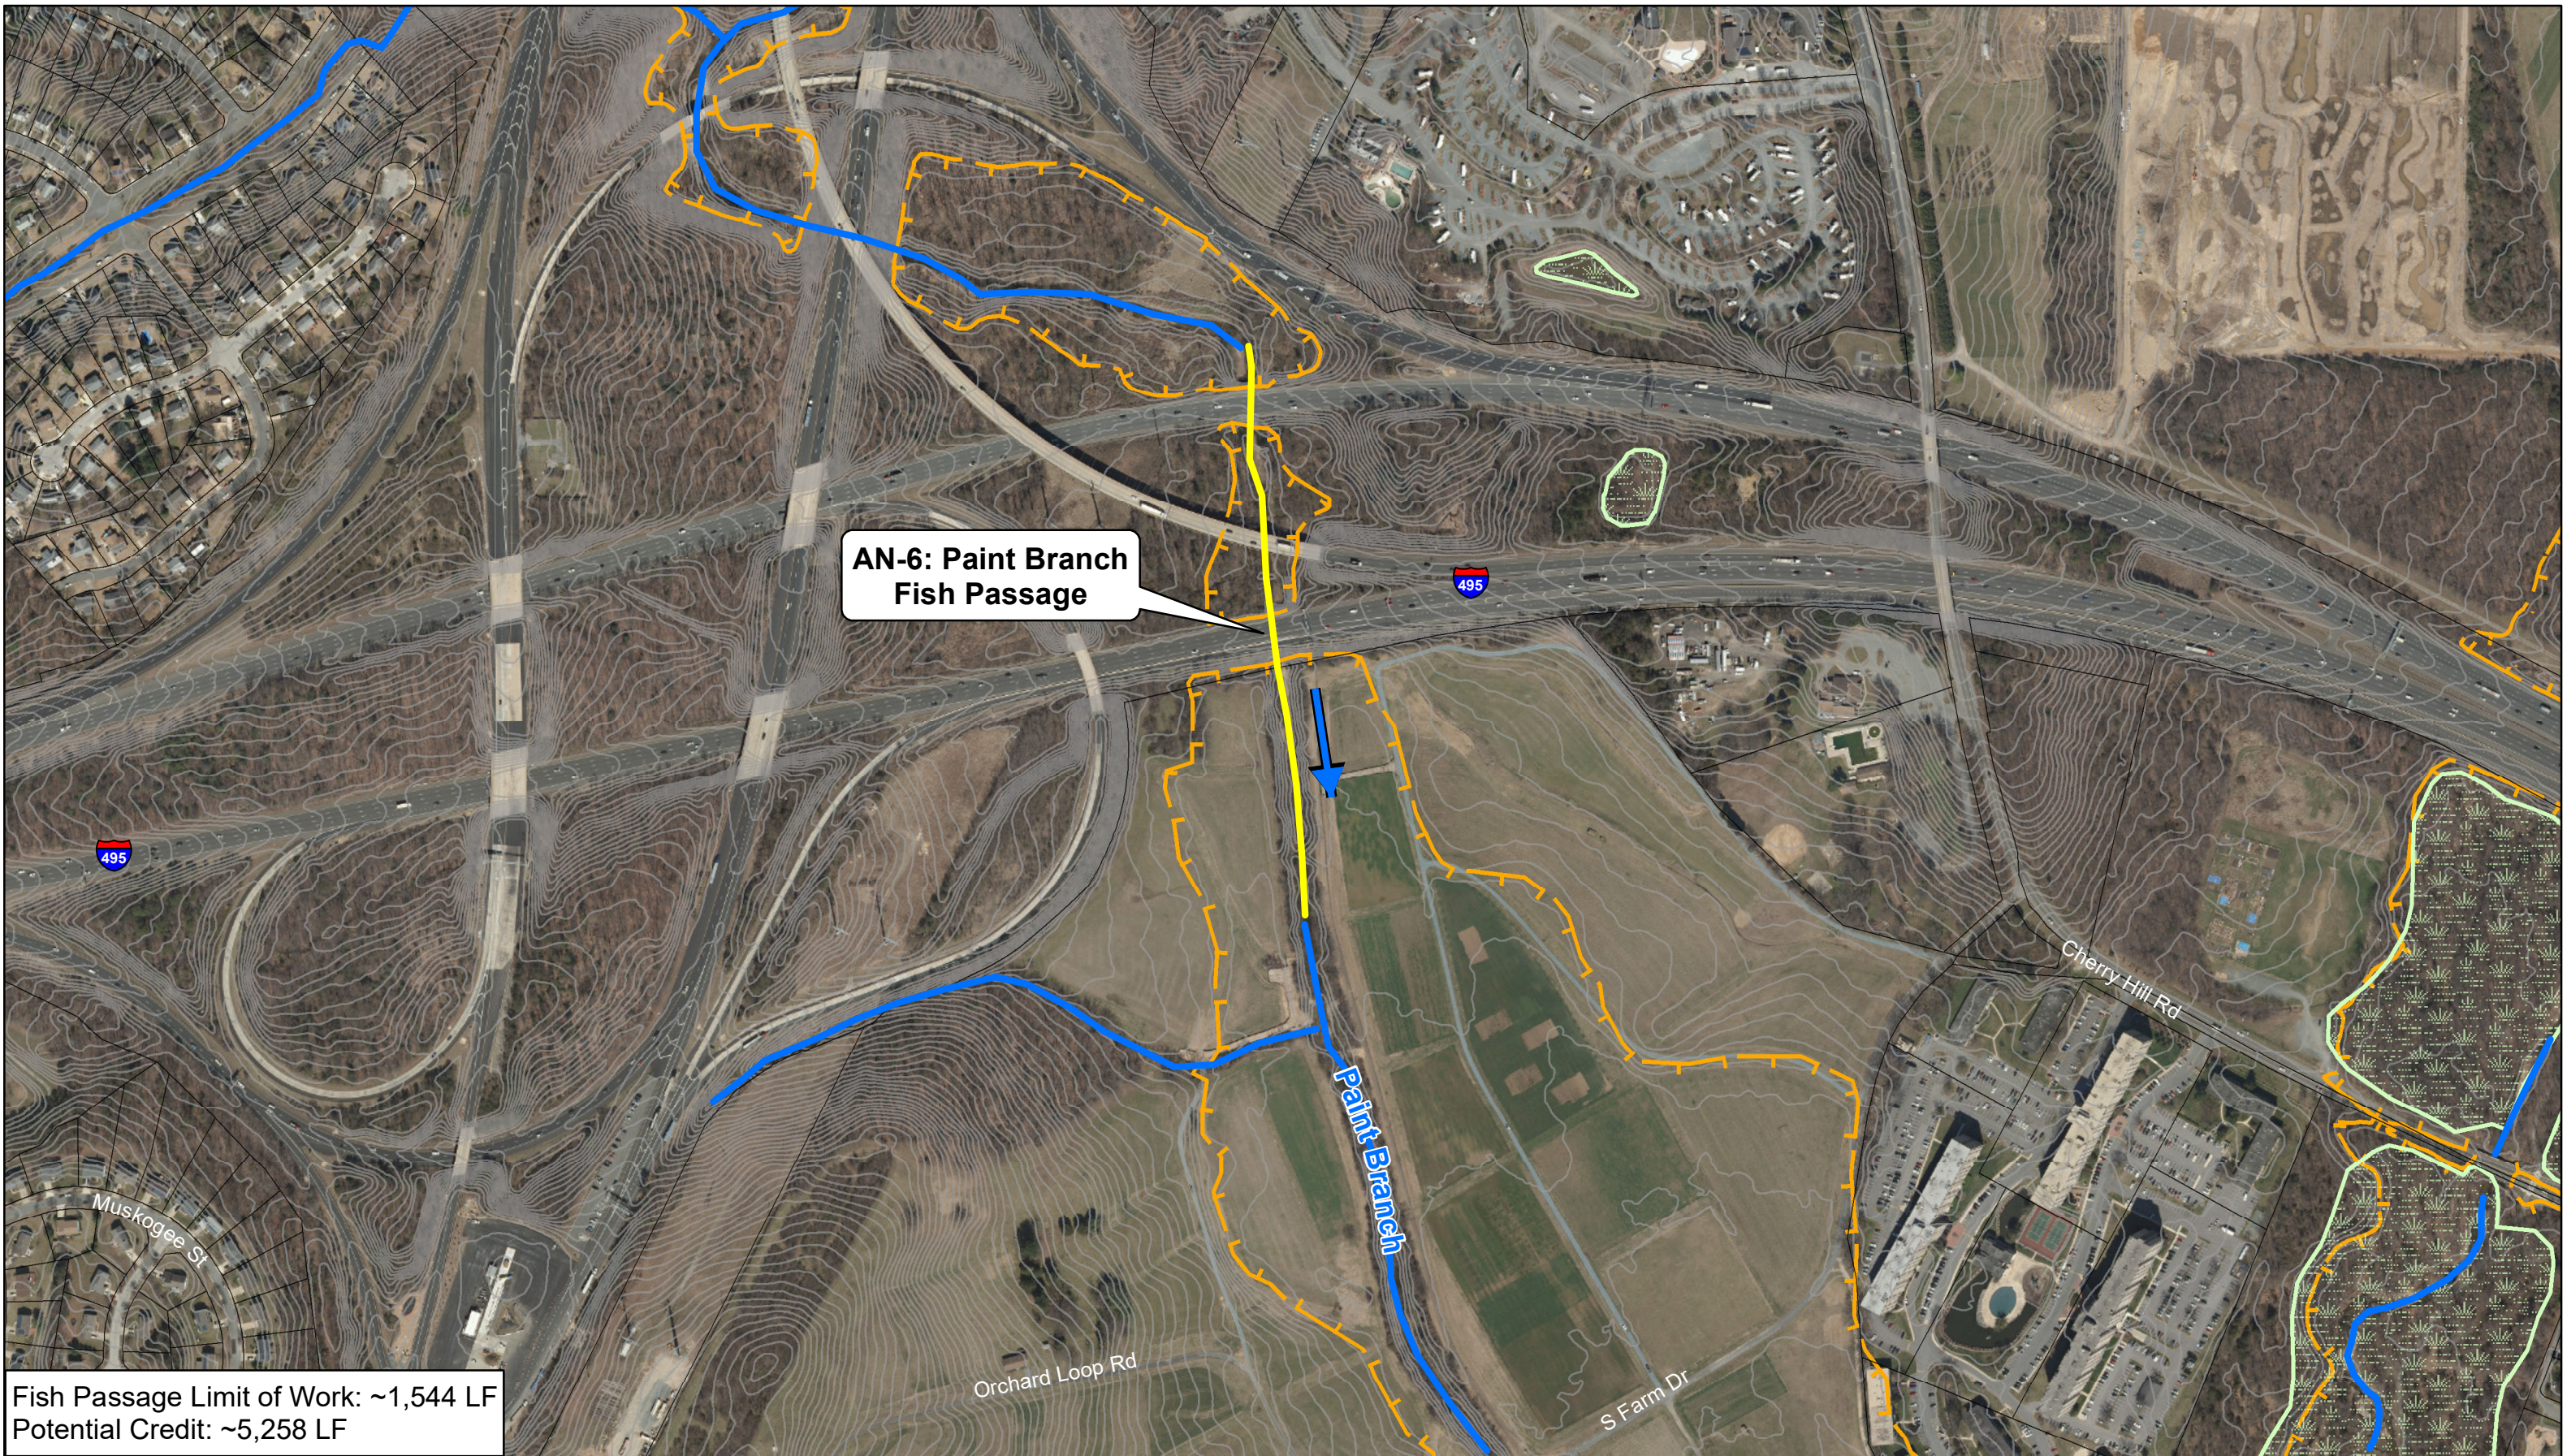
I-495 & I-270 Managed Lanes Study
Phase I Mitigation Design Plan
Stream Site AN-6
Paint Branch Fish Passage

- Demolition of failed fish passages and removal of upstream debris jam
- Incrementally raise the stream elevation through a series of constructed riffles placed downstream of the culverts
- Backwater both culverts to allow passage, while maintaining hydraulic capacity of the culverts during high flow events
- Riparian habitat enhancements by planting native tree and shrub species

Fish Passage Limit of Work: ~1,544 LF
Potential Credit: ~5,258 LF

AN-6 is a fish passage site located along Paint Branch, within the southeast portion of the I-495/I-95 Interchange. The site was originally investigated and designed to 90% for the Greenbelt Metro Access Project, before the project was canceled in 2017. The site consists of two quadruple cell box culverts (10' X 14') under I-495 that have created one-foot tall fish blockages. Fish ladders were installed just downstream of the culverts in the 1990's, but have failed since. During preliminary field investigations, a debris jam was observed at the upstream culvert that has created an additional 14-inch-tall temporary blockage. Removing these fish blockages would allow complete upstream access to 0.45 miles of high-quality habitat below a partial blockage at the I-95 northbound ramp culvert, and partial upstream access to an additional 13.84 miles of Paint Branch and its tributaries (2nd Order and greater). There is potential access to the site from the BARC property and SHA ROW that would require minimal tree impacts.

- Stream Restoration & Fish Blockage Removal – Approximately 1,544 linear feet (5,258 LF of potential credit)

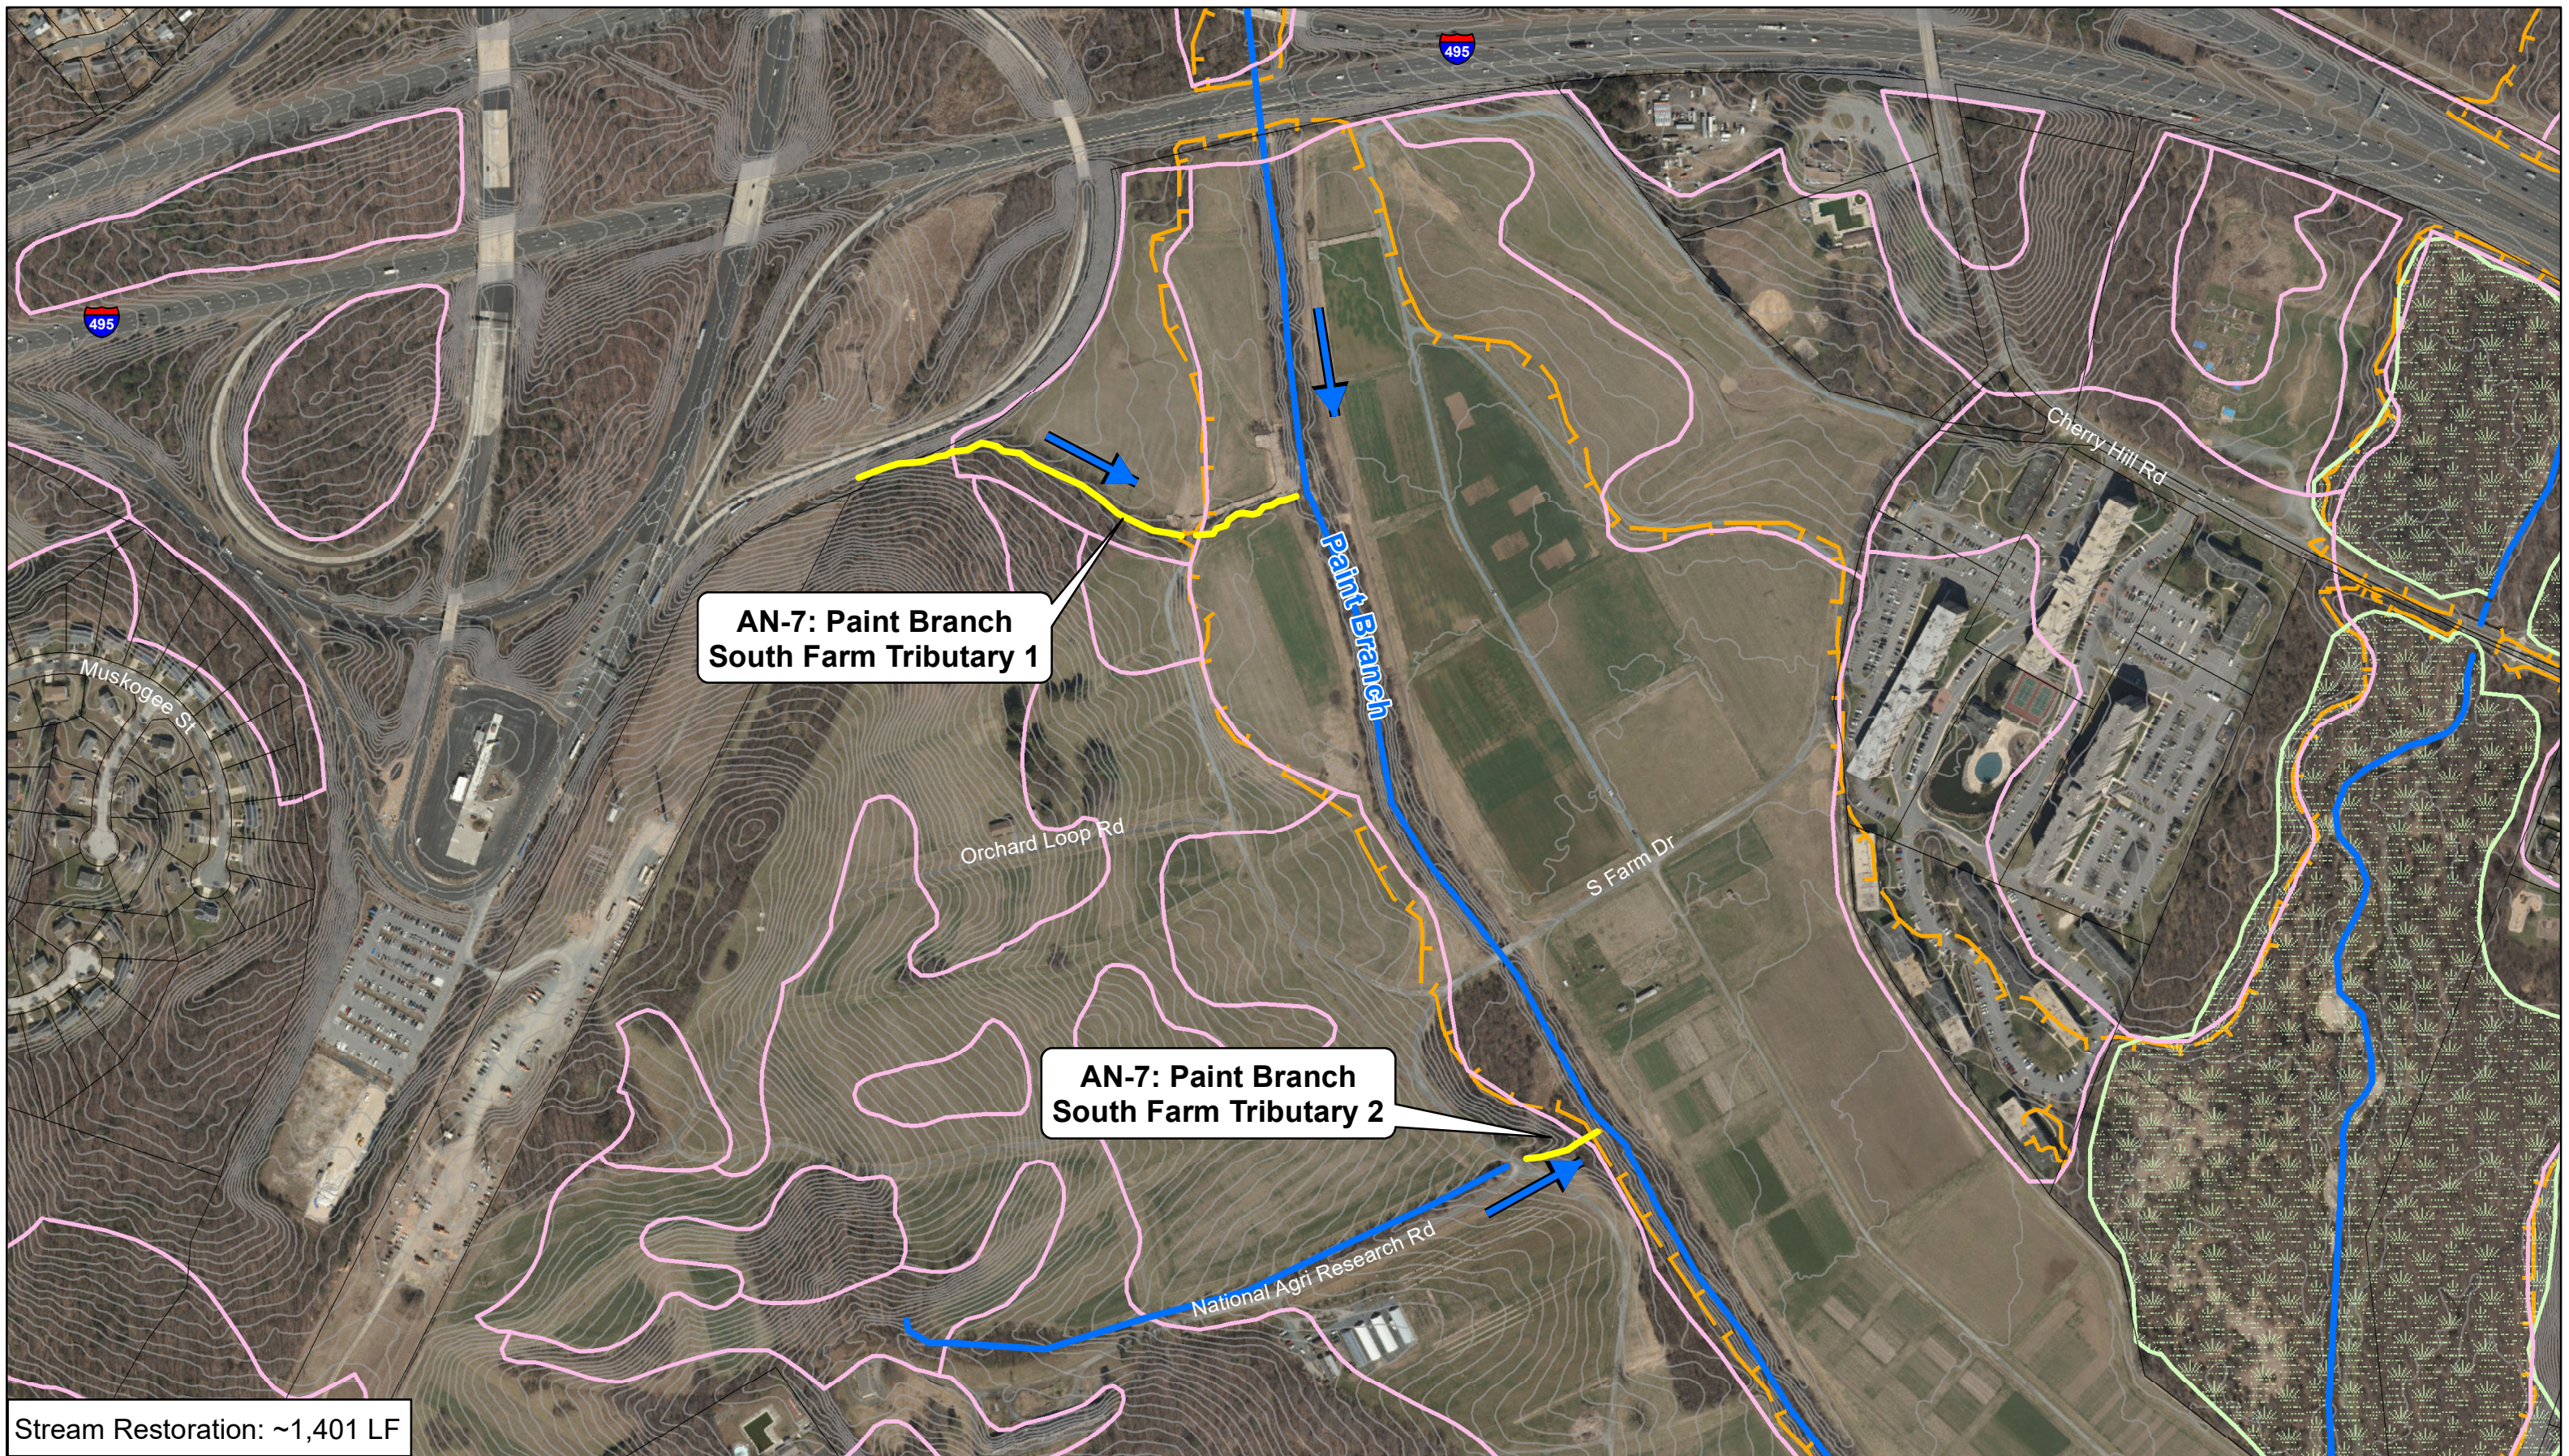
I-495 & I-270 Managed Lanes Study
Phase I Mitigation Design Plan
Stream Site AN-7
Paint Branch South Farm Tributaries

- Install instream structures to stabilize the stream bed, protect exposed utilities, and improve fish and benthic habitat
- Grade and vegetate banks to reduce erosion and instream sedimentation
- Provide fish passage at three blockages by raising the stream bed and/or removing failed culverts
- Riparian habitat enhancements by planting native trees and shrubs

Stream Restoration: ~1,401 LF

AN-7 is a stream restoration site located along two headwater streams that drain into Paint Branch, just southeast of the I-495/I-95 interchange. The site was recommended by BARC and consists of deeply incised channels surrounded by forest and agricultural fields. The northern tributary (Tributary 1) consists of a concrete lined channel and highly unstable natural channel that flows into a moderately stabilized section with localized erosion areas. There is a two-foot-tall fish blockage and exposed sewer line just downstream of where the concrete lined channel ends. The southern tributary (Tributary 2) is a small, incised channel with a failed culvert and culvert outfall channel that are creating fish blockages to an upstream reach that appears stable. There is direct access to the site from existing roads and fields, however access to the upstream end of Tributary 1 would require some forest impacts.

- Stream restoration & fish blockage removals – Approximately 1,401 linear feet

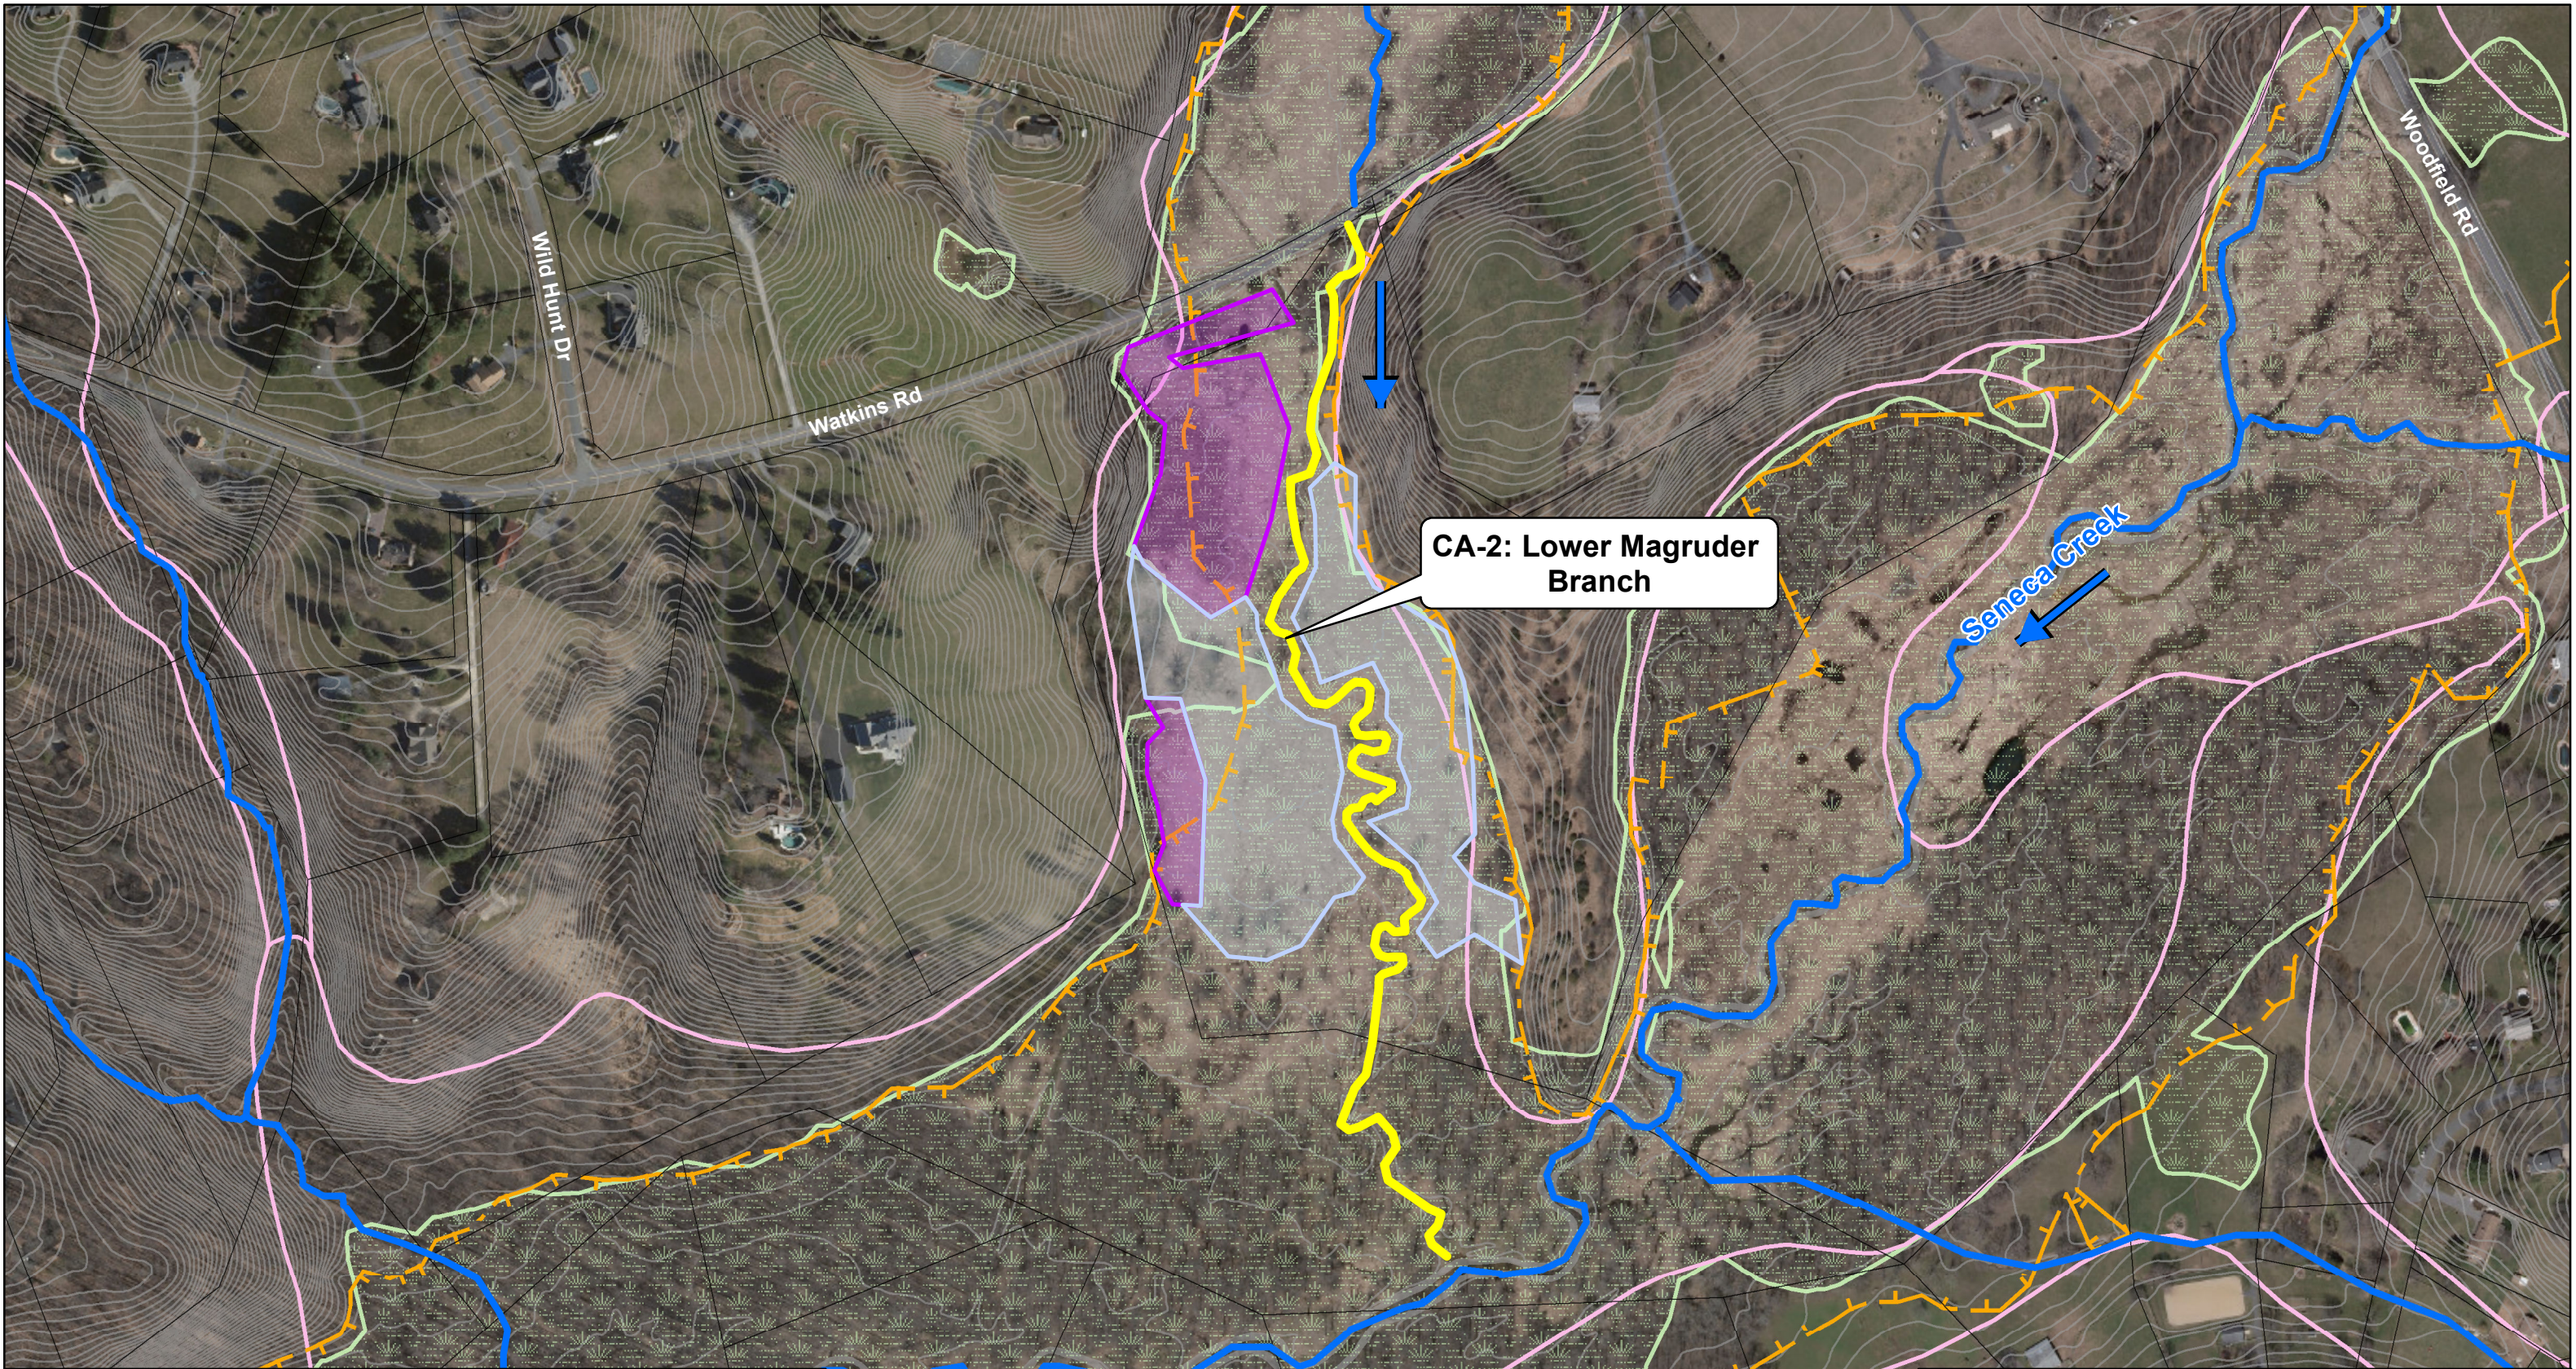
I-495 & I-270 Managed Lanes Study
Phase I Mitigation Design Plan
Wetland/Stream Site CA-2
Lower Magruder Branch

- Restore floodplain connection by relocating the channel, raising the stream bed, and/or excavating floodplain sediment to provide more-frequent floodplain access to mitigate damage from erosive flood flows.
- Installation of instream structures to provide channel stability, fish passage and habitat diversity
- Floodplain grading to expand existing wetlands and restore groundwater hydrology
- Restore forested floodplain habitat by invasive species treatment and planting native trees and shrubs

Stream Restoration: ~2,934 LF
Wetland Creation: ~7.07 ac
Wetland Enhancement: ~3.63 ac

Wetland Creation Credit: (1:1): ~7.07 ac
Wetland Enhancement Credit: (4:1): ~0.91 ac
Total Wetland Credit: ~7.98 ac

Note: NWI/DNR Wetlands layer overestimates the extent of wetlands observed during preliminary field investigations. The majority of the site consists of dry floodplain
