APPENDIX K: PUBLIC PHASE I MITIGATION DESIGN PLANS

**I-495 & I-270 Managed Lanes Study
Wetland & Stream Mitigation - Crabbs Branch
Site AN-1**

I-495 & I-270 Managed Lanes Study
Phase I Mitigation Design Plan
Wetland/Stream Site AN-1
Crabbs Branch

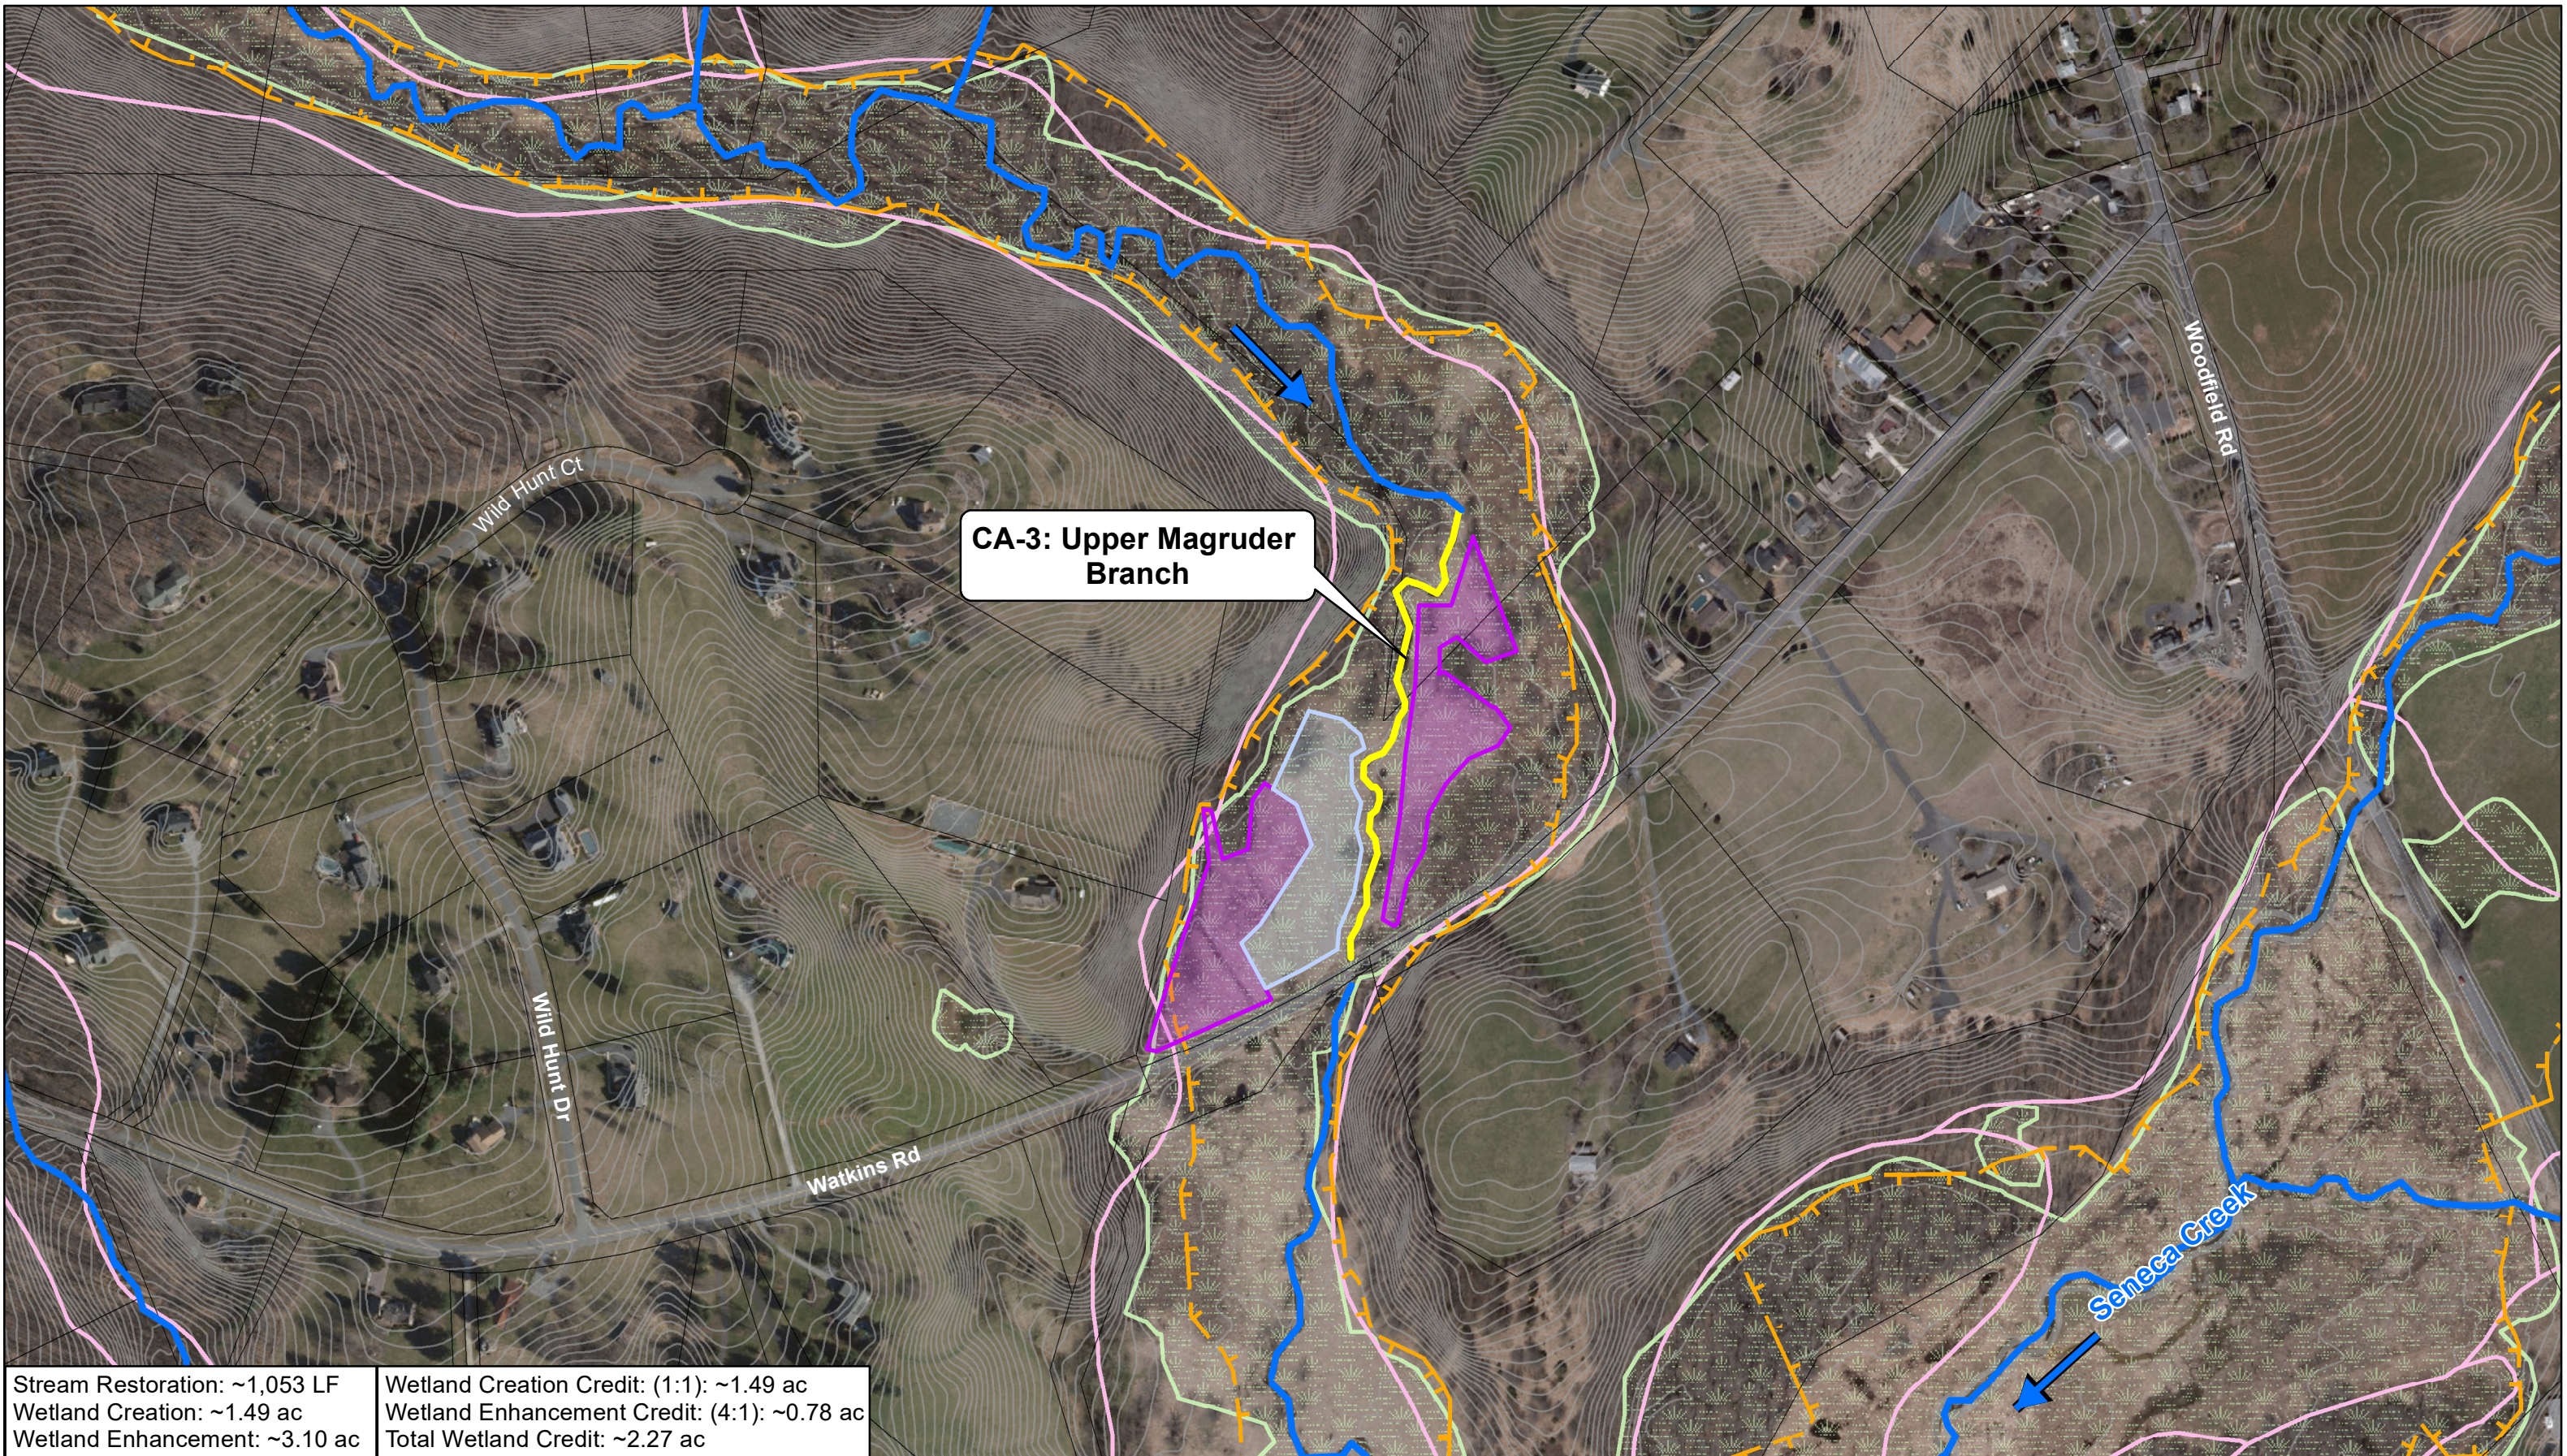
I-495 & I-270 Managed Lanes Study
Phase I Mitigation Design Plan
Wetland/Stream Site CA-3
Upper Magruder Branch

- Restore floodplain connection by relocating the channel, raising the stream bed, and/or excavating floodplain to provide more-frequent floodplain access to mitigate damage from erosive flood flows.
- Installation of instream structures to provide channel stability and in-stream habitat
- Floodplain grading to expand existing wetlands and restore groundwater hydrology
- Restore forested floodplain habitat by invasive species treatment and planting native trees and shrubs

Stream Restoration: ~1,053 LF
Wetland Creation: ~1.49 ac
Wetland Enhancement: ~3.10 ac

Wetland Creation Credit: (1:1): ~1.49 ac
Wetland Enhancement Credit: (4:1): ~0.78 ac
Total Wetland Credit: ~2.27 ac

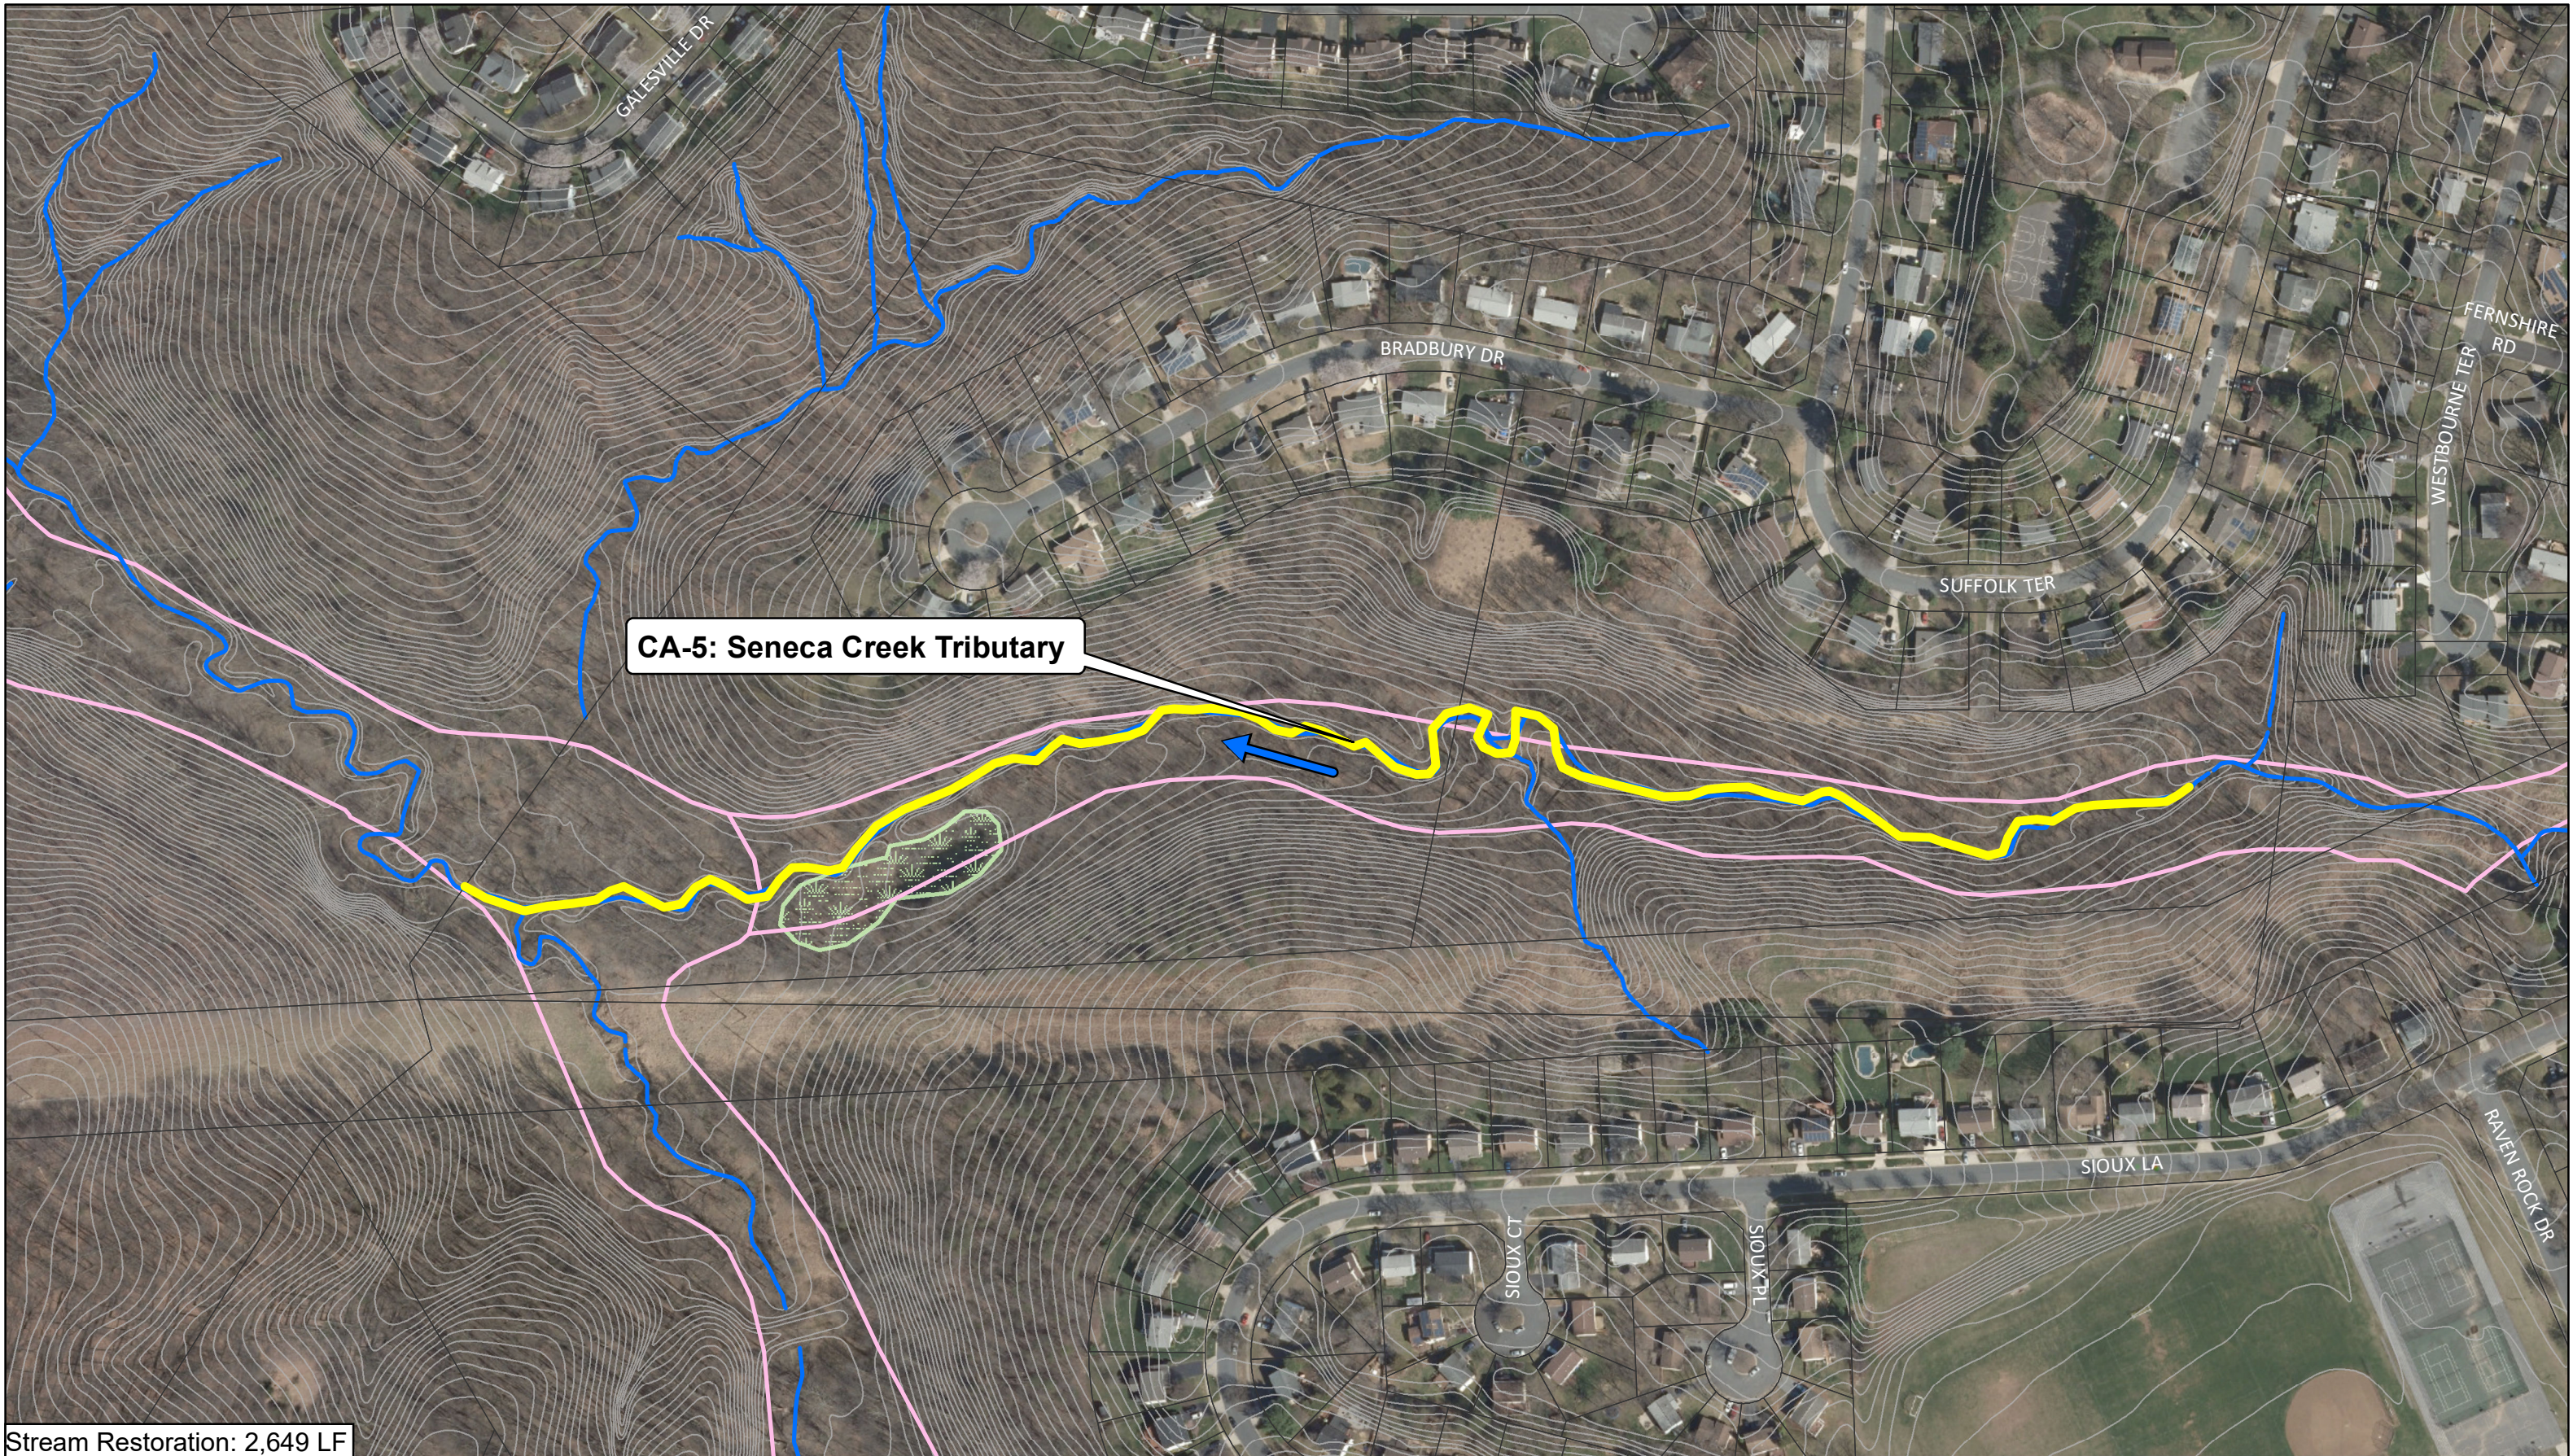
- Lay back and vegetate vertical banks to improve channel stability, reduce sediment loading, and provide floodplain connection where feasible.
- Install in-stream structures to provide grade control, protect exposed utilities, and enhance habitat
- Improve floodplain connection by raising the stream bed and/or creating floodplain benches to provide more-frequent floodplain access to mitigate damage from erosive flood flows
- Riparian habitat enhancements by invasive species treatment and seeding/planting native species
- Improve planform and profile of existing stream to enhance stream functions

Stream Restoration: 2,649 LF

CA-5 is a stream restoration site located along a tributary to Seneca Creek, south of Bradbury Drive & Suffolk Terrace. The stream corridor has steep valley walls and a narrow, forested floodplain with adjacent residential development. The reach contains a sewer line that runs parallel to stream and crosses the stream in a couple locations as well as a manhole observed in center of channel. There is a man-made pond along the left bank at the downstream end of the site. The stream is eroding the pond embankment and there are headcuts forming from the stream to the pond. The majority of the reach is highly unstable with 3-6 feet tall vertical eroded banks. There is potential access, requiring minimal tree impacts, along existing sewer line access throughout most of the site. May require clearing some smaller trees and stream crossings. Potential access for the upstream portion is located at Suffolk Terrace.

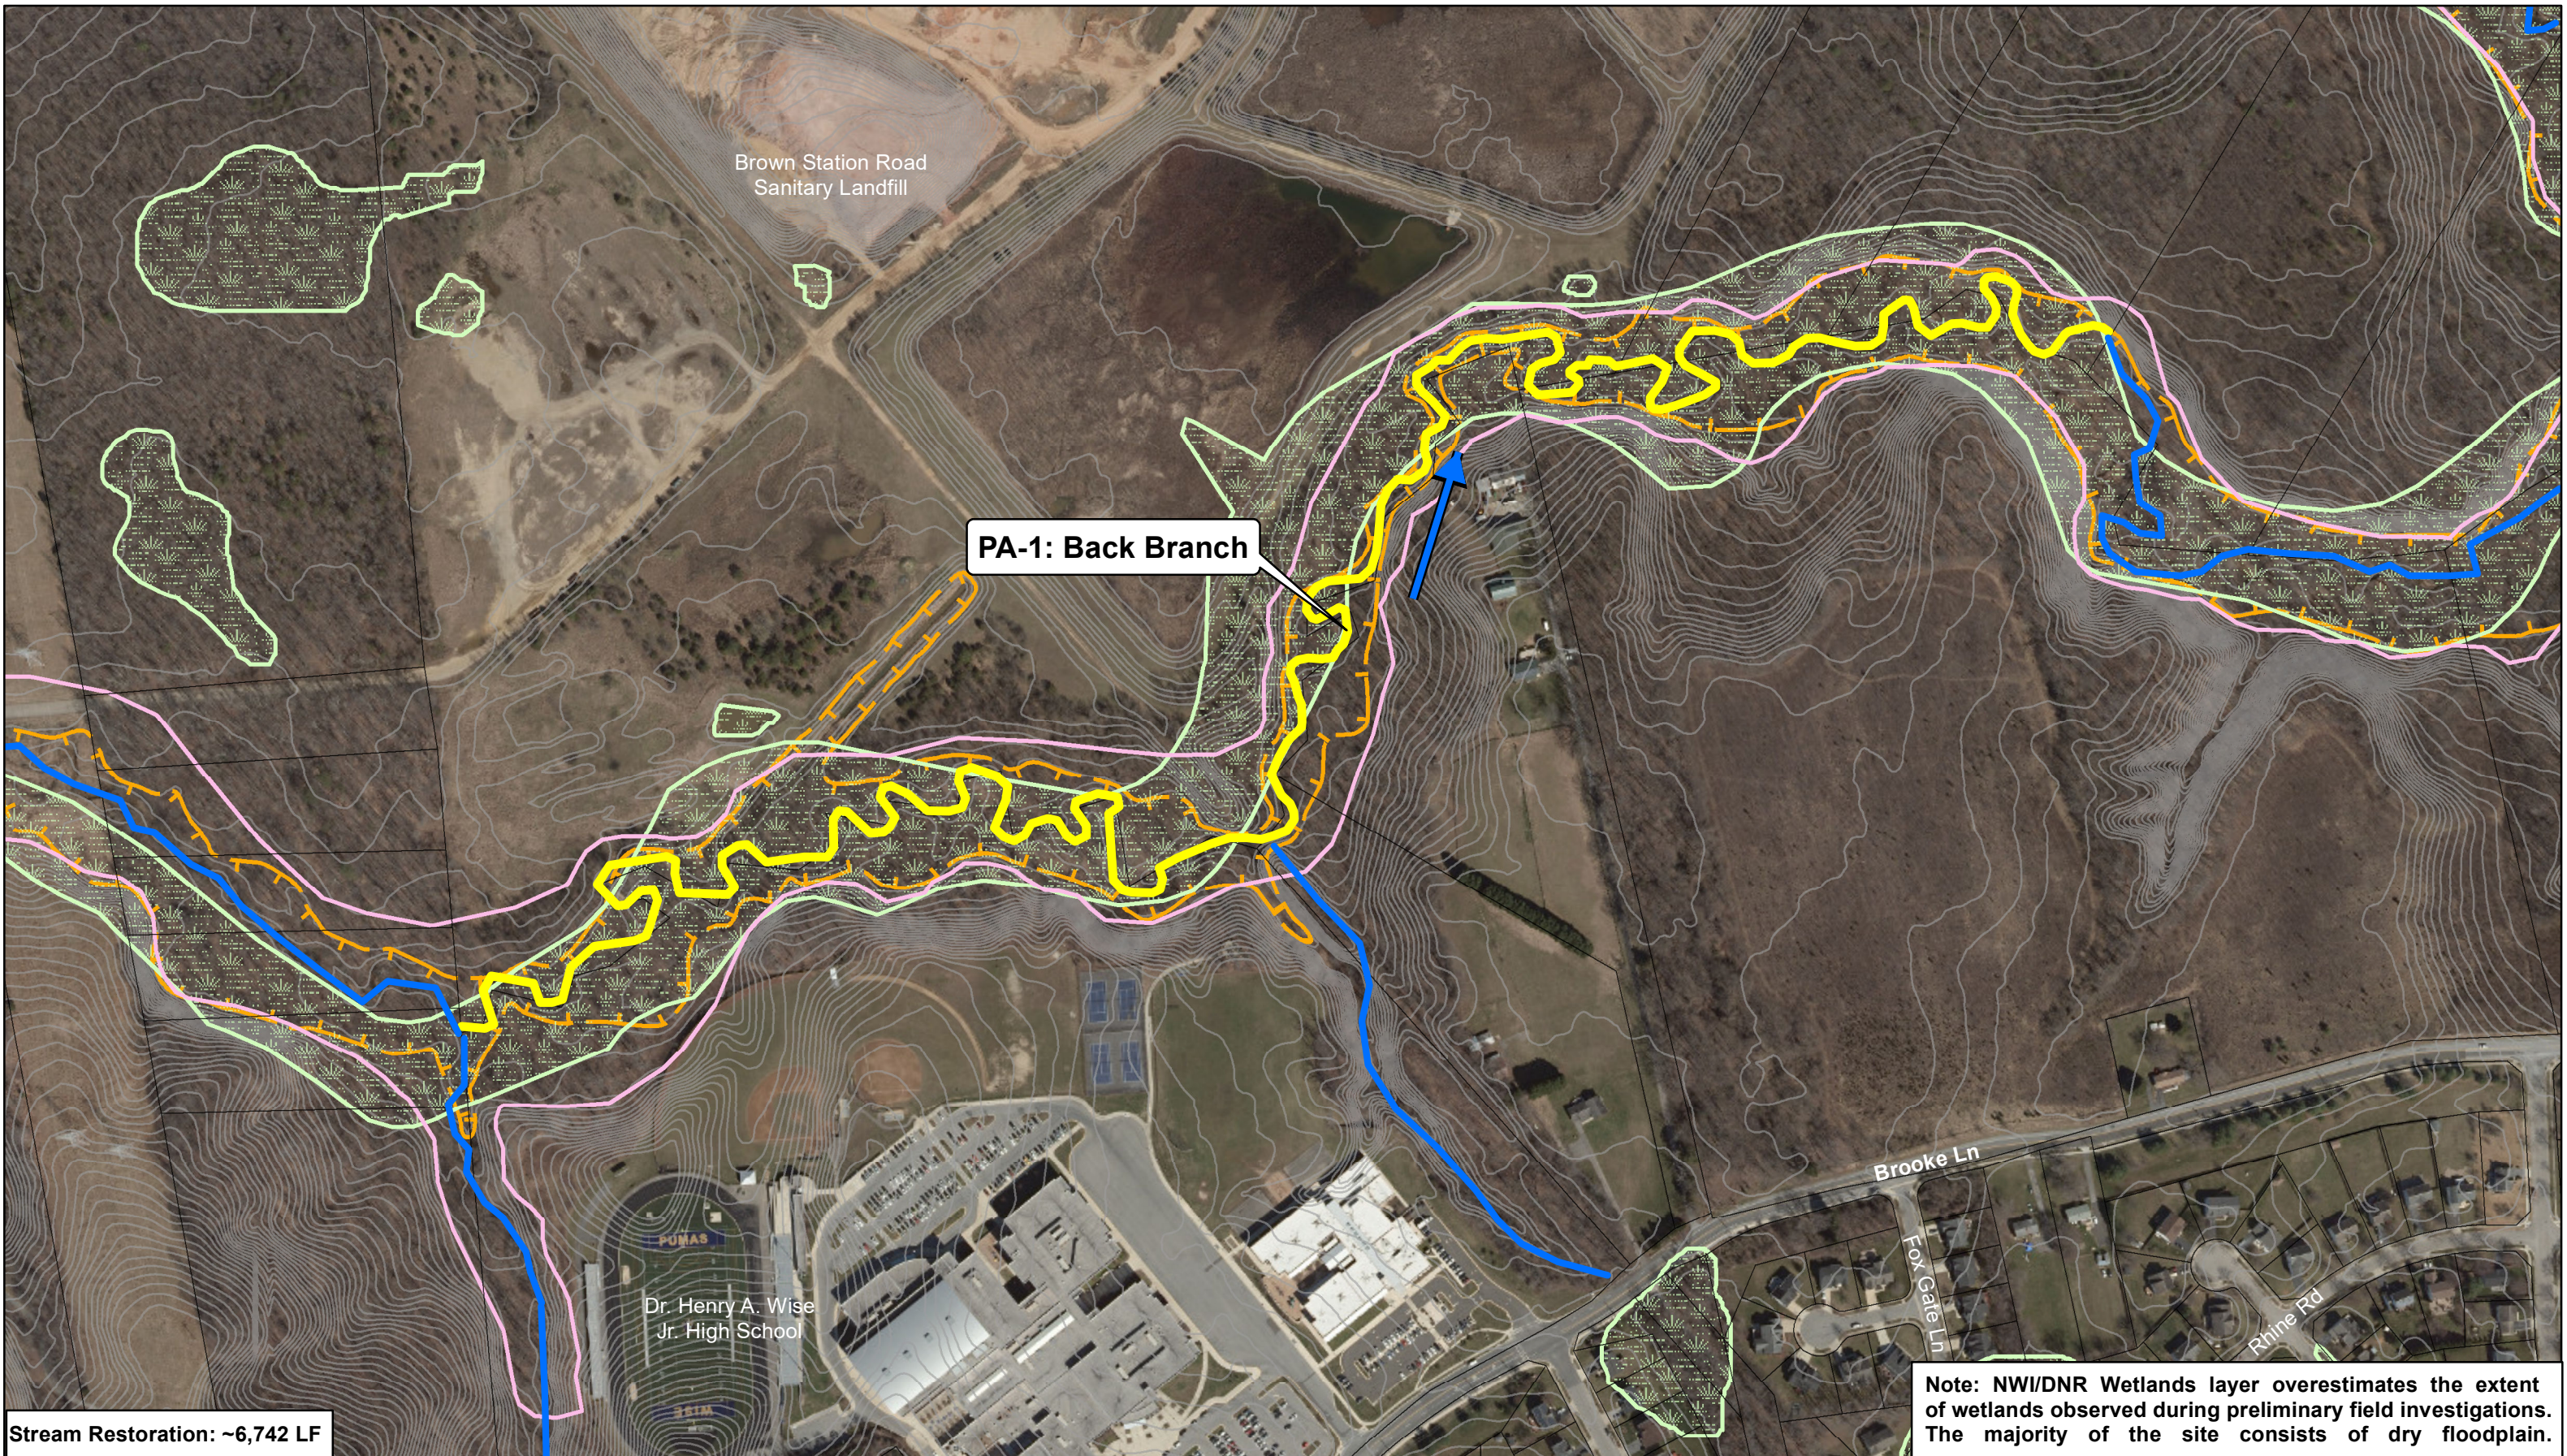
I-495 & I-270 Managed Lanes Study
Phase I Mitigation Design Plan
Stream Site PA-1
Back Branch

- Improve floodplain connection by raising the stream bed and/or creating floodplain benches to provide more-frequent floodplain access to mitigate damage from erosive flood flows
- Grade and vegetate vertical banks to reduce erosion and instream sedimentation
- Install instream structures to reduce channel incision and improve fish and benthic habitat
- Improve plan and profile of existing stream to enhance stream functions

Stream Restoration: ~6,742 LF
