APPENDIX E: PUBLIC SITE WALKTHROUGH RATING CRITERIA & FIELD ASSESSMENT FORMS

WETLAND MITIGATION RATING CRITERIA & FIELD SITE ASSESSMENT FORMS

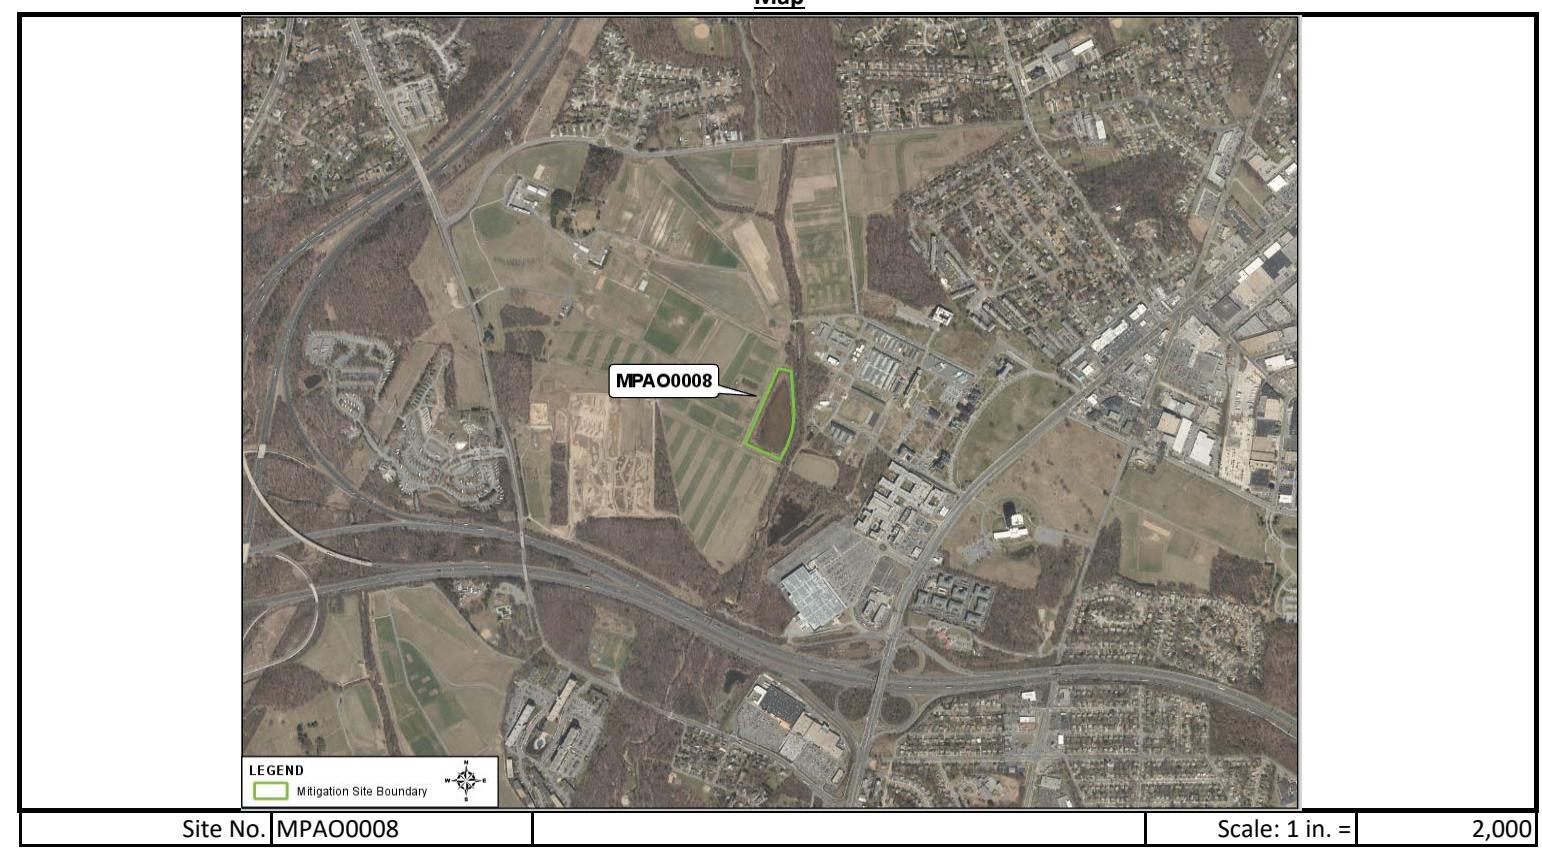
Is site currently a wetl	land?	Yes	Was site formerly a wetland?	
Condition: See photos			Condition: Site consists of open water man made pond with fring	e wetland
		Mitis	ation Site Rating	
Criteria		Score	ICriteria	Score
Soils		10	Vegetation	5
10 - Greater than 50%	hydric soil	10	10 - Herbaceous cover	5
5 - 10% to 50% hydric	soil		5 - Scrub-shrub cover	
1 - Less than 10% hvdr	ic soil		1 - Mostly forested	
Describe:			Describe:	
Water - permanently inundated with fringe wetland			Surrounded by scrub shrub - river birch, bradford pear, red maple	and sycamore
·····, ·				, ,
Hydrology		10	Land Use	10
10 - Abuts wetland or s	stream	-	10 - Agricultural or Open Space	-
5 - Adjacent to wetland	d or stream		5 - Mariginal Pasture	
1 - No connection to w	vetland or stream		1 - Old field	
Describe:			Describe:	
Majority of site is oper	n water surrounded by PEM frir	nge.	Surrounded by agricultural land and scrub shrub.

100-Year Floodplain	I	1	Habitat Value	1
10 - Yes (active eviden	ce of flooding)	-	10 - Contiguous to wetland/upland forest > 100 ac	-
5-Yes (mapped but no	eveidence of active flooding)		5 - Contiguous to wetland/upland forest 25-100 ac	
1 - No	5,		1 - Contiguous to wetland/upland forest < 25 ac	
Describe:			Describe:	
No evidence of floodin	ng. Berm surrounds pond.		Western side = active agricultural fiels. Eastern side = narrow hed	gerow.
Geomorphic Position		10	Ease of Access	1
10 - Low or concave to	pography		10 - Yes (with existing direct vehicular access to notential site)	
5 - Flat topography	pography		5- ves (open but no existing vehicular access)	
1 - High topography/st	teep slopes		1 - No (no vehicular access, clearing needed)	
Describe:			Describe:	
Manmade pond			Clearing of scrub-shrub required.	
Estimated cut to wetla	and hydrology	10	Utilities Present	5
10 - Less than 2'			10 - No utilities on site

5-between 3' - 5'			5 - Utilities but not within creation area	
1 - greater than 5'			1 - Utilities within potential creation area	
Describe:			Describe:	
Open water 4"-2' deen).		Powerlines adjacent to site	
			Total Score out of 100	63

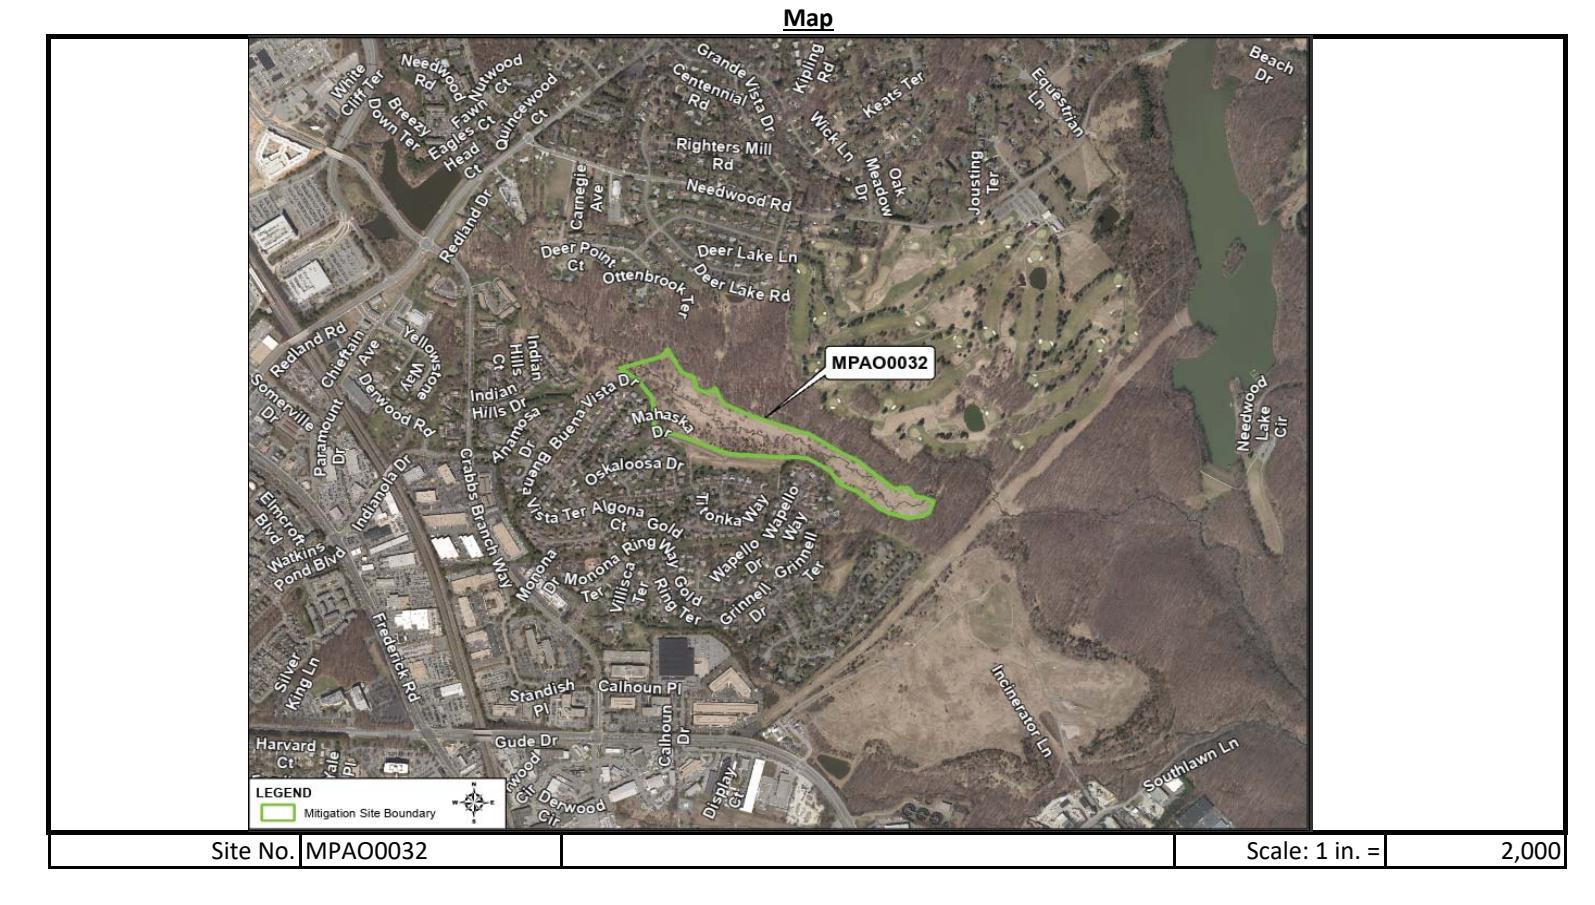
DTC analias procent?	(ovaloin holow)		Idi Field Observations	
the species present? (explain below)			Evidence of disturbance? (explain below)	
			was site formerly a wetland?	
Condition: Entire site i	Condition: Entire site in Crabbs Branch 100-year FEMA floodplain		Condition: High quality seep wetland at north western end of site.	
dominated by reed car	nary wetlands with scattered	trees.		
		N/i+i	action Site Bating	
Criteria		Score	ICriteria	Score
Soils		10	Vegetation	10
10 Greater than 50%	hydric soil	10	10 Horbasoous covor	10
5 - 10% to 50% hydric	soil		5 - Scrub-shrub cover	
1 - Less than 10% hydr	ic soil		1 - Mostly forested	
Describe:			Describe:	
Entire site located in m	nanned hydric soils Hydric so	hils verified in the	Majority of site is reed capary floodplain with scattered trees	
field	apped flyane solis. Flyane se	Jis vernied in the	Wajonty of site is recu canary hoodplain with scattered trees.

100-Year Floodplain		5	Habitat Value	10
10 - Yes (active eviden	ce of flooding)		10 - Contiguous to wetland/upland forest > 100 ac	
5-res (mapped but no	evidence of active flooding)		5 - Contiguous to wetland/upland forest 25-100 ac	
I - NU Describes			1 - Contiguous to wettand/upiand totest < 25 ac	
Describe:	- MA manned floodalain. No.	ovidonce of	Describe:	
Located in 100-year FE	INA mapped floodplain. No e	evidence of	Adjacent to 110 acres of contiguous upland forest.	
flooding.				
Geomorphic Position		10	Ease of Access	5
		10	10. Vec (with existing direct vehicular access to notential site)	3
10 - LOW OF CONCAVE LO	pography		5- ves (open but no existing vehicular access)	
1 - High tonography/st	teen slones		1 - No (no vehicular access, clearing needed)	
Describe:			Describe:	
Entire site is low topos	araphy in floodplain		Site is onen but no existing access. Potential access from maintain	ed HOA roads

Site is open, but no existing access. Forential access from maintain	
Estimated cut to wet!	and bydrology	5	litilities Precent	1
10 Loss than 2'	and hydrology	5	10. No utilities on site	1
5-between 3' - 5'			5 - 11 tilities but not within creation area	
1 - greater than 5'			1 - Utilities within potential creation area	
			Describe:	
Crown deurstein die in				
Groundwater estimate	at 3.5 below surface in no	n-wetland areas.	sewerline runs throughout floodplain.	
			Total Coore out of 400	71
			Total Score out of 100	/1

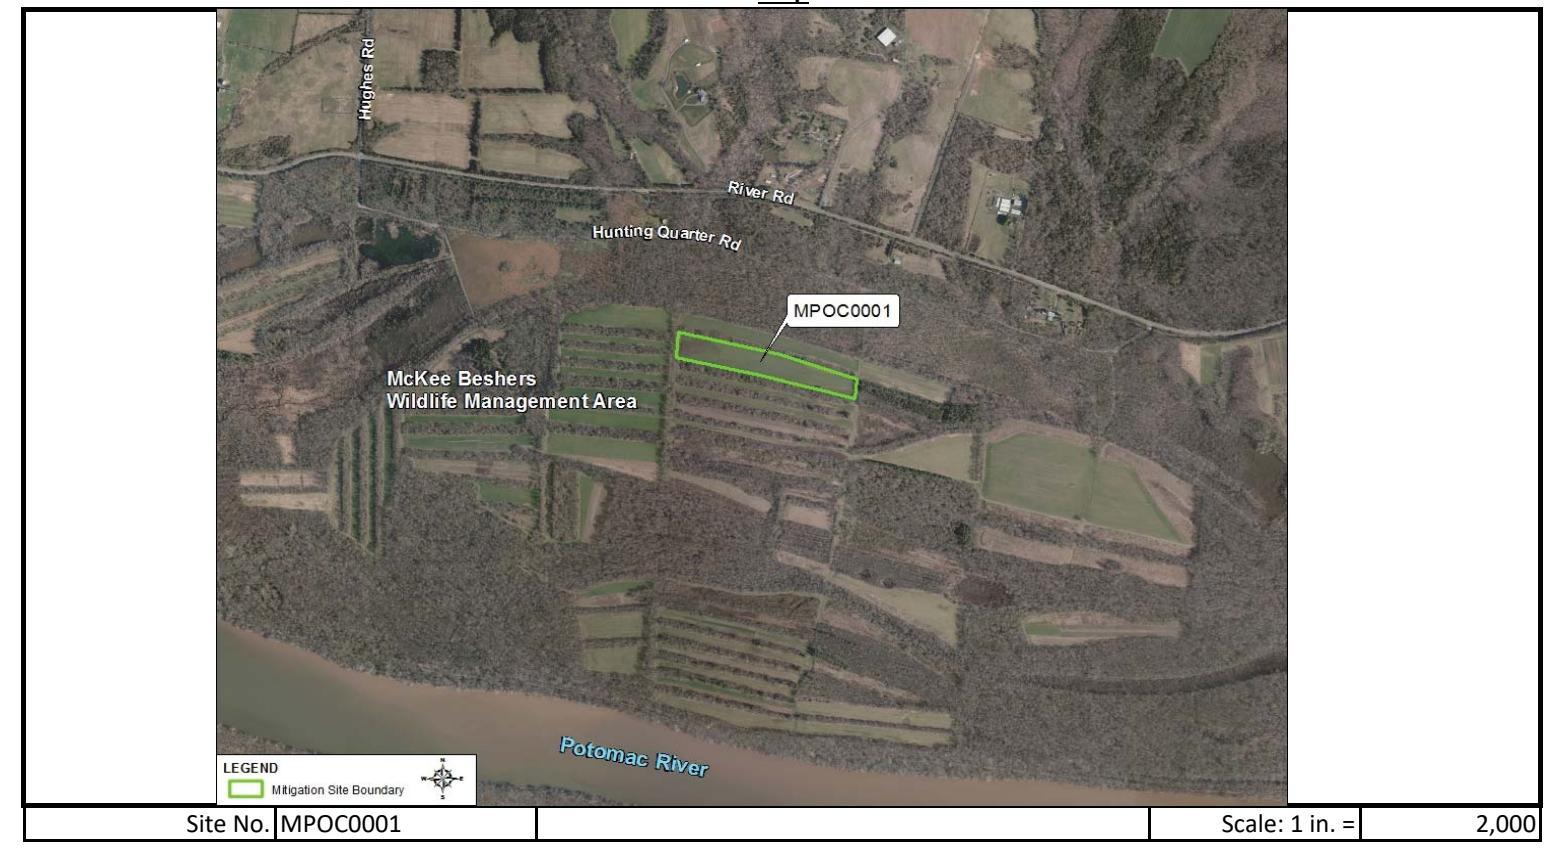
1 - Less than 10% hydric soll					
Describe:	d and have been at the instance of the		Describe:		
100% of site is mapped	d as hydric solis. No hydric soli	indicators	Active farm field - Remnant soy beans throughout site. No wet ve	g observed.	
observed during site w	valk, likely due to active farmin	g of field.			
Hydrology		10	Land Use	10	
10 - Abuts wetland or	stream		10 - Agricultural or Open Space		
5 - Adjacent to wetlan	d or stream		5 - Marginal Pasture		
1 - No connection to w	vetland or stream		1 - Old field		
Describe:			Describe:		
PFO wetland abutting	southeast corner of site. Exten	sive open water	Active farm field - Remnant soy beans throughout site. No wet ve	g observed.	
areas within site.					
100-Year Floodplain		5	Habitat Value	10	
10 - Yes (active eviden	ice of flooding)		10 - Contiguous to wetland/upland forest > 100 ac		
5-Yes (mapped but no	o evidence of active flooding)		5 - Contiguous to wetland/upland forest 25-100 ac

1 - NO			1 - Contiguous to wetland/upland forest < 25 ac		
Describe:			Describe:		
Entire site is located in	Potomac River 100 YR FEMA 1	loodplain. No	Site located in McKee Besher Wildlife Management Area (>100 ac	res of forest).	
evidence of flooding w	vithin site.				
Geomorphic Position		10	Ease of Assess	10	
Geomorphic Position		10		10	
10 - Low or concave to	pography		10 - Yes (with <u>existing</u> direct vehicular access to potential site)		
5 - Flat topography	toon clones		5- yes (open but no existing venicular access)		
1 - High topography/si	teep slopes		1 - NO (NO VENICUIAL ACCESS, Clearing needed)		
Site consists of low /fl-	t topography with gradual and	n water	Existing maintained access just east of site that connects to Uset	ng Quartar Dd	
site consists of low/fla	at topography with gradual ope	in water	Existing maintained access just east of site that connects to Hunti	ng Quarter KO.

aepressions.		10		10	
Estimated cut to wetla	anu nyurology	10	Ounces Present	10	
TO - Less than 2			10 - NO UTILITIES ON SITE		
J-Delween 3 - 5 1 - greater than 5'			1 - Utilities within notential creation area		
Describe:					
Groundwater observe	d 14" below ground surface in	non-saturated	No evidence of utilities observed within or adjacent to the site.		
areas.					
			T	05	
			I otal Score out of 100	95

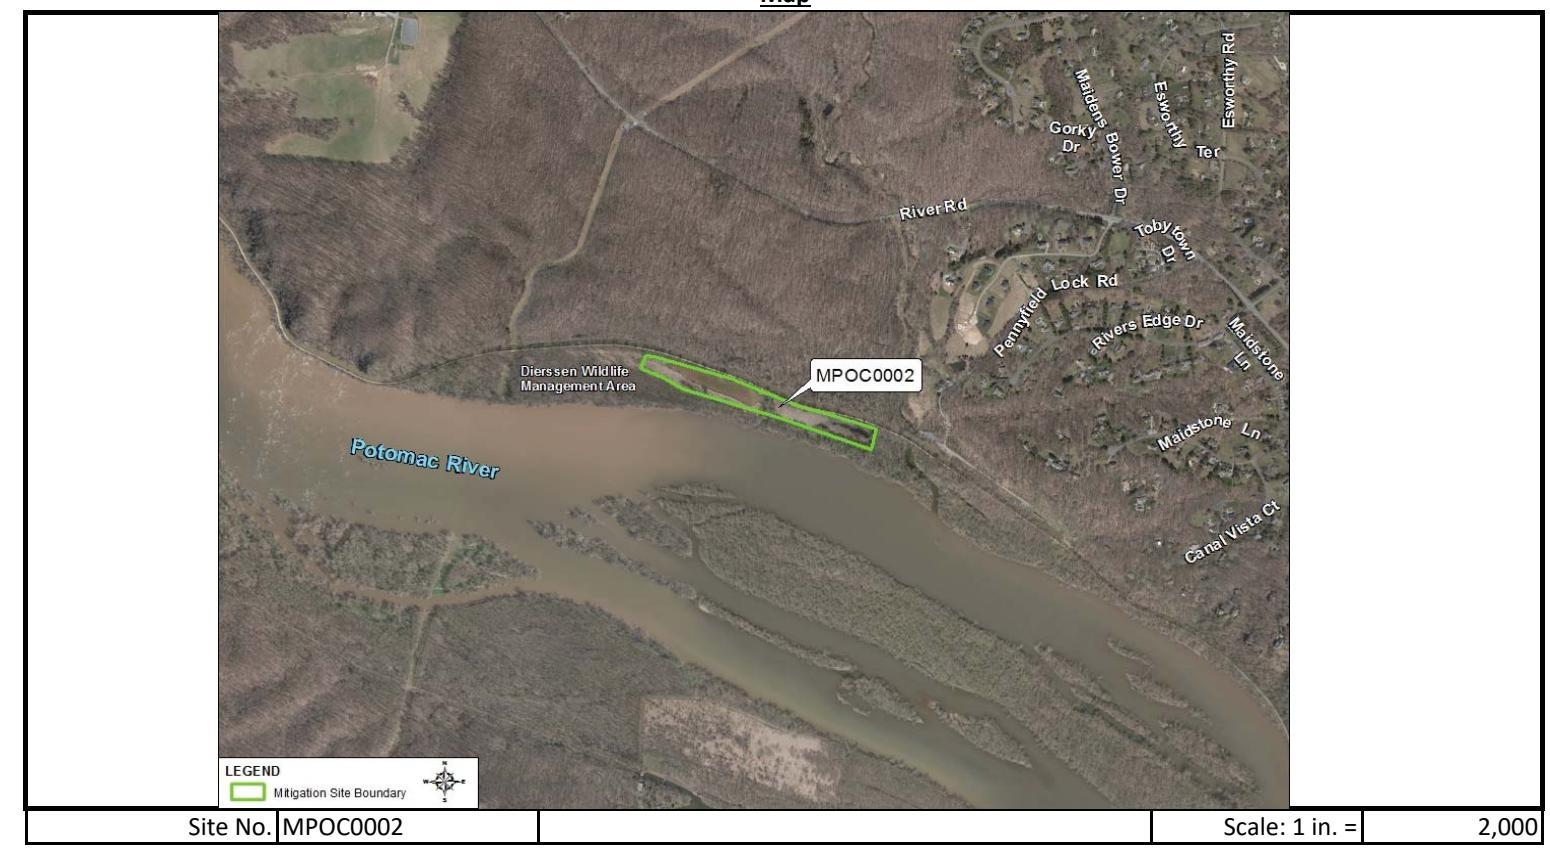
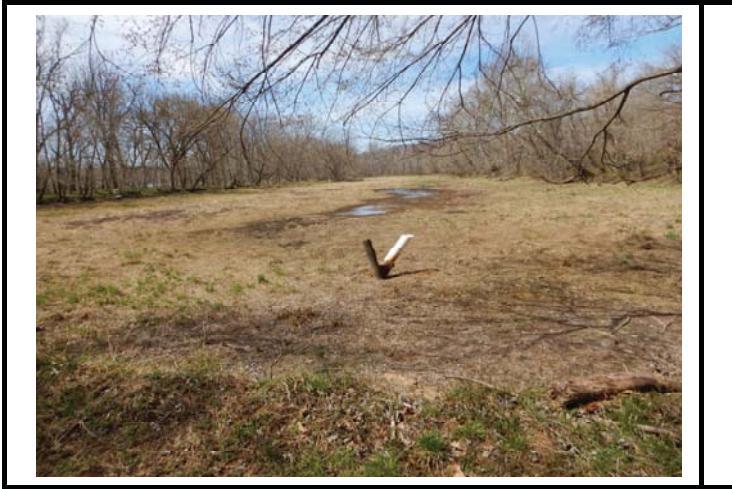
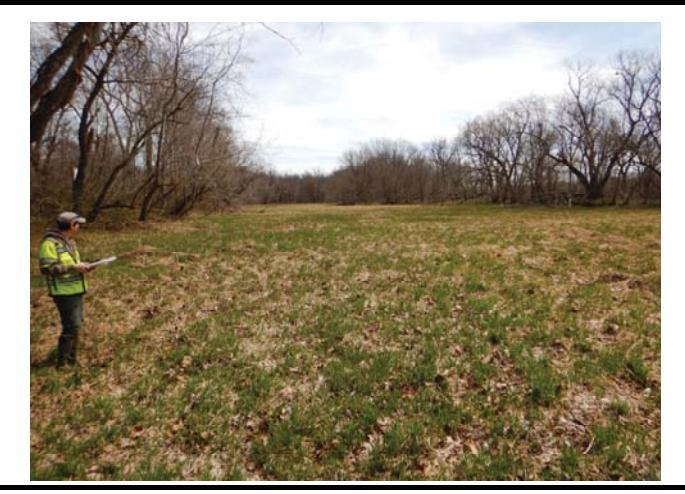
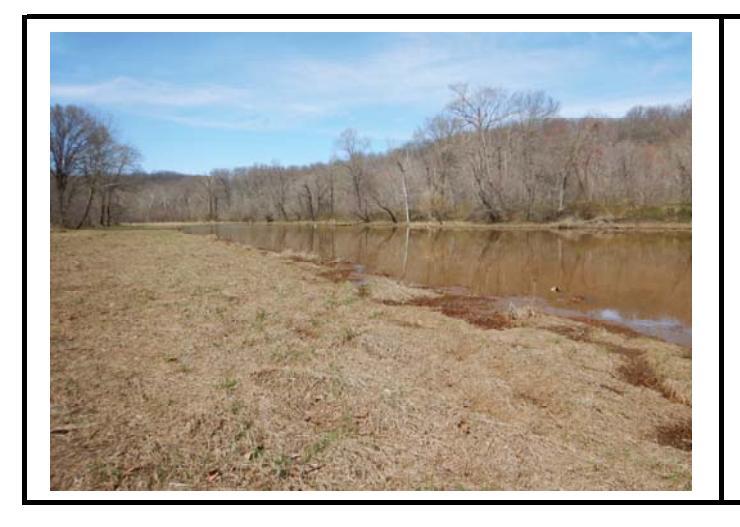
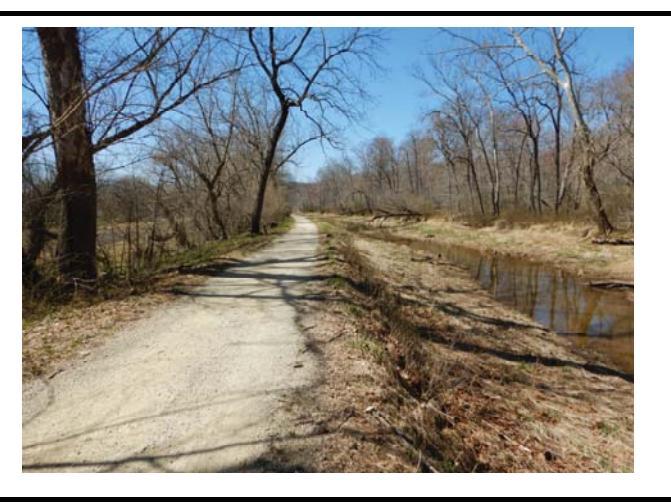
5 - 10% to 50% hydric	soil		5 - Scrub-shrub cover	
1 - Less than 10% hvdr	ic soil		1 - Mostly forested	
Describe:				
100% of site is manned as hydric soils. Hydric soil indicators observed		icators observed	Site dominated by reed capary grass with sparse cattail and black	willow
throughout impounder	a as nyune sons. Hyune son ma		Site dominated by reed canary grass with sparse cattain and black	willow.
throughout impoundin	ients during site walk.			
Hydrology		10	Land Use	5
10 - Abuts wetland or	stream		10 - Agricultural or Open Space	
5 - Adjacent to wetland	d or stream		5 - Marginal Pasture	
1 - No connection to w	vetland or stream		1 - Old field	
Describe:			Describe:	
Impoundments consist	t of open water and reed canar	y wetlands that	Site managed for waterfowl. Dominated by reed canary grass with	n sparse cattail
drain to the Potomac F	River.	,	and black willow.	
100-Vear Floodalain		5	Habitat Value	10

100-Teal Tiooupiain	se of flooding)	J	10 Contiguous to wotland/unland foract > 100 ac	10
E Voc (manned but no	ce of nooung)		E Contiguous to wetland/upland forest 25 100 ac	
5-res (mapped but no	evidence of active hooding)		5 - Contiguous to wetland/upland forest < 25-100 ac	
Describe:			Describe:	
Entire site is located in	Potomac River 100 YR FEMA f	loodplain. No	Site located in Dierssen Wildlife Management Area (40 acres) that	t connects to
evidence of flooding w	vithin site.		other forested parkland along the Potomac (>100 acres of forest).	
Geomorphic Position		10	Ease of Access	1
Geomorphic Position		10	Ease of Access	T
10 - Low or concave to	pography		10 - Yes (with <u>existing</u> direct vehicular access to potential site)	
5 - Flat topography			5- yes (open but no existing vehicular access)	
1 - High topography/st	eep slopes		1 - No (no vehicular access, clearing needed)	
Describe:			Describe:

Site consists of concav	e manmade impoundment.		Access is very limited. Would need to go through 10' wide C&O ca	anal trail that
			would require crossing two foot bridges. One bridge needs replac	ement.
Estimated cut to wetla	and hydrology	10	Utilities Present	10
10 - Less than 2'			10 - No utilities on site	
5-between 3' - 5'			5 - Utilities but not within creation area	
1 - greater than 5'			1 - Utilities within potential creation area	
Describe:			Describe:	
Groundwater obsorver	d 0-3" below ground surface th	roughout site	No evidence of utilities observed within or adjacent to the site	
	a o o below ground surface th	i ougnout site.	No evidence of utilities observed within of adjatent to the site.	
			Total Score out of 100	Q1
				01

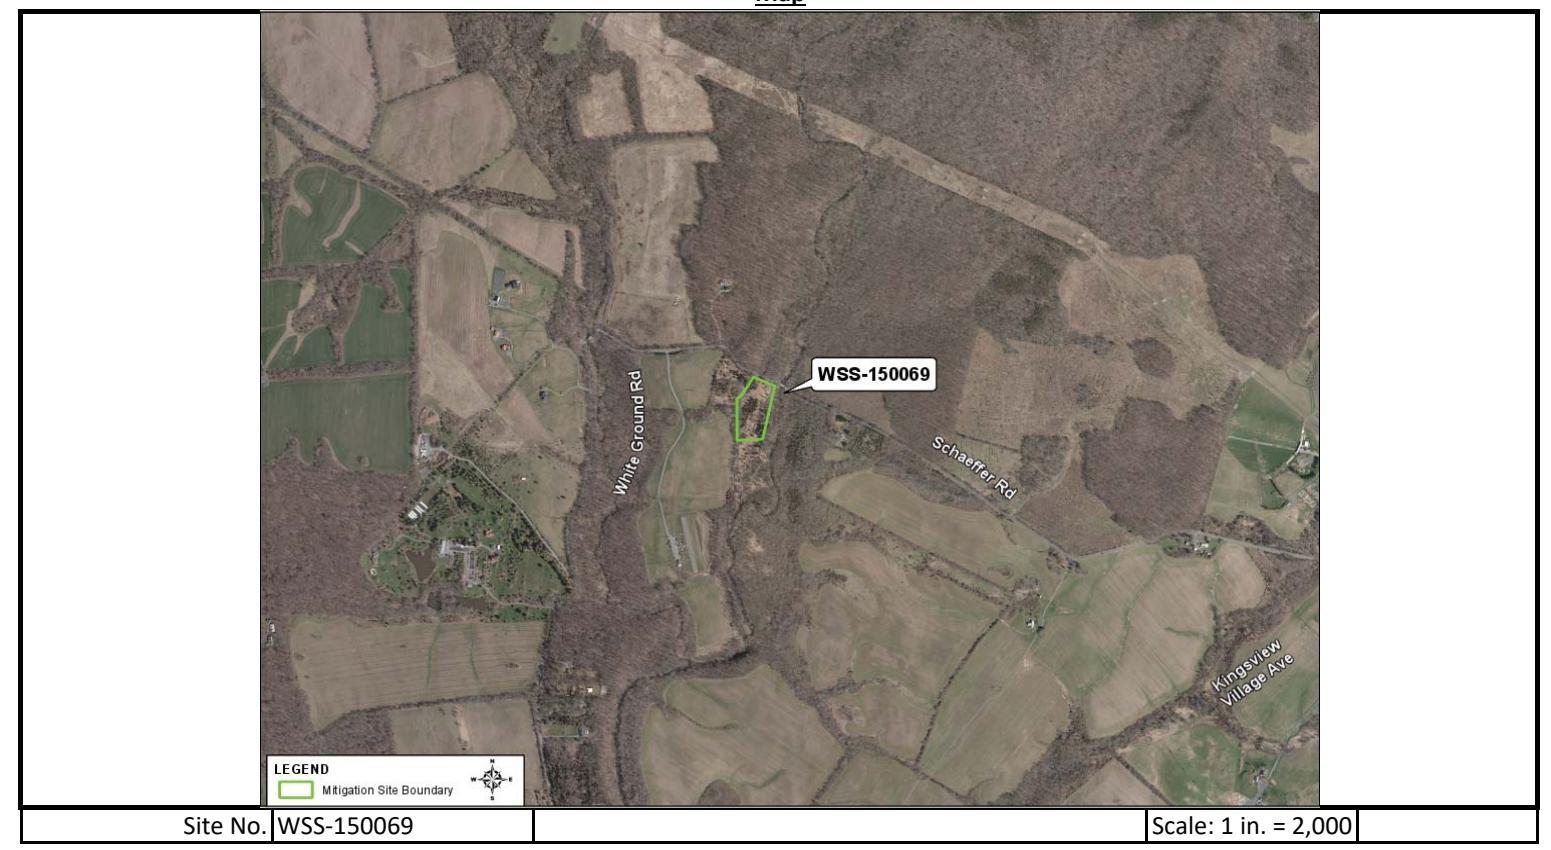
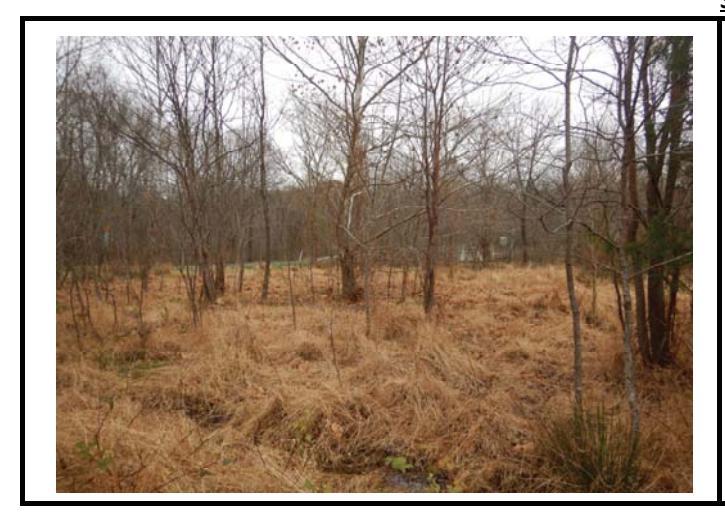
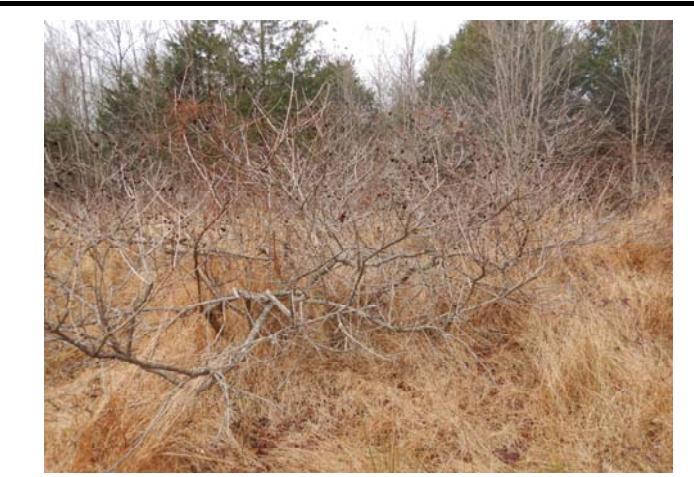
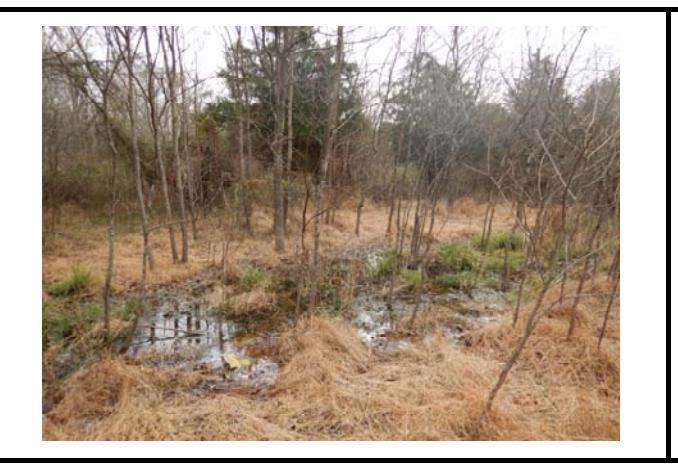
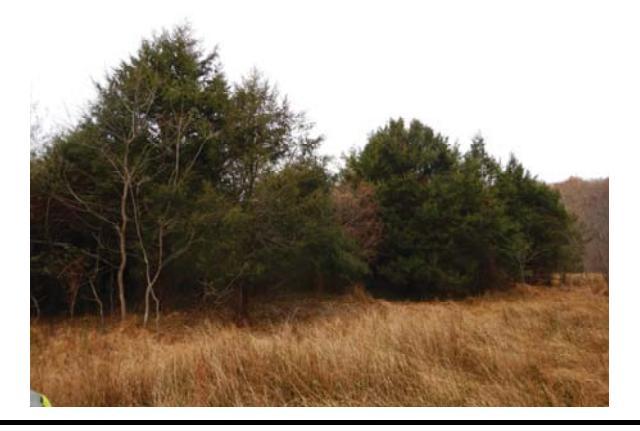
We	tland Mitigatic	on Field Site Assessment Form	
		P	roiect Details	
Project Name:	I-495/I-270 Managed Lanes	Study	Mitigation Site Number: WSS-150069	
Estimated Mitigation N	leeds (ac):	TBD

10 - Abuts wetland or st	tream	10	10 - Agricultural or Open Space	
5 - Adiacent to wetland	l or stream		5 - Marginal Pasture	
1 - No connection to we	etland or stream		1 - Old field	
Describe:			Describe:	
Majority of site is wetla	and located between two pere	nnial channels. 0-	Site is located in Little Seneca Stream Valley Park and consists of	floodplain with
2 inches of surface wate	er observed throughout wetla	nd during site	dense herbaceous vegetation and scattered tree and shrub sapling	ngs.
investigation.	-	-		-
100-Year Floodplain		5	Habitat Value	10
10 - Yes (active evidenc	e of flooding)		10 - Contiguous to wetland/upland forest > 100 ac	•
5-Yes (mapped but no	evidence of active flooding)		5 - Contiguous to wetland/upland forest 25-100 ac	
1 - No			1 - Contiguous to wetland/upland forest < 25 ac	
Describe:			Describe:	
Site located within 100-	-year FEMA floodplain. No act	ive evidence of	Site connects to Seneca Creek State Park (>100 acres of forest).

flooding observed durir	ng site visit.			
Coomorphic Desition		10		1
Geomorphic Position		10		L
10 - Low or concave top	oography		10 - Yes (with <u>existing</u> direct vehicular access to potential site)	
5 - Flat topography			5- yes (open but no existing venicular access)	
1 - High topography/ste	eep slopes		1 - NO (NO VENICUIAL ACCESS, Clearing Needed)	
Low topography Site lo	ested in 100 VB FEMA floods	ain	Site is is accessible from Schooffer Rd, however access within the	site would
Low topography. Site to	cated in 100-TK FEMA hoodp	dill.	Site is is accessible from schaener ku, nowever access within the	site would
Estimated cut to water	nd hydrology	10	Itilities Present	10
10 - Less than 2'	na nyarology	10	10 - No utilities on site	10
5-hetween 2' - 5'			5 - Itilities but not within creation area	
1 - greater than 5'			1 - Utilities within potential creation area	
Describe:			Describe:	
Majority of site is also	dy wotland 0.2 inchas of surf	o water	No ovidence of utilities absorved within as adjacent to the site

observed through and a	uy wettand. U-2 inches of surfa	ace water	ind evidence of utilities observed within or adjacent to the site.	
observed throughout m	iost of site in November.			
			Total Score out of 100	72

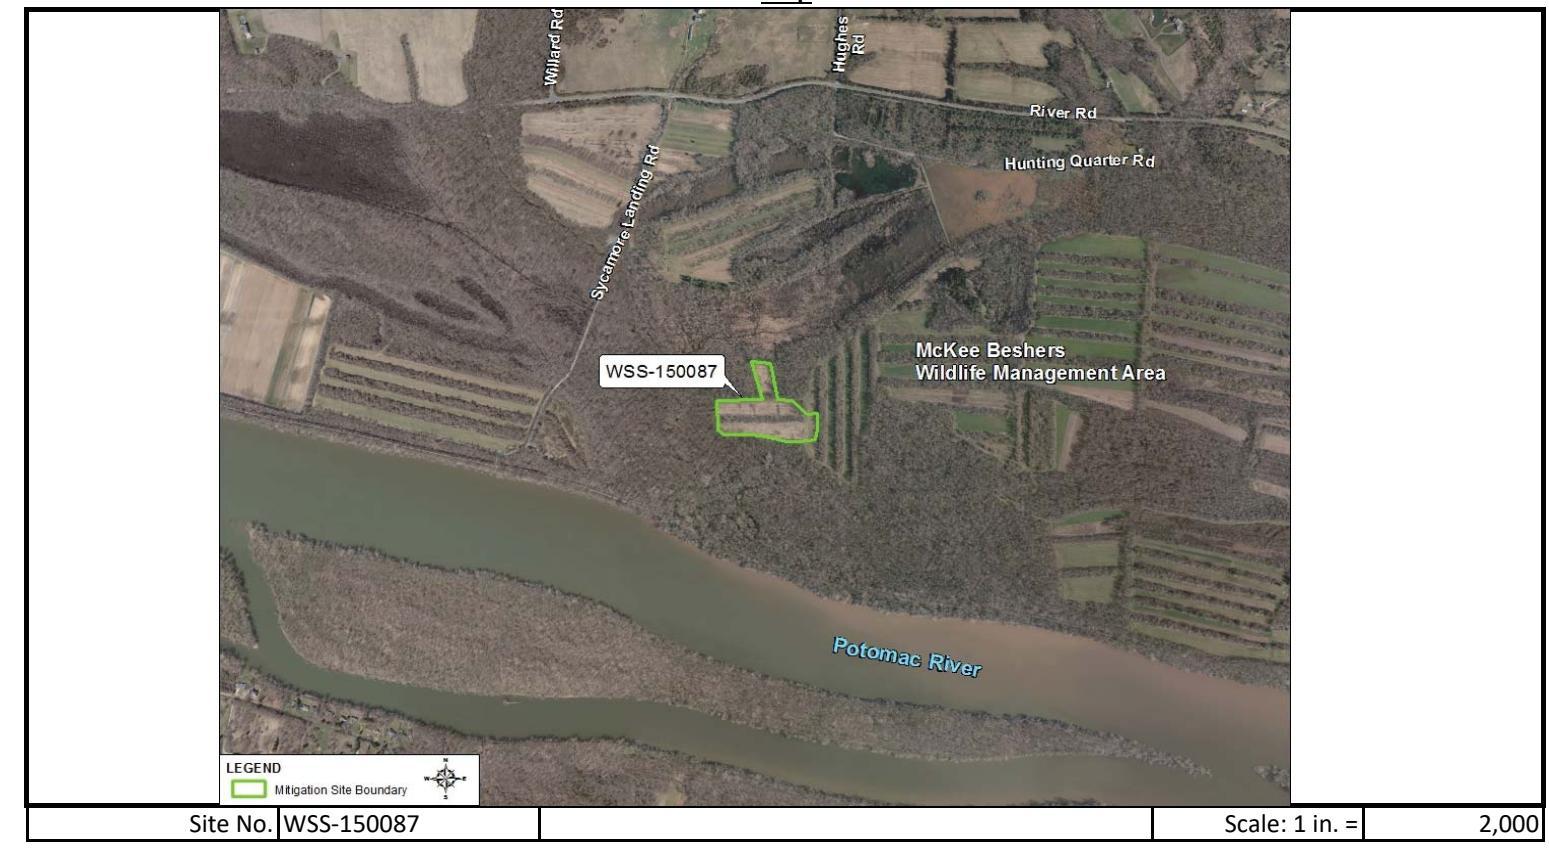
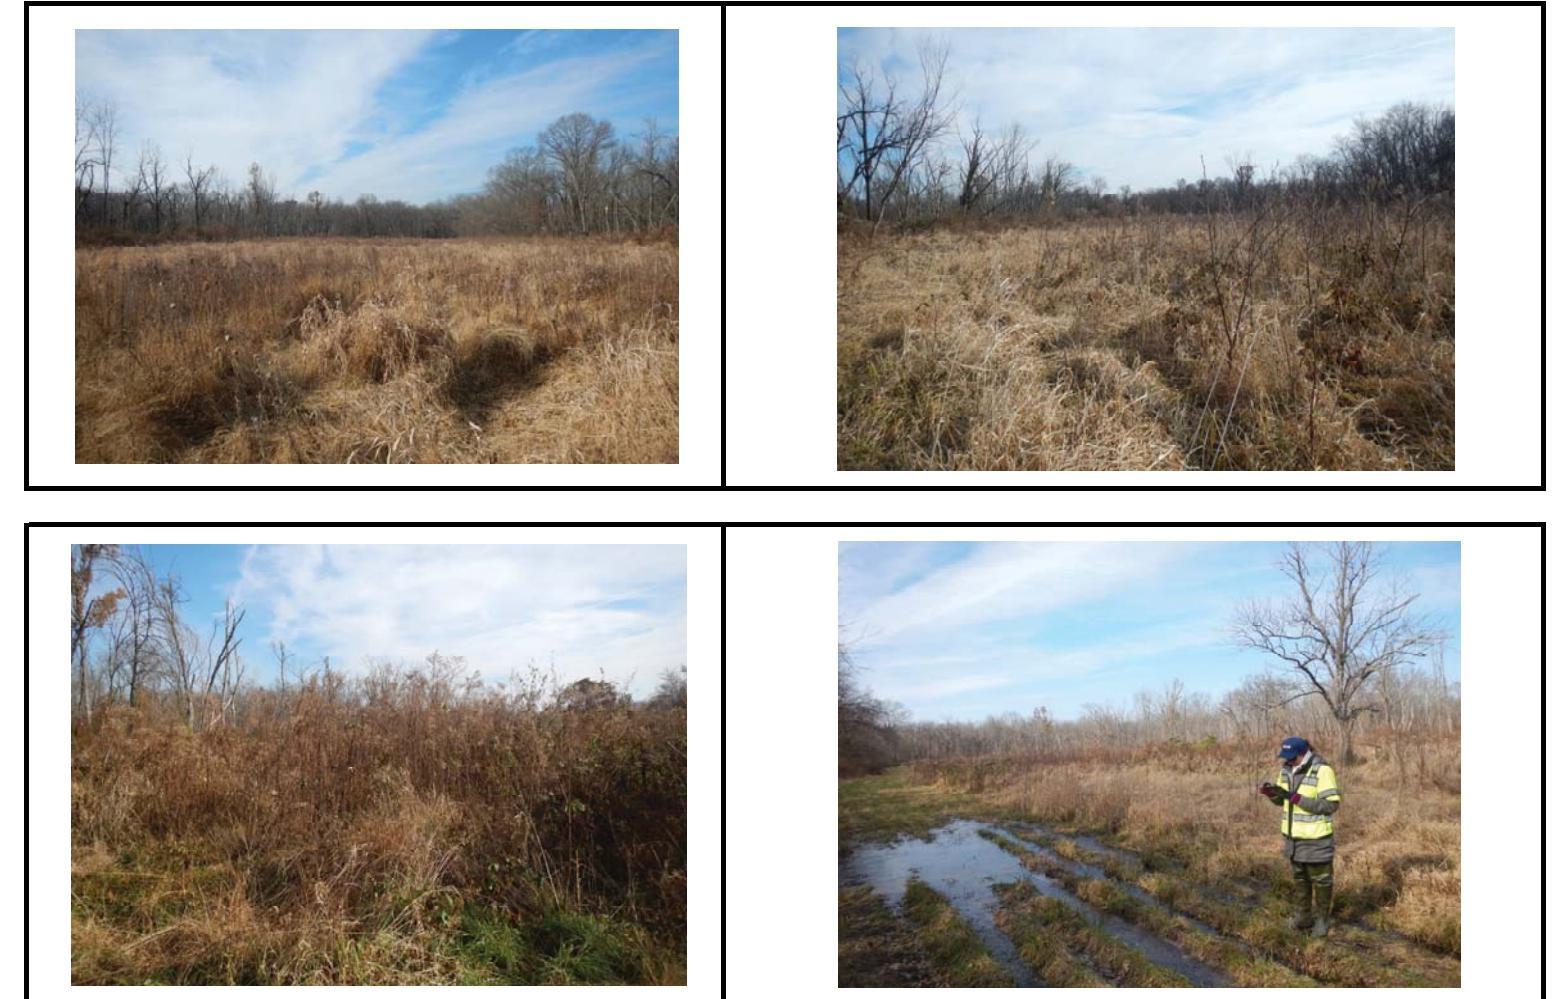
We	tland Mitigatic	on Field Site Assessment Form		
		Ρ	roject Details		
Project Name:	I-495/I-270 Managed Lanes	s Study	Mitigation Site Number: WSS-150087		
Estimated Mitigation	Needs (ac):	TBD

Is site currently a wet	land?	Partially		Possibly	
Condition: Site is locat	ted in the McKee Beshers Wild	life Management	Condition: Site surrounded by PEO wetlands. Couple of wetlands	drain through	
Condition. Site is local	equations of dry old field in the D		condition. Site surrounded by PFO wetlands. Couple of wetlands of		
Area. Majority of site o	consists of ary old field in the P	otomac River 100	site. Some areas within site appear to have been used for agricult	ure in the past.	
YR floodplain.					
		Mitig	ation Site Rating		
Criteria		Score	Criteria	Score	
Soils		10	Vegetation	10	
10 - Greater than 50%	hydric soil		10 - Herbaceous cover		
5 - 10% to 50% hydric	soil		5 - Scrub-shrub cover		
1 - Less than 10% hydr	ric soil		1 - Mostly forested		
Describe:			Describe:		
60% of site is mapped as predominately hydric soils. Majority of site is		Majority of site is	Majority of site is dominated by teasel, reed canary grass, golden	rod, and

dry field, however a co	ouple of wetlands drain throug	h the site.	dogbane. Narrow strip of trees runs through the center of the site	. Scattered tree	
, ,			saplings and shrubs were observed in the southern field.		
Undrology		10		1	
Tydrology	stroom	10	Land Use	L	
10 - Abuls weiland of 5 - Adjacent to wetland	d or stream		5 - Marginal Pacture		
1 - No connection to w	vetland or stream		1 - Old field		
Describe:			Describe:		
Site is surrounded by F	PFO wetlands and a couple of F	PFM wetlands	Site is located in the McKee Beshers Wildlife Management Area ar	nd consists mostly	
drain through the site			of old field	ia consists mostly	
drain through the site.					
100-Year Floodplain		10	Habitat Value	10	
10 - Yes (active eviden	ce of flooding)	10	10 - Contiguous to wetland/unland forest > 100 ac	10	
5-Yes (mapped but no	evidence of active flooding)		5 - Contiguous to wetland/upland forest 25-100 ac		
1 - No			1 - Contiguous to wetland/upland forest < 25 ac

Describe:			Describe:		
Entire site is located in	n Potomac River 100 YR FEMA f	loodplain. Active	Site located in McKee Besher Wildlife Management Area (>100 ac	res of forest).	
evidence (debris) of flo	ooding at the southern bounda	ry of the site.		····,	
(.,			
Geomorphic Position		10	Ease of Access	10	
10 - Low or concave to	pography		10 - Yes (with existing direct vehicular access to potential site)		
5 - Flat topography	1 3 1 7		5- yes (open but no existing vehicular access)		
1 - High topography/st	teep slopes		1 - No (no vehicular access, clearing needed)		
Describe:			Describe:		
Site consists of low top	pography surrounded by wetla	nds.	Existing maintained access along edge of adjacent farm fields that	connects to	
			Hunting Quarter Rd.		
Estimated cut to wetla	and hydrology	10	Utilities Present	10	
10 - Less than 2'			10 - No utilities on site		
5-between 3' - 5'			5 - Utilities but not within creation area

1 - greater than 5'			1 - Utilities within potential creation area		
Describe:			Describe:		
Groundwater observe	d 6" - 2' below ground surface.		No evidence of utilities observed within or adiacent to the site.		
			Total Score out of 100	91

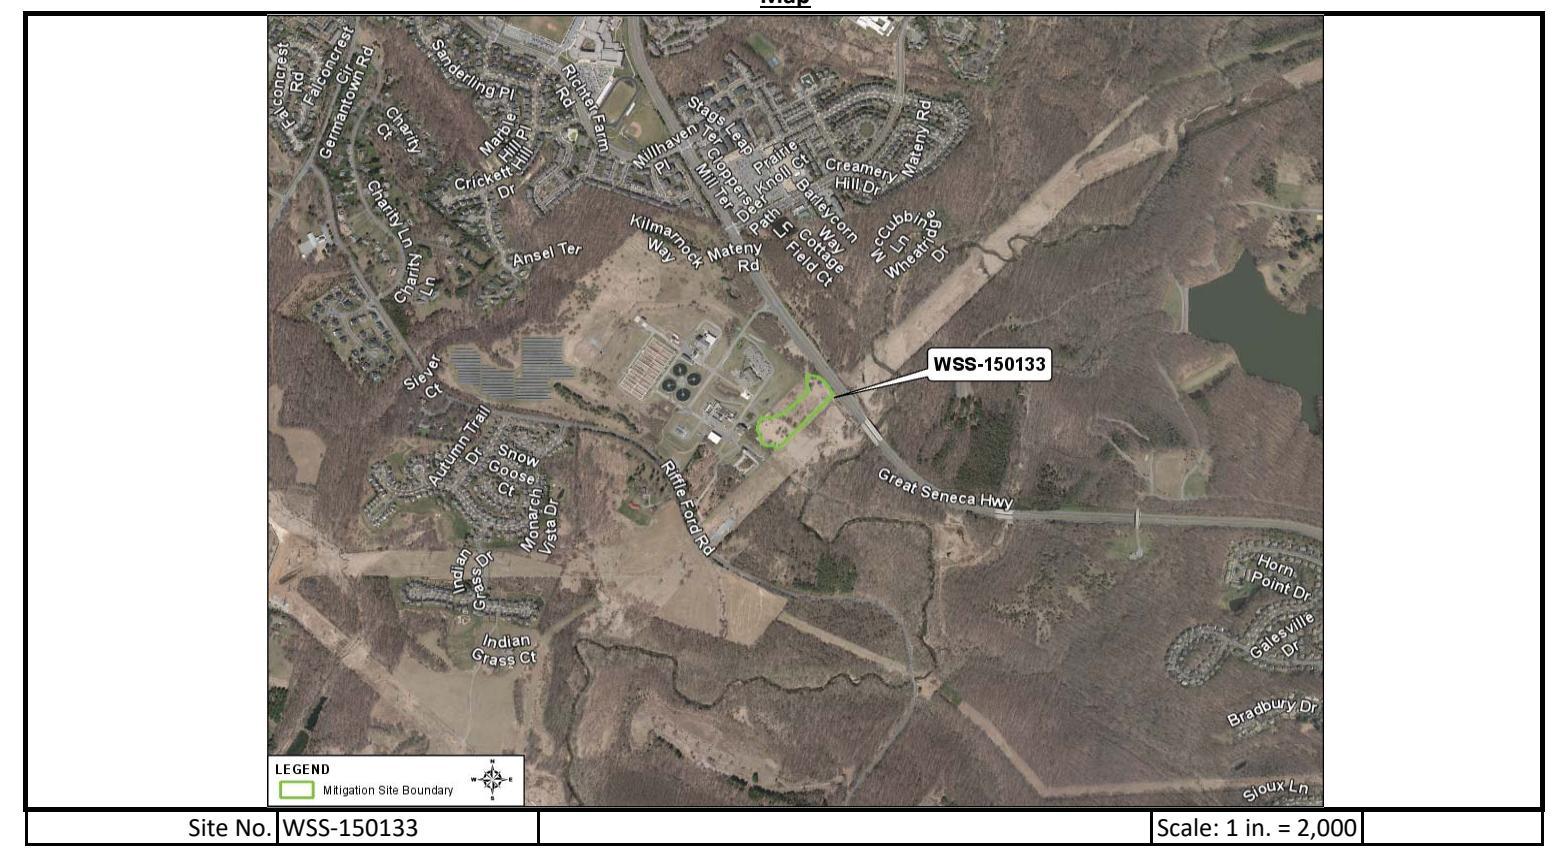
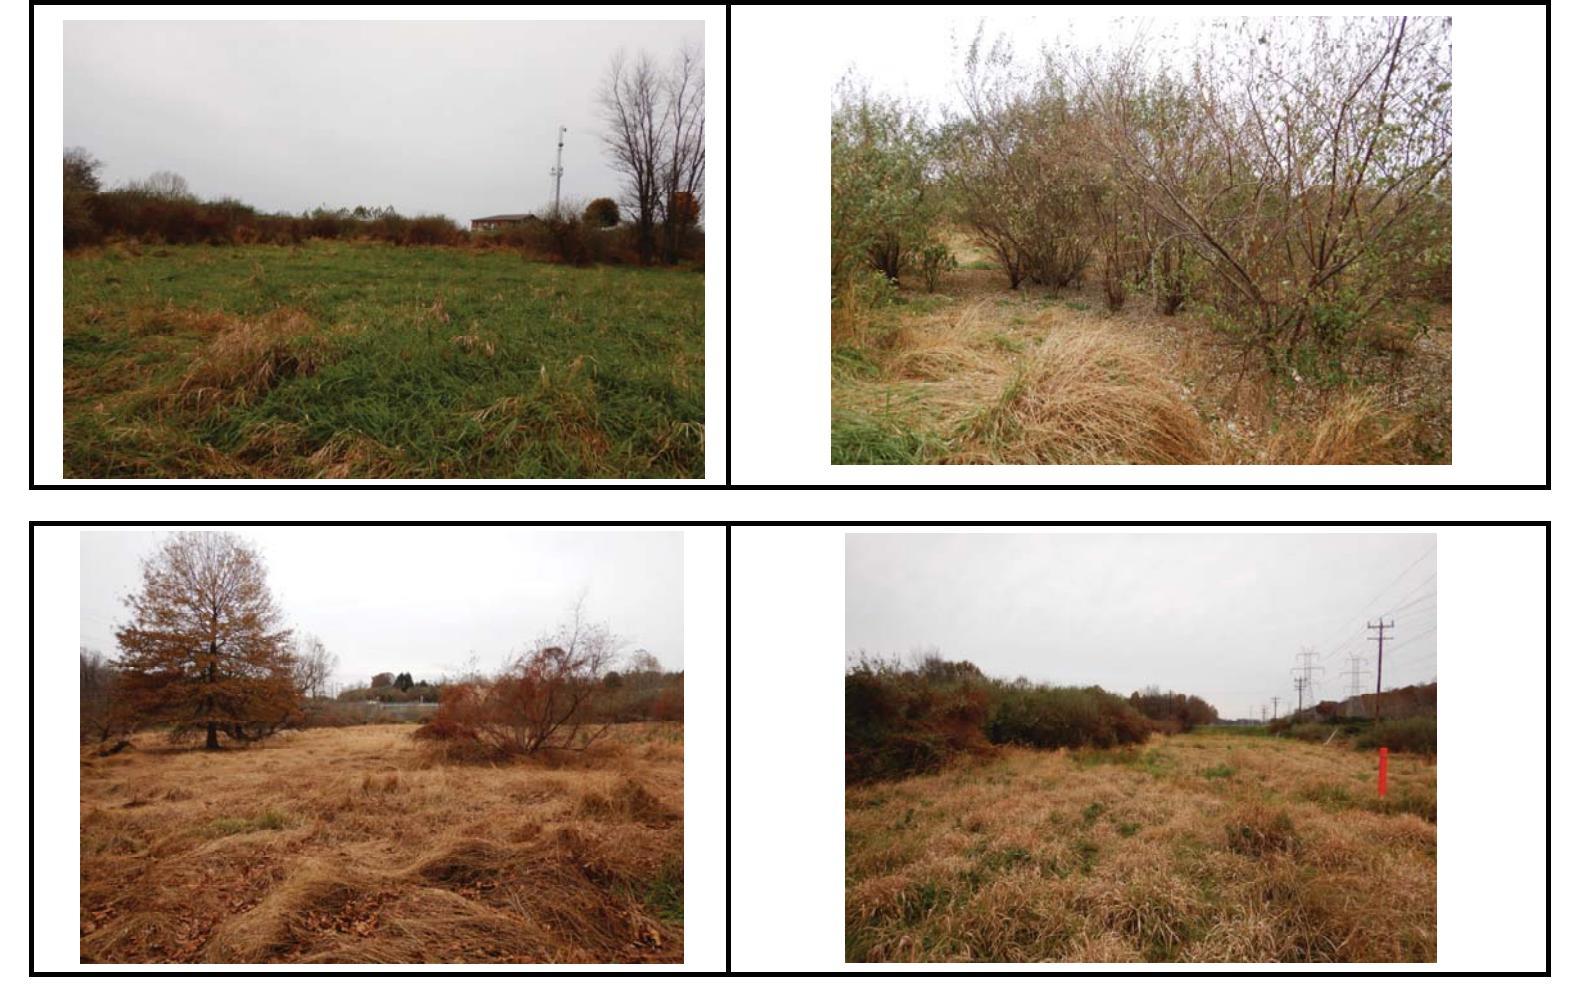
Property Owner(s).			al Field Observations	
	veloie holow)	Additiona	al Field Observations	Vac
RIE species present? (e)	kplain below)	Bartially	Evidence of disturbance? (explain below)	res
Condition: Wostorn port	ion of site consists of existin	g DEM (2.1 acros)	Condition: Contor portion of site (1.8 acros) consists of dry upland	d on a hillslong
with scattered trees that	t receives drainage from uns	tream sewage	dominated by autumn olive. Eastern portion of site (0.9 acres) co	nsists of low area
treatment plant	receives dramage nom ups	tream sewage	dominated by addition onvel Eastern portion of site (0.5 acres) co dominated by reed capary that may partially be wetland	
dominated by reed canary that may partially be welland.				
		Mitig	ation Site Rating	
		Score	<u>Criteria</u>	<u>Score</u>
Solis	udric coil	5	vegetation	10
5 - 10% to $50%$ hydric so	il		5 - Scrub-shrub cover	
1 - Less than 10% hydric	soil		1 - Mostly forested

5-Yes (mapped but no e	vidence of active flooding)		5 - Contiguous to wetland/upland forest 25-100 ac	
1 - NO			1 - Contiguous to wetland/upland forest < 25 ac	
Describe: Western portion of site i	s located in 100 VR FEMA flo	odalain No	Describe: Powerlines run between the site and Seneca Creek State Park	
evidence of active floodi	ing		rowenines fun between the site and seneta creek state fark.	
Geomorphic Position		5	Ease of Access	5
10 - Low or concave topo	ography		10 - Yes (with <u>existing</u> direct vehicular access to potential site)	
5 - Flat topography			5- yes (open but no existing vehicular access)	
1 - High topography/stee	ep slopes		1 - NO (NO VENICUlar access, clearing needed)	
Eastern and western nor	tion of site consist of concav	e tonogranhy	Existing access road from Seneca Creek Hwy to powerlines. Access	s to rest of site
Center portion of site co	nsists of high tonography w/	gradual slones	will require access under nowerlines or scrub/shrub clearing	3 to rest of site

Estimated cut to wetlan	d hydrology	5	Utilities Present	1
10 - Less than 2'	, ,,		10 - No utilities on site	<u></u>
5-between 3' - 5'			5 - Utilities but not within creation area	
1 - greater than 5'			1 - Utilities within potential creation area	
Describe:			Describe:	
Eastern and western por	tion of site would require 0-	2' cut to	Gas line and overhead powerlines run along southern border of s	ite.
groundwater, however o	enter portion of site would I	ikely require		
greater than 3' cut to gro	oundwater.			
			Total Score out of 100	E2
