APPENDIX E: PUBLIC SITE WALKTHROUGH RATING CRITERIA & FIELD ASSESSMENT FORMS

WETLAND MITIGATION RATING CRITERIA & FIELD SITE ASSESSMENT FORMS

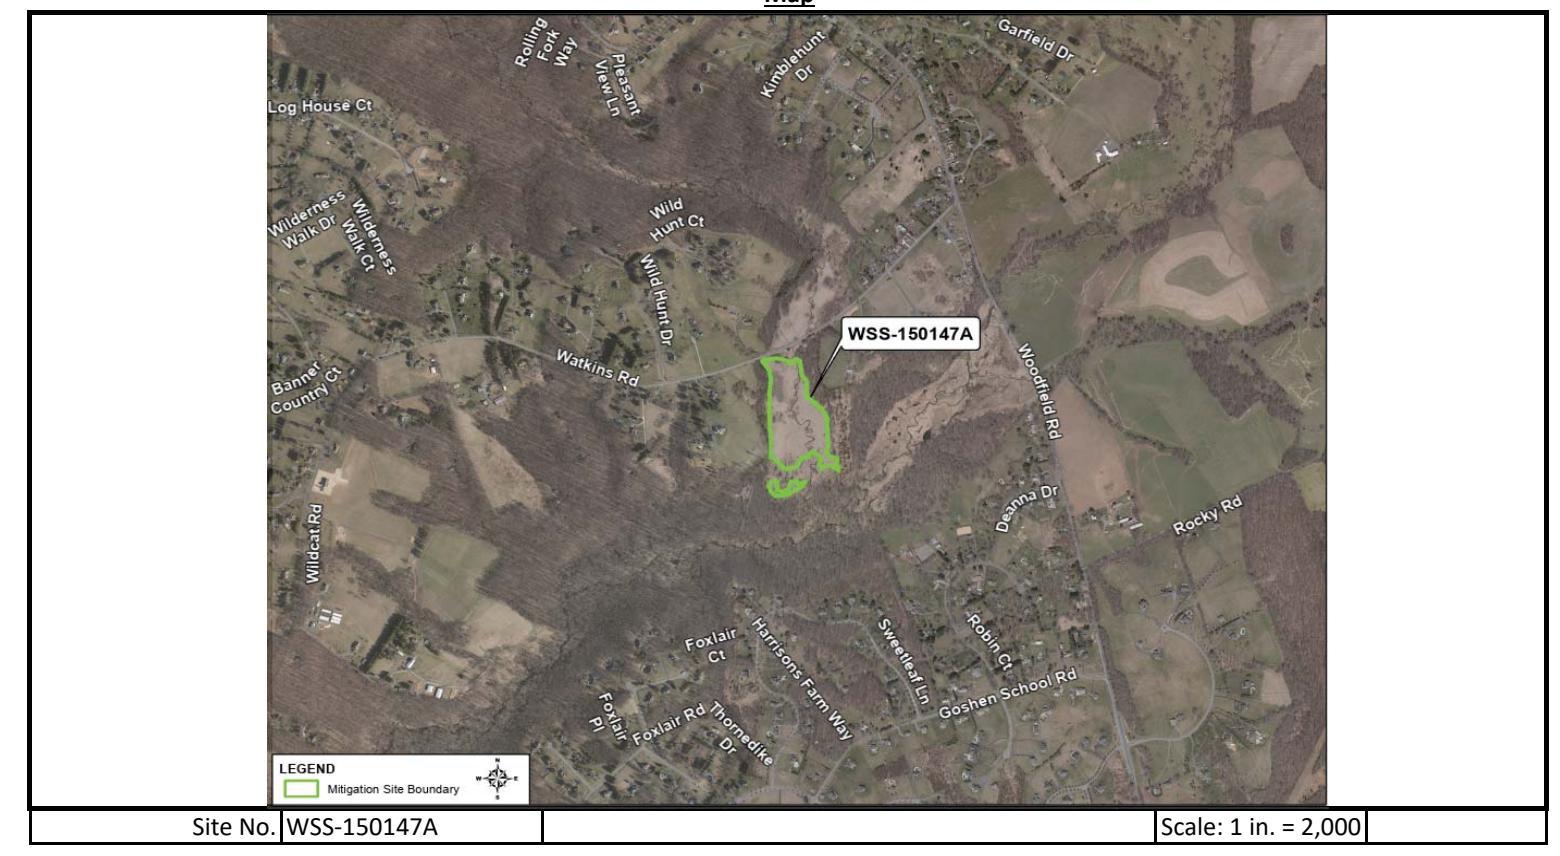
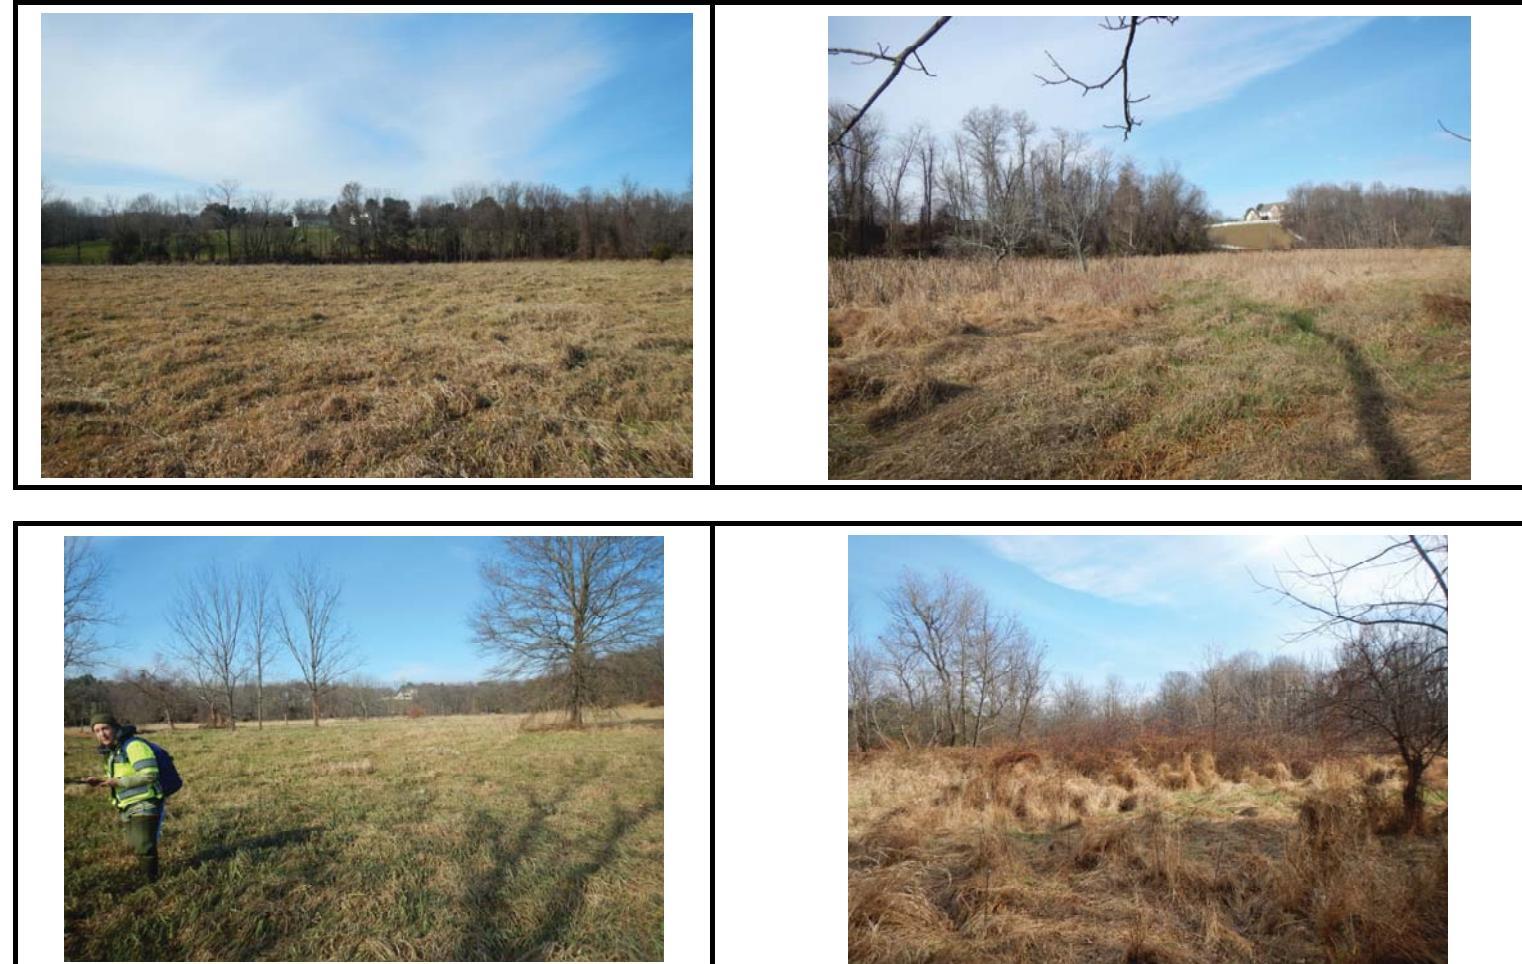
Property Owner(s):	Maryland National Capital	Park & Planning Co	Commission	
		Addition	al Field Observations	
RTE species present? (e	explain below)	TBD	Evidence of disturbance? (explain below)	No
Is site currently a wetla	and?	Partially	 Was site formerly a wetland?	Likely
Condition: Entire site is	located in the 100 YB floodnl	ain to Magruder	Condition: The entire eastern side and portions of the western side	e of the
Branch There are two la	arge PEM wetlands dominate	d by cattail and	floodplain are dry and dominated by reed capary grass. There are	scattered black
reed capary grass in the	western floodplain	u by cattair and	willow black walnut and pin oak trees within the site	
reeu canary grass in the	western noouplain.		whilew, black wanter, and philoak trees within the site.	
		Mitig	gation Site Rating	
<u>Criteria</u>		Score	Criteria	<u>Score</u>
Soils		10	Vegetation	10
10 - Greater than 50% h	ydric soil		10 - Herbaceous cover

100-Year Floodplain		10	Habitat Value	10
10 - Yes (active evidence	e of flooding)		10 - Contiguous to wetland/upland forest > 100 ac	
5-Yes (mapped but no e	evidence of active flooding)		5 - Contiguous to wetland/upland forest 25-100 ac	
1 - No			1 - Contiguous to wetland/upland forest < 25 ac	
Describe:			Describe:	
Majority of site is locate	ed in Magruder Branch 100 Y	R FEMA	Site connects downstream to Great Seneca Creek Park (>100 acres	s of forest).
floodplain. Active evider	nce of flooding (matted dowr	ι veg & water		
staining).				
Geomorphic Position		10	Ease of Access	5
10 - Low or concave top	ography		10 - Yes (with existing direct vehicular access to potential site)	
5 - Flat topography			5- yes (open but no existing vehicular access)	
1 - High topography/ste	ep slopes		1 - No (no vehicular access, clearing needed)	
Describe:			Describe:	
Site consists of low topo	ography surrounded by uplan	d slopes. Entire	Site is open, but no existing vehicular access. Potential access direct	ctly off Watkins

site within 100YR floodp	plain.		Road.	
Estimated cut to wetlar	nd hydrology	5	Utilities Present	10
10 - Less than 2'			10 - No utilities on site	
5-between 3' - 5'			5 - Utilities but not within creation area	
1 - greater than 5'			1 - Utilities within potential creation area	
Describe:			Describe:	
Groundwater observed	2.5' below ground surface in	non-wetland	No utilities observed within site, however overhead powerlines alo	ong watkins road
floodplain areas.			just outside site boundaries.	
			Total Score out of 100	85

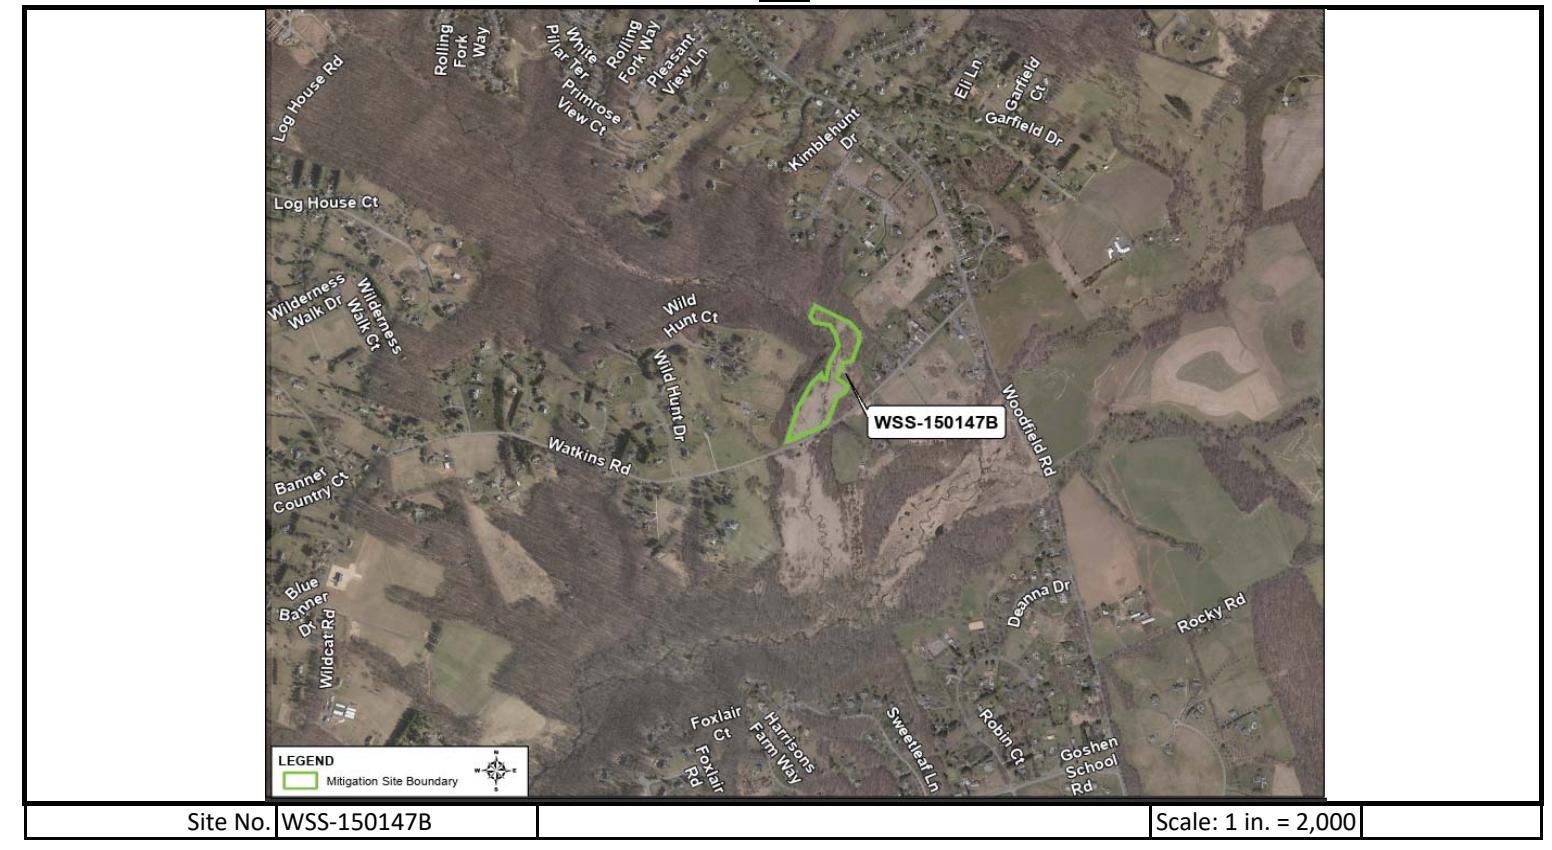
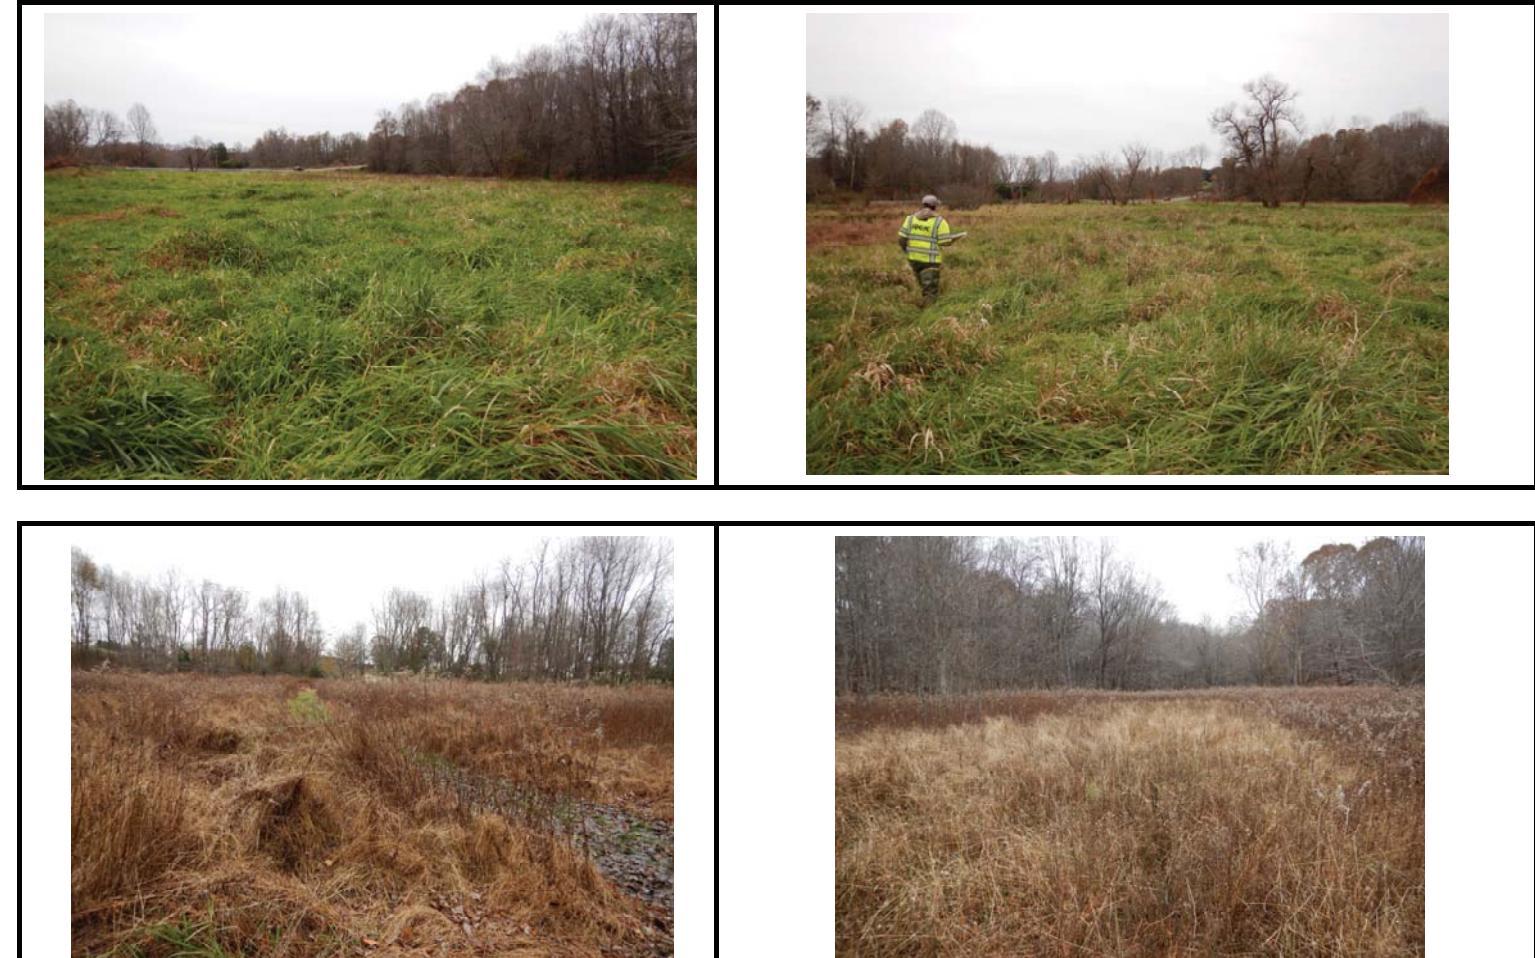
Wetland Mitigation Field Site Assessment Form				
		Pi	roject Details		
Project Name:	I-495/I-270 Managed Lanes	s Study	Mitigation Site Number: WSS-150147B		
Estimated Mitigation N	leeds (ac):	TBD

Is site currently a wetla	and?	Partially	Was site formerly a wetland?	Likely	
Condition: Entire site is	located in the 100 YR floodpl	ain to Magruder	Condition: Drier portions of floodplain are dominated by reed cana	ary grass or	
Branch. Large portions	of floodplain consist of PEM w	vetland	golden rod. Seep wetlands along toe of valley slopes at edge of floo	odplain. High	
dominated by reed can	ary grass.		quality PSS wetland along southeastern side of site.		
		N/i+i~	intion Site Dating		
Criteria		Score	Criteria	Score	
Soils		10	Vegetation	10	
10 - Greater than 50% h	avdric soil	10	10 - Herbaceous cover	10	
5 - 10% to 50% hydric s	oil		5 - Scrub-shrub cover		
1 - Less than 10% hydrid	c soil		1 - Mostly forested		
Describe:			Describe:		
Entire site is located in	mapped hydric soils. Large po	rtions of the site	Majority of site is dominated by reed canary grass, with scattered b	olack willow.	
were verified as hydric	soils in the field.		Large area in northeastern corner of site dominated by Canada gol	denrod.

Active evidence of floor	ding at upstream end of site (r	matted down veg			
& sediment deposition)		10	Free of Assess		
Geomorphic Position		10	Lase of Access	5	
10 - Low or concave top	oography		10 - Yes (with <u>existing</u> direct vehicular access to potential site)		
5 - Flat topography	an clones		5- yes (open but no existing venicular access)		
1 - High topography/ste	sep slopes		1 - No (no veniculai access, clearing needed)		
Site consists of low tone	ography surrounded by uplan	d slones Entire	Site is onen, hut no existing vehicular access. Potential access direc	tly off Watkins	
site within 100VR flood	nlain	a stopes. Little	Road	ity on watkins	
Estimated cut to wetla	nd hydrology	5	Utilities Present	10	
10 - Less than 2'	01	-	10 - No utilities on site		
5-between 3' - 5'			5 - Utilities but not within creation area		
1 - greater than 5'			1 - Utilities within potential creation area		
Describe:			Describe:

Groundwater observed	2-3' below ground surface in	non-wetland	No utilities observed within site.		
floodplain areas.	0	-			
			I		
			Total Score out of 100	85

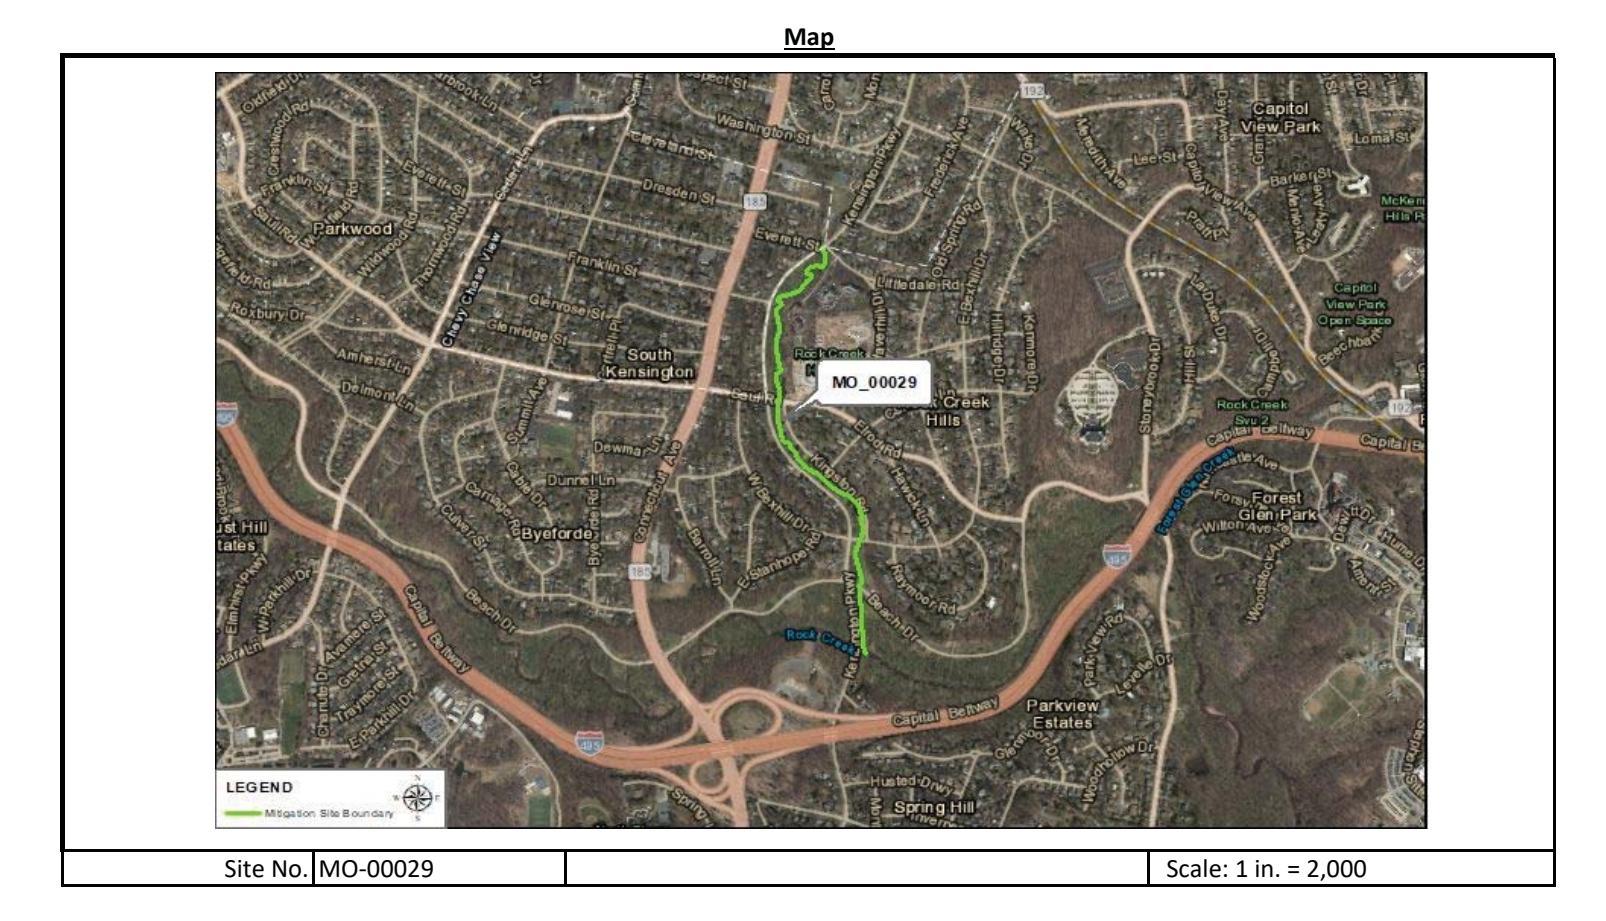
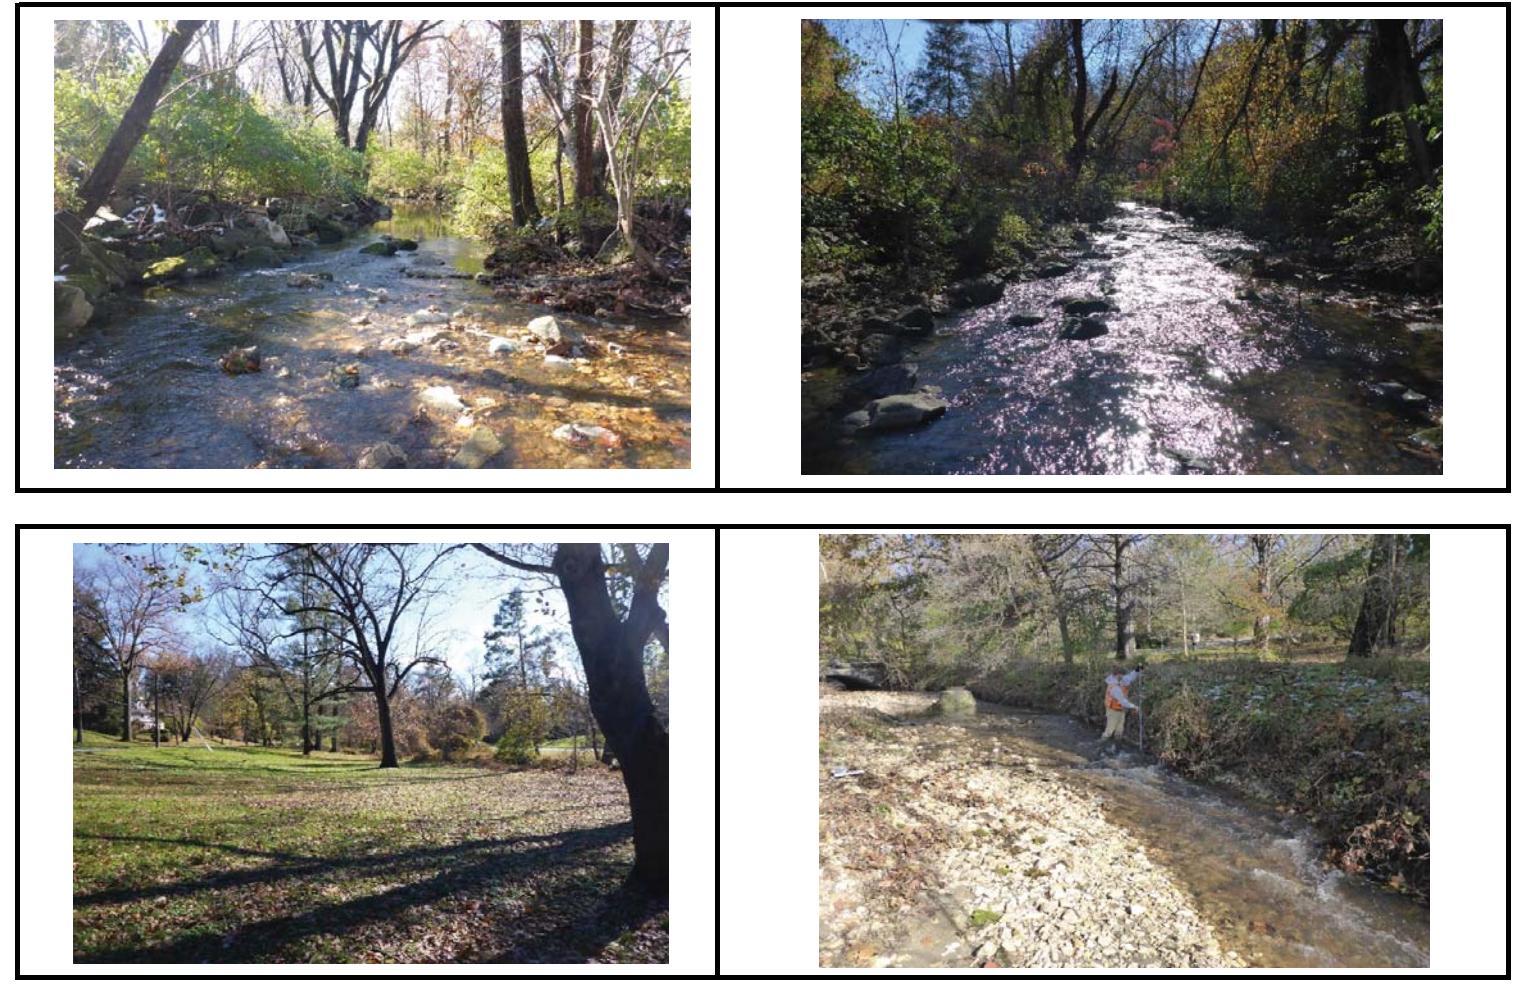
-	_		
Degree of Channel Incisi	ion	5	Land Use	1
10 - Bank Height greater	than 10 feet		10 - Agricultural or Open Space	
5 - Bank Height between 1 - Bank Height less than	a and to reet		5 - Marginal Pasture 1 - Old field/ Developed/Forested	
Describe:				
Banks are ~4-6 ft. tall.			Stream flows parallel to residential road in neighborhood.	
Existing Eloodalain Acco		10	Opportunity for Ecological Lift	5
10 - No evidence of out of	of bank flooding	10	10 - Conditions exist for several aspects of lift to be achieved	and sustained
5- Yes (Infrequent out of	f bank flow)		5 - Lift limited to one or few aspects	
1 - Yes (evidence of freq	uent flooding)		1 - Conditions are such that Lift is difficult to achieve and sust	ain
Describe:			Describe:	
In general, channel is inc	ised ~4-6 feet. Channel is	more incised	Site is between two roadways, thus limited potential buffer. S	Several crossings
downstream of Beach Di	r.		make bed elevation poor, little room for floodplain connectio	'n.

Opportunity for Floodpl	ain Development	1	Ease of Access	10
10 - Existing space for flo	odplain greater than 10 ti	mes stream width	10 - Yes (with <u>existing</u> direct vehicular access to potential site)
1 - Little to no space for	floodnlain development		1 - No (no vehicular access, clearing needed)	
Describe:			Describe:	
Potential for 3 times stream width, would require clearing. Contained		Directly off Kensington Pkwy. & Kingston Rd.		
by two roads Kensingtor	Pkwy. & Kingston Rd.	0		
, 0	, 0			
Drainage Area Evaluatio	n	5	l Itilities Present	1
10 -D.A. less than 1 sq. n	ni.		10 - No utilities on site	<u> </u>
5- D. A. between 1 & 3 s	q. mi.		5 - Utilities but not within restoration area	
1 - D. A. greater than 3 s	q. mi.		1 - Utilities within potential restoration area	
Describe:			Describe:	
Drainage area - 1.71 squ	are miles.		Several exposed crossings in stream.	
· · · · ·			-	
			Total Score out of 100	53

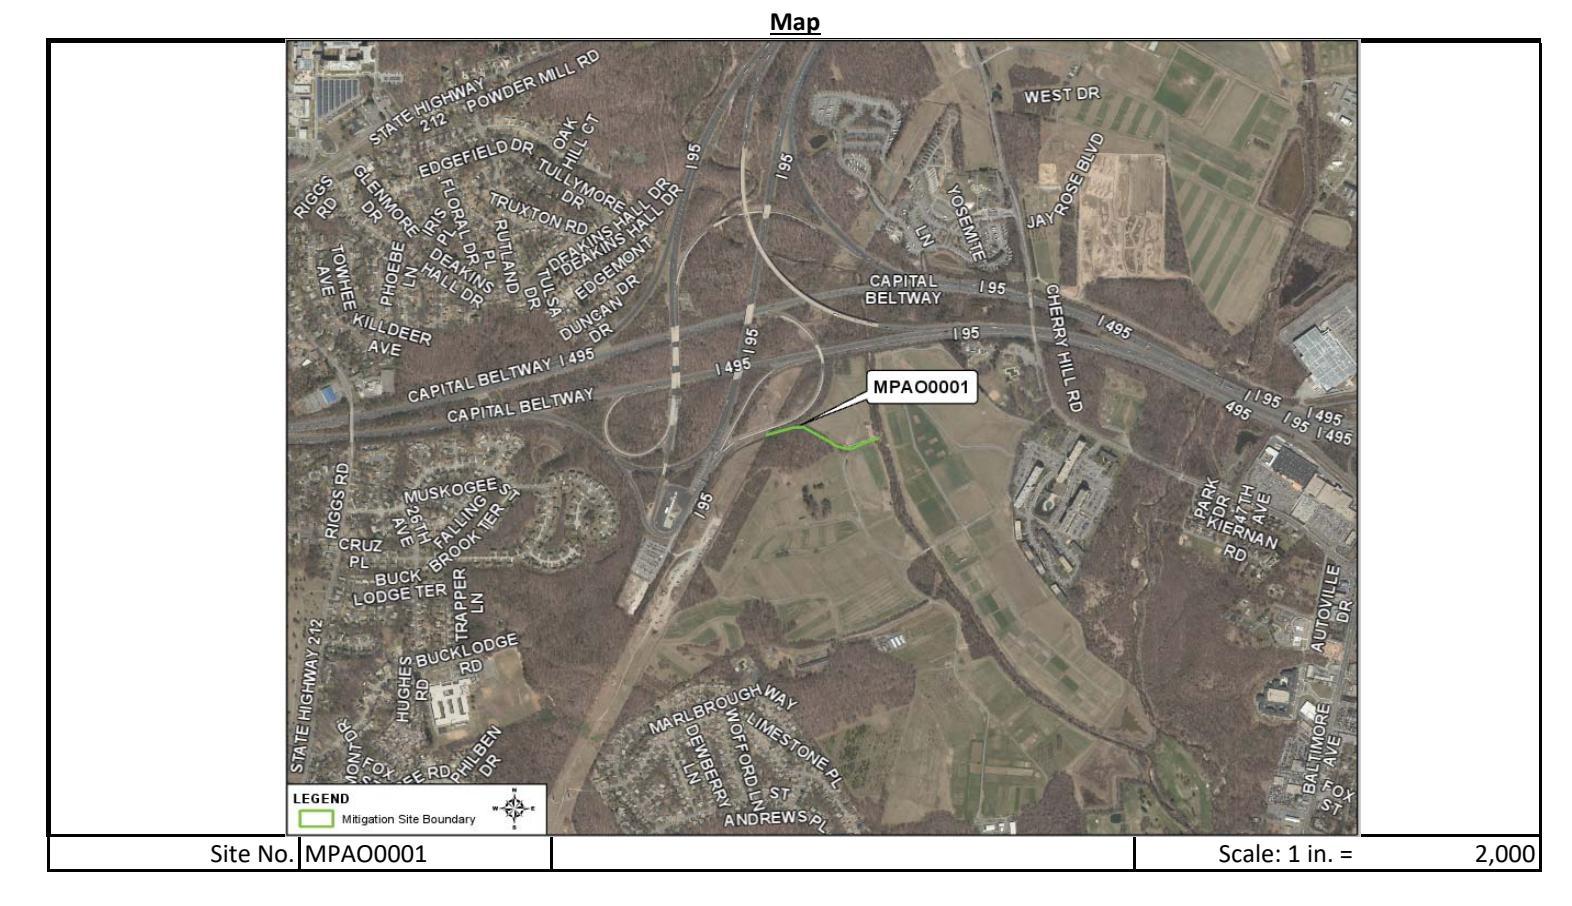
1 - Yes (evidence of frequent flooding)		1 - Conditions are such that Lift is difficult to achieve and sustain		
Describe:		Describe:		
No evidence of floodplain connection; channel de	eply incised.	No floodplain potential, no water quality potential. In the upstream reach,		
		potential exists for channel stabilization and instream habi	tat uplift.	
Opportunity for Floodplain Development	1	Ease of Access	5	
10 - Existing space for floodplain greater than 10 t	imes stream width	10 - Yes (with existing direct vehicular access to potential s	ite)	
5 - Existing space for floodplain 3 to 10 times stream	am width	5- yes (open but no existing vehicular access)		
1 - Little to no space for floodplain development		1 - No (no vehicular access, clearing needed)		
Describe:		Describe:		
Downstream = adjacent agricultural fields in use b	y BARC	Downstream = existing access through agricultural field		
Upstream = steep slopes and narrow valley		Upstream = forested and steep slopes

0.17 square miles		Exposed sewer crossing. Gas line and power lines run para	lel to stream.	
		Total Score out of 10	JO 52

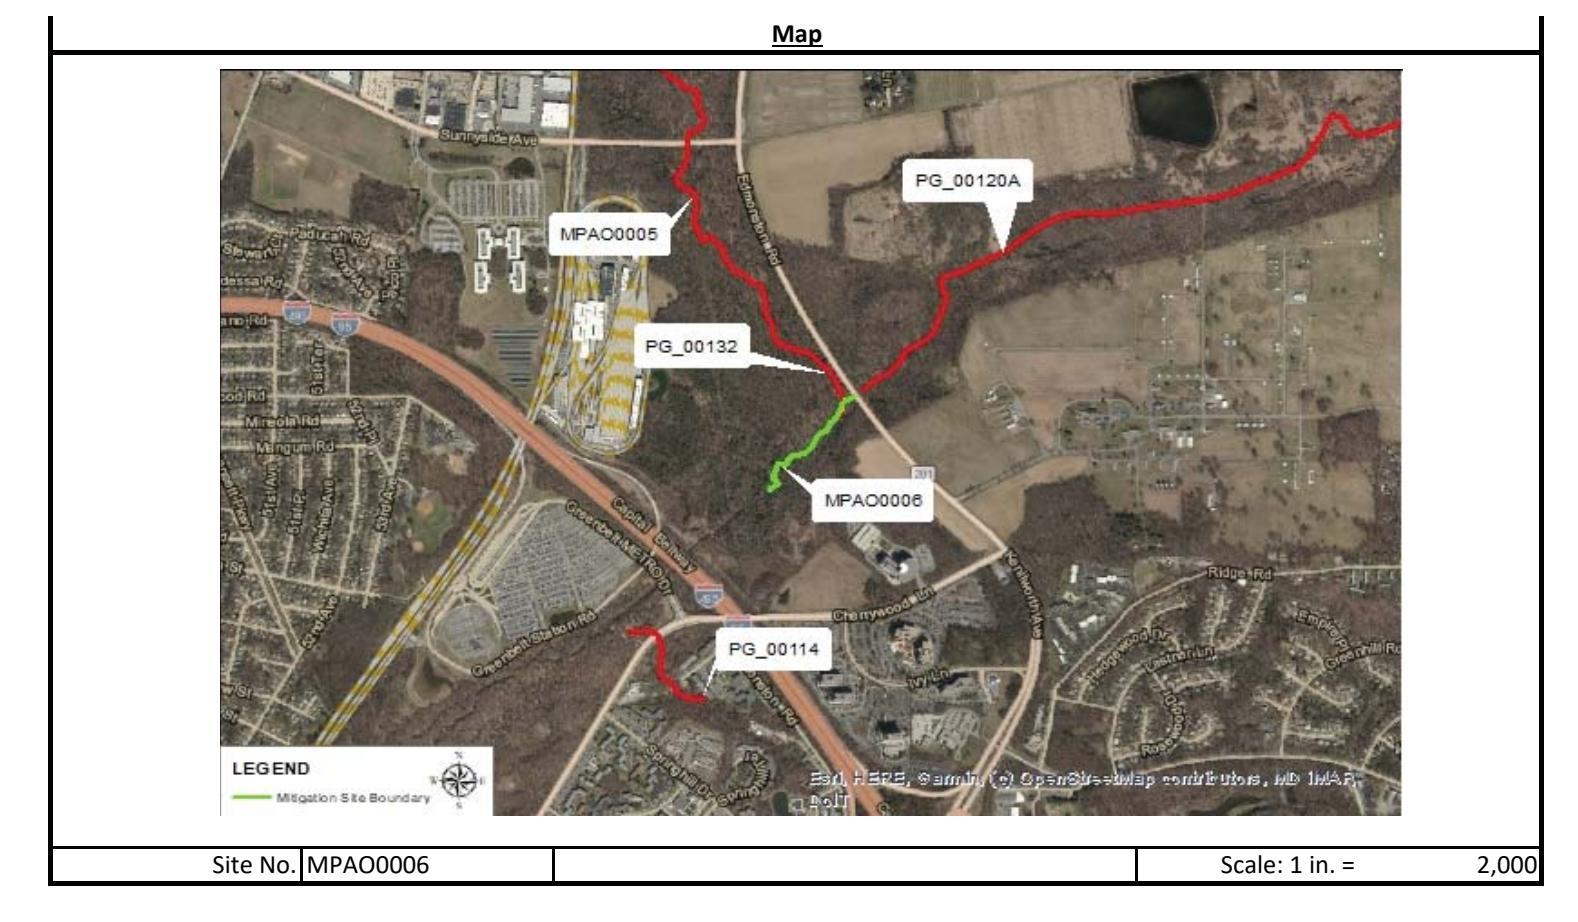
1 - Yes (evidence of freq	uent flooding)		1 - Conditions are such that Lift is difficult to achieve and sustain		
Describe:			Describe:		
Infrequent out-of-bank	flow evident by rack lines a	nd deposition,	Lateral stability, habitat enhancement, floodplain reconnection, bedform		
especially within braide	d area.		diversity.		
Opportunity for Floodp	lain Development	10	Ease of Access	1	
10 - Existing space for fl	oodplain greater than 10 ti	mes stream width	10 - Yes (with <u>existing</u> direct vehicular access	s to potential site)	
5 - Existing space for no	odpiain 3 to 10 times strea	m width	5- yes (open but no existing venicular access		
1 - Little to no space for Describe:			1 - No (no venicular access, clearing needed)	<u> </u>	
Describe. Space for floodplain evi	sts hut tree impacts may li	mit	No existing access field on left hank outside	of rinarian is a notential access	
	sts, but tree impacts may in	init.	no existing access, new officer bank outside	adad

Drainage Area Evaluatio	on	1	Utilities Present	10	
10 -D.A. less than 1 sq. r	mi.	-	10 - No utilities on site	_	
5- D. A. between 1 & 3 s	sq. mi.		5 - Utilities but not within restoration area		
1 - D. A. greater than 3 s	sq. mi.		1 - Utilities within potential restoration area		
Describe:			Describe:		
DA = 23.9 mi ²			No utilities were visible		
			<u>Total Scc</u>	ore out of 100 44

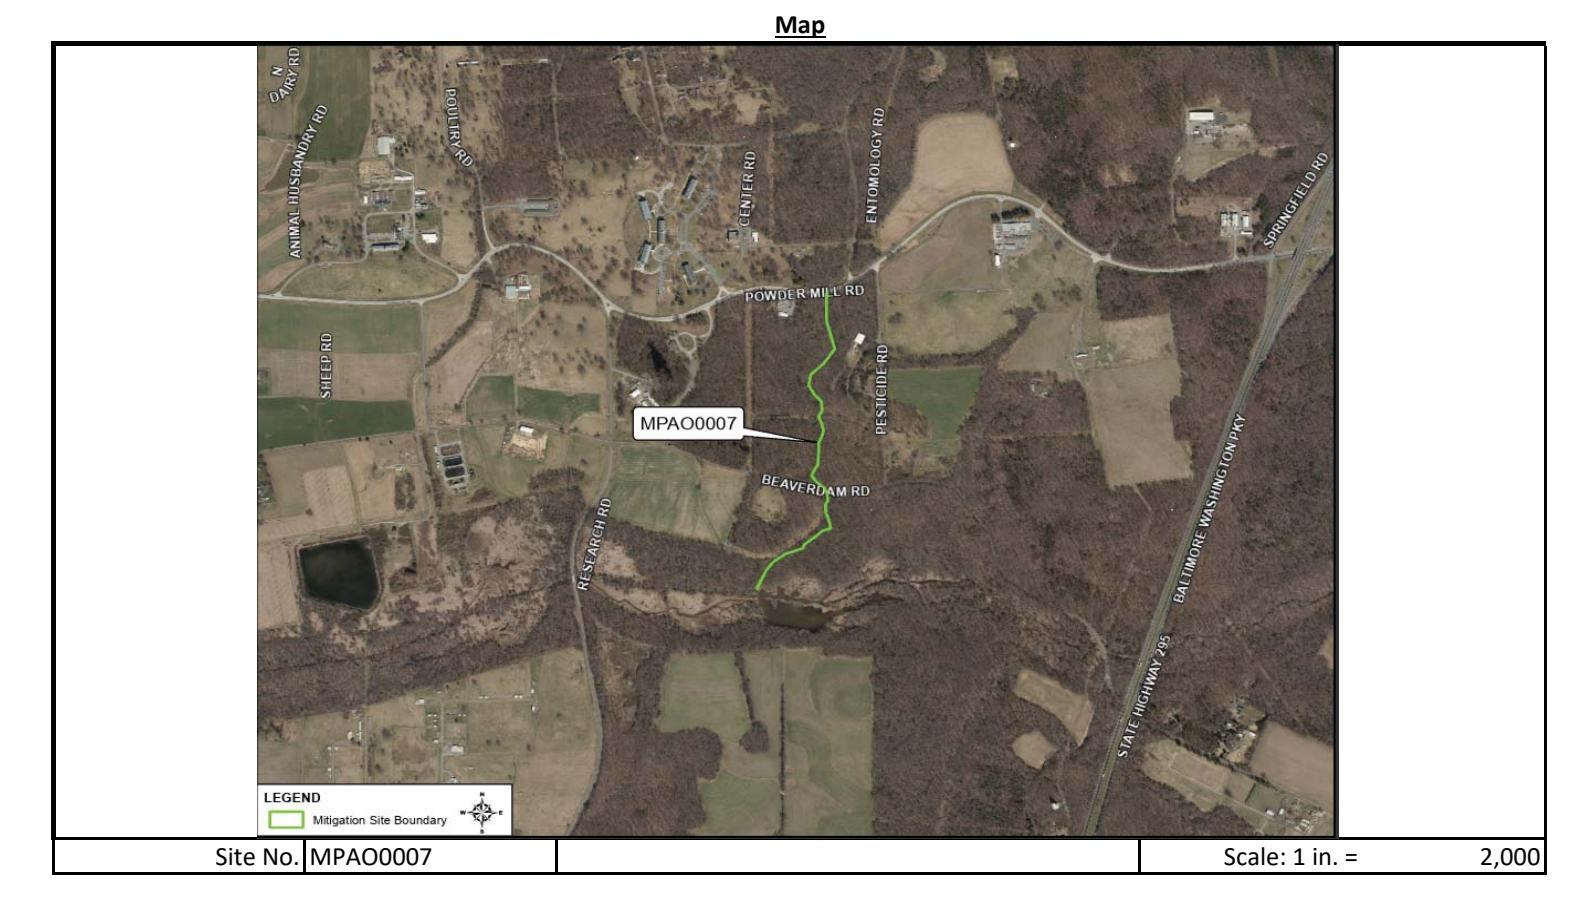
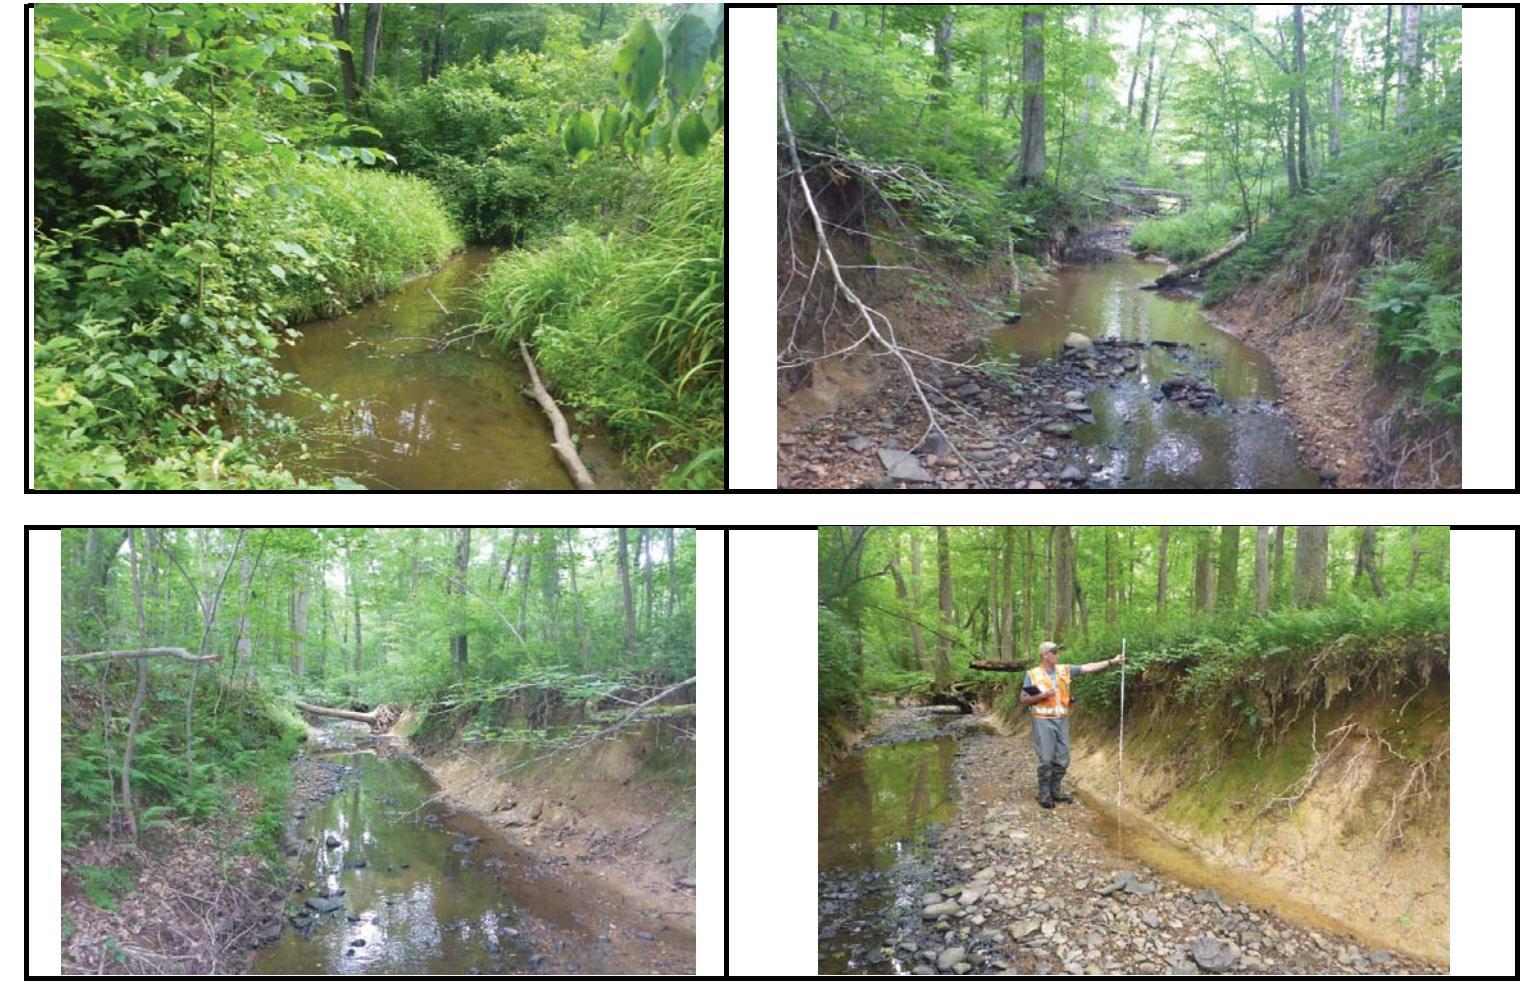
1 - Yes (evidence of frequent flooding)		1 - Conditions are such that Lift is difficult to achieve and sustain		
Describe:		Describe:		
Some areas of floodplain access within old down c	ut channel at upper	Opportunities for floodplain access, vertical and late	ral stability, habitat	
2/3 of site. Lower 1/3 features more frequent acce	ess to floodplain.	creation.		
Opportunity for Floodplain Development	10	Ease of Access	5	
10 - Existing space for floodplain greater than 10 t	imes stream width	10 - Yes (with <u>existing</u> direct vehicular access to pote	ential site)	
5 - Existing space for floodplain 3 to 10 times strea	am width	5- yes (open but no existing vehicular access)		
1 - Little to no space for floodplain development		1 - No (no vehicular access, clearing needed)		
Describe: Space exists but mature forest may limit expansive	o floodalain	Describe:	ways and Dowdor	
development		Mill/Reaver Dam Rd. Clearing needed to access othe	vays and FOWDER

development.		will/Beaver Dam Ru. Clearing needed to access othe	portions of the reach.	
Drainage Area Evaluation	10	Utilities Present	1	
10 -D.A. less than 1 sq. mi.		10 - No utilities on site		
5- D. A. between 1 & 3 sq. mi.		5 - Utilities but not within restoration area		
1 - D. A. greater than 3 sq. ml.		1 - Other within potential restoration area		
Describe:		Describe:		
DA = 0.66mi ²		Remnant utilities present as well as active sewer cro	ssing and manholes.	
		Total Score out	; of 100 53

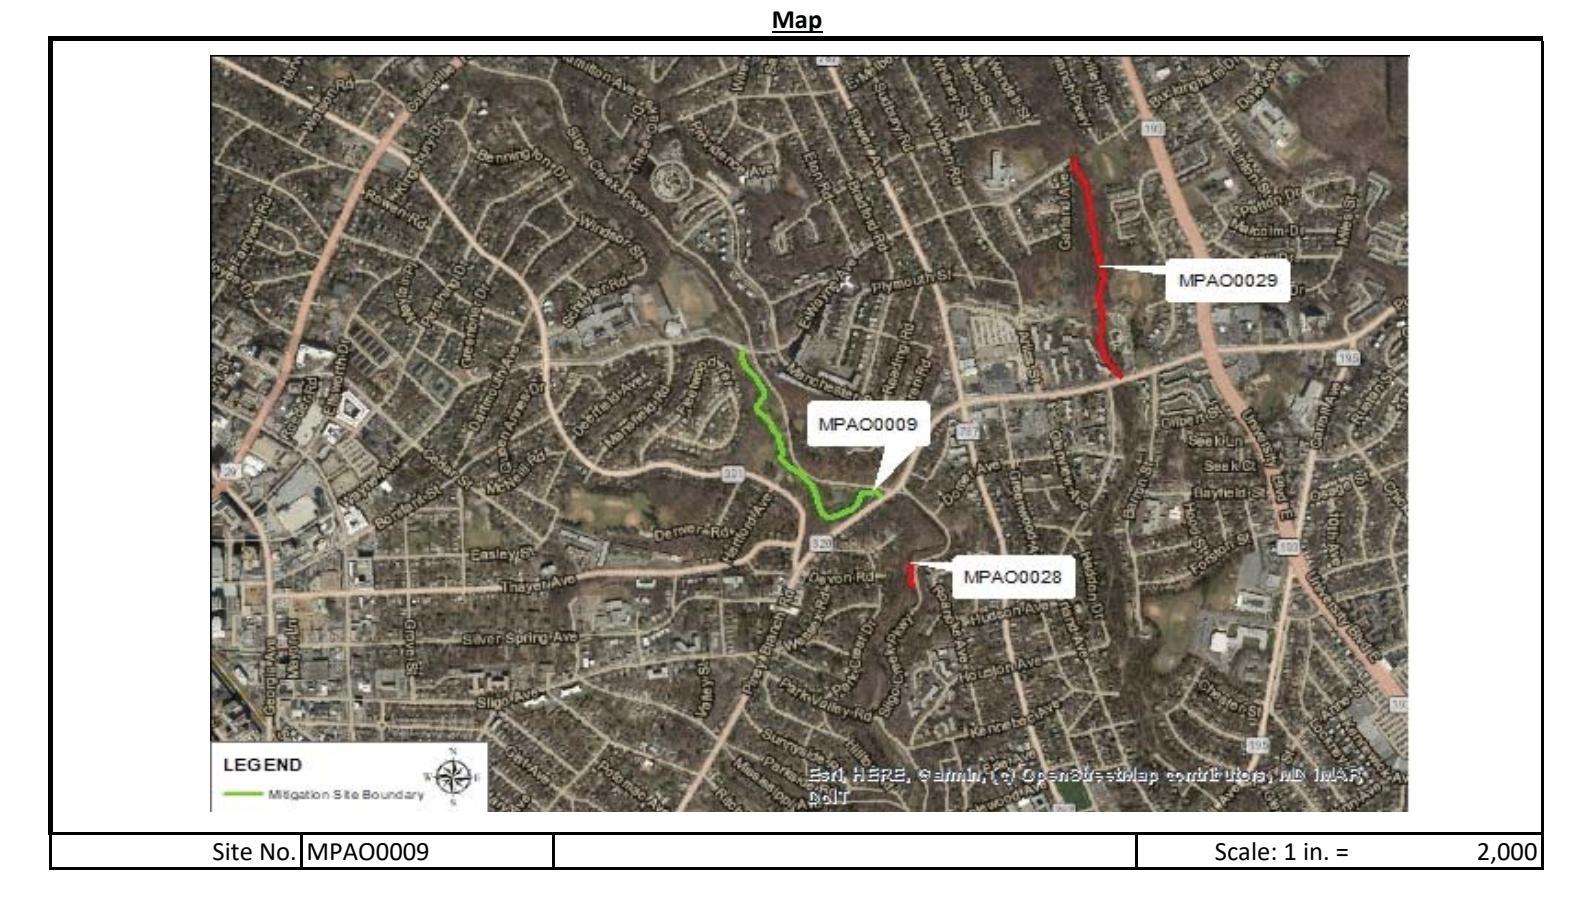
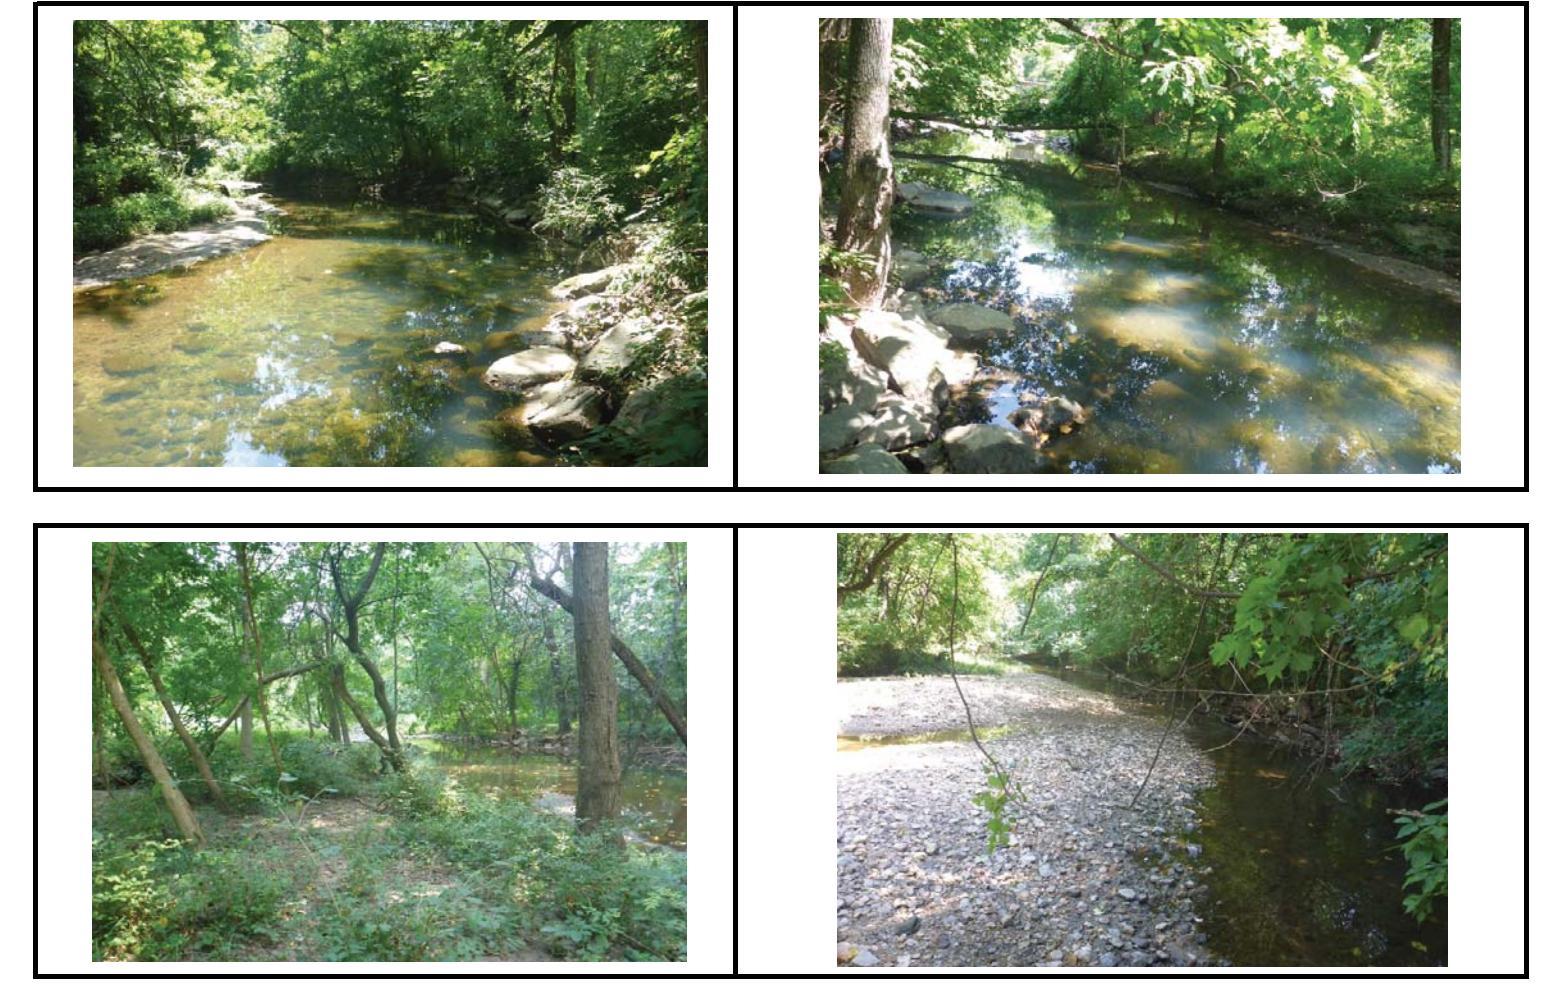
5 - Bank Height betweer	n 3 and 10 feet		5 - Marginal Pasture	
1 - Bank Height less thar	n 3 feet		1 - Old field/ Developed/Forested	
Describe:			Describe:	
~5'			Forest	
Existing Floodplain Acce	ess	5	Opportunity for Ecological Lift	1
10 - No evidence of out	of bank flooding		10 - Conditions exist for several aspects of lift to be achieved	and sustained
5- Yes (Infrequent out of	f bank flow)		5 - Lift limited to one or few aspects	
1 - Yes (evidence of freq	uent flooding)		1 - Conditions are such that Lift is difficult to achieve and sust	ain
Describe:			Describe:	
Certain sections have so	ft sediment on upper bank	'S	Lots of riprap, not a lot of existing instabilities.	
	te seament on apper bank			
Onnortunity for Floodal	ain Davalanmant	5	Face of Accord	5
Opportunity for Floodpi	ain Development		Ease of Access	5
10 - Existing space for fice	booplain greater than 10 ti	mes stream width	10 - Yes (with <u>existing</u> direct venicular access to potential site)

5 - Existing space for floo	depiain 3 to 10 times strea	m width	5- yes (open but no existing venicular access)	
1 - Little to no space for	fioodplain development		1 - No (no venicular access, clearing needed)	
Describe:			Describe:	
Space available. Constric	cted by adjacent roadway t	to the east and	Next to multiple trails with parking and roads.	
path/development to th	e west.			
Drainago Aroa Evaluatio		1	Litilities Brosent	1
10 DA loss than 1 can		T	10 No utilities on site	1
10 -D.A. less than 1 sq. n	ni.		10 - No utilities on site	
5- D. A. between 1 & 3 s	q. mi.		5 - Utilities but not within restoration area	
1 - D. A. greater than 3 s	q. mi.		1 - Utilities within potential restoration area	
Describe:			Describe:

6.12 sq. mi			Multiple sewer crossings and outfalls.	
			. .	
			Total Score out of 100	30
