APPENDIX E: PUBLIC SITE WALKTHROUGH RATING CRITERIA & FIELD ASSESSMENT FORMS

WETLAND MITIGATION RATING CRITERIA & FIELD SITE ASSESSMENT FORMS

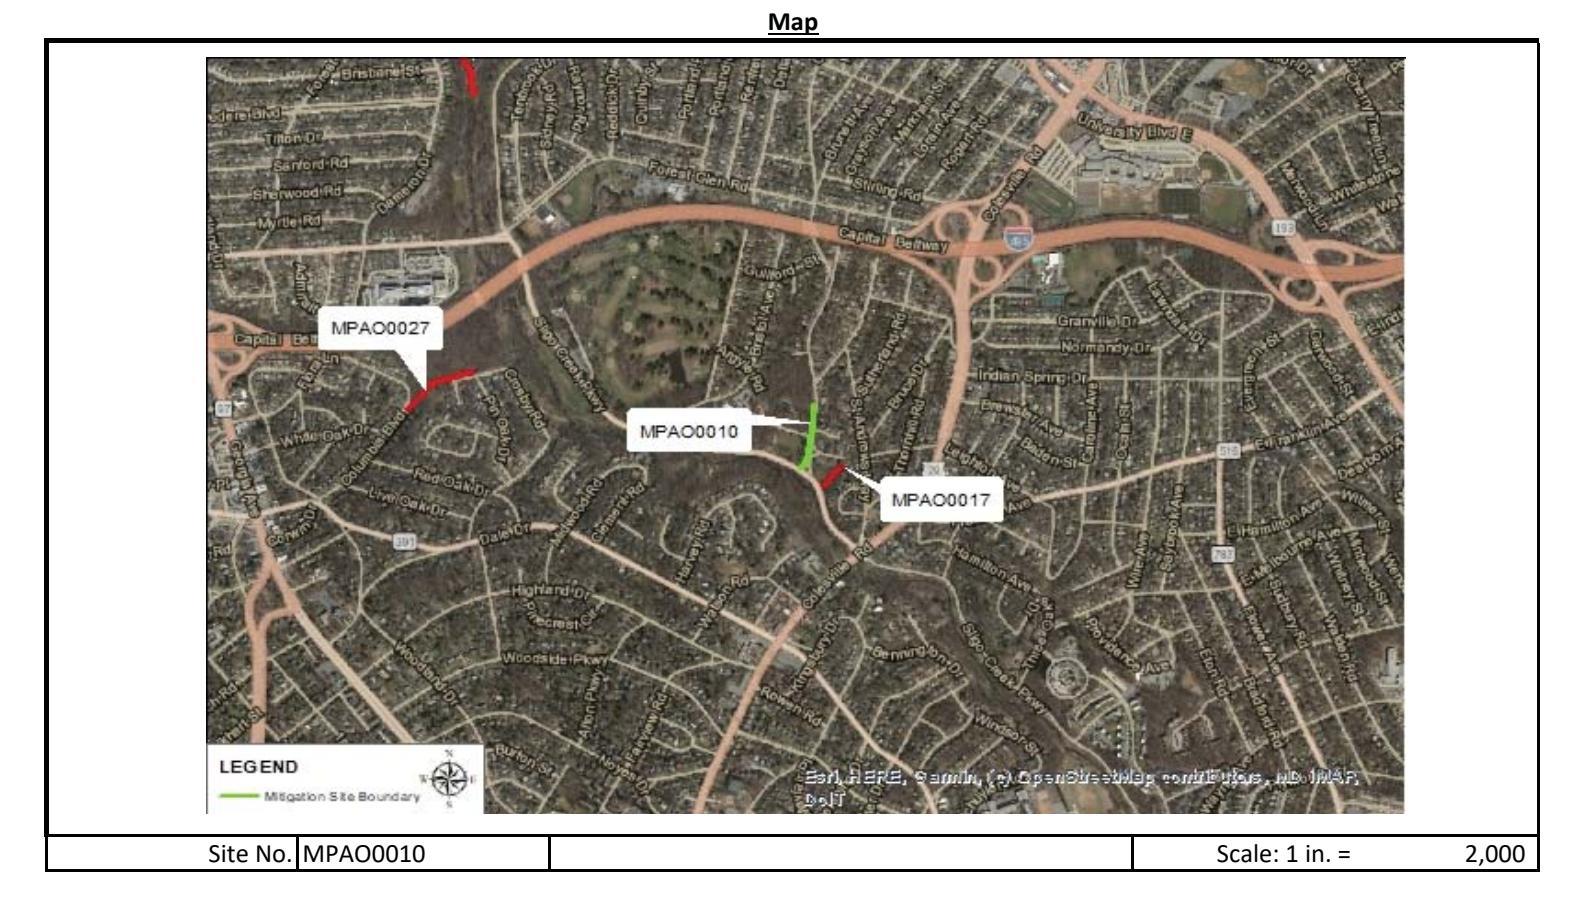
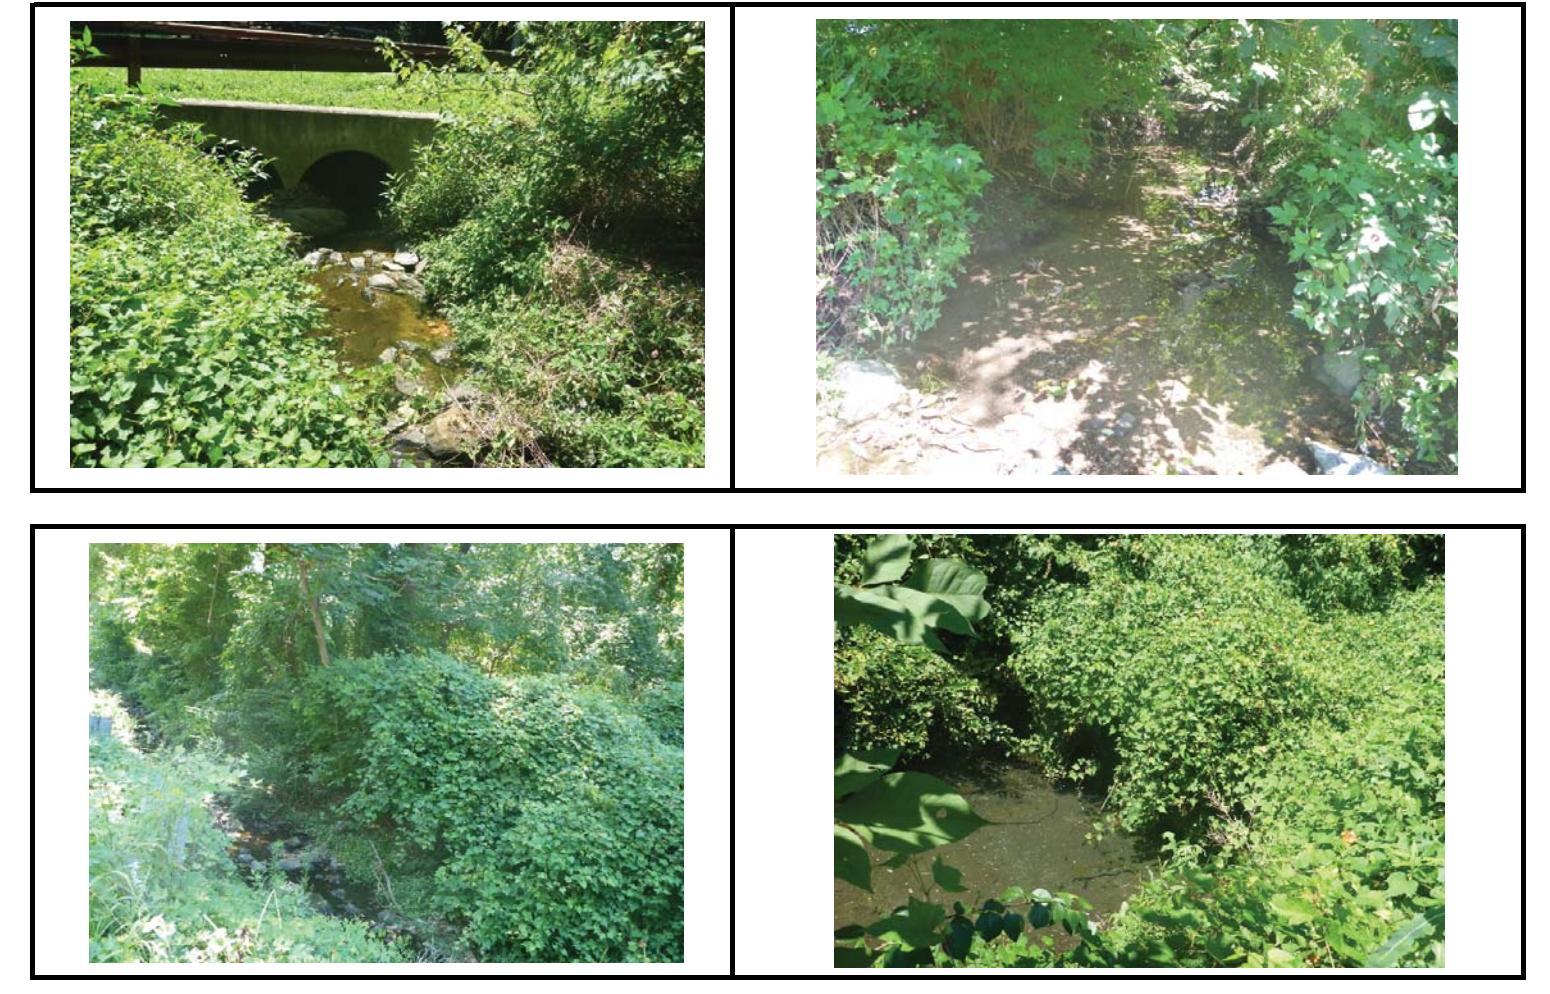
Low bench in upstream	section.		Right bank is along road, but uplift lateral stability and habi	tat.
Opportunity for Floodp	lain Development	5	Ease of Access	10
10 - Existing space for fl	oodplain greater than 10 tir	mes stream width	10 - Yes (with <u>existing</u> direct vehicular access to potential si	te)
5 - Existing space for flo	odplain 3 to 10 times stream	n width	5- yes (open but no existing vehicular access)	
1 - Little to no space for	noodplain development		1 - No (no venicular access, clearing needed)	
Describe:	by adjacent readway. Opp	ortunity oxists to	Describe:	on field on the
the west	by aujacent roadway. Oppo	Dituility exists to	Along roduway and at MINCPPC entrance, with adjacent ope	
11C WESL.			עטייוזנו כמווו ווצווג אמווג.	
Drainage Area Evaluatio	on	10	Utilities Present	1
IU-D.A. less than 1 sq. r	ni.		10 - NO UTILITIES ON SITE	
J-D.A. Delweell I & 3 S 1 - D A greater than ? (sa mi		1 - Utilities within notential restoration area

·····			
			1: 1 cowor crossing at MANCADC entrement	
u.29 sy. miles			T, T SEWEL CLOSSING AL MINCEPPC ENTLANCE	
			Total Score out of 10	0 48

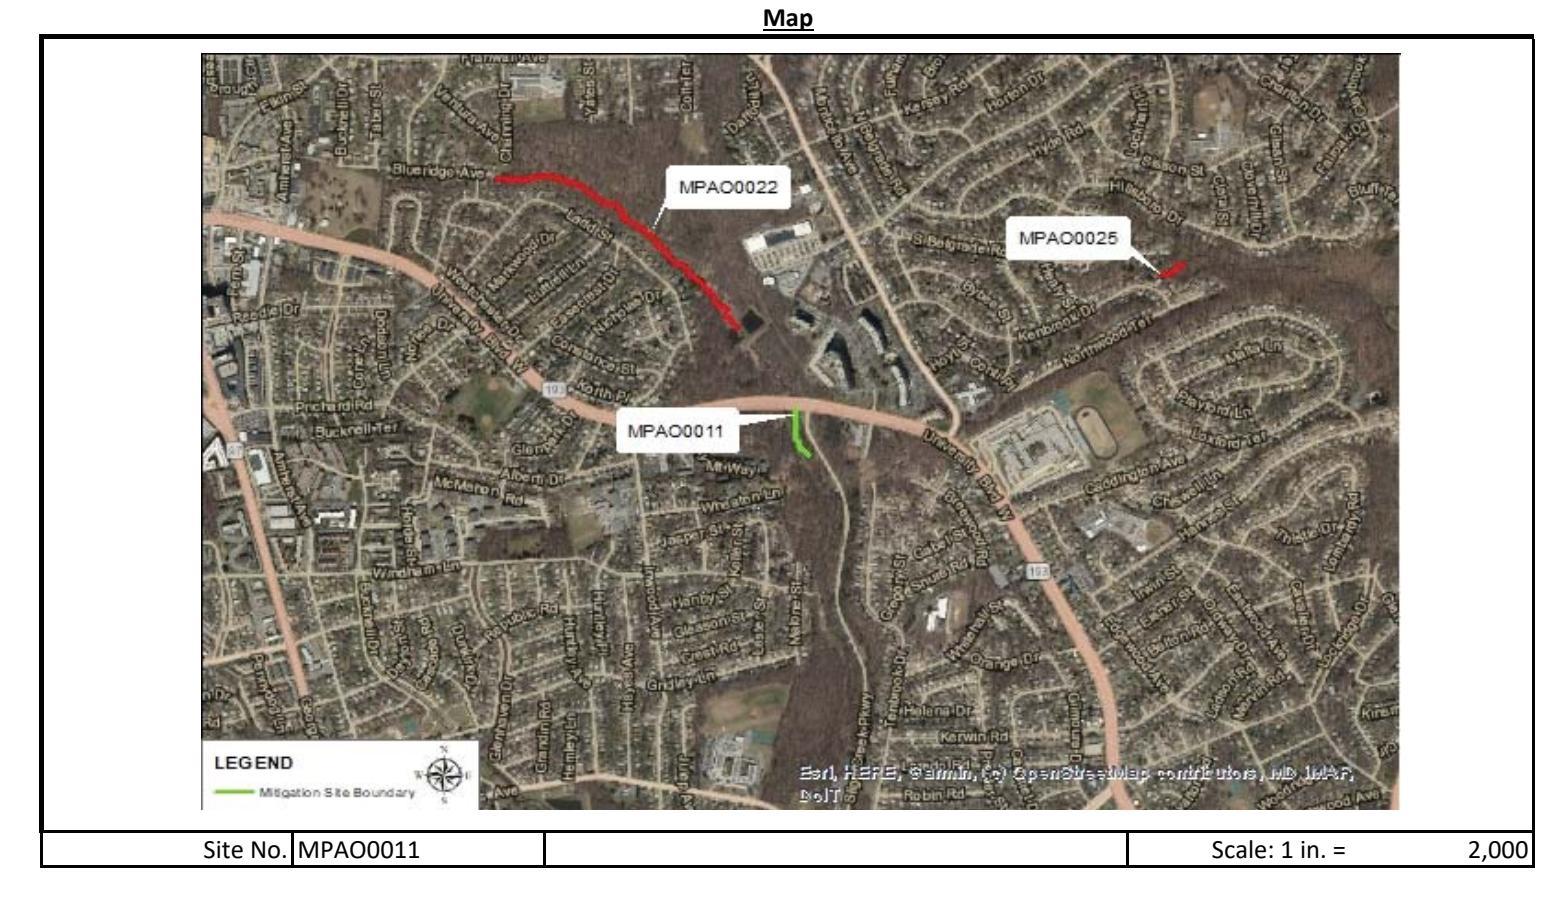
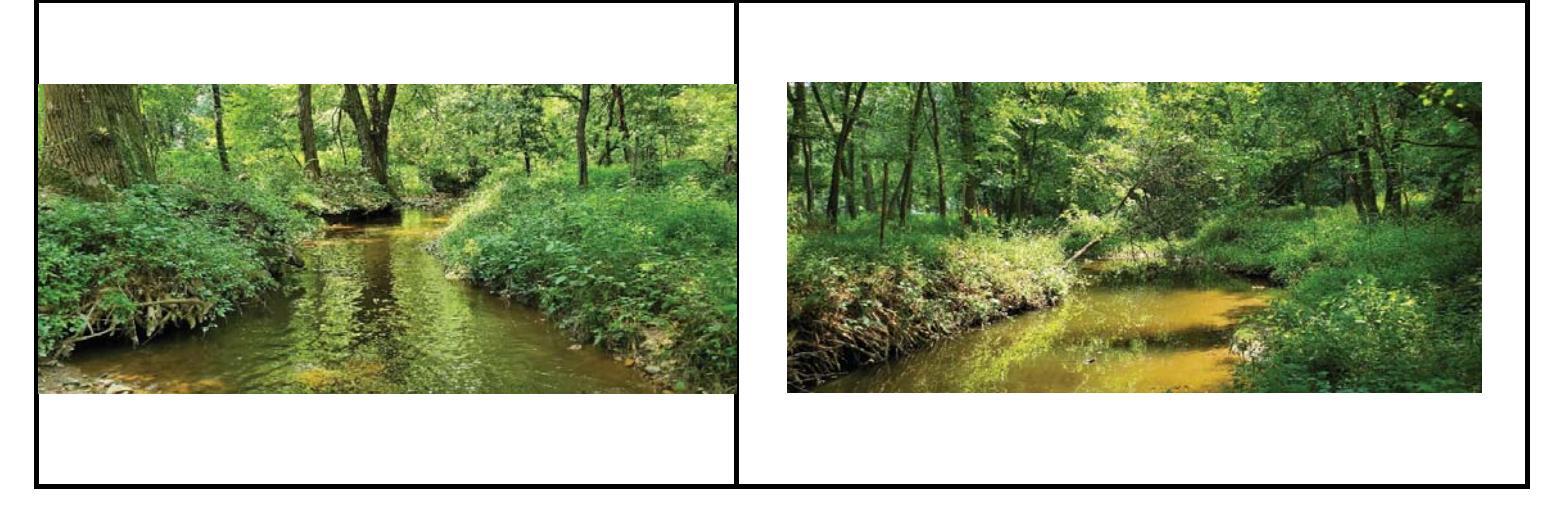
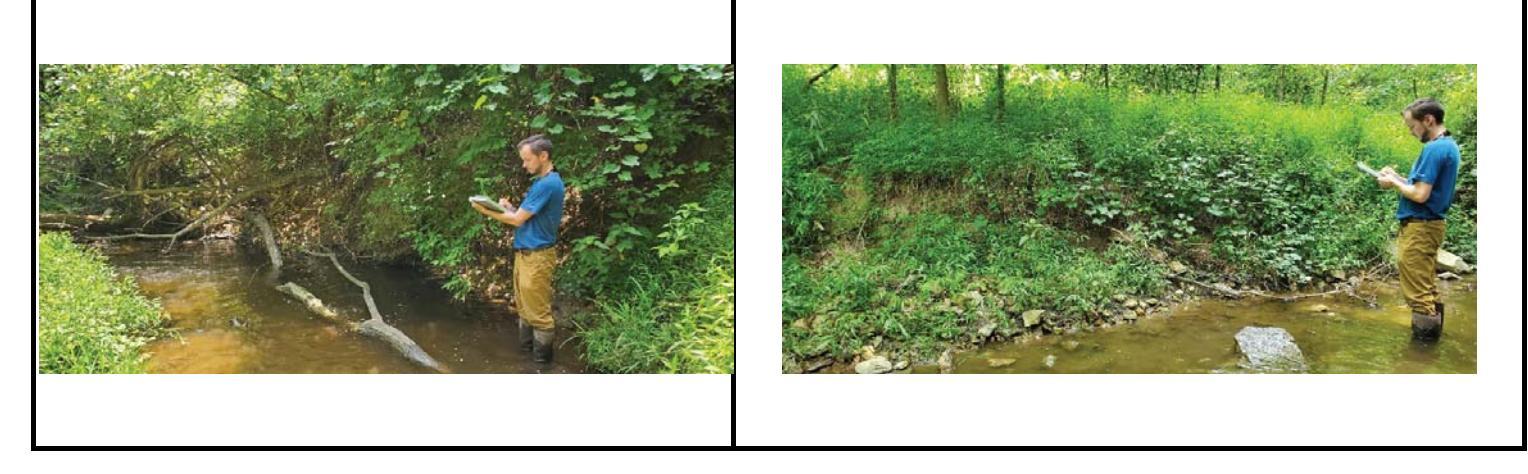
10 Bank Hoight groater	than 10 foot	5	Land Use	L
5 - Bank Height hetweer	1111 10 leel		5 - Marginal Pacture	
1 - Bank Height less than	n 3 feet		1 - Old field/ Developed/Forested	
Describe:			Describe	
~4.5 feet			Forested park	
n internetin Anna			 A state for producted 11fts 	5
Existing Floodplain Acce	:SS of bank flooding	5	Opportunity for Ecological LITT	C bend sustained
LO - NO evidence of out	of Dank Hooding		10 - Conditions exist for several aspects of firt to be achieved a	and sustained
1 - Yes (evidence of freq	uent flooding)		1 - Conditions are such that Lift is difficult to achieve and susta	ain
Describe:			Describe	
Gets out on bars, but no	t out of overall channel.		Fish passage. lateral migration, floodplain access, bedform div	versitv.
			· ····································	,
Opportunity for Floodpl	ain Development	5	Ease of Access	5
10 - Existing space for flo	oodplain greater than 10 tir	mes stream width	10 - Yes (with existing direct vehicular access to potential site)

5 - Existing space for floo	odplain 3 to 10 times stream	m width	5- yes (open but no existing vehicular access)	
1 - Little to no space for	floodplain development		1 - No (no vehicular access, clearing needed)	
Describe:			Describe:	
Confined by trail and roa	adway.		Some clearing required.	
Drainage Area Evaluatio	on	10	Utilities Present	1
10 -D.A. less than 1 sq. n	ni.		10 - No utilities on site	
5- D. A. between 1 & 3 s	q. mi.		5 - Utilities but not within restoration area	
1 - D. A. greater than 3 s	q. mi.		1 - Utilities within potential restoration area	
Describe:			Describe:

0.87 sq. miles				
			Total Cases and af 400	40
			LOTAL SCORE OUT OF 1001	43

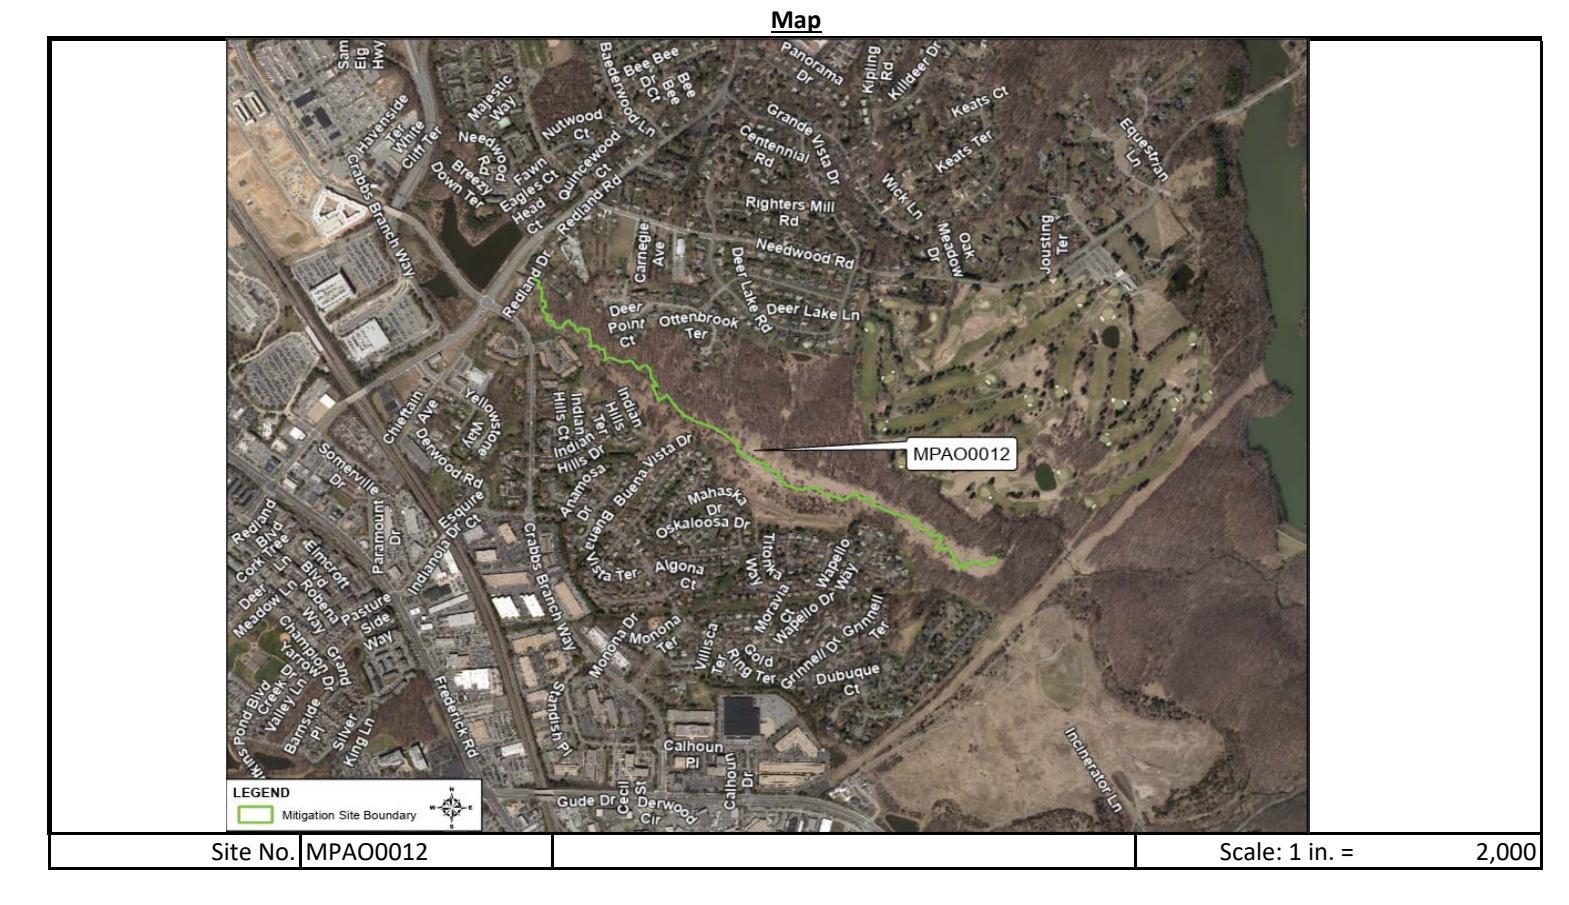
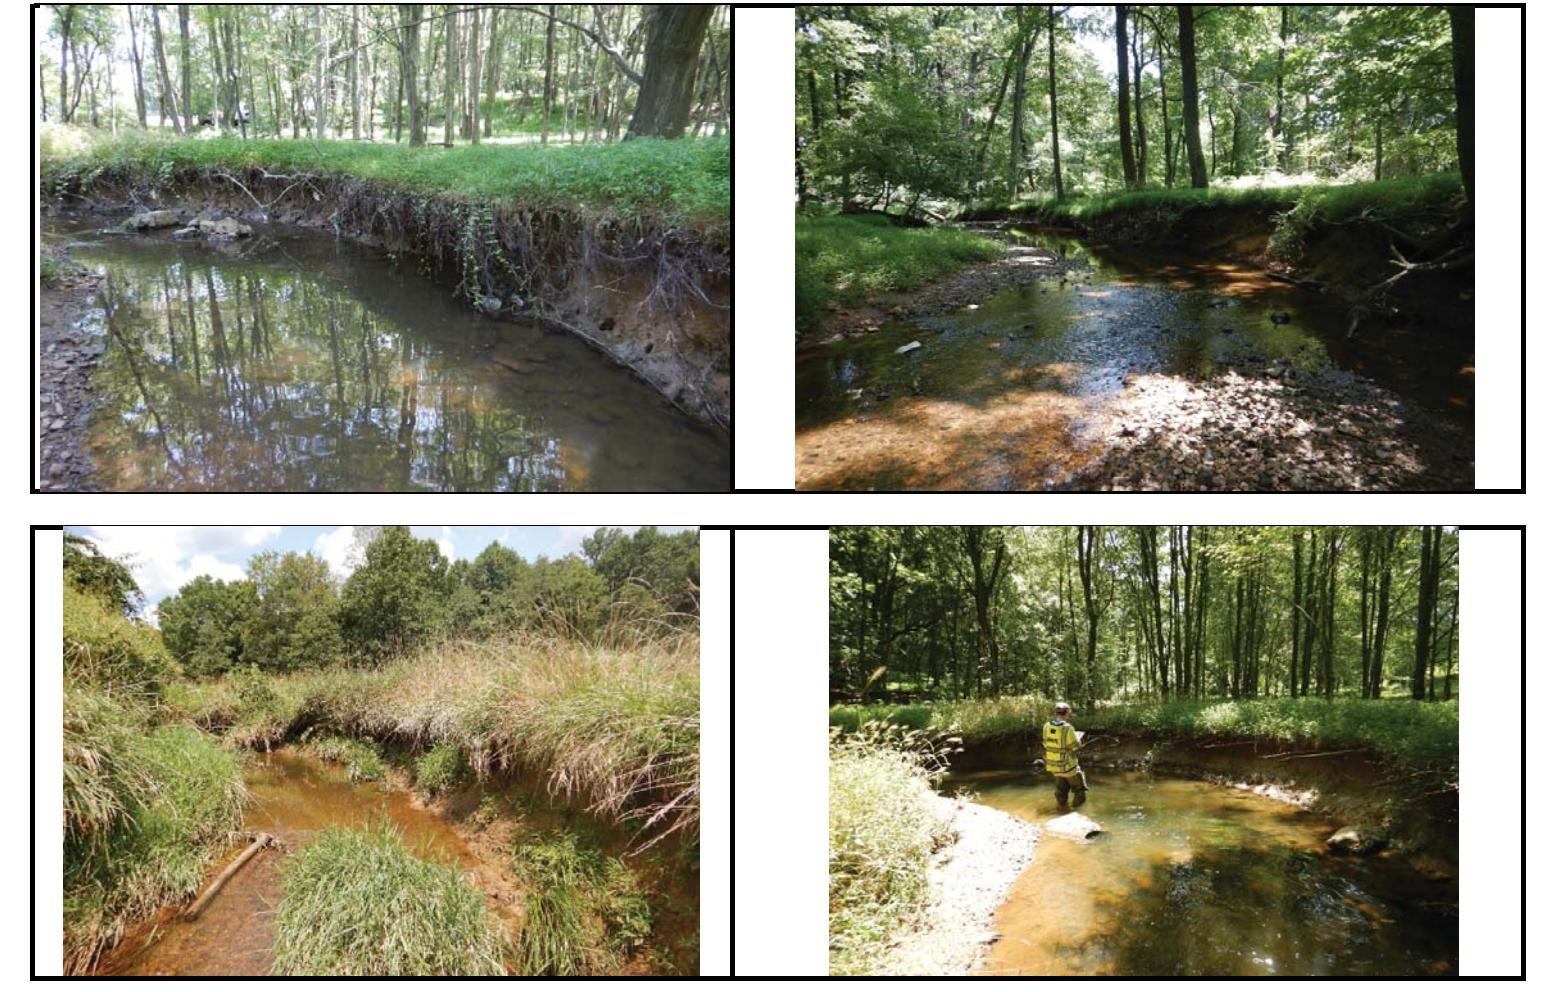
Describe:	a of El Doonly indicad		Describe:		
Bank neight 3-8°. Average	e of 5°. Deeply incised.		Park floodplain dominated by reed canary grass.		
Existing Floodplain Acces	ss	10	Opportunity for Ecological Lift	10	
10 - No evidence of out c	of bank flooding		10 - Conditions exist for several aspects of lift to be achieved a	and sustained	
5- Yes (Infrequent out of	bank flow)		5 - Lift limited to one or few aspects		
1 - Yes (evidence of frequ	uent flooding)		1 - Conditions are such that Lift is difficult to achieve and susta	ain	
Describe:			Describe:		
No evidence of out of ba	nk flooding.		Opportunities exist for sediment reduction, floodplain connectivity, aquatic		
			habitat, riparian buffer plantings, and water quality.	,,,	
Opportunity for Floodpla	ain Development	10	Ease of Access	5	
10 - Existing space for flo	odplain greater than 10 tir	nes stream width	10 - Yes (with existing direct vehicular access to potential site)

5 - Existing space for floo	odplain 3 to 10 times strear	n width	5- yes (open but no existing vehicular access)		
1 - Little to no space for f	floodplain development		1 - No (no vehicular access, clearing needed)		
Describe:	· · ·		Describe:		
Greater than 100' wide fl	loodplain on both sides of	channel.	Reed-canary floodplain with scattered trees.		
			, ,		
				4	
Drainage Area Evaluation	n	5	Utilities Present	1	
10 -D.A. less than 1 sq. m	וו.		10 - No utilities on site		
5- D. A. between 1 & 3 sc	ą. mi.		5 - Utilities but not within restoration area		
1 - D. A. greater than 3 so	q. mi.		1 - Utilities within potential restoration area		
Describe:			Describe:

1.89 square miles			Sewer line present throughout reach.		
			Total Score out of 100	71

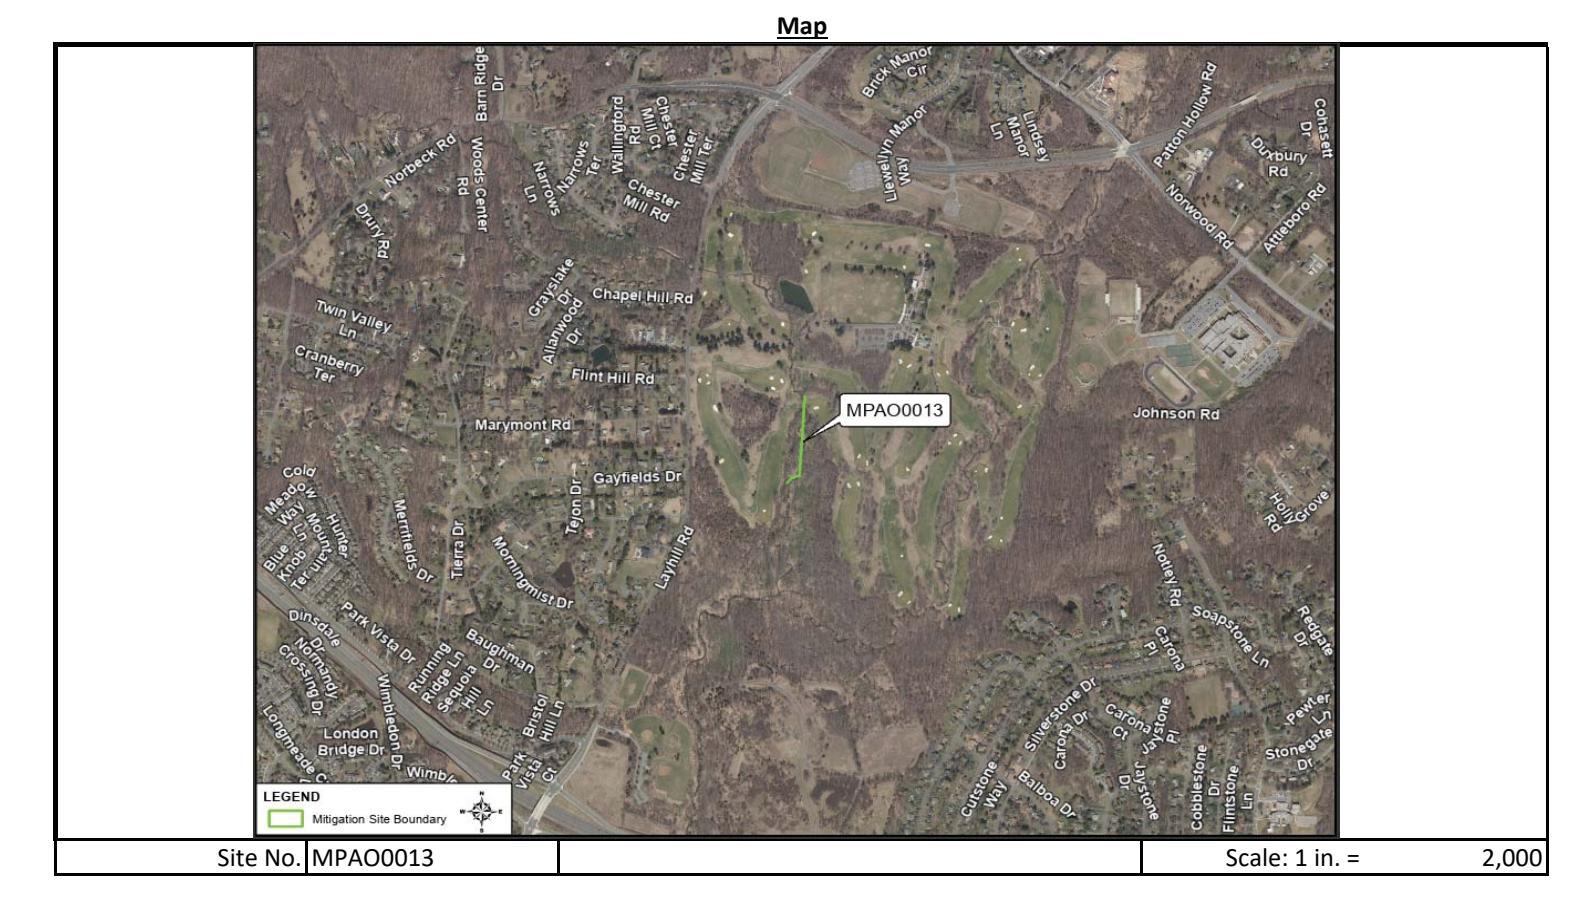
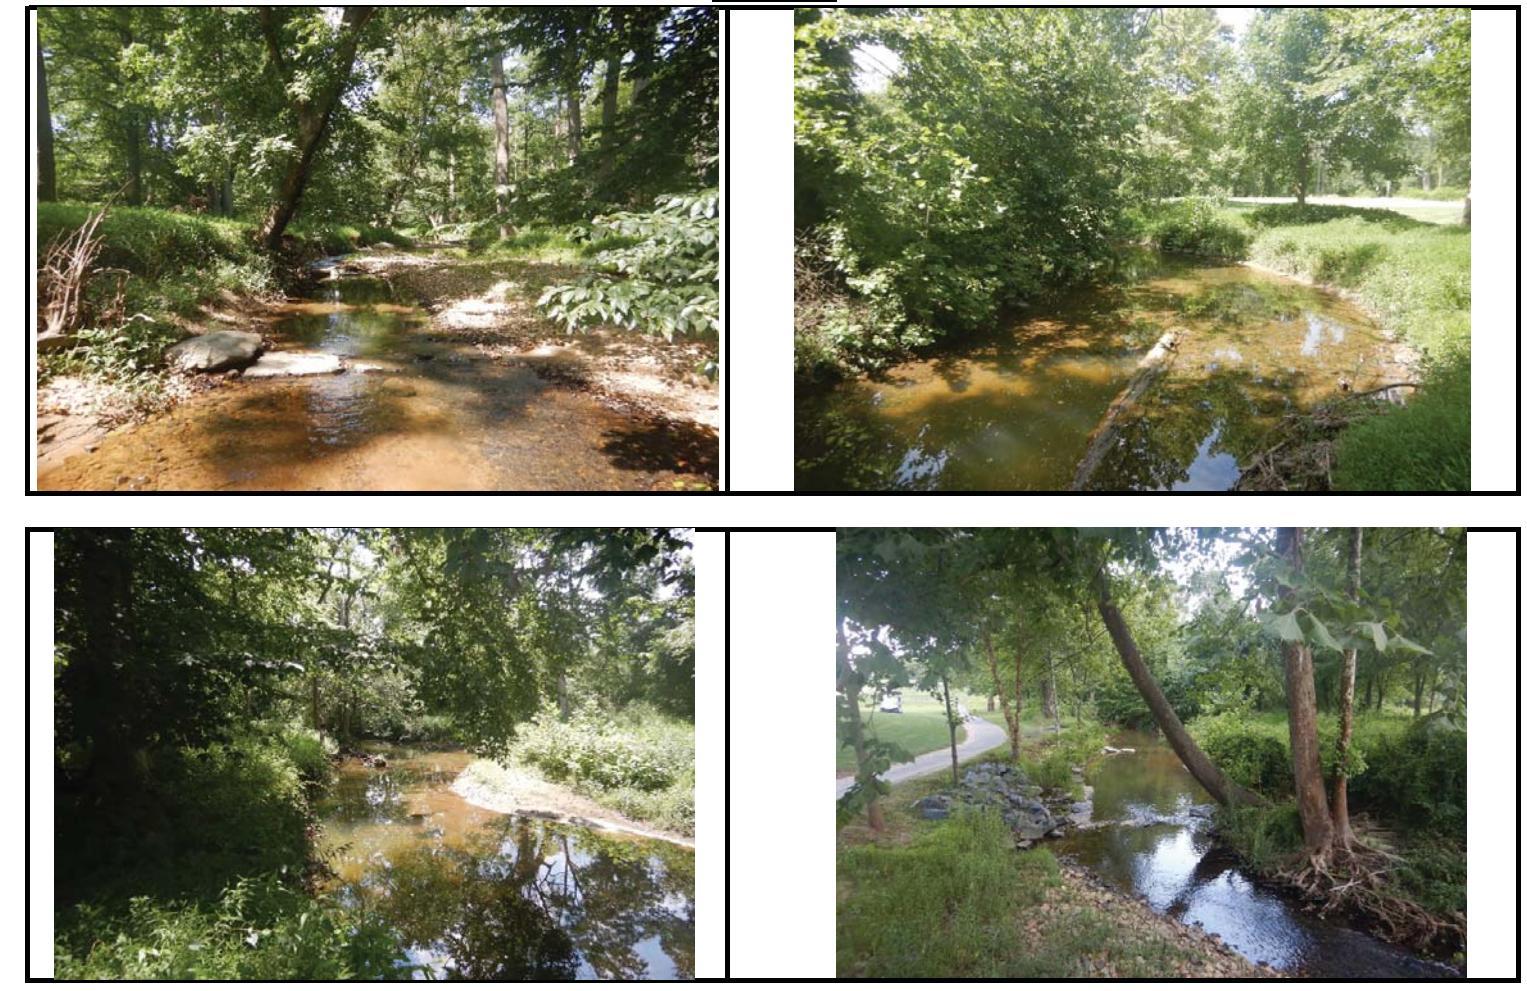
5 - Existing space for floodplain	3 to 10 times stream	nes stream width	5- ves (open but no existing vehicular ac	ress)	
1 - Little to no space for floodpl	ain development	ii widtii	1 - No (no vehicular access, clearing need	ded)	
Describe:			Describe:	<u> </u>	
Western and northern floodplai	in limited by golf co	urse. Some	Mostly dense forest. Small upstream seg	gment adjacent to golf course is open.	
potential in eastern floodplain.	, 0		, , , , ,		
Drainage Area Evaluation	I	1	Litilities Present	1	
10 -D.A. less than 1 sq. mi.		-	10 - No utilities on site	<u> </u>	
5- D. A. between 1 & 3 sq. mi.			5 - Utilities but not within restoration are	еа	
1 - D. A. greater than 3 sq. mi.			1 - Utilities within potential restoration a	area	
Describe:			Describe:

4.87 square miles			Sewerlines present throughout floodplai	in	
			Total	Score out of 100 35

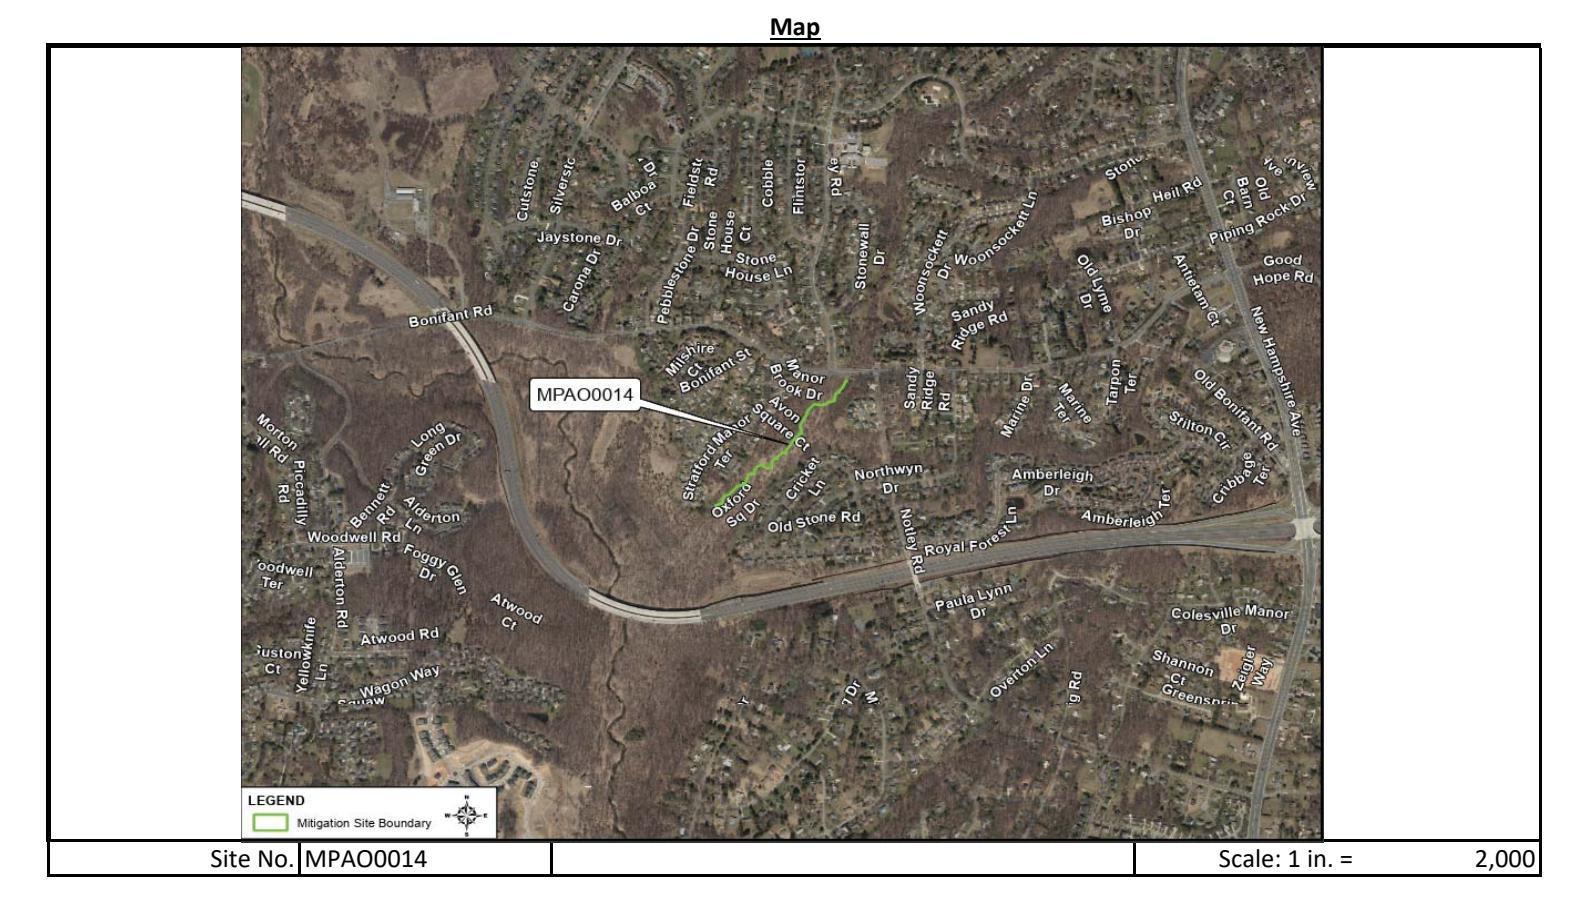
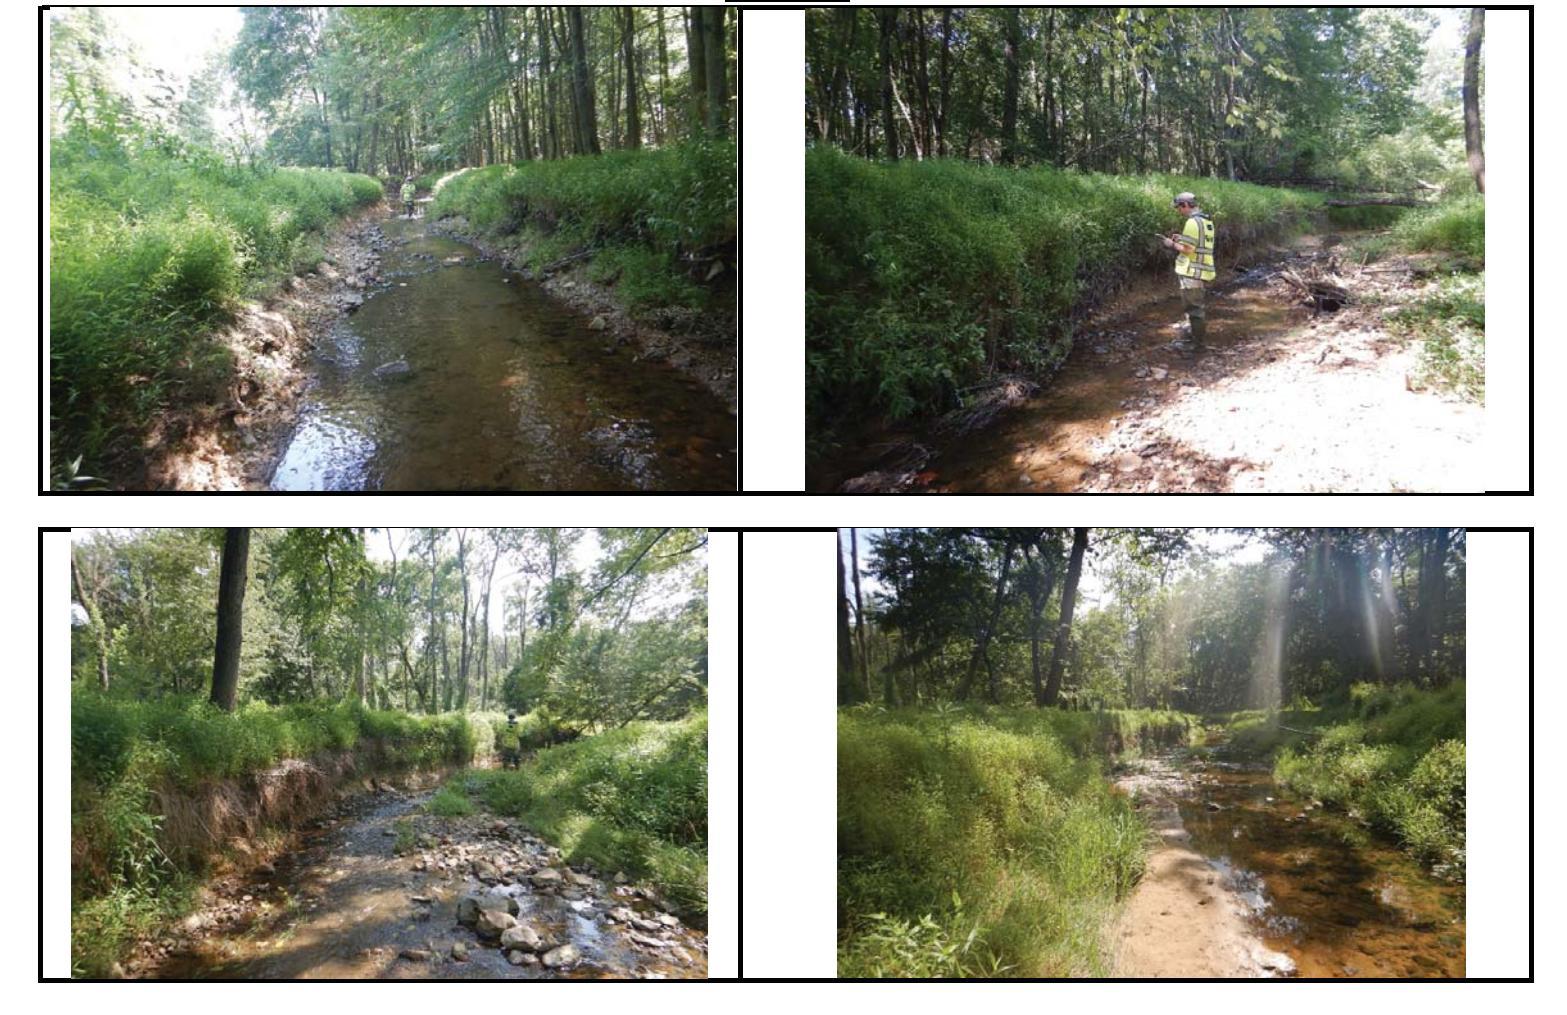
Describe:			Describe:		
Severe erosion through	Severe erosion throughout		Disturbed forested land. Lots of dead ash and invasives.		
_					
Degree of Channel Incis	sion	5	Land Use	1	
10 - Bank Height greater	r than 10 feet		10 - Agricultural or Open Space		
5 - Bank Height betweer	n 3 and 10 feet		5 - Marginal Pasture		
1 - Bank Height less than	n 3 feet		1 - Old field/ Developed/Forested		
Describe:			Describe:		
Bank Height 3-8', Avera	ge of 6'		Forested parkland		
Existing Floodplain Acco	229	10	Opportunity for Ecological Lift	10	
10 - No evidence of out	of bank flooding		10 - Conditions exist for several aspects of lift to be achieved	and sustained	
5- Yes (Infrequent out o	of bank flow)		5 - Lift limited to one or few aspects		
1 - Yes (evidence of freq	juent flooding)		1 - Conditions are such that Lift is difficult to achieve and sustain		
Describe:			Describe		
No evidence. Deeply inc	cised channel.		Opportunities for sediment reduction, floodplain connectivity, fish passage,

. ,			water quality, invasive treatment, and aquatic habitat.		
Opportunity for Floodp	lain Development	5	Ease of Access	5	
10 - Existing space for fl	oodplain greater than 10 tir	mes stream width	10 - Yes (with existing direct vehicular access to potential site	;)	
5 - Existing space for flo	odplain 3 to 10 times stream	n width	5- yes (open but no existing vehicular access)		
 Little to no space for 	floodplain development		1 - No (no vehicular access, clearing needed)		
Describe:			Describe:		
Limited in western flood	plain due to valley slope		Access through old restoration access route that is currently	covered with	
			invasives. Requires small tree impacts.		
Drainage Area Evaluatio	on	10	Utilities Present	1	
10 -D.A. less than 1 sg. r	mi.		10 - No utilities on site		
5- D. A. between 1 & 3 s	sq. mi.		5 - Utilities but not within restoration area		
1 - D. A. greater than 3 s	sq. mi.		1 - Utilities within potential restoration area

Describe:		-	Describe:		
1.05 square miles			Sewer line throughout reach		
			Total Score out of 100	5.8	
				50

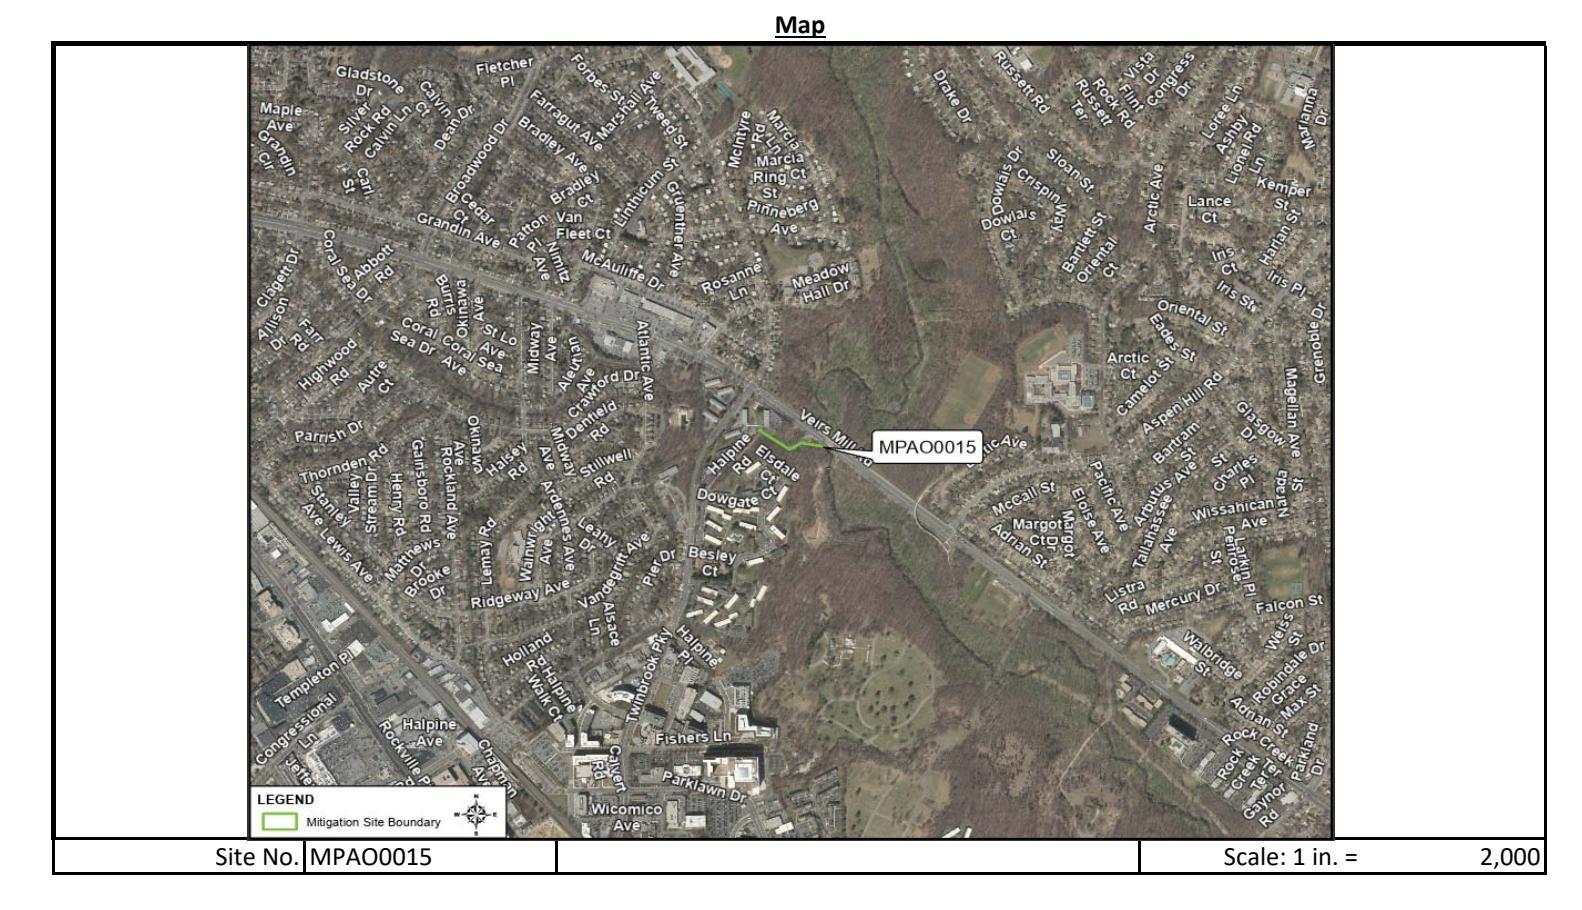
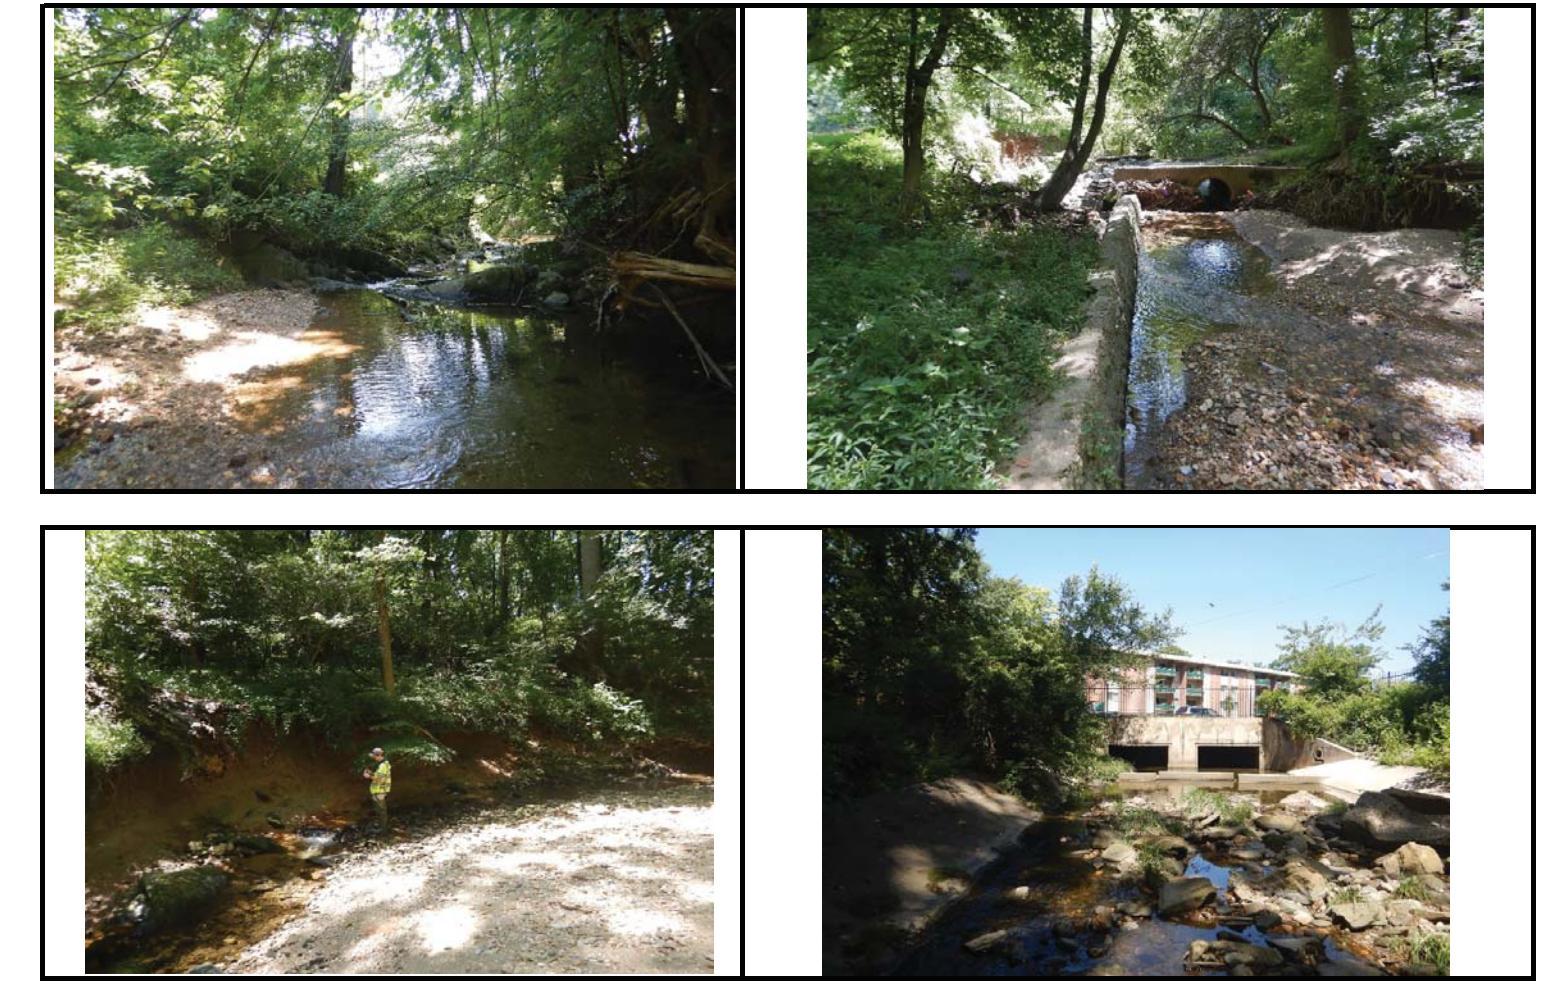
10 . Bank Height greater than 10	faat	5	10 Agricultural or Open Space	Ŧ	
5 Rank Height hetween 3 and 1	n faat		5 Marginal Dacture		
1 Rank Height Less than 3 feet	UTEEL		J - Malginai Fascule 1 Old field/ Developed/Forested		
Describe			Describe		
2 10' tall banks			Ecrosted parkland		
			l orested parkiand

Describe:			Describe:		
No potential in southern floodpla	ain - valley slope. I	imited potential in	Existing sewerline access with small tree plantings		
northern FP.					
Drainage Area Evaluation		1	Utilities Present	1	
10 -D.A. less than 1 sq. mi.		_	10 - No utilities on site		
5- D. A. between 1 & 3 sg. mi.			5 - Utilities but not within restoration area		
1 - D. A. greater than 3 sq. mi.			1 - Utilities within potential restoration area		
Describe:			Describe:

25.9 square miles			Convertings (converteressing		
55.8 square filles			Sewernines/sewer crossing		
				-1	
			Total Score out of 100	<u>)</u> 22
