APPENDIX E: PUBLIC SITE WALKTHROUGH RATING CRITERIA & FIELD ASSESSMENT FORMS

WETLAND MITIGATION RATING CRITERIA & FIELD SITE ASSESSMENT FORMS

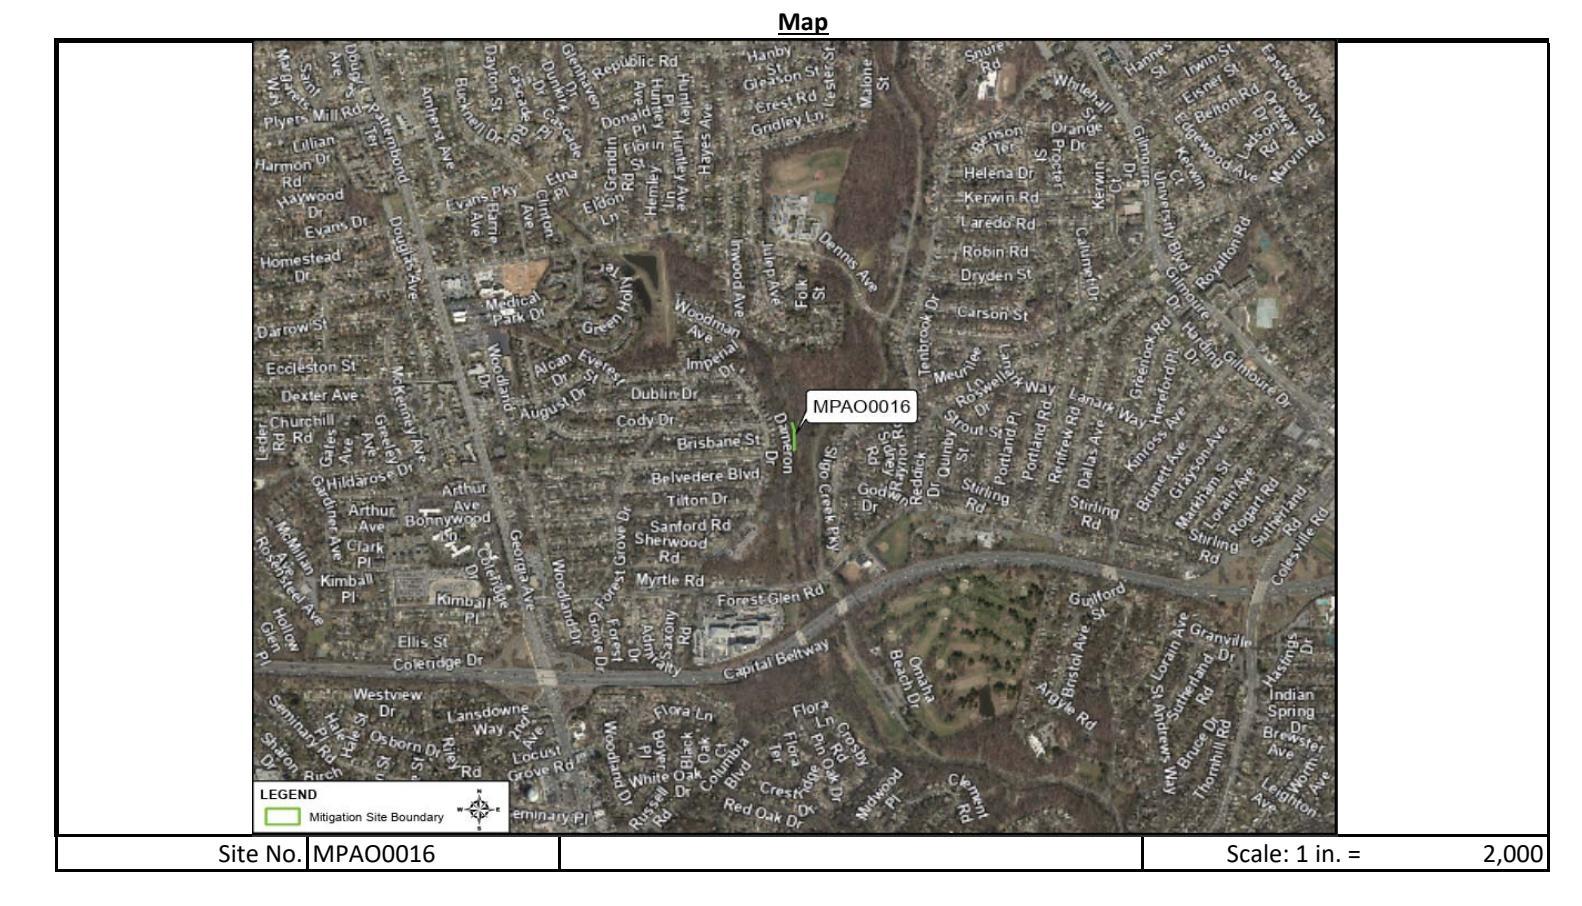
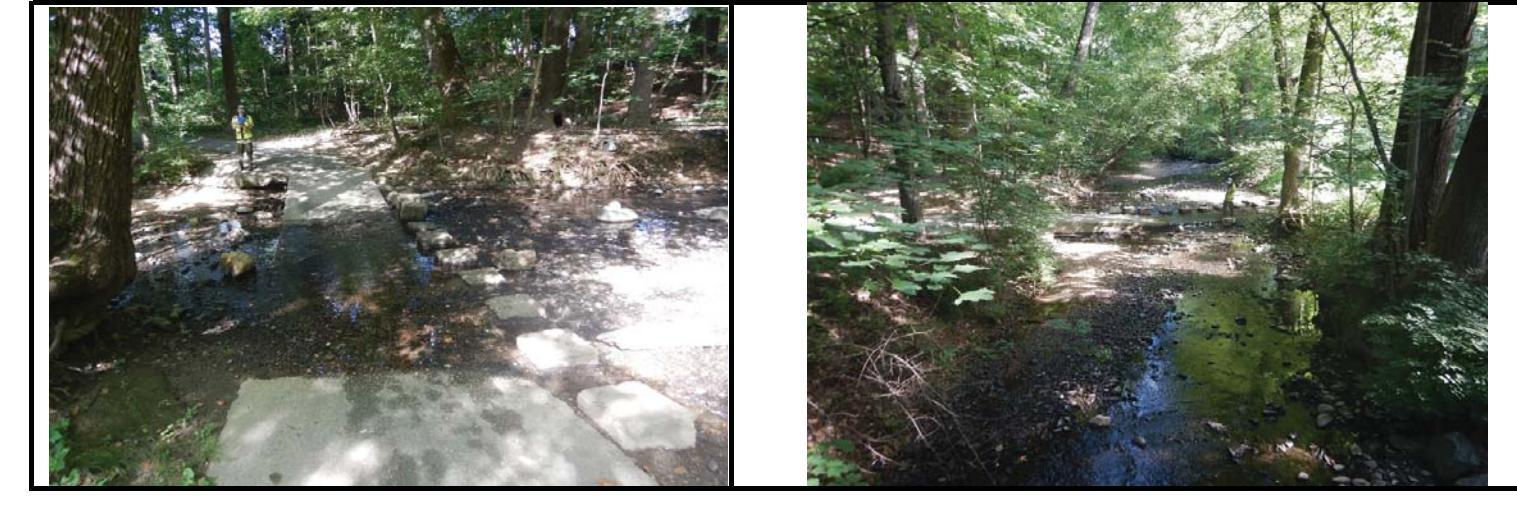
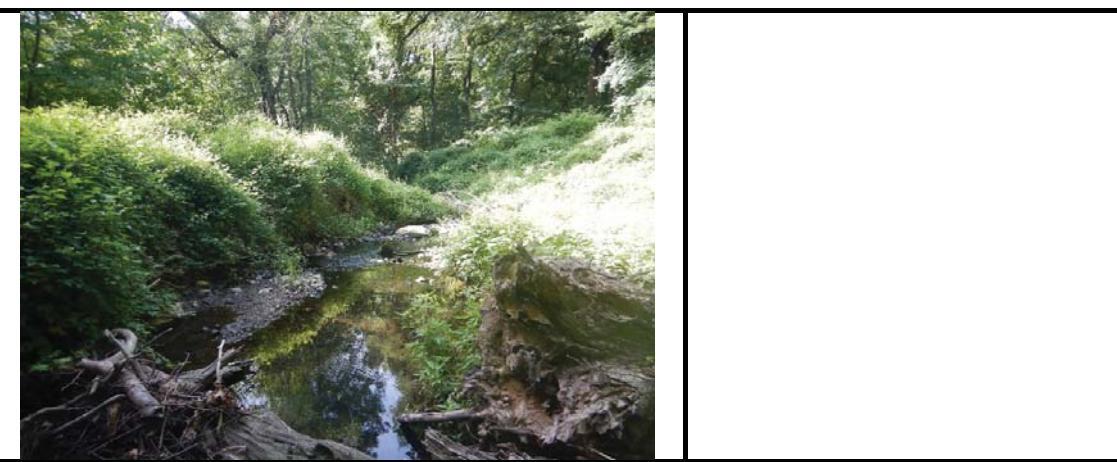
5 - Bank Height between 3 and 10 feet		5 - Marginal Pasture	
1 - Bank Height less than 3 teet		1 - Old field/ Developed/Forested	
Describe:		Describe:	
4-8 tali danks.		Forested parkiand	
Existing Floodplain Access	10	Opportunity for Ecological Lift	5
10 - No evidence of out of bank flooding		10 - Conditions exist for several aspects of lift to be achieved	and sustained
5- Yes (Infrequent out of bank flow)		5 - Lift limited to one or few aspects	
1 - Yes (evidence of frequent flooding)		1 - Conditions are such that Lift is difficult to achieve and sustain	
Describe:		Describe:	
No evidence of flooding.		Opportunities for sediment reduction and riparian buffer plantings.	
	1	Free of Assess	E
Opportunity for Floodplain Development	⊥ timos stroam width	Ease of Access 10 - Ves (with existing direct vehicular access to potential site	5
5 - Existing space for floodplain 3 to 10 times stre	am width	5- ves (open but no existing vehicular access))

3 - Existing space for floodplain 3 to 10 times stream width 1 - Little to no space for floodplain development		1 - No (no vehicular access, clearing needed)	
		Describe	
l imited by adjacent trail and sligo creek		Forest with patchy open invasive areas. Potential access along trail	
.,,			8
Drainage Area Evaluation	T	Litilities Dresent	1
Drainage Area Evaluation	5	Utilities Present	Ţ
10 - D.A. less than 1 sq. mi.		10 - NO utilities of site	
D-D.A. between I & 3 sq. ml.		5 - Utilities but not within restoration area	
Describe:		Describe:

1.32 square miles		Sewerline in floodplain	
		Total Score out of 100	39

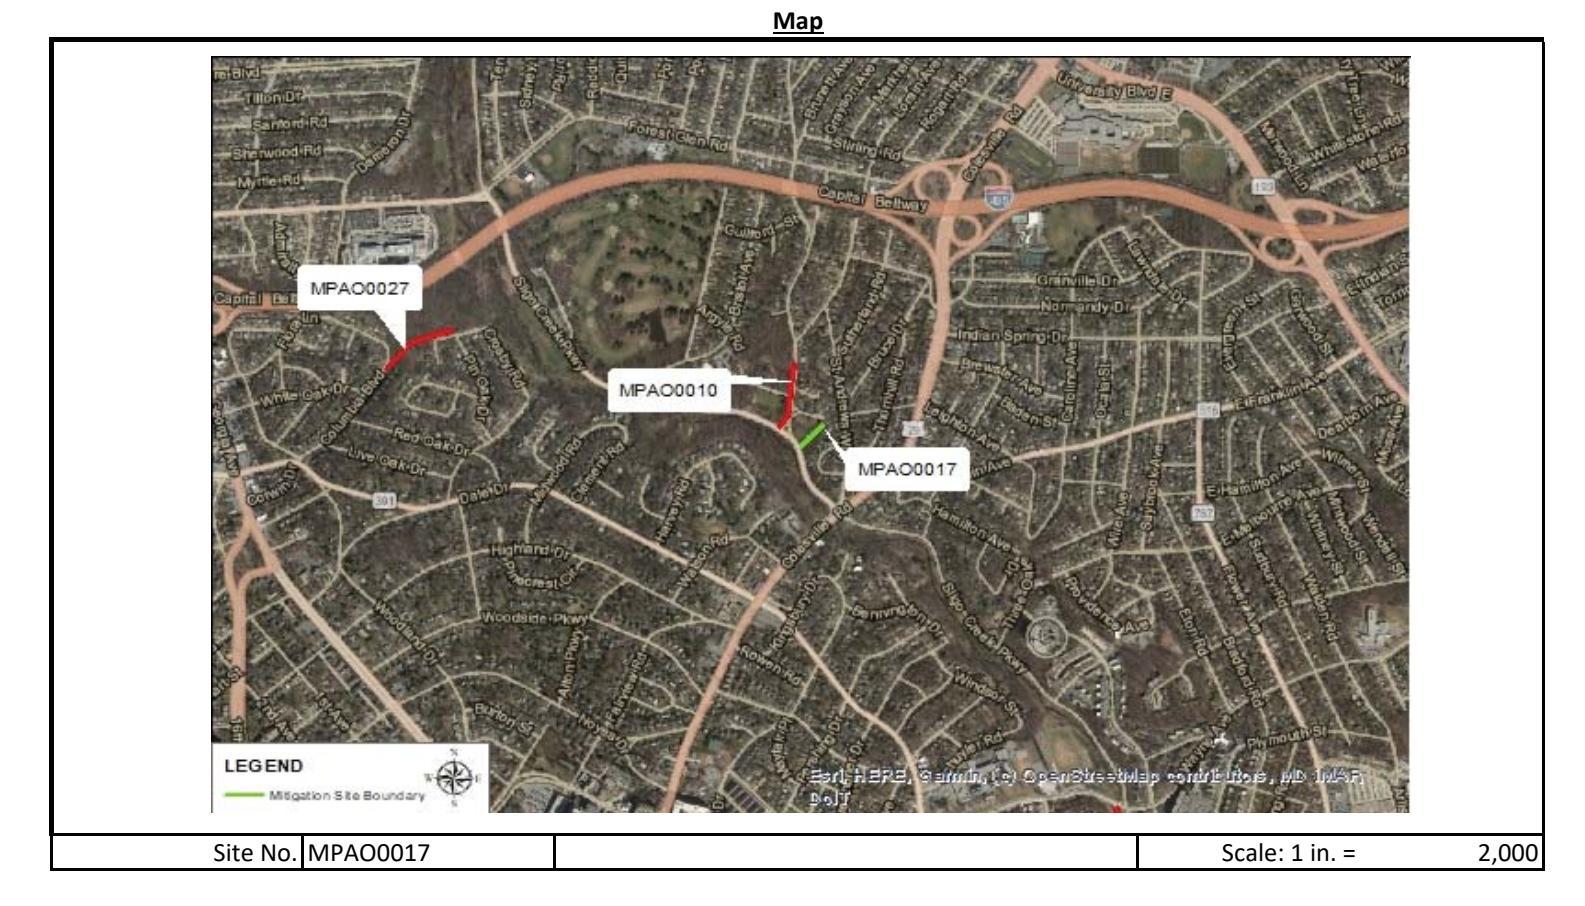
-		
Fuinting Flag dutate Arra		-		r	F
10 No ovidence of out	255 of bank flooding	5	Opportunity for Ecological Lift	s of lift to be achieved a	o bd custainad
5- Yes (Infrequent out of	f hank flow)		5 - Lift limited to one or few aspects	s of fift to be achieved a	nu sustaineu
1 - Yes (evidence of freq	uent flooding)		1 - Conditions are such that Lift is difficult to achieve and sustain		
Describe:			Describe:		
5' at upstream end, 2' at	t downstream end, ~3' or le	ess on average	Buffer, vertical lateral at perched pipe

0.0864 sq. mi			Sewer line parallel		
			Tota	I Score out of 100	61

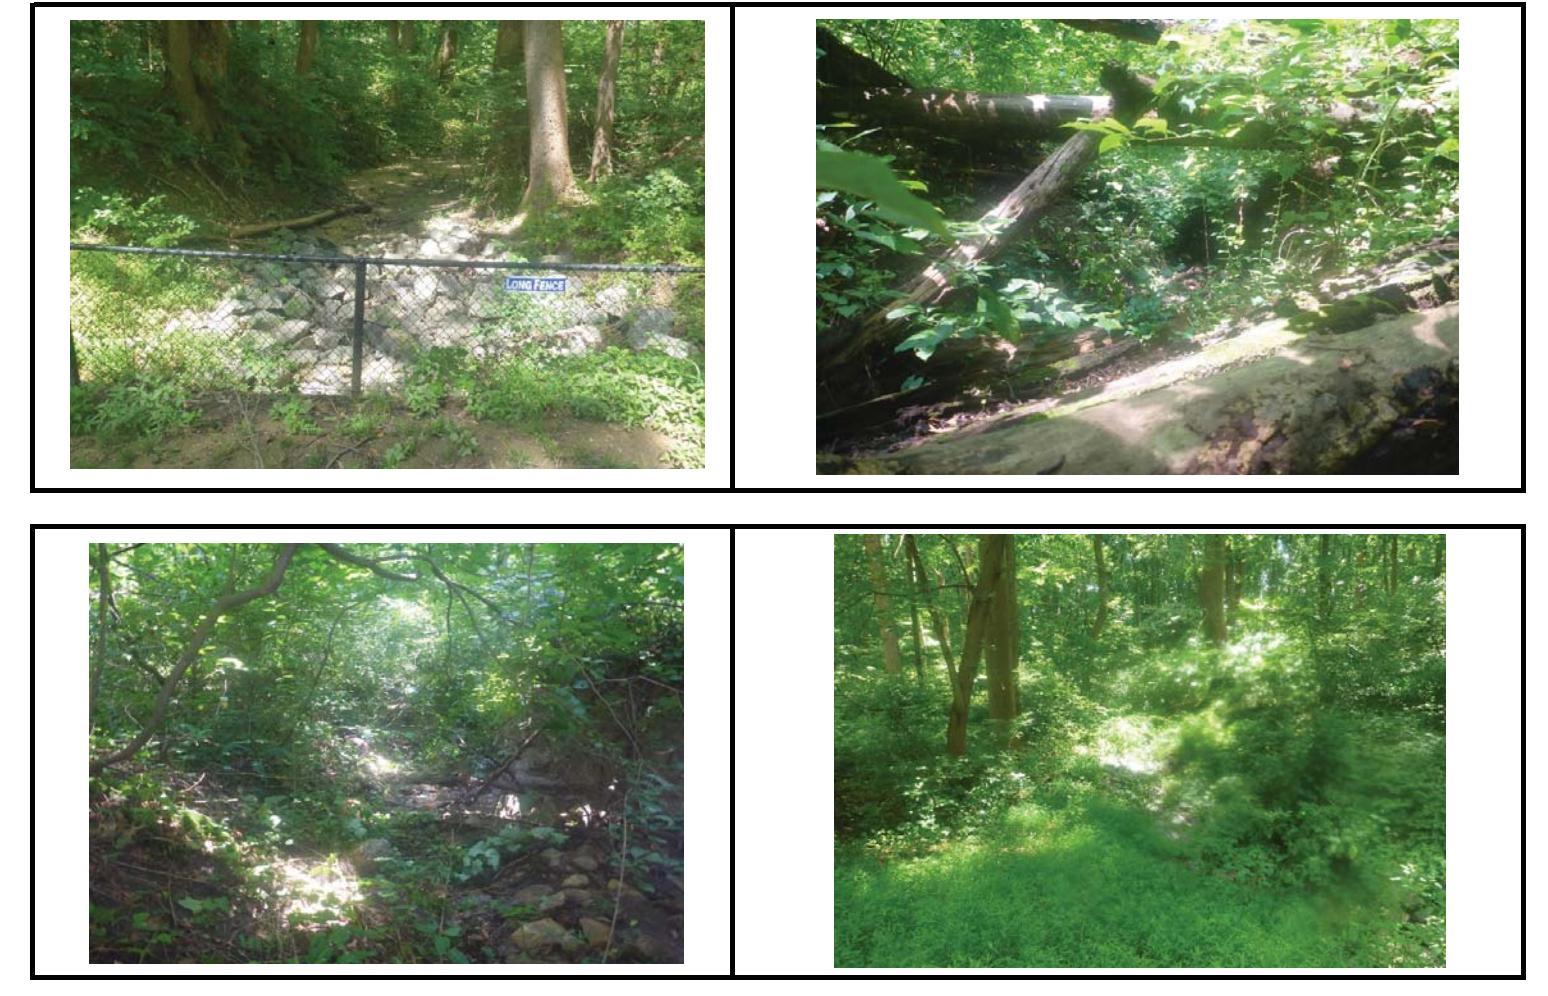
Site Photos

Str	eam Mitigation	Field Site Assessment Form			
		Pro	ject Details			
Project Name:	I-495/I-270 Managed Lan	es Study	Mitigation Site Number:	MPAO0018		
Projects Estimated Stream	n Mitigation Needs (LF):	TBD	-			
Data of Field Associations	7/24/2010		Consultant Firm (Investigator(s))			
Date of Field Assessment:	7/24/2019 Sito	Location Dotails	taken from deskton review	CRI/IVID, SN		
County:	Montgomery	Cross Roads	2000 Shorefield Rd Silver Spring MD			
Basin (HUC 8):	Middle Potomac-Anacost	ia-Occoquan	MDE Watershed (8 digit):	2140205		
Proximity to Impacted S	tream (mi.):		Lat/Long:	39.055863	-77.040362	
			Site Data			
Parcel Size (ac):	2 parcels - 16.9, 18		Potential Restoration Reach (LF):	530		
Site Opportunities:	XChannel Restoration	Livestock Exclusion	Riparian Buffer Planting	Habitat Enhancement	Fish Passage	
Stream Order:	1st	Stream Hydrology:	Perennial	Stream Use: IV		
Drainage Area to Reach	(sq. mi.)	0.39

-			
Opportunity for Floodpl	ain Development	5	Ease of Access		10	
10 - Existing space for flo	odplain greater than 10 ti	mes stream width	10 - Yes (with <u>existing</u> direct venicular a	access to potential site)		
1 - Little to no space for	floodnlain development	in width	1 - No (no vehicular access clearing ne	access)		
Lescribe		Le rio (no veniculai access, cleaning needed)				
Jescribe. 3-10 but would require tree impacts		Paved park trail parallel to channel, easy to cut across floodplain				
			<i>s, ce eacaeaa<i>eaaaaaaaaaa<i>aaa</i></i></i>			
Drainage Area Evoluctio	n	10	Litilities Procent	I	10	
10 -D A less than 1 sq. n	ni	10	10 - No utilities on site		10	
5- D. A. between 1 & 3 s	 a. mi.		5 - Utilities but not within restoration a	area		
1 - D. A. greater than 3 s	q. mi.		1 - Utilities within potential restoration	n area		
Describe:	<u>.</u>		Describe:			
Drainage area - 0.39 sou	are miles.		None observed

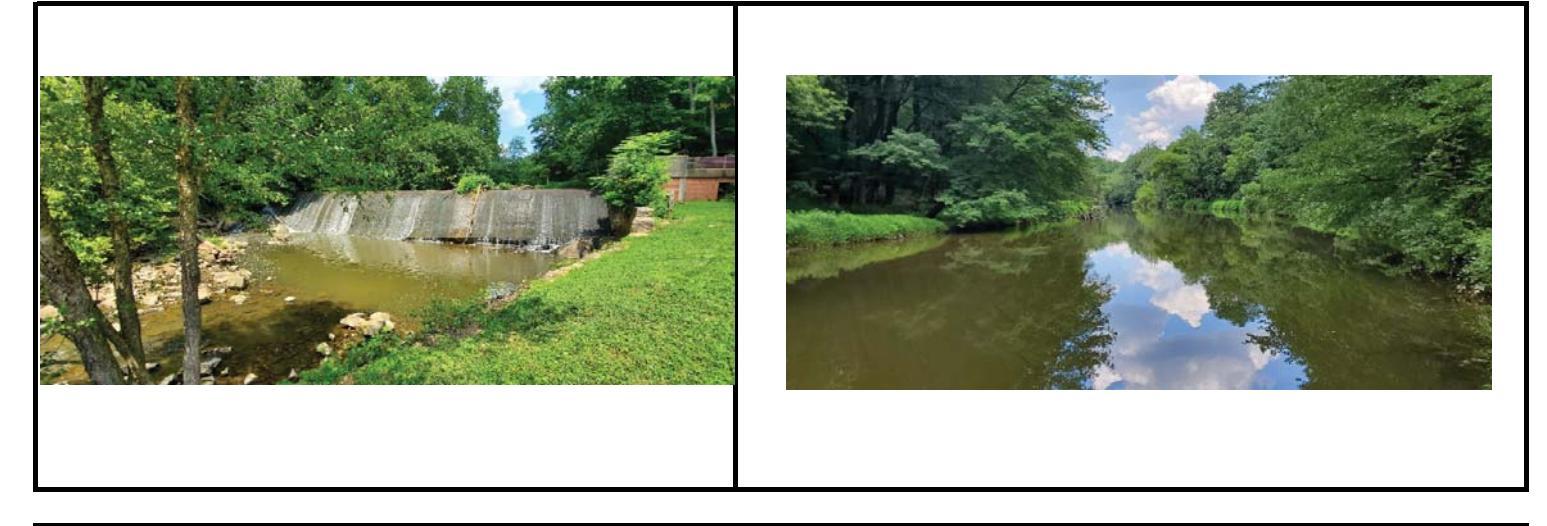
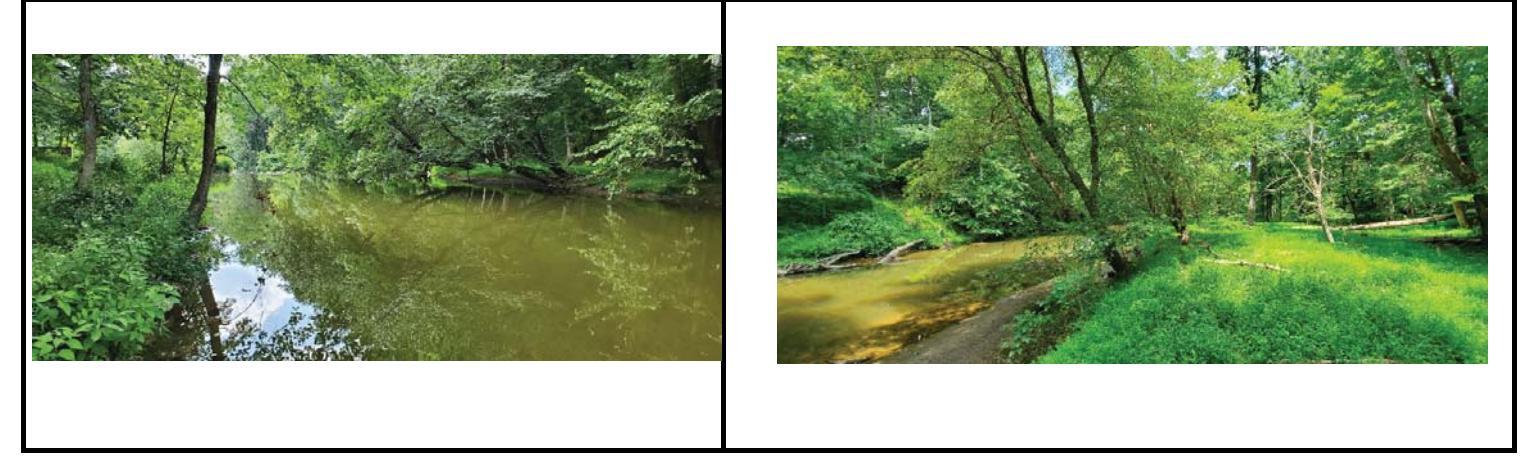
Site Photos

Str	eam Mitigation	Field Site Assessment Form		
		Pro	vject Details		
Project Name:	I-495/I-270 Managed Lan	es Study	Mitigation Site Number: MPAO0019		
Projects Estimated Stream	m Mitigation Needs (LF):	TBD	-		
Data of Field Assessment:	7/25/2010		Consultant Firm/Investigator(s): CRI/SI MD		
Date of field Assessment.	Site	Location Details	s-taken from deskton review		
County:	Montgomery	Cross Roads:	10721 Columbia Pike Silver Spring MD		
Basin (HUC 8):	Middle Potomac-Anacost	ia-Occoquan	MDE Watershed (8 digit): 2140205		
Proximity to Impacted S	Stream (mi.):	0.88	Lat/Long: 39.034176	-77.010231	
			Site Data		
Parcel Size (ac):	2 parcels - 2.7, 34		Potential Restoration Reach (LF): 3,616		
Site Opportunities:	XChannel Restoration	Livestock Exclusion	Riparian Buffer PlantingX_Habitat Enhancement	_XFish Passage	
Stream Order:	3rd	Stream Hydrology:	Perennial Stream Use:	IV	
Drainage Area to Reach	(sq. mi.)	26.9	Monnod Coiles

Land Use: Property Address:	10721 Columbia Pike Silv	or Spring MD	Iviapped Solis: Blocktown channery	Silt Ioam, 25-45%	
Property Owner(s):	MNCPPC		siopes, very rocky;	Galla silt loam	
		General F	ield Observations		
Is there evidence that t	he stream has been distur	bed by some kind	Can the stream restoration be reasonably done within the c	onfines of the	
of human action, like gr	ading, dumping, livestock	, culvert, etc?	parcel or does it require connections beyond the parcel limits? Explain		
Explain:			Explain:	•	
Yes, dam and riprap			Yes. All within 1 parcel		
Cultura da		Mitigat	tion Site Rating	6	
		Score		<u>Score</u>	
Estimated Bank erosion	within reach	5	Vegetation	1	
10 - Greater than 50%			10 - Herbaceous cover (non-wetland)		
1 - Less than 10%			1 - Mostly forested and/or wetland		
Describe:			Describe:		
~15% alternating means	ler		Mature forest		
Degree of Channel Incis	ion	5	Land Use	1

5 - Existing space for flo	odplain 3 to 10 times stream	m width	5- yes (open but no existing vehicular access)	,	
1 - Little to no space for floodplain development		1 - No (no vehicular access, clearing needed)			
Describe:		Describe:			
Tree impacts expected		Some clearing required			
Drainage Area Evaluatio	on	1	Utilities Present	1	
10 -D.A. less than 1 sq. r	ni.		10 - No utilities on site		
5- D. A. between 1 & 3 s	q. mi.		5 - Utilities but not within restoration area		
1 - D. A. greater than 3 s	q. mi.		1 - Utilities within potential restoration area		
Describe:			Describe:

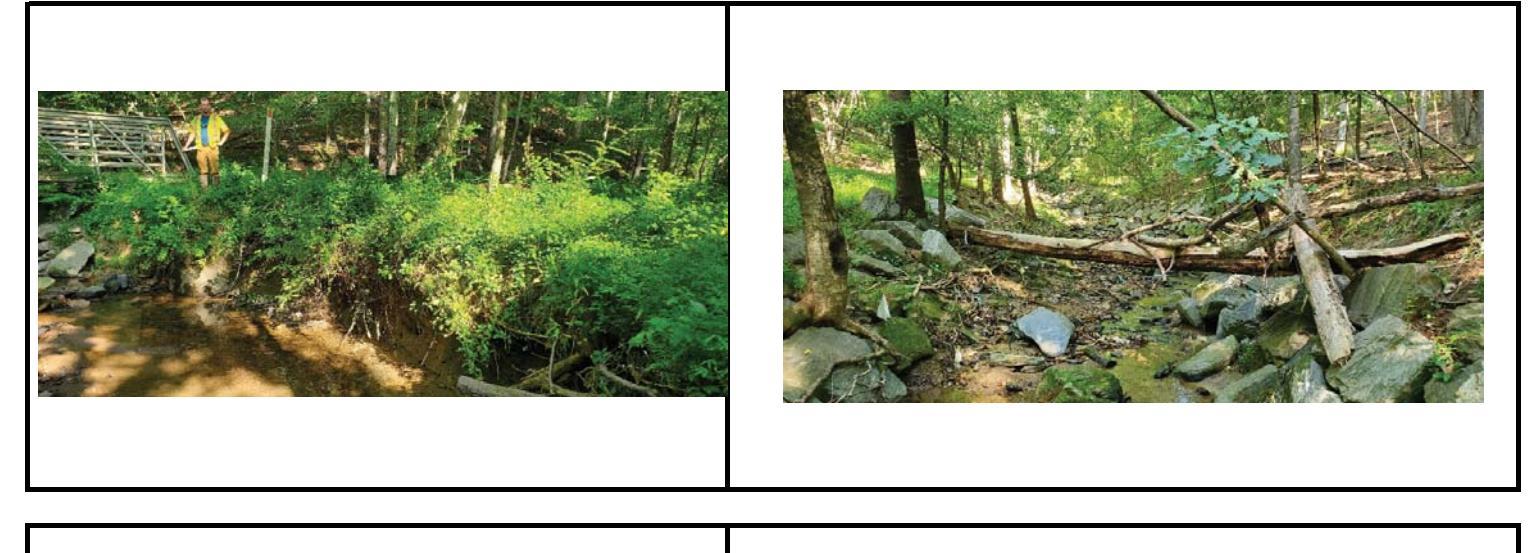
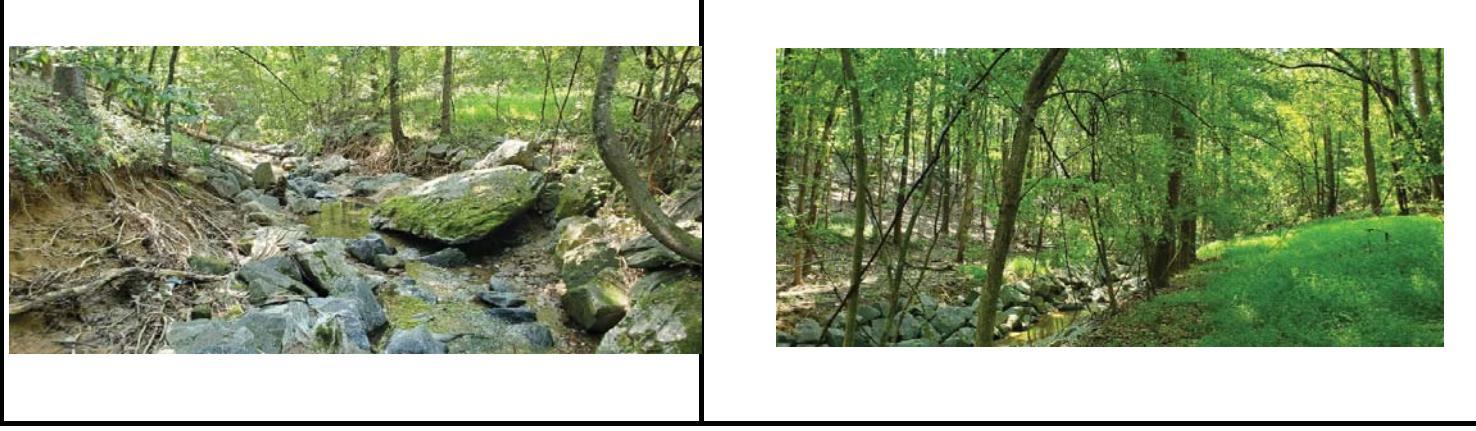
Site Photos

Describe:			Describe:		
Some areas slightly low	er than 10		Mature forest		
Eviating Flagshalain Ass		10	One output its for Foological Lift	E	
Existing Floodplain Acco	ess of bank flooding	10	Opportunity for Ecological Lift	ond sustained	
5- Ves (Infrequent out o	of bank flow)		5 - Lift limited to one or few scherts	and sustained	
1 - Yes (evidence of free	uent flooding)		1 - Conditions are such that Lift is difficult to achieve and sustain		
Describe:	Juent nooung/		Describe		
No evidence of out of b	ank flow		Lateral migration, geomorphic stability, habitat enhancement, bedform		
			diversity		
			arveisity		
Opportunity for Floodp	lain Development	1	Ease of Access	5	
10 - Existing space for fl	oodplain greater than 10 ti	mes stream width	10 - Yes (with existing direct vehicular access to potential site)	
5 - Existing space for flo	odplain 3 to 10 times strea	m width	5- yes (open but no existing vehicular access)

1 - Little to no space for floodplain development		1 - No (no vehicular access, clearing needed)			
Describe:		Describe:			
Steep valley, confined by utility and mature forest buffer		Several access points off trails, some tree clearing required at	roadways		
			(Bromley St, Lovejoy St, Lamberton Dr)		
Drainage Area Evaluatio	on	10	Utilities Present	1	
10 -D.A. less than 1 sq. r	mi.	<u> </u>	10 - No utilities on site		
5- D. A. between 1 & 3 s	sq. mi.		5 - Utilities but not within restoration area		
1 - D. A. greater than 3 s	sq. mi.		1 - Utilities within potential restoration area		
Describe:			Describe:

0.55 sq. mi			Utilities throughout reach		
			l č		
			Total Score out of 100	54

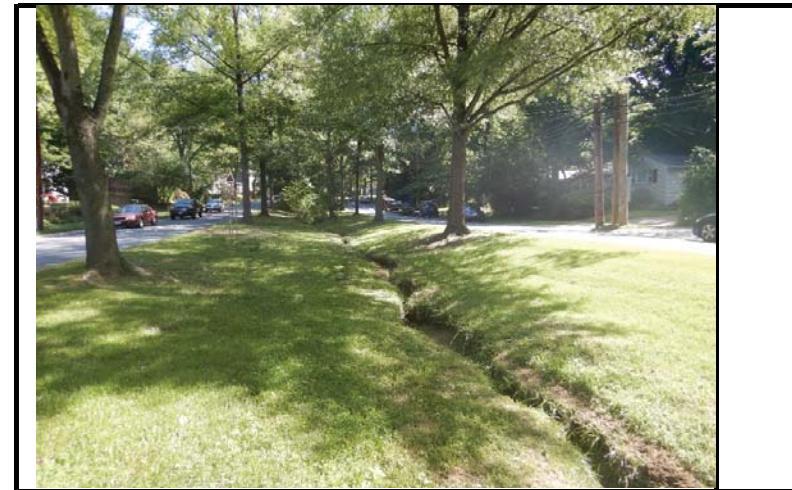
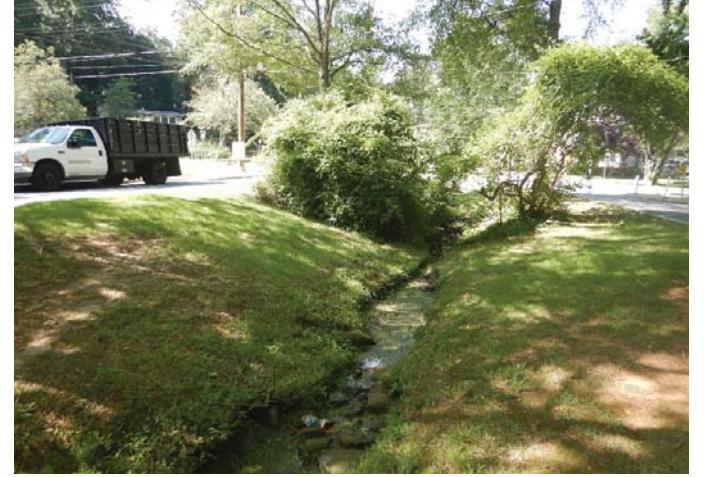
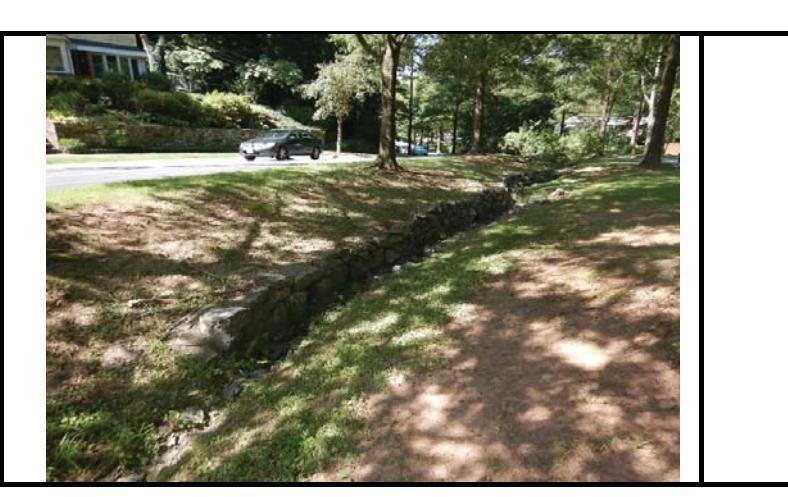
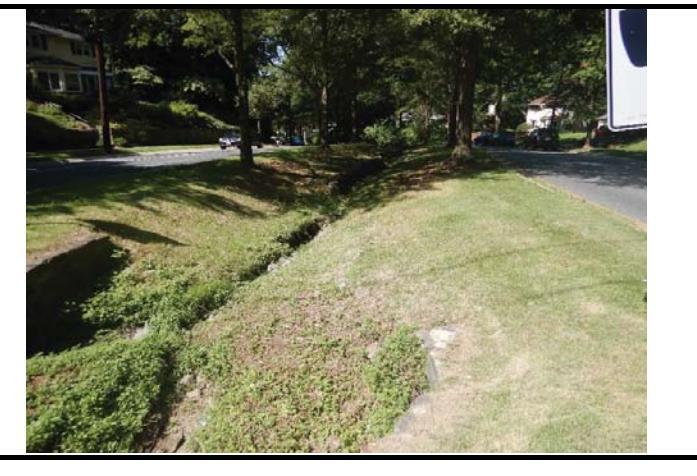
No floodplain exists - eph	hmeral channel		No opportunities - ephemeral channel		
Opportunity for Floodpl	ain Development	1	Ease of Access		10
10 - Existing space for flo	odplain greater than 10 ti	mes stream width	10 - Yes (with <u>existing</u> direct vehicular acce	ess to potential site)	
5 - Existing space for floor	odplain 3 to 10 times strea	m width	5- yes (open but no existing vehicular acce	ss)	
1 - Little to no space for f	floodplain development		1 - No (no vehicular access, clearing neede	d)	
Describe:			Describe:		
County Row between roa	ads and houses		Open lawn with scattered large trees		
Drainago Aroa Evaluatio	n	10	Utilities Present		1
Drainage Area Evaluatio	n N	10	10 No utilitios on site		1
IU-D.A. less than I sq. fr	11. 		10 - NO utilities on site		
J- D. A. Delween I & 3 S(4. 1111. n. mi		5 - ounces but not within restoration area 1 - Utilities within not ontial restoration area	22

I - D. A. greater than 3 S	y. 1111.		1 - ounces within potential restoration are	a	
Describe:			Describe:		
0.05 square miles			Sewerlines in floodplain		
			Total So	core out of 100	55

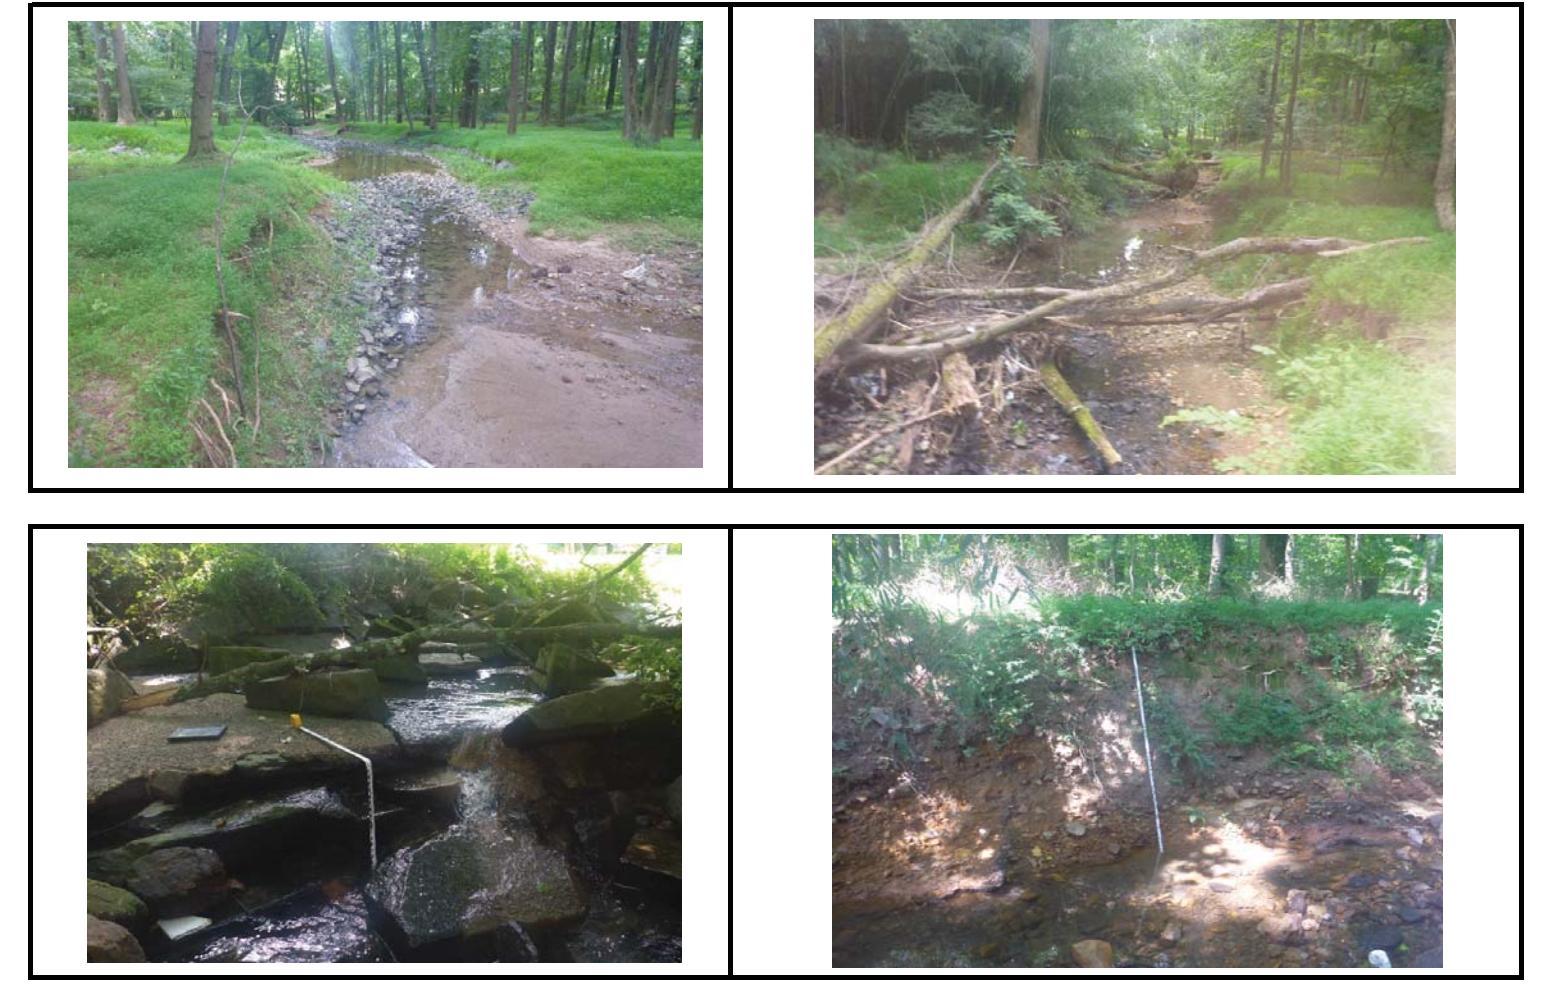
Site Photos

75%-100% eroded ban	KS		Forested buffer, bamboo stands on right bank	
Degree of Channel Inci	sion	5	Land Use	1
10 - Bank Height greate	er than 10 feet	<u></u>	10 - Agricultural or Open Space	
5 - Bank Height betwee	n 3 and 10 feet		5 - Marginal Pasture	
1 - Bank Height less tha	in 3 feet		1 - Old field/ Developed/Forested	
Describe:			Describe:	
8-9' incised channel			Forested land use immediately adjacent to stream, residentia	al outside buffer
			area	
Existing Floodplain Acc	cess	10	Opportunity for Ecological Lift	5
10 - No evidence of out	t of bank flooding	<u>.</u>	10 - Conditions exist for several aspects of lift to be achieved	and sustained
5- Yes (Infrequent out o	of bank flow)		5 - Lift limited to one or few aspects	
1 - Yes (evidence of fre	quent flooding)		1 - Conditions are such that Lift is difficult to achieve and sus	tain
Describe:			Describe:	
Flows completely confi	ned in channel		Vertical/lateral

Describe:			Describe:	
0.35 sq mi			Manhole exposed on left bank	
			Total Score out of 100	E.2
				/ 33

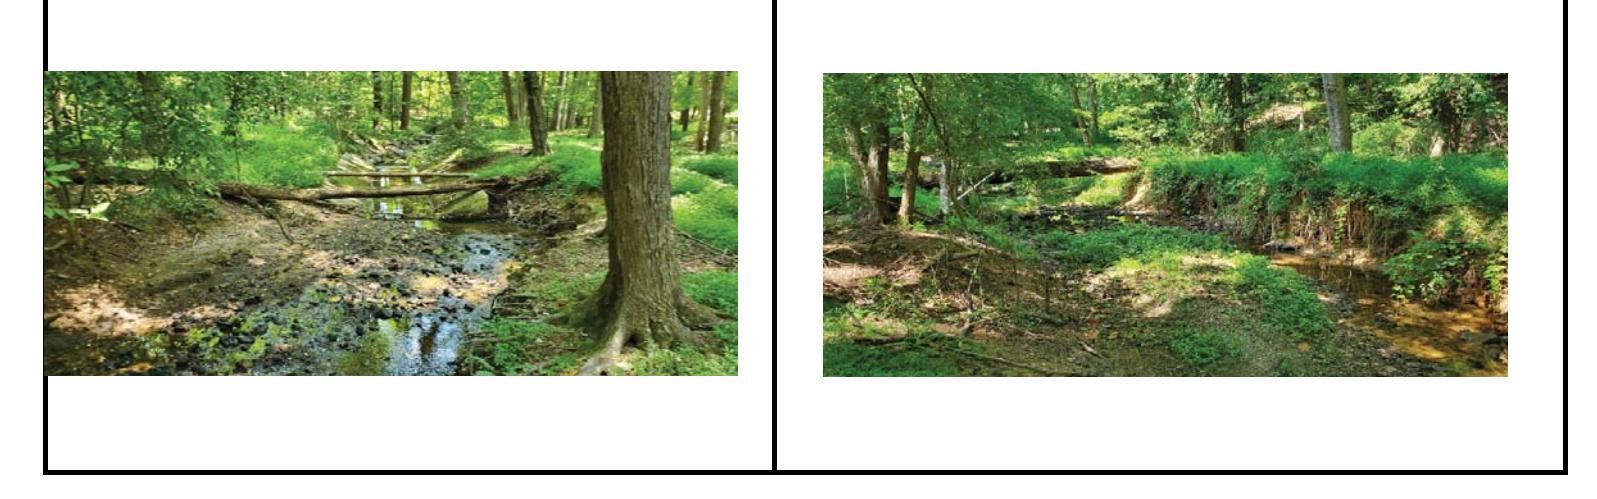
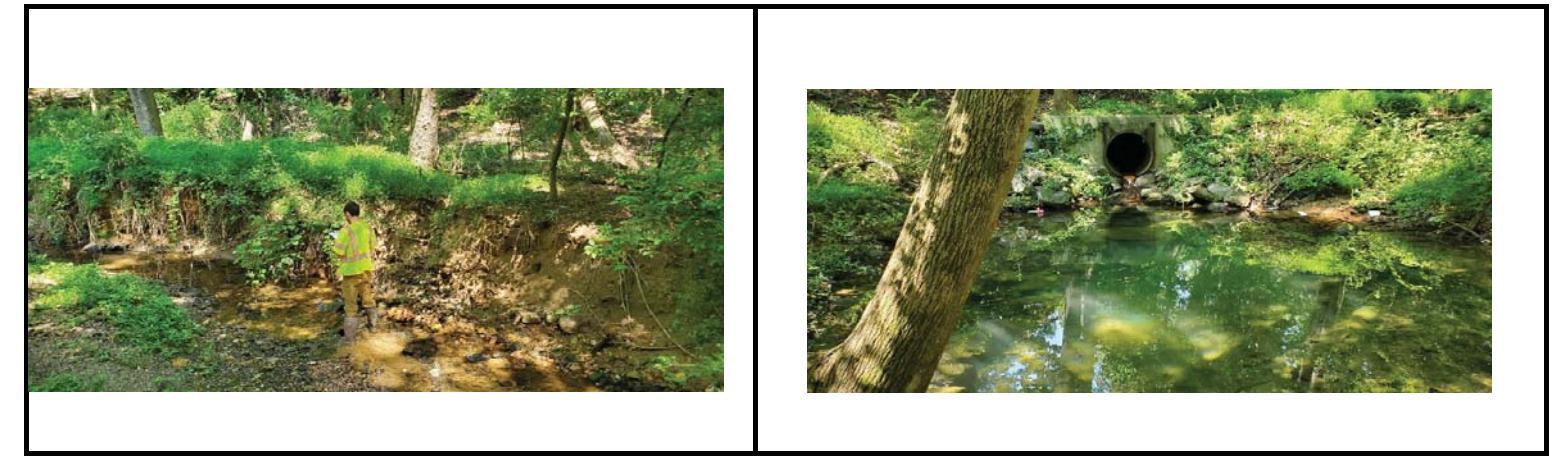
<u>Site Photos</u>

5 - 10% to 50% 5 - Scrub-shrub cover (non-wetland) 1 - Less than 10% 1 - Mostly forested and/or wetland Describe: Describe: Approximately 60% eroded, mostly on the left bank. Eroded banks average 5' tall. Mature Forest Degree of Channel Incision 5 Loss Neight Less than 3 feet 10 - Agricultural or Open Space S - Bank Height Itess than 3 feet 0 Describe: Describe: Left bank approximately 5'. Right bank approximately 4'. Mostly forested some developed. Existing Floodplain Access 10 Do - No evidence of out of bank flooding 10 - Conditions are such that Lift is difficult to achieve and sustained S - Yes (Infrequent flooding) 1 - Conditions are such that Lift is difficult to achieve and sustained S - Ves (Infrequent floodplain 2 to 10 times stream width 10 - Yes (with existing direct vehicular access) to potential site) S - Stisting space f	10 - Greater than 50%	Within reach	10	10 - Herbaceous cover (non-wetland)		1

0.15 sq.mi Sewer utilities within the potential restoration area. Total Score out of 100 49	Describe:			Describe:			
Total Score out of 100 49	0.15 sq.mi			Sewer utilities within the potential rest	oration area.		
Total Score out of 100 49							
				Tot	al Score out of 100	Δ٩

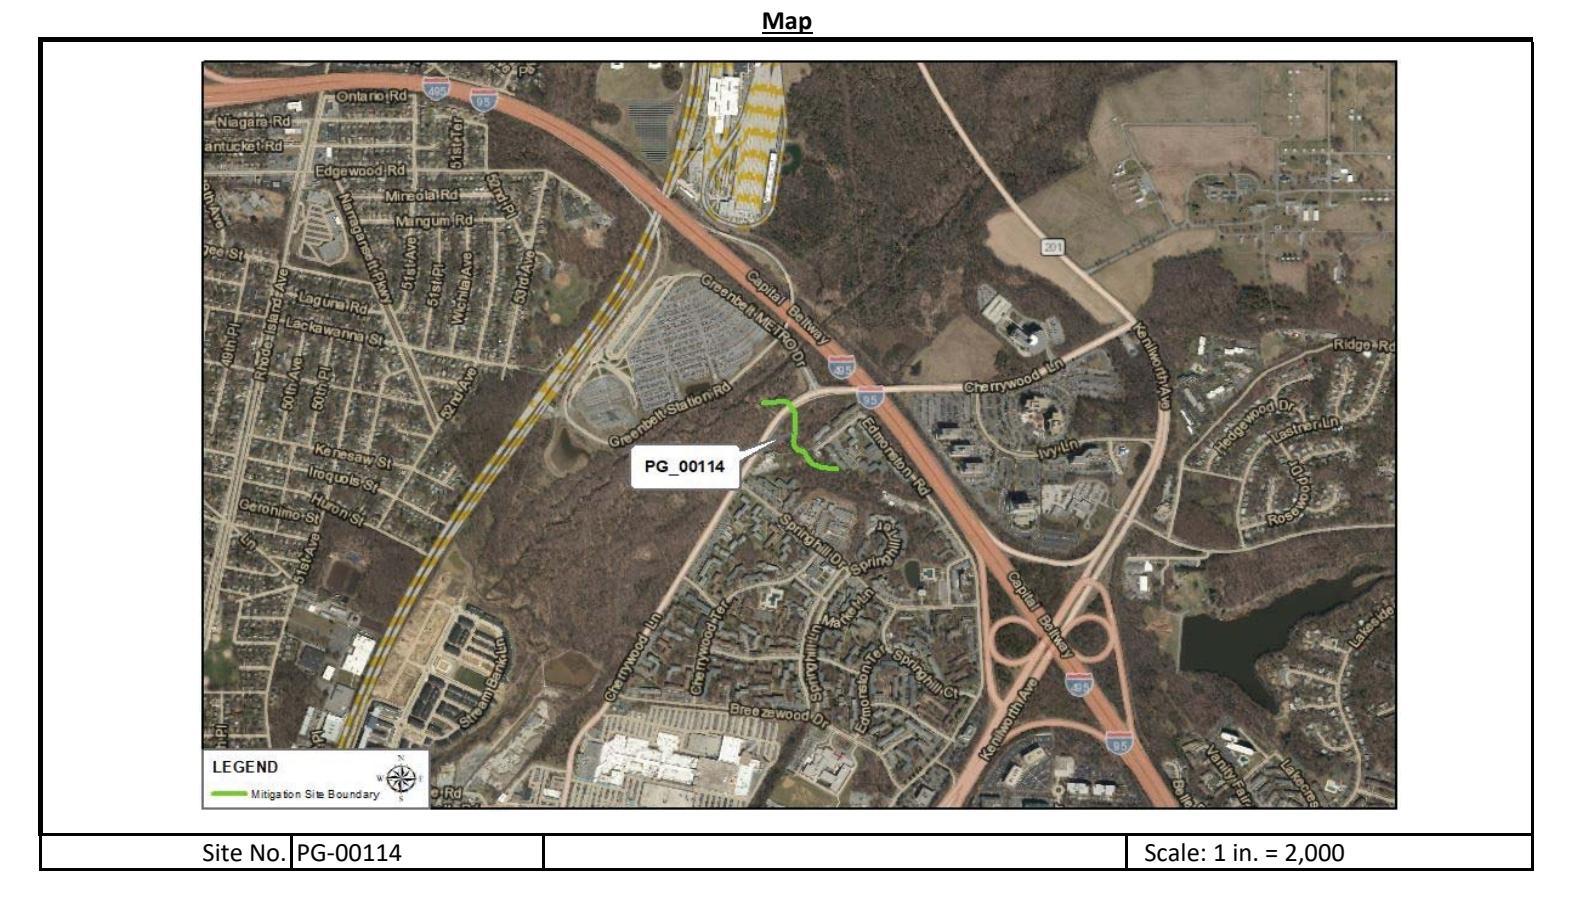
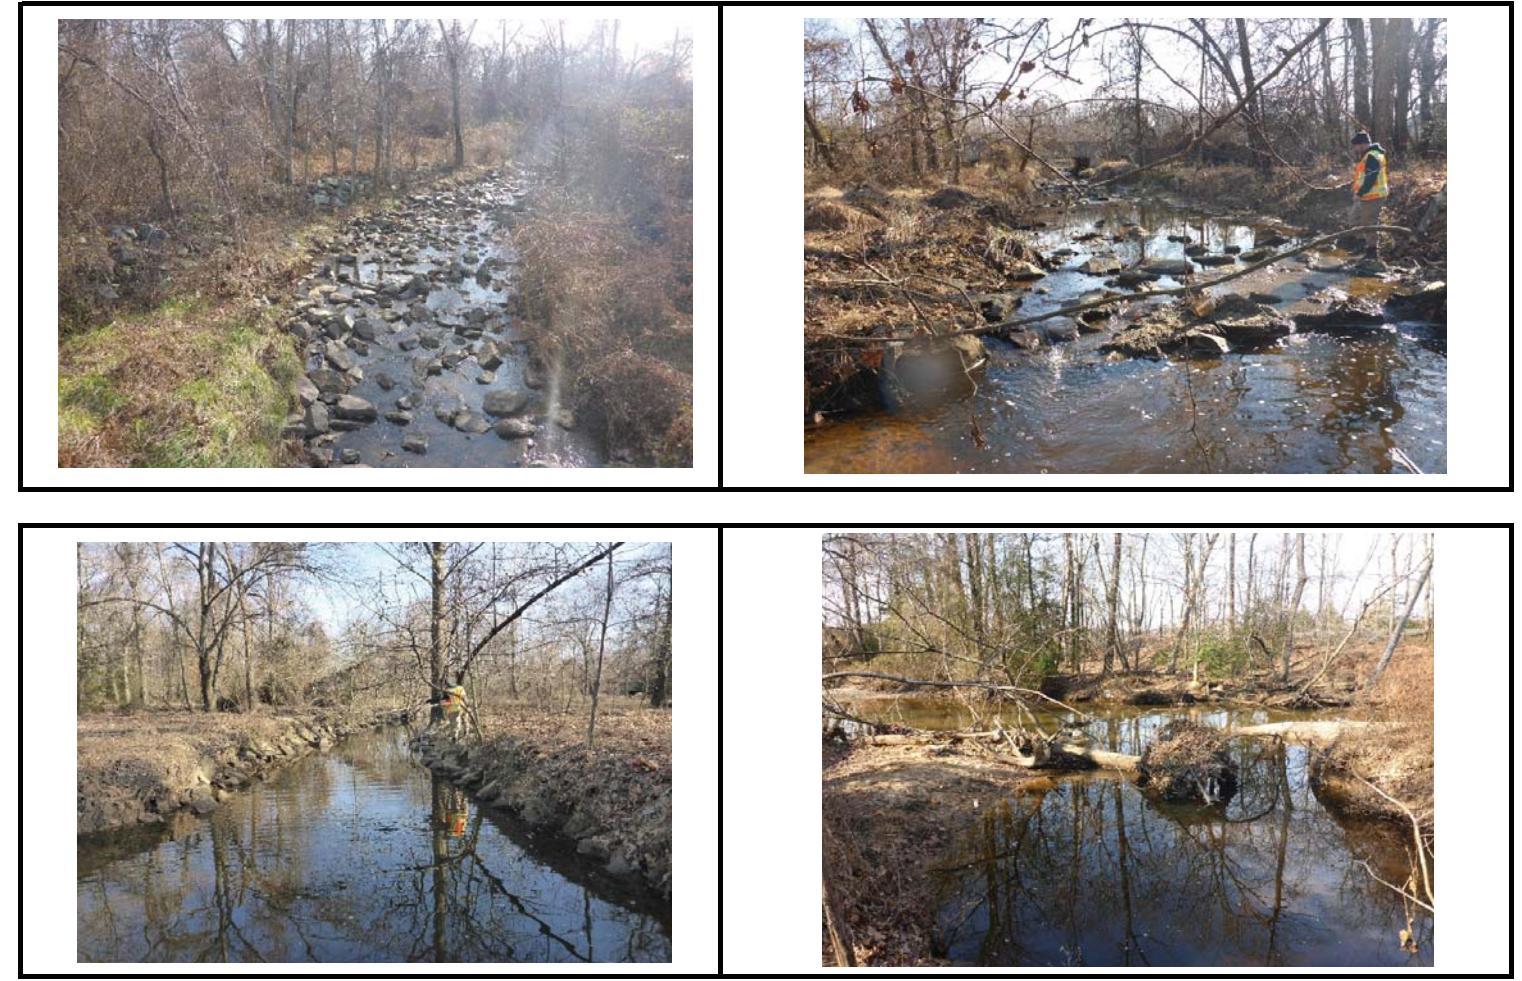
1 - Ves (Initequent out of 1	Dalik Howj Lent flooding)		1 - Conditions are such that Lift is difficult to achieve and sustain		
Describe:			Describe:	cam	
Banks are relatively low.	evidence of frequent out-	of-bank flow is	Possibility for geomorphic stability at confluence with Indian	Creek, otherwise	
nresent	evidence of frequent out		low opportunity exists		
present.					
Opportunity for Floodpla	ain Development	10	Ease of Access	1	
10 - Existing space for flo	odplain greater than 10 ti	mes stream width	10 - Yes (with existing direct vehicular access to potential site	e)	
5 - Existing space for floo	dplain 3 to 10 times strea	m width	5- yes (open but no existing vehicular access)		
1 - Little to no space for floodplain development			1 - No (no vehicular access, clearing needed)		
Describe:			Describe:		
Fairly open areas are present immediately adjacent to stream with			Access road with clearing is needed. Possible traffic pattern change on

low tree impact.			Cherrywood Lane.		
Drainage Area Evaluation	n	5	Utilities Present	5	
10 -D.A. less than 1 sq. m	i.		10 - No utilities on site		
5- D. A. between 1 & 3 sq. mi.		5 - Utilities but not within restoration area			
1 - D. A. greater than 3 sq. mi.			1 - Utilities within potential restoration area		
Describe:			Describe:		
Drainage area - 1.47 squa	are miles.		Overhead power lines are present at upstream end of stream near bridge, w	which may restrict	
			access.	T	
			Total Score out of 100	31
