APPENDIX E: PUBLIC SITE WALKTHROUGH RATING CRITERIA & FIELD ASSESSMENT FORMS

WETLAND MITIGATION RATING CRITERIA & FIELD SITE ASSESSMENT FORMS

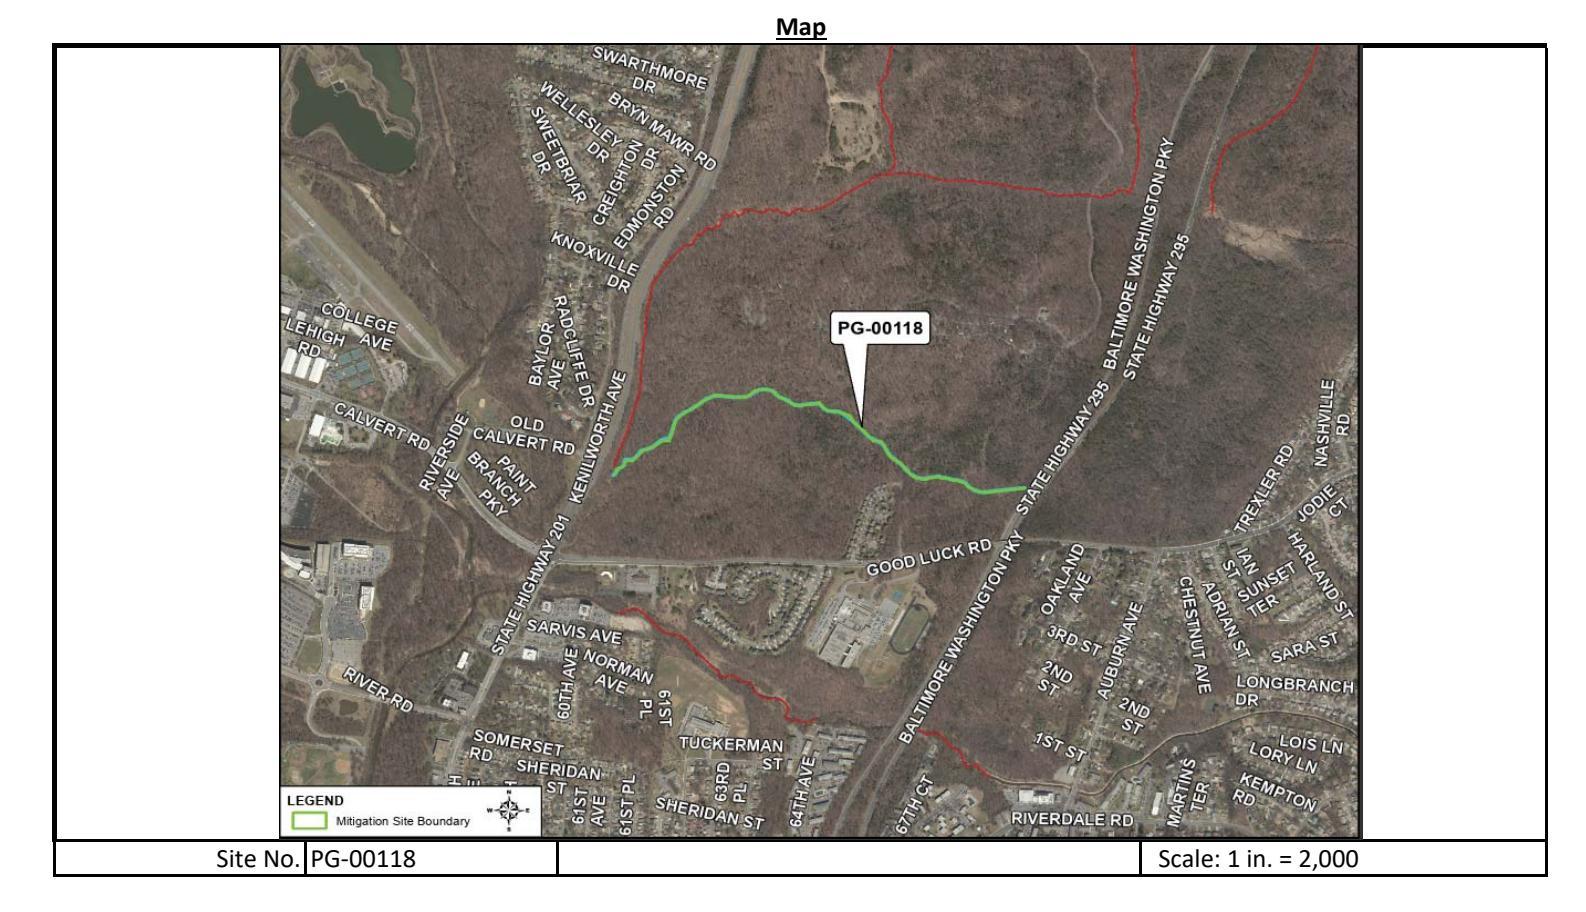
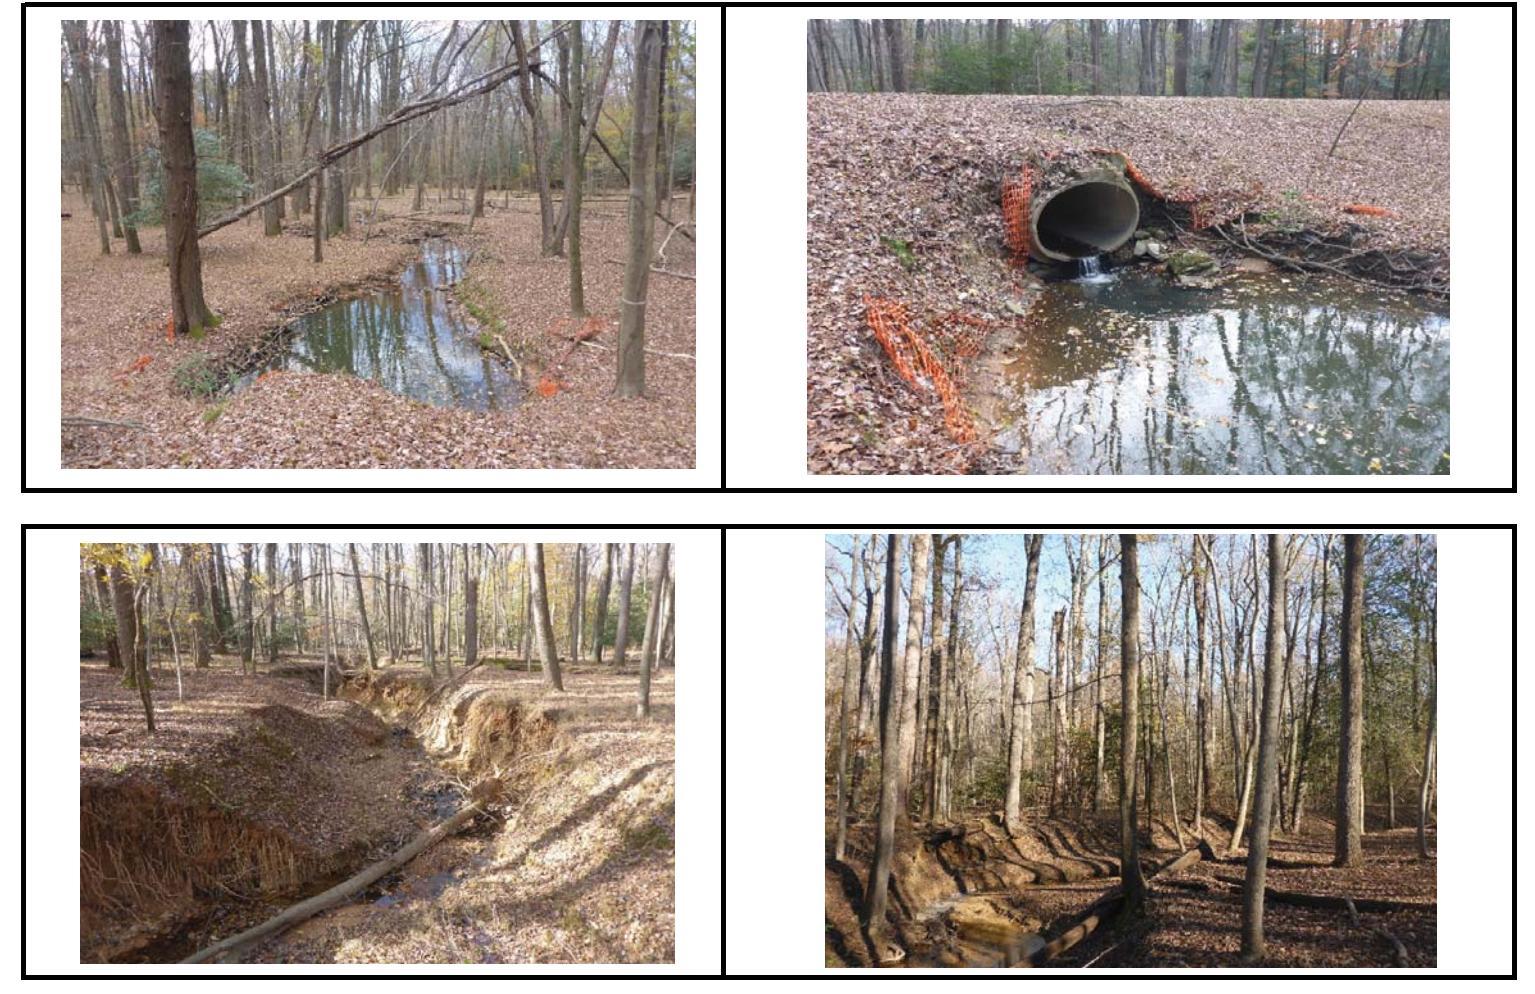
Top 2/3 of stream reach	with ~6-10 ft banks. Botto	m 1/3 of stream	Site located within a national park with mature forest.		
reach with ~3-6 ft banks	•				
Existing Floodplain Acce	200	10	Opportunity for Ecological Lift	5	
10 - No evidence of out	of bank flooding		10 - Conditions exist for several aspects of lift to be achieve	d and sustained	
5- Yes (Infrequent out of	f bank flow)		5 - Lift limited to one or few aspects		
1 - Yes (evidence of freq	uent flooding)		1 - Conditions are such that Lift is difficult to achieve and sustain		
Describe:			Describe:		
No rack lines or sedimer	nt noted outside of banks. A	Appears to be	Possibility for habitat creation and stabilization of bed and l	banks.	
forming inset "C" channe	el within eroded gully.				
		10			
Opportunity for Floodpl	ain Development	10	Ease of Access	1	
10 - Existing space for flo	odplain greater than 10 tir	nes stream width	10 - Yes (with <u>existing</u> direct venicular access to potential si	te)

1 - Little to no snace for	floodnlain development		1 - No (no vehicular access, clearing needed)		
Describe:	noouplain acvelopment		Describe:		
Steep, narrow valley. Str	ream is located within a der	nselv forested.	Site is located within a denselv forested national park. Foot	trails present.	
incised "B" channel Flo	odplain reconnection woul	d require immense			
tree impacts					
Drainage Area Evaluatio	an I	10	l Itilities Dresent	5	
10 -D A loss than 1 so n	ni	10	10 - No utilities on site	J	
5- D. A. between 1 & 3 s	a. mi.		5 - Utilities but not within restoration area		
1 - D. A. greater than 3 s	iq. mi.		1 - Utilities within potential restoration area		
Describe:	·		Describe:		
Drainage area = 0.49 sou	uare mile.		Sewer utility present at downstream end of reach		
			Total Score out of 10	0 58

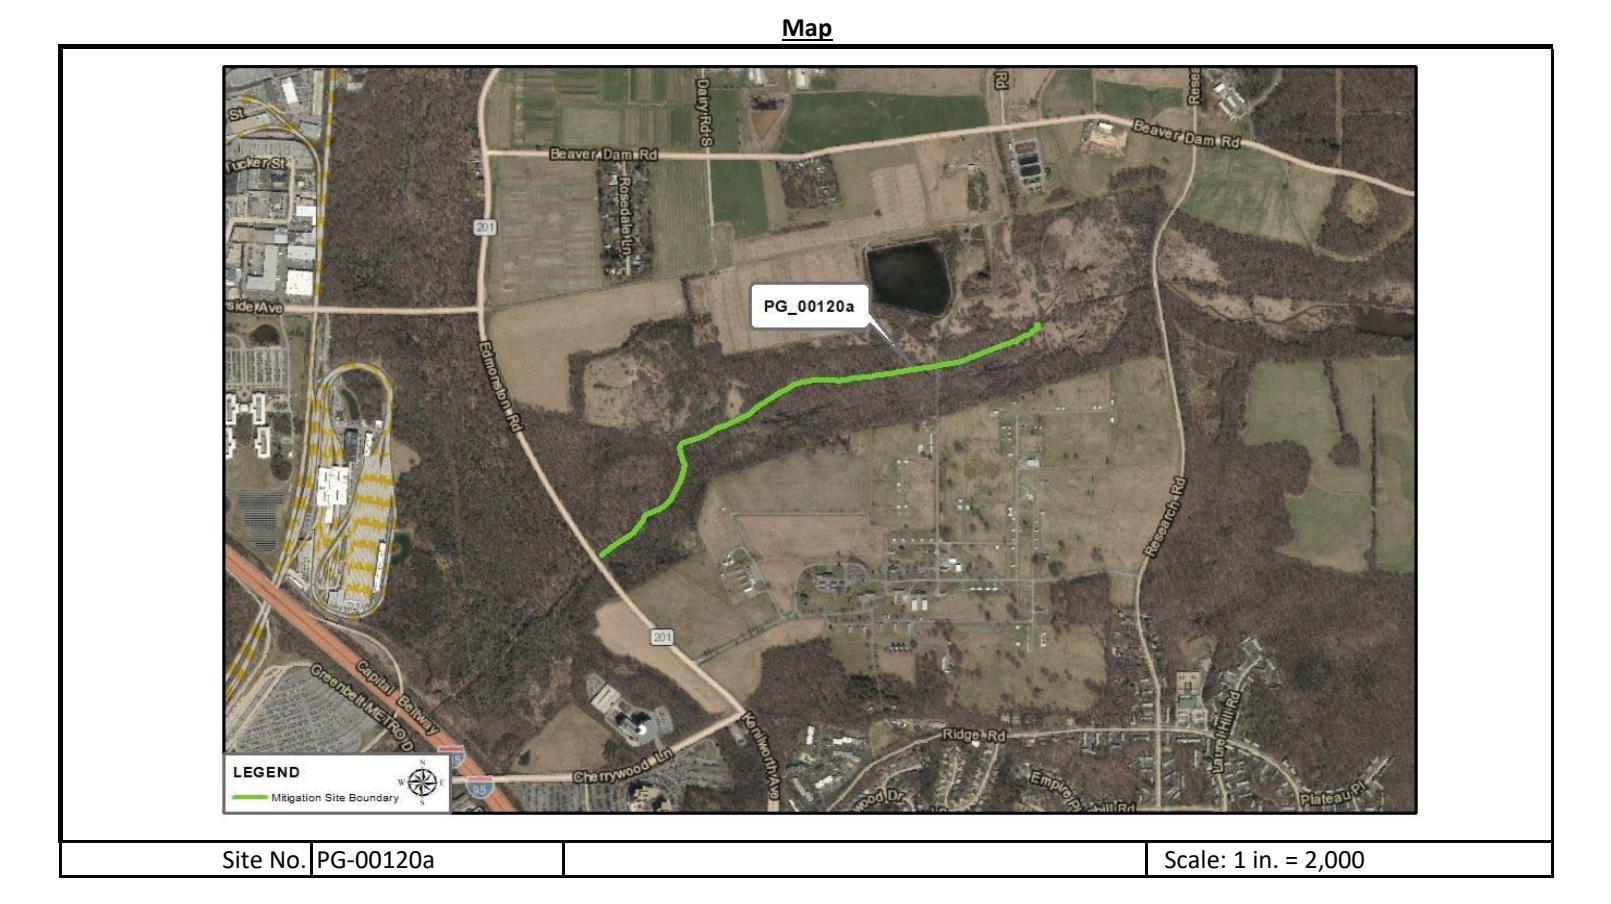
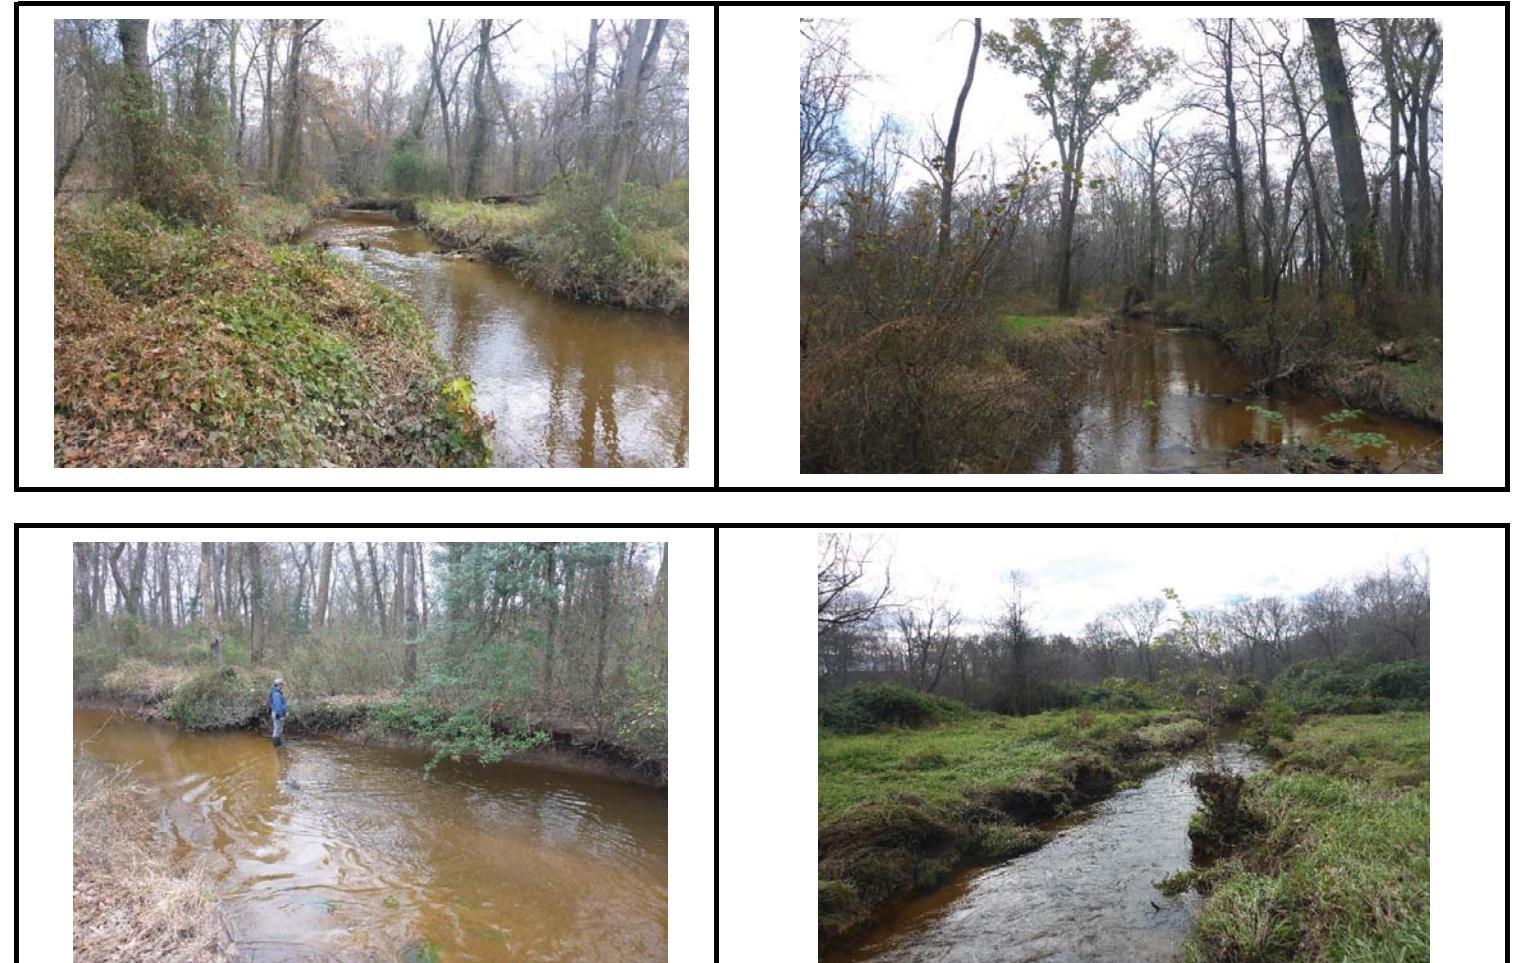
5- Yes (Infrequent out of	bank flow)		5 - Lift limited to one or few aspects		1
1 - Yes (evidence of frequence of frequence)	Jent flooding)		1 - Conditions are such that Lift is diffic	cuit to achieve and susta	1111
Describe. Pack lines and fine sodim	agent donosition on both h	nks/within the	Some notential in reducing bank eresit	on increasing geometry	nic stability
floodolain are present fo	ient deposition on both be	anks/ within the	babitat creation and wotland onbance	omont	ne stability,
noouplain are present to	in the extent of the reach.		habitat creation, and wetiand enhance	inent.	
Opportunity for Floodpl	ain Development	10	Ease of Access		5
10 - Existing space for flo	podplain greater than 10 ti	mes stream width	10 - Yes (with existing direct vehicular	access to potential site)	
5 - Existing space for floc	odplain 3 to 10 times strea	m width	5- yes (open but no existing vehicular a	access)

1 - Little to no space for	floodplain development		1 - No (no vehicular access, clearing ne	eded)	
Describe:			Describe:		
Wide, flat valley is prese	nt within a mature forest,	but sparse trees	Multiple access points from downstrea	am to upstream end of r	each with
may allow for minimal tr	ee disturbance.		minimal tree removal required.		
Drainage Area Evaluatio	n	1	Utilities Present		5
10 -D.A. less than 1 sq. m	ni.	-	10 - No utilities on site		
5- D. A. between 1 & 3 so	ą. mi.		5 - Utilities but not within restoration a	area	
1 - D. A. greater than 3 so	q. mi.		1 - Utilities within potential restoration	n area	
Describe:			Describe:		
Drainage area - 14.1 squ	are miles.		Powerline ROW crosses stream.		
			Tota	al Score out of 100	49

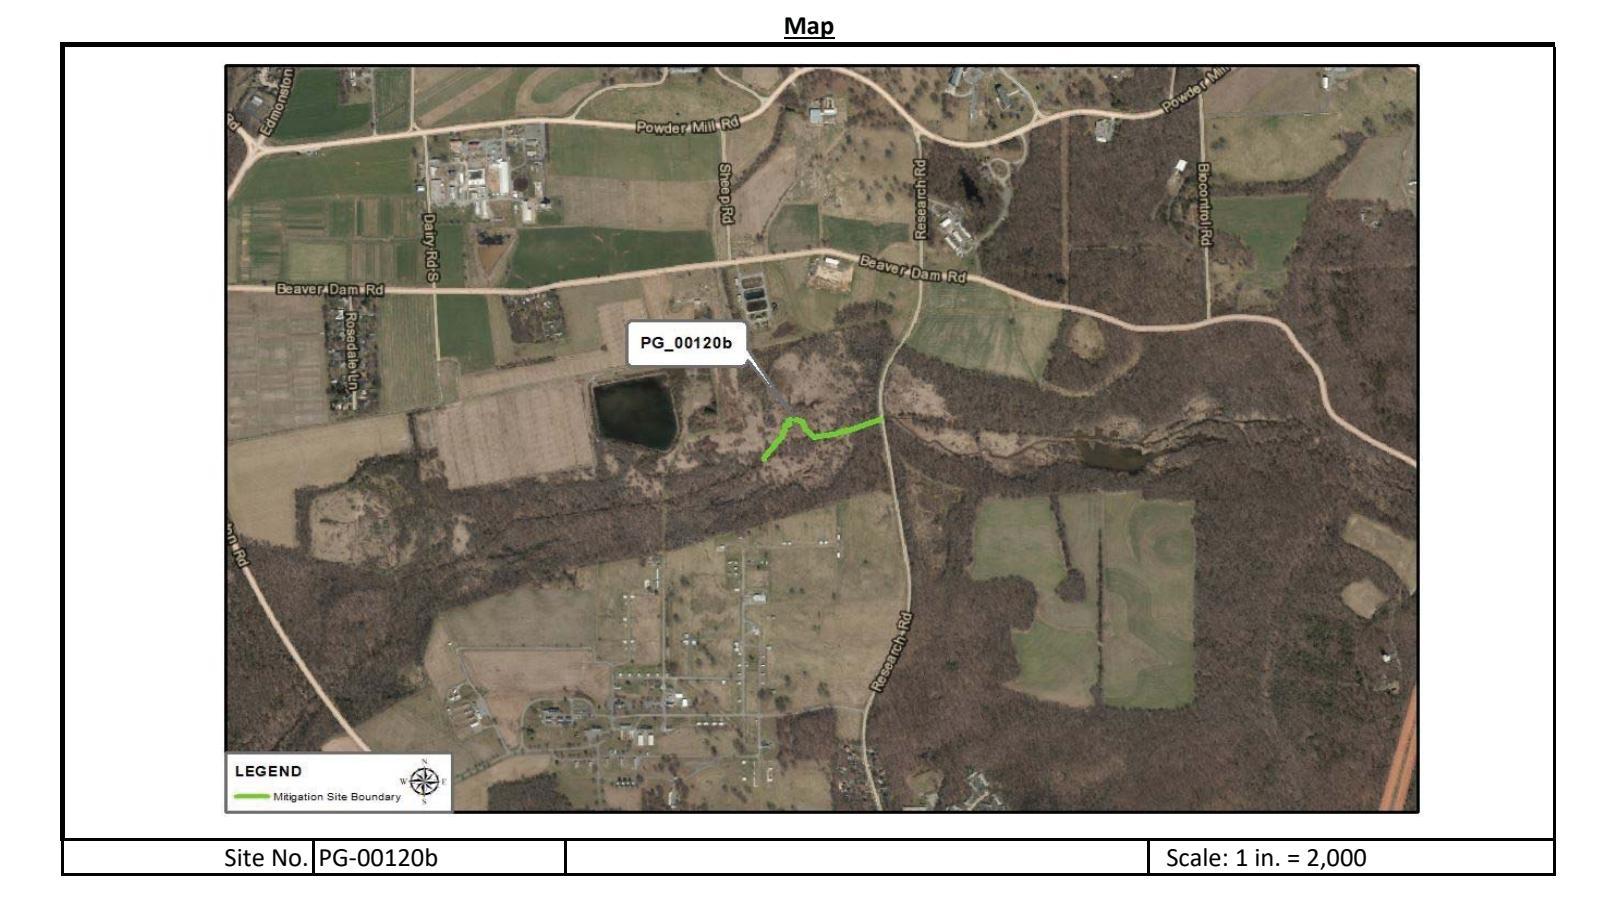
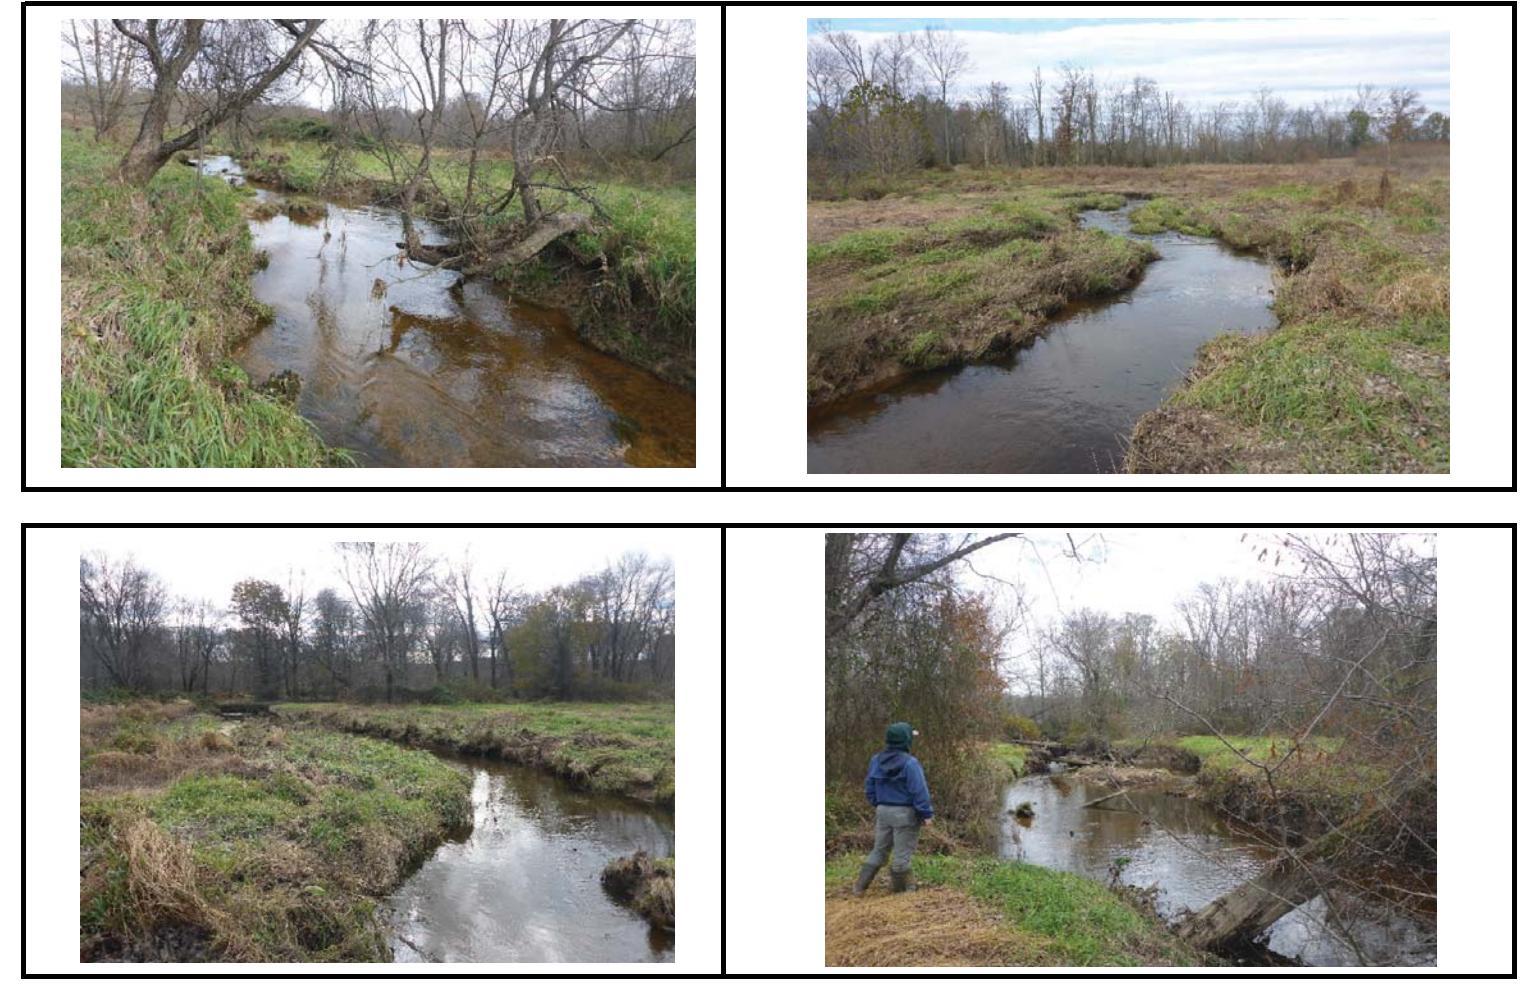
Evidence of floodplain ac	ccess is present at the dow	nstream end of the	e Some potential in reducing bank erosion, increasing geomorphic stability,	
stream reach, but not up	ostream.		habitat creation, floodplain access, and developing stream but	fer.
Opportunity for Floodpl	ain Development	10	Ease of Access	5
10 - Existing space for flo	odplain greater than 10 ti	mes stream width	10 - Yes (with existing direct vehicular access to potential site)	
5 - Existing space for floc	odplain 3 to 10 times strea	m width	5- yes (open but no existing vehicular access)	
1 - Little to no space for	floodplain development		1 - No (no vehicular access, clearing needed)	
Describe:			Describe:	
Wide open flat valley wit	th no trees present.		Site is in close proximity to roads and powerline ROW.	
Drainage Area Evaluatio	n	1	Utilities Present	10
10 -D.A. less than 1 sq. m	ni.		10 - No utilities on site	
5- D. A. between 1 & 3 so	q. mi.		5 - Utilities but not within restoration area

1 - D. A. greater than 3 s	q. mi.		1 - Utilities within potential restoration area	
Describe:			Describe:	
Drainage area - 13.1 squ	are miles.		No utilities observed.	
J			l	
			Total Score out of 100	67

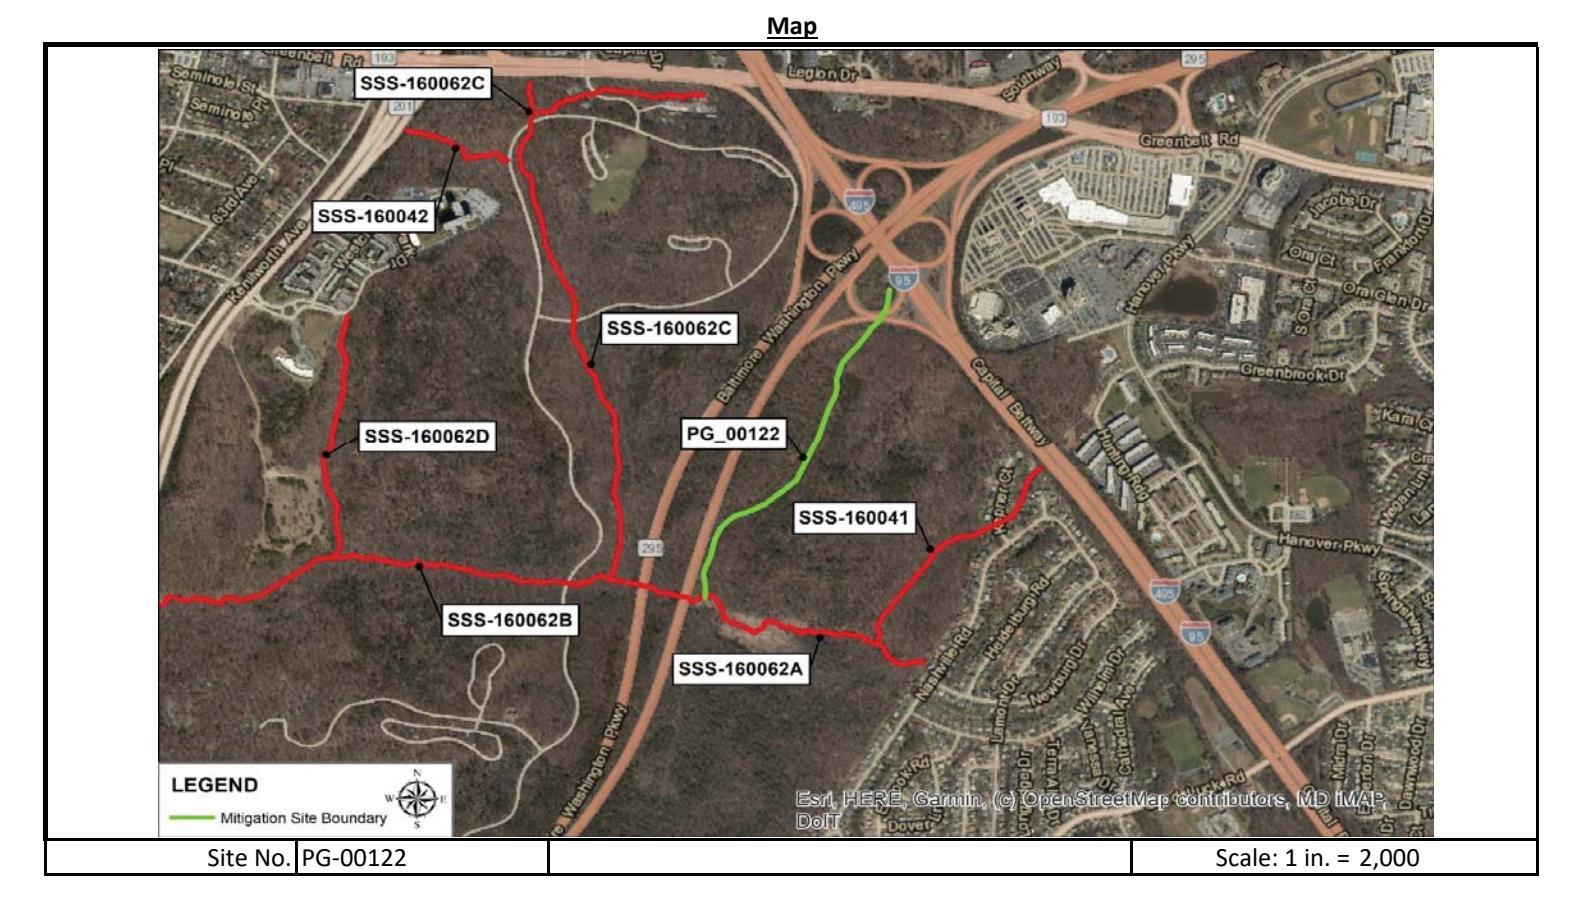
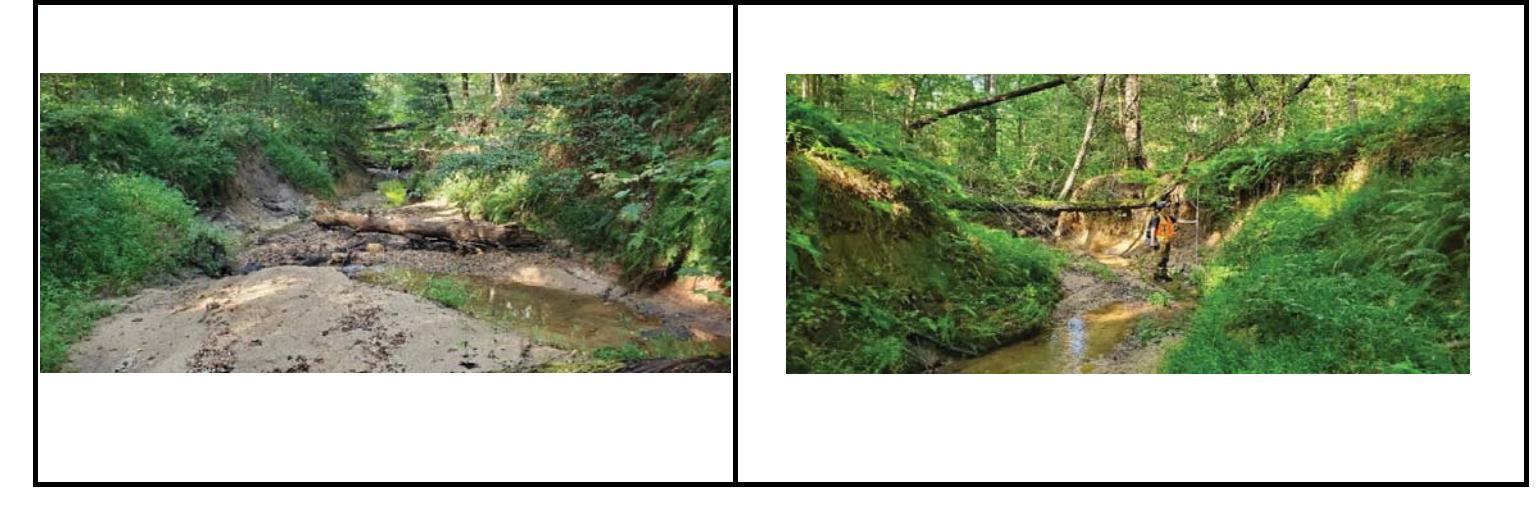
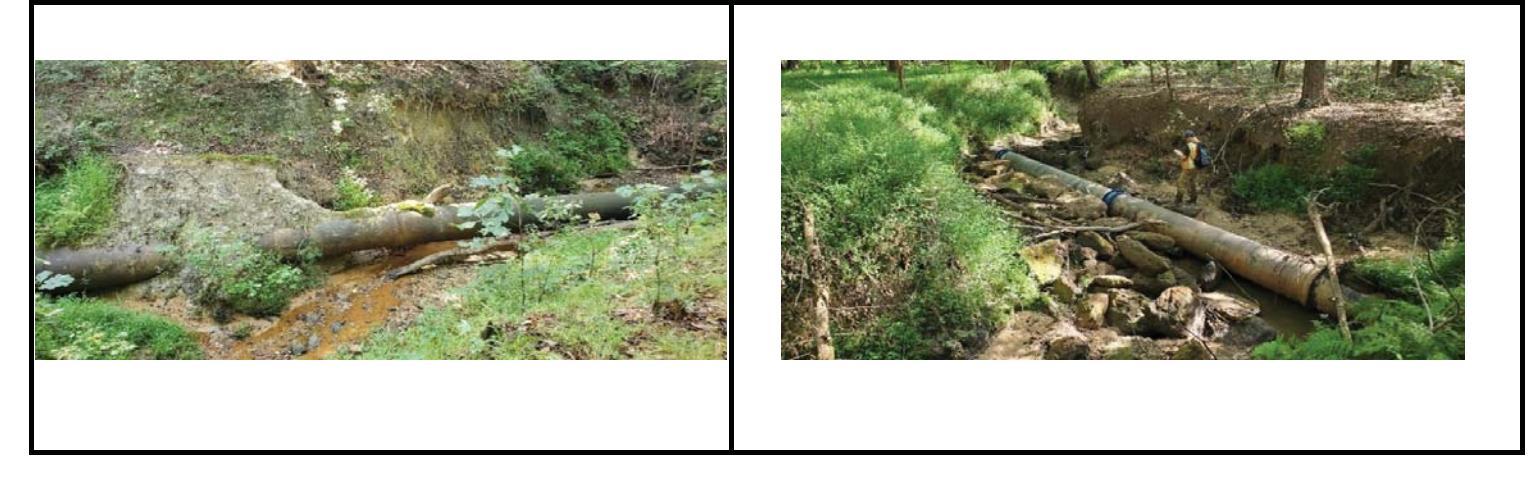
····			,	,	
Opportunity for Floodpl	ain Development	5	Ease of Access		
10 - Existing space for flo	odplain greater than 10 ti	mes stream width	10 - Yes (with <u>existing</u> direct vehicular a	ccess to potential site)	
5 - Existing space for floo	dplain 3 to 10 times streai	n width	5- yes (open but no existing venicular ac	;Cess) vdad)	
1 - Little to no space for i			1 - NO (NO VENICULAI access, cleaning nee		
Describe: Space for 10 times width	with massive tree loss or	raising of channel	Describe:		
had		aising of channel	No access existing, clearing needed with	I SHA ROW	
beu					
Drainage Area Evaluatio	n	10	Utilities Present		
10 -D.A. less than 1 sq. m	ni.		10 - No utilities on site		
5- D. A. between 1 & 3 so	q. mi.		5 - Utilities but not within restoration and	ea	
1 - D. A. greater than 3 so	q. mı.		1 - Utilities within potential restoration	area	
Describe:			Describe:

0.21 square miles			Utilities exposed throughout site within	stream	
			T-+-	Score out of 100	
			lota

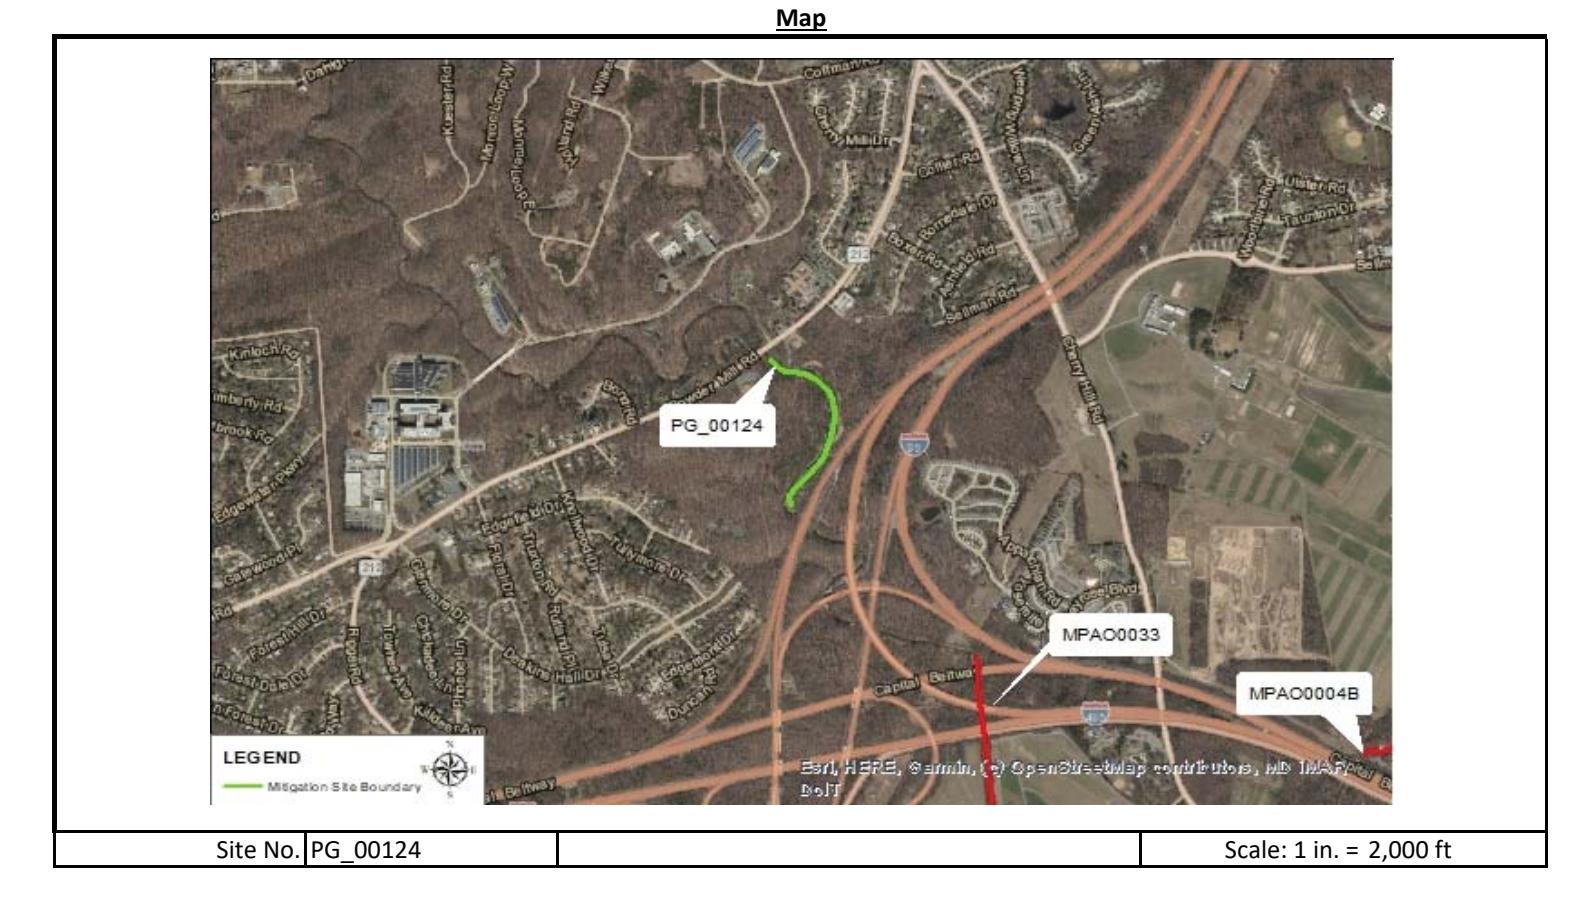
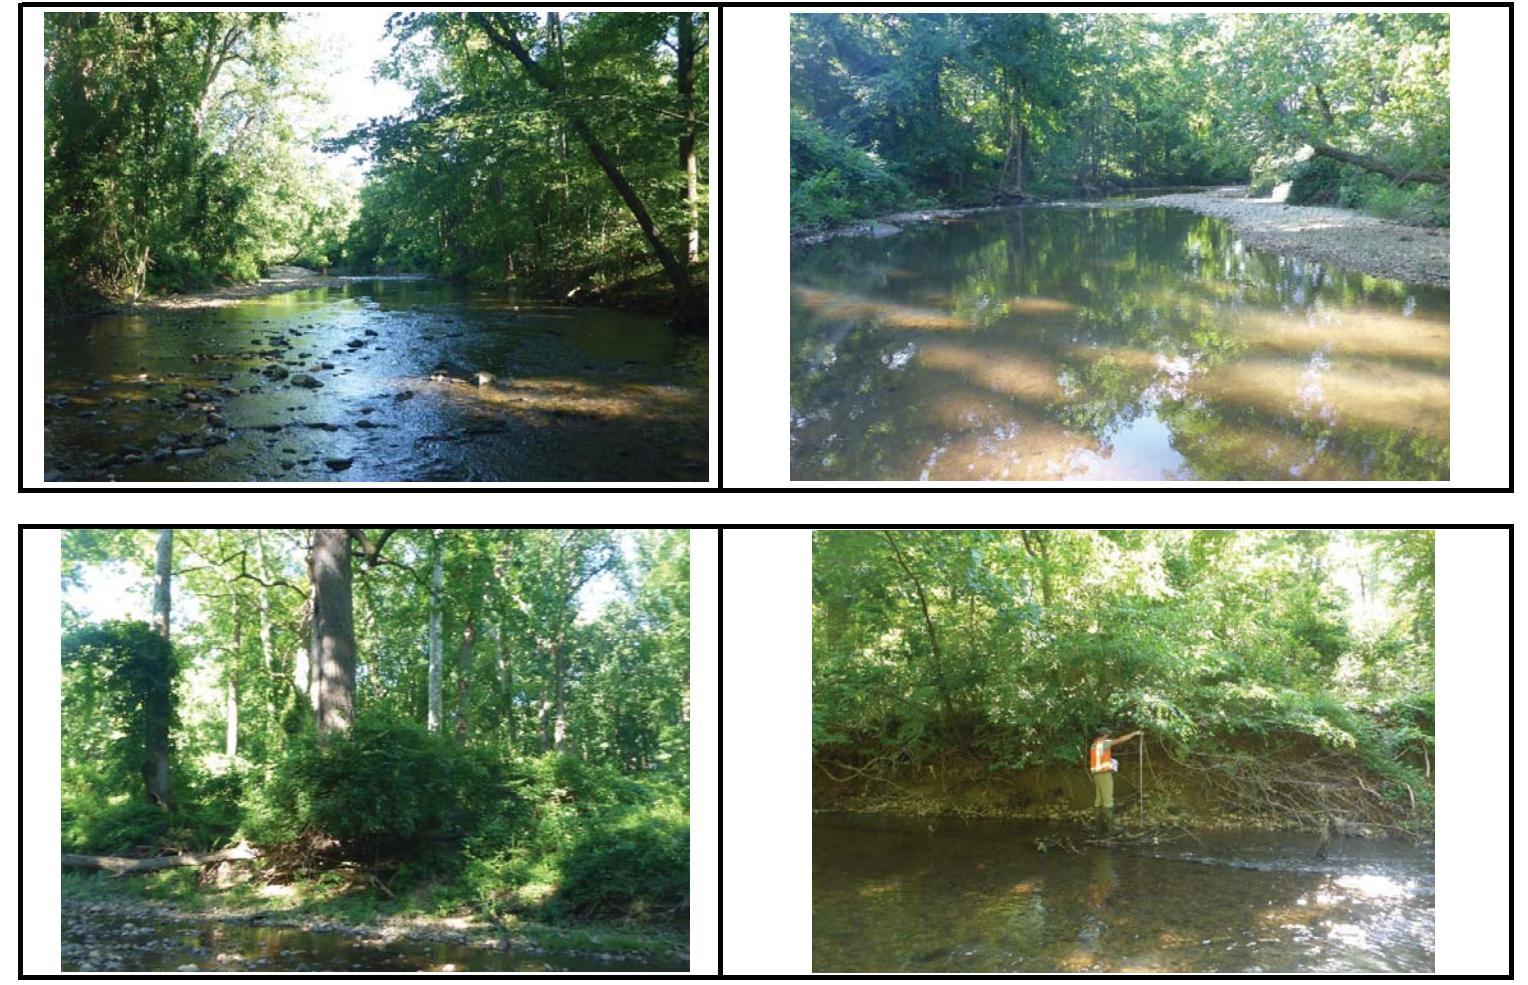
Str	eam Mitigation	Field Site Assessment Form		
	Pro	<u>oject Details</u>		
Project Name: I-495/I-270 Managed Lar	nes Study	Mitigation Site Number:	PG_00124	
Projects Estimated Stream Mitigation Needs (LF)	: TBD

1 - Yes (evidence of frequent flooding)		1 - Conditions are such that Lift is diffic	ult to achieve and sustain	
Describe:		Describe:		
Some signs of FP access, sand on FP at DS end of s	ite, may be due to	In good condition, only real uplift is FP reconnection, would require extensive		
backwater from debris jam at culvert.		impact to mature forest.		
Onnertunity for Floodalain Development	5	Face of Access		
Opportunity for Floodplain Development	imes stream width	Lase of Access	access to notential site)	
5 - Existing space for floodplain greater than 10 th	m width	5- yes (open but no existing vehicular a	cress)	
1 - Little to no space for floodplain development		1 - No (no vehicular access, clearing ne	eded)	
Describe [.]		Describe:		
Valley wall on RB. road on LB. mature forest on ex	isting FP.	Old access road to sewer on RB. young	tree planting along road.	
Drainage Area Evaluation	1	Utilities Present		1

15.8 sq. mi		Sewer line running along LB.		
		Tota	I Score out of 100	30

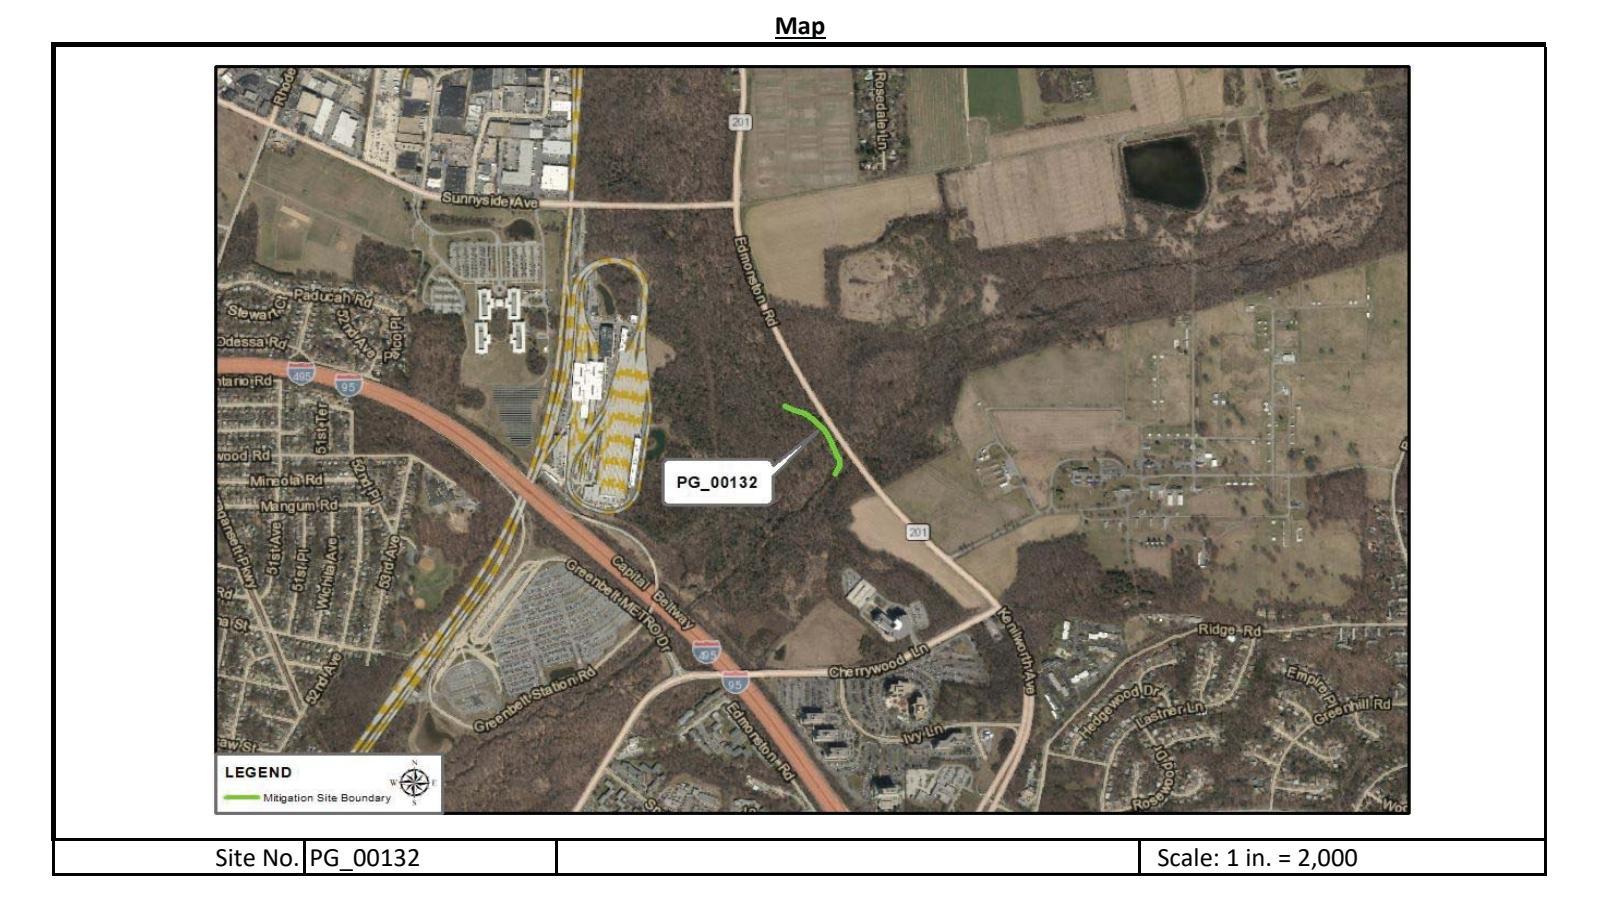
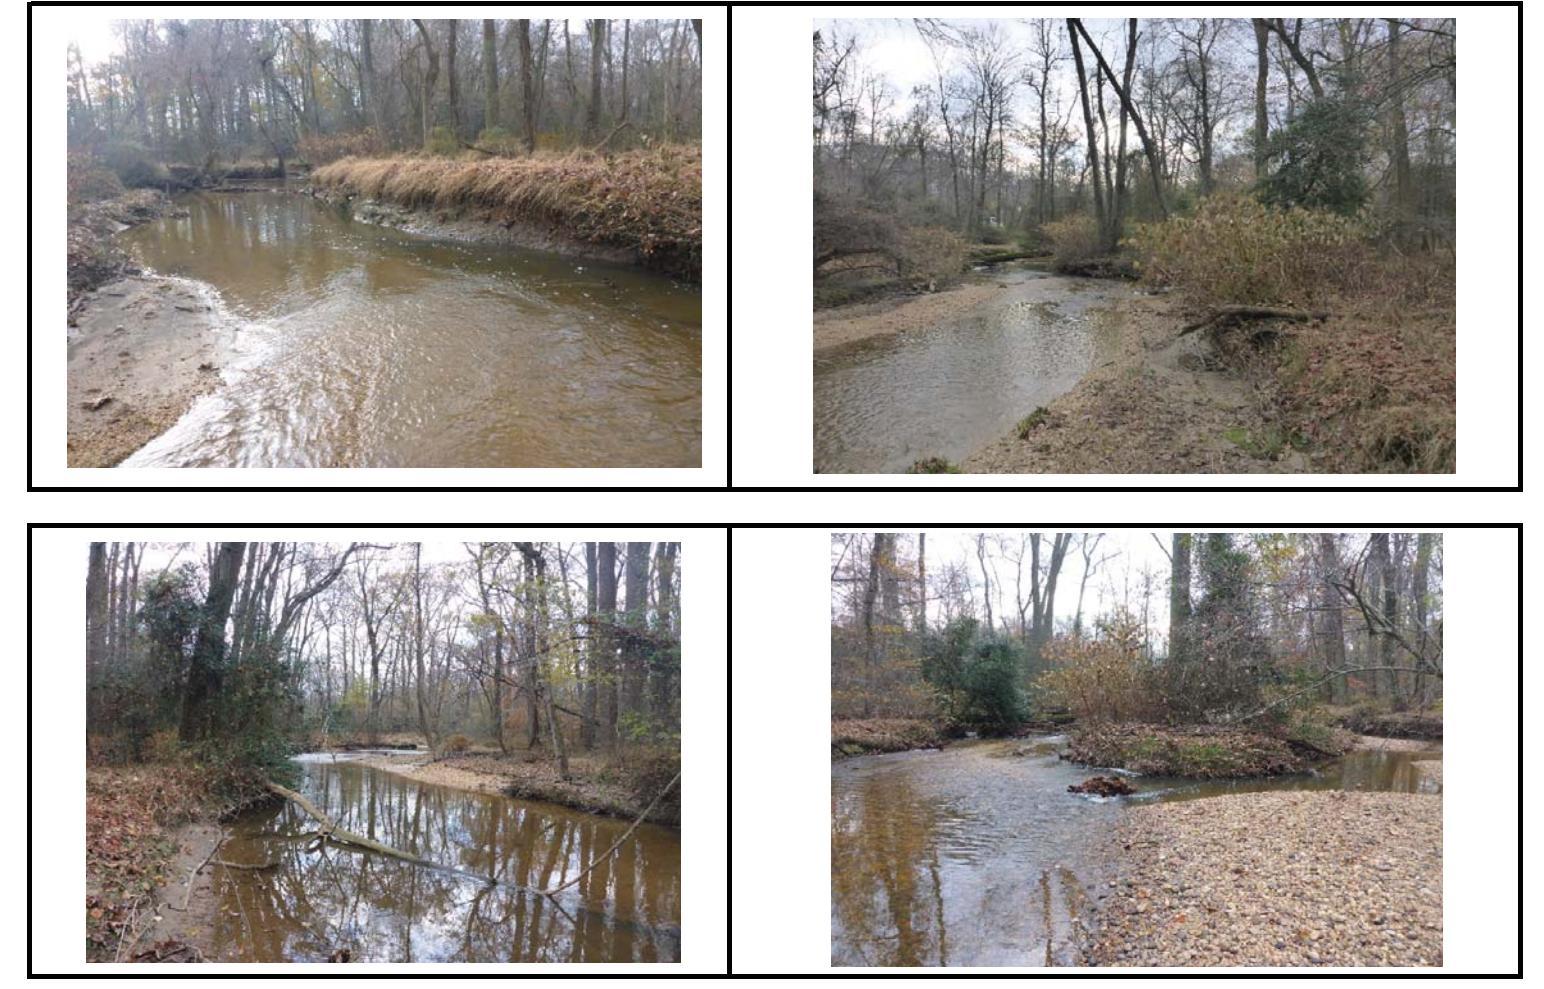
1 - Little to no space for I	loodplain development		1 - No (no vehicular access, clearing ne	eded)	
Describe:			Describe:	•.	
Mature forest with many	rrees present within a fla	t, wide valley.	Eamonston Road in close proximity to	site.	
		4		r	40
Urainage Area Evaluatio	n	1	Utilities Present		10
D.A. less than 1 sq. m	II. n mi		10 - NO UTILITIES ON SITE	200	
J = D. A. Delweell I & 3 S(1 - D A greater than 2 c_{1}	1 n. mi		1 - Utilities within notential restoration	n ca Narea	
	1		Describe:		
Drainage area - 9.77 squa	are miles.		NO UTILITIES ODSERVED.

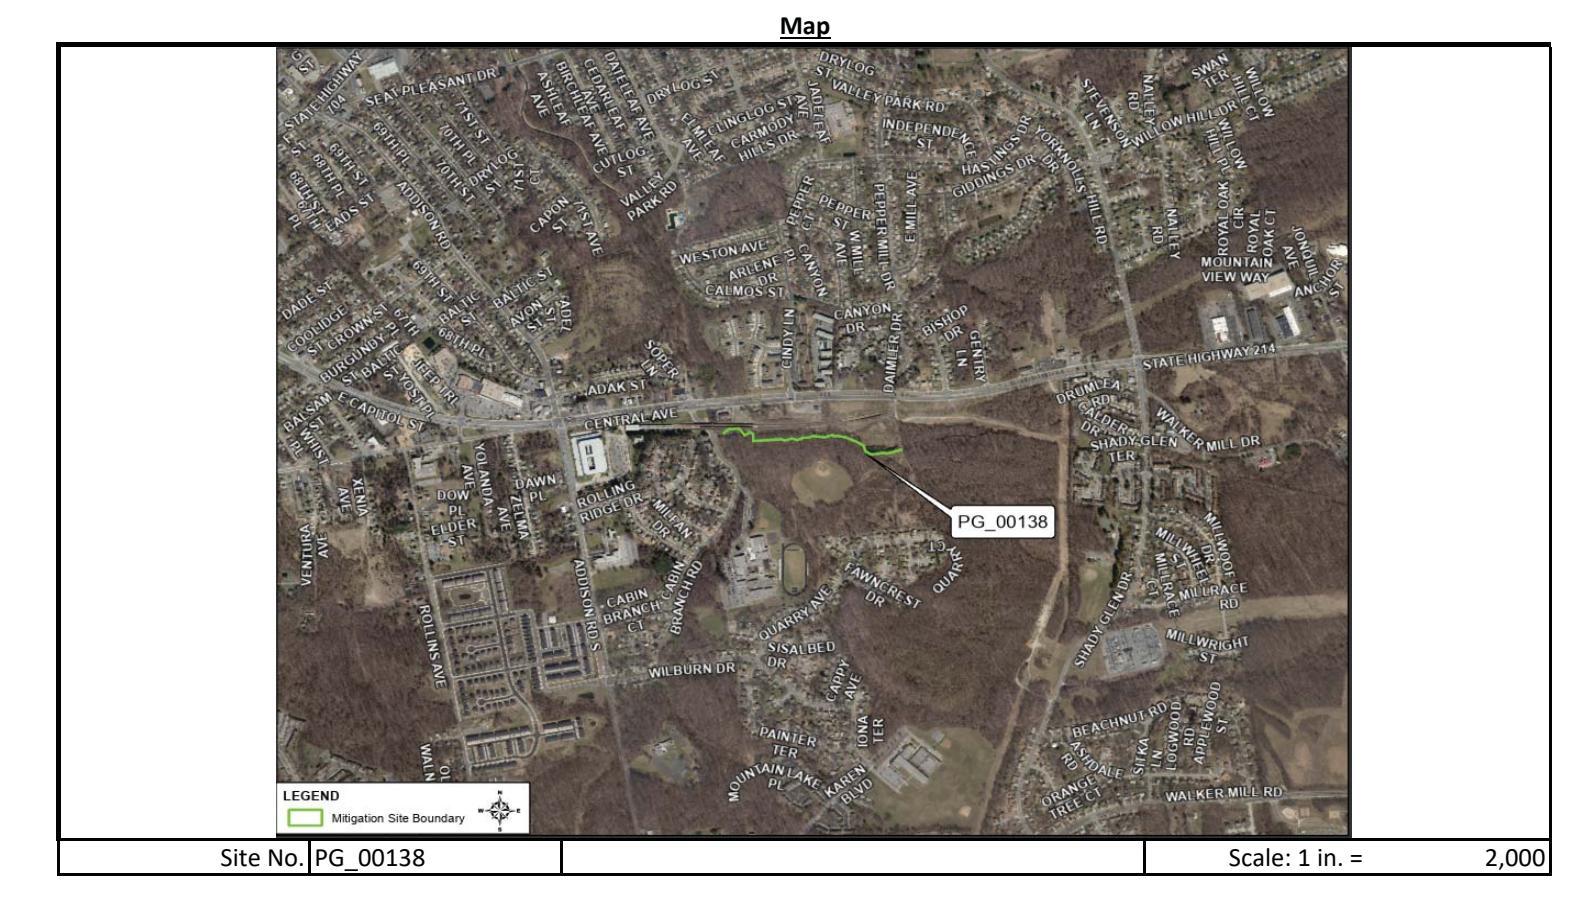
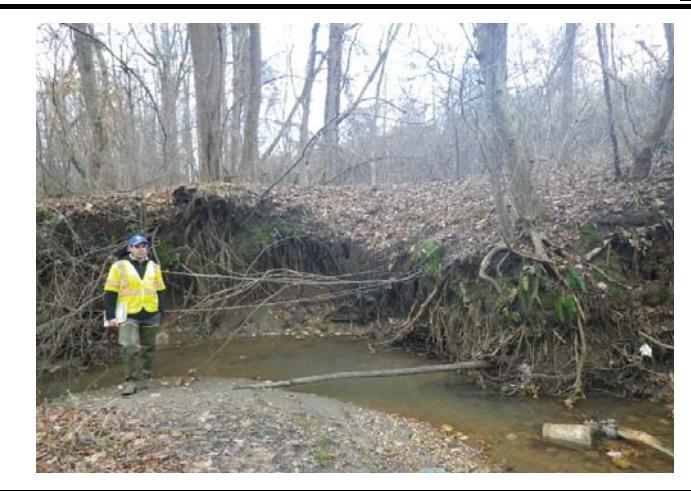
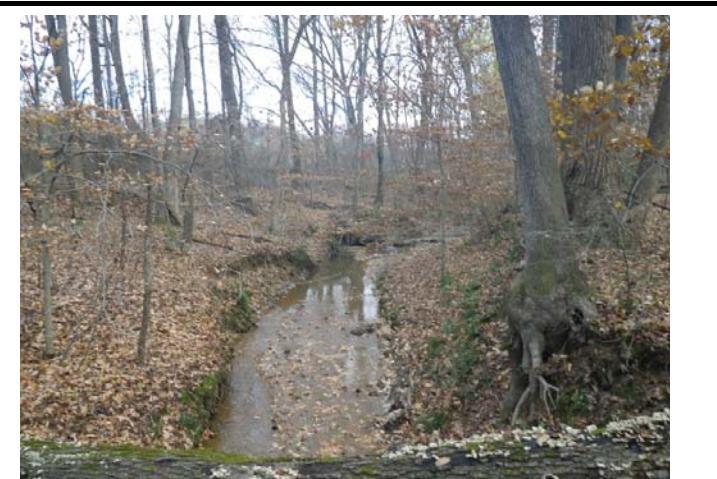
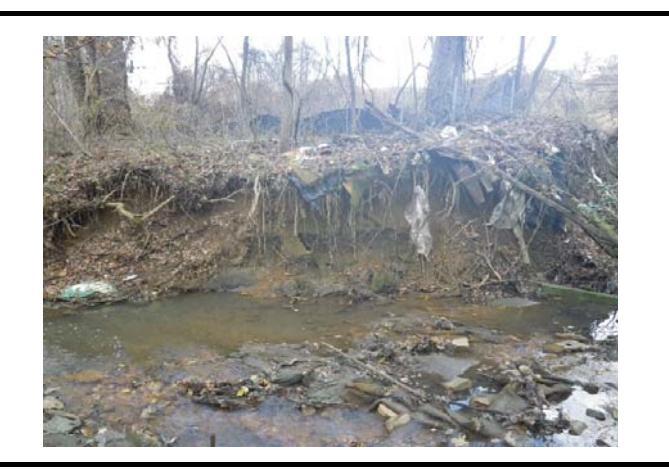
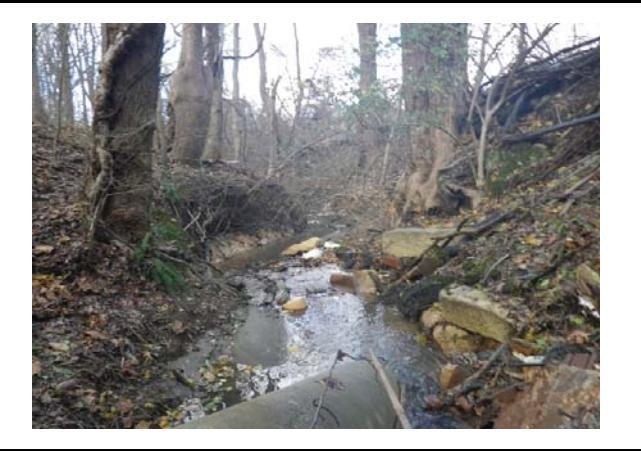
-			
Opportunity for Floodp	lain Development	5	Ease of Access	1	
10 - Existing space for fl	oodplain greater than 10 ti	mes stream width	10 - Yes (with <u>existing</u> direct vehicular acce	ess to potential site)	
5 - Existing space for flo	odpiain 3 to 10 times strea	m width	5- yes (open but no existing venicular acce	25S)	
1 - Little to no space for Describe:			1 - NO (NO VENICULAI ACCESS, Cleaning neede	30)	
Somo opportunitios for	floodalain dovelopment in	couthorn	Majority of site is surrounded by mid succ	sossional forest however there is an	
floodoloin, however nor	thorn floodalain dovelopment	southern	ald sower line access route along the site	that consists of onon proper with	
motro orcharder or	mern noouplain developm	ient is innited by	ou sewer line access route along the site i	that consists of open areas with	
metro embankment.			scattered smaller trees.		
Drainage Area Evaluatio	on	10	Utilities Present	1

10 -D.A. less than 1 sq. r	nı.		10 - No utilities on site	_	
5- D. A. Detween $1 \& 3 s$	iq. mi.		5 - Utilities but not within restoration area	1	
I - D. A. greater than 3 s	y, III.		1 - Other within potential restoration are	Ed	
Describe:			Describe:	a	
Drainage area - 0.26 squ	lare miles		Sewer line runs parallel to stream in south	iern floodplain.	
			<u>Total S</u>	core out of 100 49
