APPENDIX E: PUBLIC SITE WALKTHROUGH RATING CRITERIA & FIELD ASSESSMENT FORMS

WETLAND MITIGATION RATING CRITERIA & FIELD SITE ASSESSMENT FORMS

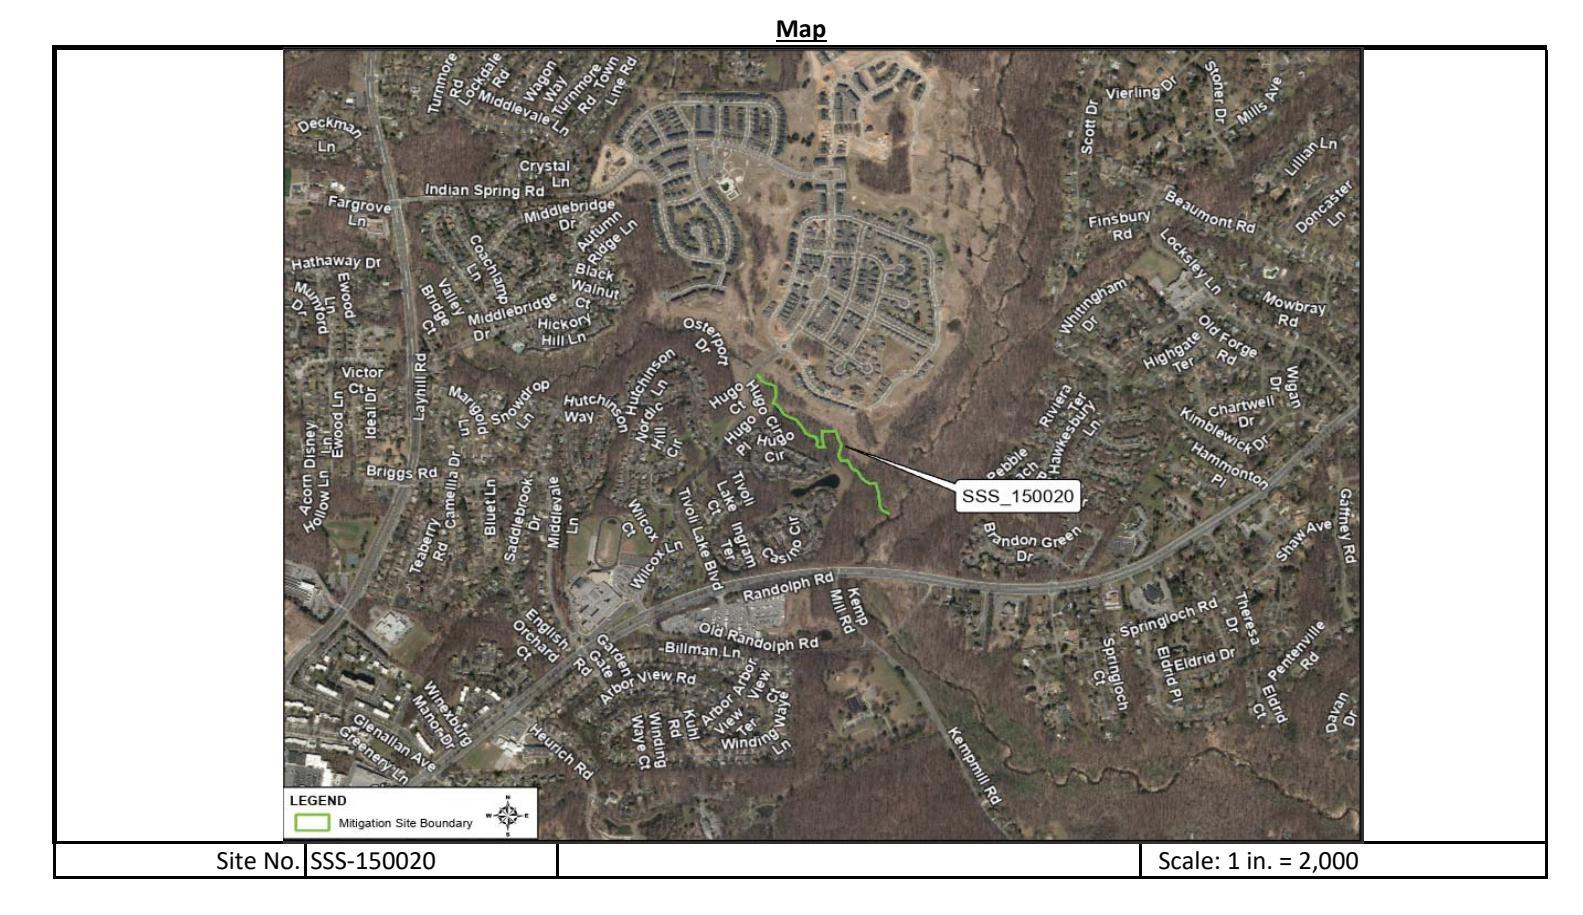
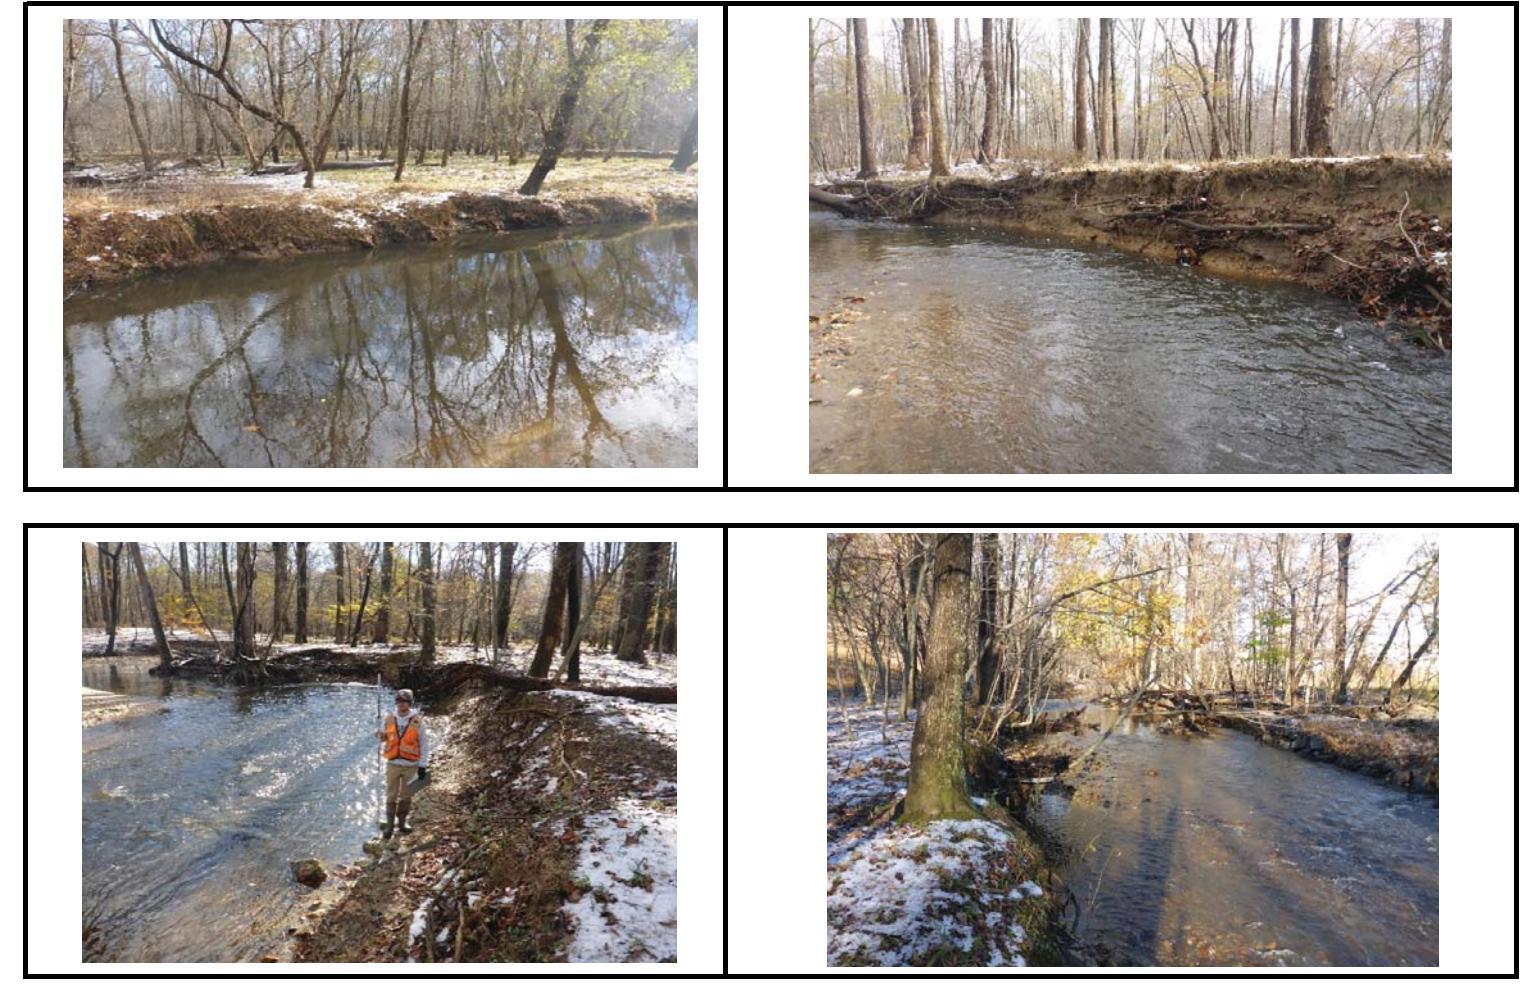
5-Yes (Infrequent out of	bank flow)		5 - Lift limited to one or few aspects		
1 - Yes (evidence of freq	uent flooding)		1 - Conditions are such that Lift is difficult to achieve and sustair	1	
Describe:		a	Describe:		
No evidence of rack lines	s or sediment deposition o	n floodplain.	Potential for habitat enhancement, increasing geomorphic stabi	llity.	
Opportunity for Eloodal	ain Develonment	1	Fase of Access	1	
10 - Existing space for flo	odplain greater than 10 ti	mes stream width	10 - Yes (with existing direct vehicular access to potential site)		
5 - Existing space for floo	odplain 3 to 10 times strea	m width	5- yes (open but no existing vehicular access)		
1 - Little to no space for	floodplain development		1 - No (no vehicular access, clearing needed)		
Describe:			Describe:		
It may be difficult to raise the channel at confluence with Northwest		e with Northwest	The best access to site is through neighborhood west of site or v	via Trivoli Lake

Branch Anacostia River.	Floodplain consists of mate	ure forest.	Blvd.		
Drainage Area Evaluatio	n	1	Utilities Present	1	
10 -D.A. less than 1 sq. n	ni		10 - No utilities on site		
5- D. A. between 1 & 3 s	ą. mi. a. mi		5 - Utilities but not within restoration area		
1 - D. A. greater than 3 S	ų. m.		1 - orinnes within potential restoration area		
Describe:					
Drainage area - 4.5 squa	re miles.		Sewer crossing observed at upstream end, but may be possible	to avoid.	
			Sewer within floodplain.		
			Total Score out of 100	31

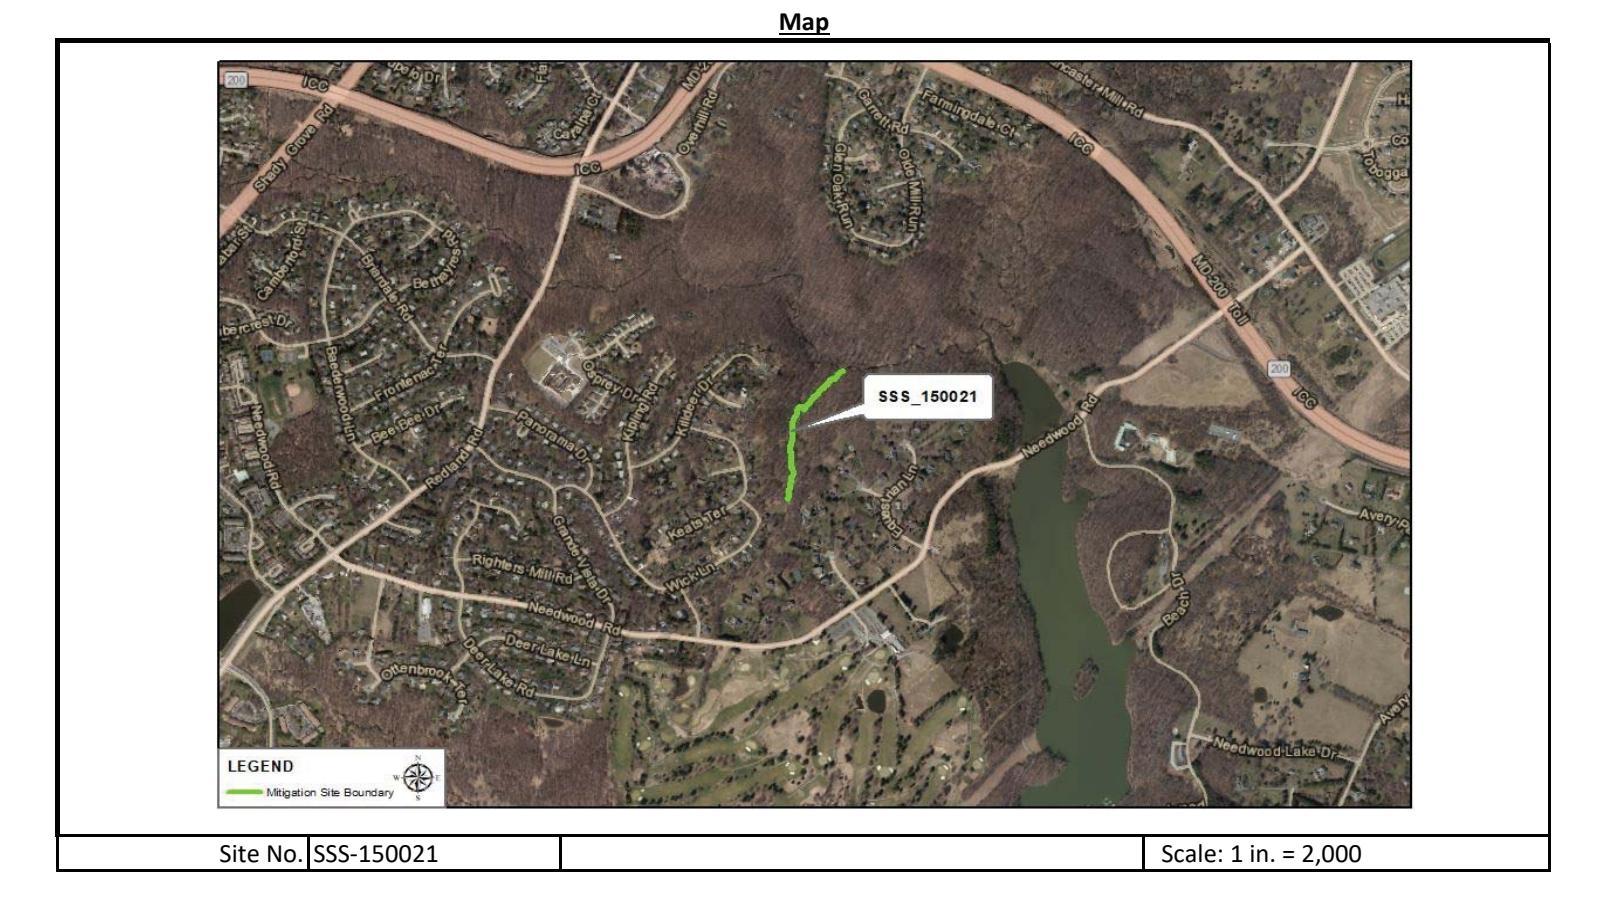
Str	eam Mitigation	Field Site Assessment Form		
		Pro	oject Details		
Project Name:	I-495/I-270 Managed Lan	es Study	Mitigation Site Number: SSS-150021		
Projects Estimated Stream	m Mitigation Needs (LF):	TBD

Approximately 70% of b	anks are eroded, ranging n	om "4-9 ft. tall,	vegetation is mostly forested, with many vines and invasive sp	becles noted.	
alternating at meanders	. Several areas of severe en	osion.

vegetation and rack line	s present.		reconnectivity, stabilizing severely eroded banks, and improving vegetative		
			cover with plantings		
Opportunity for Floodp	lain Development	10	Ease of Access	5	
10 - Existing space for flo	podplain greater than 10 ti	mes stream width	10 - Yes (with existing direct vehicular access to potential site)		
5 - Existing space for floo	odplain 3 to 10 times strea	m width	5- yes (open but no existing vehicular access)		
1 - Little to no space for	floodplain development		1 - No (no vehicular access, clearing needed)		
Describe:			Describe:		
Wide valley present, but	t stream is incised so the ch	annel would have	There appears to be good access from Wick Lane with little ma	aintenance of	
to be raised to floodplai	n.		traffic needed and minor tree trimming.		
Ducing an Array Freedow 11		10	Likiliking Dunggut	F	
		10	Unites Present	5	
IU-D.A. less than 1 sq. n	III. a mi		IU - NO UTILITIES ON SITE

5- D. A. Detween 1 & 3 s	ų. mi.		5 - Ouncies but not within restoration area		
I - D. A. greater than 3 s	ı q. m.		1 - Other within potential restoration area		
Describe:			Describe:		
Drainage area - 0.32 squ	iare mile.		Sewer manhole present at upstream end and approximately 1	.50 feet from	
			channel at edge of valley.		
			Total Score out of 100	62	
			Total Score out of 100	02

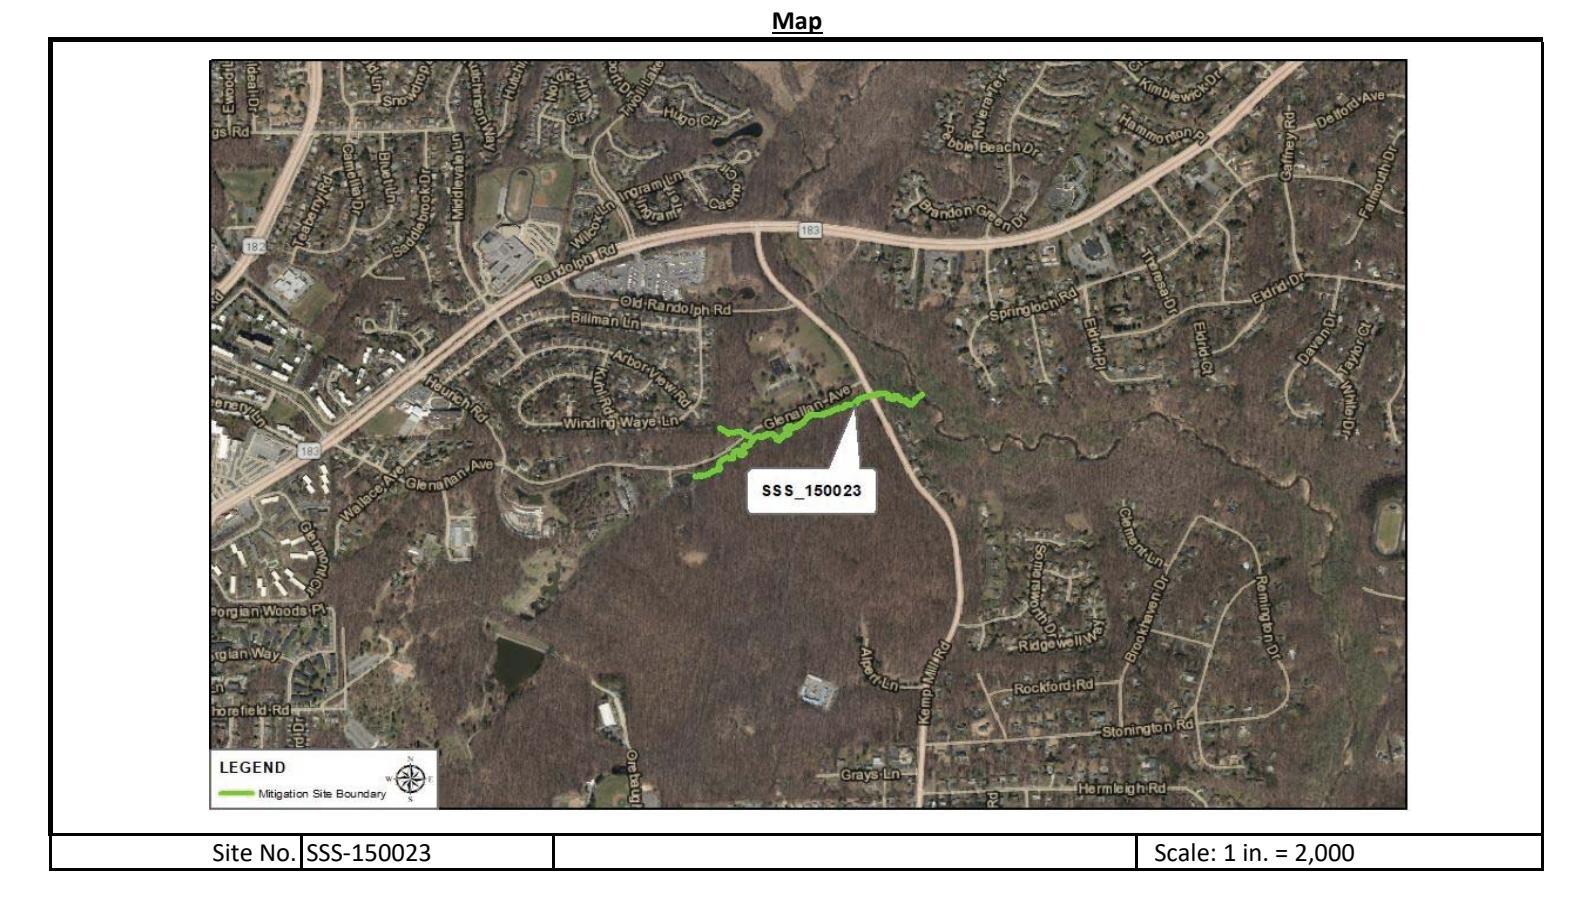
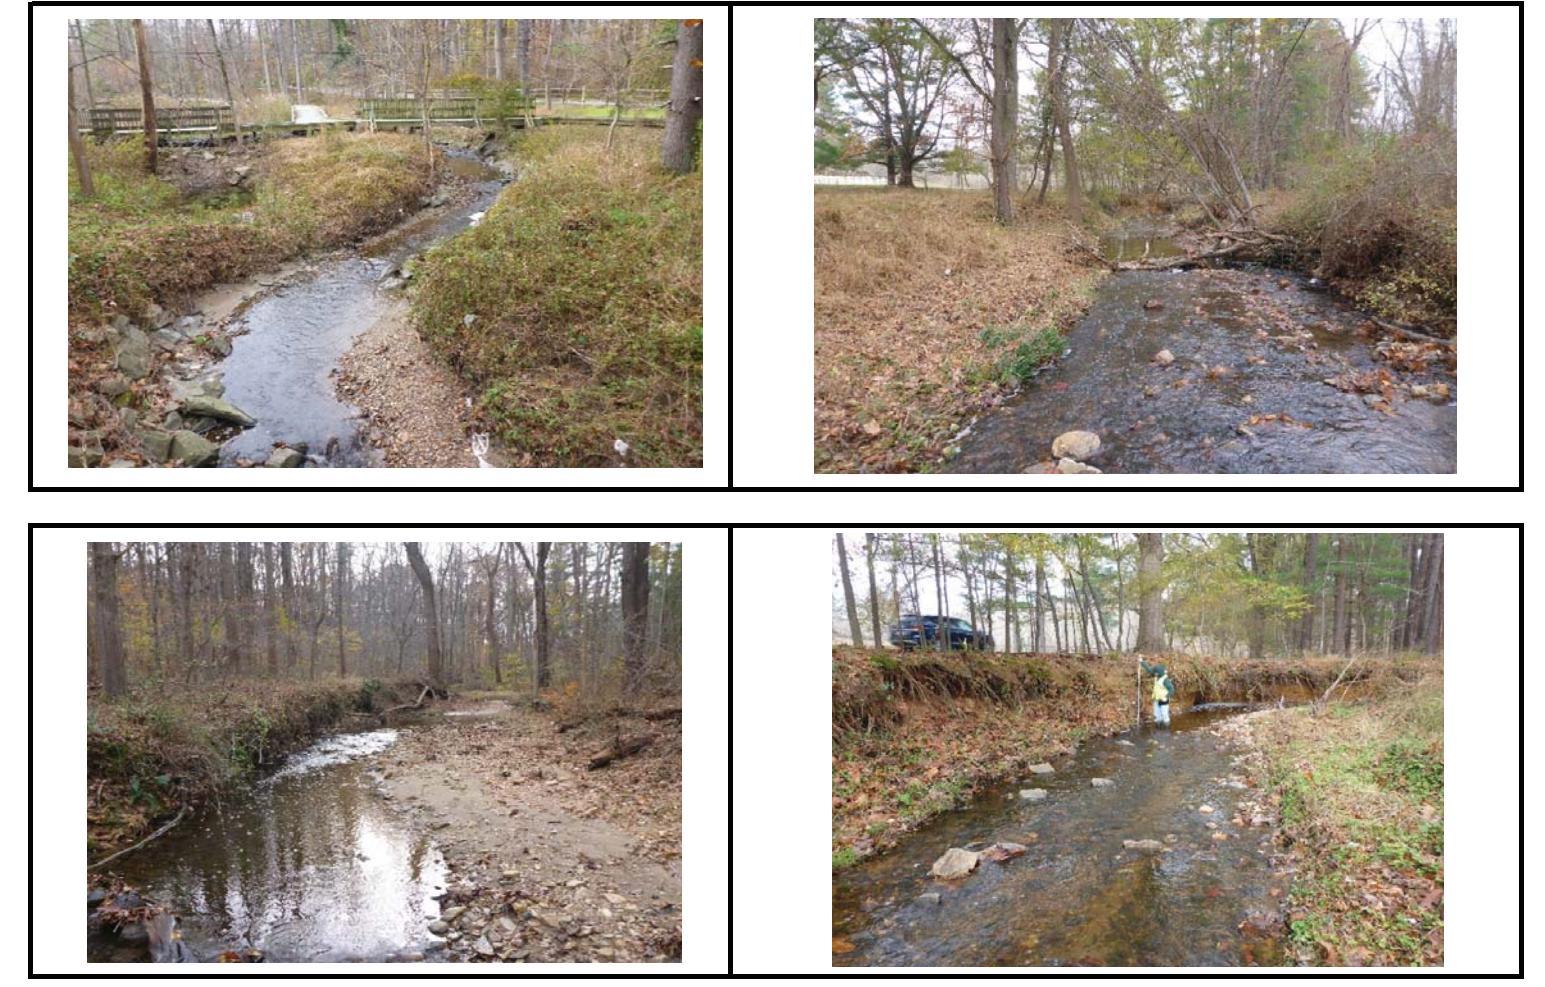
Str	eam Mitigation	Field Site Assessment Form	
		Pro	oject Details	
Project Name:	I-495/I-270 Managed Lan	ies Study	Mitigation Site Number: SSS-150023	
Projects Estimated Stream	n Mitigation Needs (LF):	TBD

-	bank contains greater than 200 feet of mature forest buffer.	
Degree of Channel Incisi	on	5	Land Use	1
10 - Bank Height greater	than 10 feet		10 - Agricultural or Open Space	
5 - Bank Height between	3 and 10 feet		5 - Marginal Pasture	
1 - Bank Height less than	3 feet		1 - Old field/ Developed/Forested	
Describe:	staly 1 ft on average		Describe:	
Balik heights are approxime	Itely 4 It. On average.		Land use consists of forested park land.	
Existing Floodplain Acce	SS	5	Opportunity for Ecological Lift	10
10 - No evidence of out o	of bank flooding		10 - Conditions exist for several aspects of lift to be achieved a	and sustained
5- Yes (Infrequent out of	bank flow)		5 - Lift limited to one or few aspects	
1 - Yes (evidence of frequence of trequence of the second	uent flooding)		1 - Conditions are such that Lift is difficult to achieve and susta	ain
Describe:	· · · · · ·		Describe:	
Few areas get out-of-bar	nk flow during storm event	ts. Evidence of fine	Potential for geomorphic uplift, increase floodplain access, pro	ovide sediment

sediment deposits prese	nt.		deposition, enhance habitat.	
Opportunity for Floodpl	ain Development	5	Ease of Access	5
10 - Existing space for floo	odplain greater than 10 ti	mes stream width	10 - Yes (with <u>existing</u> direct venicular access to potential site)	
1 - Little to no space for	floodalain development	in width	1 - No (no vehicular access, clearing needed)	
Describe:			Describe:	
Eloodalain development would require moderate tree impacts		Potential access off of Glenallan Ave and Kemp Mill Rd. Minor	clearing may be	
Potential exists specifica	lly on left stream bank	fice impacts.	required	cicaring may be
i otentiai exists specifica	ny on iert stream bank.			
				10
Drainage Area Evaluatio	n	5	Utilities Present	10
IU-D.A. less than I sq. m	11. a. mi		10 - No utilities on site	
5- D. A. between 1 & 3 so	ą. mi. a. mi		5 - Utilities but not within restoration area	
Describer	4			
Describe:

Drainage area - 1.18 squ	are miles.		No utilities observed.	
			Total Score out of 100	52

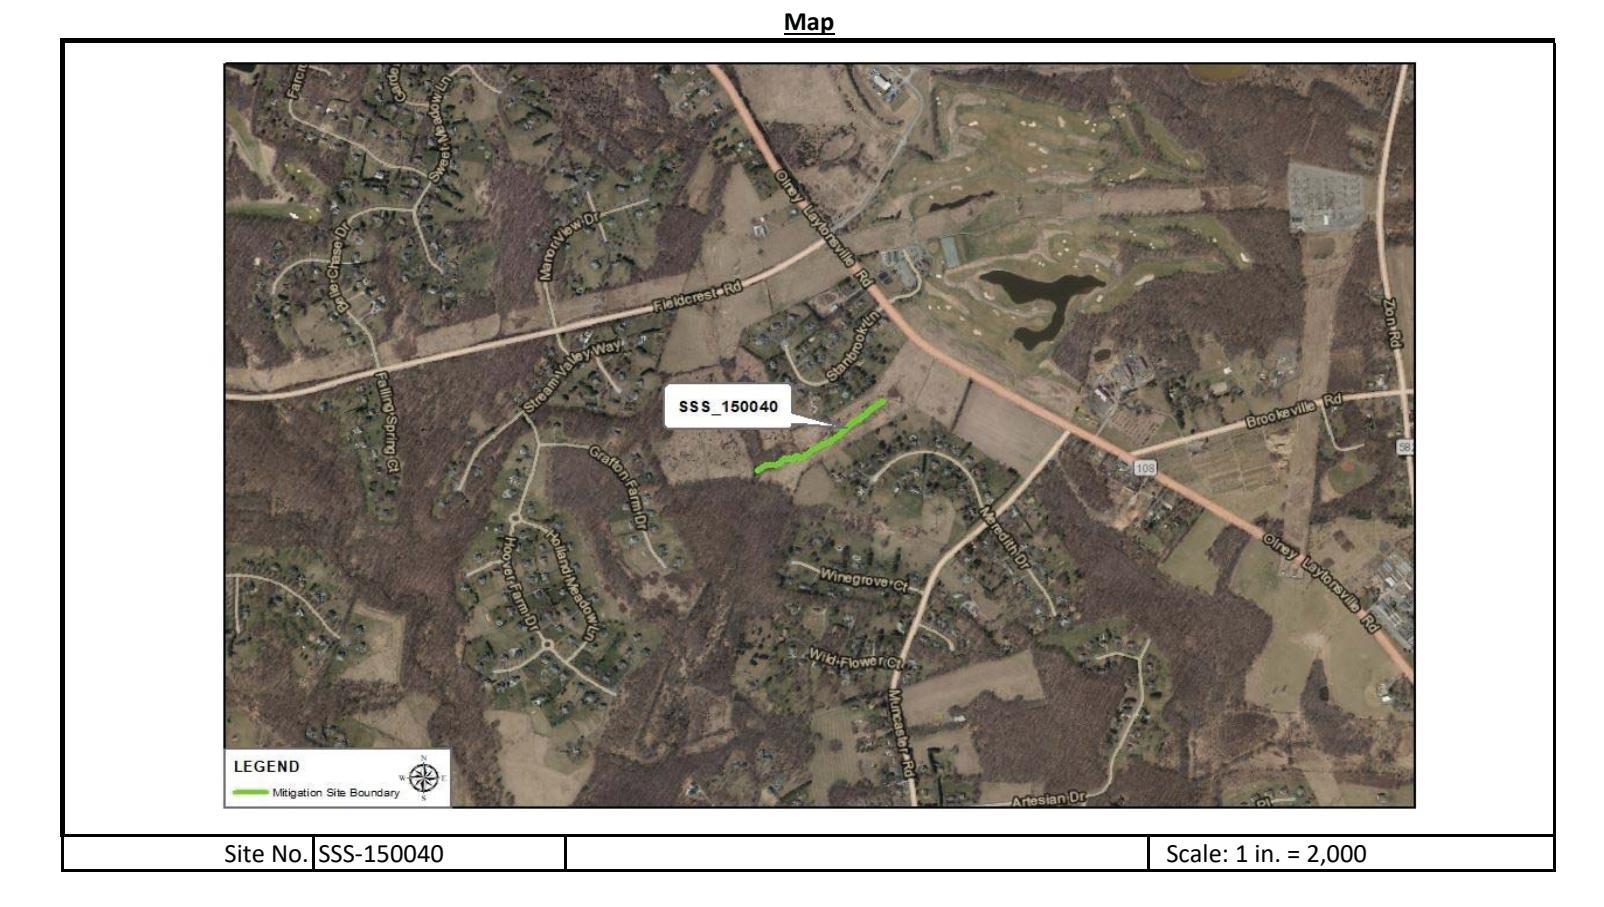
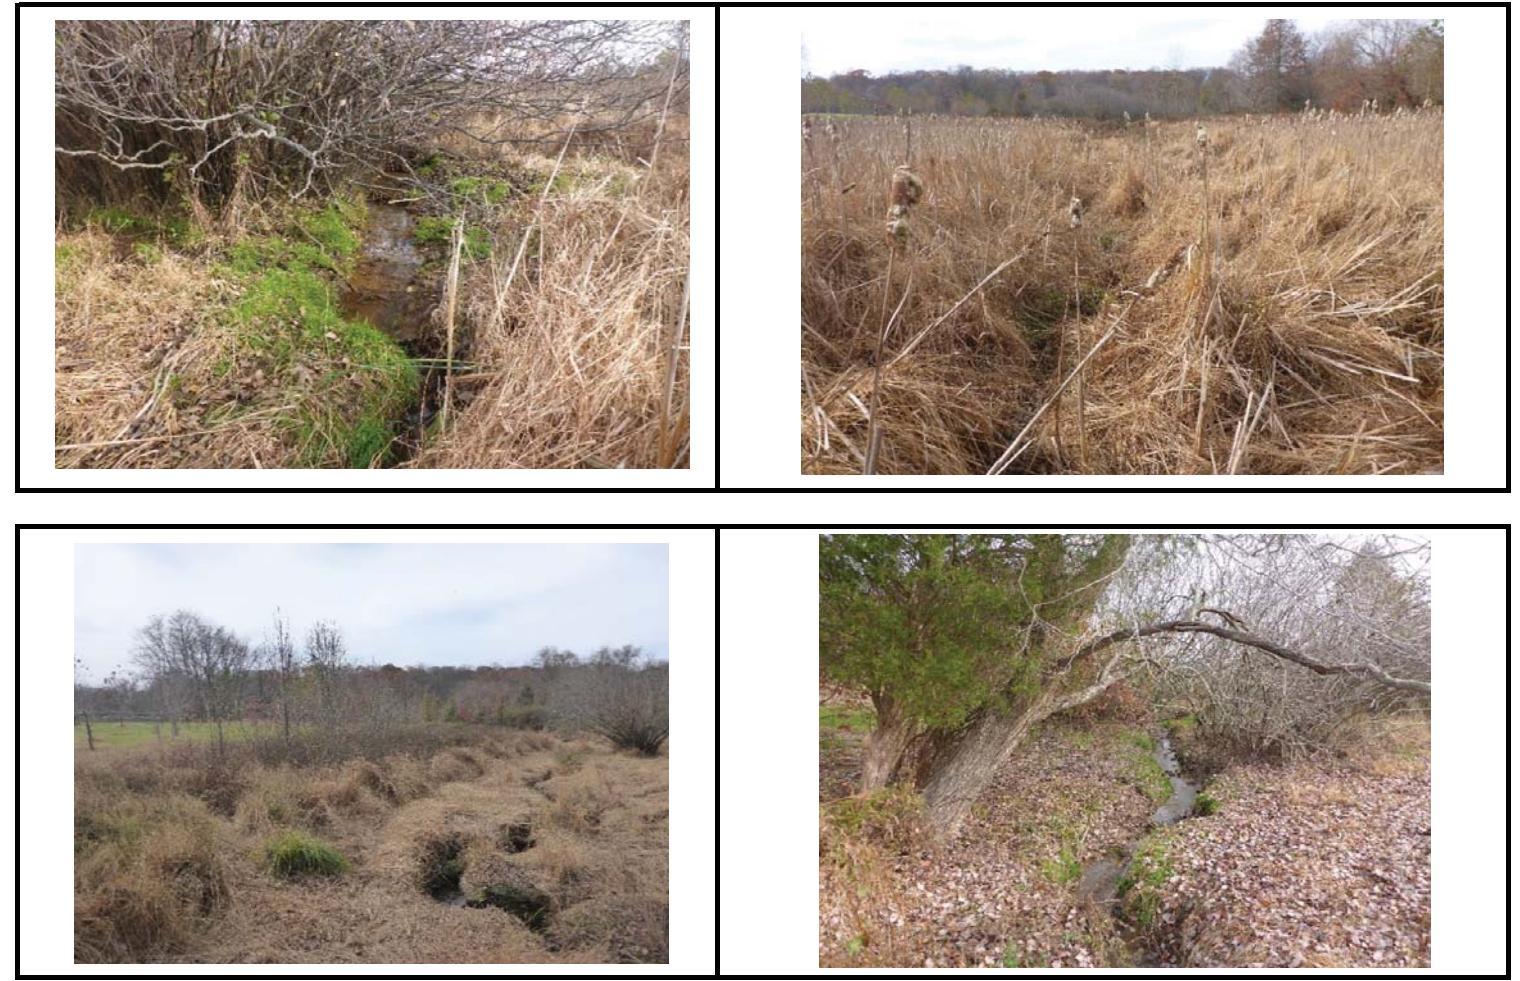
Str	eam Mitigation	Field Site Assessment Form		
		Pro	oject Details		
Project Name:	I-495/I-270 Managed Lan	ies Study	Mitigation Site Number:	SSS-150040	
Projects Estimated Stream	m Mitigation Needs (LF):	TBD	-

headcuts, characteristic	of stable "E"channel.		scrub-shrub wetland present. Some mu	ultiflora rose observed.	Johne
Degree of Channel Incis	ion	1	Land Use		1
10 - Bank Height greater	than 10 feet	-	10 - Agricultural or Open Space		-
5 - Bank Height hetweer	3 and 10 feet		5 - Marginal Pasture		
1 - Bank Height less than	13 feet		1 - Old field/ Developed/Forested		
Doscribo:			Poscribo:		
Describe. Incision characteristic of	stable "F" channel (~1 5 ff	t tall hanks)	Wet meadow and tree plantings prese	nt Rinarian huffer will develop i	into
	stable E channel (1.5 h	tan banksy.	forest.		into
Existing Floodplain Acce	ess	1	Opportunity for Ecological Lift		1
10 - No evidence of out	of bank flooding		10 - Conditions exist for several aspects	s of lift to be achieved and susta	ained
5- Yes (Infrequent out of	f bank flow)		5 - Lift limited to one or few aspects		
1 - Yes (evidence of freq	uent flooding)		1 - Conditions are such that Lift is diffic	ult to achieve and sustain

Describe:			Describe:		
Low banks present throu	ughout reach. Flatland gras	sses present.	Potential exists for lift as stable channe	l is present with existing wetlar	nds and
Standing water noted w	ithin floodplain	· · · · ·	tree plantings to enhance riparian buff	er	
			tree plantings to enhance riparian bar		
Opportunity for Floodpl	ain Development	5	Fase of Access	1	10
10 - Existing space for flo	podplain greater than 10 ti	mes stream width	10 - Yes (with existing direct vehicular a	access to potential site)	_
5 - Existing space for floo	odplain 3 to 10 times strea	m width	5- ves (open but no existing vehicular a	iccess)	
1 - Little to no space for	floodplain development		1 - No (no vehicular access, clearing ne	eded)	
Describe:			Describe:	- /	
Eloodolain is already 3-1	0 times the stream width f	for most of the	Existing park entrance is present in ad	dition to a maintained nath nar	allel to
roach	o times the stream water		the stream	allon to a maintainea path part

the stream.		
Drainage Area Evaluation	on	10	Utilities Present	1	10
10 -D.A. less than 1 sq. n	ni.		10 - No utilities on site		
5- D. A. between 1 & 3 s	q. mi.		5 - Utilities but not within restoration a	rea	
1 - D. A. greater than 3 s	q. mi.		1 - Utilities within potential restoration	area	
Describe:			Describe:		
Drainage area is less tha	n 1 square mile.		No utilities observed.		
	, 		l		
			Tota	I Score out of 100 4	15

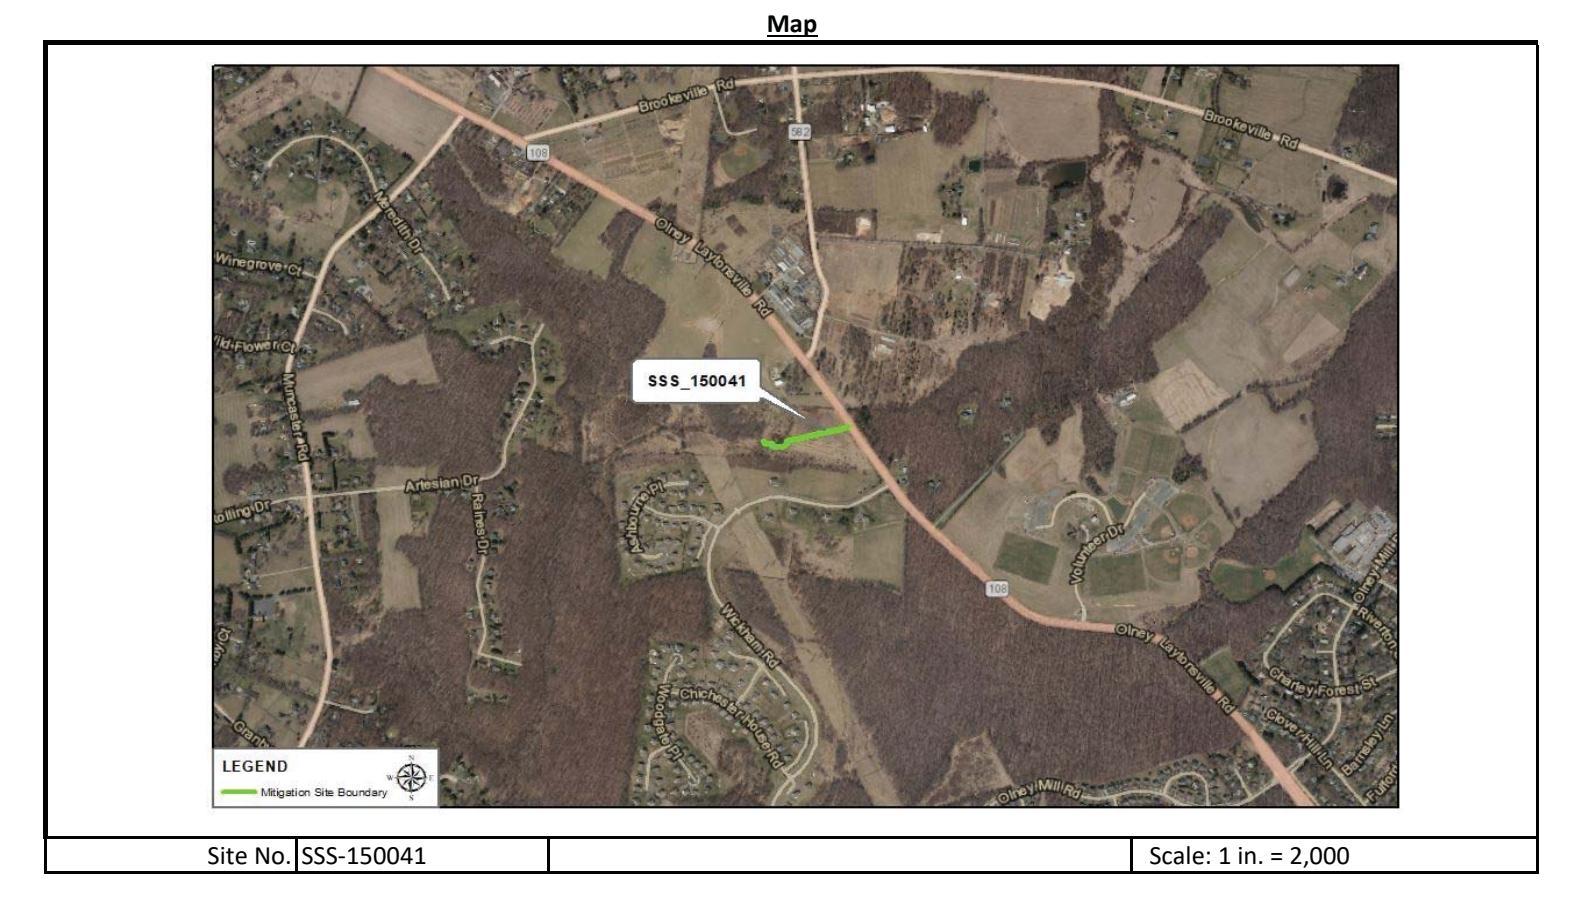
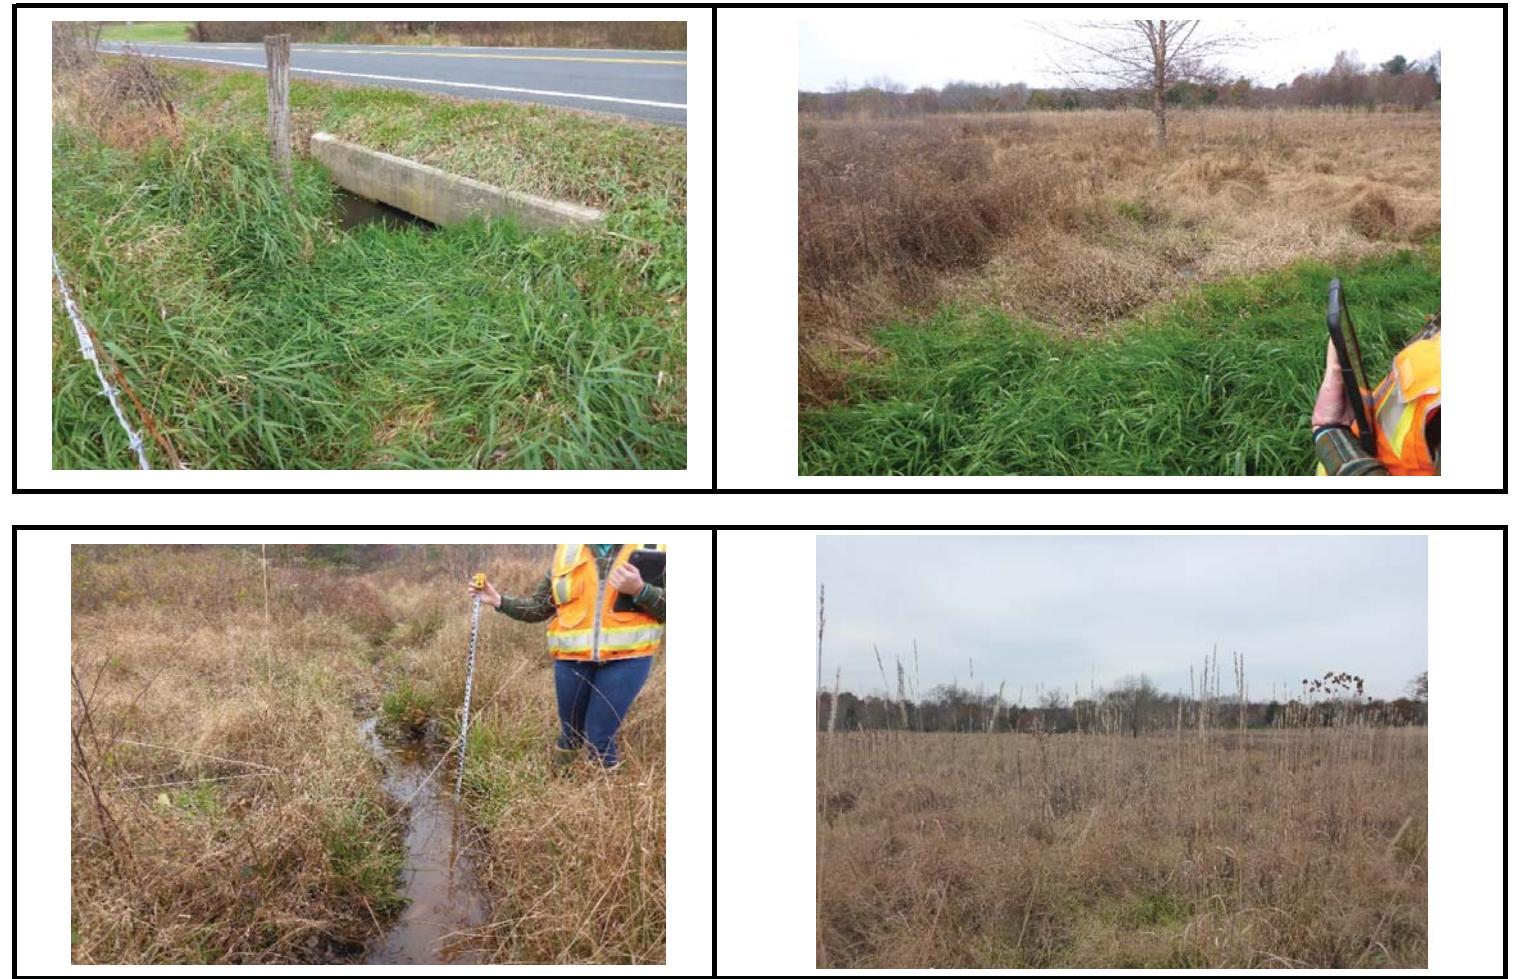
5 - 10% to 50%		5 - Scrub-shrub cover (non-wetland)		
1 - Less than 10%		1 - Mostly forested and/or wetland		
Describe:		Describe:		
No bank erosion observed.		Wetland meadow present throughout site.

-	
Degree of Channel Incision	1	Land Use	5	
10 - Bank Height greater than 10 feet		10 - Agricultural or Open Space		
5 - Bank Height less than 3 feet		5 - Marginal Pasture		
Describe:		Describe:		
Bank height is less than 1 foot tall throughout	site.	Possible fallow agricultural field, currently wetland meadow.		
Existing Floodplain Access	1	Opportunity for Ecological Lift	5	
10 - No evidence of out of bank flooding		10 - Conditions exist for several aspects of lift to be achieved a	and sustained	
5- Yes (infrequent out of bank now)		5 - LIT IIMITED to one of rew aspects		
Describe		Describe		
Stream banks are low Standing water and sat	irated soils are present	Potential to improve riparian buffer and enhance babitat. Stre	am is stable but	
within the floodplain. Vegetation bent over		has been historically straightened		
within the noouplain. Vegetation bent over.		has been historically straightened.

Describe:		Describe:		
Drainage area - 0.13 square mile.		No utilities observed.

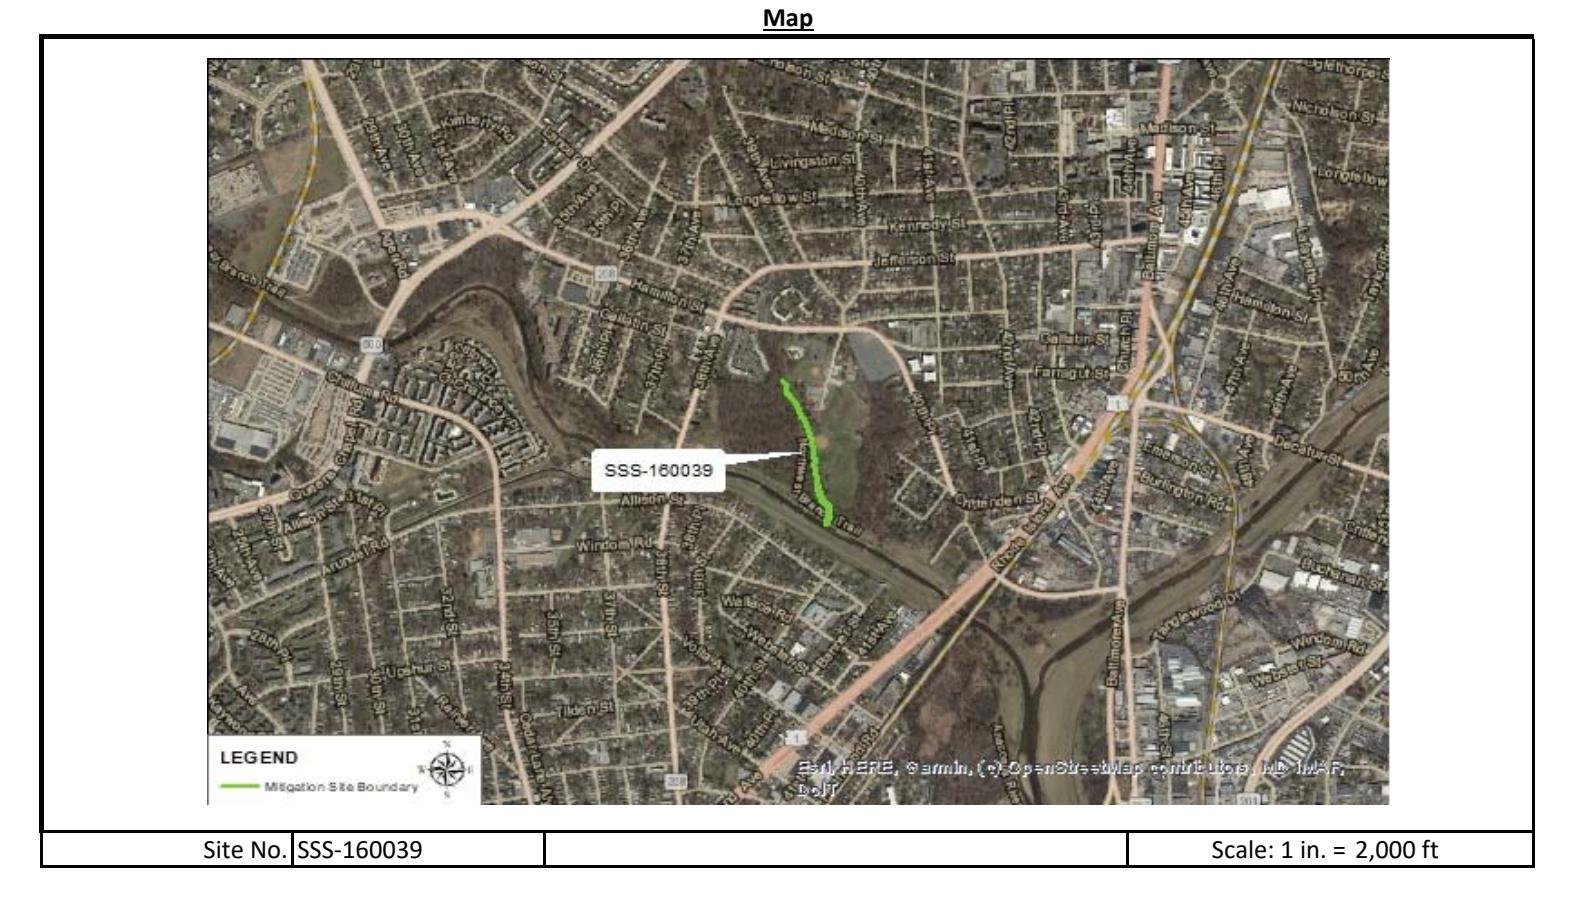
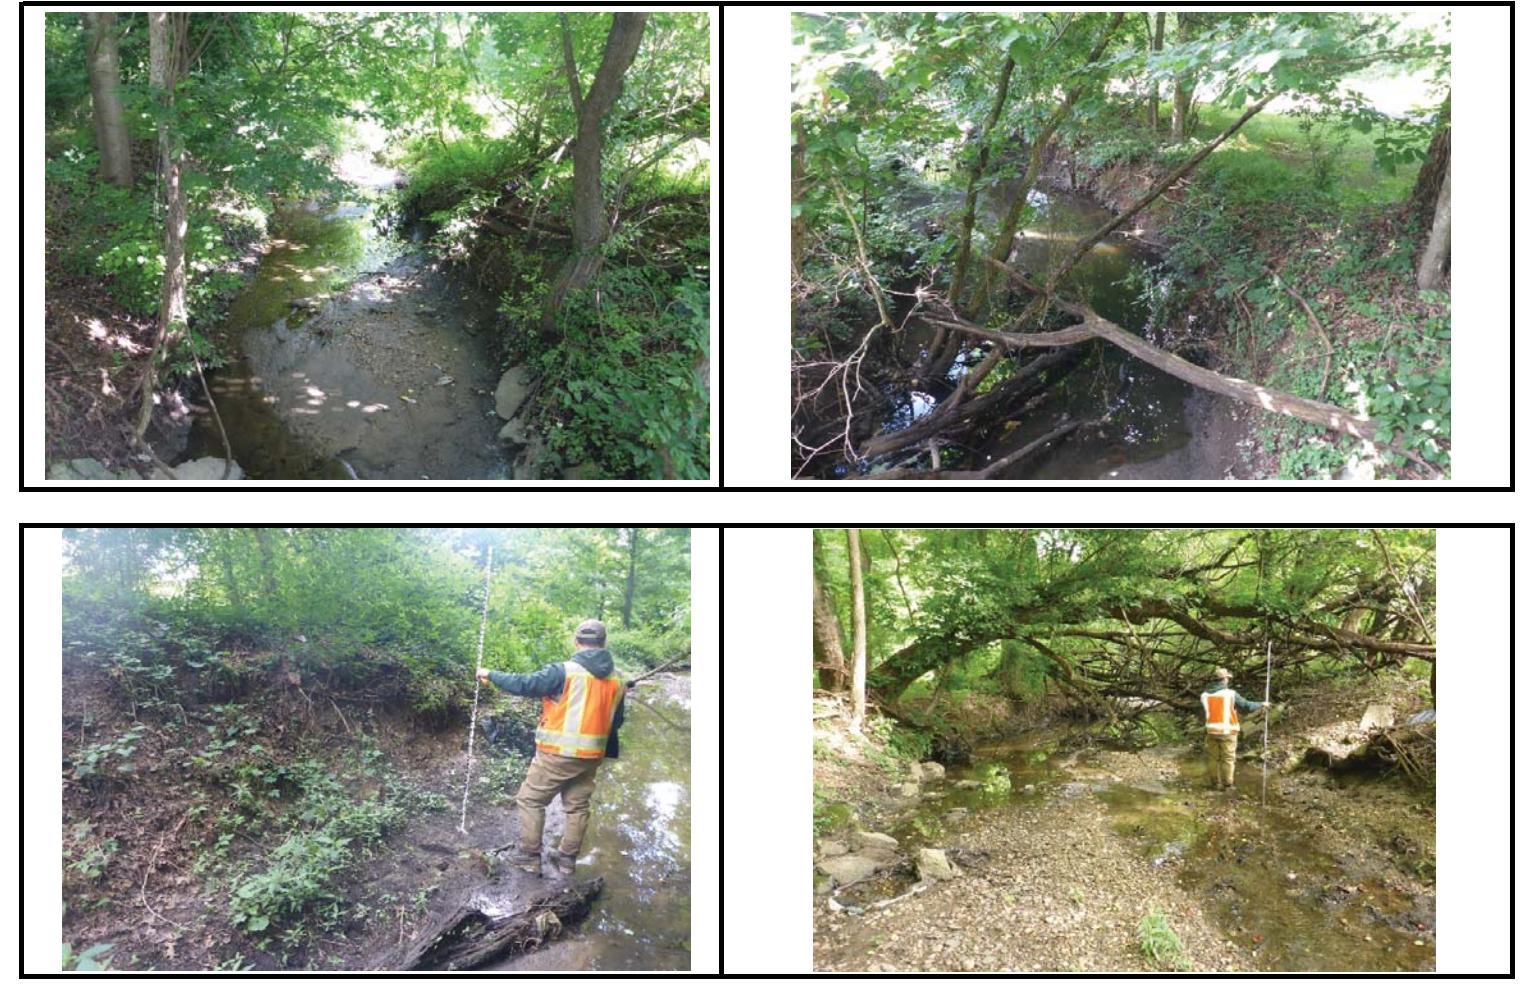
Stream Mitigation Field Site Assessment Form				
Project Details				
Project Name: I-495/I-270 Managed La	nes Study	Mitigation Site Number: SSS-160039		
Projects Estimated Stream Mitigation Needs (LF): TBD	_

5 - Bank Height between 3 and 10 feet		5 - Marginal Pasture		
1 - Bank Height less than 3 feet		1 - Old field/ Developed/Forested		
Describe:		Describe:		
Approximately 5' tall eroded banks, entrenched st	tream channel and	Adjacent land use is forest and developed/ park and open space.		
over widened.				
Existing Floodplain Access	5	Opportunity for Ecological Lift	5	
10 - No evidence of out of bank flooding	-	10 - Conditions exist for several aspect	s of lift to be achieved and sustained	
5- Yes (Infrequent out of bank flow)		5 - Lift limited to one or few aspects		
1 - Yes (evidence of frequent flooding)		1 - Conditions are such that Lift is difficult to achieve and sustain		
Describe:		Describe:		
Mostly 5' banks but some inside banks and other	locations have small	Poor water quality is limiting, increase floodplain, provide lateral stability.		
vegetated henches		increase habitat		
Opportunity for Floodplain Development	10	Ease of Access	5

10 - Existing space for floodplain greater than 10 t	imes stream width	10 - Yes (with <u>existing</u> direct vehicular a	access to potential site)	
5 - Existing space for floodplain 3 to 10 times stree	am width	5- yes (open but no existing vehicular a	access)	
1 - Little to no space for floodplain development		1 - No (no vehicular access, clearing needed)		
Describe:		Describe:		
Stream is over widened		Adjacent to public park with ample par	rking.	
Drainage Area Evaluation	10	Utilities Present	1	
10 -D.A. less than 1 sq. mi.		10 - No utilities on site		
5- D. A. between 1 & 3 sq. mi.		5 - Utilities but not within restoration area		
1 - D. A. greater than 3 sq. mi.		1 - Utilities within potential restoration area		
Describe:		Describe:		
DA = 0.46 ac		Sewer manhole potentially near site, c	rossing at footbridge, gas line crossing.	
		Tota	al Score out of 100 52

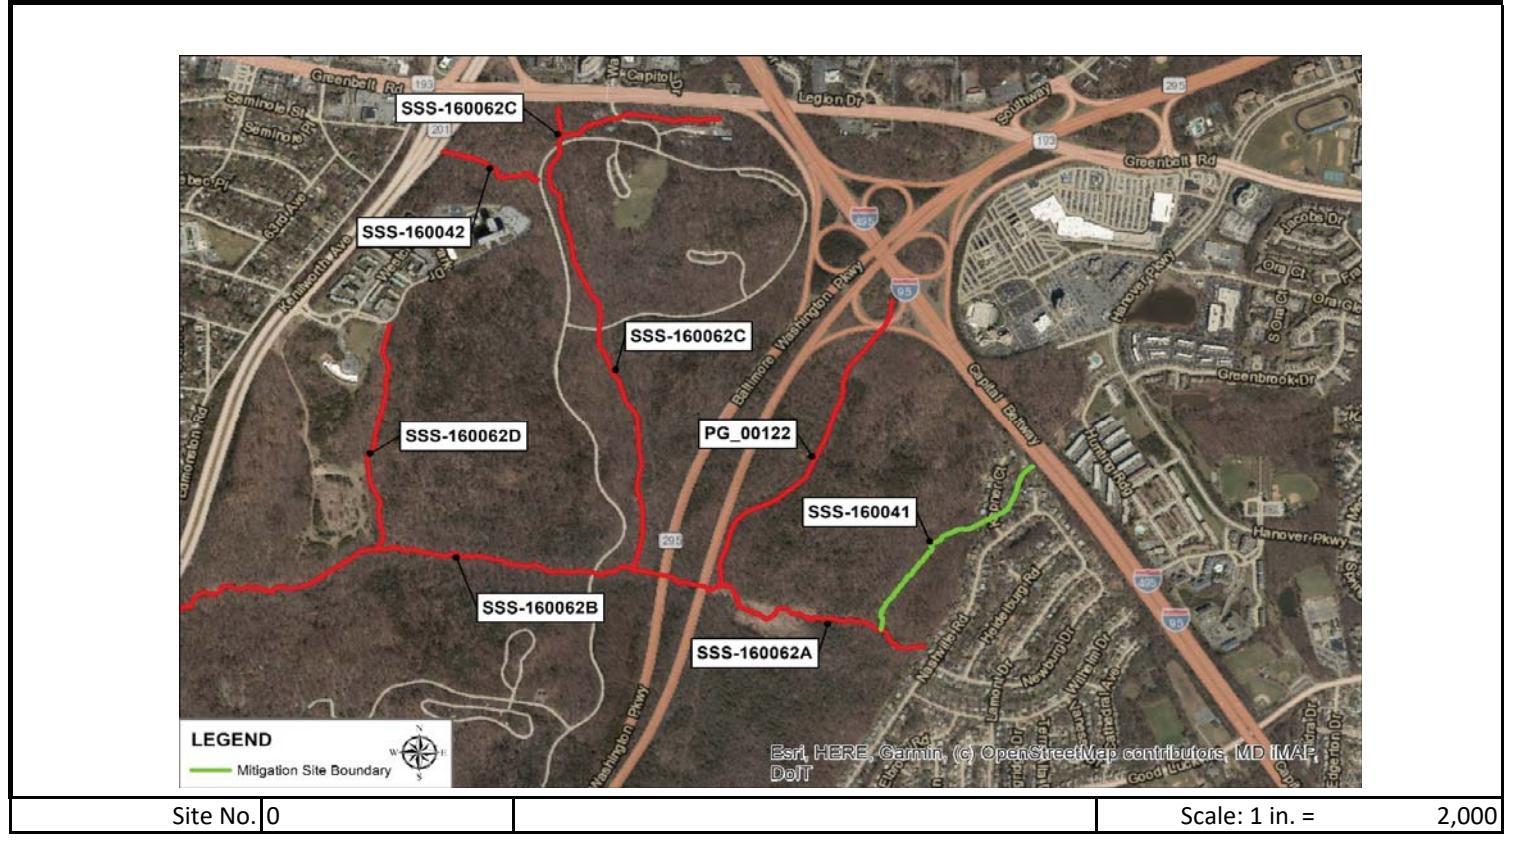
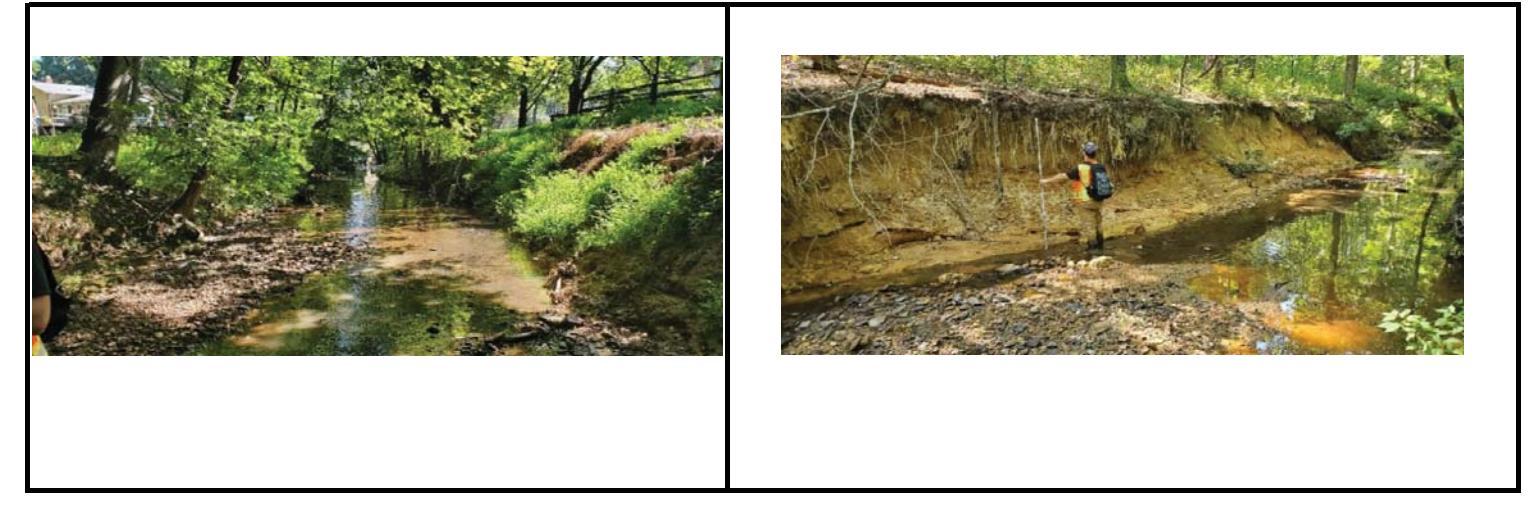
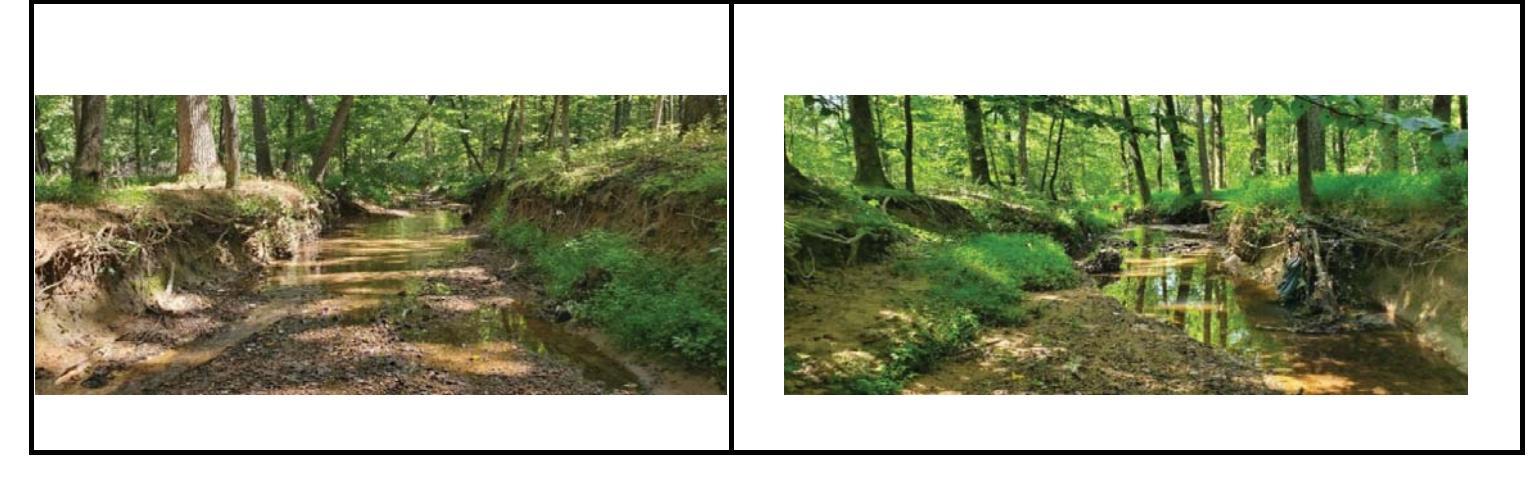
Stream Mitigation Field Site Assessment Form					
		Pro	oject Details		
Project Name:	495/27	0	Mitigation Site Number:	SSS-	160041
Projects Estimated Stre	eam Mitigation Needs (LF):	TBD

5 - Bank Height betwee	en 3 and 10 feet		5 - Marginal Pasture		
1 - Bank Height less tha	in 3 feet		1 - Old field/ Developed/Forested		
Describe:			Describe:		
Average bank height ~6	5 feet		Forested		
Existing Eloodalain Acc	2205	10	Opportunity for Ecological Lift		5
10 - No evidence of out	t of bank flooding	10	10 - Conditions exist for several aspects	of lift to be achieved and	J
5-Yes (Infrequent out o	of bank flow)		5 - Lift limited to one or few aspects		
1 - Yes (evidence of free	auent flooding)		1 - Conditions are such that Lift is difficult to achieve and sustain		
Describe:			Describe:		
Very little if any out of l	bank flow evident		Vertical/lateral stability , bedform diversity, floodplain reconnection		
-,,				<i>,,</i> ,,	
Opportunity for Floodp	olain Development	10	Ease of Access		1
10 - Existing space for f	loodplain greater than 10 ti	mes stream width	10 - Yes (with <u>existing</u> direct vehicular a	ccess to potential site)

5 - Existing space for flo	odplain 3 to 10 times stream	m width	5- yes (open but no existing vehicular ad	ccess)	
1 - Little to no space for floodplain development		1 - No (no vehicular access, clearing needed)			
Describe:		Describe:			
Existing space for ten times stream width with tree loss, or channel		No access existing, clearing needed. Pot	cential access from Kepner	rd	
bed being raised					
Drainage Area Evaluati	ion	10	Utilities Present	I	10
10 -D.A. less than 1 so	mi.		10 - No utilities on site	I	10
5- D. A. between 1 & 3	sg. mi.		5 - Utilities but not within restoration a	rea	
1 - D. A. greater than 3	sq. mi.		1 - Utilities within potential restoration	area	
Describe:	<u> </u>		Describe:

0.97			No utilities within NPS narcel		
			Tota	Score out of 100	63
