APPENDIX E: PUBLIC SITE WALKTHROUGH RATING CRITERIA & FIELD ASSESSMENT FORMS

WETLAND MITIGATION RATING CRITERIA & FIELD SITE ASSESSMENT FORMS

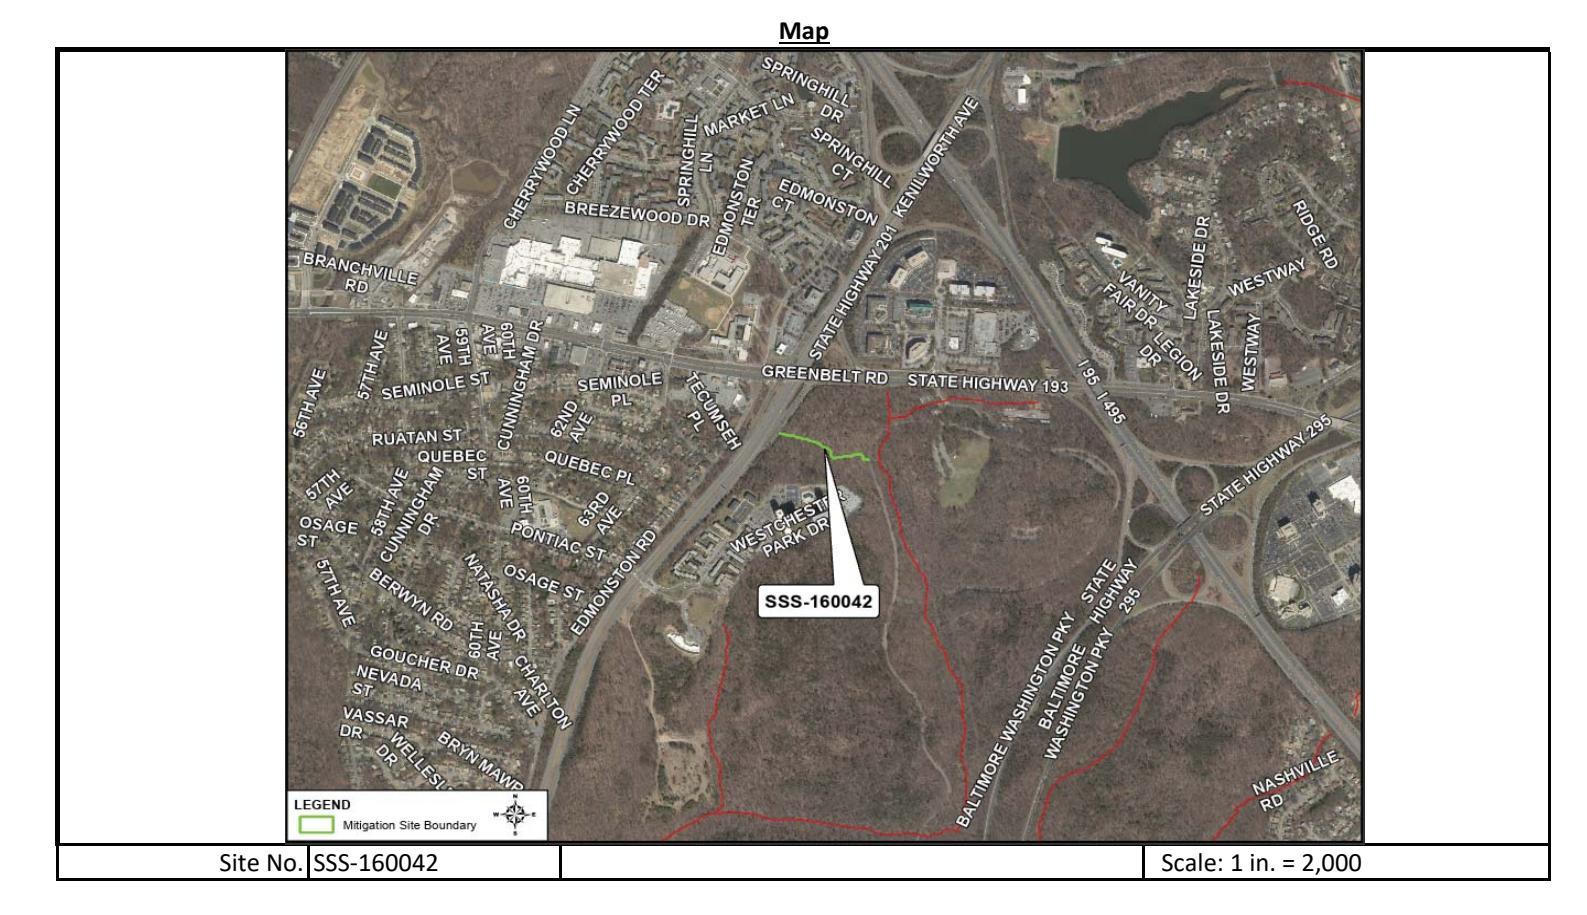
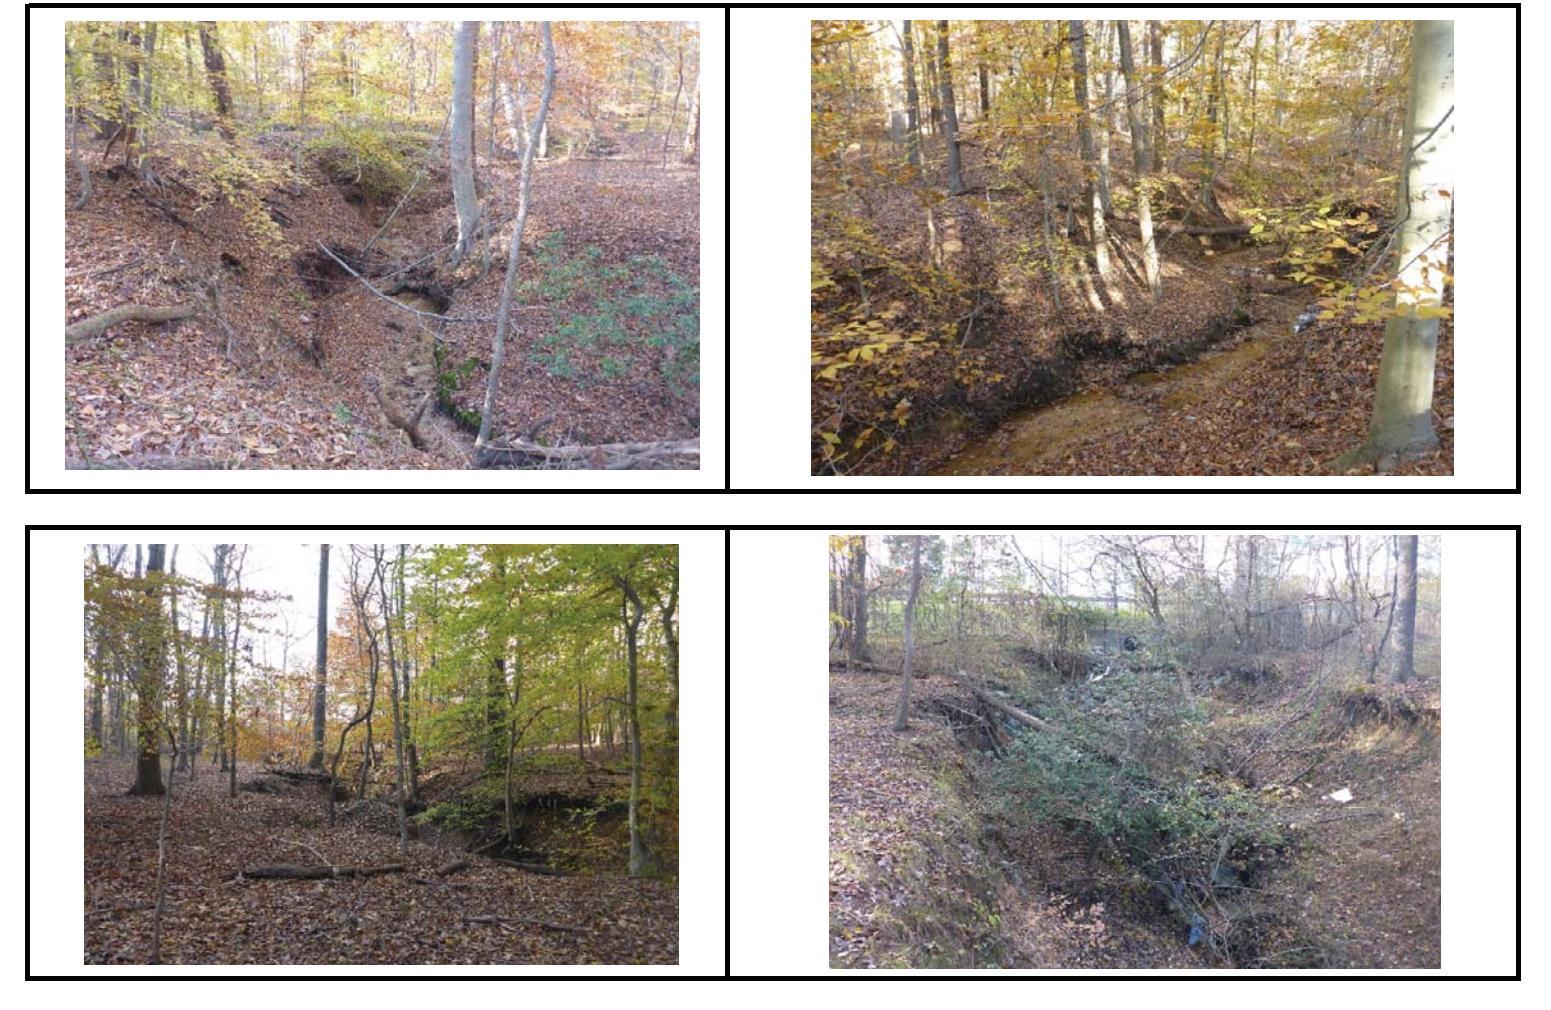
Describe:	<u> </u>		Describe:		
Flows down valley wall of mainstem, no real floodplain present.		Roads at upstream and downstream end	d, but dense forest pre	sent throughout	
			reach.		
Drainage Area Evaluatio	'n	10	Utilities Present		10
10 -D.A. less than 1 so n	ni.		10 - No utilities on site		
5- D. A. between 1 & 3 s	g. mi.		5 - Utilities but not within restoration are	еа	
1 - D. A. greater than 3 sq. mi.		1 - Utilities within potential restoration a	area		
Describe:			Describe:		
Drainage area - 0.03 cou	are mile		No utilities observed		
			Total	Score out of 100	55

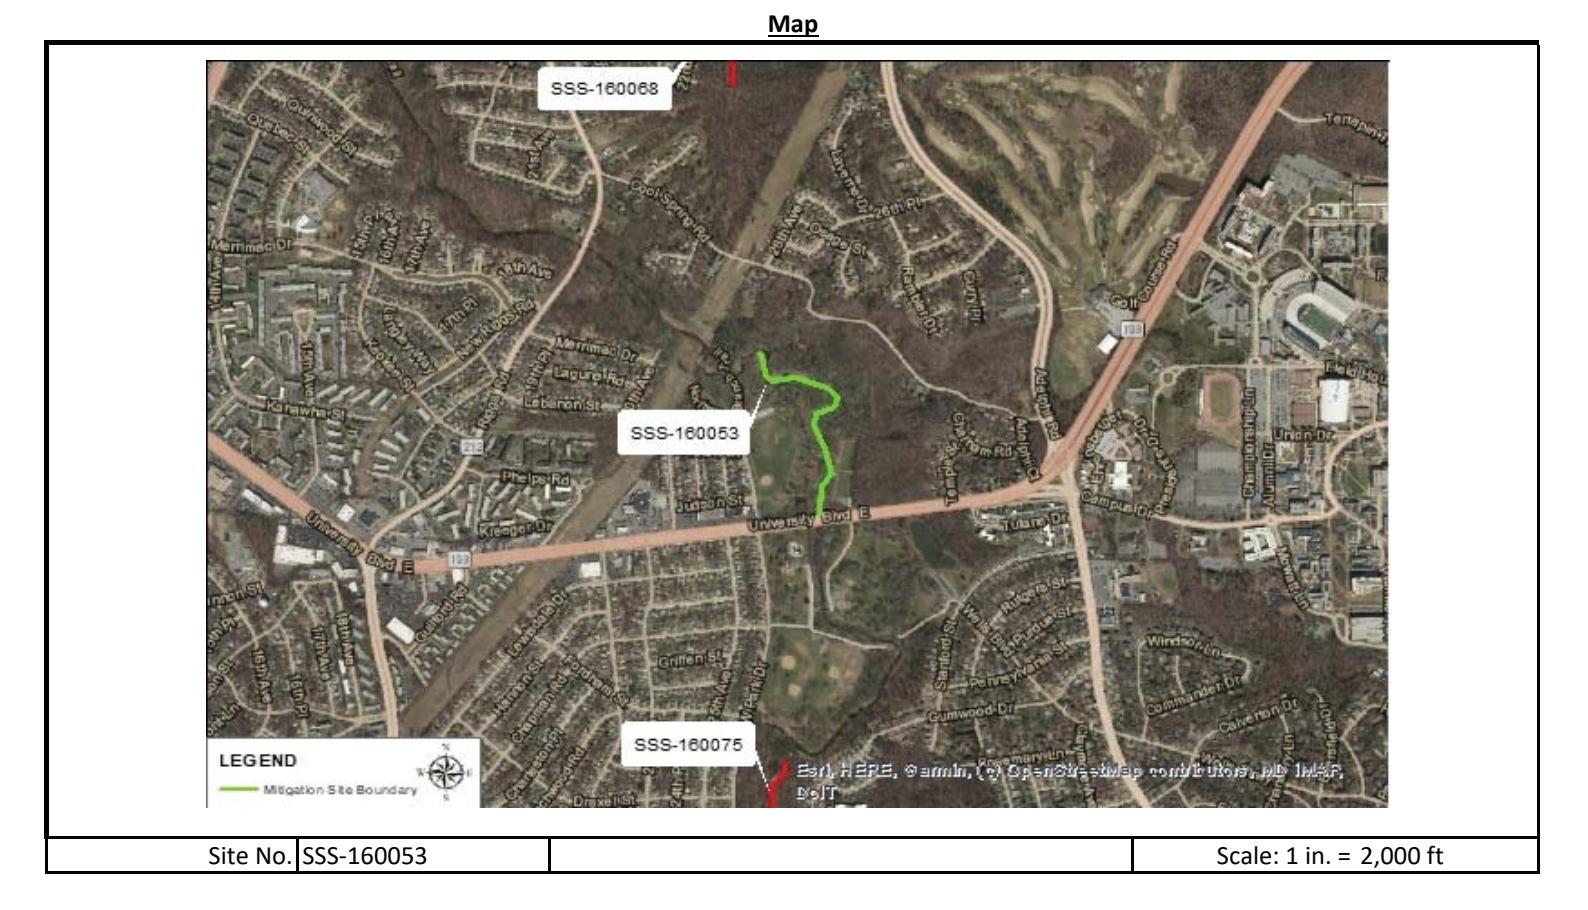
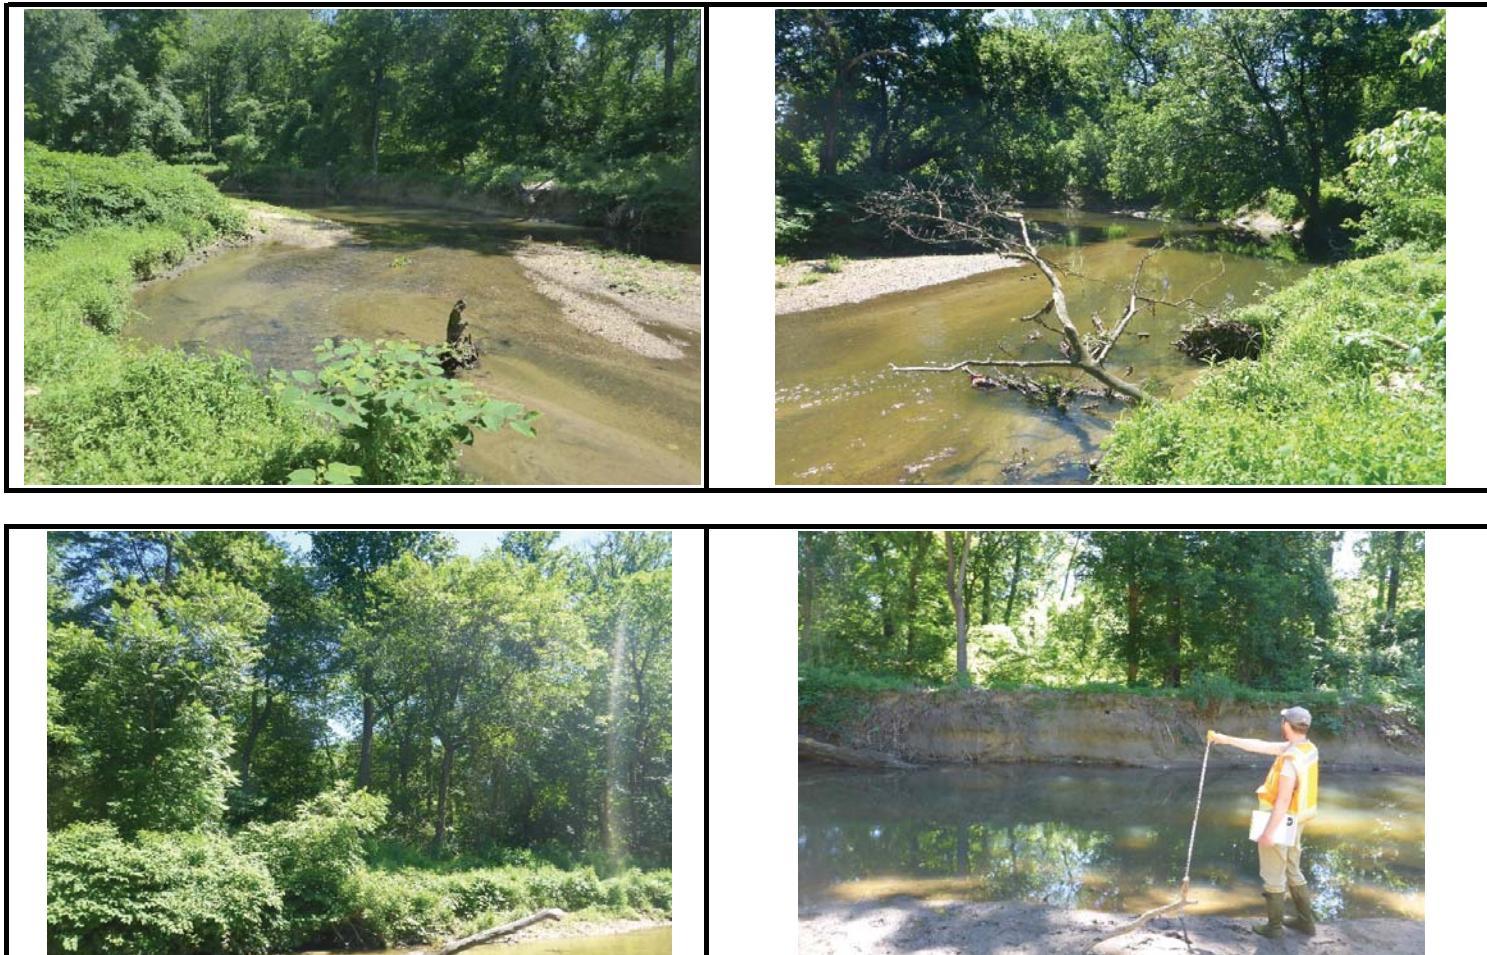
Property Address: Main Parcel: 8000 W Park	Dr, Adelphi, MD, 2	20783		
Property Owner(s): Maryland National Capita	Park & Planning C	ommission		
	General F	Field Observations	C C U	
Is there evidence that the stream has been disturb	ed by some kind	Can the stream restoration be reasonably done within th	ie confines of the	
of human action, like grading, dumping, livestock,	culvert, etc?	parcel or does it require connections beyond the parcel I	imits? Explain	
Explain:		Explain:		
Yes, bank armoring in multiple places, bridges US a	nd DS of reach	Yes, can be done within parcel		
	Mitigat	tion Site Pating		
Criteria	Score	Criteria	Score	
Estimated Bank erosion within reach	5	Vegetation	1	
10 - Greater than 50%	5	10 - Herbaceous cover (non-wetland)		
5 - 10% to 50%		5 - Scrub-shrub cover (non-wetland)		
1 - Less than 10%		1 - Mostly forested and/or wetland		
Describe:		Describe:		
Closer to 10%, some patches of hig - very high eros	ion on outer meand	d Mature forest

Degree of Channel Incision	5	Land Use	1	
10 - Bank Height greater than 10 feet		10 - Agricultural or Open Space		
5 - Bank Height between 3 and 10 feet		5 - Marginal Pasture		
1 - Ballk Height less than 5 leet		Describe:		
5-8' hanks but good hars and EP henches		Describe. Mature forest		
5 6 banks but good bars and 11 benefics		Watare forest		
Existing Floodplain Access	1	Opportunity for Ecological Lift	1	
10 - No evidence of out of bank flooding		10 - Conditions exist for several aspects of lift to be achiev	ed and sustained	
5- Yes (Infrequent out of bank flow)		5 - Lift limited to one or few aspects		
1 - Yes (evidence of frequent flooding)		1 - Conditions are such that Lift is difficult to achieve and sustain		
Describe:		Describe: Not much needed other than some miner hank rehab/stabilization		
Sand deposition and rackines of FP		Not much needed other than some minor bank renab/sta	DIIIZATION

Opportunity for Floodplain Development	10	Ease of Access	5	
10 - Existing space for floodplain greater than 10 tir	nes stream width	10 - Yes (with existing direct vehicular access to potential	site)	
5 - Existing space for floodplain 3 to 10 times strear	n width	5- yes (open but no existing vehicular access)		
1 - Little to no space for floodplain development		1 - No (no vehicular access, clearing needed)		
Describe:		Describe:		
Flat, wide floodplain area		Could access without extensive forest impacts		
Drainage Area Evoluction	1	Litilities Dresent	F	
Urainage Area Evaluation 1		10 - No utilities on site	5	
10 - D.A. less than 1 sq. ml.		5 - Utilities but not within restoration area		
D-D.A. between 1 & 5 Sq. mi. 1 - D.A. greater than 3 sq. mi		1 - Utilities within potential restoration area		
Lecribe		Describe:		
		Sower procent but not close to streem		
Sewel present but not close to stream				
		Total Score out of 1	00 २५

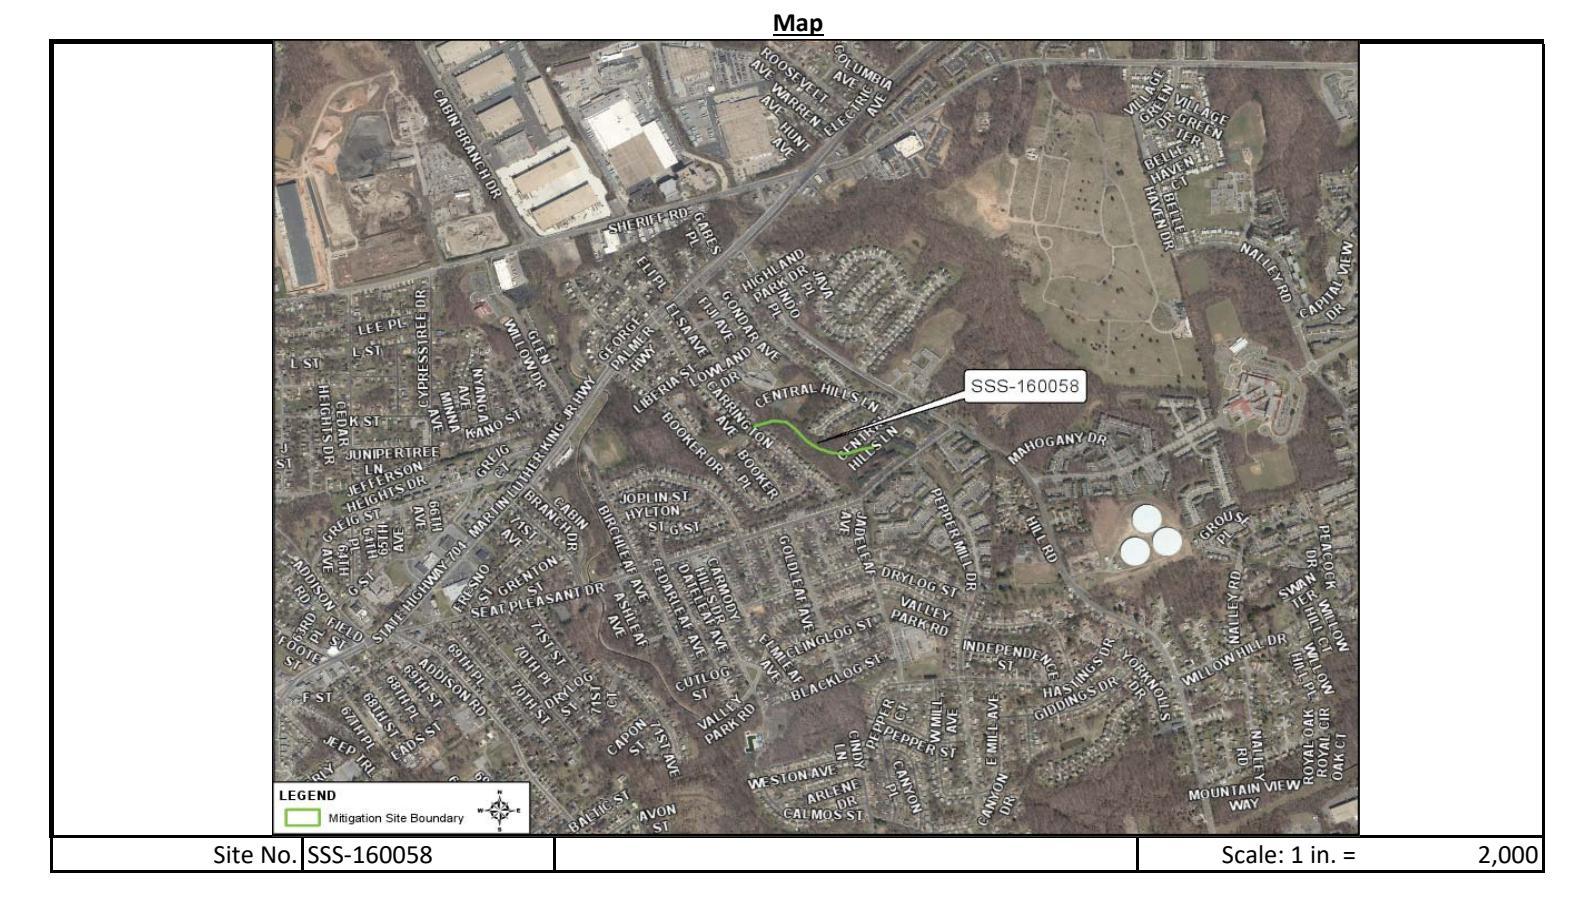
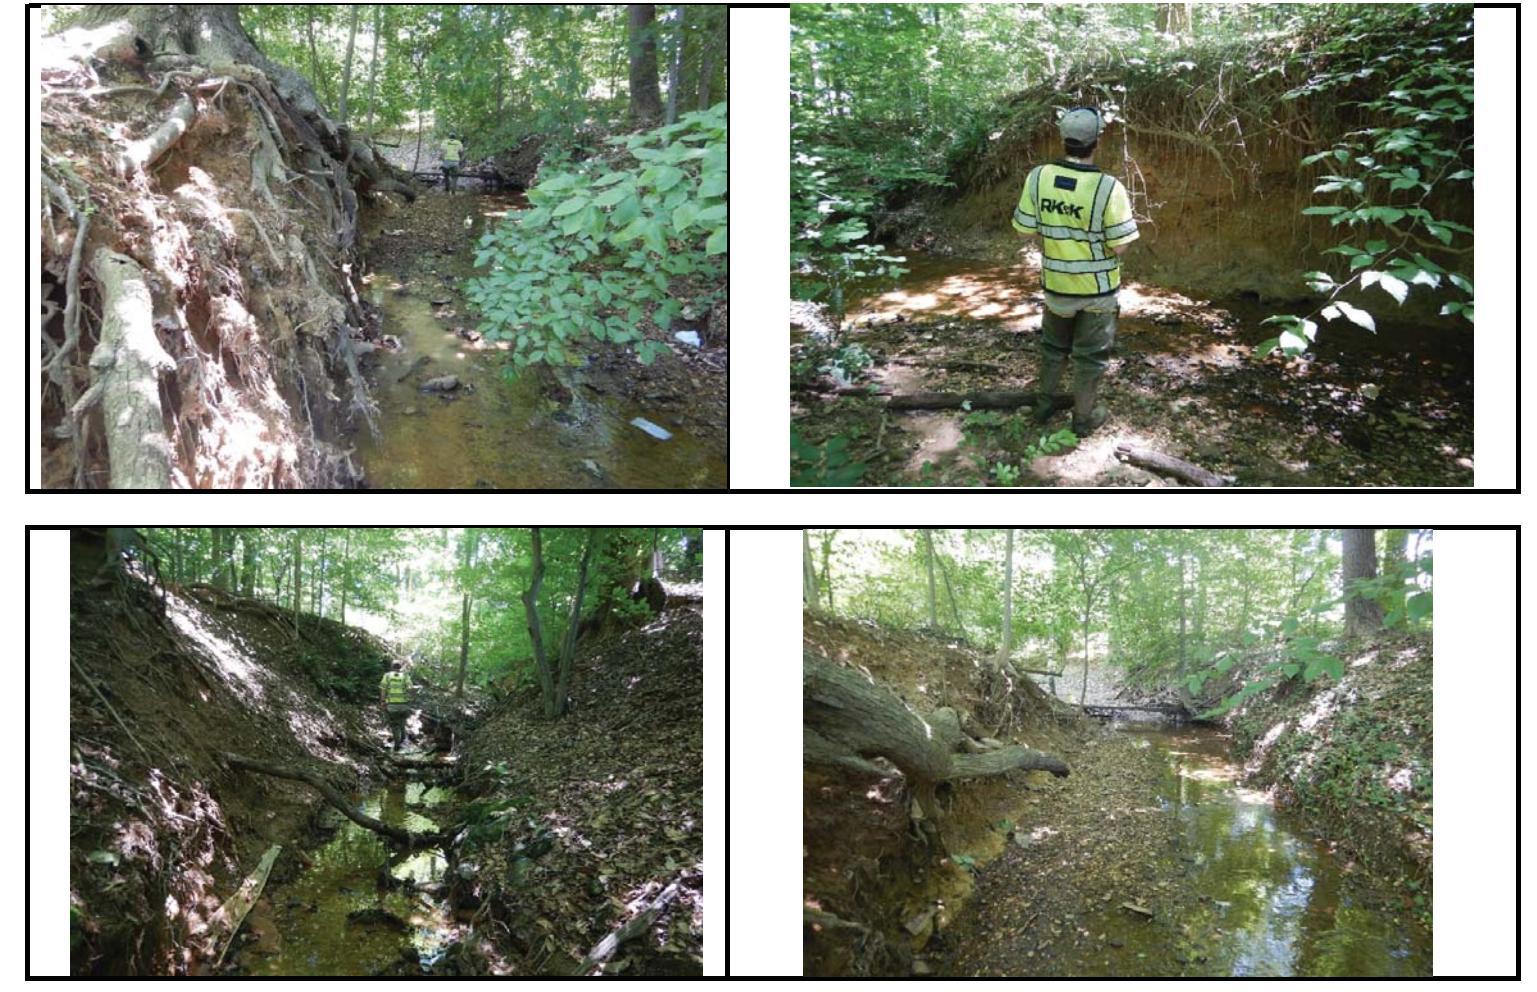
Degree of Channel Insision	F		1	
10 - Bank Height greater than 10 feet	5	10 - Agricultural or Open Space	±	
5 - Bank Height between 3 and 10 feet		5 - Marginal Pasture		
1 - Bank Height less than 3 feet		1 - Old field/ Developed/Forested		
Describe:		Describe:		
5-10' tall banks		Forested parkland		
Evicting Flooduloin Access	10	Onnortunity for Ecological Lift	5	
Existing Floodplain Access	10	Opportunity for Ecological Lift	ond sustained	
5- Yes (Infrequent out of bank flow)		5 - Lift limited to one or few aspects		
1 - Yes (evidence of frequent flooding)		1 - Conditions are such that Lift is difficult to achieve and sustain		
Describe:		Describe:		
No evidence, deeply incised channel		Opportunities for sediment reduction, instream habitat. Limited to a few		
		aspects.		
Opportunity for Floodplain Development	1	Ease of Access	5	
10 - Existing space for floodplain greater than 10 ti	mes stream width	10 - Yes (with existing direct vehicular access to potential site

5 - Existing space for floodplain 3 to 10 times strea	m width	5- yes (open but no existing vehicular access)		
1 - Little to no space for floodplain development		1 - No (no vehicular access, clearing needed)		
Describe:		Describe:		
Limited by adjacent houses and recreational fields		No existing access. Old WSSC path with small tree impacts.		
Drainage Area Evaluation	10	Utilities Present	1	
10 -D.A. less than 1 sq. mi.		10 - No utilities on site		
5- D. A. between 1 & 3 sq. mi.		5 - Utilities but not within restoration area		
1 - D. A. greater than 3 sq. mi.		1 - Utilities within potential restoration area		
Describe:		Describe:

0.18 square miles		Sewerline runs along northern side of channel.		
Total Score out of 100 44

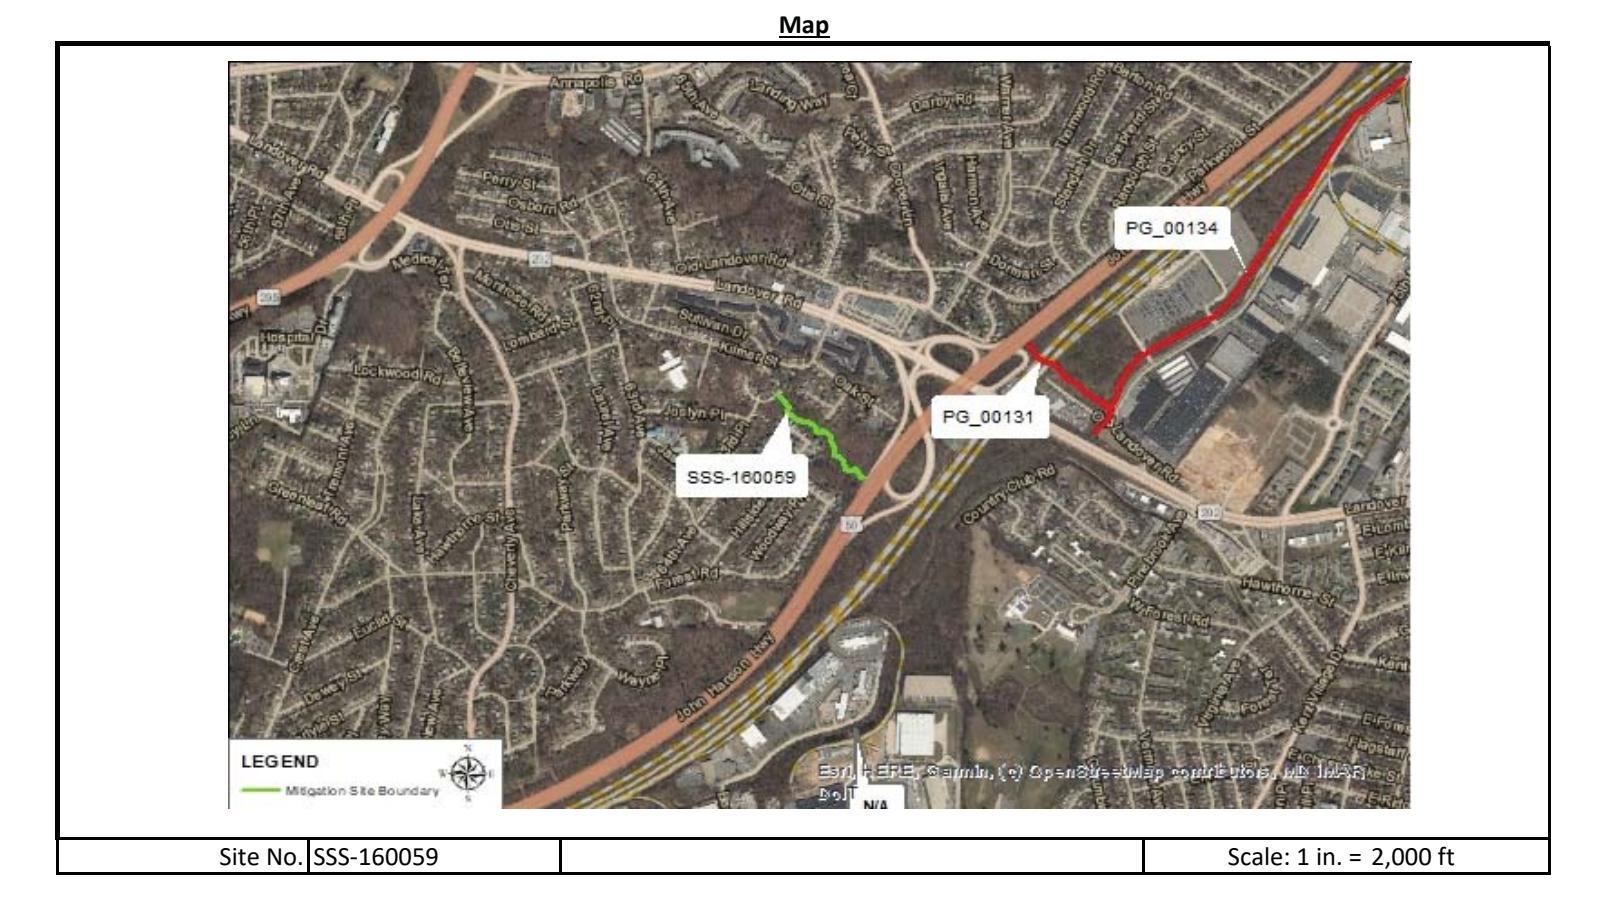
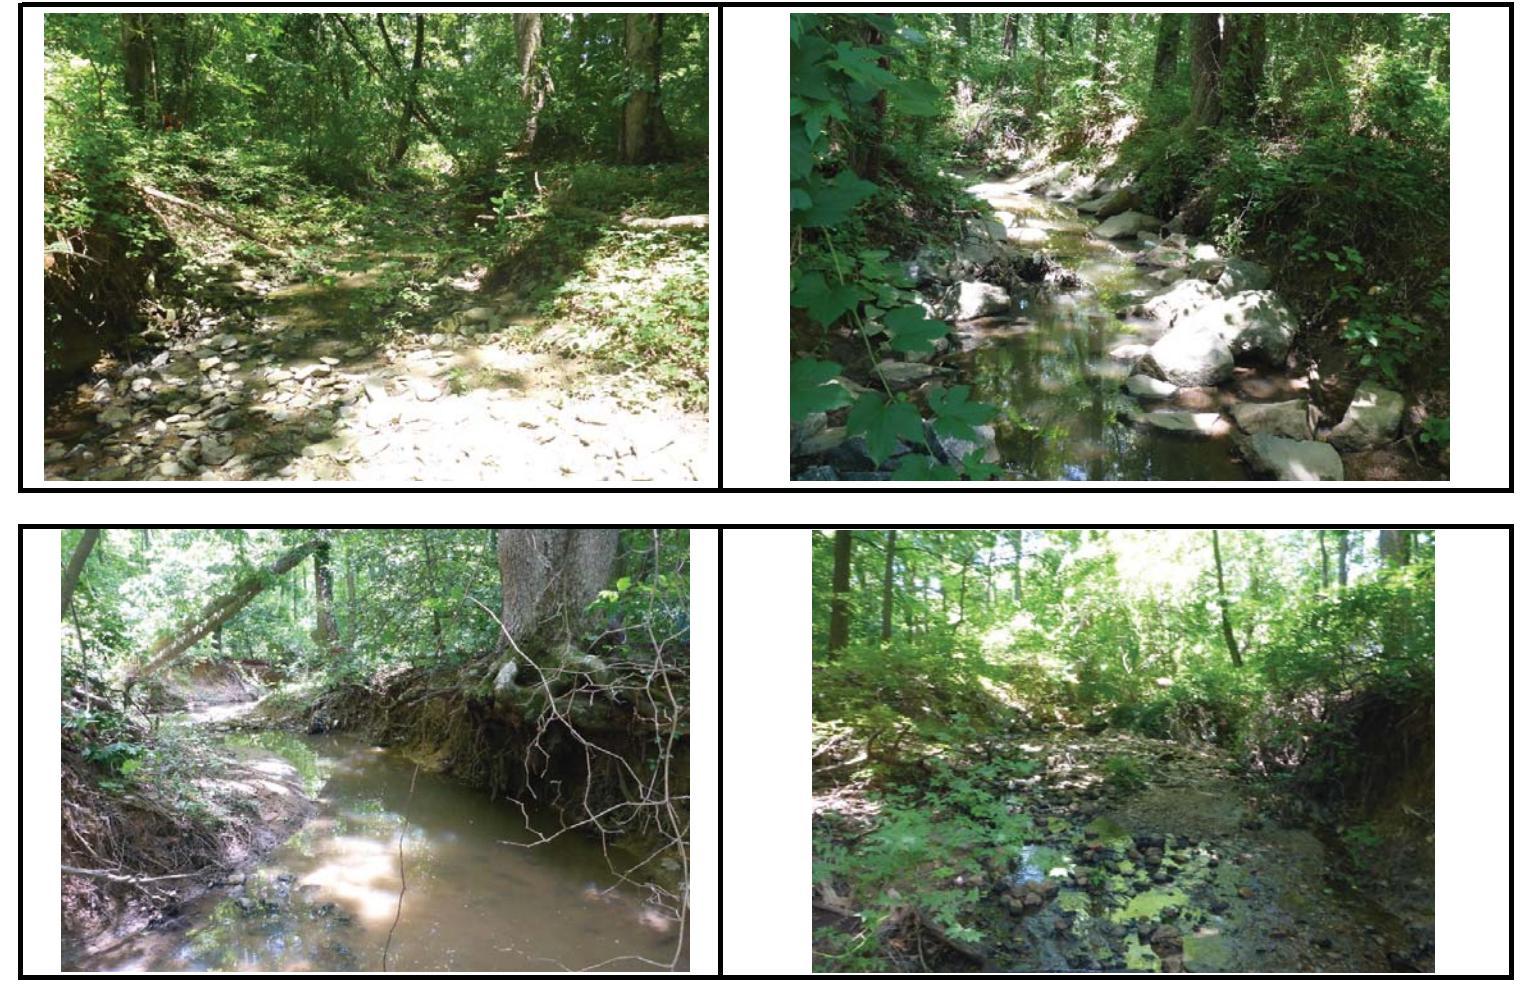
Str	eam Mitigation	Field Site Assessment Form	
	Pro	bject Details	
Project Name: I-495/I-270 Managed Lar	nes Study	Mitigation Site Number: SSS-160059	
Projects Estimated Stream Mitigation Needs (LF)	TBD

-		
Existing Floodplain Access	5	Opportunity for Ecological Lift	5
10 - No evidence of out of bank flooding		10 - Conditions exist for several aspects of lift to be ac	inleved and sustained
5- Yes (Infrequent out of bank flow)		5 - Lift limited to one or few aspects	
1 - fes (evidence of frequent hooding)		1 - Conditions are such that Lift is difficult to achieve and sustain	
Describe:		Describe:	
Rarely accesses FP and only in specific areas		Lateral migration, vertical instability, habitat enhance	ment
Opportunity for Floodplain Development	5	Fase of Access	1
10 - Existing space for floodplain greater than 10 t	mes stream width	10 - Yes (with existing direct vehicular access to poten	itial site)
5 - Existing space for floodplain 3 to 10 times strea	m width	5- yes (open but no existing vehicular access)	•
1 - Little to no space for floodplain development		1 - No (no vehicular access, clearing needed)

Describe:		Describe:	
Lower end of stream may be over 10 times, but m	ajority of the	Stream ins entirely within forested buffer	
stream only has an opportunity for 3-10 times the stream width			
, .			
Drainage Area Evaluation	10	Utilities Present	1
10 -D.A. less than 1 sq. mi.		10 - No utilities on site	
5- D. A. between 1 & 3 sq. mi.		5 - Utilities but not within restoration area	
1 - D. A. greater than 3 sq. mi.		1 - Utilities within potential restoration area	
Describe:		Describe:	
DA=0.17 sq mi O		Overhead lines and possible sewer crossing observed	
			4 +
		Total Score out o	ot 100 39

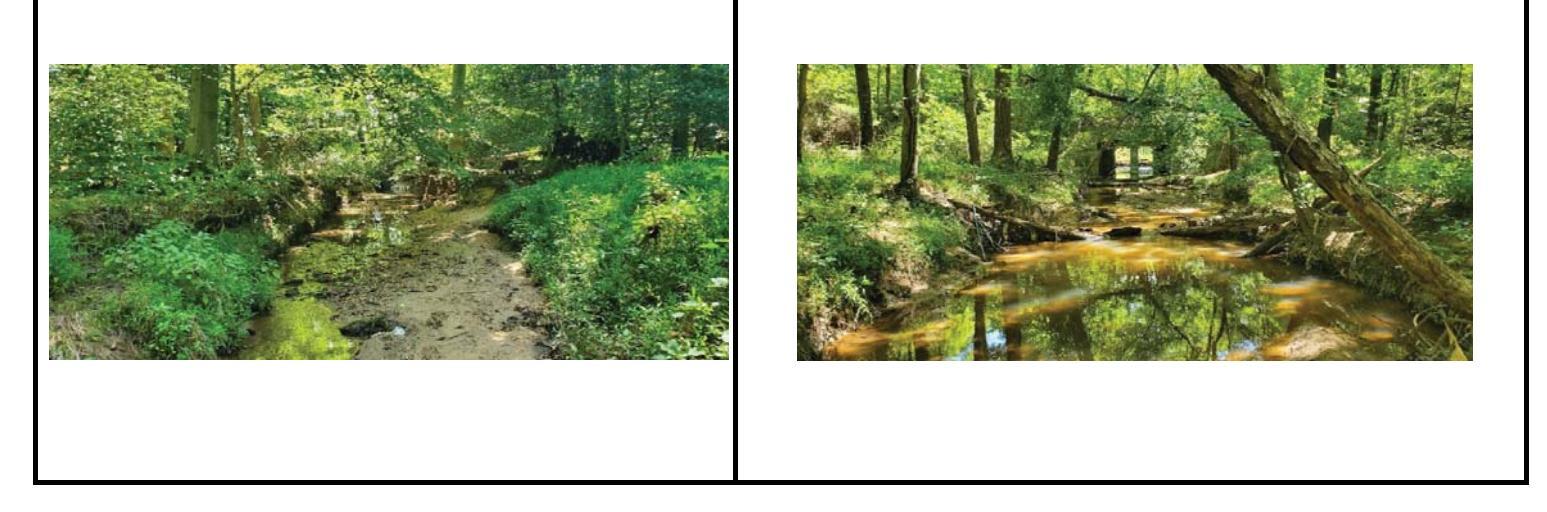
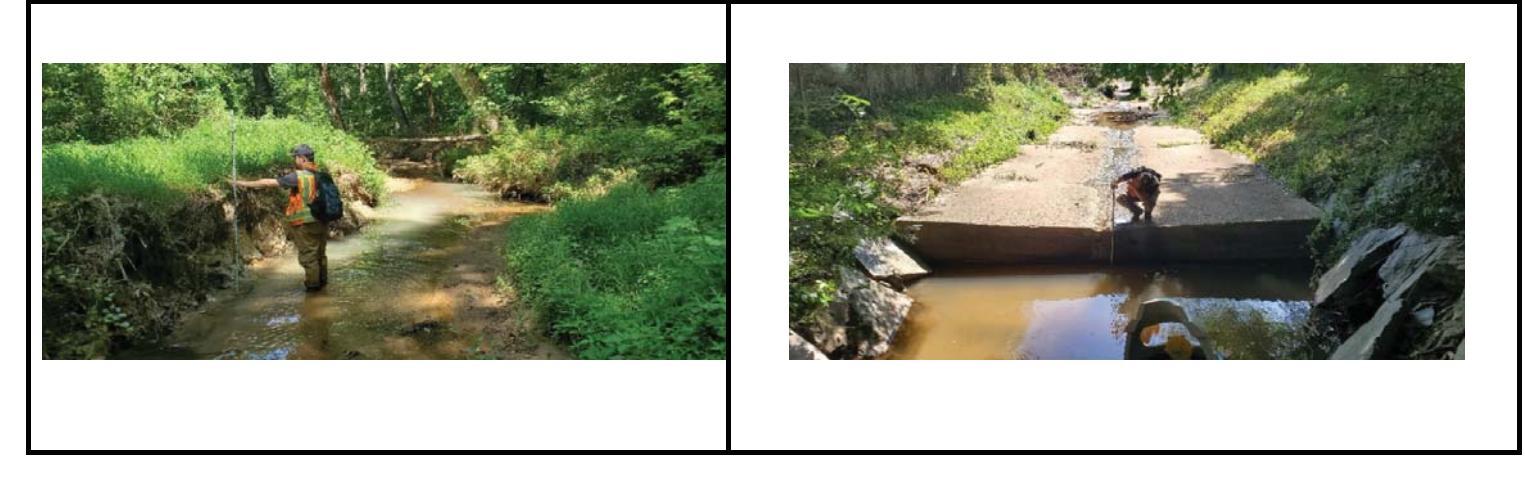
Site Photos

Conoral I	ri-ld Ohaamadiana	
Is there evidence that th	e stream has been distur	<u>General r</u>	FIEID Ubservations	of the
of human action like gr	ading dumning livestock	culvert atc?	parcel or does it require connections beyond the narcel limits? Evol	lain
	aunig, uuniping, neeseen			lanı
Explain: Channelization at upstre	am extent multiple 295 c	ulverts	Explain. Vec NPS property Addressing concrete aprop at upstream extent m	av require
channenzation at aporte	am extent, maniple 200 0		additional access	ayrequire
		Mitiga	ation Site Rating	
Criteria		Score	<u> Criteria</u>	Score
Estimated Bank erosion	within reach	5	5 Vegetation	1
10 - Greater than 50%		<u> </u>	10 - Herbaceous cover (non-wetland)	
5 - 10% to 50%			5 - Scrub-shrub cover (non-wetland)	
1 - Less than 10%			1 - Mostly forested and/or wetland	
Describe:			Describe:	
~40% of banks eroded			Forested

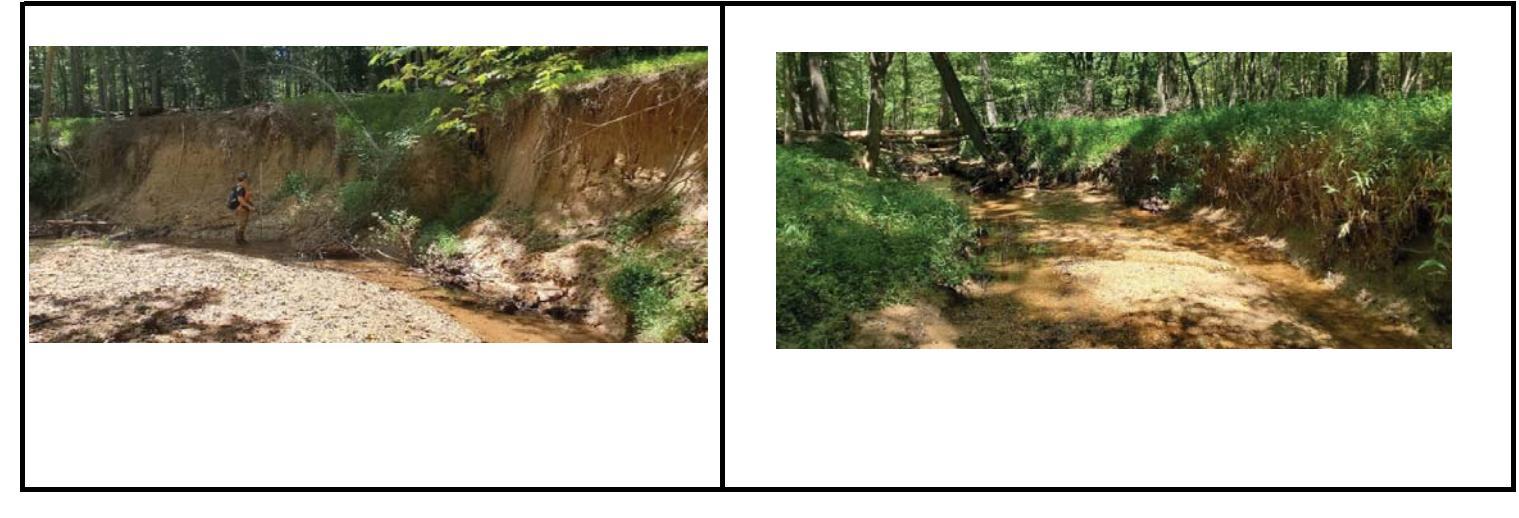
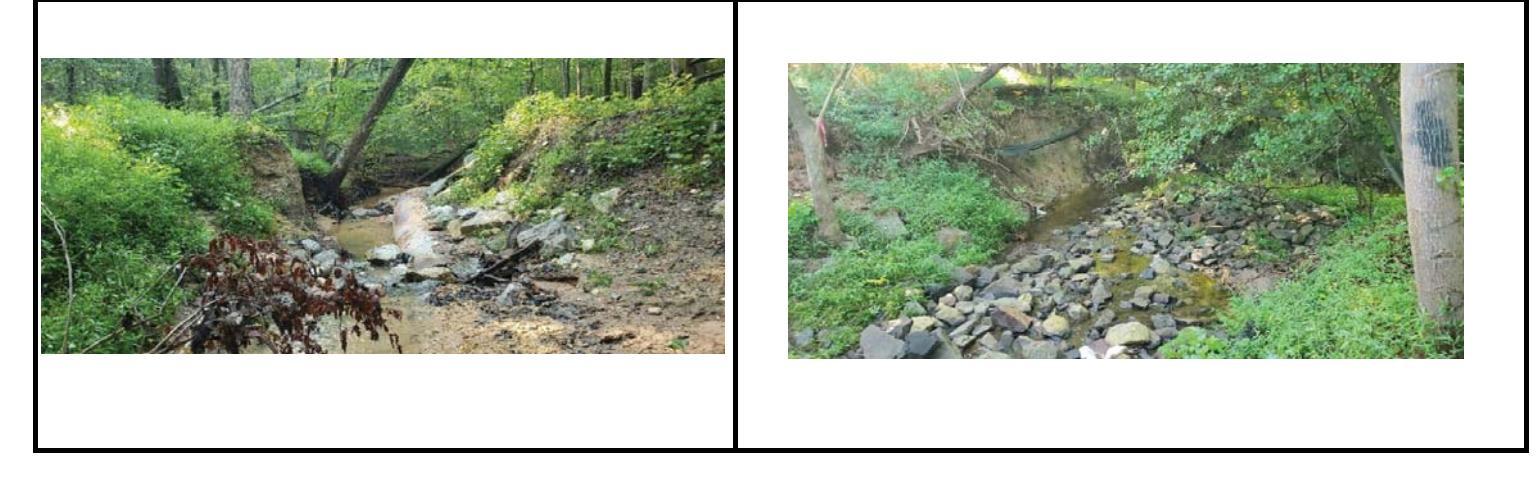
1 - Little to no space for f	floodplain development		1 - No (no vehicular access, clearing nee	eded)
Describe:			Describe:	
Greater than 10 times st	ream width exists with tre	e clearing	Some areas of direct access via road an	d trail, clearing needed in most areas
		40		
Drainage Area Evaluatio	n N	10	10 No utilitios on site	1
$_{2}$ D.A. less than 1 sq. m	n. n mi		10 - NO UTITUES ON SITE	rea
$1 - D \Delta$ greater than 2 of	1 n mi		1 - Utilities within potential restoration	area
	4		Doscribo:

0.59			Sewer utility throughout site parallels s	tream
			Toto	Score out of 100
			101d	1 JEDIE DUL DI 100 58

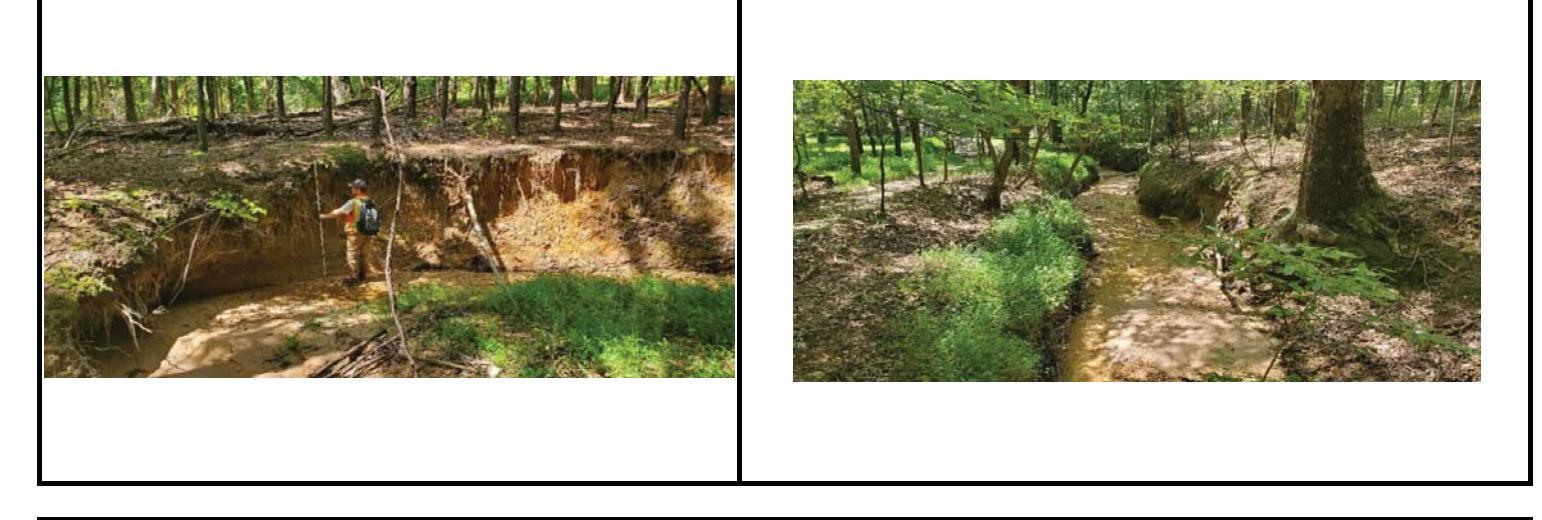
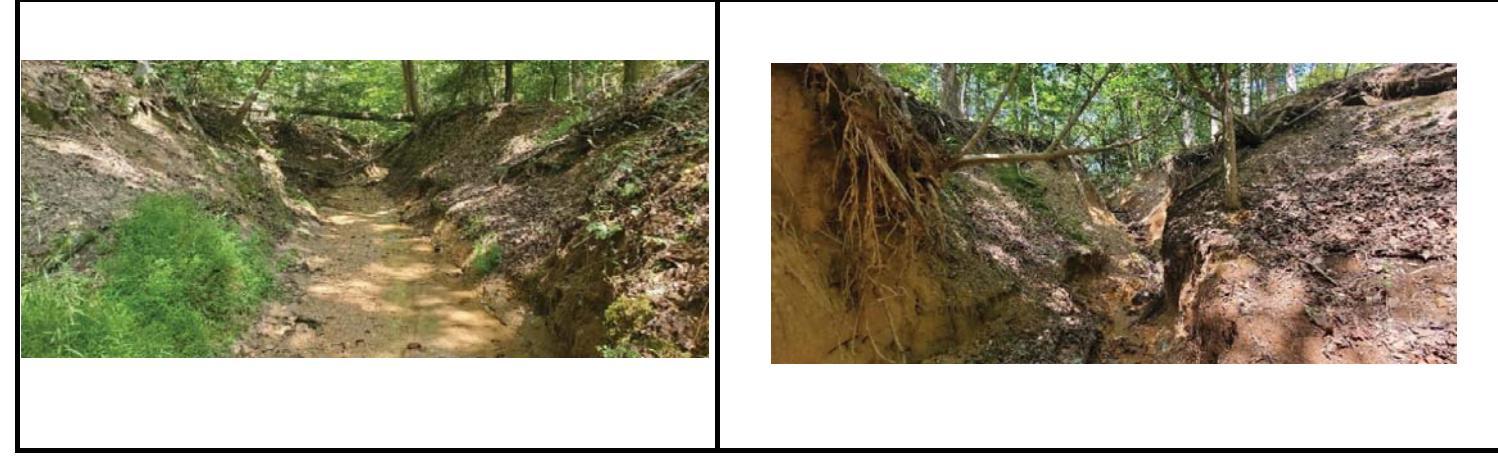
Describe:		Describe:		
About 85% eroded due to downcutting		Forested		
6				
	10	Lond Har		
Degree of Channel Incision	10	Land Use	1	
5 - Bank Height between 3 and 10 feet		5 - Marginal Pacture		
1 - Bank Height less than 3 feet		1 - Old field/ Developed/Forested		
Describe:		Describe		
Average bank height around 12', some lower banks ne	ar confluence	Forested		
с с <i>у</i>				
Existing Elondalain Access	10	Opportunity for Ecological Lift	5	
10 - No evidence of out of bank flooding	10	10 - Conditions exist for several aspects of lift to be achieved and	sustained	
5- Yes (Infrequent out of bank flow)		5 - Lift limited to one or few aspects	sustanteu	
1 - Yes (evidence of frequent flooding)		1 - Conditions are such that Lift is difficult to achieve and sustain		
Describe:		Describe:		
No evidence of floodplain access		Vertical/lateral stability, bedform diversity, floodplain access at do	ownstream	
		extent

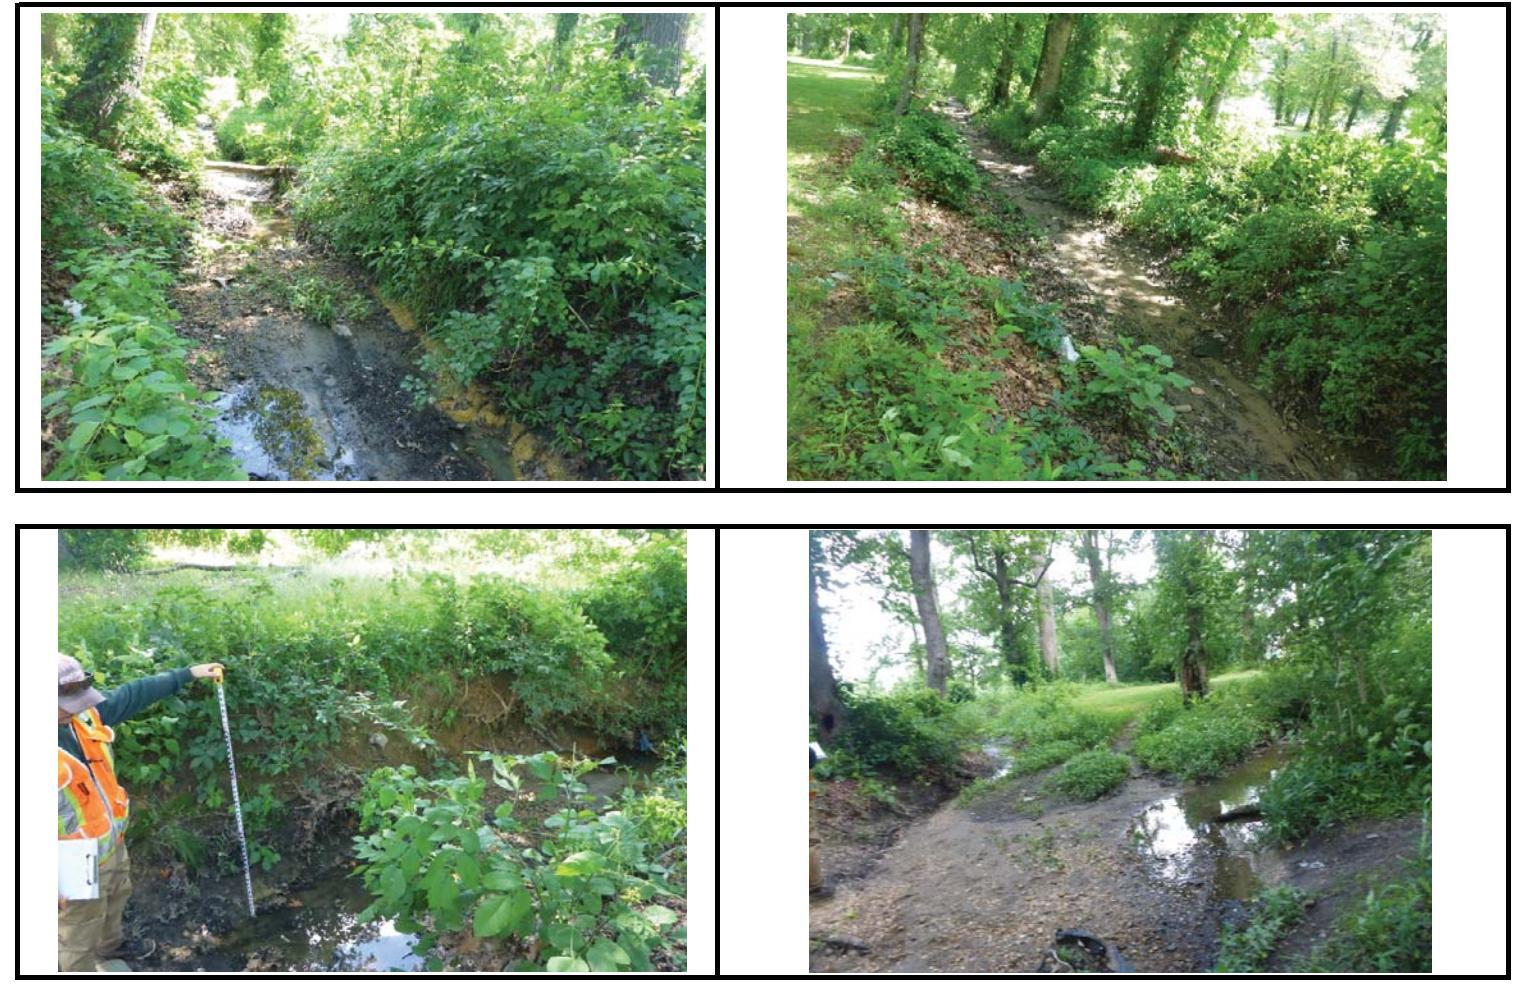
Site Photos

Describe [.]			Describe:	
No existing floodplain ac	Cess		Vertical stability, lateral stability, flood	Iplain access, habitat enhancement
			,,,,,,,,,,,,,,,,,,,,,,,,,,,,,,,,,,,,,,,	
Opportunity for Floodpla	ain Development	10	Ease of Access	10
10 - Existing space for flo	odplain greater than 10 ti	mes stream width	10 - Yes (with <u>existing</u> direct vehicular	access to potential site)
5 - Existing space for floo	dplain 3 to 10 times strea	m width	5- yes (open but no existing vehicular	access)
1 - Little to no space for f	loodplain development		1 - No (no vehicular access, clearing ne	eded)
Describe:			Describe:	· · ·
Sape exists for ten times	the stream width		Access form the park parking lot or ad	Jacent roadway
Drainage Area Evaluation	n	10	Utilities Present	10
10 -D.A. less than 1 sa. m	i.		10 - No utilities on site	
5- D. A. between 1 & 3 so	ą. mi.		5 - Utilities but not within restoration	area
