APPENDIX E: PUBLIC SITE WALKTHROUGH RATING CRITERIA & FIELD ASSESSMENT FORMS

WETLAND MITIGATION RATING CRITERIA & FIELD SITE ASSESSMENT FORMS

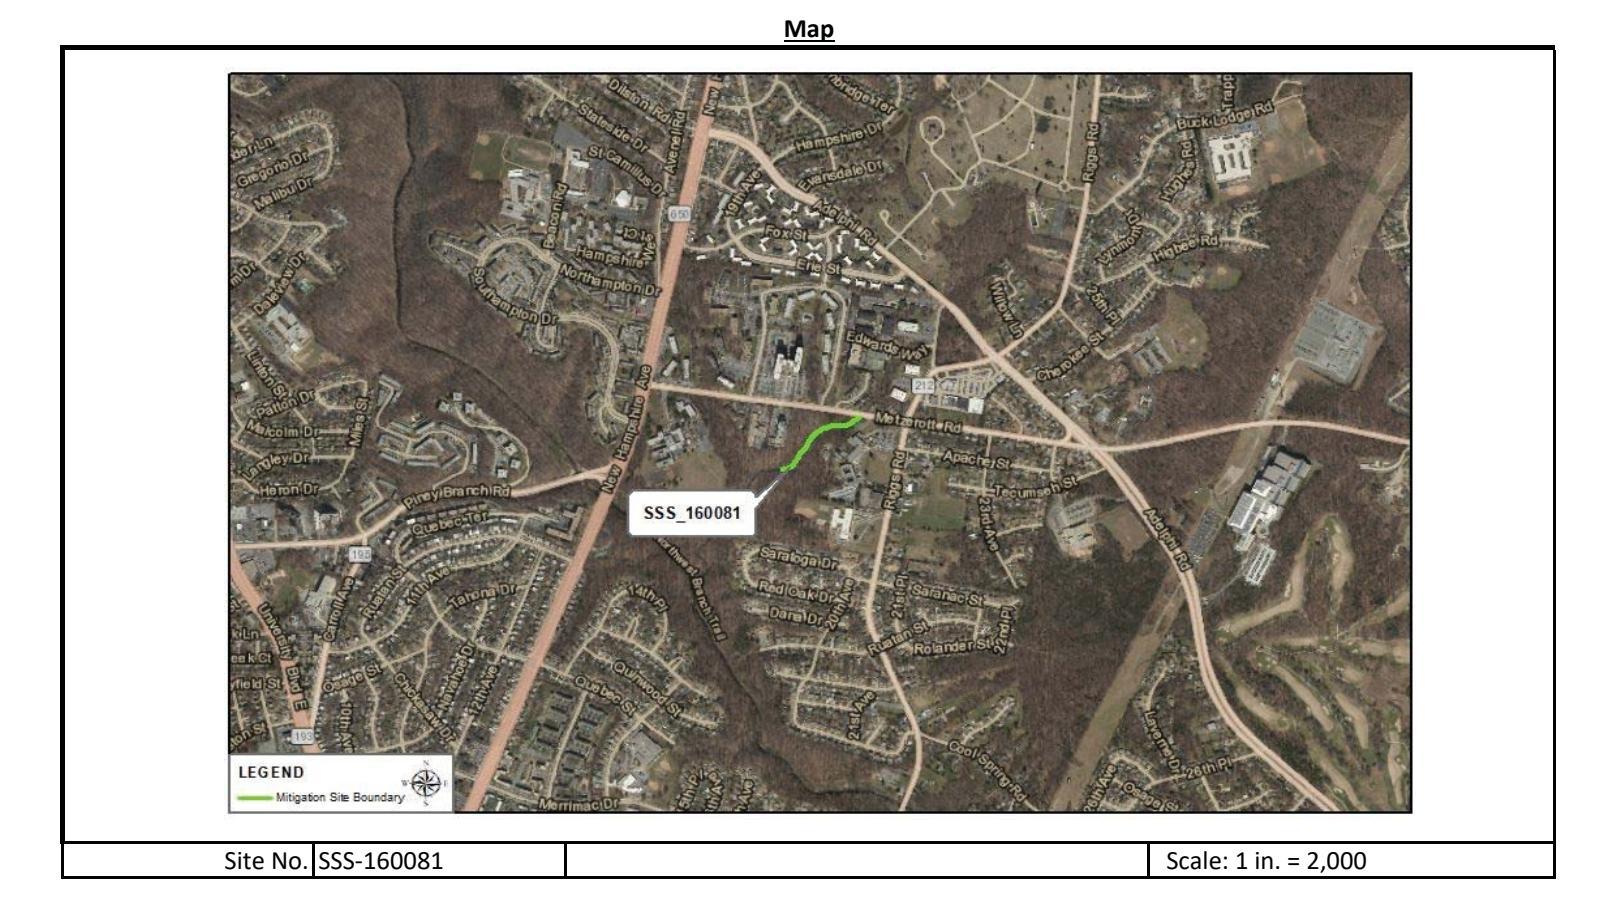
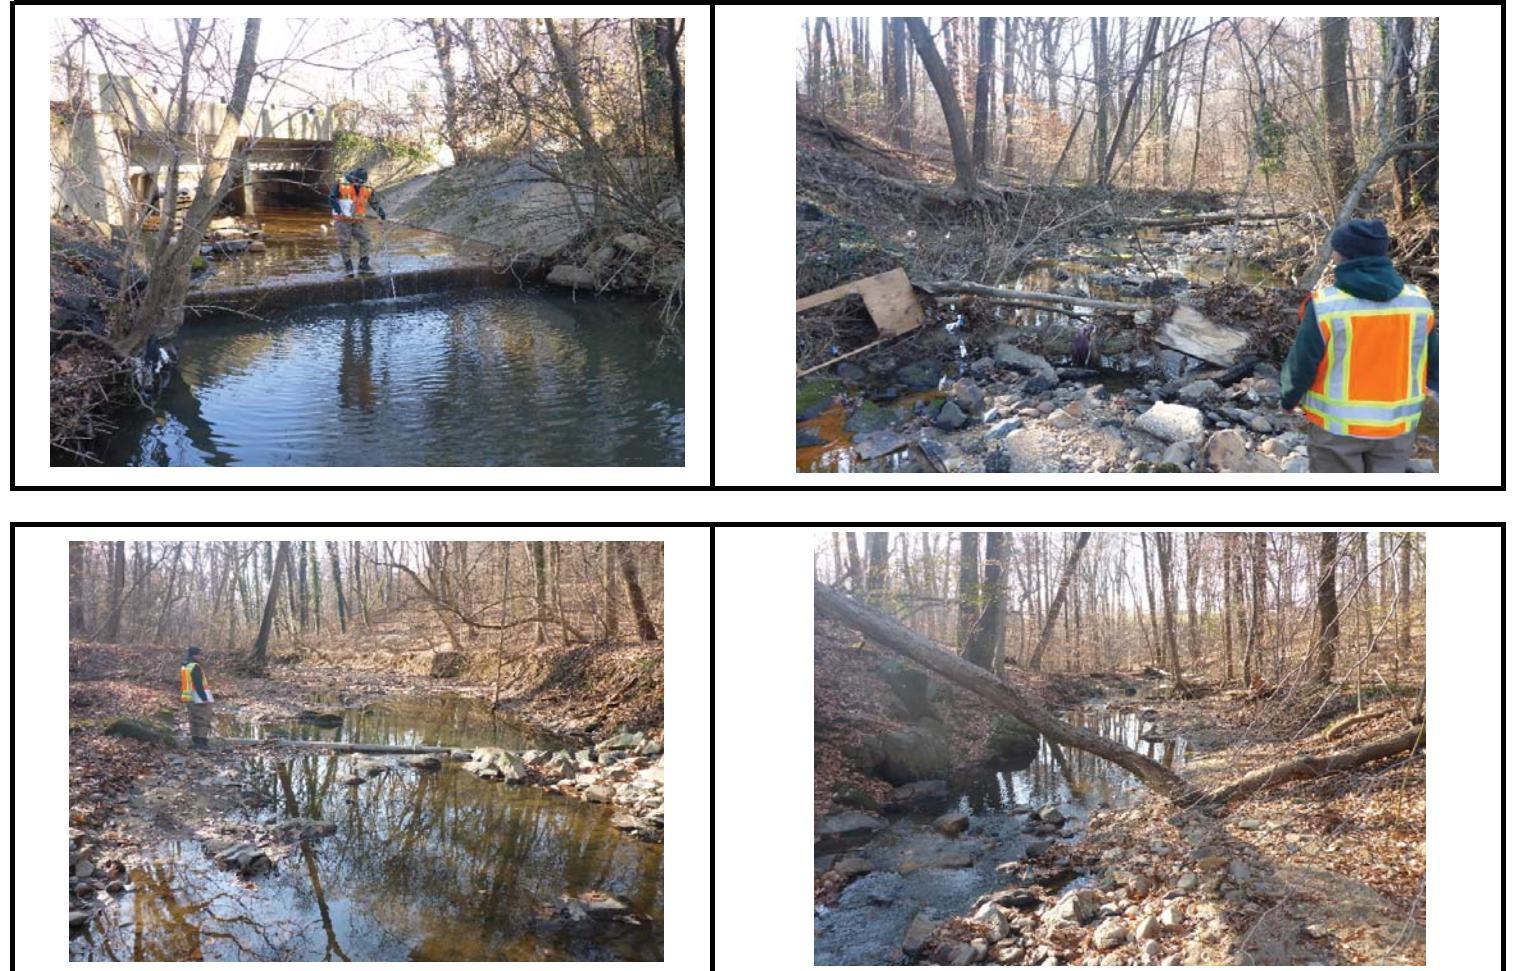
Describe:	· • · · · · · ·		Describe:		
No evidence of out of ba	ank flooding, despite down	stream bank height	Potential exists for habitat enhancement and increasing geom	orphic stability.	
being lower.					
Opportunity for Eloodal	ain Develonment	5	Fase of Access	1	
10 - Existing space for flo	podplain greater than 10 ti	mes stream width	10 - Yes (with existing direct vehicular access to potential site)	i	
5 - Existing space for floo	odplain 3 to 10 times strea	m width	5- yes (open but no existing vehicular access)		
1 - Little to no space for	floodplain development		1 - No (no vehicular access, clearing needed)		
Describe:			Describe:		
Confined stream valley is	s present, especially upstre	eam, but potential	No access road present. Lots of clearing would be required or	possible lane	
to develop floodplain ex	ists.		closure needed as site is a steep valley.		
Drainage Area Evaluatio	on	10	Utilities Present	1

10 -D.A. less than 1 sq. n	ni.		10 - No utilities on site		
5- D. A. between 1 & 3 s	q. mi.		5 - Utilities but not within restoration area		
1 - D. A. greater than 3 s	q. mi.		1 - Utilities within potential restoration area		
Describe:					
Drainage area - 0.92 squ	are mile.		Sewer crossing stream (exposed) with sewer parallel to stream	i for much of	
			reach.		
			Page 1 of 3 I Otal Score out of 100	44

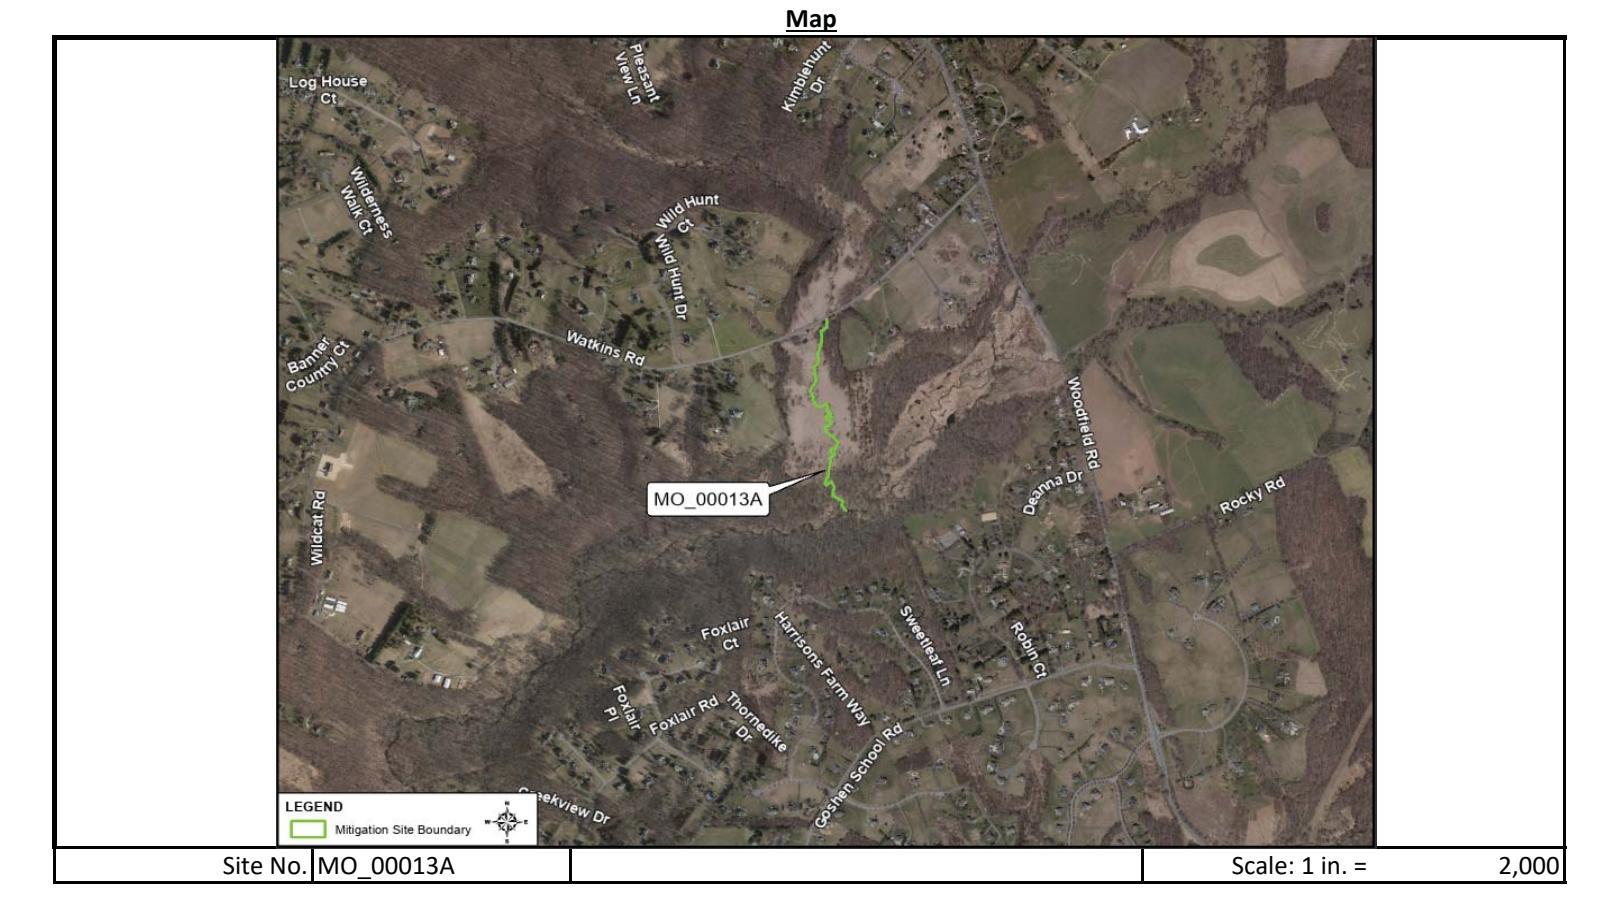
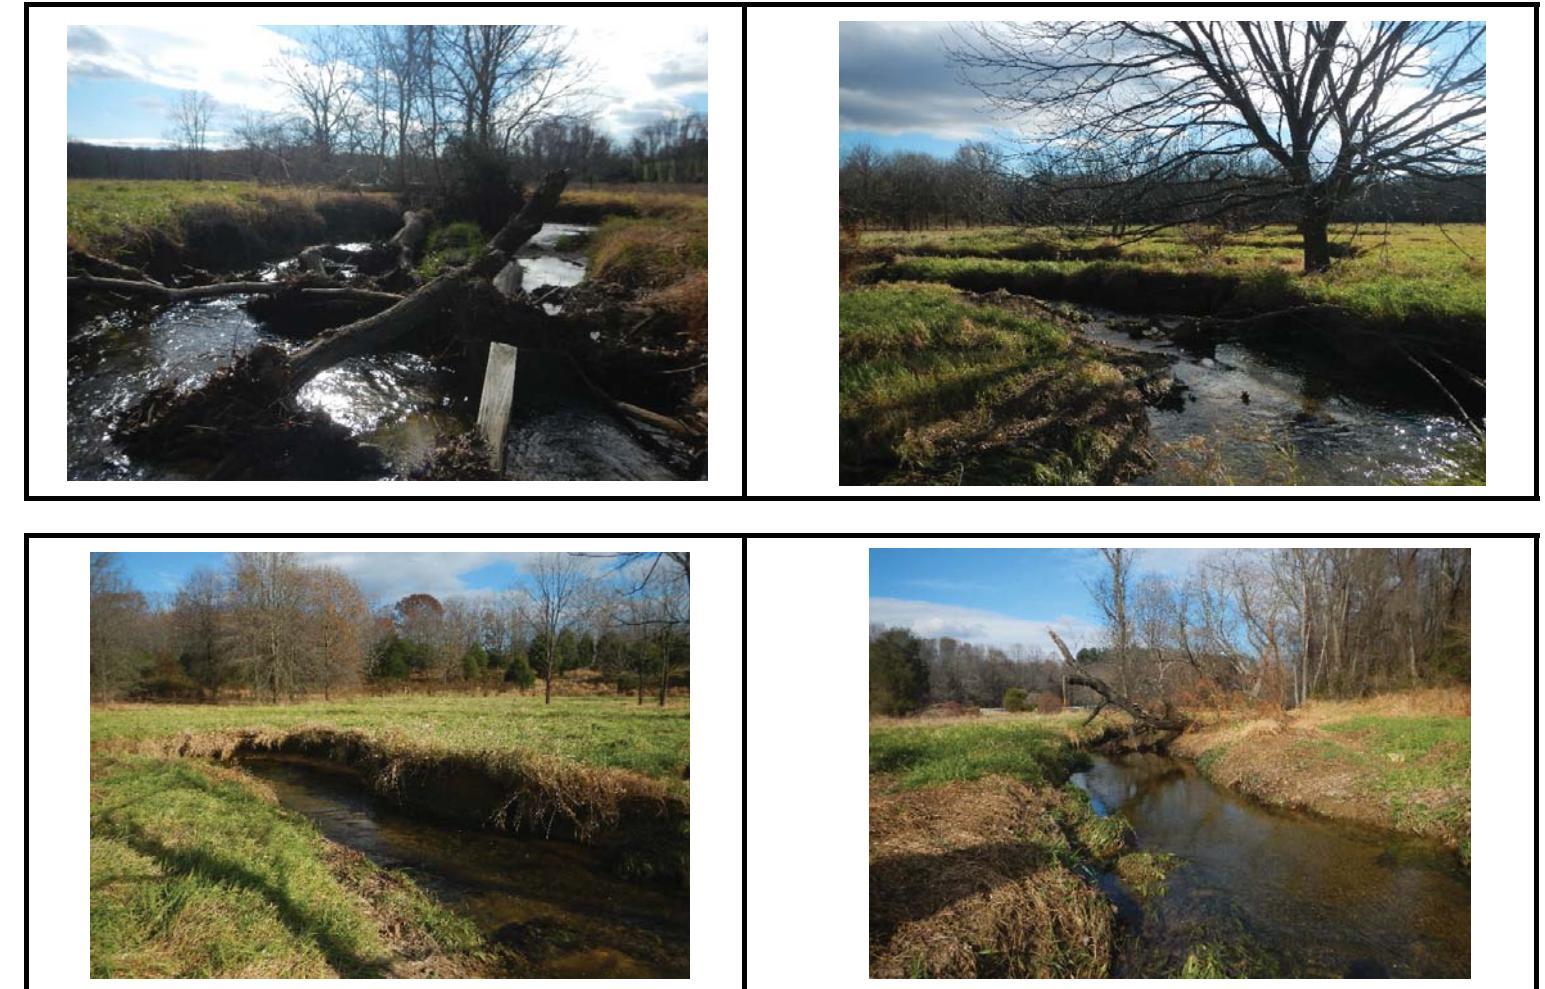
Site Photos

5- Yes (Infrequent out o	of bank flow)		5 - Lift limited to one or few aspects			
1 - Yes (evidence of free	quent flooding)		1 - Conditions are such that Lift is difficult to achieve and sustain			
Describe:			Describe:			
Some evidence of out-c	of-bank flows in floodplain n	ear channel-	High potential for reducing erosion.	improving instream hab	itat, floodplain	
matted down yeg			connection wetland creation/enhancement & improving water quality			
mattea aown veg.			connection, wettand creation, enhal	icement & improving we	iter quanty.	
Opportunity for Flood	plain Development	10	Ease of Access		5	
10 - Existing space for f	loodplain greater than 10 tir	nes stream width	10 - Yes (with existing direct vehicula	ar access to potential sit	e)	
5 - Existing space for flo	odplain 3 to 10 times strear	n width	5- yes (open but no existing vehicula	ar access)		
1 - Little to no space for	floodplain development		1 - No (no vehicular access, clearing	needed)

Describe:			Describe:			
Broad, flat floodplain greater than 10 times stream width.		No existing access into site from Wa	tkins Road. Majority of s	ite is open field		
			dominated by reed canary grass.		·	
			, ,,,,			
Drainage Area Evaluati	on	1	Utilities Present		5	
10 -D.A. less than 1 sq.	mi.		10 - No utilities on site			
5- D. A. between 1 & 3 sq. mi.			5 - Utilities but not within restoration area			
1 - D. A. greater than 3	sq. mi.		1 - Utilities within potential restoration area			
Describe: D			Describe:			
Drainage area - 3.48 so	uare miles.		Powerlines along Watkins Rd. just no	orth of site.		
				tal Score out of 100	61

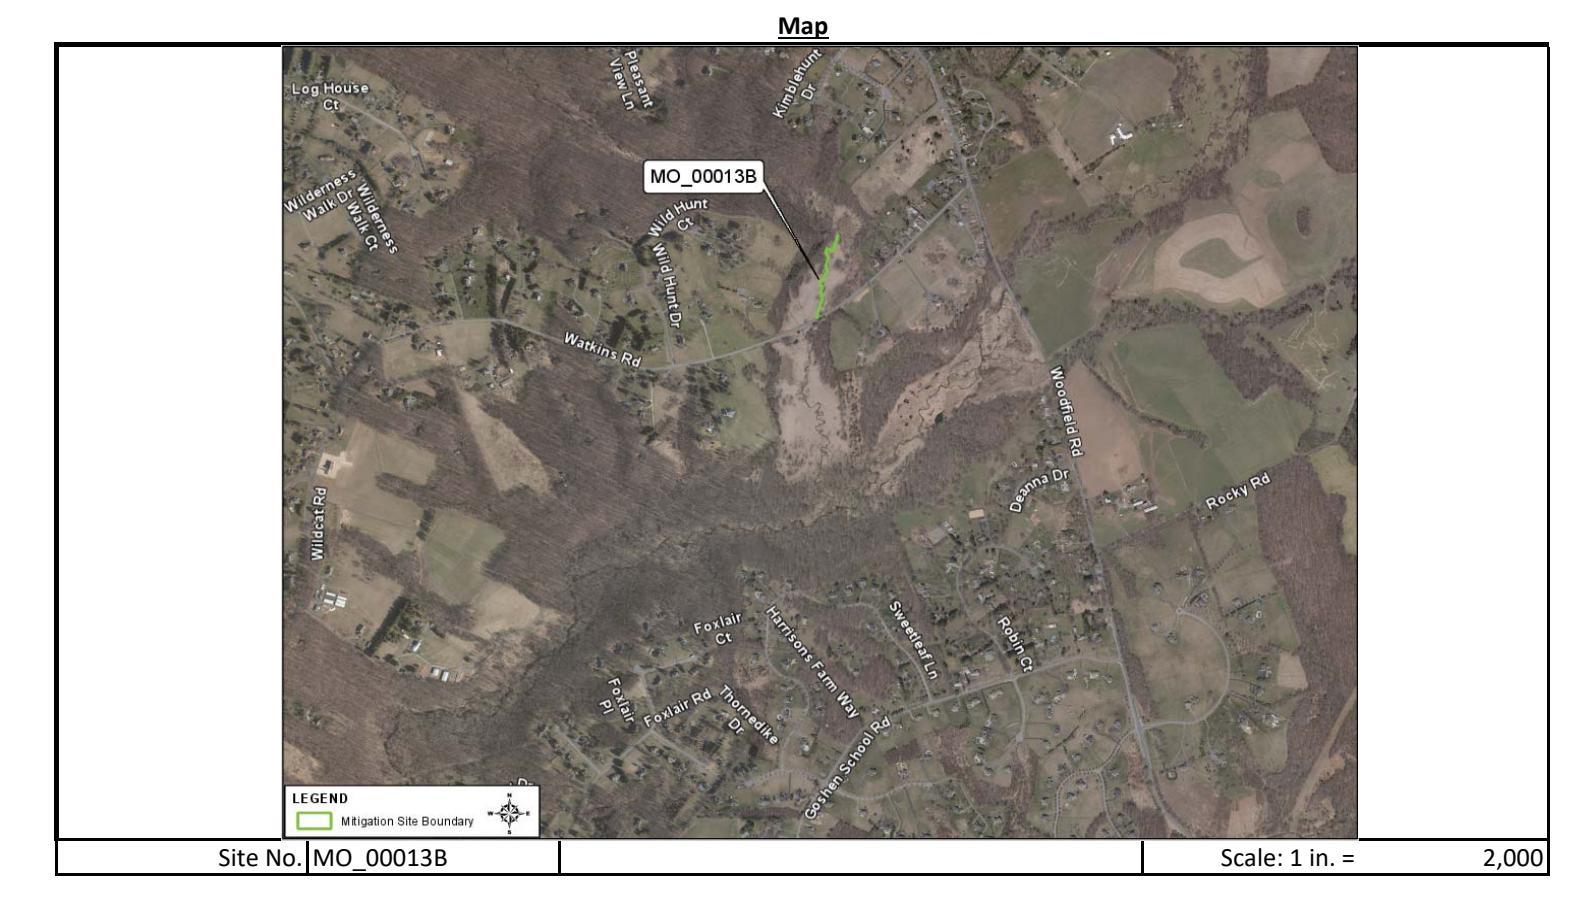
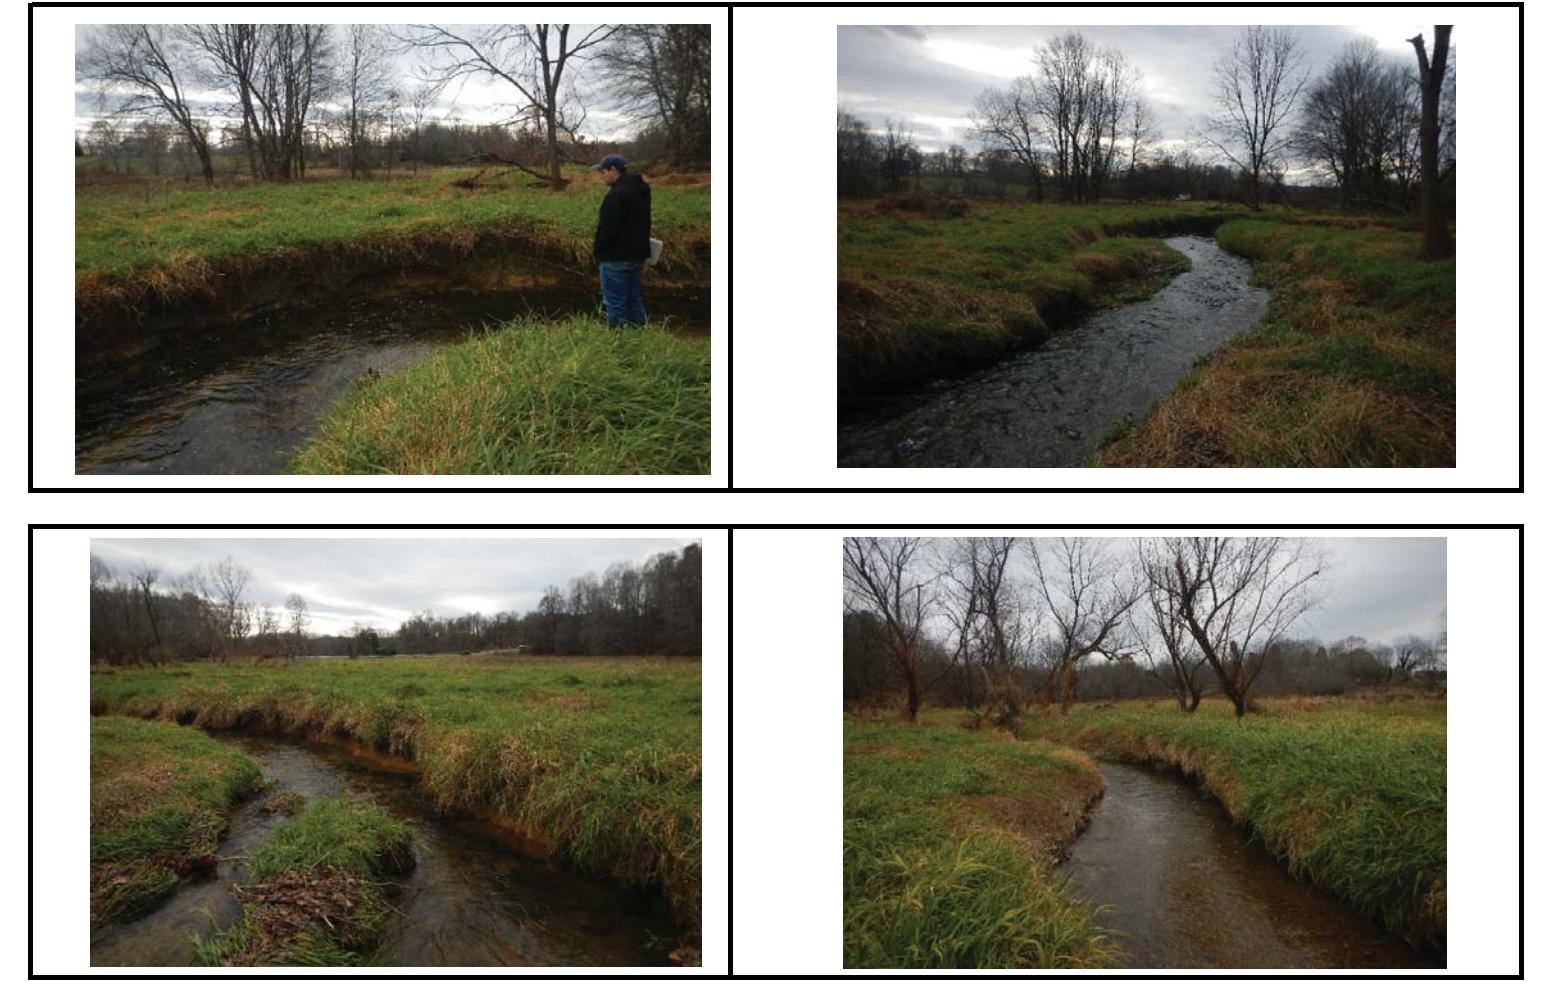
1 - Yes (evidence of freq	uent flooding)		1 - Conditions are such that Lift is difficult to achieve and sustain			
Describe:			Describe:			
Some evidence of out-o	t-bank flows in floodplain r	hear channel-	High potential for reducing erosion, improving instream habit	tat, floodplain		
matted down veg.			connection, wetland creation/enhancement & improving wa	ter quality.		
Opportunity for Floodn	lain Develonment	10	Fase of Arcess	5		
10 - Existing space for flo	oodplain greater than 10 ti	mes stream width	10 - Yes (with existing direct vehicular access to potential site	2) 2)		
5 - Existing space for flo	odplain 3 to 10 times strea	m width	5- yes (open but no existing vehicular access)	,		
1 - Little to no space for floodplain development			1 - No (no vehicular access, clearing needed)			
Describe:			Describe:			
Broad, flat floodplain greater than 10 times stream width.			No existing access into site from Watkins Road. Majority of si	te is open field

dominated by reed canary grass.			
Droinago Area Evoluati		1	Litilities Dresent	10		
10 -D A less than 1 sq. r	ni	1	10 - No utilities on site	10		
5- D. A. between 1 & 3 s	 a. mi.		5 - Utilities but not within restoration area			
1 - D. A. greater than 3 sq. mi.			1 - Utilities within potential restoration area			
Describe:			Describe:			
Drainage area - 3.35 square miles. No utilities observed within or adjacent to site.						
<u> </u>						
			Total Score out of 100	66		
				00

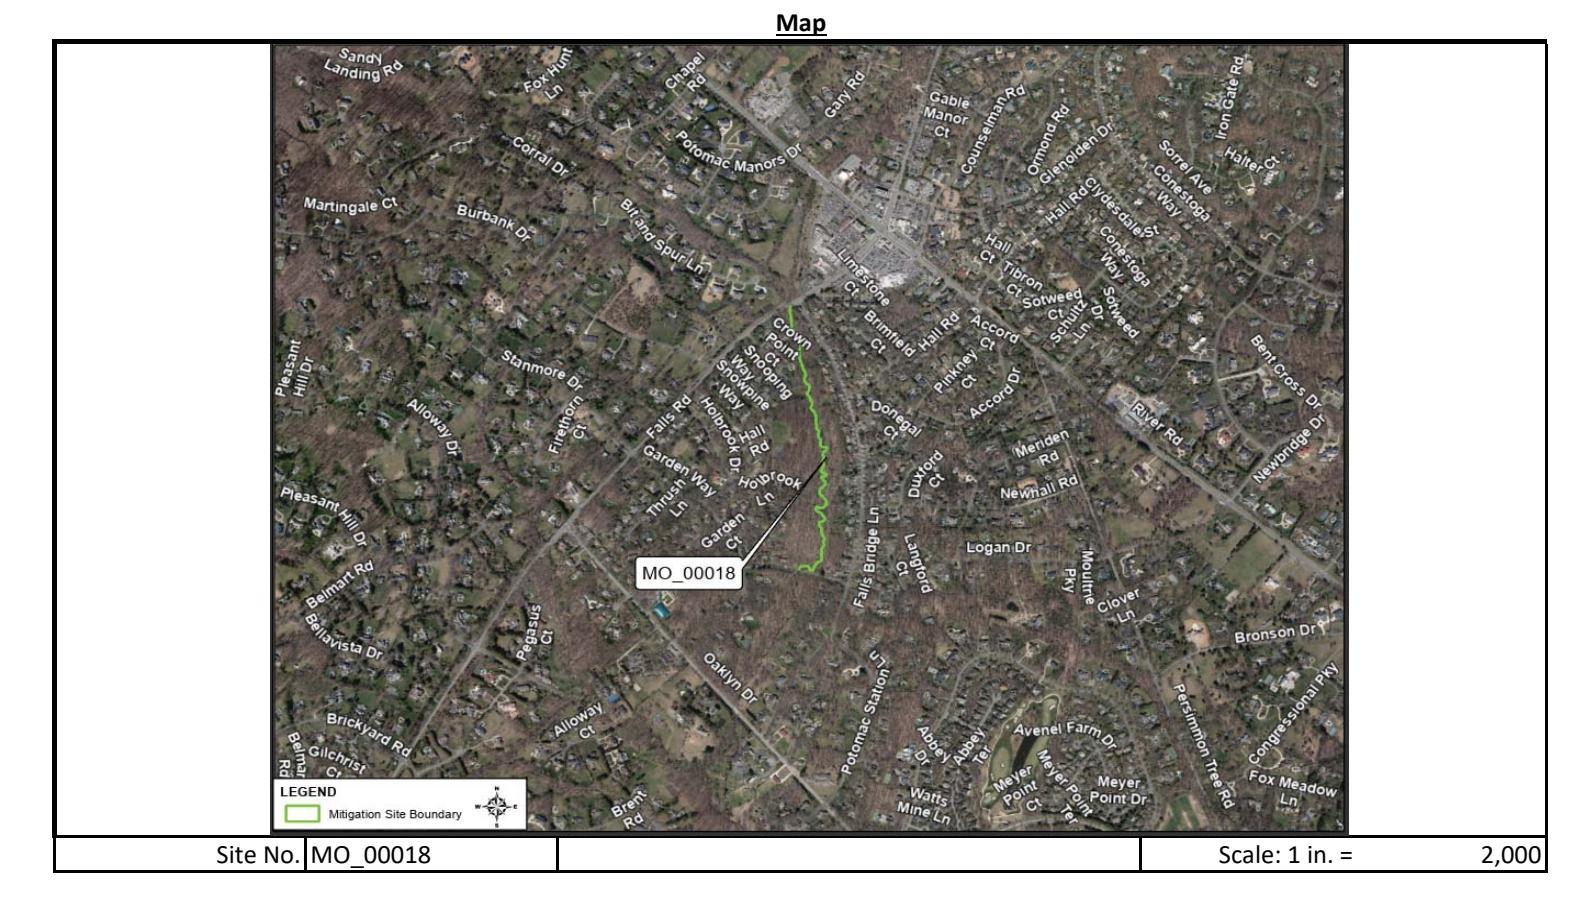
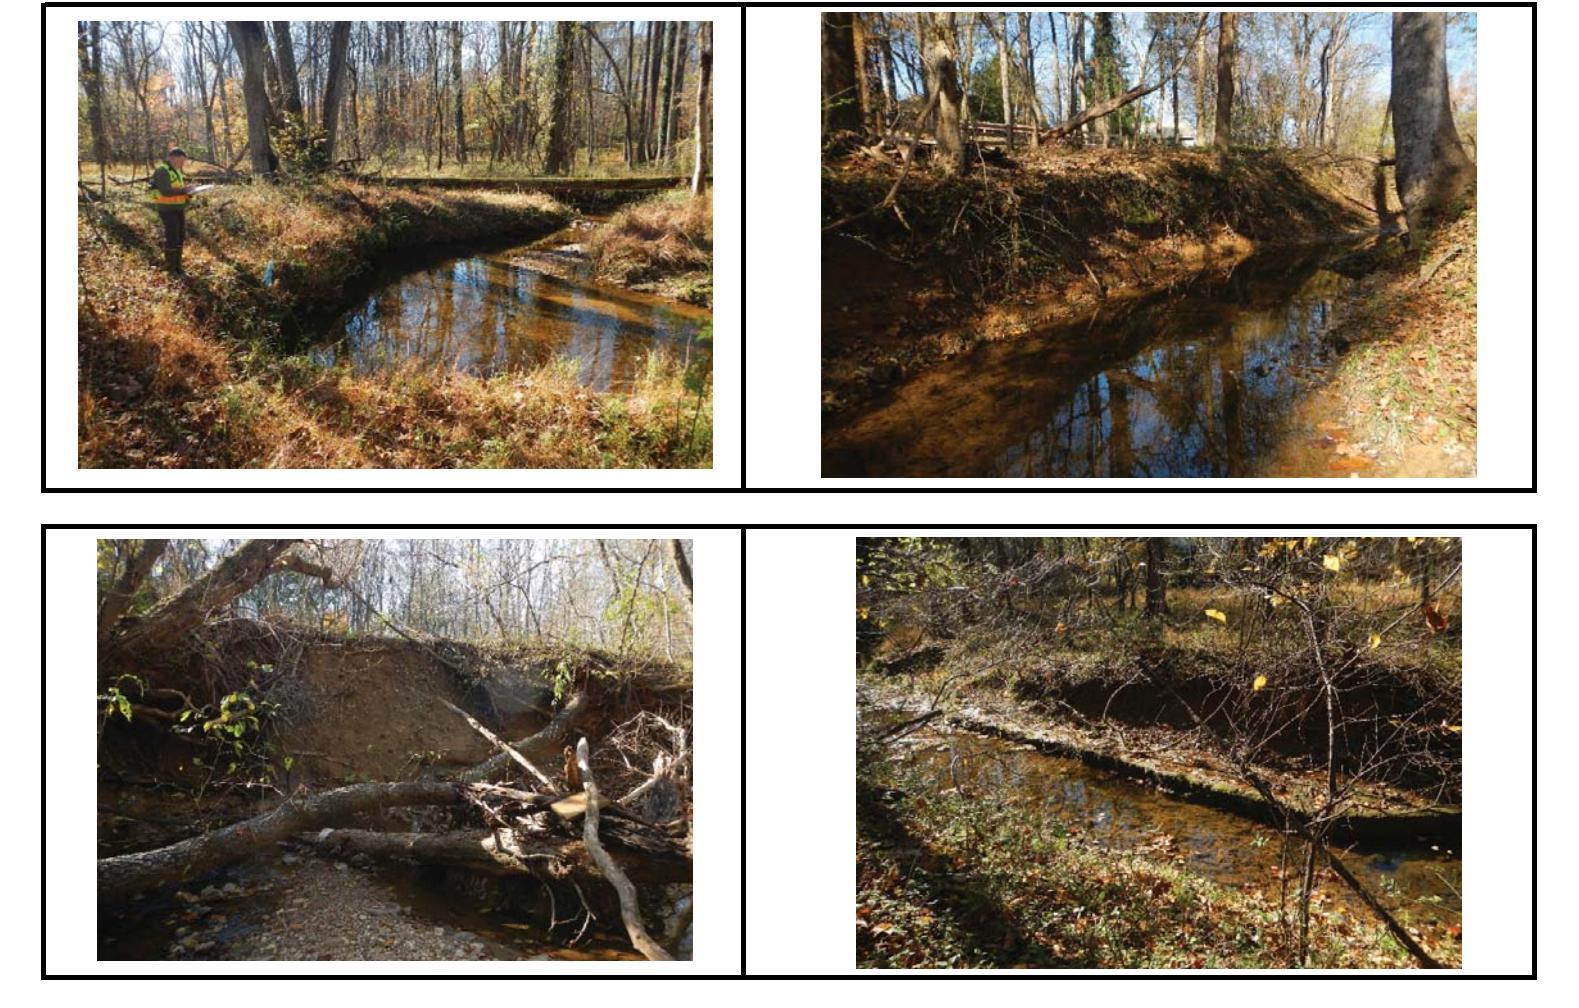
Site Photos

1 - Yes (evidence of frequ	uent flooding)		1 - Conditions are such that Lift is difficult to achieve and sust	ain	
Describe:			Describe:		
Floodplain is broad and f	lat. Some segments appea	r to be connected	Potential in reducing bank erosion, improving floodplain conn	lection, providing	
to floodplain with minor	evidence of out of bank flo	ows.	fish passage, and improving fish/benthic habitat.		
Opportunity for Eloodal	ain Dovelonment	5	Ease of Access	5	
10 - Existing space for flo	and Development	mes stream width	10 - Yes (with existing direct vehicular access to notential site)		
5 - Existing space for floo	dolain 3 to 10 times stream	n width	5- ves (open but no existing vehicular access)	/	
1 - Little to no space for floodplain development			1 - No (no vehicular access, clearing needed)		
Describe:			Describe:		
Floodplain is broad and flat. Floodplain development is limited in			Potential access through old sewer line clearing east of stream	n. Some tree

some segments by adjacent landowners and valley slopes.			clearing would likely be required to access stream.		
	,				
Drainage Area Evaluatio	n	5	Utilities Present	1	
10 -D.A. less than 1 sq. m	ni.		10 - No utilities on site		
5- D. A. between 1 & 3 sq. mi.		5 - Utilities but not within restoration area			
1 - D. A. greater than 3 sq. mi.			1 - Utilities within potential restoration area		
Describe:			Describe:		
Drainage area is 1.13 sq.	Drainage area is 1.13 sq. mi. Sewer line runs parallel to stream in eastern floodplain.				
			Total Score out of 100	43

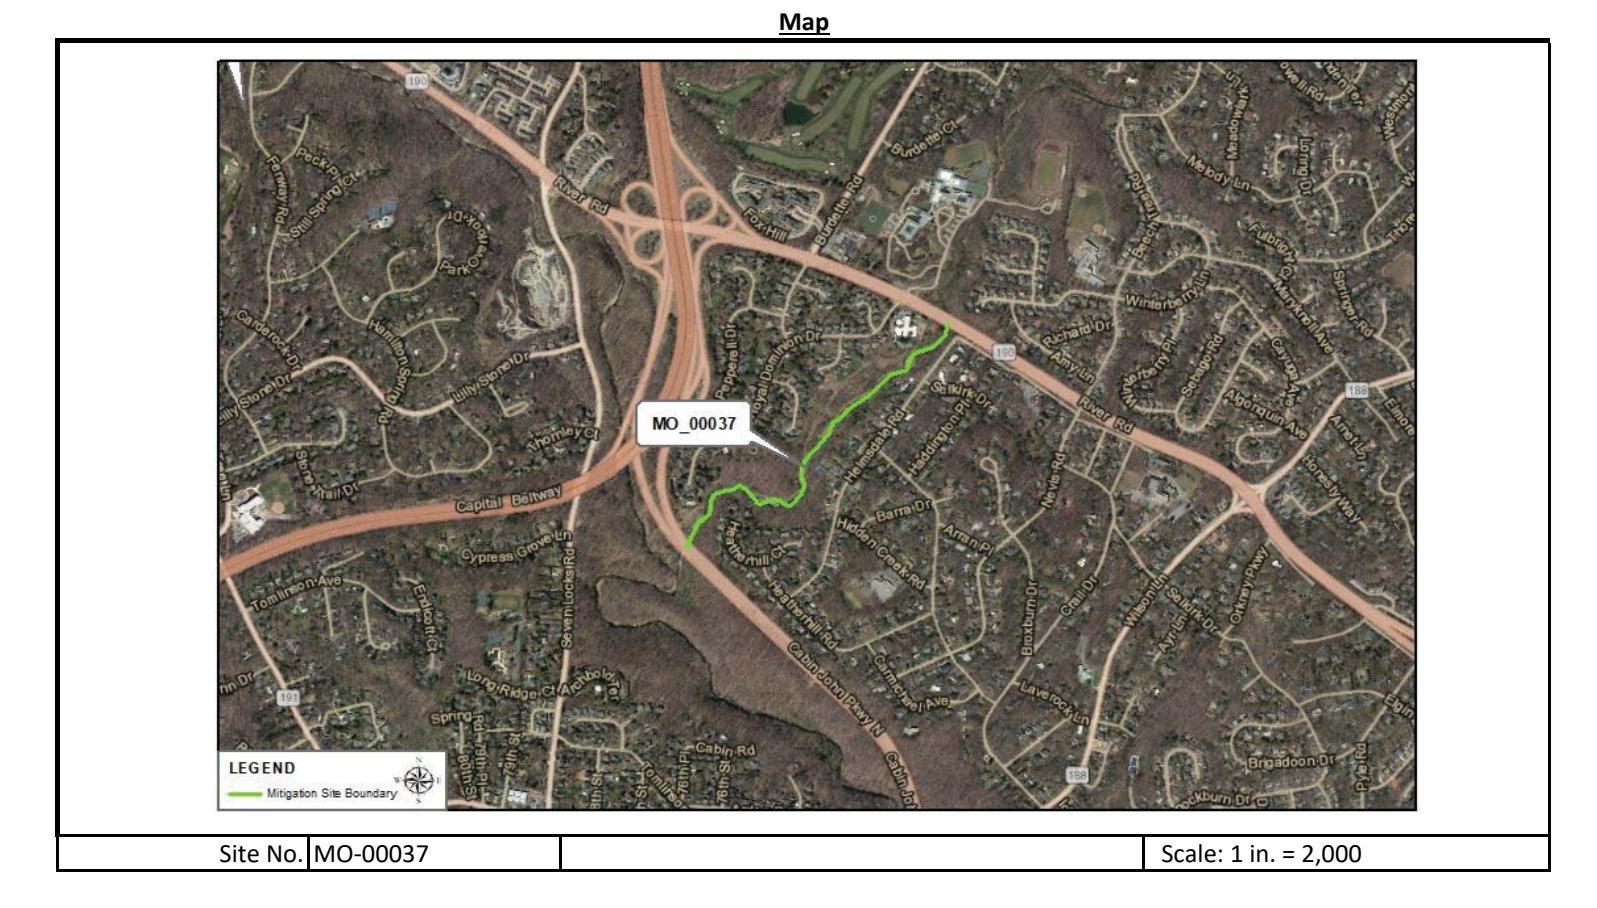
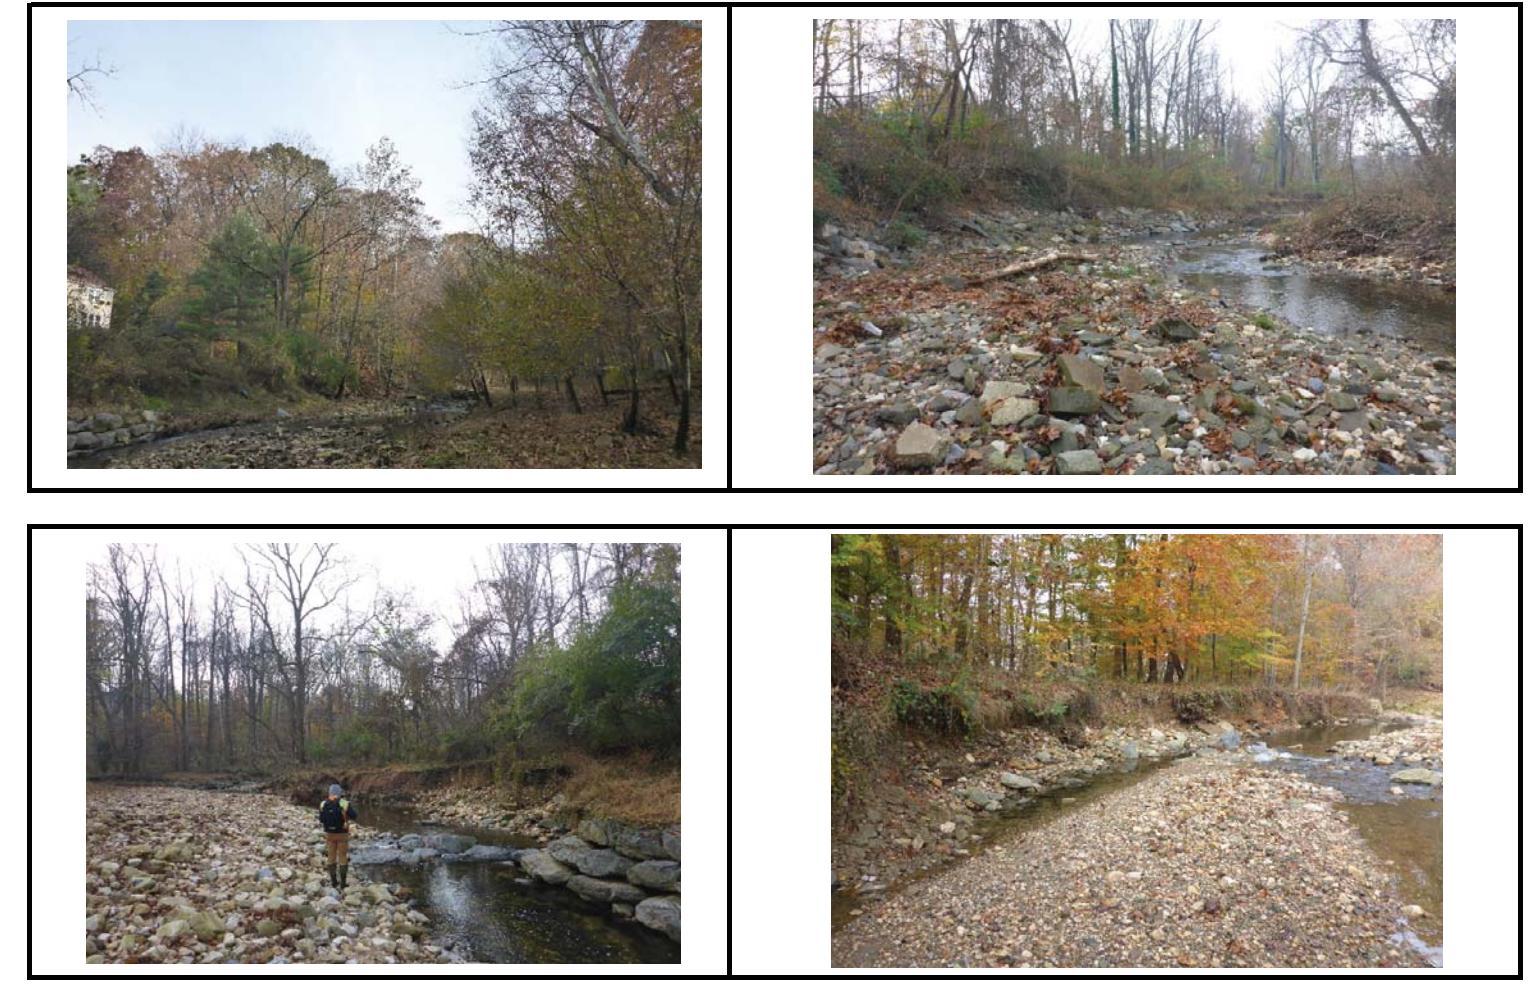
5- Yes (Infrequent out of	f hank flow)		5 - Lift limited to one or few aspects	and sustained	
1 - Yes (evidence of frequence)	uent flooding)		1 - Conditions are such that Lift is difficult to achieve and sustain		
Describe:	aent 1100an.8)		Describe		
Inset floodplain in some	areas of the incised chann	el. evidence of	Increase bank stability, provide low benches for storm relief	. increase available	
flows on top of low benc	⁻ hes		habitat increase vegetative cover in areas	,	
Opportunity for Floodpl	ain Development	5	Ease of Access	10	
10 - Existing space for flo	oodplain greater than 10 ti	mes stream width	10 - Yes (with existing direct vehicular access to potential site	e)	
5 - Existing space for floo	odplain 3 to 10 times strea	m width	5- yes (open but no existing vehicular access)		
1 - Little to no space for floodplain development			1 - No (no vehicular access, clearing needed)		
Describe:			Describe:

Area exists to narrow flows and provide inset floodplain benches.			Access paths from previous restoration can be used, off of C	abin John Parkway	
			and off of Helmsdale Road.		
Drainage Area Evaluatio	on	1	Utilities Present	1	
10 -D.A. less than 1 sq. n	ni.		10 - No utilities on site		
5- D. A. between 1 & 3 s	q. mi.		5 - Utilities but not within restoration area		
1 - D. A. greater than 3 s	q. mi.		1 - Utilities within potential restoration area		
Describe:			Describe:		
Drainage area - 4.3 squa	Drainage area - 4.3 square miles. Exposed manholes along streambank; One observed crossing exposed.				
·					
			Total Score out of 100	44

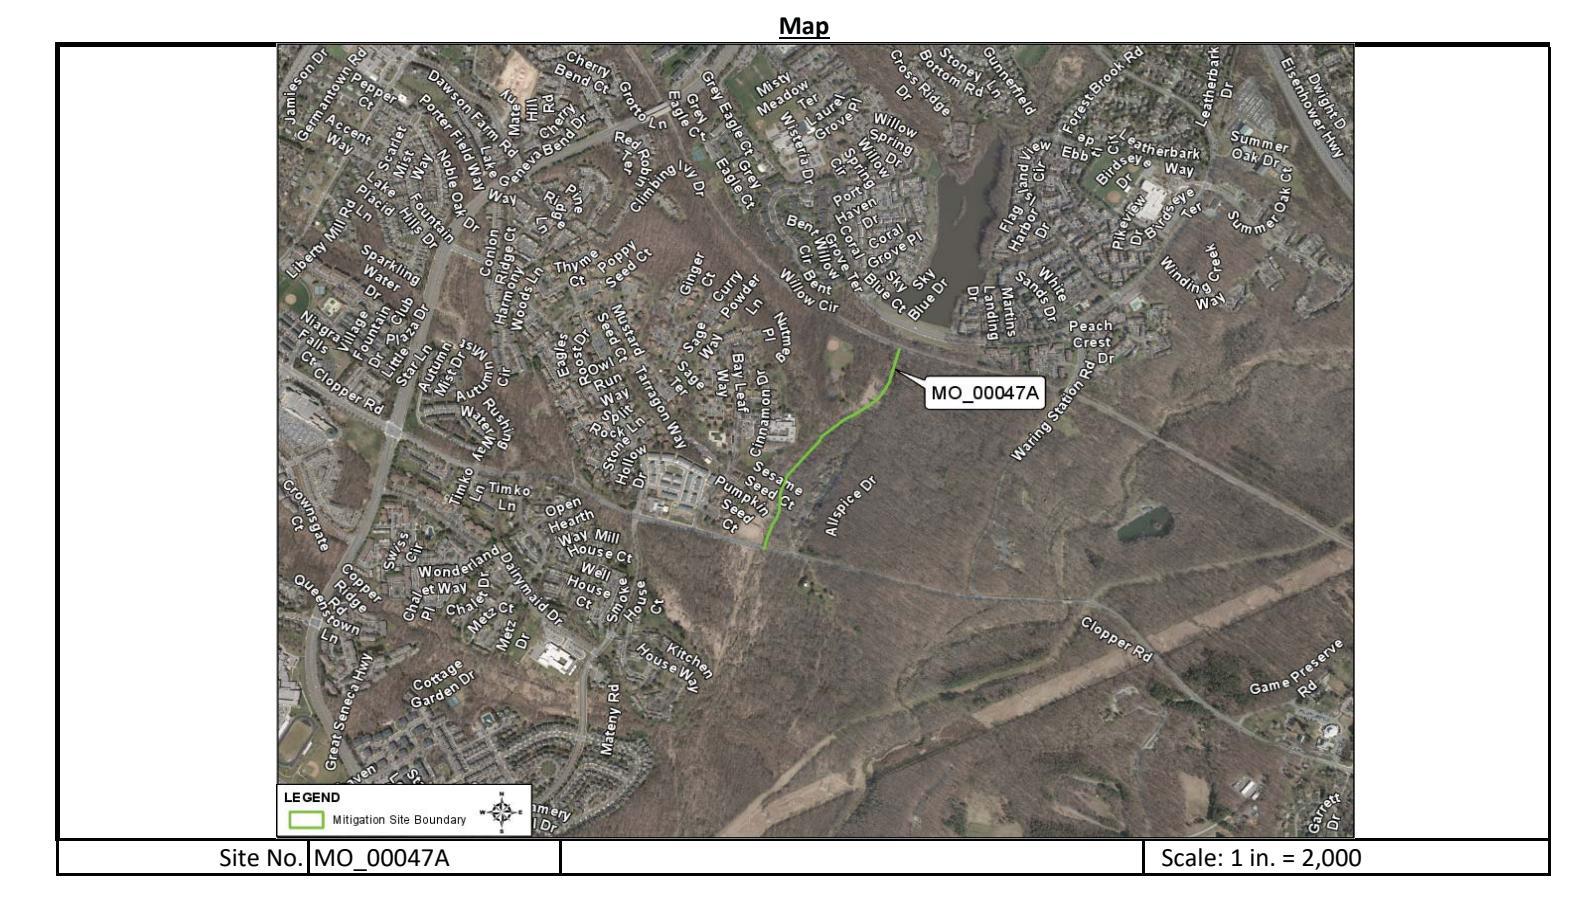
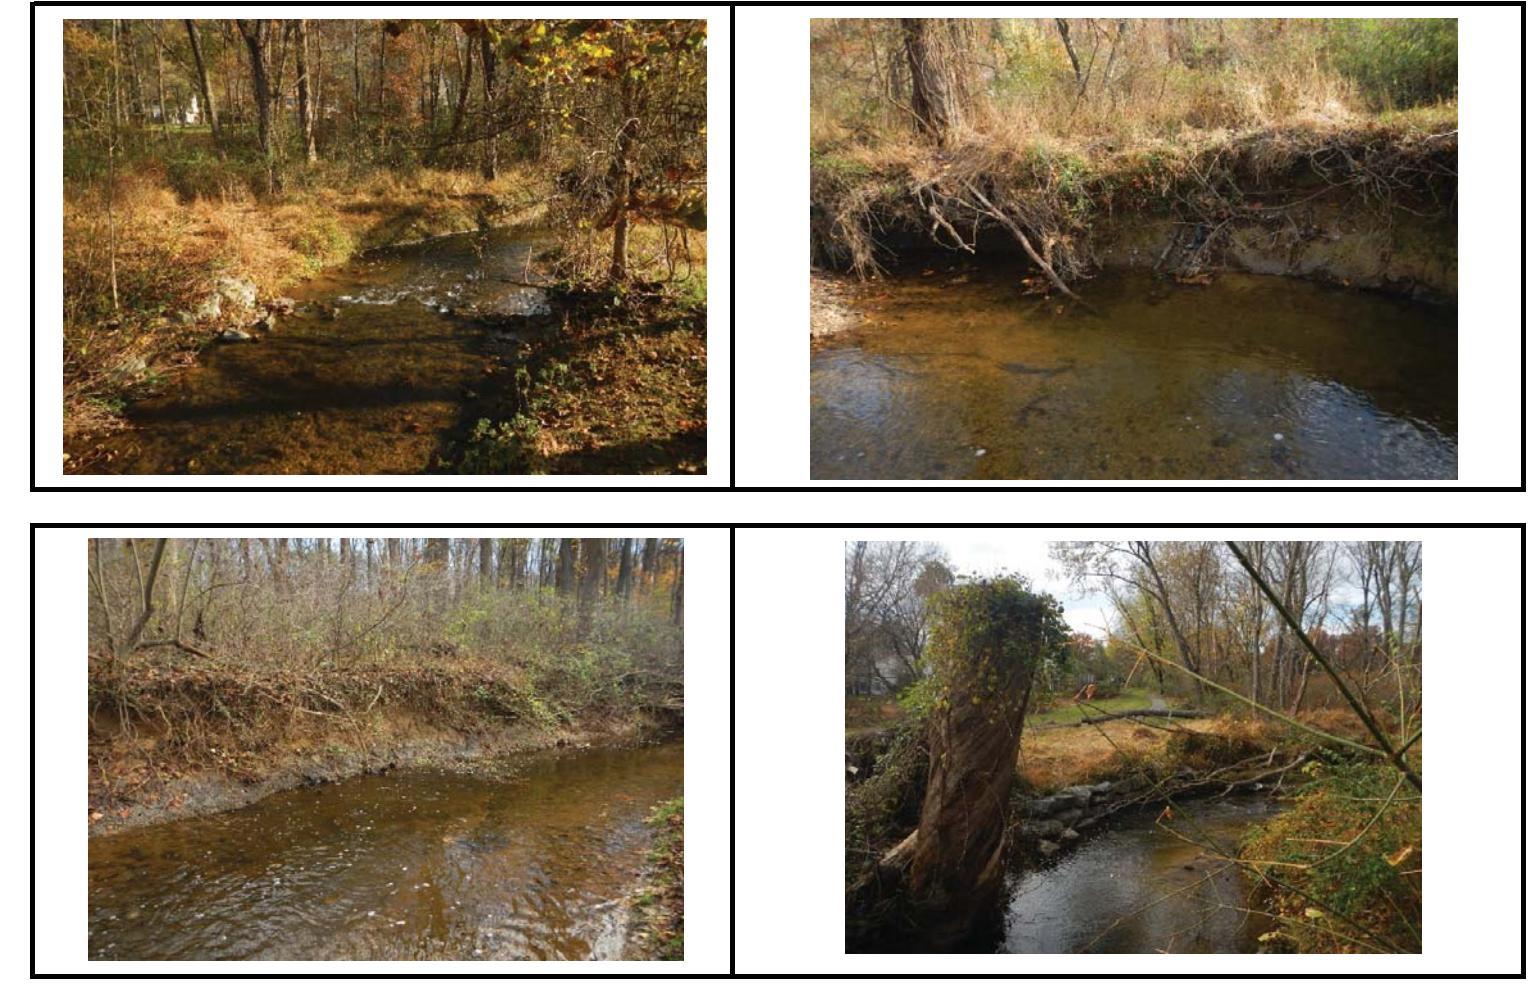
Describe:			Describe:		
Some evidence of matte	ed down vegetation near to	p of bank.	Some opportunity for sediment reduction, wetland creation	n/enhancement,	
			riparian plantings, aquatic habitat improvements, and fish p	bassage.	
				_	
Opportunity for Floodp	lain Development	5	Ease of Access	10	
10 - Existing space for flo	oodplain greater than 10 ti	mes stream width	10 - Yes (with <u>existing</u> direct vehicular access to potential si	te)	
5 - Existing space for floodplain 3 to 10 times stream width			5- yes (open but no existing vehicular access)		
1 - Little to no space for floodplain development			1 - NO (NO VENICULAR ACCESS, Clearing needed)		
Describe. Electricitation development limited in costain procedure to edicate the sub-			Describe.		
recreation areas and parking lots			Existing access route from sewer line repairs.		
recreation areas and pai	rking lots.				
Drainago Aroa Evaluatio	on	5	Litilities Present	1

10 -D A less than 1 car	ni	5	10 - No utilities on site		
5- D. A. between 1 & 3 c	 a. mi.		5 - Utilities but not within restoration area		
1 - D. A. greater than 3 sq. mi.			1 - Utilities within potential restoration area		
			Describe		
Drainago Aroa - 2.02 square miles			Sewer line runs narallel to stream in wostorn floodnlain		
Siamage Area - 2.32 Sqt	zure miles.		sewer mie runs paraner to stream in western noouplain.		
			Total Score out of 10	0 42
