APPENDIX E: PUBLIC SITE WALKTHROUGH RATING CRITERIA & FIELD ASSESSMENT FORMS

WETLAND MITIGATION RATING CRITERIA & FIELD SITE ASSESSMENT FORMS

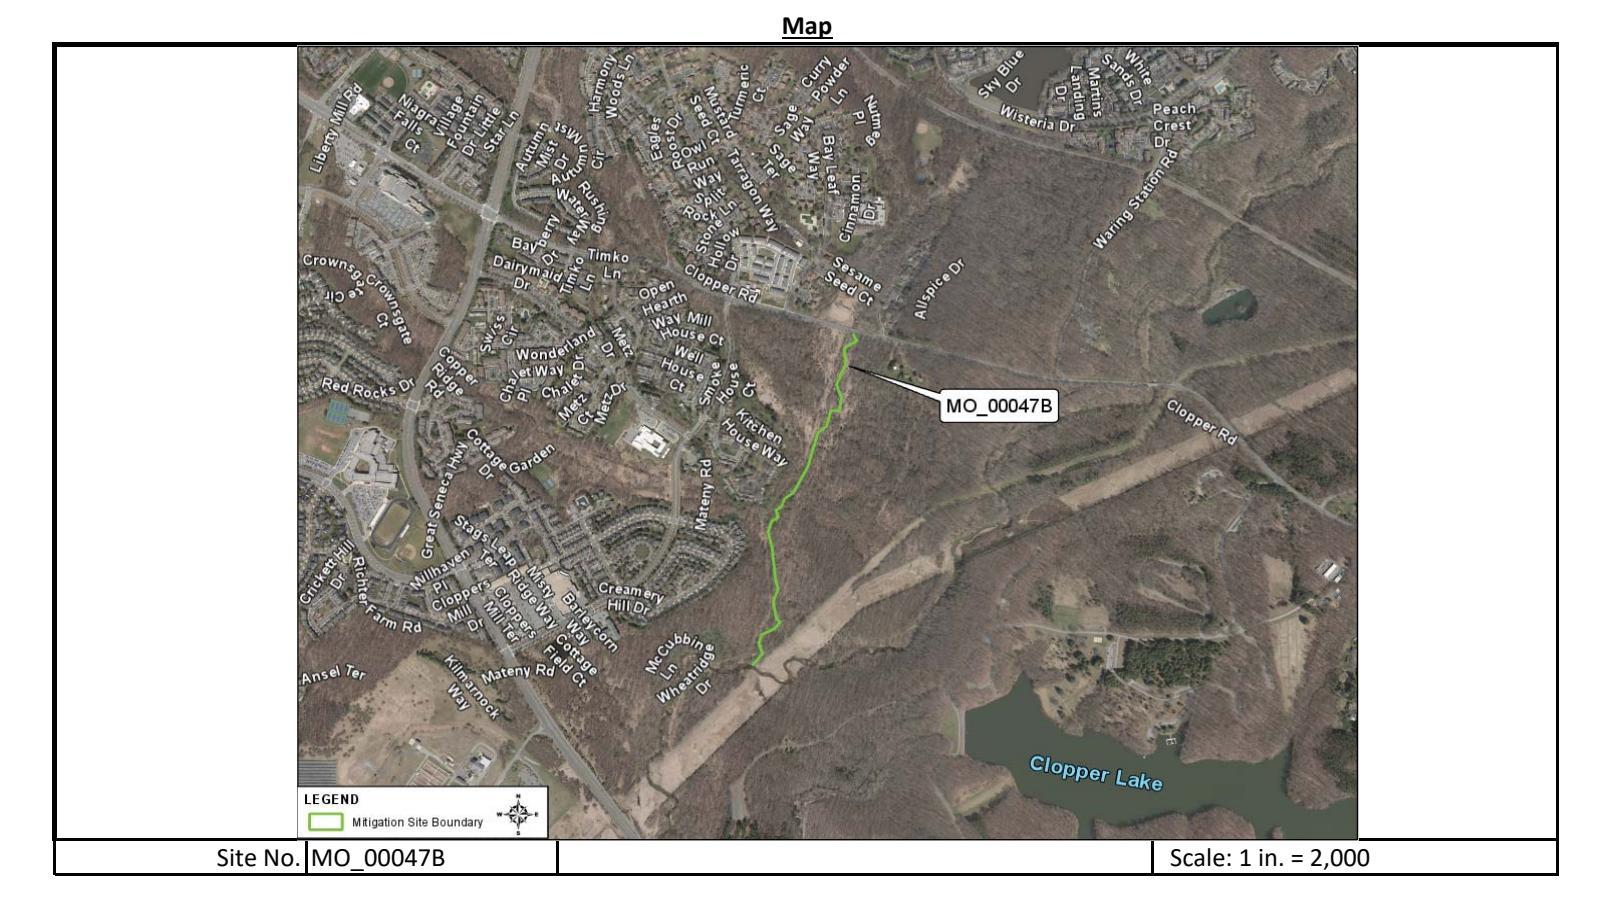
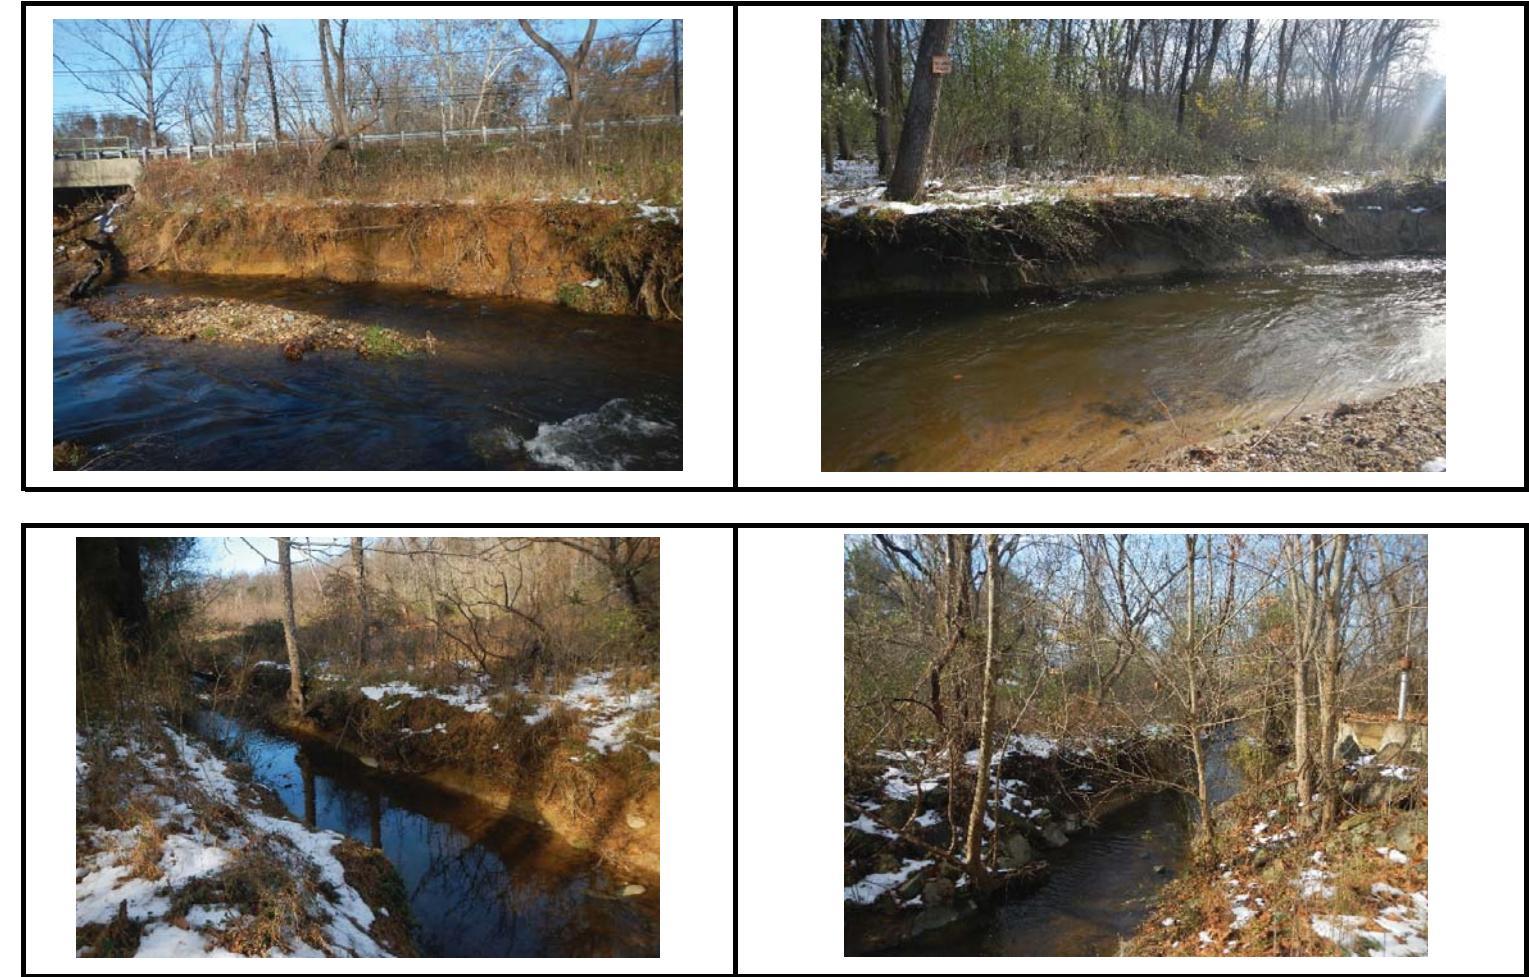
5. Vos (Infroquent out of	hank flow)		10 - Conditions exist for several aspects of lift to be achieved and sustained		
1 - Yes (evidence of frequ	ient flooding)		1 - Conditions are such that Lift is difficult to achieve and sustain		
Describe:					
Some wrack lines observe	ed in floodplain near top o	f hank	Some potential for reducing erosion and improving aquatic habitat and		
		, burne	floodplain connection		
Opportunity for Floodpla	ain Development	5	Ease of Access		5
10 - Existing space for flo	odplain greater than 10 tin	nes stream width	10 - Yes (with <u>existing</u> direct vehicular a	access to potential site)	
5 - Existing space for floo	dplain 3 to 10 times stream	n width	5- yes (open but no existing vehicular a	access)	
1 - Little to no space for floodplain development			1 - No (no vehicular access, clearing needed)		
Describe:			Describe:		
Floodplain development in center and downstream sections of site are		Existing sewer line access for northern section of site. Center and downstream

limited by adjacent neighborhoods and valley slopes. Some floodplain s			sections would require tree clearing.		
development potential at	t upstream end of site.				
Drainage Area Evaluation	n	1	Utilities Present		1
10 -D.A. less than 1 sg. m	ii.		10 - No utilities on site		<u>.</u>
5- D. A. between 1 & 3 sq. mi. 5 - Utilities but not within restoration area					
1 - D. A. greater than 3 sc	ą. mi		1 - Utilities within potential restoration area		
Describe:			Describe:		
Drainage area - 4.35 squa	are miles		Sewer line runs parallel to stream in w	estern floodplain.	
			Tot	al Score out of 100	34

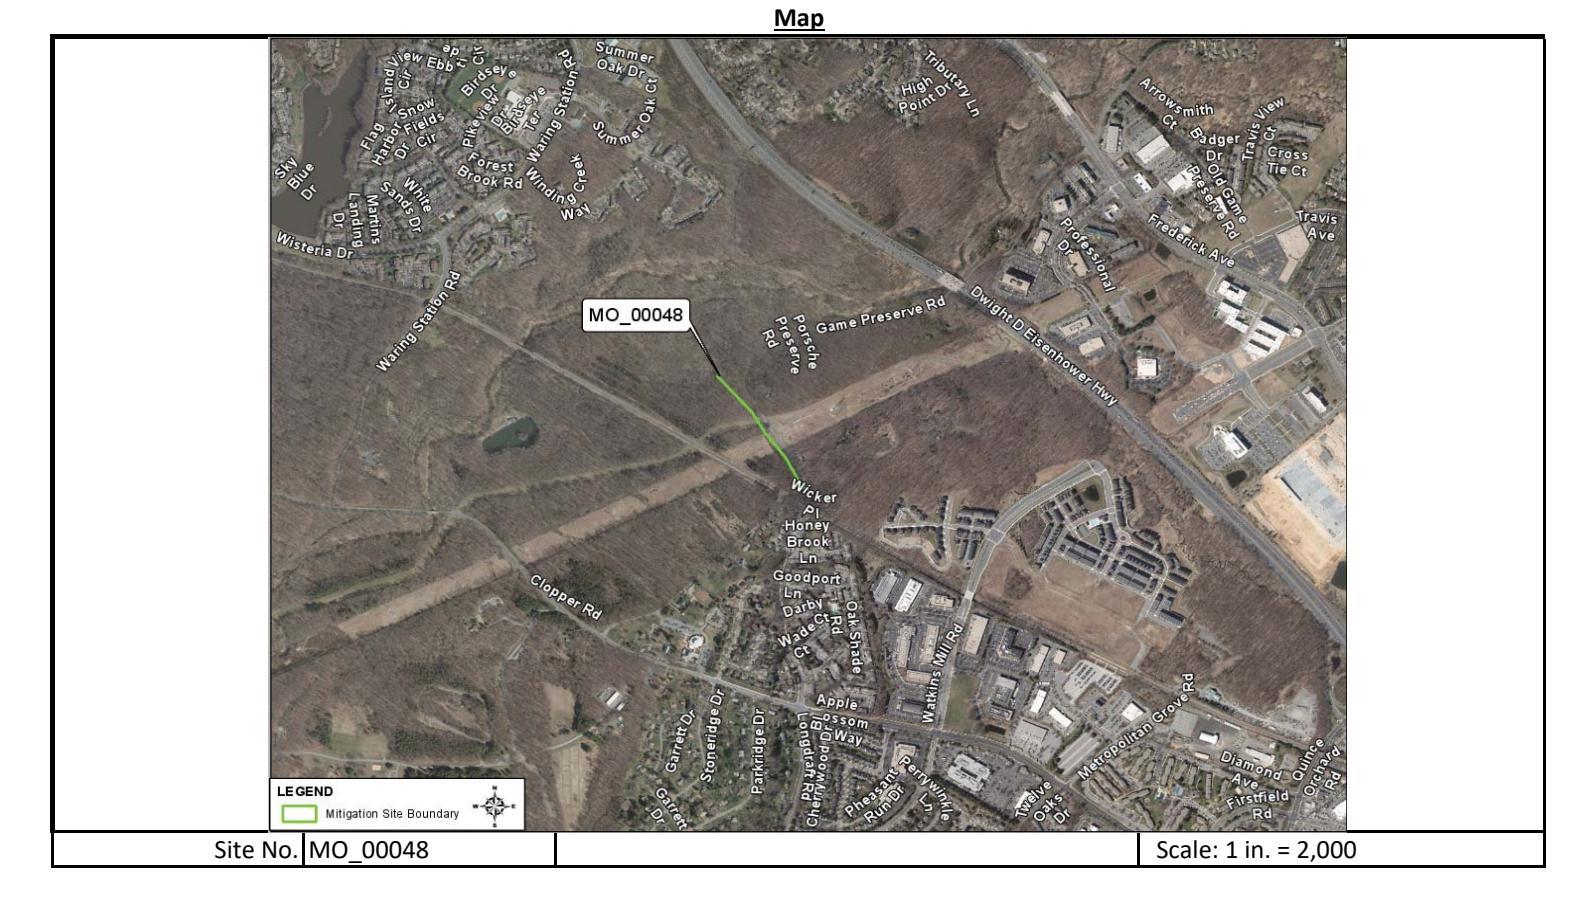
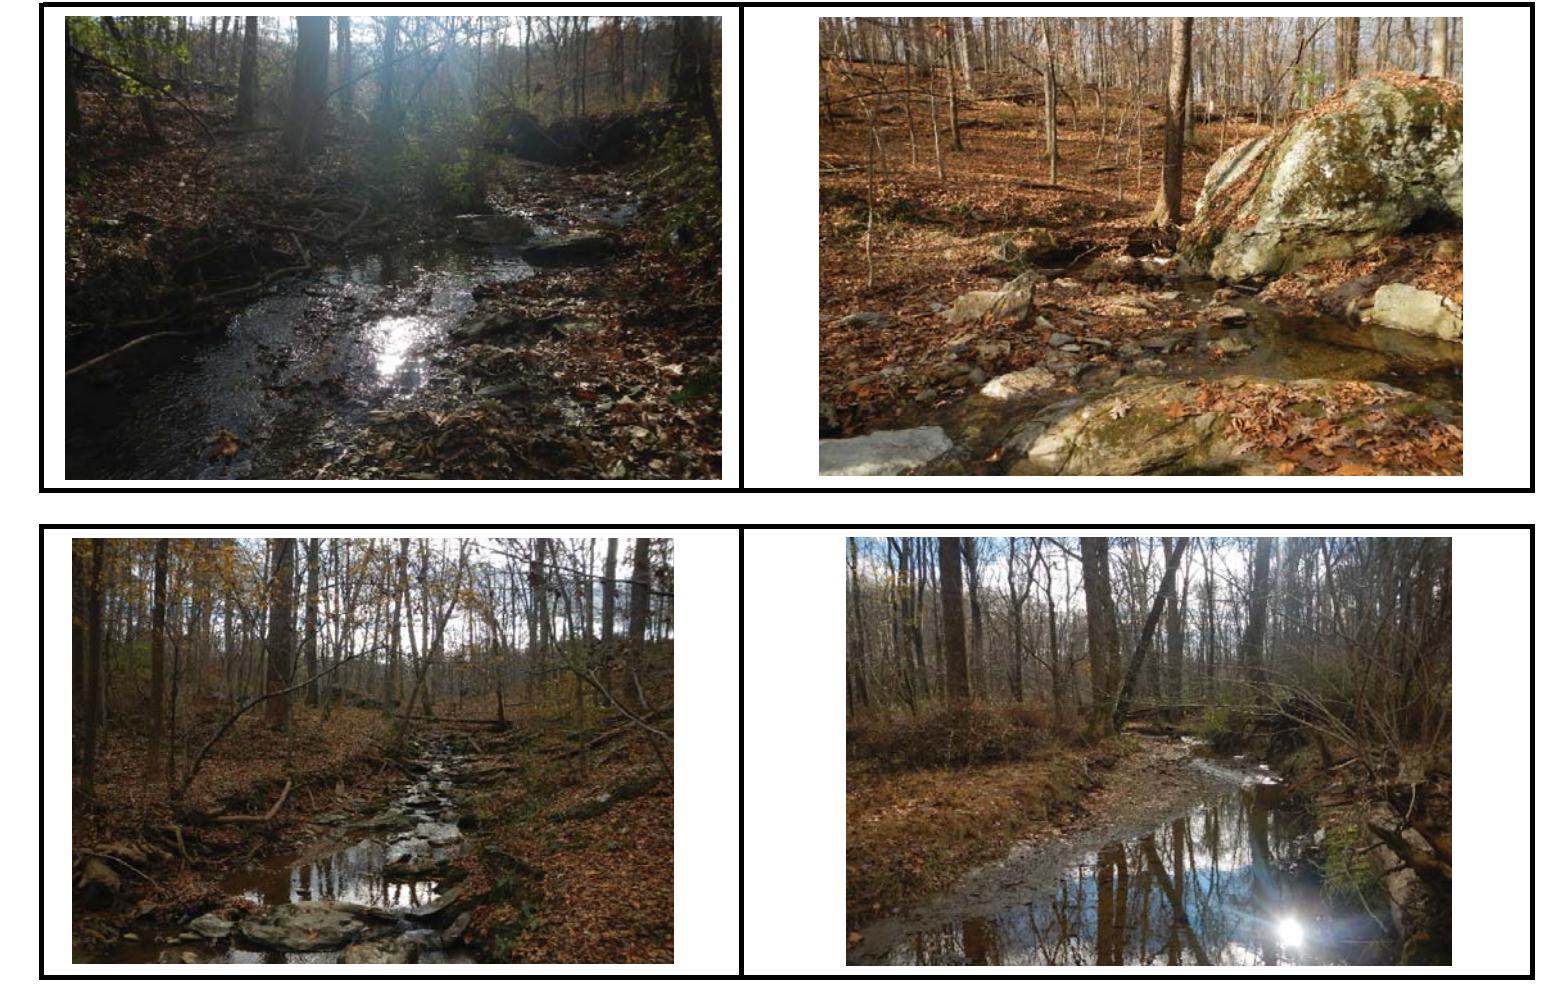
Site Photos

1 - Yes (evidence of freq	uent flooding)		1 - Conditions are such that Lift is diffic	cult to achieve and sustain	in
Describe:			Describe:		
Incised channel. Some of	ut-of-bank flows is evident	at top of bank.	Limited potential for improving instrea	im habitat , reducing ero	sion and
			floodplain development. Existing instre	eam habitat is good. Mos	st of site has
Our entry it. for the educ	- in Development	1	minor erosion and floodplain is restrict	ted by steep/narrow vall	<u>ev.</u>
Opportunity for Floodpl	ain Development	L mas stroom width	Ease of Access	accoss to notontial site)	T
5 Existing space for floo	odulain 2 to 10 timos stroa	mwidth	5 yos (open but no existing vehicular		
1 - Little to no snace for	floodnlain develonment		1 - No (no vehicular access clearing ne	veded)	
Describe:			Pescribe:	.cucu,	
Steen/narrow forested y	alley and adjacent roadwa	v limit notential for	Forest clearing would be required for t	the majority of the site

floodalain development	Bedrock outcrons observ	ad in floodnlain	rorest cleaning would be required for t	ine majority of the site.	
Ducine and Auge Fuelwetic		10	Litilities Dresent	r	F
Drainage Area Evaluatio	201	TÜ	10 No utilities on site		Э
5 - D A between 1 8.2 c	ni. a mi		5 - Itilities but not within restaration	area	
$1 - D \Delta$ greater than $2 c$	η α mi		1 - Utilities within potential restoration	n area	
	۲· ·'''·		Describe:		
				anth of -!+-	
Drainage area - 0.0002 s	quare miles.		Gas line and overnead powerlines just	South of Site.	
				10	
			Tota	al Score out of 100	31

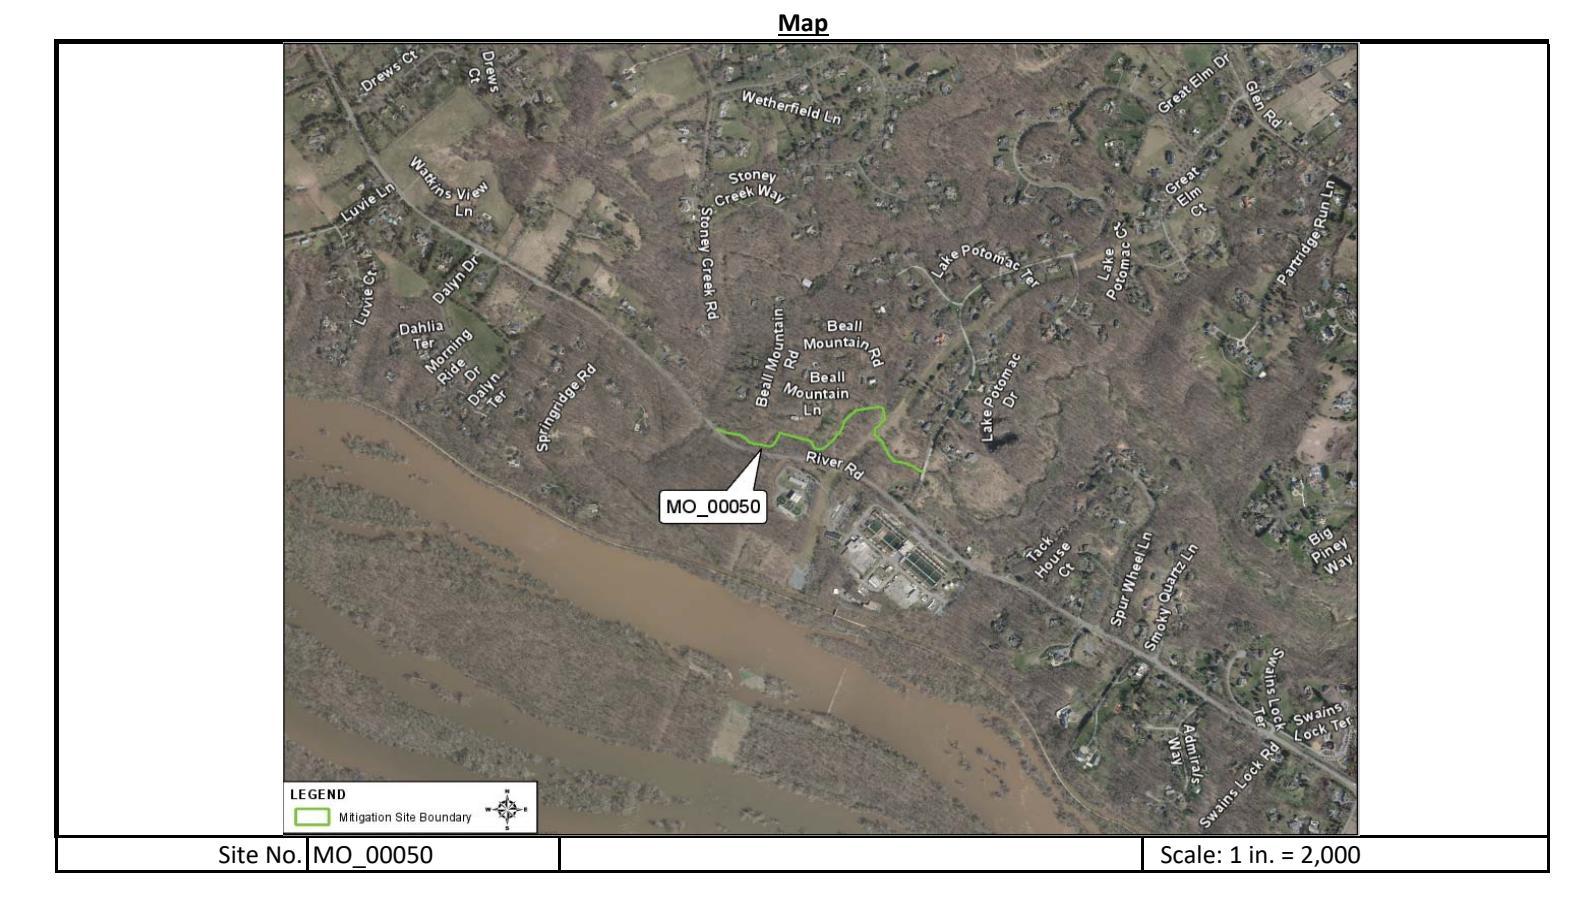
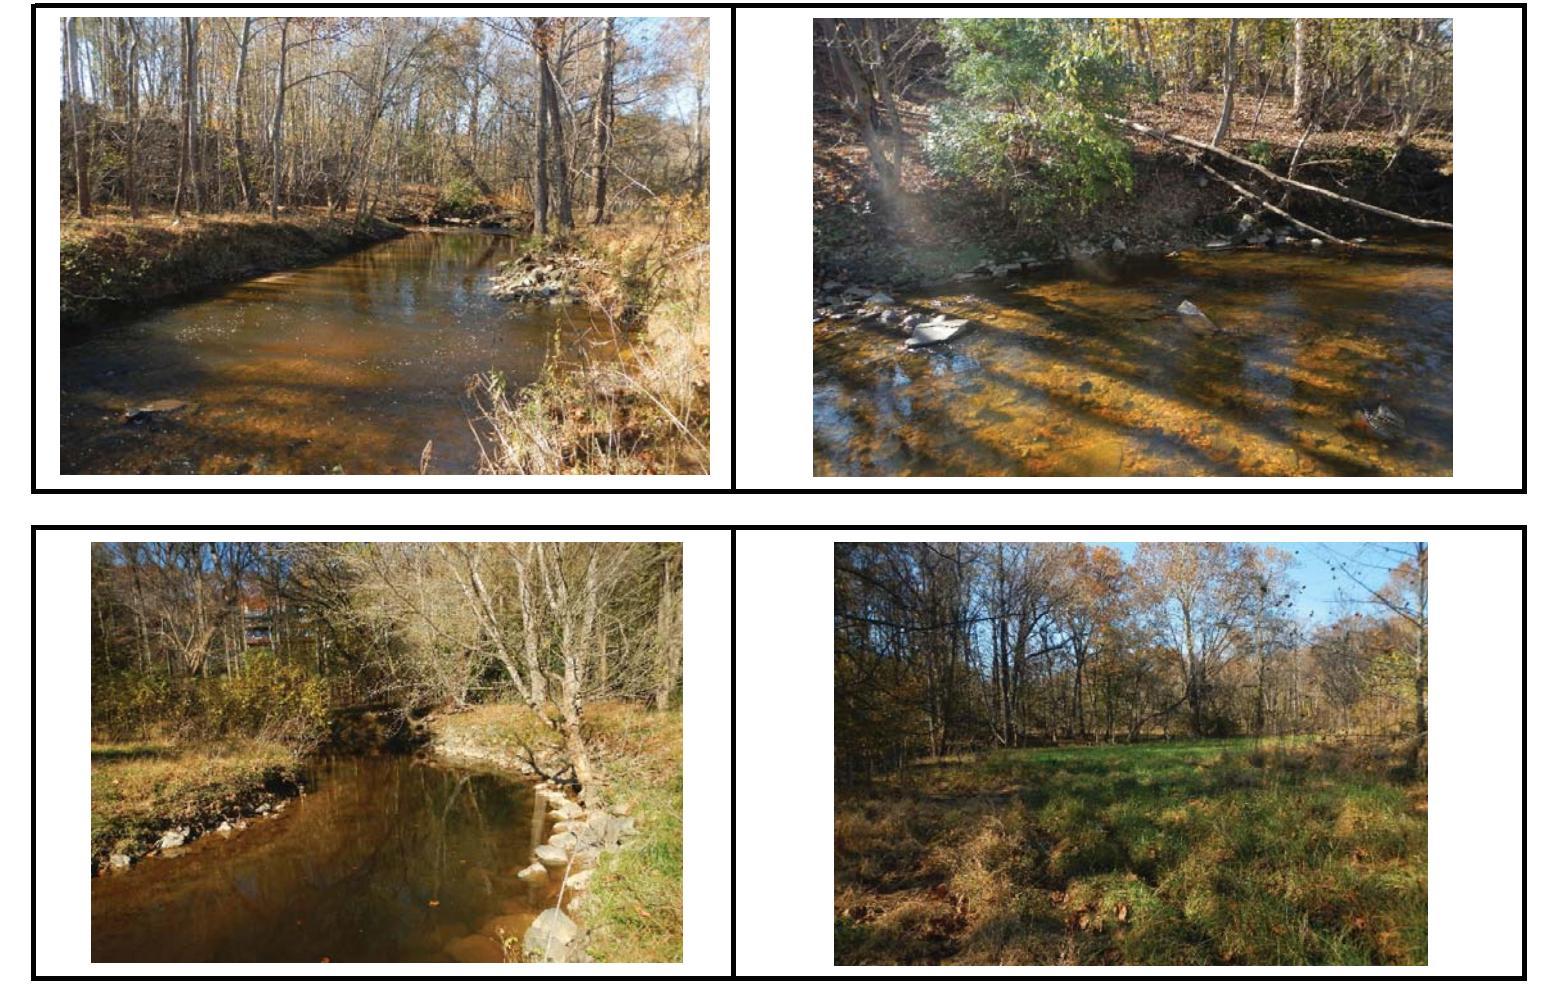
Describe:		Describe:		
Some evidence of matted down vegetation at to	p of banks.	Majority of banks appear stable. Large stream with existing aqu	uatic habitat.	
		Limited opportunity for floodplain development due to utilities	and valley	
		slope. Short segment on public property.		
Opportunity for Floodplain Development	1	Ease of Access	10	
10 - Existing space for floodplain greater than 10	times stream width	10 - Yes (with <u>existing</u> direct vehicular access to potential site)		
5 - Existing space for floodplain 3 to 10 times stre	eam width	5- yes (open but no existing venicular access)		
		1 - No (no veniculai access, clearing needed)		
Describe: Elegendelain development limited due to utilities a	nd vallov clono	Describe:	Accoss passas	
noouplain development innited due to utilities a	na vancy slope.	through DEM wetland	. Access passes	
Drainage Area Evaluation	1	Litilities Procent	1	
10 -D A less than 1 sq mi	1	10 - No utilities on site	L

5 - Utilities but not within restoration area		
1 - D. A. greater than 3 sq. mi.		1 - Utilities within potential restoration area		
Describe:		Describe:		
Drainage area - 16.6 square miles		Overhead powerlines and underground gas lines at downstroat	m and of site	
Brande area 10.0 square miles.		Likely sewer line along stream, however no manholes were ob	arved	
		Likely server fine along scream, however no mannoles were obs		
		Total Score out of 100	27

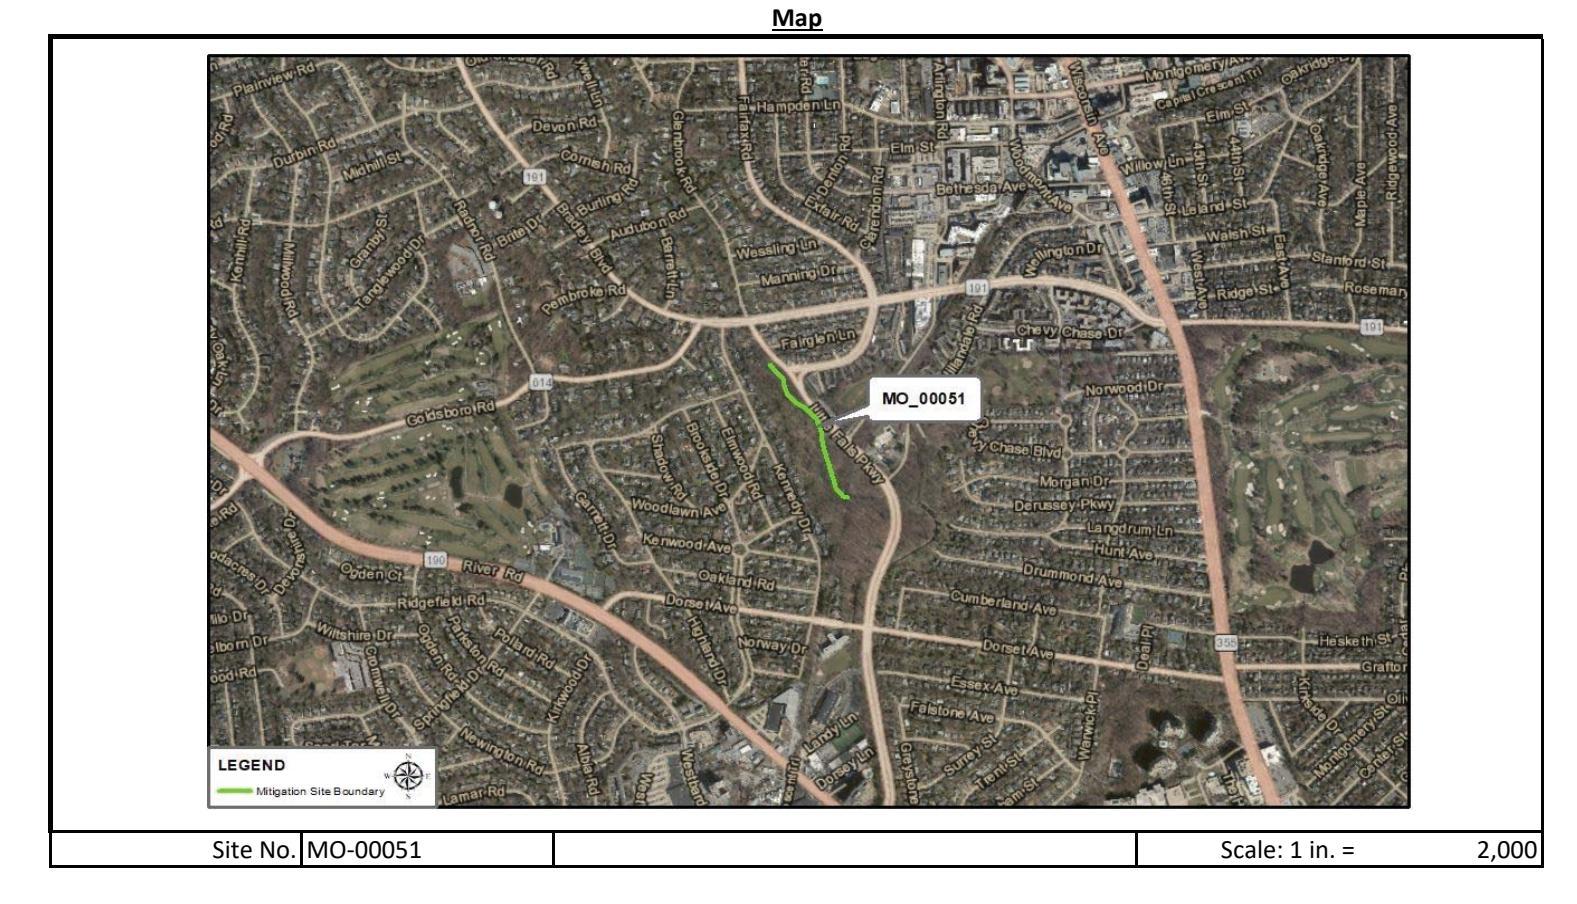
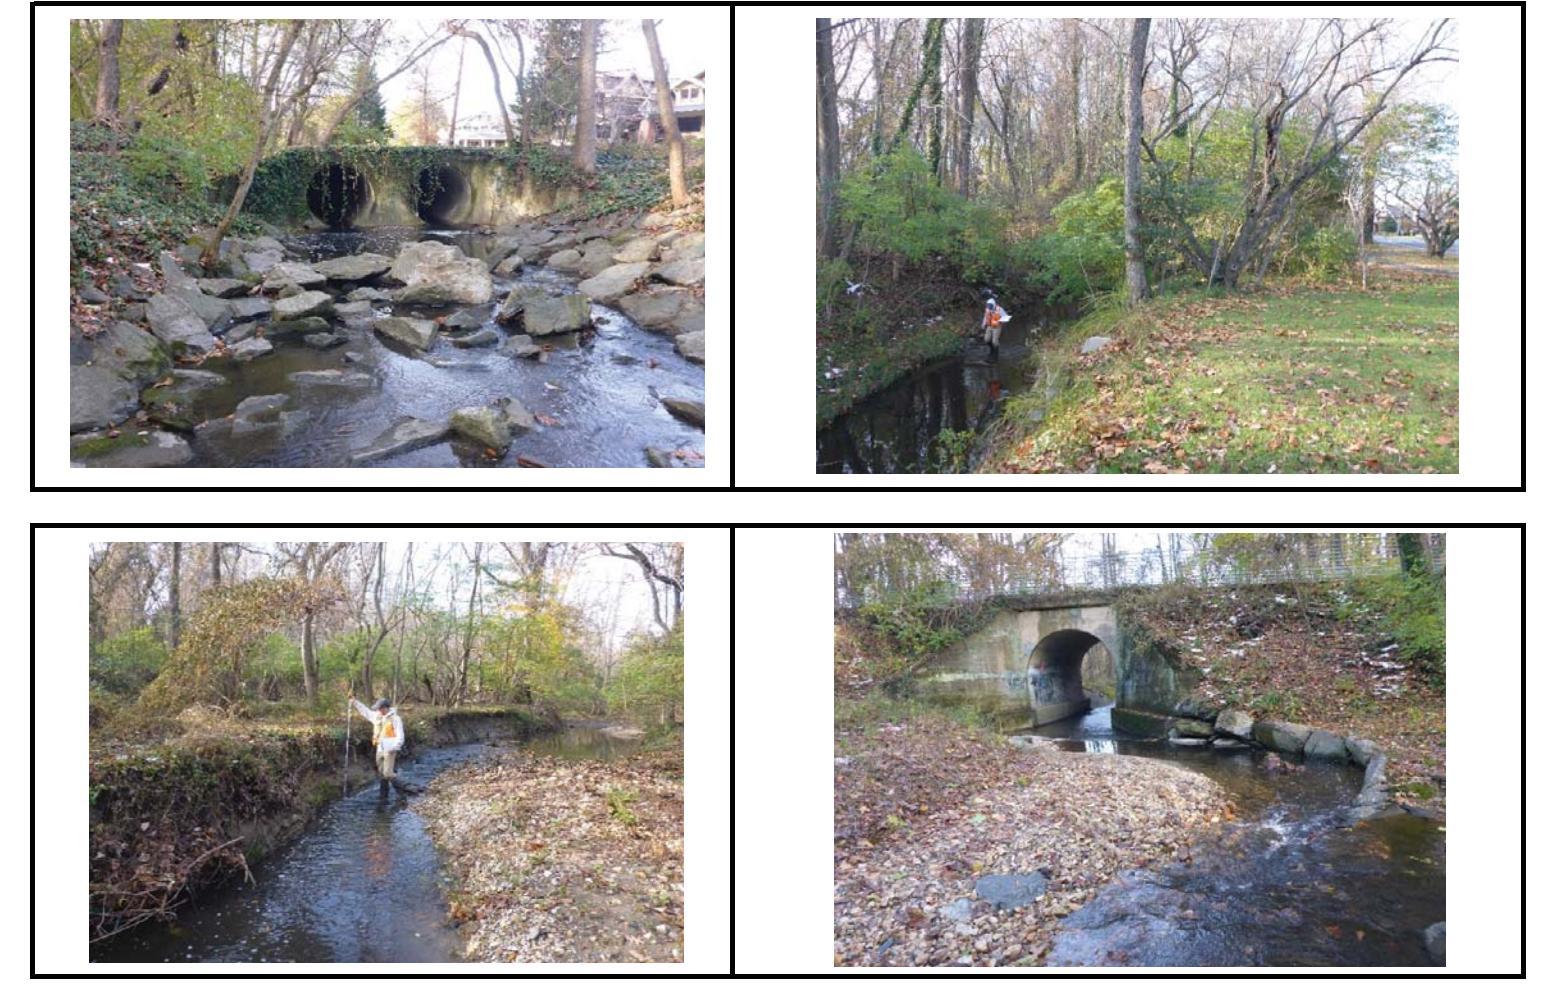
Str	eam Mitigation	Field Site Assessment Form	
		Pro	oject Details	
Project Name:	I-495/I-270 Managed Lan	es Study	Mitigation Site Number: MO-00051	
Projects Estimated Stream	n Mitigation Needs (LF):	TBD		
	11/10/0010		Consultant Firm (Investigate data -	
Date of Field Assessment:	11/16/2018	Location Dataila	Consultant Firm/Investigator(s): CRI/MD, SJ	
Country	Montgomony	Location Details	S-TAKEN TROM GESKTOP REVIEW	
County: Basin (HUC 8)	Middle Potomac-Catoctic	Cross Roads:	MDE Watershed (8 digit): 21/0202	
Proximity to Impacted S	tream (mi.):	2.3	Lat/Long: 38.974004	-77.102571
,		(Site Data	
Parcel Size (ac):	8 narcels - 32 1 39 4 0 3 0	≤ 3 0 3 0 3 0 4 0 5	Potential Restoration Reach (LE): 2 160	
Site Opportunities:	X Channel Restoration	Livestock Exclusion	X Riparian Buffer Planting Habitat Enhancement	Fish Passage
Stream Order:	 1st	Stream Hydrology:	Perennial Stream Use: 1	
Drainage Area to Reach	(sq. mi.)	0.48

Land Use:	Forest		Mapped Soils: Glenelg-Urban land cor	nplex, Gaila silt
Property Address:	Main Parcel - Little Falls F	arkway, Bethesda, I	MD 20814 loam	•
Property Owner(s):	Maryland National Capita	al Park & Planning Co	ommission & Mo. County RO	
		General F	ield Observations	
Is there evidence that the	ie stream has been distur	bed by some kind	Can the stream restoration be reasonably done within the con	ifines of the
of human action, like gra	ading, dumping, livestock	, culvert, etc?	parcel or does it require connections beyond the parcel limits	? Explain
Explain:			Explain:	
Yes, rip-rap placed down	stream of culvert at the to	op of the study	Site located on M-NCPPC parkland & Mo. County ROW. Can acc	ess directly
reach. Riffle grade contro	ol and other grade control	structures	from Little Falls Parkway.	
observed near trail cross	ing at downstream end			
		<u>Mitigat</u>	tion Site Rating	
<u>Criteria</u>		<u>Score</u>	Criteria	<u>Score</u>

Estimated Bank erosion	within reach	5	Vegetation	1
10 - Greater than 50%			10 - Herbaceous cover (non-wetland)	
5 - 10% to 50%			5 - Scrub-shrub cover (non-wetland)	
1 - Less than 10%			1 - Mostly forested and/or wetland	
Describe:			Describe:	
Approximately 30% of ba	anks are eroded.		Mowed lawn present on left bank for 2/3 of reach; inadequate	buffer.
Degree of Channel Incisi	on	5	Land Use	1
10 - Bank Height greater	than 10 feet		10 - Agricultural or Open Space	
5 - Bank Height between	3 and 10 feet		5 - Marginal Pasture	
1 - Bank Height less than Describe:	3 leet		1 - Old Held/ Developed/Forested	
Banks are ~2 E ft tall			Earost graater than 100 ft on right bank left bank is developed	(recidential
Baliks ale 5-5 It. tall.			Polest greater than 100 ft. of fight bank, left bank is developed	/iesidential.
Existing Floodplain Acce	SS	5	Opportunity for Ecological Lift	5
10 - No evidence of out o	of bank flooding		10 - Conditions exist for several aspects of lift to be achieved an	id sustained

5-Yes (Infrequent out of	bank flow)		5 - Lift limited to one or few aspects	
1 - Yes (evidence of frequence of frequence)	Jent flooding)		1 - Conditions are such that Lift is difficult to achieve and sustain Described	n
Describe:				
Areas of low bank storm	relief.		Upstream section is highly developed, constrained on left bank	by road,
			channel elevation controlled upstream/downstream by culverts	s, possible
Onnortunity for Floodal	ain Davalanmant	5	floodplain reconnection.	5
10 Existing space for flo	am Development	mos stroom width	Lase of Access	J
5 - Existing space for floo	udplain 3 to 10 times strea	m width	5- ves (open but no existing vehicular access)	
1 - Little to no space for	floodolain development		1 - No (no vehicular access clearing needed)	
Describe:			Describe:	
2/3 of stream can be acc	essed with tree impacts. T	op 1/3 constrained	Mapped out potential access from previous work from Little Fal	lls Pkwv.

by valley and road. Poter	ntial exists to make low he	nches		
by valley and road. Poter		nones.		
	-	10		1
Urainage Area Evaluatio	n	10	Utilities Present	1
10 - D.A. less than 1 sq. m	II. n mi		10 - NO UTITIES ON SITE	
J = D. A. Delweell I & 3 S(1 = D A greater than 2 $c_{\rm e}$	4 a mi		1 - Utilities within notential restoration area	
Describe:	1			
	ara mila		Describe:	
Drainage area - 0.48 squ	are mile.		Runs parallel to stream. Possible crossings.	
			Total Score out of 100	43

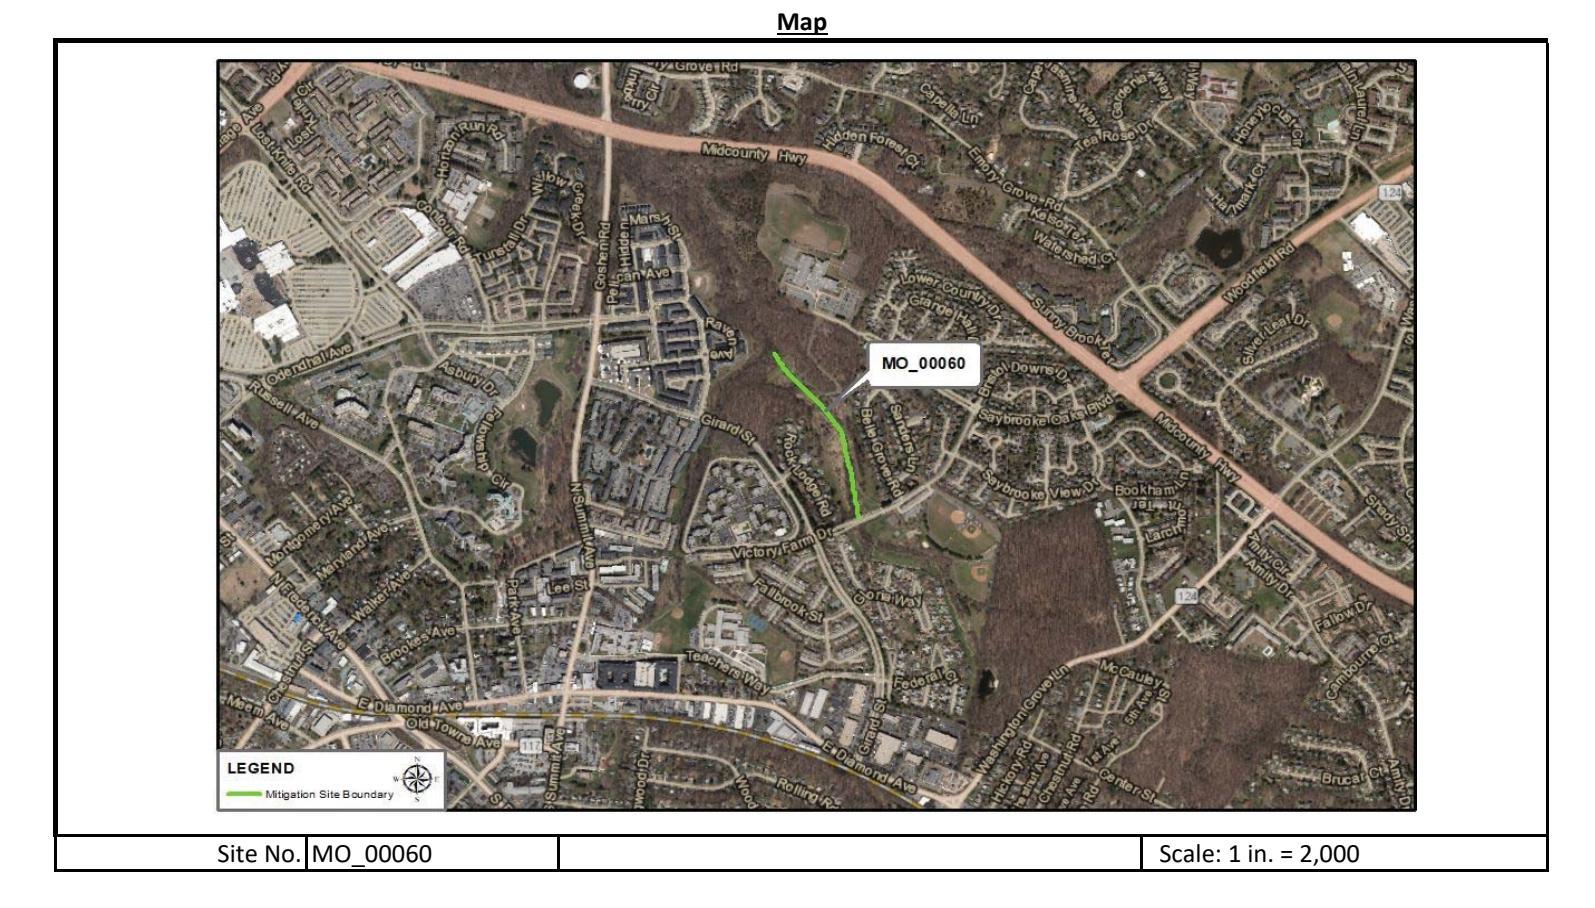
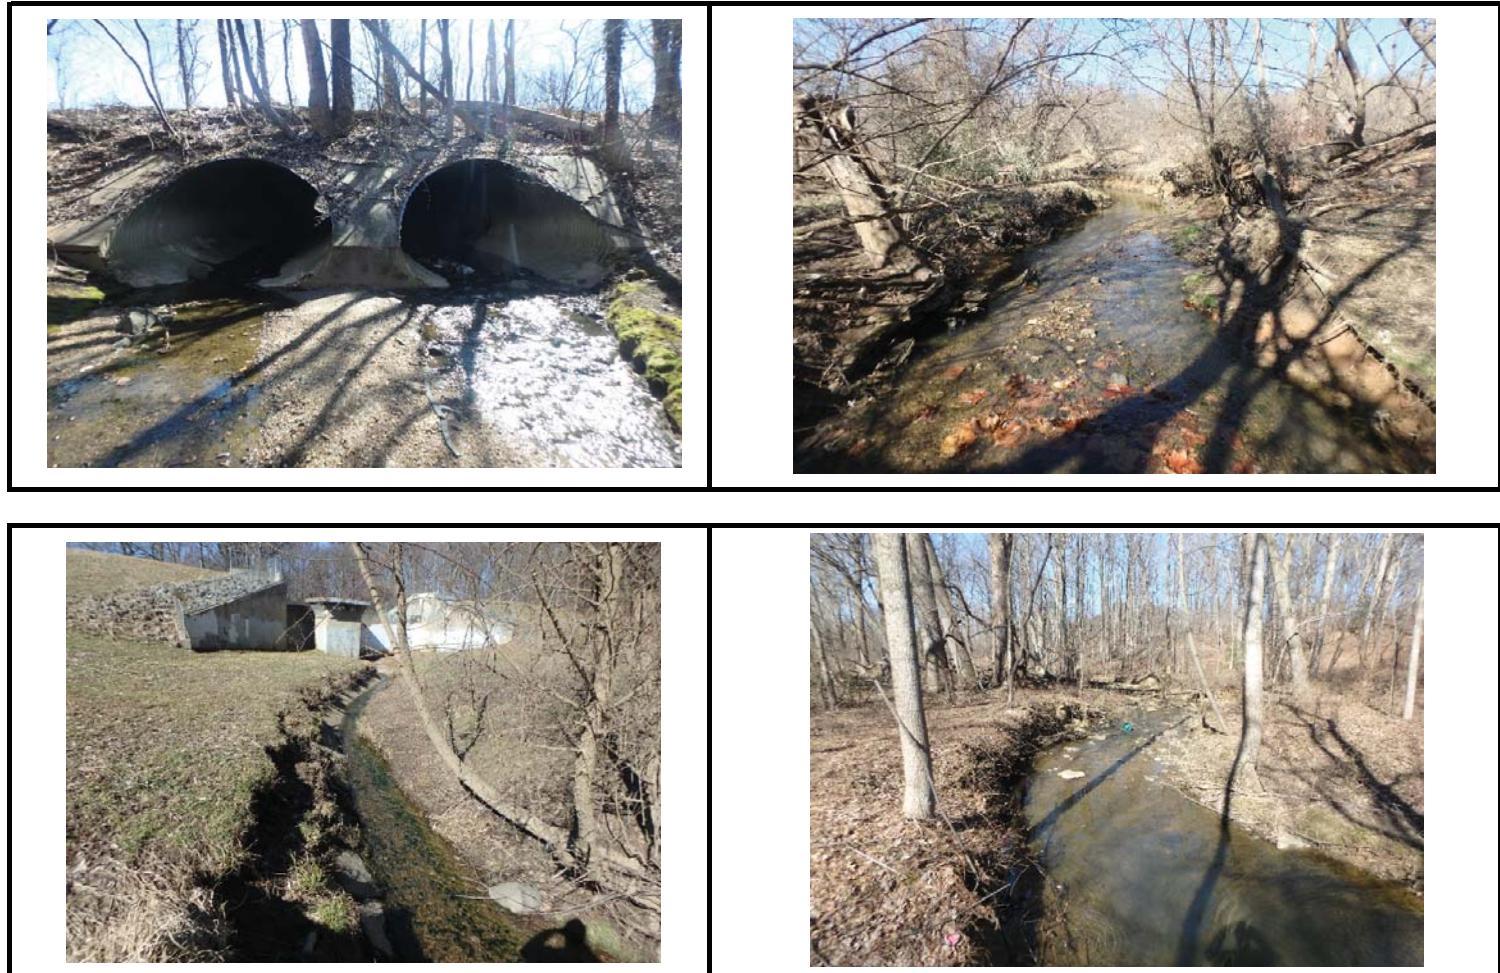
Str	eam Mitigation	Field Site Assessment Form	
		Pro	bject Details	
Project Name:	I-495/I-270 Managed Lan	es Study	Mitigation Site Number: MO_00060	
Projects Estimated Stream	n Mitigation Needs (LF):	TBD	-	
Date of Field Assessment:	2/25/2019		Consultant Firm/Investigator(s): CRI/DS_IG_LE	
Date of field Assessment.	Site	Location Details	s-taken from deskton review	
County:	Montgomery	Cross Roads:	victory Farm Dr. & Belle Grove Rd.	
Basin (HUC 8):	Middle Potomac-Catoctir	1	MDE Watershed (8 digit): 02140208	
Proximity to Impacted S	tream (mi.):	1.57	Lat/Long: 39.14979	94 -77.184313
			Site Data	
Parcel Size (ac):	2 parcels - 5.3, 27.9		Potential Restoration Reach (LF): 1,93	34
Site Opportunities:	XChannel Restoration	Livestock Exclusion	XRiparian Buffer PlantingXHabitat Enhanceme	ent
Stream Order:	1st	Stream Hydrology:	Perennial Stream Us	e:
Drainage Area to Reach	(sq. mi.) Modium Donsity Posidon	0.78 tial Forest	Mannad Saila

Land Use: Property Address	Main Parcel - Victory Far	nal, Foresi ns Drive Gaithersh	Hatboro	silt loam
Property Owner(s):	City of Gaithersburg	ns brive, Gaithersb		
	, 0	General F	ield Observations	
Is there evidence that th	ne stream has been distur	bed by some kind	Can the stream restoration be reasonably done within the	e confines of the
of human action, like gra	ading, dumping, livestock	, culvert, etc?	parcel or does it require connections beyond the parcel lin	mits? Explain
Explain:			Explain:	
Yes; Culverts, stream cro	ssing present.		Yes; Can be done within parcel, City of Gaithersburg land/p	oark.
Critoria		<u>Mitiga</u>	tion Site Rating	Scoro
Criteria Estimated Bank areaion	within roach	<u>3001e</u>	Vegetation	<u>3core</u>
10 Greater than 50%	within reach	5	Vegetation	5
5 - 10% to 50%			5 - Scrub-shrub cover (non-wetland)	
1 - Less than 10%			1 - Mostly forested and/or wetland	
Describe:			Describe:

1 - Yes (evidence of frequence of frequence)	uent flooding)		1 - Conditions are such that Lift is difficult to achieve and si	Jstain
Describe:	low in areas where channy	l is loss incised	Describe:	Loustainad
		er is less incised.	Hydraulics, hydrology, geomorphic int can be achieved and	sustameu.
Opportunity for Floodpl	ain Development	5	Ease of Access	10
10 - Existing space for flo	podplain greater than 10 ti	mes stream width	10 - Yes (with existing direct vehicular access to potential s	ite)
5 - Existing space for floc	odplain 3 to 10 times stream	m width	5- yes (open but no existing vehicular access)	
1 - Little to no space for	floodplain development		1 - No (no vehicular access, clearing needed)	
Describe:			Describe:	
Most existing space alon	g right bank, limited by sev	wer utility and	Clearing needed in some areas, existing paved path paralle	ls stream for entire
wetland on left bank.			reach.

Drainage Area Evaluatio	n	10	Utilities Present	1
10 -D.A. less than 1 sq. m	ni		10 - No utilities on site	
5- D. A. between 1 & 3 so	q. mi.		5 - Utilities but not within restoration area	
I - D. A. greater than 3 s	q. mi.		1 - Utilities within potential restoration area	
Describe:				
Drainage area - 0.78 squ	are mile.		Sewer parallel to site, potential crossing.	
			Total Score out of 10	0 52

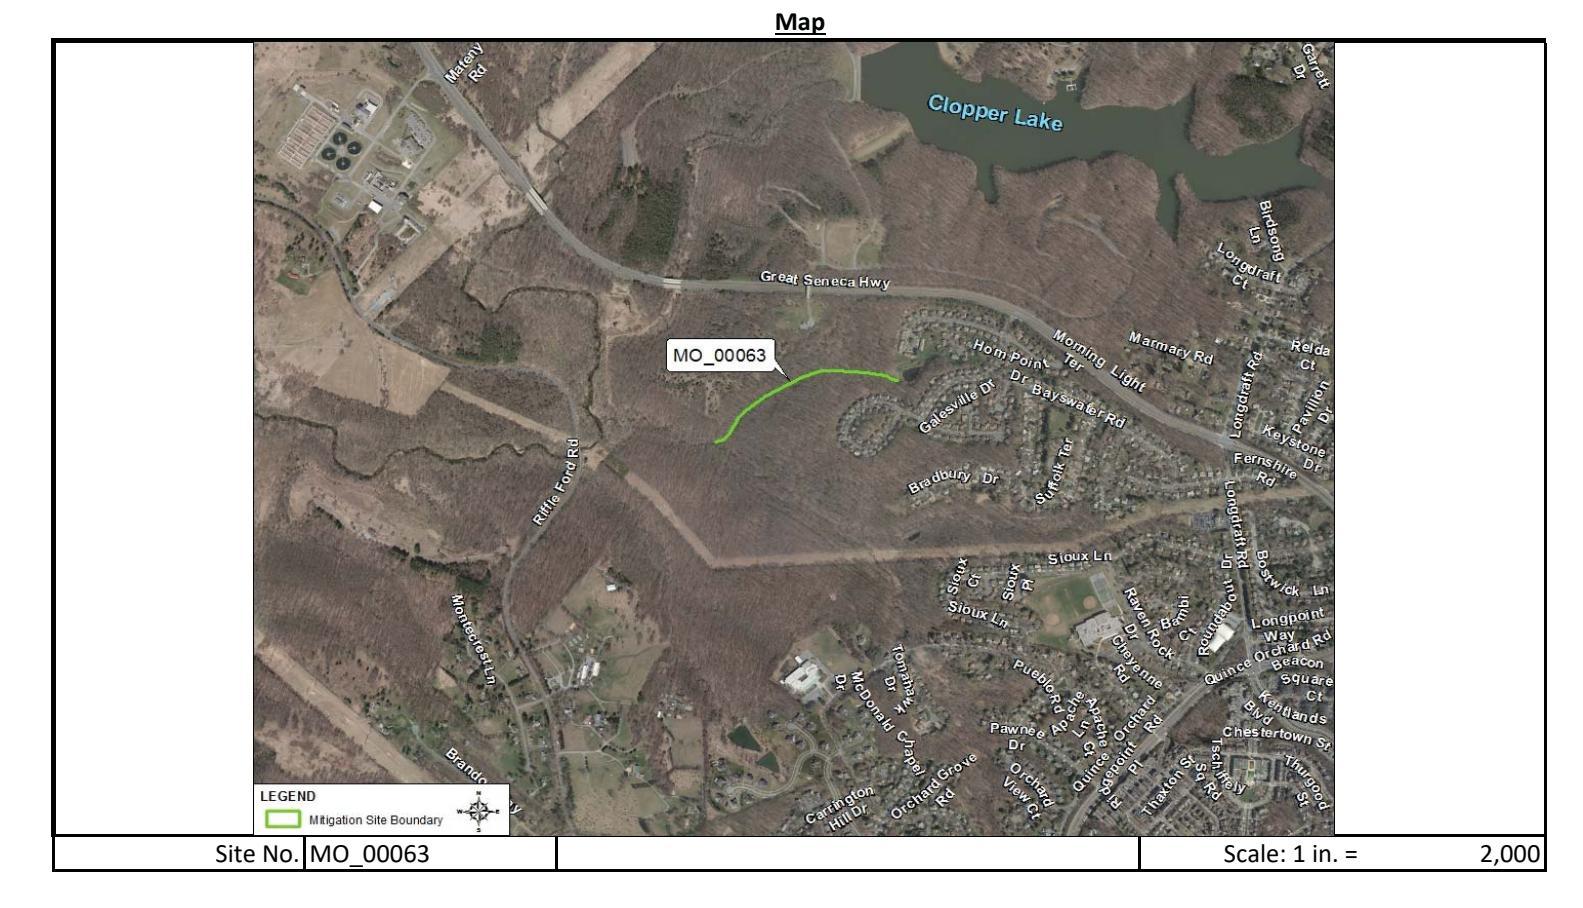
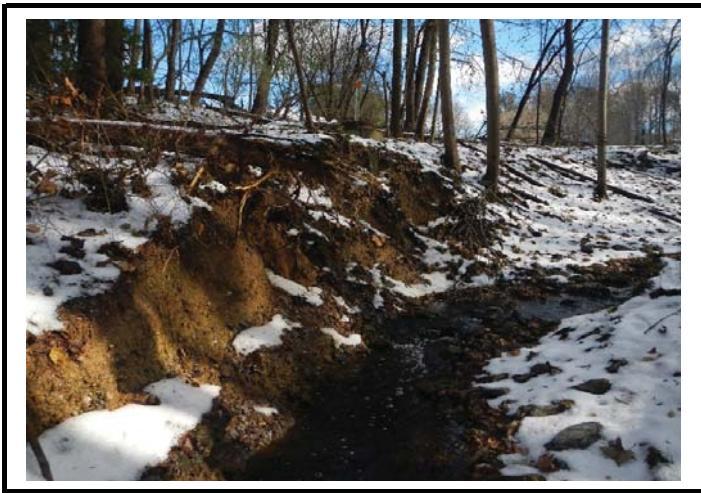
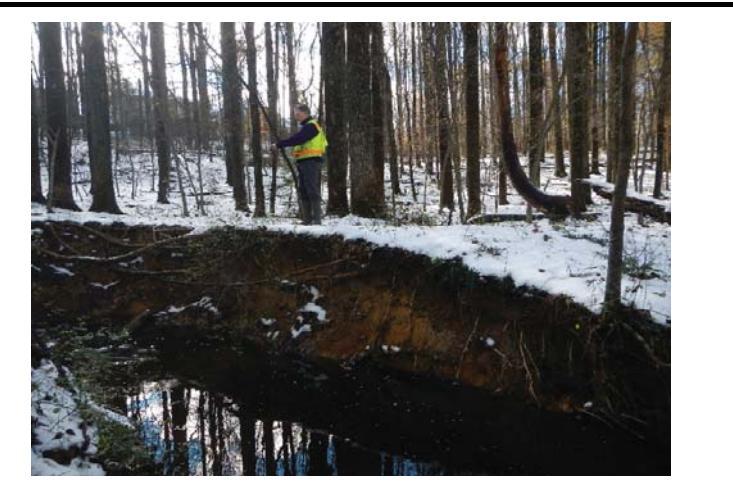
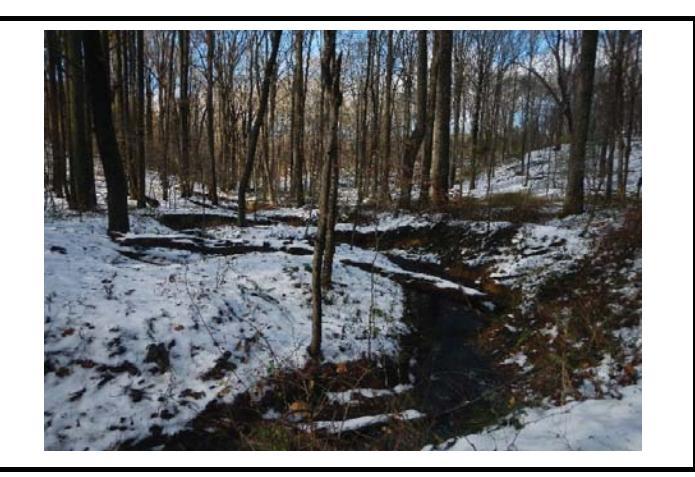
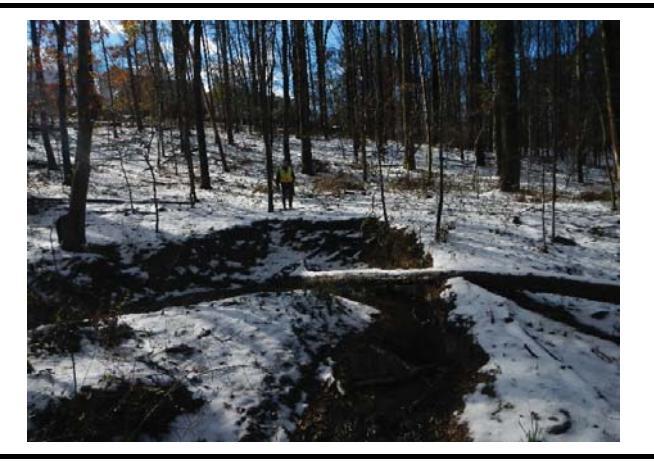
Stream Mitigation Field Site Assessment Form				
		Pro	pject Details	
Project Name:	I-495/I-270 Manage	d Lanes Study	Mitigation Site Number: MO 00063	
Projects Estimated Strean	n Mitigation Needs (LF):	TBD

-	• • •		_	
Date of Field Assessment:	11/16/2018		Consultant Firm/Investigator(s): RK&K/KJH	<i>,</i> DB
	Site	Location Details	s-taken from desktop review	
County:	Montgomery	Cross Roads:	: Morning Light Ter. & Morning Light Ct.	
Basin (HUC 8):	Middle Potoma	c-Catoctin	MDE Watershed (8 digit): 0214020)8
Proximity to Impacted Str	eam (mi.):	2.64	Lat/Long: 39.13487705	-77.26027051
		(Site Data	
Parcel Size (ac):	1 411 3	<u>.</u>	Potential Restoration Reach (IF): 2 240	
Site Opportunities:	X Channel Restoration	Livestock Exclusion	Pinarian Ruffer Planting X Habitat Enhancement	Y Eich Dassage
Stream Order:		Stream Hydrology	· Nparian burier Flancing nabitat Enhancement	AFISH Fassage
Drainage Area to Reach (0.16		
Land Lice.	Forest	0.10	Manned Soils: Brinklow blocktown cha	annery silt loam
Property Address	FUIESL	;	11900 Clopper Pd	siniery site ioani
Property Owner(s)		Maryland De	nartment of Natural Resources

meanders & meander brea	akthroughs.		specimen tree impacts along channel. No wetlands observed.	
Degree of Channel Incisio	~	5	Land Lico	1
10 Ponk Hoight groater th	ll han 10 faat	J	10 Arrigultural or Open Space	±
10 - Balik Height between 2			10 - Agricultural of Open Space	
5 - Bank Height between 5	and to reet		5 - Marginai Pasture	
1 - Bank Height less than 5	feet		1 - Old field/ Developed/Forested	
Describe:			Describe:	
Banks are 3-10 feet tall.			Entire site surrounded by mid-successional good quality forest	in Seneca Creek
			State Park. Potential specimen tree impacts along channel.	
Fuisting Floodulain Assoc			One ontenity for Foological Life	10
Existing Floodplain Access) head flooding	5	Opportunity for Ecological Lift	UL De di su stalina d
10 - No evidence of out of	bank flooding		10 - Conditions exist for several aspects of lift to be achieved a	nd sustained
5- Yes (Infrequent out of b	ank flow)		5 - Lift limited to one or few aspects

1 - Yes (evidence of freque	ent flooding)		1 - Conditions are such that Lift is difficult to achieve and susta	in
Describe:			Describe:	
Some evidence of out-of-b	bank flow in localized area	as.	Good potential for reducing erosion, improving instream habit	at, and providing
			fish passage.	
Opportunity for Floodplai	in Development	5	Ease of Access	10
10 - Existing space for floo	dplain greater than 10 tir	mes stream width	10 - Yes (with existing direct vehicular access to potential site)	
5 - Existing space for flood	Iplain 3 to 10 times strear	n width	5- ves (open but no existing vehicular access)	
1 - Little to no space for flo	oodplain development		1 - No (no vehicular access, clearing needed)	
Some opportunity for floo	dalain development, hov	vever sections of	Existing sewer line access for majority of site. Northern section	may require
			Existing sewer line access for majority of site. Northern section	inay require

the site are limited by the	narrow/steep valley and	sewerine	some scrub/snrub clearing.	
constraints.				
Drainage Area Evaluation		10	Utilities Present	1
10 -D.A. less than 1 sq. mi.			10 - No utilities on site	
5- D. A. between 1 & 3 sg.	mi.		5 - Utilities but not within restoration area	
1 - D. A. greater than 3 sq.	. mi.		1 - Utilities within potential restoration area	
Describe.			Describe:	
Drainage Area - 0.78 squai	re miles		Sewer line runs parallel to stream along northern hillslope.	
			Total Score out of 100	58
