APPENDIX E: PUBLIC SITE WALKTHROUGH RATING CRITERIA & FIELD ASSESSMENT FORMS

WETLAND MITIGATION RATING CRITERIA & FIELD SITE ASSESSMENT FORMS

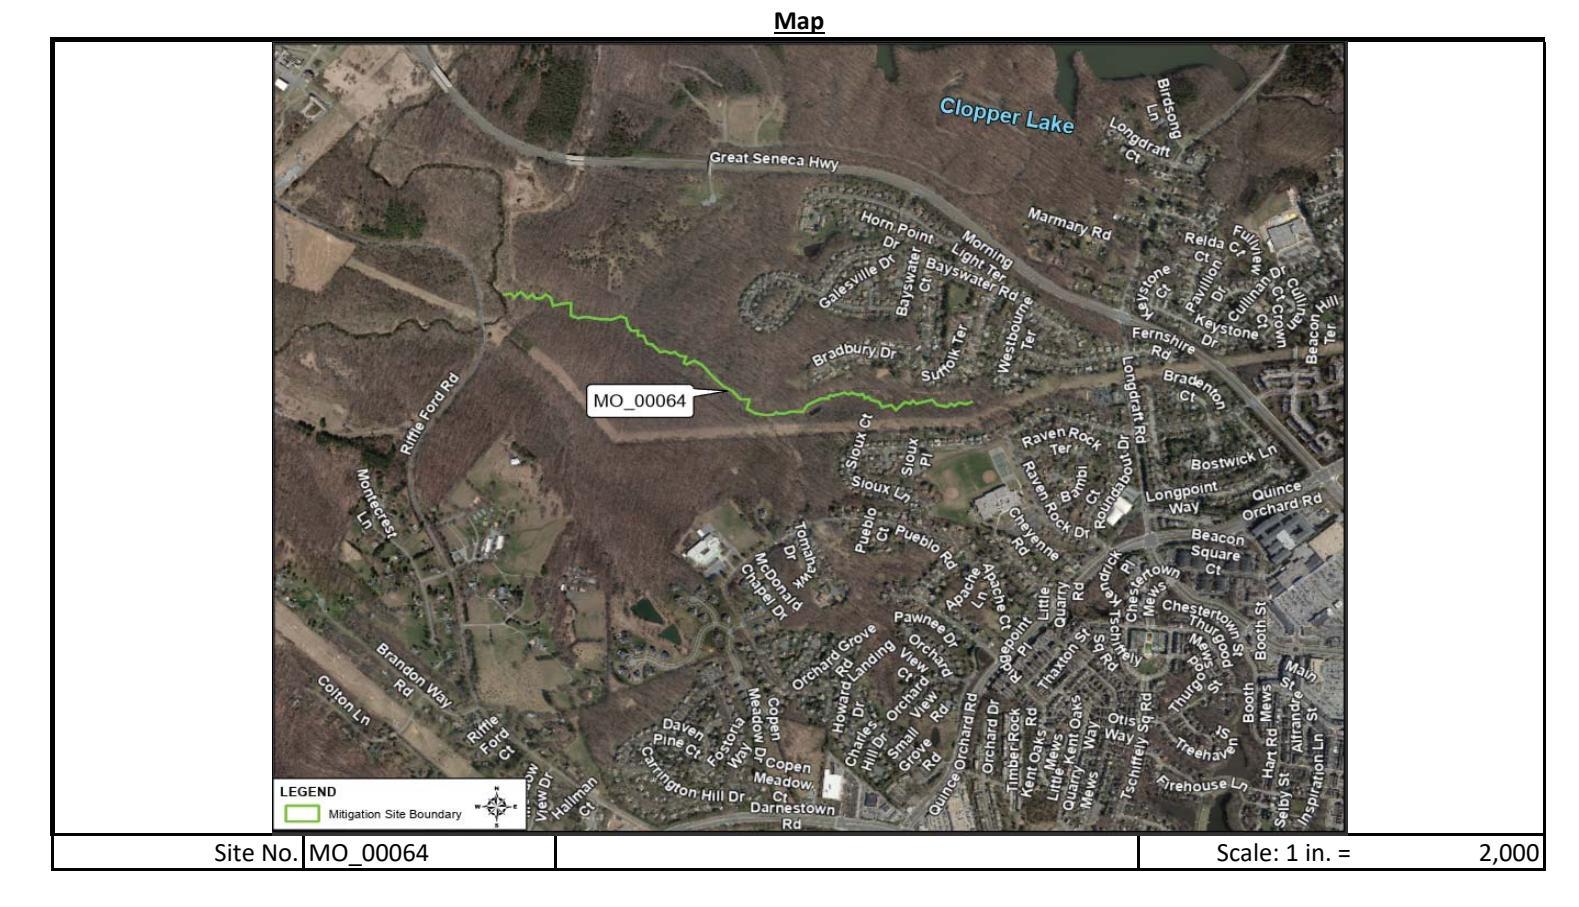
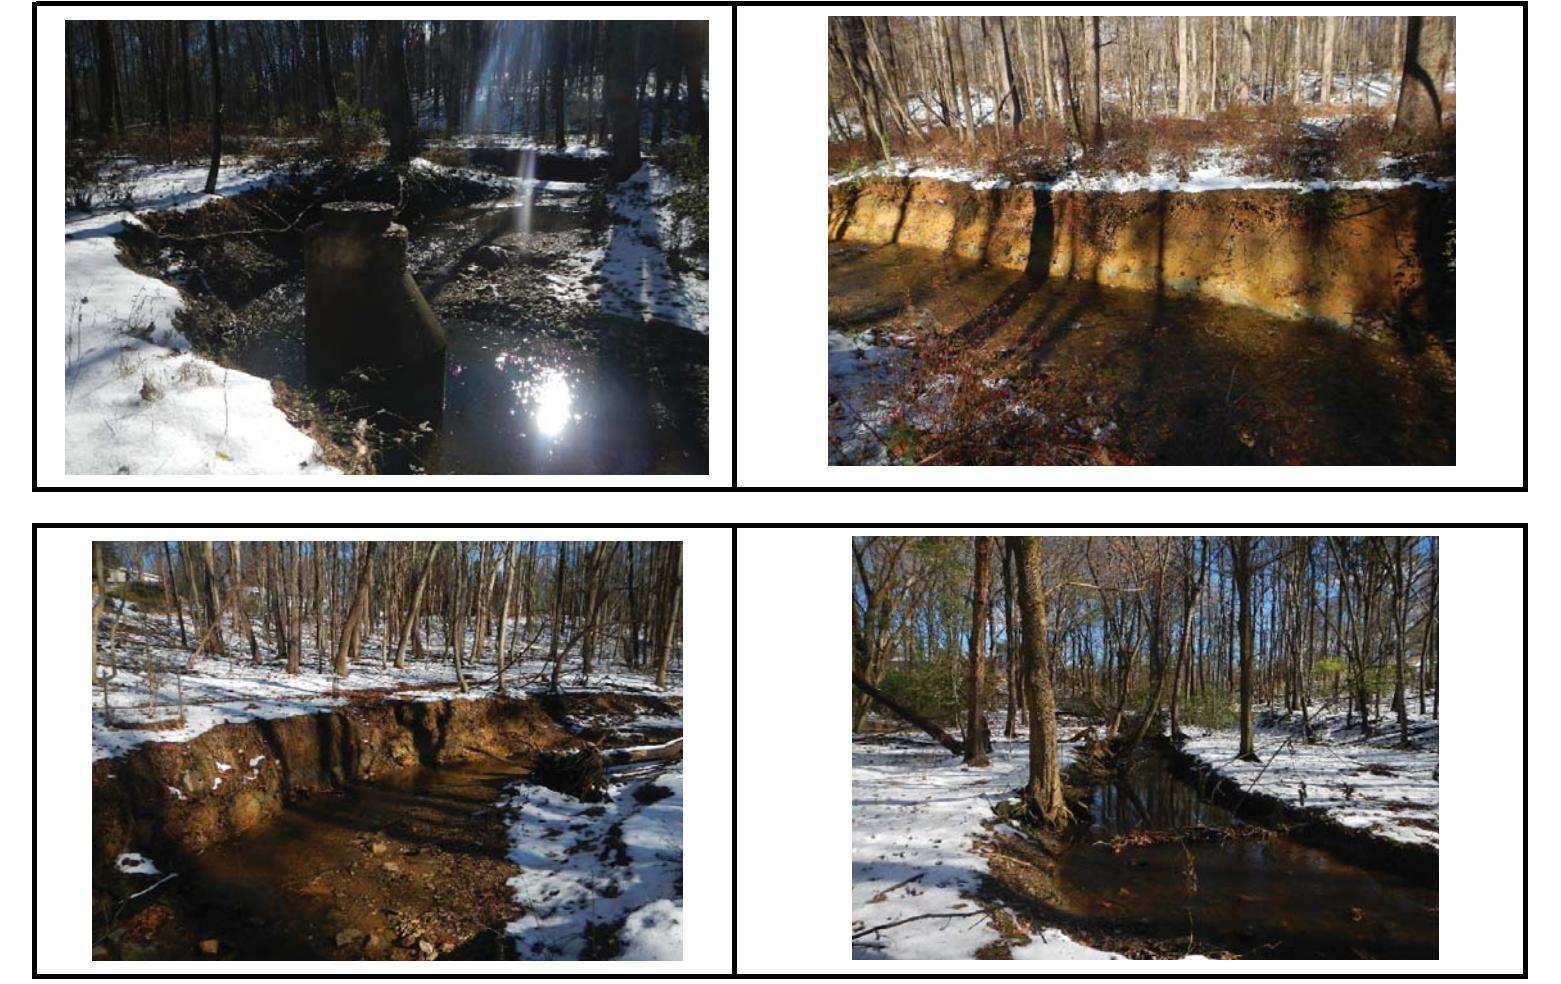
Site Photos

Stream Mitigation Field Site Assessment Form				
		Pro	oject Details		
Project Name:	I-495/I-270 Managed Lan	es Study	Mitigation Site Number:	MO_00064	
Projects Estimated Strea	am Mitigation Needs (LF)	TBD	_		
Data of Field Assessments	11/16/2019		Concultant Firm (Investigator(c))	סק חוא/איא	
Date of Field Assessment:	11/10/2010 Sito	Location Detail	s-taken from deskton review	rrary rjn, Db	
County:	Montgomery	Cross Roads	Bradbury Dr. & Suffolk Terrace		
Basin (HUC 8):	Middle Potomac-Catoctir		MDE Watershed (8 digit):	02140208	
Proximity to Impacted S	Stream (mi.):	2.64	Lat/Long:	39.13030063	-77.25646132
	· ·	1	Site Data		
Parcel Size (ac):	3 parcels - 1.411.3, 16.3 8	2 9.3	Potential Restoration Reach (LF):	6.945	
Site Opportunities:	X Channel Restoration	Livestock Exclusion	Riparian Buffer Planting	X Habitat Enhancement	Fish Passage
Stream Order:	2nd	Stream Hydrology	Perennial	Stream Use:	
Drainage Area to Reach	(sq. mi.)	1.05

Land Use:	Fores	t	Mapped Soils:	Codorus silt loam & Bai	ile silt loam
Property Address:	Main Parcel - 11900 Clop	per Rd.	-		
Property Owner(s):	Maryland Department of	Natural Resources	& Maryland National Capital Park & Pla	nning Commission	
		<u>General F</u>	ield Observations		
Is there evidence that t	he stream has been distur	bed by some kind	Can the stream restoration be reason	ably done within the co	onfines of the
of human action, like gr	ading, dumping, livestock	, culvert, etc?	parcel or does it require connections	beyond the parcel limit	s? Explain
Explain:			Explain:		
Several sewer crossings.	Instream stormwater stru	cture just	Restoration is feasible within one MDN	IR parcel and two M-M(CPC parcels.
upstream along trib that flows into site mainstem. Footbridge					
crossing at northern end	d of site.				
		<u>Mitiga</u>	tion Site Rating		
<u>Criteria</u>		<u>Score</u>	Criteria		<u>Score</u>

10 - No evidence of out	of hank flooding	5	10 - Conditions exist for several aspect	s of lift to be achieved a	and sustained
5- Yes (Infrequent out of	f hank flow)		5 - Lift limited to one or few aspects	.3 OF INT TO DE ACINEVEU A	ina sastamea
1 - Yes (evidence of freq	uent flooding)		1 - Conditions are such that Lift is difficult to achieve and sustain		
Describe:			Describe:		
Minor evidence of out-o	f-hank flows near top of h	ank	Good potential for reducing erosion in	ostream habitat improve	ements and
			improving downstream floodplain acco		inches, and
					10
Opportunity for Floodp	lain Development	5	Ease of Access		10
10 - Existing space for fig	bodplain greater than 10 ti	mes stream width	10 - Yes (with <u>existing</u> direct venicular	access to potential site)	
5 - Existing space for floo	floodplain 3 to 10 times strea	m width	5- yes (open but no existing venicular a	access)	
			1 - NO (NO VENICULAI ACCESS, Clearing he	eueu)

Describe:	d by parrow (steep valley 1	Detential for	Describe:	mast of site May requir	o cloaring como
	u by narrow/steep valley.			most of site. May requir	e clearing some
floodplain access improv	vements in downstream se	ction where	smaller trees and stream crossings.		
tioodplain is wider and v	alley is less steep.				
Drainage Area Evaluatio	on	5	Utilities Present		1
10 -D.A. less than 1 sq. r	ni.		10 - No utilities on site		
5- D. A. between 1 & 3 s	q. mi.		5 - Utilities but not within restoration a	area	
1 - D. A. greater than 3 s	iq. mi.		1 - Utilities within potential restoration	1 area	
Describe:			Describe:		
Drainage area - 1.05 squ	are miles.		Sewer line runs parallel to stream and	crosses the stream in a	couple locations.
			Manhole observed in center of channe	<u></u>

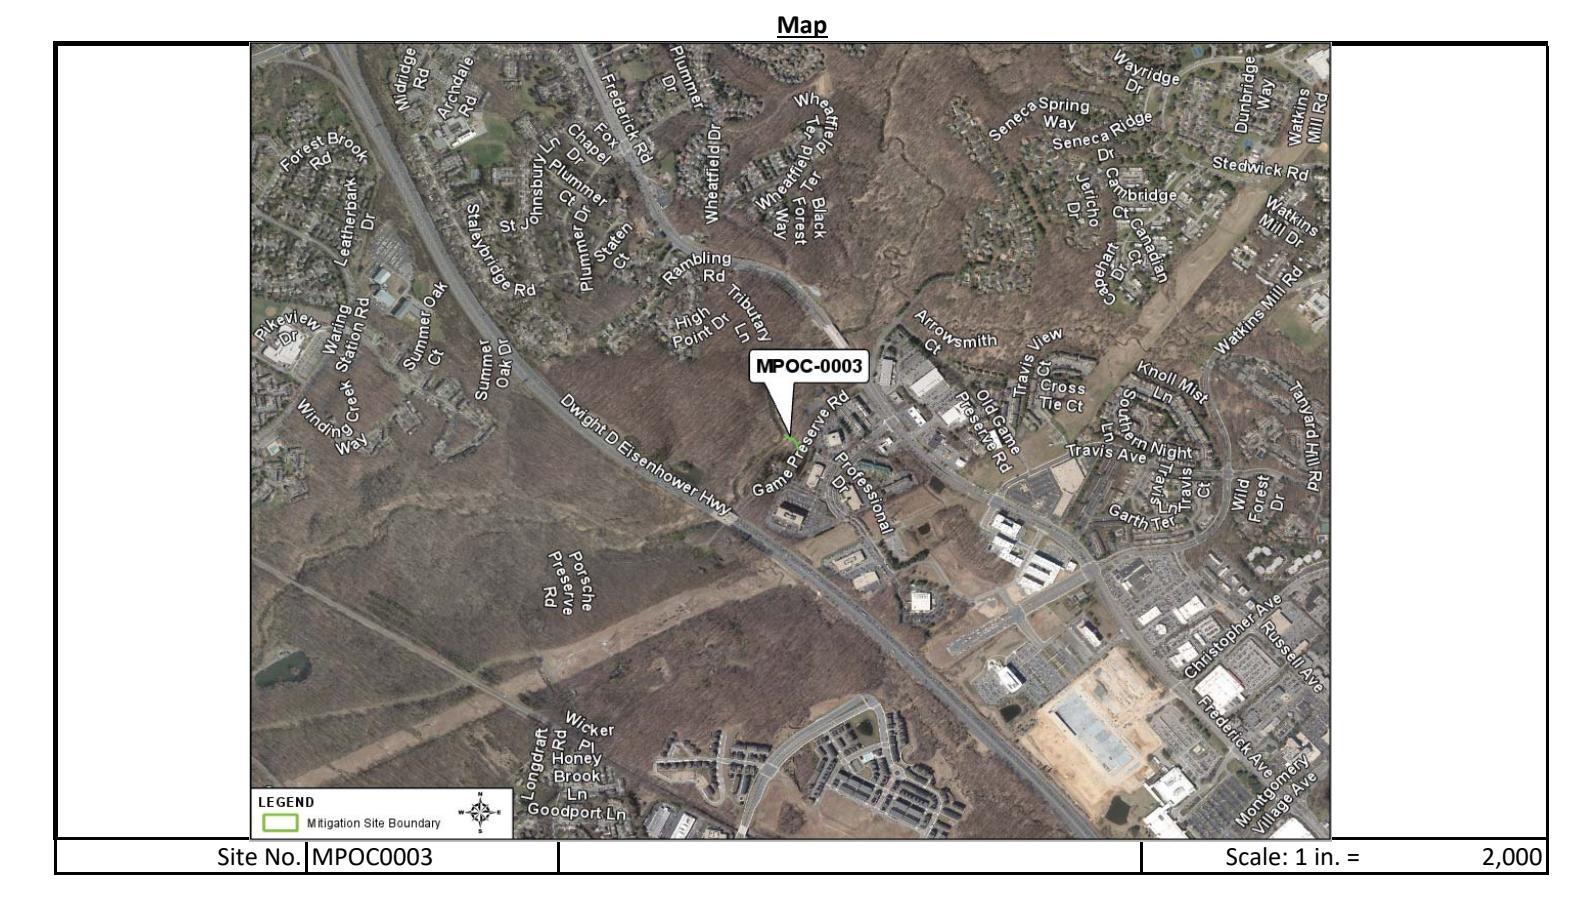
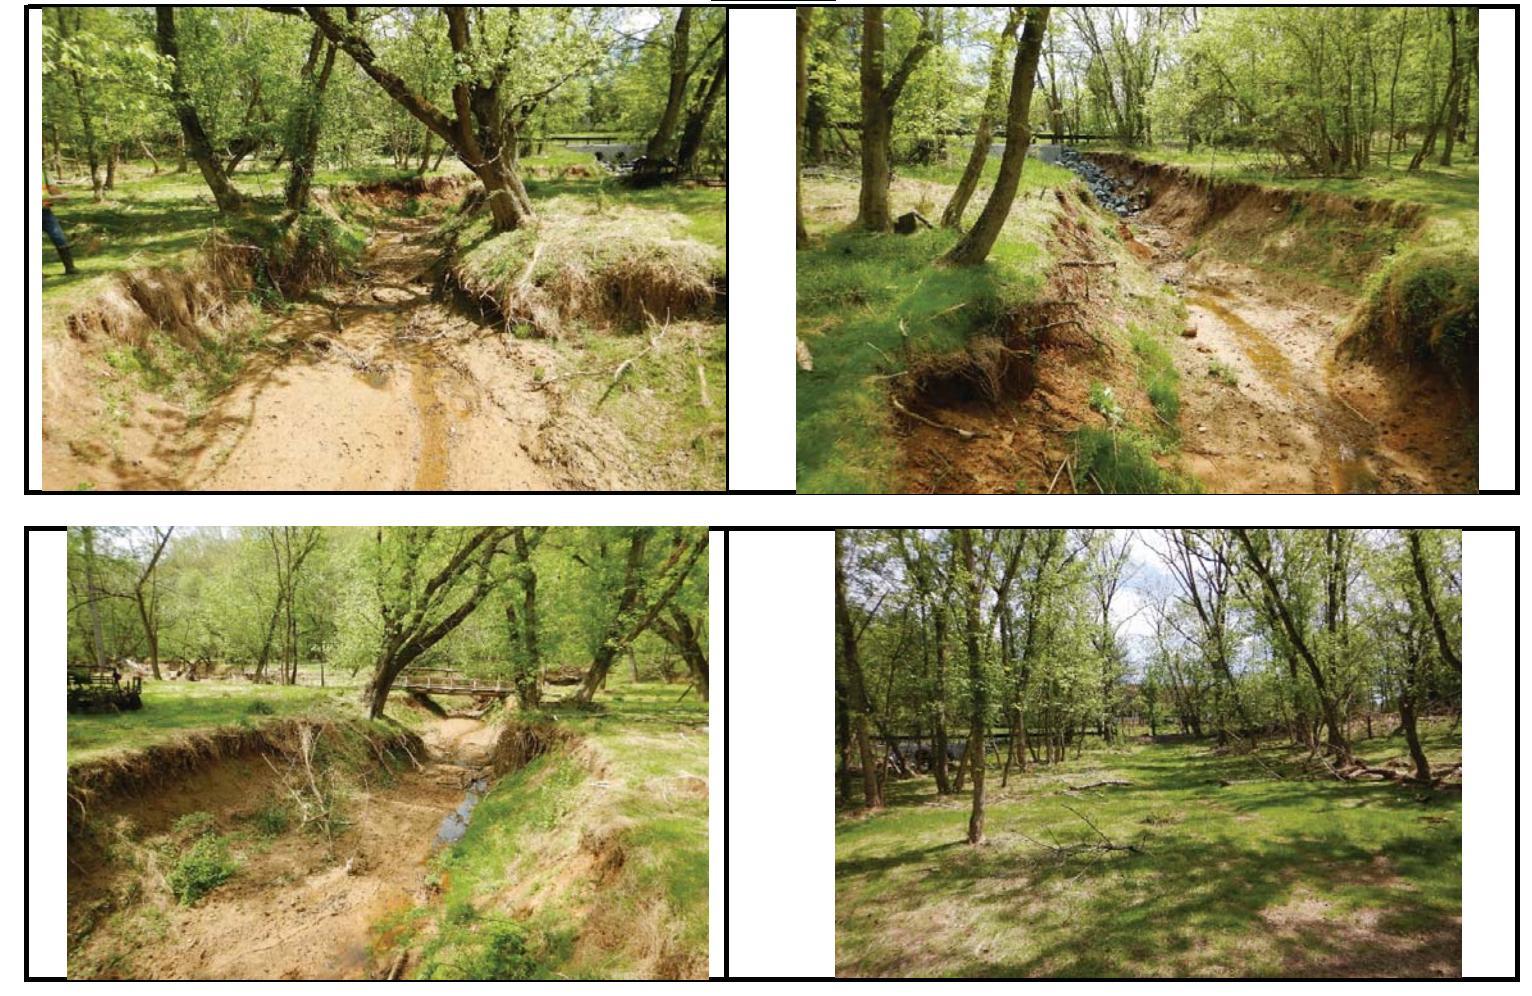
Stream Mitigation Field Site Assessment Form				
		Pro	ject Details		
Project Name:	I-495/I-270 Manage	d Lanes Study	Mitigation Site Number: MPOC0003		
Projects Estimated Stre	am Mitigation Needs (LF):	TBD	-		
Date of Field Assessment:	4/23/2019		Consultant Firm/Investigator(s): RK&K/KIH, DB		
	Site	Location Details	s-taken from desktop review		
County:	Montgomery	Cross Roads:	Game Preserve Road and Frederick Road		
Basin (HUC 8):	Middle Potomac-Catoctin	I	MDE Watershed (8 digit): 020700)08	
Proximity to Impacted S	Stream (mi.):	2.03	Lat/Long: 39.163101	-77.229916	
		9	<u>Site Data</u>		
Parcel Size (ac):	83		Potential Restoration Reach (LF): 207		
Site Opportunities:	X_Channel Restoration	Livestock Exclusion	XRiparian Buffer PlantingHabitat Enhancement	Fish Passage	
Stream Order: Drainage Area to Reach	(sq. mi)	Stream Hydrology:	Perennial Stream Use:	1	
Land Use:	Parkland (Forested)	<1 1	Mapped Soils: 16D. 17C. 54A

Property Address:	Game Preserve Road, Gai	thersburg, MD			
Property Owner(s):	State of MD DNR				
		<u>General F</u>	ield Observations		
Is there evidence that t	he stream has been distur	oed by some kind	Can the stream restoration be reasonably done within the c	onfines of the	
of human action, like gr	ading, dumping, livestock,	culvert, etc?	parcel or does it require connections beyond the parcel limi	ts? Explain	
Explain:			Explain:		
Yes, perched culvert wit	h rip-rap revetment		Yes - all DNR parkland.		
		Mitigo	tion Cito Dating		
Criteria		Score	lCriteria	Score	
Estimated Bank erosion	within reach	10	Vegetation	1	
10 - Greater than 50%	Within reach	10	10 - Herbaceous cover (non-wetland)	-	
5 - 10% to 50%			5 - Scrub-shrub cover (non-wetland)		
1 - Less than 10%			1 - Mostly forested and/or wetland		
Describe:			Describe:		
Entire reach degraded			Scattered trees connected to forest		
		_			
Degree of Channel Incis	ion	5	Land Use	1

10 - Bank Height greater	than 10 feet		10 - Agricultural or Open Space		
5 - Bank Height betweer 1 - Bank Height less thar	n 3 drid 10 reet		5 - Marginal Pasture		
Describe:	151661				
8-10' tall banks			Parkland - forested floodplain.		
Existing Eloodalain Acc	255	10	Opportunity for Ecological Lift	1	
10 - No evidence of out	of bank flooding	10	10 - Conditions exist for several aspects of lift to be achieved	and sustained	
5- Yes (Infrequent out o	f bank flow)		5 - Lift limited to one or few aspects		
1 - Yes (evidence of freq	uent flooding)		1 - Conditions are such that Lift is difficult to achieve and sust	ain	
Describe:			Describe:		
Incised short channel			Limited opportunity. Mostly mitigate for erosion. Small tribut	ary, no habitat	
			potential.		
Opportunity for Floodp	lain Development	1	Ease of Access	5	
10 - Existing space for flo	bodplain greater than 10 til	mes stream width	10 - Yes (with <u>existing</u> direct vehicular access to potential site)

5 - Existing space for floo	floodplain 3 to 10 times stream	n width	5- yes (open but no existing venicular access)		
Tributary to larger syste	m. Steep reach		Adjacent to an old cleared road. May involve some tree remo	val.	
in butting to larger syste				•	
Drainage Area Evaluatio	on	10	Utilities Present	1	
10 -D.A. less than 1 sq. r	ni.	-	10 - No utilities on site	<u>.</u>	
5- D. A. between 1 & 3 s	q. mi.		5 - Utilities but not within restoration area		
1 - D. A. greater than 3 s	iq. mi.		1 - Utilities within potential restoration area		
Describe:			Describe:		
<1 sq. mi.			Sewer in downstream section runs parallel to Seneca Creek.		
			Total Score out of 100	45

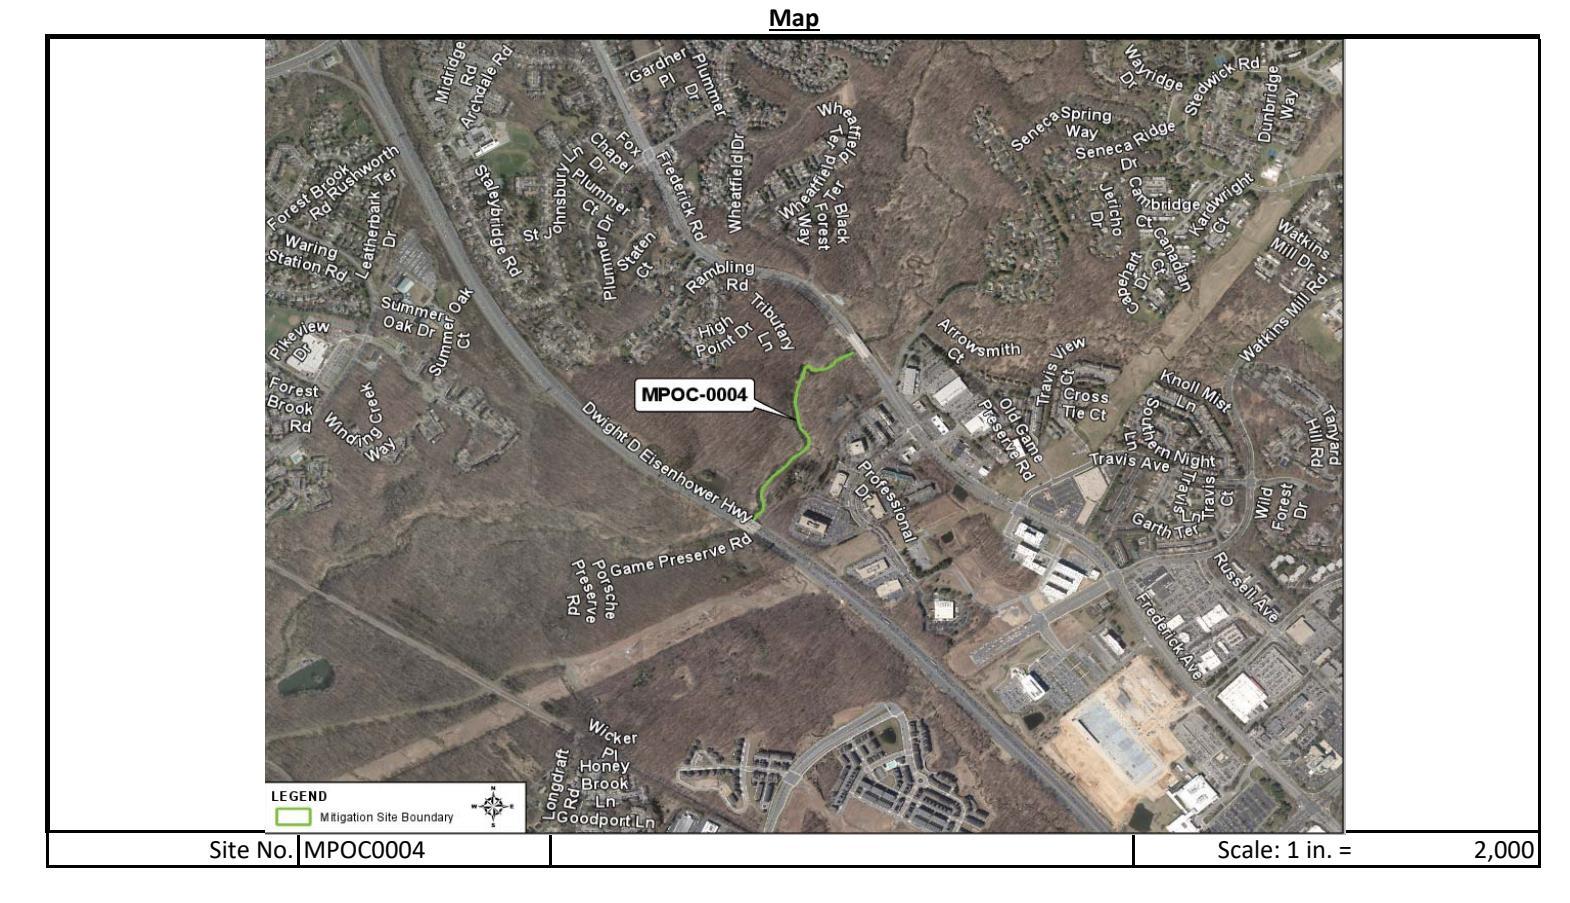
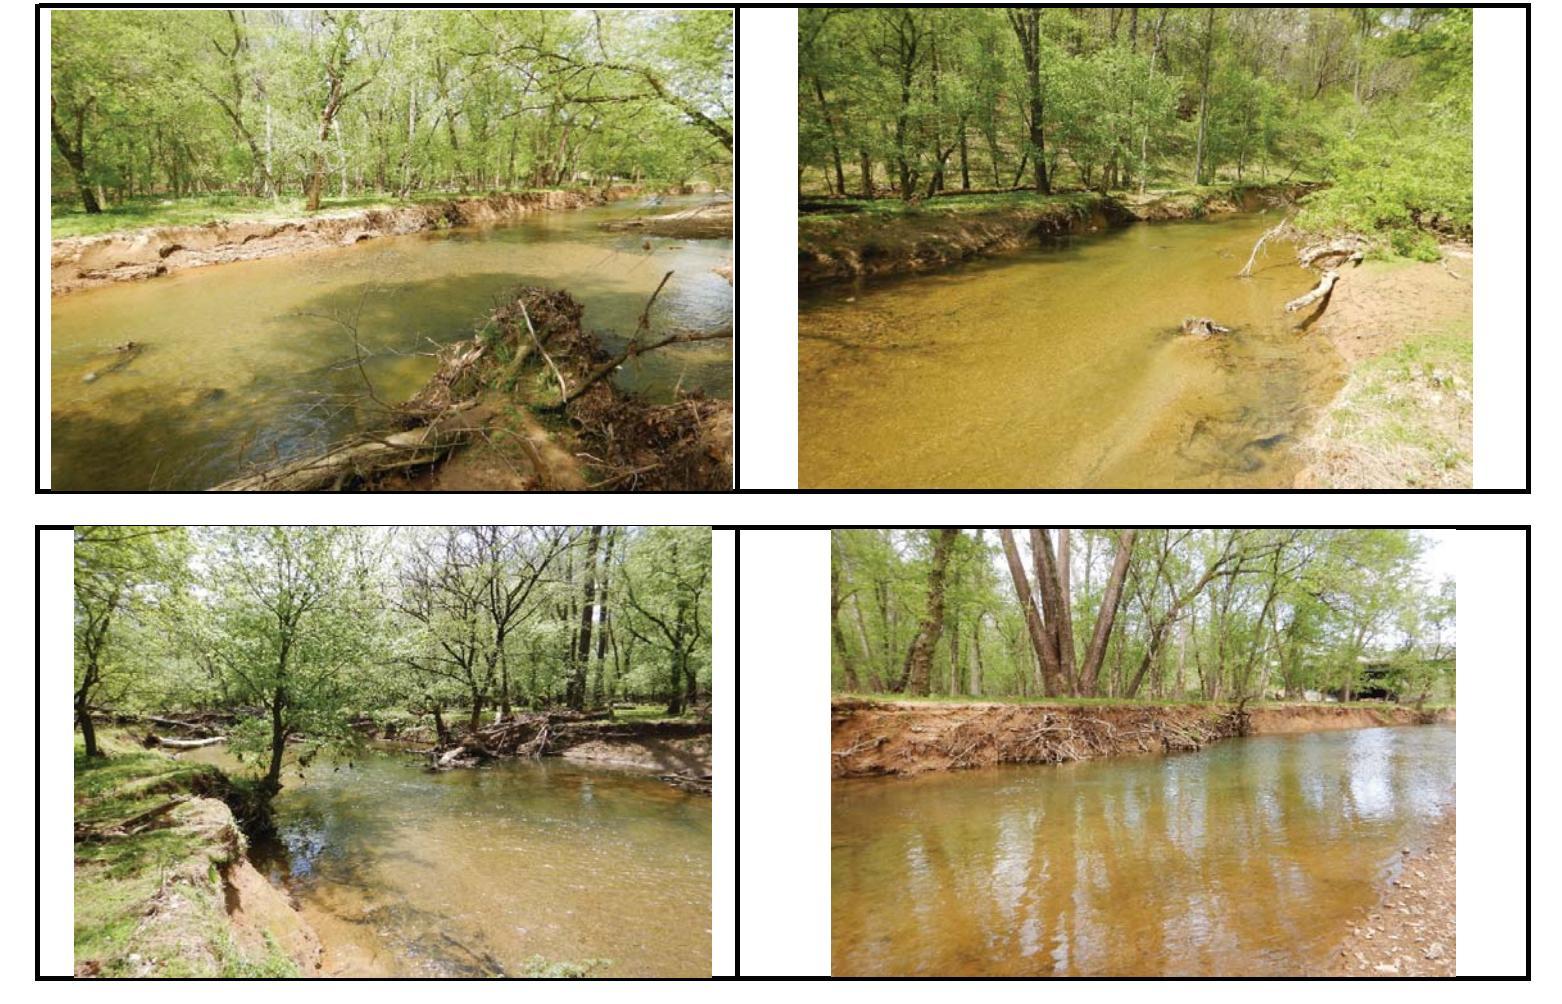
Site Photos

Str	eam Mitigation	Field Site Assessment Form	
		Pro	ject Details	
Project Name:	I-495/I-270 Manage	d Lanes Study	Mitigation Site Number: MPOC0004	
Projects Estimated Strea	am Mitigation Needs (LF):	TBD	-	
Date of Field Assessment:	4/23/2019		Consultant Firm/Investigator(s): RK&K/KIH, DB	
bate of field / socionienti	Site	Location Details	s-taken from desktop review	
County:	Montgomery	Cross Roads:	Game Preserve Road and Frederick Road	đ
Basin (HUC 8):	Middle Potomac-Catoctin	I	MDE Watershed (8 digit): 0207	0008
Proximity to Impacted S	Stream (mi.):	1.98	Lat/Long: 39.16343	6 -77.230249
		<u>.</u>	Site Data	
Parcel Size (ac):	83		Potential Restoration Reach (LF): 2,50	3
Site Opportunities:	XChannel Restoration	Livestock Exclusion	XRiparian Buffer PlantingHabitat Enhanceme	ntFish Passage
Stream Order:	3rd	Stream Hydrology:	Perennial Stream Use	3: IV
Drainage Area to Reach	(sq. mi.) Parkland (Forested)	41	Manned Soils: 544

Property Address:	Game Preserve Road, Gai	thersburg, MD		
Property Owner(s):	State of MD DNR			
		General F	ield Observations	
Is there evidence that t	he stream has been disturl	ped by some kind	Can the stream restoration be reasonably done within the	confines of the
of human action, like gr	ading, dumping, livestock,	culvert, etc?	parcel or does it require connections beyond the parcel lin	nits? Explain
Explain:			Explain:	
Yes, bridge spans upstre	am side		Yes - all DNR parkland.	
		Mitigat	tion Site Rating	
<u>Criteria</u>		<u>Score</u>	<u>Criteria</u>	<u>Score</u>
Estimated Bank erosion	within reach	10	Vegetation	1
10 - Greater than 50%			10 - Herbaceous cover (non-wetland)	
5 - 10% to 50%			5 - Scrub-shrub cover (non-wetland)	
1 - Less than 10%			1 - Mostly forested and/or wetland	
Describe:	aut waa ah		Describe:	
Severe erosion through	but reach.		Forested riparian hoodplain	
Degree of Channel Incis	ion	5	l and Lise	1

10 - Bank Height greater	r than 10 feet	5	10 - Agricultural or Open Space	-
5 - Bank Height betweer	n 3 and 10 feet		5 - Marginal Pasture	
1 - Bank Height less than	n 3 feet		1 - Old field/ Developed/Forested	
Describe:			Describe:	
3-4' tall banks			Parkland - forested.	
Existing Floodplain Acce	200	1	Opportunity for Ecological Lift	1
10 - No evidence of out	of bank flooding	-	10 - Conditions exist for several aspects of lift to be achieve	d and sustained
5- Yes (Infrequent out of	f bank flow)		5 - Lift limited to one or few aspects	
1 - Yes (evidence of freq	uent flooding)		1 - Conditions are such that Lift is difficult to achieve and su	stain
Describe:			Describe:	
Evidence of sediment de	eposition in floodplain.		Potential for reducing bank erosion. Limited potential for ha	abitat improvement
			and floodplain access.	
Opportunity for Floodp	lain Development	1	Ease of Access	1
10 - Existing space for flo	podplain greater than 10 til	mes stream width	10 - Yes (with <u>existing</u> direct vehicular access to potential si	te)

5 - Existing space for floo	odplain 3 to 10 times stream	m width	5- yes (open but no existing vehicular access)	
1 - Little to no space for	noouplain development		1 - NO (NO VENICULAI ACCESS, Cleaning needed)	
Describe:	onnected to floodalain		Describe:	
Large Stream - arreauy o			Forested hoodplain. No existing access.	
Drainage Area Evaluatio	on	1	Utilities Present	1
IU-D.A. less than 1 sq. r	ni.		10 - NO UTILITIES ON SITE	
J- D. A. Delween I & 3 S 1 - D A greater than 2 c	y. mi. sa mi		 - other sour not within restoration area 1 - Utilities within notential restoration area 	
Describe:	<u>'Y</u> • ''''•			
41 caupro milos			Utilities procent in floodalain, conitary courses	
41 Square miles			otilities present in hoodplain - sanitary sewer.	
			<u> </u>	0
			Total Score out of 10	U 23

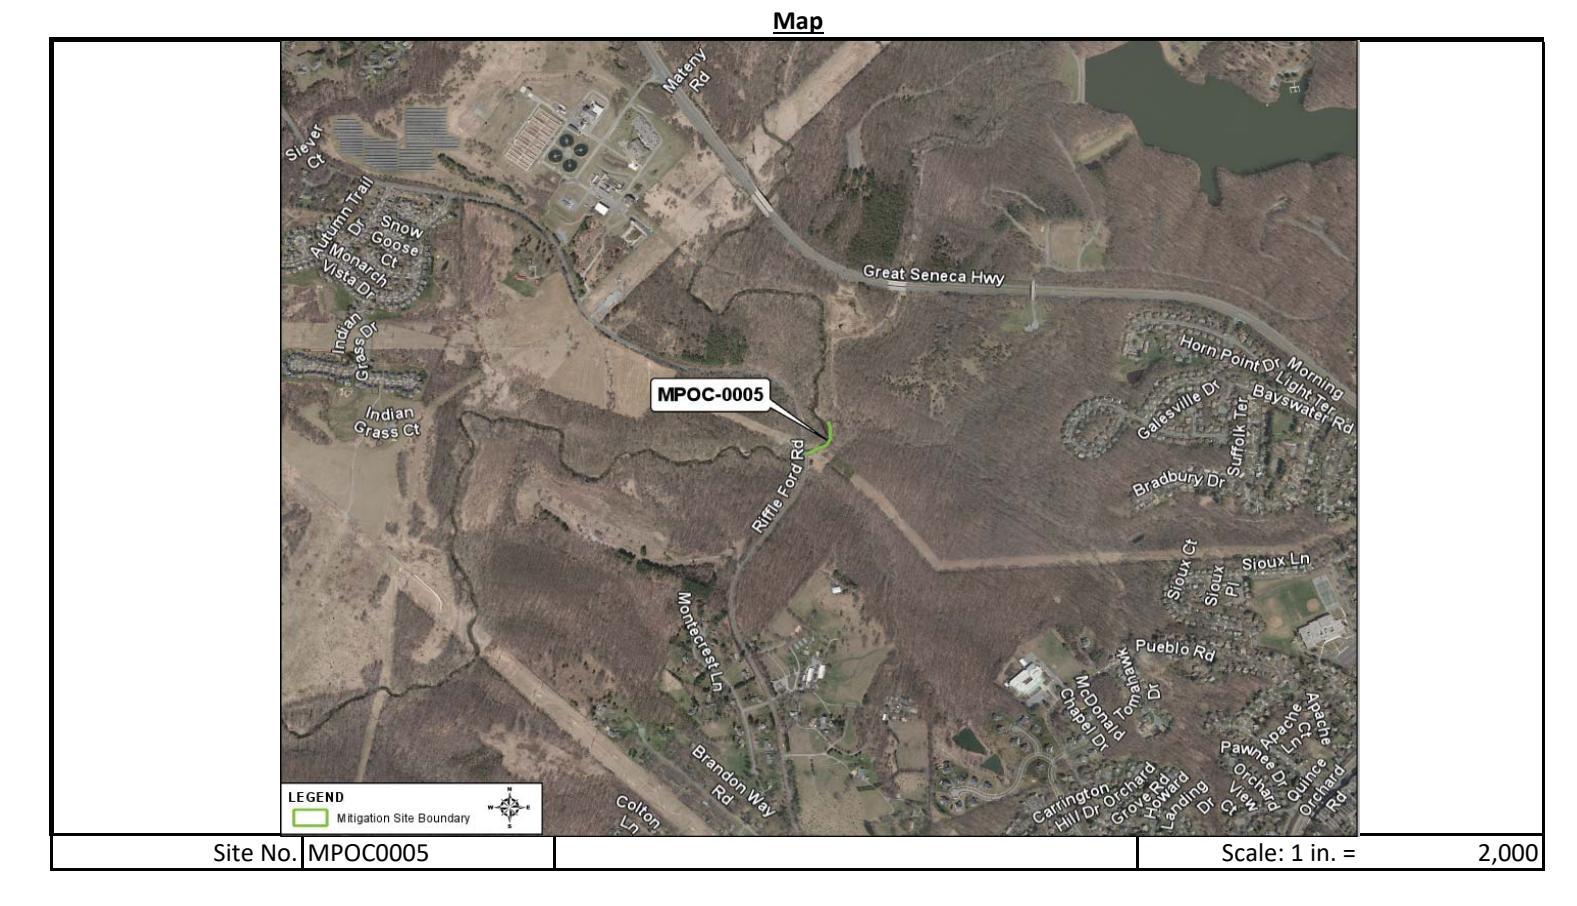
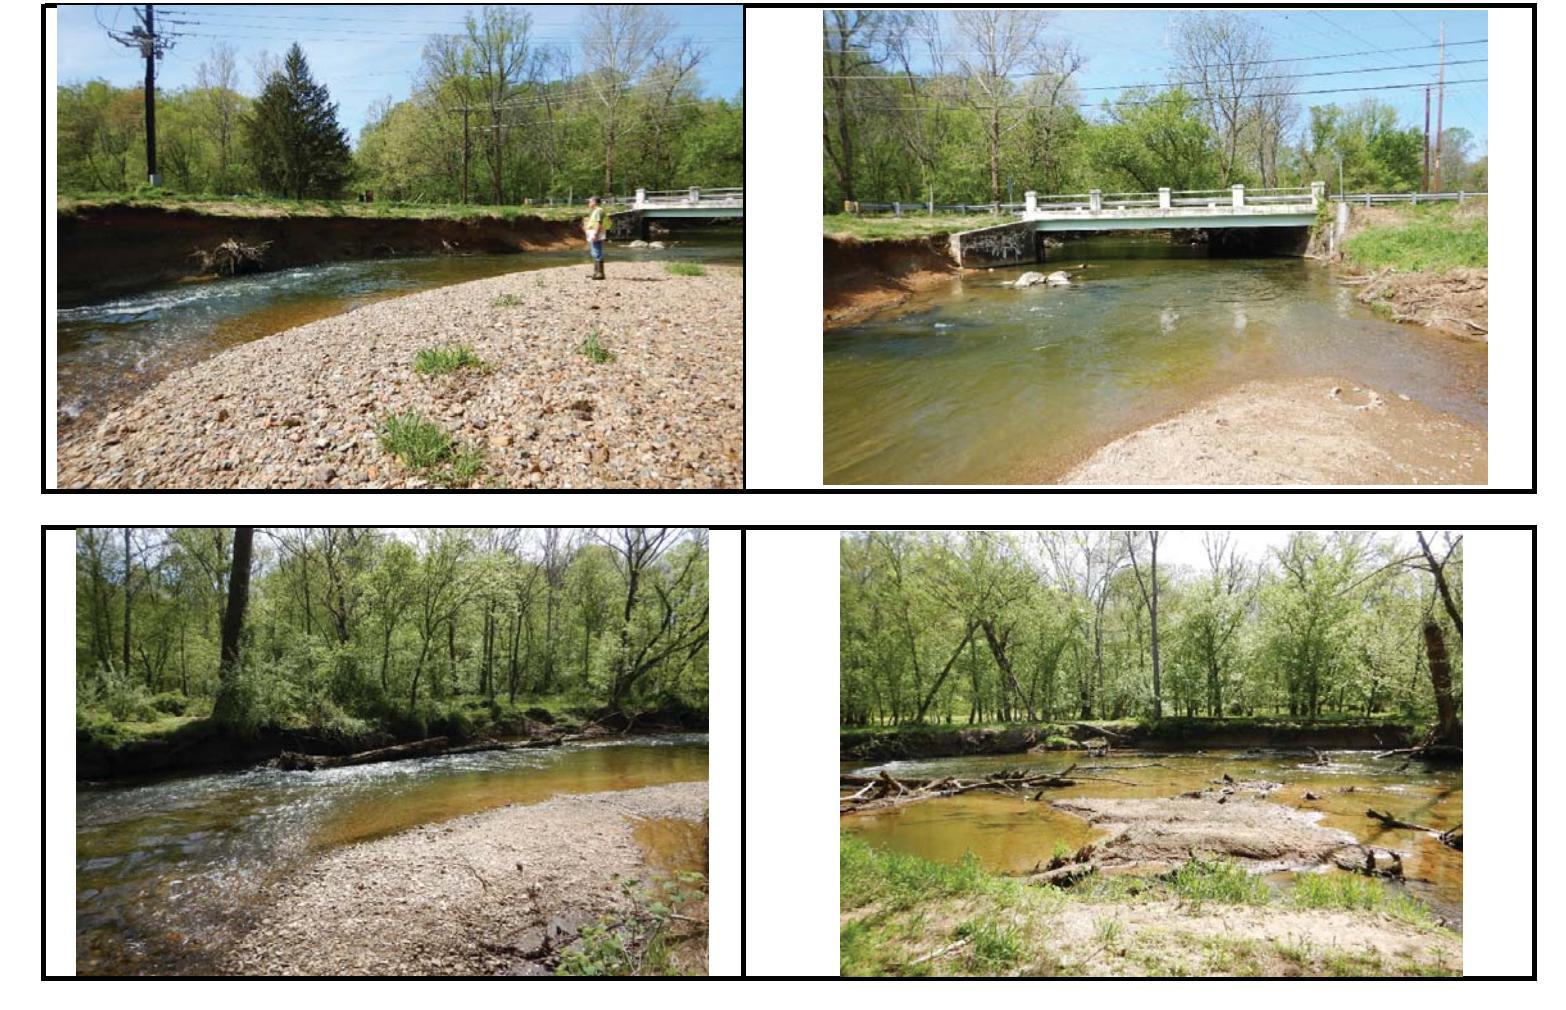
Str	eam Mitigation	Field Site Assessment Form		
		Pro	ject Details		
Project Name:	I-495/I-270 Manage	d Lanes Study	Mitigation Site Number: MPOC0005		
Projects Estimated Strea	am Mitigation Needs (LF):	TBD			
Date of Field Assessment:	4/23/2019	Levelien Deteile	Consultant Firm/Investigator(s): RK&K/KJH, DB		
Country	<u>Site</u>	Location Details	S-taken from desktop review		
	Middle Detemac Categorie	Cross Roads:	MDE Watershed (9 digit): 0207(1008	
Proximity to Impacted S	itream (mi.):	3.05	Lat/Long: 39.13313	-77.267205

0.00	Sito Data		
Parcel Size (ac):	229	<u>-</u>	Dice Data Potential Restoration Reach (IF):	8	
Site Opportunities:	X Channel Restoration	Livestock Exclusion	X Riparian Buffer Planting Habitat Enhancemen	<u>-</u> It Fish Passage	
Stream Order:	2nd	Stream Hydrology:	Perennial Stream Use	:	
Drainage Area to Reach	(sq. mi.)	44			
Land Use:	Parkland (Forested)		Mapped Soils: 54A		
Property Address:	Riffle Ford Road, Seneca	Creek State Park			
Property Owner(s):	State of MD DNR				
		General F	ield Observations		
Is there evidence that the	ie stream has been distur	ed by some kind	Can the stream restoration be reasonably done within the	confines of the	
of human action, like gra	ading, dumping, livestock	. culvert, etc?	parcel or does it require connections beyond the parcel lim	its? Explain	
Explain:			Explain:		
Yes, imbricated stone wa	all at upstream end. Bridge	crossing	Yes - all DNR parkland.		
downstream

5-Yes (Infrequent out of	hank flow)		5 - Lift limited to one or few aspects		
1 - Yes (evidence of freat	uent flooding)		1 - Conditions are such that Lift is difficult to achieve and sustain		
Describe:					
Large system. Evidence o	of sediment deposition in f	loodplain	Potential for reducing bank erosion. No potential for habitat	; improvement.	
			Floodplain is already set and accessed		
Opportunity for Floodpl	ain Development	1	Ease of Access	5	
10 - Existing space for flo	oodplain greater than 10 ti	mes stream width	10 - Yes (with <u>existing</u> direct vehicular access to potential sit	e)	
5 - Existing space for floo	odplain 3 to 10 times strea	m width	5- yes (open but no existing vehicular access)		
1 - Little to no space for	floodplain development		1 - No (no vehicular access, clearing needed)		
Describe:			Describe:		
Floodplain access limited	d by adjacent road and trai	l.	Good trail adjacent to site with some forest impacts from the	e trail.

Drainage Area Evaluatio	in	1	Utilities Present	1	
10 -D.A. less than 1 sq. m	ni.		10 - No utilities on site		
5- D. A. between 1 & 3 so	q. mi.		5 - Utilities but not within restoration area		
1 - D. A. greater than 3 s	q. mi.		1 - Utilities within potential restoration area		
Describe:			Describe:		
44 square miles			Mostly sanitary sewer and overhead powerlines.		
			Total Score out of 100	27

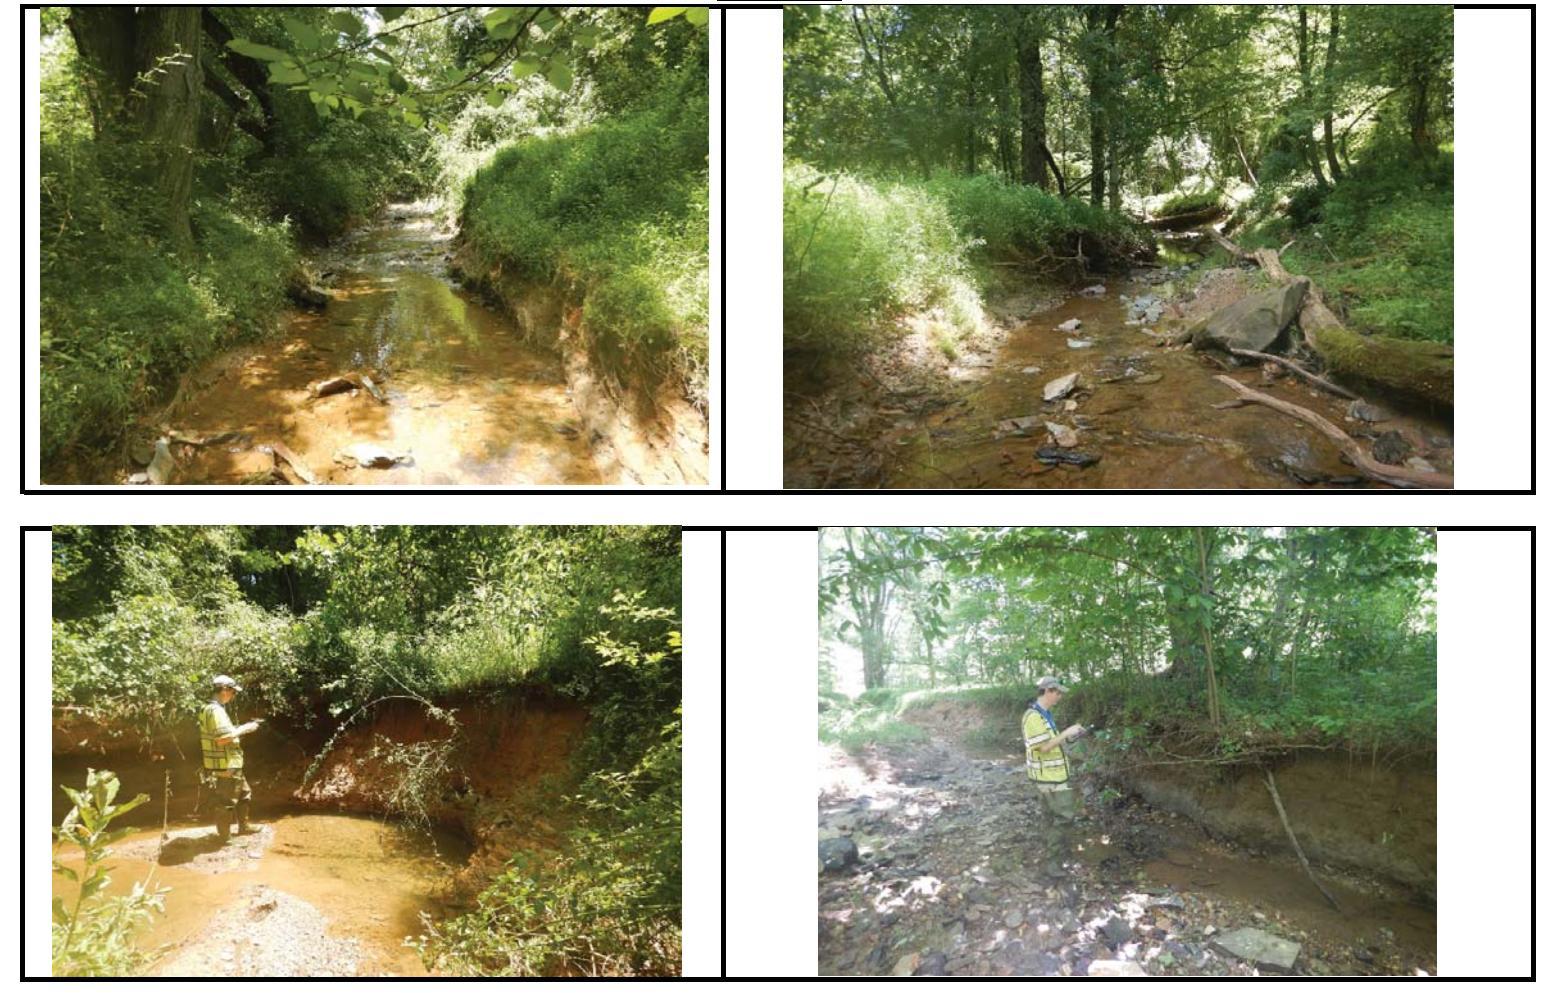
St	ream Mitigation	I Field Site Assessment Form		
		Pr	oject Details		
Project Name: Projects Estimated Strea	I-495/I-270 Manage m Mitigation Needs (LF):	d Lanes Study	Mitigation Site Number: MPOC0008 (combined	with MPOC0007)	
Date of Field Assessment:	7/17/2019		Consultant Firm/Investigator(s): RK&K KJH, AJN		
	<u>Sit</u>	e Location Detai	ls-taken from desktop review		
County:	Montgomery	Cross Roads:	Glen Road and Travilah Road		
Basin (HUC 8):	Middle Potomac-Catoctin		MDE Watershed (8 digit): 02140	202	
Proximity to Impacted S	tream (mi.):	4.67	Lat/Long: 39.069438	-77.258469	
			Site Data		
Parcel Size (ac):	15.8		Potential Restoration Reach (LF): 2,419		
Site Opportunities:	X_Channel Restoration	Livestock Exclusion	Riparian Buffer PlantingHabitat Enhancement	_X_Fish Passage	
Stream Order:	1st	Stream Hydrology:	Perennial Stream Use:	I	
Drainage Area to Reach	(sq. mi.)	0.25			
Land Use:	Forested		Mapped Soils: Baile silt loam

Property Address:	Glen Road				
Property Owner(s):	M-NCPPC				
		General	Field Observations		
Is there evidence that th	e stream has been disturb	ed by some kind of	Can the stream restoration be reasonably done within the co	nfines of the parcel	
human action, like gradi	ng, dumping, livestock, cu	lvert, etc? Explain	or does it require connections beyond the parcel limits? Expl	ain	
Explain:			Explain:		
No evidence. Bedrock th	roughout majority of stream	mbed. Combine	Two small segments on private property. MNCPPC recommen	dation	
with MPOC0007					
		Mitiga	ation Site Rating		
Criteria		Score	Criteria	Score	
Estimated Bank erosion	within reach	5	Vegetation	1	
10 - Greater than 50%		_	10 - Herbaceous cover (non-wetland)		
5 - 10% to 50%			5 - Scrub-shrub cover (non-wetland)		
1 - Less than 10%			1 - Mostly forested and/or wetland		
Moderate bank erosion t	brougbout		Ecrested parkland Mid-successional: red manle sycamore pe	arsimmon

Describe:			Describe:		
Limited by steep valley sl	opes and adjacent private	properties	Clearing of trees would need to occur.		
Drainago Aroa Fueluetta	n	10	Utilition Procent	10	
10 DA loss then 1 to 1		10	10 No utilities on site	10	
IU-U.A. less than I sq. m	II. . mi		LU - IND ULIIILLES OIL SILE		
J- D. A. Delween I & 3 SC	4. 1111. Nami		5 - Other of the solution of the state of the solution of the		
I - D. A. greater than 3 St	4				
Describe:			Describe:

0.25 square miles			None observed		
			Total Score out of 100	44

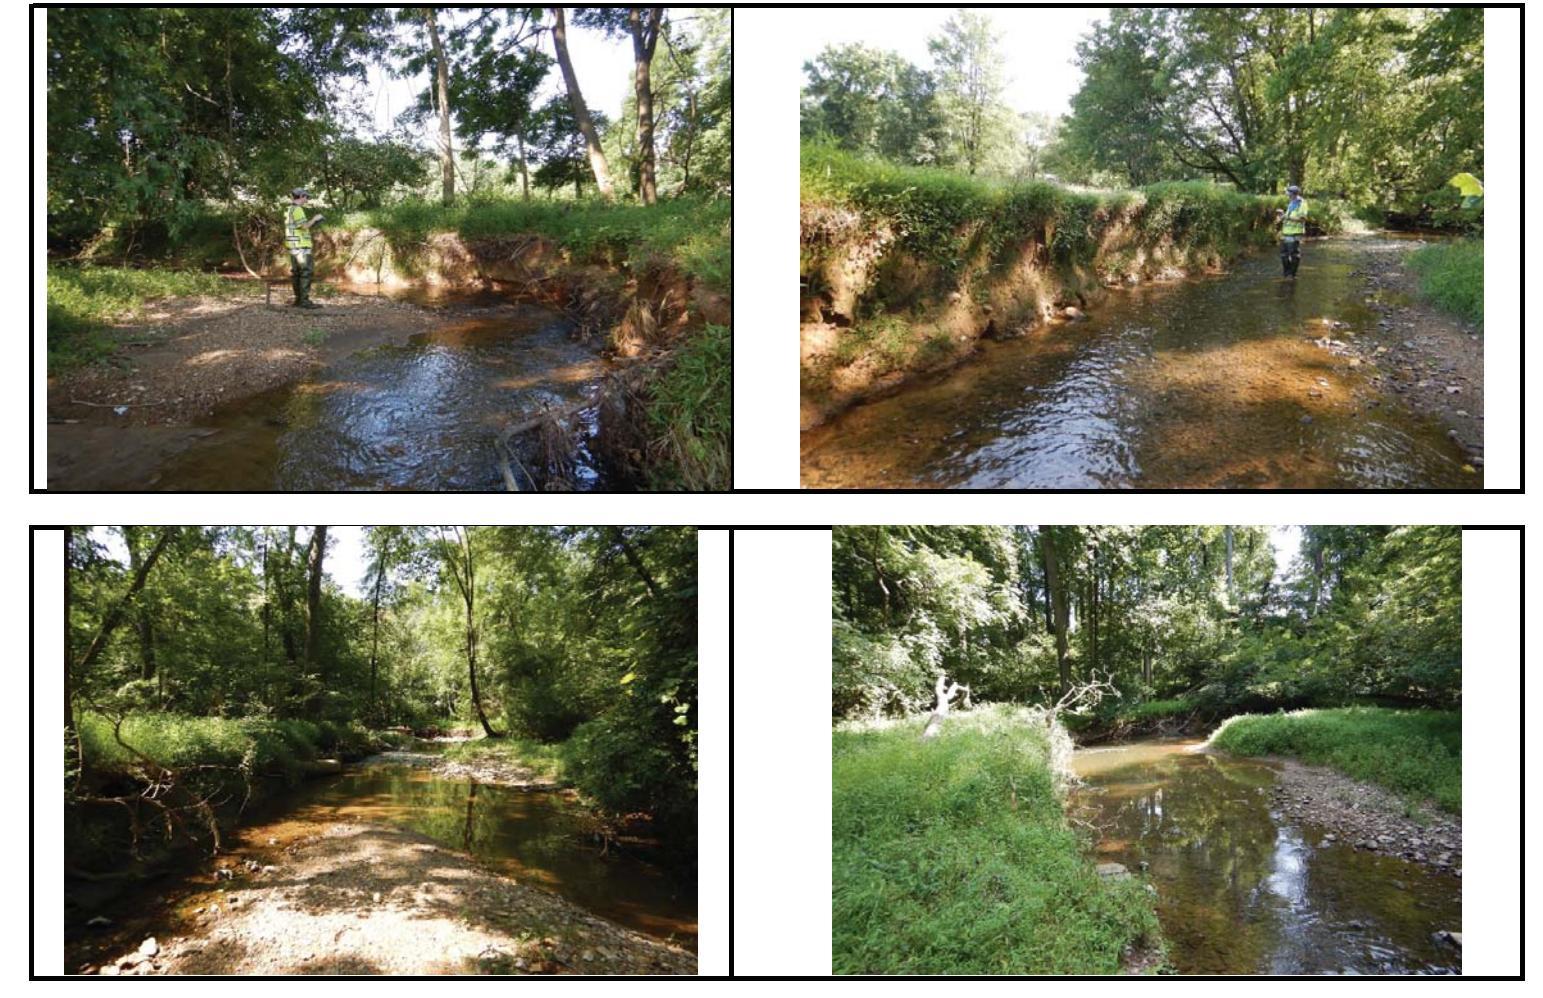
Str	eam Mitigation	Field Site Assessment Form		
		Pro	ject Details		
Project Name:	I-495/I-270 Manage	d Lanes Study	Mitigation Site Number: MPOC-0009		
Projects Estimated Strea	am Mitigation Needs (LF):	TBD

1 - Yes (evidence of freq	uent flooding)		1 - Conditions are such that Lift is difficult to achieve and sust	ain	
Describe:			Describe:		
No evidence of out of ba	ank flooding		Opportunities for sediment reduction, floodplain connectivity	, aquatic habitat,	
			wetland creation, water quality, an riparian buffer planting.		
Opportunity for Floodpl	ain Development	5	Ease of Access	5	
10 - Existing space for flo	podplain greater than 10 tir	mes stream width	10 - Yes (with existing direct vehicular access to potential site)	
5 - Existing space for floo	odplain 3 to 10 times stream	n width	5- yes (open but no existing vehicular access)		
1 - Little to no space for	floodplain development		1 - No (no vehicular access, clearing needed)		
Describe:			Describe:		
Some restrictions due to	valley slopes and resident	ial housing	DS - open meadow and existing path. US - forested.		
Drainage Area Evaluatio	an an	5	Utilities Present	1

2.91 square miles			Sewer line runs parallel to stream.		
			l		
			Total Score out of 100	53

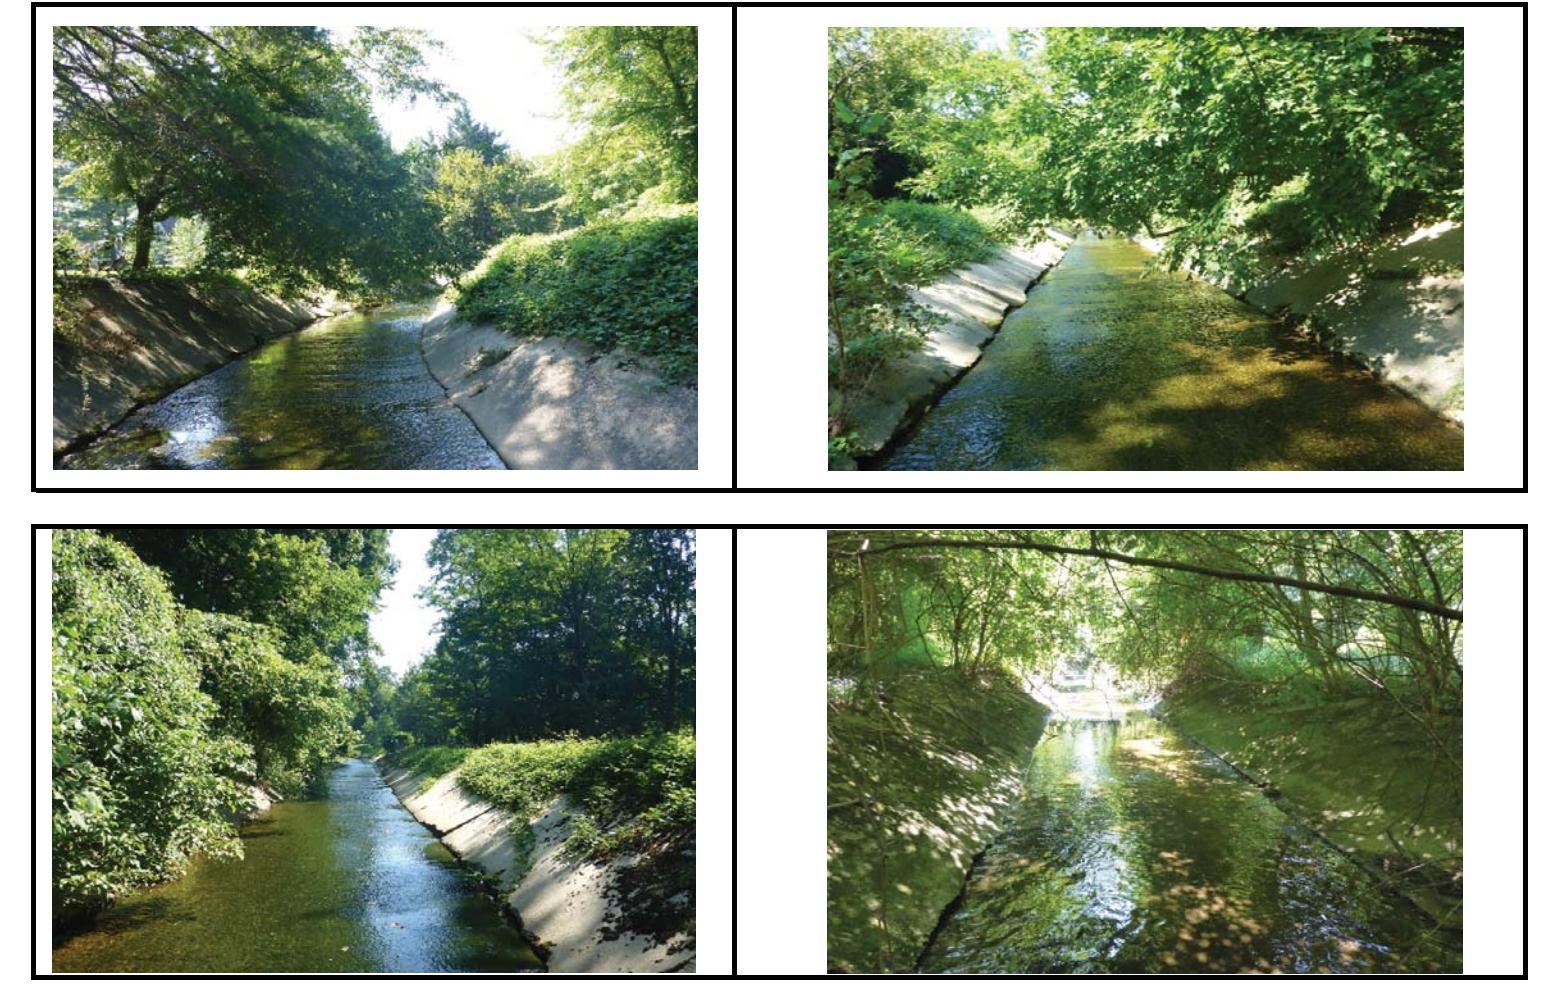
Str	eam Mitigation	Field Site Assessment Form			
		Pro	oject Details			
Project Name:	1-495/I-270 Manage	ed Lanes Study	Mitigation Site Number: M	POC0010		
Projects Estimated Strea	m Mitigation Needs (LF):	TBD

Describe:			Describe:			
Concrete 2:1; Approxima	ately 4 feet		Mostly mowed parkland			
		10		10		
Existing Floodplain Acce	SS	10	Opportunity for Ecological Lift	10		
10 - No evidence of out o	of bank flooding		10 - Conditions exist for several aspects of	lift to be achieved and sustained		
5- Yes (Infrequent out of	bank flow)		5 - Lift limited to one or few aspects	to a shirt of a state in		
1 - Yes (evidence of frequ	uent flooding)		1 - Conditions are such that Lift is difficult	to achieve and sustain		
Describe:			Describe:			
No evidence of grass			Habitat enhancement; floodplain reconnection; bedform diversity			
Ownerstandten fan Flandel		F	F			
Opportunity for Floodpl	ain Development	5	Ease of Access	5		
10 - Existing space for flo	odplain greater than 10 tin	hes stream width	10 - Yes (with <u>existing</u> direct venicular acce	ess to potential site)		
5 - Existing space for floodplain 3 to 10 times stream width			5- yes (open but no existing vehicular access)

1 - Little to no space for floodplain development			1 - No (no vehicular access, clearing needed)			
Describe:		Describe:				
Closer to 3, but concrete	channel is significantly ove	r widened	Recent utility access from upstream road of	crossing		
Drainage Area Fuelust			Litilities Present	I		
		5	10 No utilitios en site	I		
IU-D.A. less than 1 sq. m	11. a. mi		10 - NO UTILITIES ON SITE			
D - D . A. between 1 & 3 so	4. []]]. a. mi		 Otilities but not within restoration area Utilities within netential actionation 	1		
ים - D. A. greater than 3 so	ų. IIII.		1 - Oundes within potential restoration are	Ed		
Describe:			Describe:			
Drainage area - 1.259 mi	les		Sewer along stream bank and could cross			
			Total	Score out of 100 57
