APPENDIX E: PUBLIC SITE WALKTHROUGH RATING CRITERIA & FIELD ASSESSMENT FORMS

WETLAND MITIGATION RATING CRITERIA & FIELD SITE ASSESSMENT FORMS

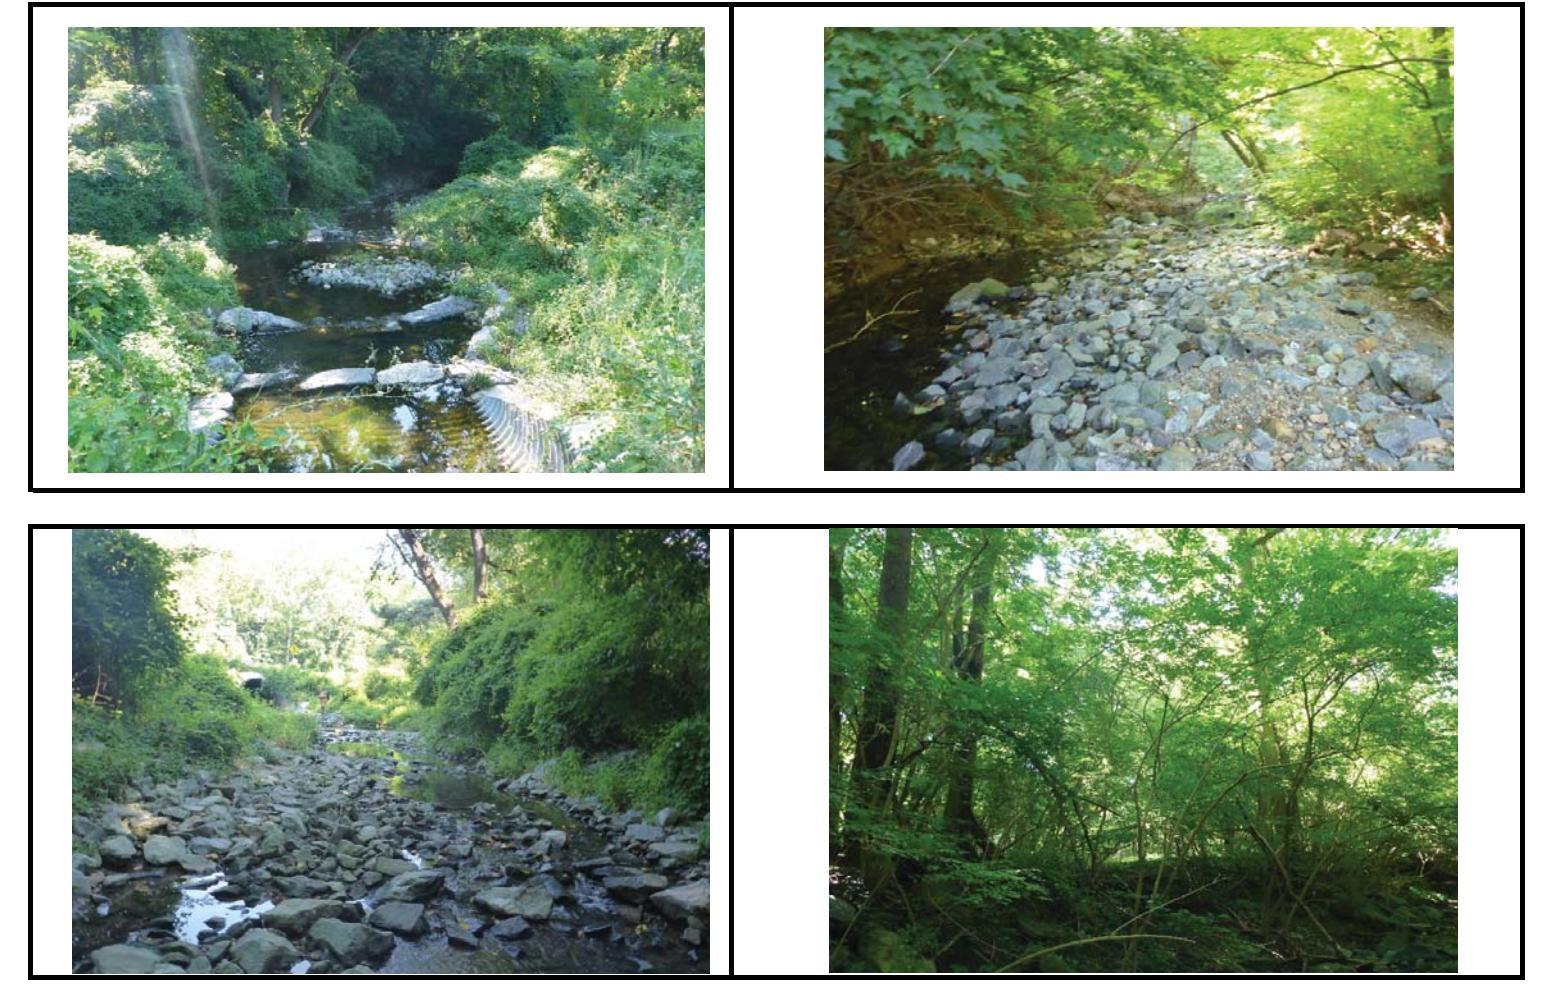
Sti	ream Mitigation	Field Site Assessment Form		
		Pro	oject Details		
Project Name:	1-495/I-270 Manag	ed Lane Study	Mitigation Site Number:	MPOC0011	
Projects Estimated Strea	m Mitigation Needs (LF):	TBD	-

1 - Bank Height less than	3 feet		1 - Old field/ Developed/Forested		
Describe:			Describe:		
Approximately 4-6 feet			Forested parkland		
Existing Floodplain Acces	S	10	Opportunity for Ecological Lift		5
10 - No evidence of out o	f bank flooding		10 - Conditions exist for several aspects	of lift to be achieved and	d sustained
5- Yes (Infrequent out of	bank flow)		5 - Lift limited to one or few aspects		
1 - Yes (evidence of frequ	ent flooding)		1 - Conditions are such that Lift is difficu	It to achieve and sustain	1
Describe:			Describe:		
No obvious evidence of fl	ooding.		Bank stability; floodplain reconnection;	habitat	
Opportunity for Floodpla	in Development	5	Ease of Access		5
10 - Existing space for floo	odplain greater than 10 tir	nes stream width	10 - Yes (with <u>existing</u> direct vehicular ad	ccess to potential site)	
5 - Existing space for floo	dplain 3 to 10 times strear	n width	5- yes (open but no existing vehicular ac	cess)

1 - Little to no space for f	loodplain development		1 - No (no vehicular access, clearing nee	ded)	
Describe:			Describe:		
More forest but plenty of	space		MNCPPC trail along stream but clearing	needed	
Drainage Area Evaluation	ı	10	Utilities Present		1
10 -D.A. less than 1 sq. m	i.		10 - No utilities on site		
5- D. A. between 1 & 3 sq	. mi.		5 - Utilities but not within restoration ar	ea	
1 - D. A. greater than 3 so	. mi.		1 - Utilities within potential restoration	area	
Describe:			Describe:		
Drainage area - 0.56 squa	ire miles		Multiple utility crossings		
			Tota	IL SCORE OUT OF 100	48

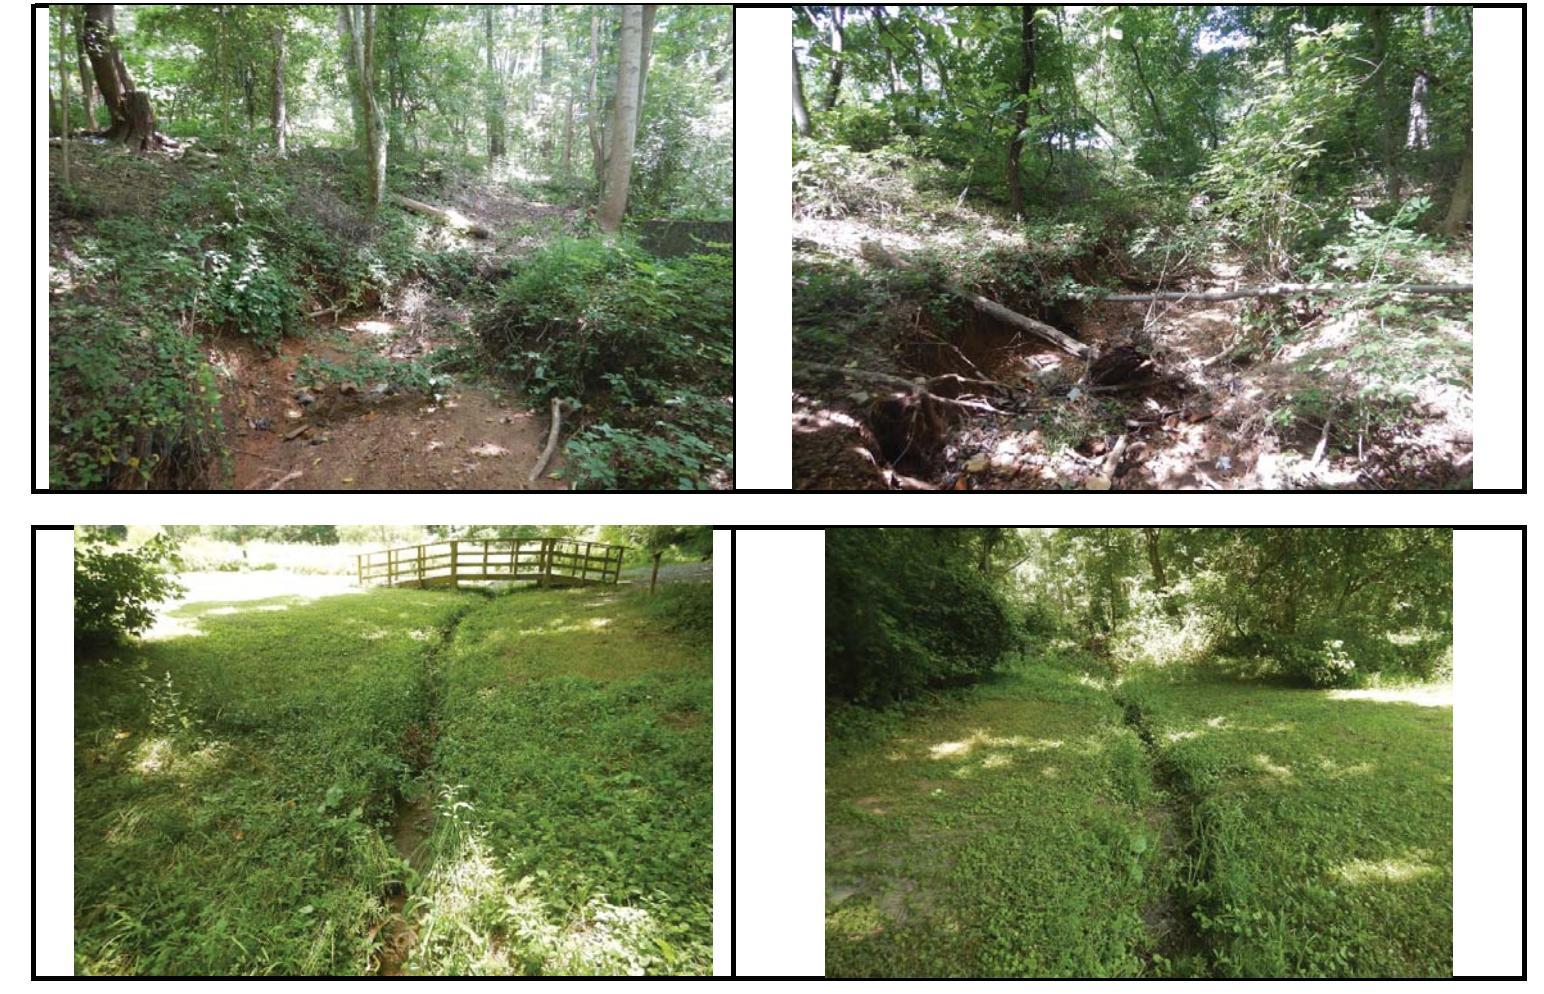
Stream Mitigation Field Site Assessment Form					
		Pro	ject Details		
Project Name:	I-495/I-270 Manage	ed Lanes Study	Mitigation Site Number: MPOC0012		
Projects Estimated Strea	m Mitigation Needs (LF):				
Data of Field Accoremonts	7/17/2010		Consultant Firm (Investigator(s): RK8.K: KIH AIN		
Date of Field Assessment:	/1//2019	Location Details	taken from deskton review		
County:	Montgomery	Cross Roads:	Democracy Blvd, and Seven Locks Rd		
Basin (HUC 8):	Middle Potomac-Catoctir		MDE Watershed (8 digit): 02140	0207	
Proximity to Impacted St	tream (mi.):	. 0.77	Lat/Long: 39.024472	2 -77.158008	
		(Site Data		
Parcel Size (ac):	34	<u>-</u>	Potential Restoration Reach (LF): 93	9	
Site Opportunities:	Channel Restoration	Livestock Exclusion	Riparian Buffer Planting Habitat Enhancemen	T X Fish Passage	
Stream Order:	1st	Stream Hydrology:	Ephemeral Stream Use	:	
Drainage Area to Reach	(sq. mi.)	0.06			
Land Use:	Forested parkland		Mapped Soils: Blocktown channery	silt loam

Property Address:	Democracy Blvd.				
Property Owner(s):	M-NCPPC				
		General F	ield Observations		
Is there evidence that th	e stream has been distur	bed by some kind	Can the stream restoration be reasonably done within the	confines of the	
of human action, like gra	ding, dumping, livestock,	, culvert, etc?	parcel or does it require connections beyond the parcel lim	nits? Explain	
Explain:			Explain:		
No.			Ephemeral channel draining to a wetland, that drains back in	nto the ephemeral	
			channel. All on MNCPPC property. MNCPPC recommendation	on.	
		<u>Mitigat</u>	tion Site Rating		
<u>Criteria</u>		<u>Score</u>	<u>Criteria</u>	<u>Score</u>	
Estimated Bank erosion	within reach	5	Vegetation	1	
10 - Greater than 50%			10 - Herbaceous cover (non-wetland)		
5 - 10% to 50%			5 - Scrub-shrub cover (non-wetland)		
1 - Less than 10%			1 - Mostly forested and/or wetland		
Describe:			Describe:		
Minor to moderate erosi	on throughout		Mid successional forest. Middle portion of site is an open m	eadow/potential

5. Vos (Infroquent out of	hank flow)		5 Lift limited to one or few aspects	a and sustained	
1 - Ves (evidence of freque	uent flooding)		5 - LITE limited to one or few aspects		
Describer	ient hooding/		1 - Conditions are such that Lift is difficult to achieve and sustain		
Describe:			Describe:		
No evidence of flooding			No opportunites - epitemeral channel.		
One out we the four Floodel	in Development	1	Face of Assass	10	
10 Existing space for flood	ain Development	T mos stroam width	Ease of Access 10 - Ves (with existing direct vehicular access to potential sit	10	
5 - Existing space for floo	dupian greater than 10 tr dupian 3 to 10 times stres	m width	5- ves (open but no existing vehicular access)	.e)	
1 - Little to no snace for f	Ioodolain development		1 - No (no vehicular access, clearing needed)		
No opportunity - steep valley that drains to an open meadow			Existing 15' wide nath. Would require tree clearing to get to channel

0.06 square miles			None observed within site		
			±

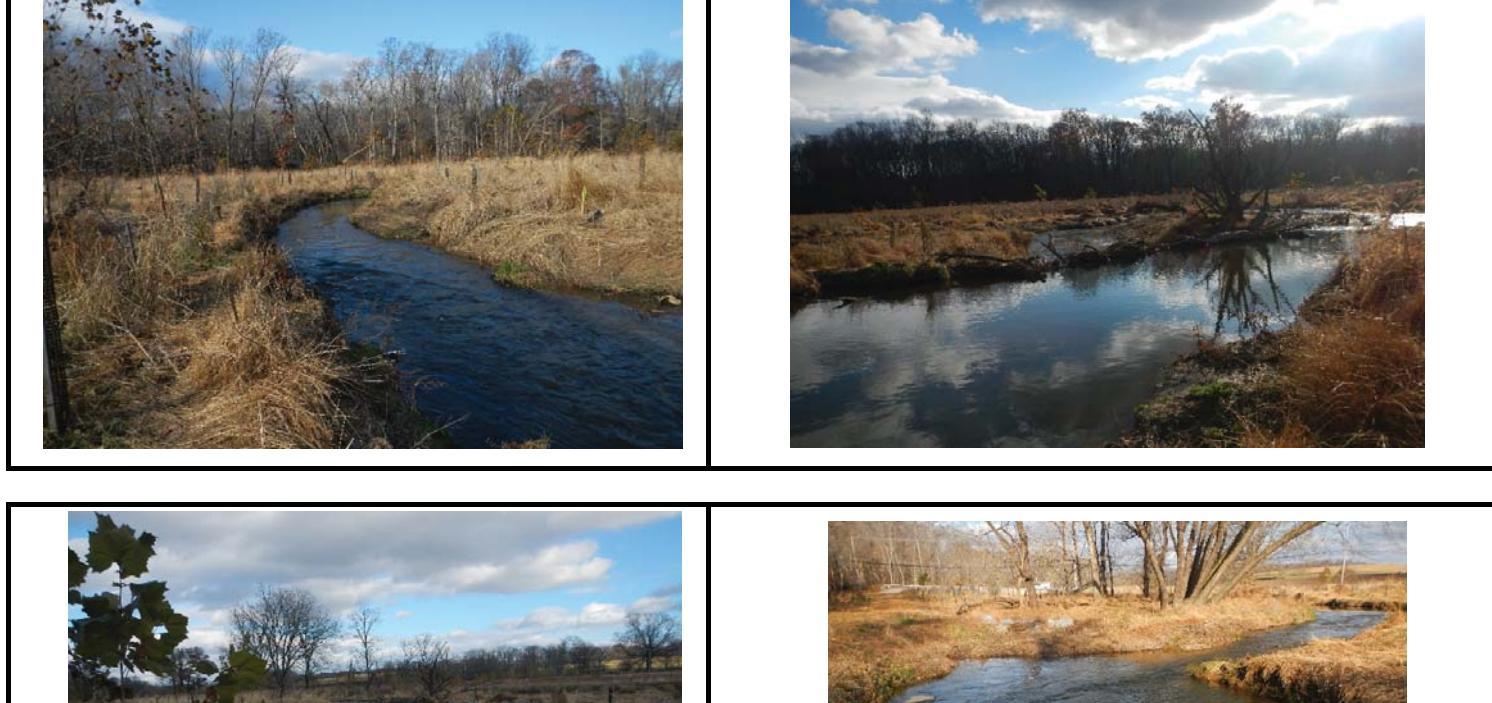
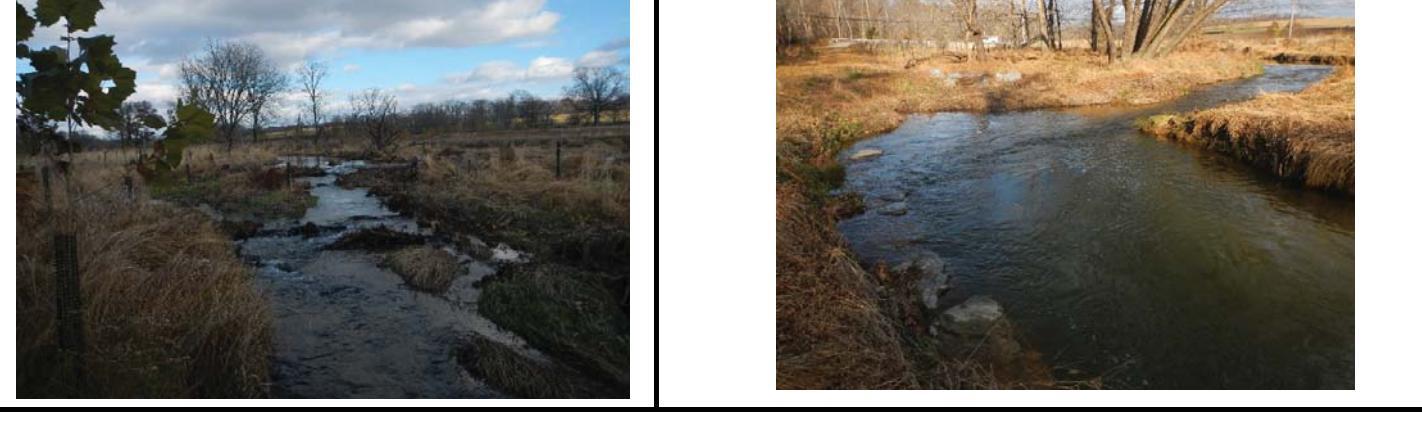
Stream Mitigation Field Site Assessment Form					
		Pro	ject Details		
Project Name:	I-495/I-270 Managed Lan	es Study	Mitigation Site Number: SSS-150006		
Projects Estimated Strea	am Mitigation Needs (LF):	TBD	-		
Date of Field Assessment:	11/20/2018		Consultant Firm/Investigator(s): RK&K/KIH, BDM		
	Site	Location Details	s-taken from desktop review		
County:	Montgomery	Cross Roads:	Woodfield Rd. & Watkins Rd.		
Basin (HUC 8):	Middle Potomac-Catoctir	1	MDE Watershed (8 digit): 02140208		
Proximity to Impacted S	tream (mi.):	6.4	Lat/Long: 39.23314874	-77.18283808	
		0	Site Data		
Parcel Size (ac):	48.28		Potential Restoration Reach (LF): 3,529		
Site Opportunities:	Channel Restoration	Livestock Exclusion	Riparian Buffer PlantingHabitat Enhancement	Fish Passage	
Stream Order:	3rd	Stream Hydrology:	Perennial Stream Use:		
Land Use:	Forest - Existing Wetland	9.01 Mitigation Site	Manned Soils: Hathoro silt loam & Cod	lorus silt loam

5- Yes (Infrequent out of	bank flow)		5 - Lift limited to one or few aspects		
1 - Yes (evidence of freq	uent flooding)		1 - Conditions are such that Lift is difficult to achieve and sustain		
Describe: Evidence of out of bank	flooding in coveral areas t	aroughout site	Describe:	an and habitat	
Evidence of out-of-bank	mooding in several areas the	nrougnout site -	Existing restoration site with little potential for erosion reduction	on and nabitat	
woody debris plies, sedi	ment deposition & matted	down veg.	improvements.		
Opportunity for Floodpl	ain Development	1	Ease of Access	5	
10 - Existing space for flo	podplain greater than 10 ti	mes stream width	10 - Yes (with existing direct vehicular access to potential site)	_	
5 - Existing space for floo	odplain 3 to 10 times strea	m width	5- yes (open but no existing vehicular access)		
1 - Little to no space for floodplain development		1 - No (no vehicular access, clearing needed)

Describe:			Describe:		
Plenty of space for floodplain, however stream is already connected		Existing access from previous restoration at northern end of sit	e, however		
to the adjacent floodplain. Low banks, evidence of out-of-bank flows, acce			access to the stream would require removal of recent tree plan	itings.	
and existing floodplain w	vetlands.				
Drainage Area Evaluatio	on	1	Utilities Present	5	
10 -D.A. less than 1 sq. n	ni.		10 - No utilities on site		
5- D. A. between 1 & 3 s	q. mi.		5 - Utilities but not within restoration area		
1 - D. A. greater than 3 s	q. mi.		1 - Utilities within potential restoration area		
Describe:			Describe:		
Drainage area - 9.01 squ	are miles.		Overhead powerlines along road just outside site.		
			Total Score out of 100	22

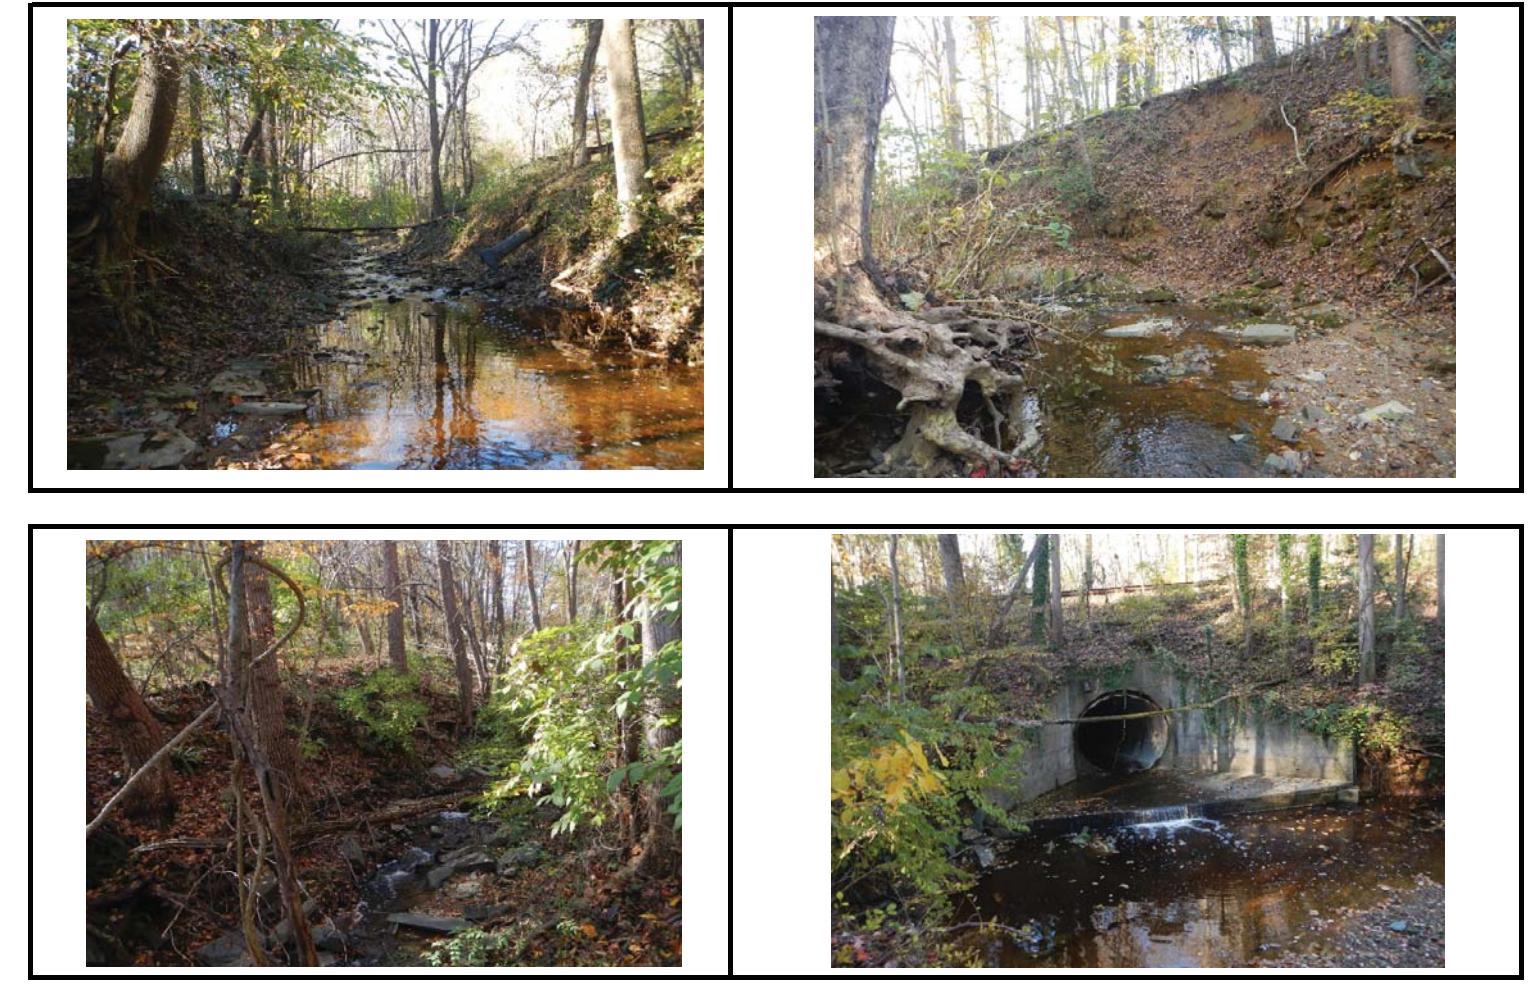
Stream Mitigation Field Site Assessment Form					
		Pro	ject Details		
Project Name:	I-495/I-270 Managed Lan	es Study	Mitigation Site Number:	SSS-150017	
Projects Estimated Strea	m Mitigation Needs (LF):	TBD			
Date of Field Assessment:	11/8/2018		Consultant Firm/Investigator(s):	RK&K/KIH DB	
	Site	Location Details	s-taken from desktop review		
County:	Montgomery	Cross Roads:	Carderock Springs Dr. & Fenway Rd.		
Basin (HUC 8):	Middle Potomac-Catoctin	1	MDE Watershed (8 digit):	2140207	
Proximity to Impacted S	tream (mi.):	0.6	Lat/Long:	38.99502015	-77.17030611
		<u>.</u>	<u>Site Data</u>		
Parcel Size (ac):	3 parcels - 1.7, 5.8 & 6.5		Potential Restoration Reach (LF):	1,084	
Site Opportunities:	X_Channel Restoration	Livestock Exclusion	XRiparian Buffer Planting	Habitat Enhancement	_XFish Passage
Stream Order:	2nd	Stream Hydrology:	Perennial	Stream Use:	
Land Lise	(sq. m.) Medium density resident	0.78 ial	Manned Soils:	Blocktown channery silt	loam

steep valley slopes to the	e south.		upstream end of site that appears to h	ave been cleared in the p	ast for sewer
			repairs.		
Drainage Area Evaluatio	n	10	Utilities Present		1
10 -D.A. less than 1 sq. m	1i.		10 - No utilities on site		
5- D. A. between 1 & 3 so	η. mi. α. mi		5 - Utilities but not within restoration a	irea	
1 - D. A. greater than 3 so	y. IIII.		1 - Utilities within potential restoration	i drea	
Describe:					
Drainage area - 0.78 squa	are miles.		Sewer line runs parallel to stream.

- Tota	al Score out of 100	44

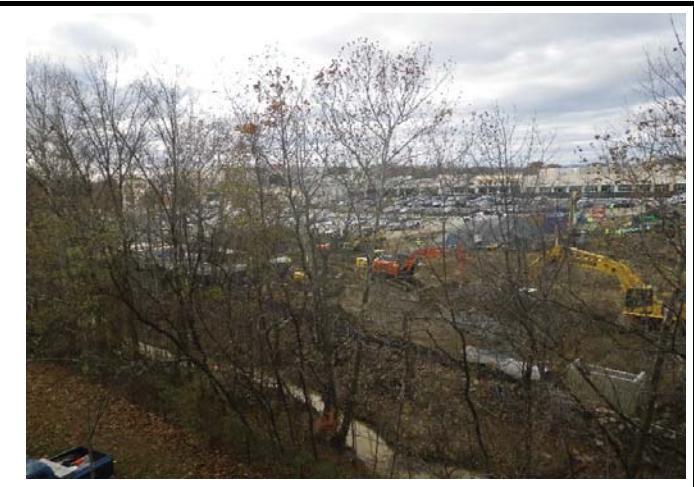
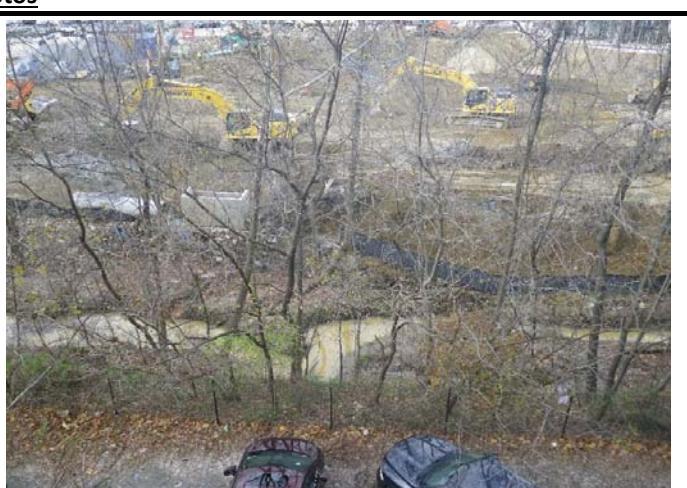
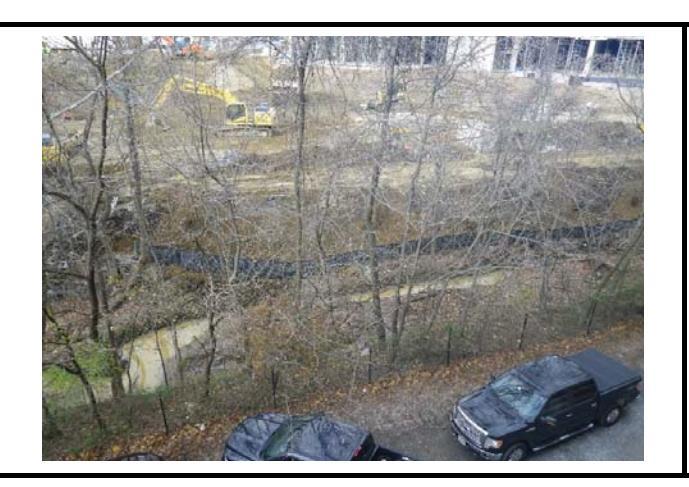
Str	eam Mitigation	Field Site Assessment Form		
		Pro	bject Details		
Project Name:	I-495/I-270 Manage	d Lanes Study	Mitigation Site Number: PG_00008		
Projects Estimated Strea	am Mitigation Needs (LF):	IBD	-		
Date of Field Assessment:	11/27/2018		Consultant Firm/Investigator(s): RK&K/KJ	H, BDM	
	Site	Location Details	s-taken from desktop review	,	
County:	Prince George's	Cross Roads:	Harry S Truman Dr. N. & Shoppers Way		
Basin (HUC 8):	Patuxe	nt	MDE Watershed (8 digit): 02131	103	
Proximity to Impacted S	tream (mi.):	0.09	Lat/Long: 38.90121886	-/6.84465/43	
	2 Demode 40	10. 20	Site Data		
Parcel Size (ac): Site Opportunities:	2 Parcels - 16.	28, 49.39	Potential Restoration Reach (LF): 1,682		
Stream Order:		Stream Hydrology	Perennial Stream Use	:	
Drainage Area to Reach	(sq. mi.)	0.2		-	
Land Use:	Commercial		Mapped Soils: Urban land-Collington	1-Wist complex	
Property Address:	801 Capital Centre Blvd, I	Jpper Marlboro 20	774-0000

floodplain.			potential for floodplain development or improving water quality.		
Opportunity for Floodpl	ain Development	1	Ease of Access	1	
10 - Existing space for flo	odplain greater than 10 ti	mes stream width	10 - Yes (with <u>existing</u> direct vehicular access to potential site)		
1 - Little to no space for f	floodplain development		1 - No (no vehicular access, clearing needed)		
Describe:			Describe:		
No potential for floodplain improvements due to the site being			Site surrounded by narrow strip of forest.		
surrounded by development.					
Drainage Area Evaluatio	n	10	Utilities Present	5	
10 -D.A. less than 1 sq. m	ni.		10 - No utilities on site	Ē	
5- D. A. between 1 & 3 sq. mi. 5- Utilities but not within restoration area					
1 - D. A. greater than 3 so	q. mi.		1 - Utilities within potential restoration area		
Describe:			Describe:		
Drainage Area - 0.2 squa	re miles		Storm drains located just outside site.

Total Score out of 100	21	
				51

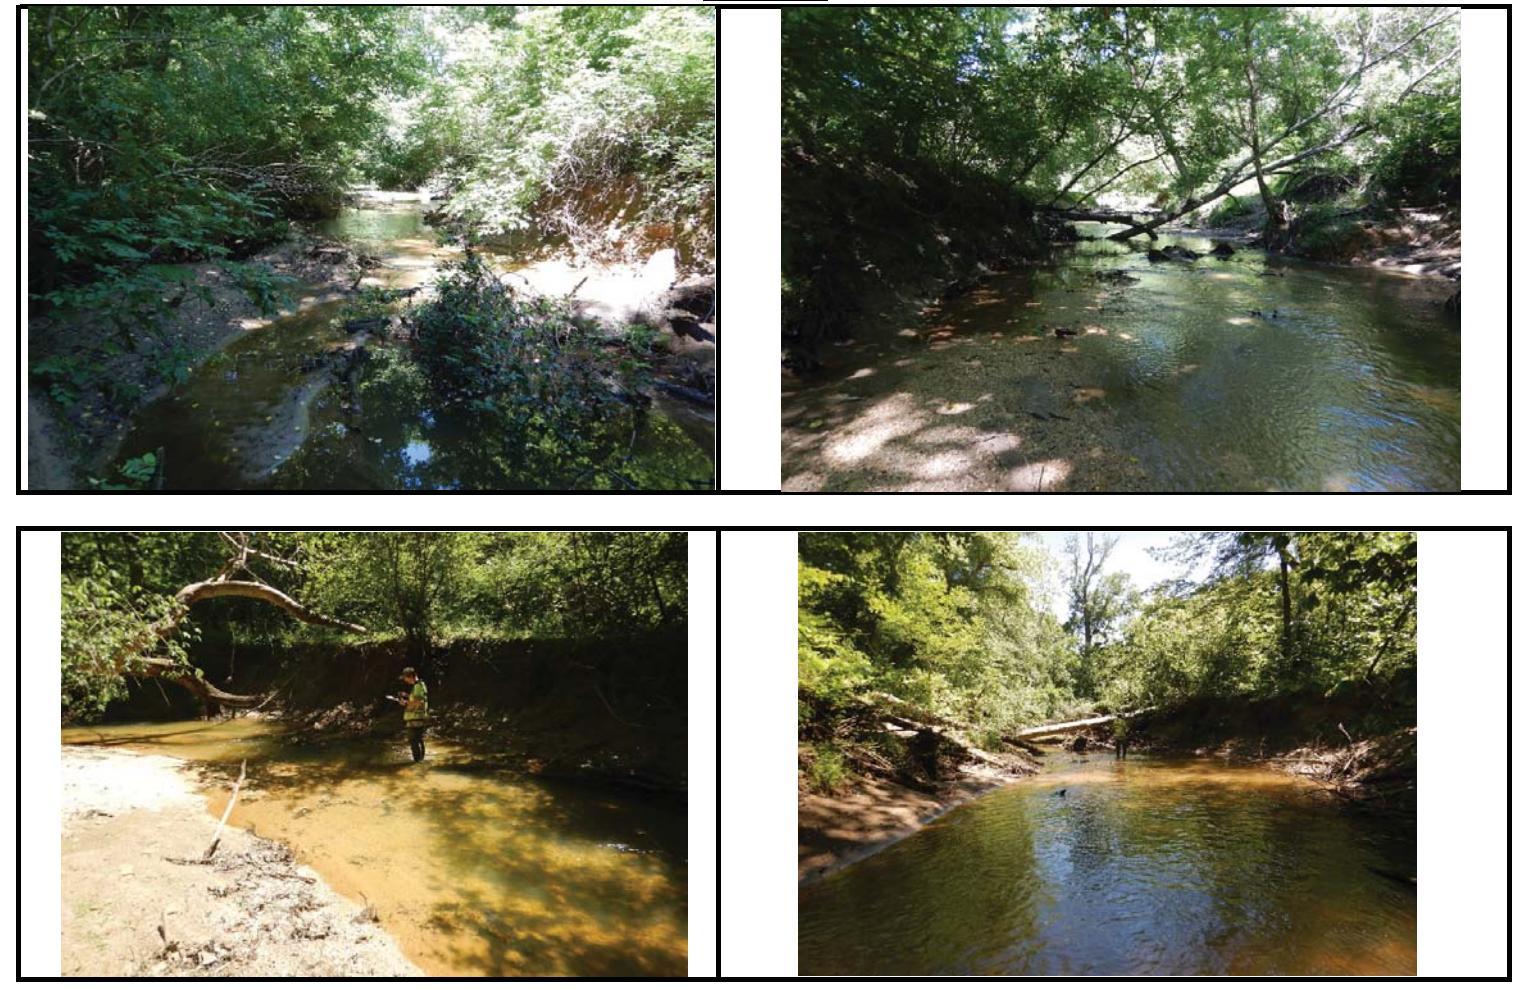
Str	eam Mitigation	Field Site Assessment Form		
		Pro	ject Details		
Project Name:	I-495/I-270 Manage	d Lanes Study	Mitigation Site Number: PG00017		
Projects Estimated Strea	am Mitigation Needs (LF):	TBD	<u>.</u>		
Data of Field Accorrmont:	6/11/2010		Consultant Firm (Investigator(s): DK&K/KIH CAS		
Date of Field Assessment.	Site	Location Details	consultant rinny investigator(s). RRARY KIT, CAS		
County:	Prince George's	Cross Roads	Croom Road and Grandbaven Ave		
Basin (HUC 8):	Middle Potomac-Anacost	ia-Occoquan	MDE Watershed (8 digit): 02060)006	
Proximity to Impacted S	itream (mi.):	6.25 miles	Lat/Long: 38.778987	-76.774976	
			Site Data		
Parcel Size (ac):	15.2		Potential Restoration Reach (LF): 2,935	5	
Site Opportunities:	XChannel Restoration	Livestock Exclusion	Riparian Buffer PlantingHabitat Enhancemen	tFish Passage	
Stream Order:	3rd	Stream Hydrology:	Perennial Stream Use	:1	
Drainage Area to Reach	(sq. mi.)	13

1 - Yes (evidence of frequence of frequence of frequence of the second	uent flooding)		1 - Conditions are such that Lift is difficult to achieve and sustain		
Describe:			Describe:		
No evidence of flooding			Opportunities for sediment reduction, floodplain connectivity, water quality.		
			Existing good instream woody habitat.		
Opportunity for Floodpl	ain Development	5	Ease of Access	1	
10 - Existing space for flo	bodplain greater than 10 til	nes stream width	10 - Yes (with <u>existing</u> direct venicular access to potential sit	e)	
5 - Existing space for floc	floodolain 3 to 10 times stream	n width	5- yes (open but no existing venicular access)		
~ 200' on both sides for t	floodalain development		Mid-successional forest with dense understory - no existing	access	
				access.

-	
Drainage Area Evaluatio	on	1	Utilities Present	1	
IU-D.A. less than 1 sq. m	nı. Almi		10 - NO UTILITIES ON SITE		
5- D. A. Detween I & 3 St 1 - D. A. groater than 3 of	y. mi		 Definition of the second second		
1 - D. A. greater than 3 S	y. iiii.				
13 square miles			Sewerline along smaller tributary. Overhead powerline along	g tributary.	
				1	
			Total Score out of 100	40

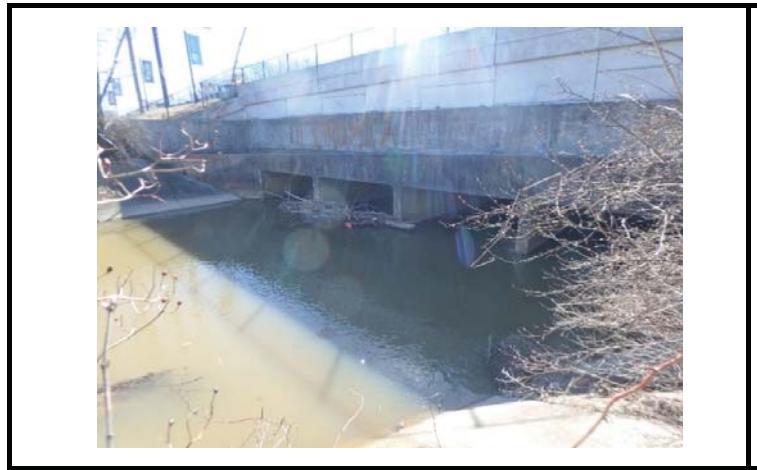
Looking downstream at culvert from right bank

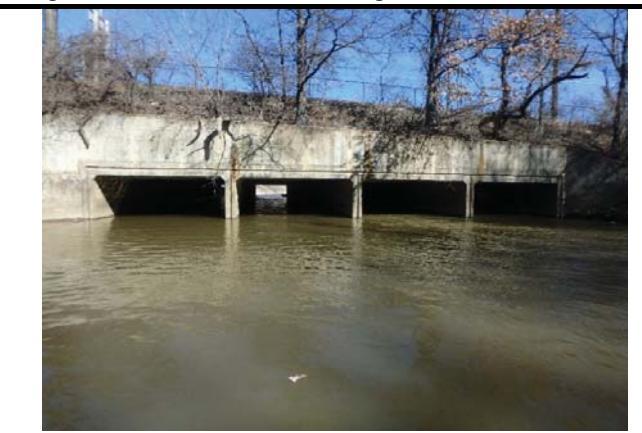
Downstream of culvert - facing upstream

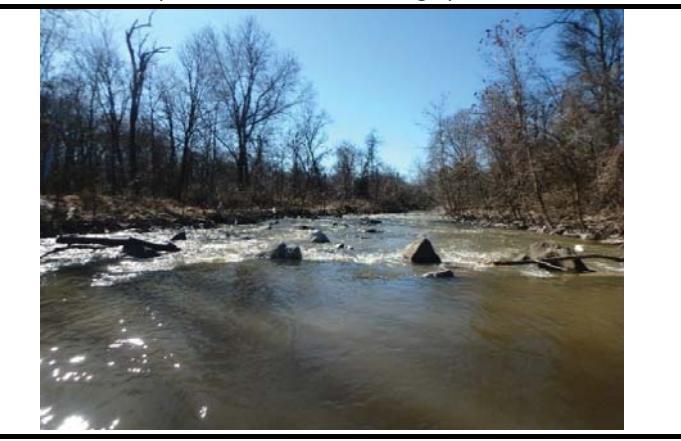
Channel overview downstream of culvert - facing downstream

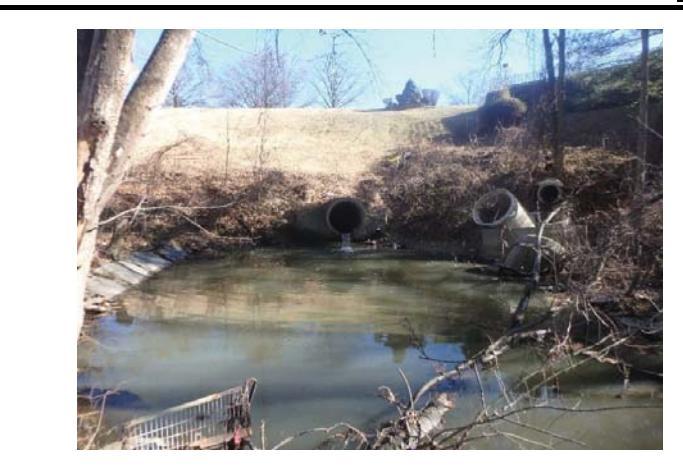
Culvert outfall/blockage - facing upstream

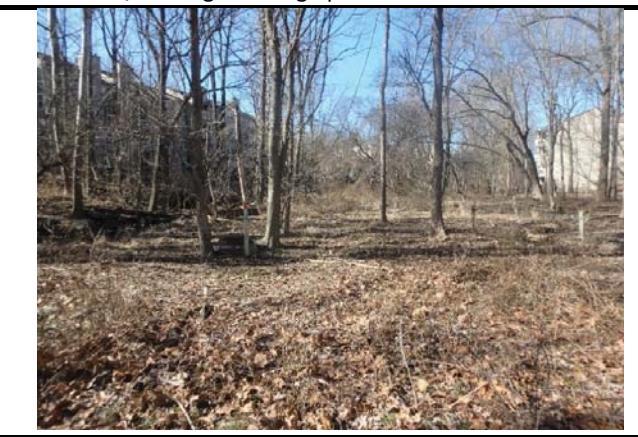
Downstream of blockage - looking at sewer manholes

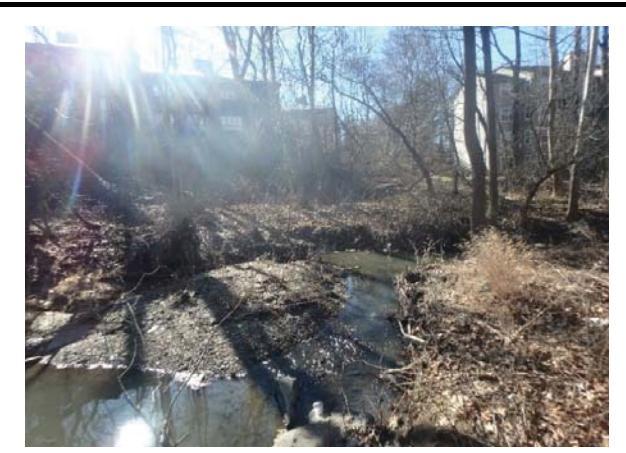
Channel overview downstream of blockage - facing downstream

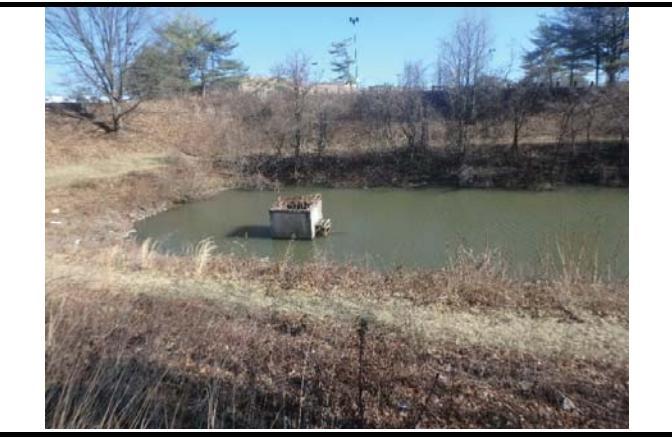
Upstream of culvert looking at pond

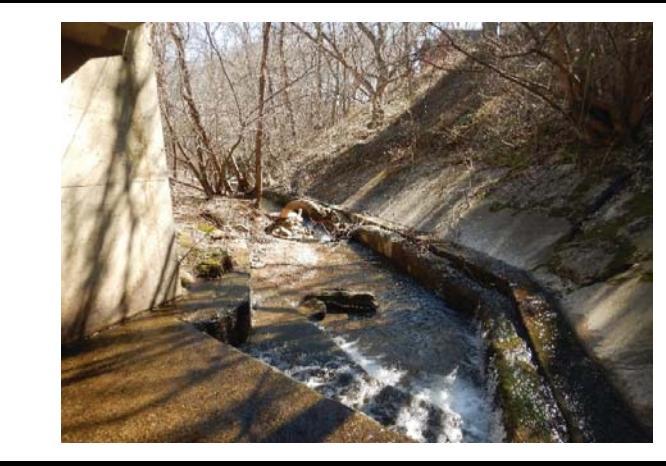
Culvert outfall - facing downstream

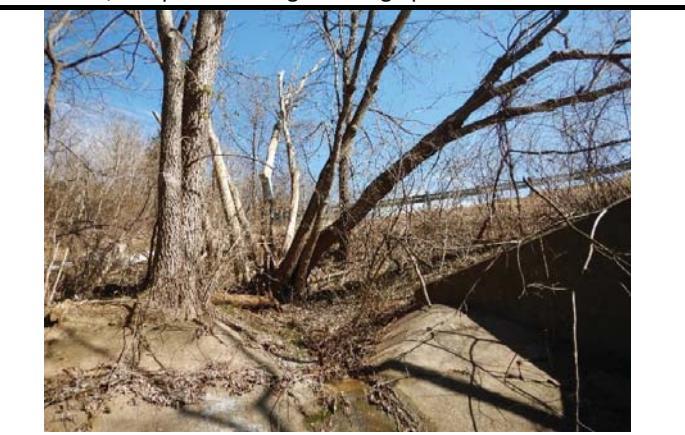
Left Bank at upstream end looking downstream

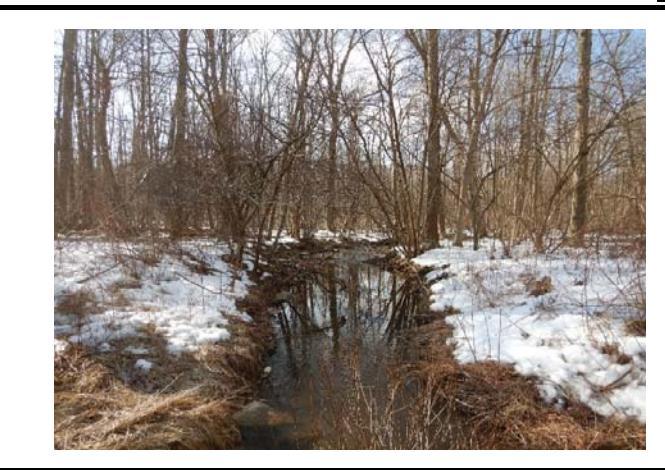
At downstream end of culvert looking downstream

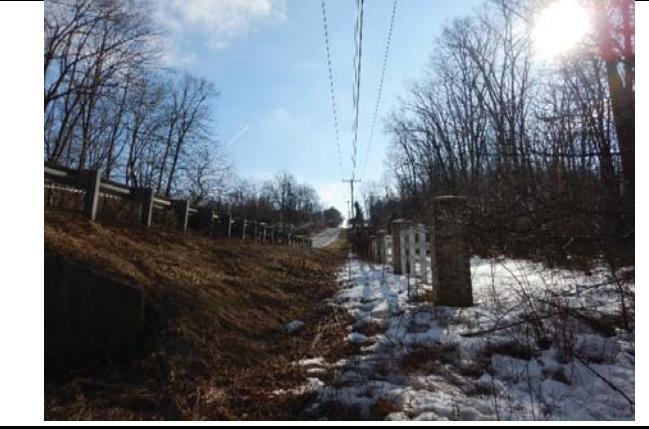
Left bank at downstream end looking at overhead utility

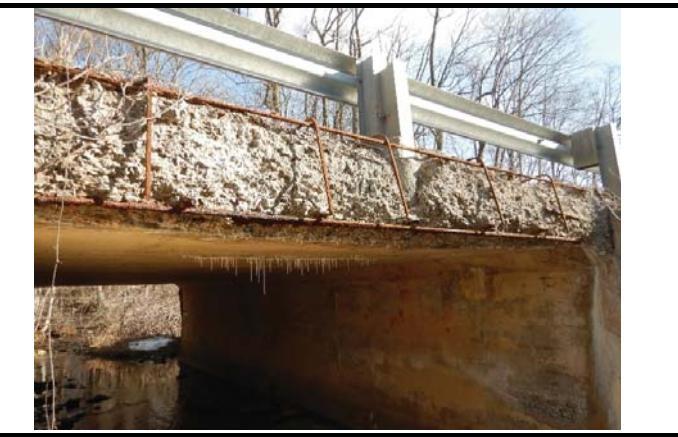
Deteriorating concrete on culvert

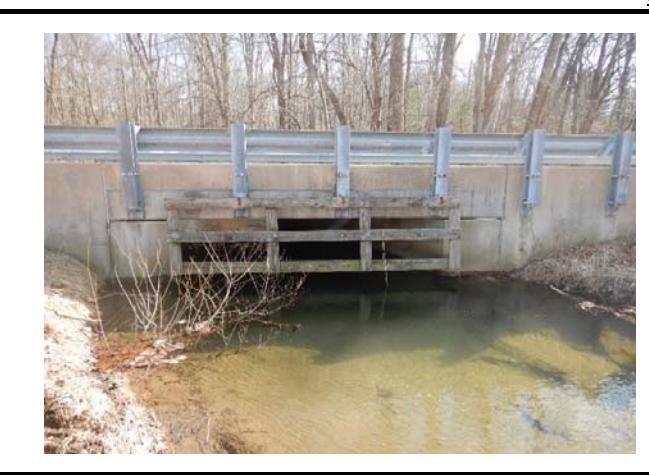
Culvert outfall/no blockage - facing upstream

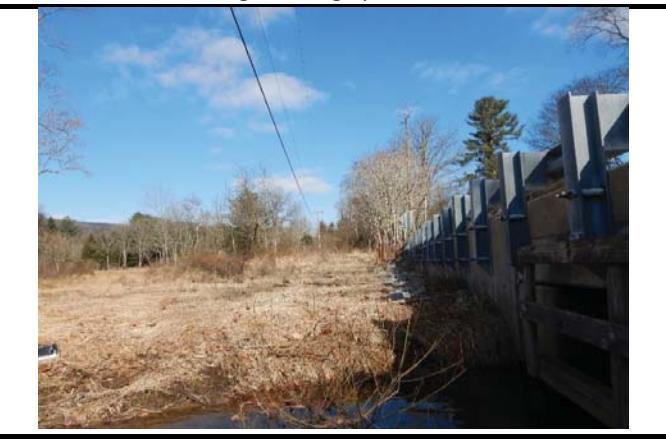
Left bank at downstream edge looking at powerlines and guardrail

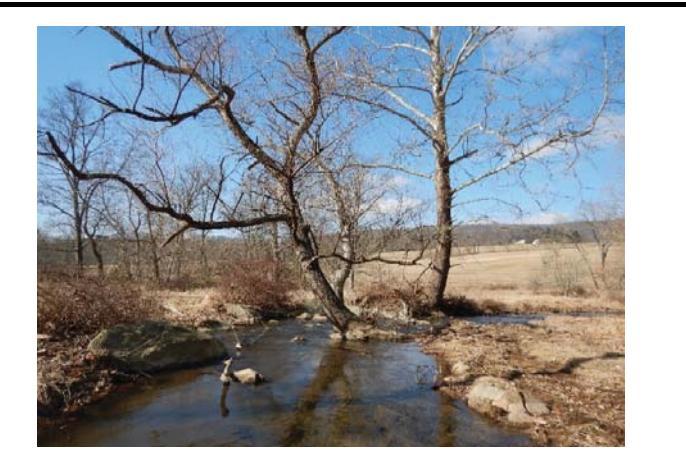
Channel overview downstream of culvert - facing downstream

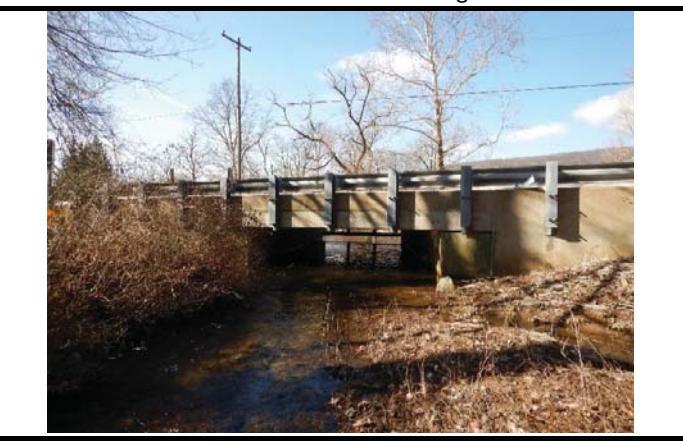
Upstream looking downstream at culvert

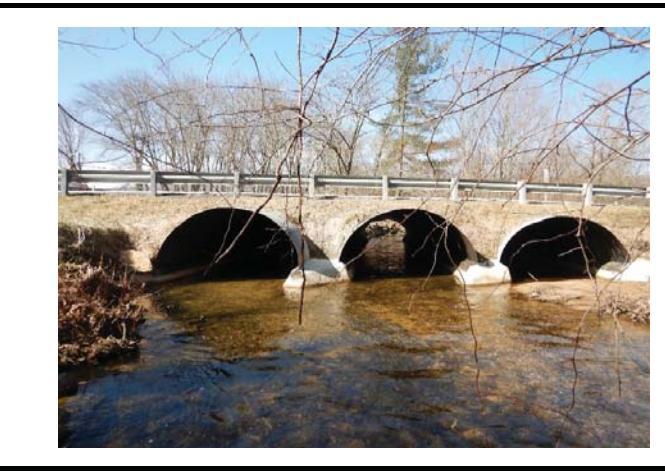
Culvert outfall/no blockage - facing upstream

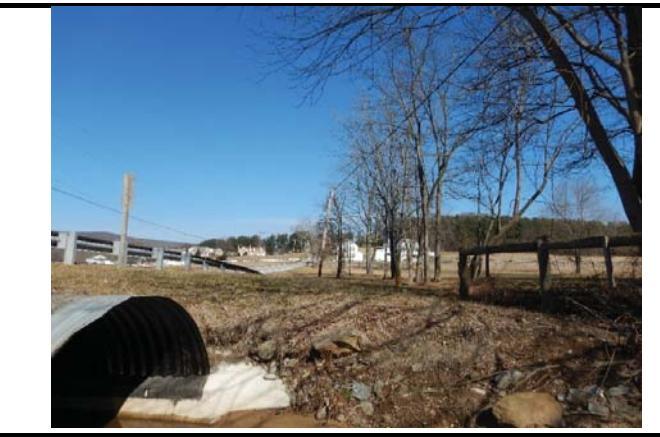
Left bank at downstream end looking at powerlines and guardrail

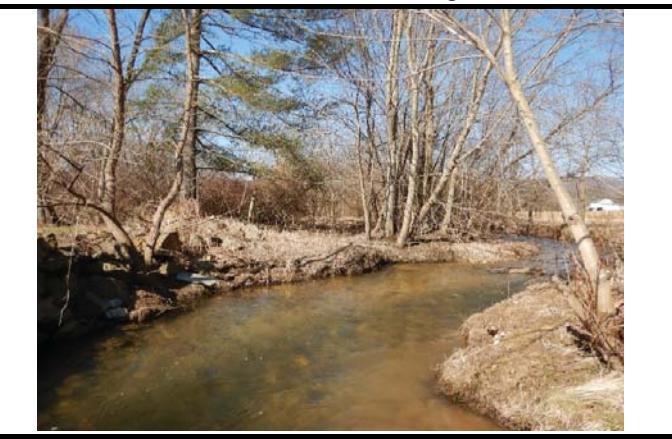
Upstream of culvert looking upstream

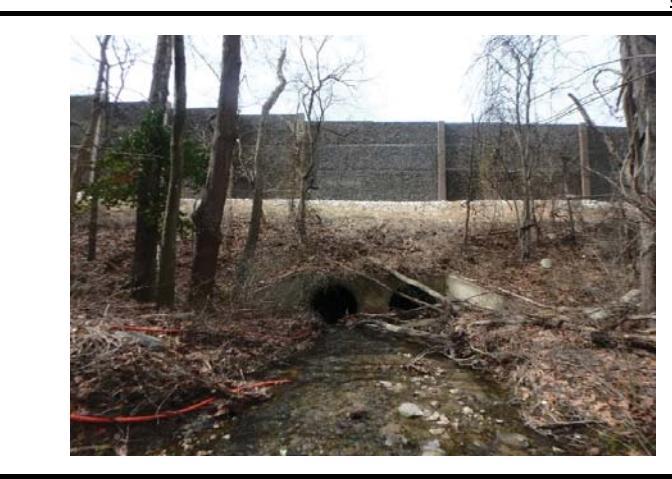
Upstream looking downstream at culvert

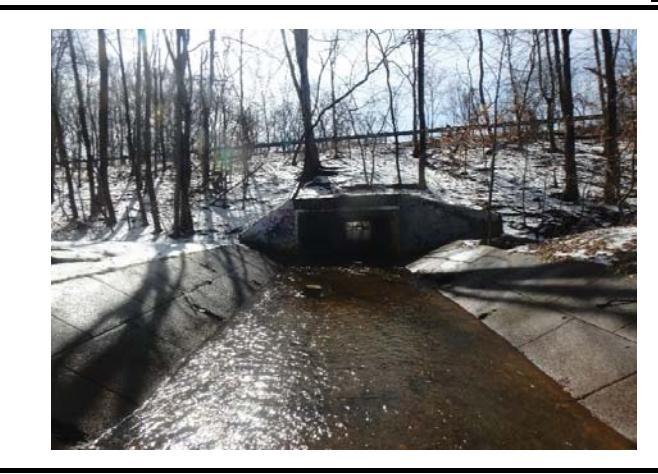
Channel overview downstream of 1st blockage in ROW

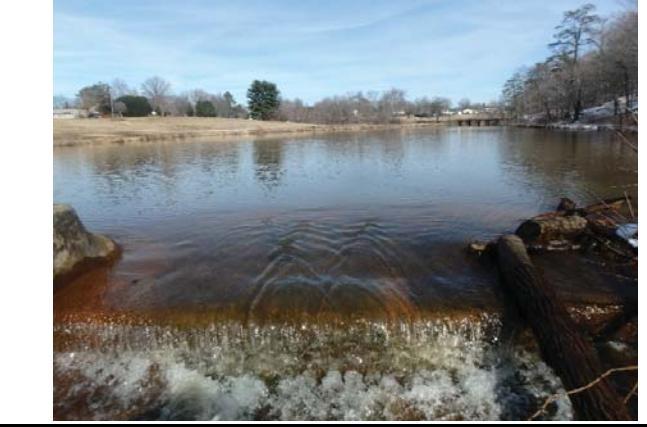
Upstream of 3rd blockage looking upstream at pond

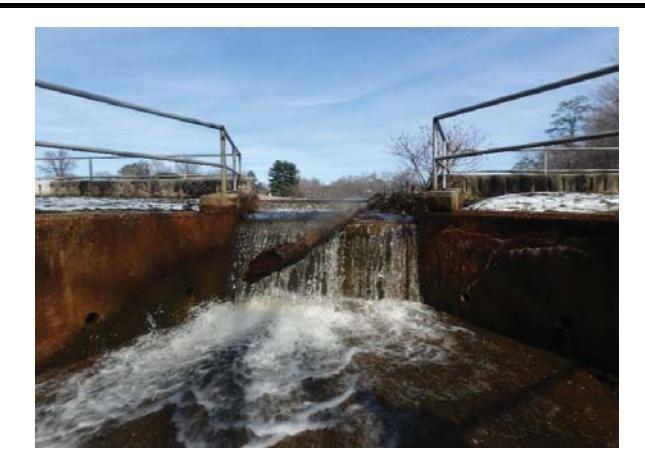
Upstream at 1st blockage looking upstream at 2nd/3rd blockages

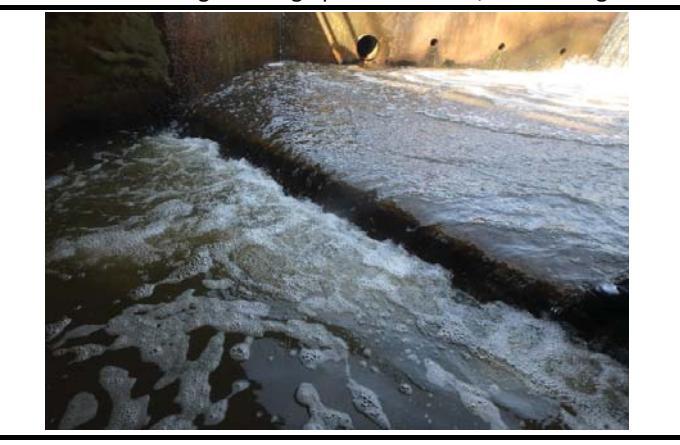
Look upstream at 1st blockage within ROW

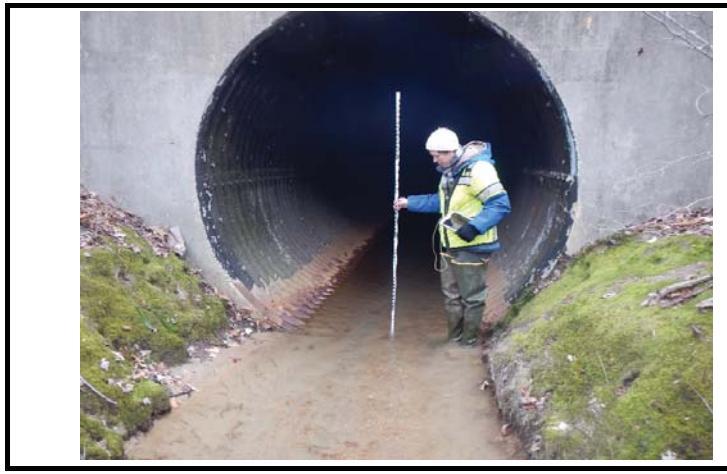
Culvert inlet - facing downstream

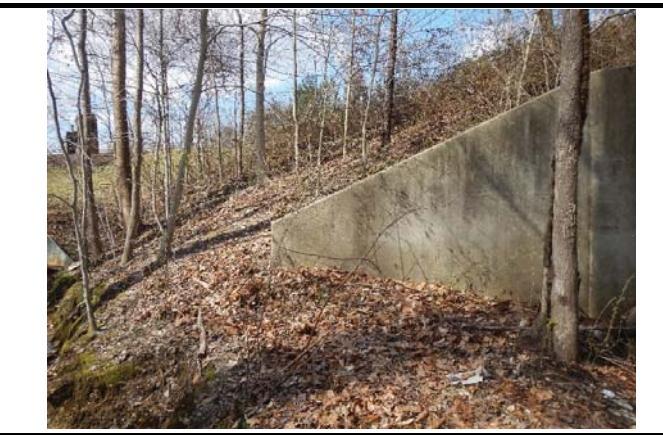
Culvert outfall - facing upstream

Slopes adjacent to culvert outfall, facing roadway

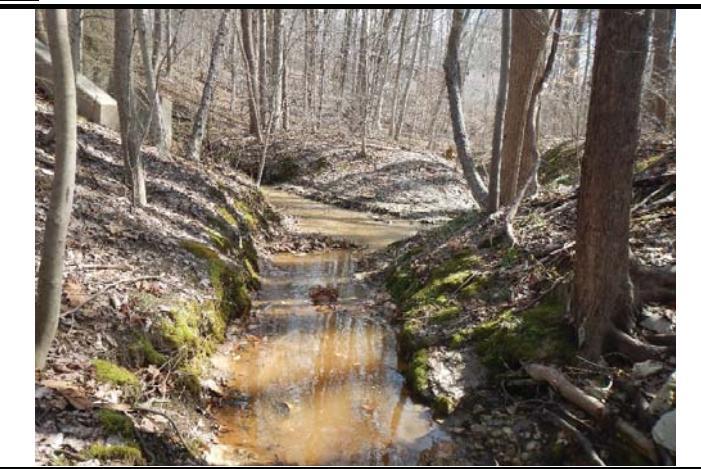
Channel overview - facing downstream

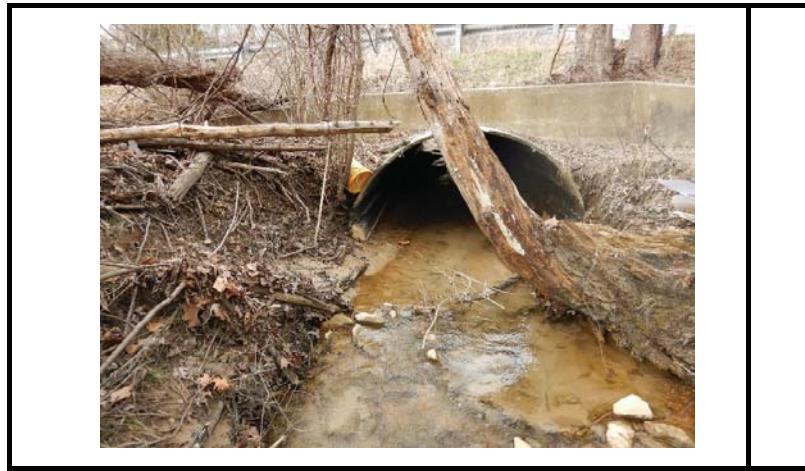
Culvert outfall - facing upstream

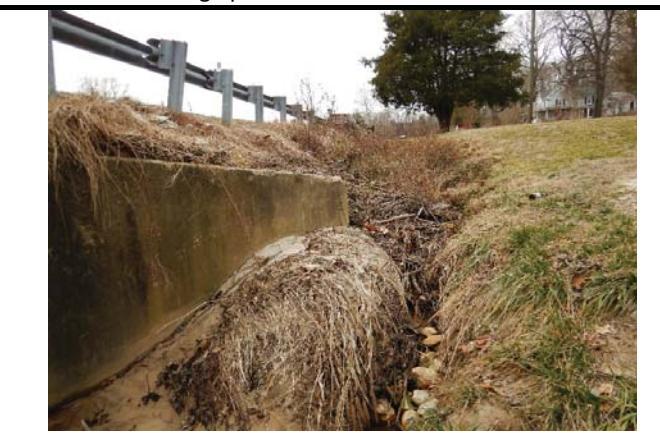
Access from road adjacent to culvert

Channel overview downstream of culvert - facing downstream

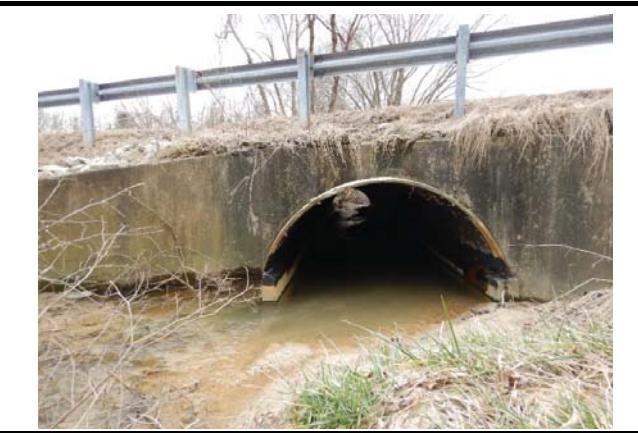
Culvert inlet - facing downstream

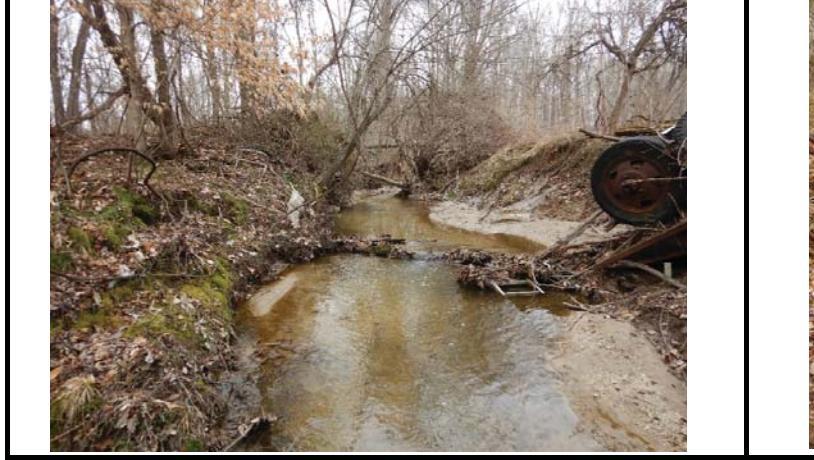
Channel overview upstream of culvert - facing upstream

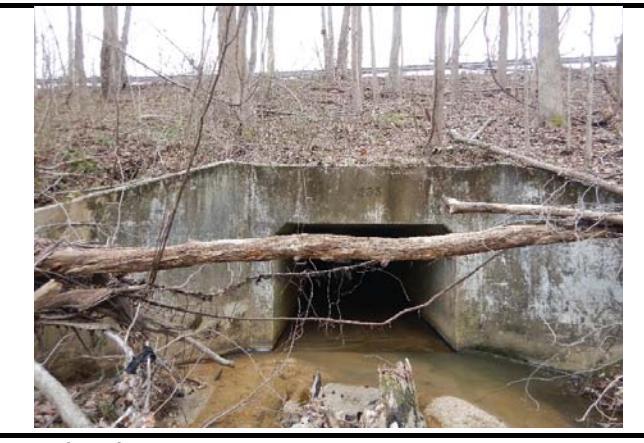
Culvert outfall - facing upstream

Channel overview downstream of sulvert - facing downstream
