APPENDIX E: PUBLIC SITE WALKTHROUGH RATING CRITERIA & FIELD ASSESSMENT FORMS

WETLAND MITIGATION RATING CRITERIA & FIELD SITE ASSESSMENT FORMS

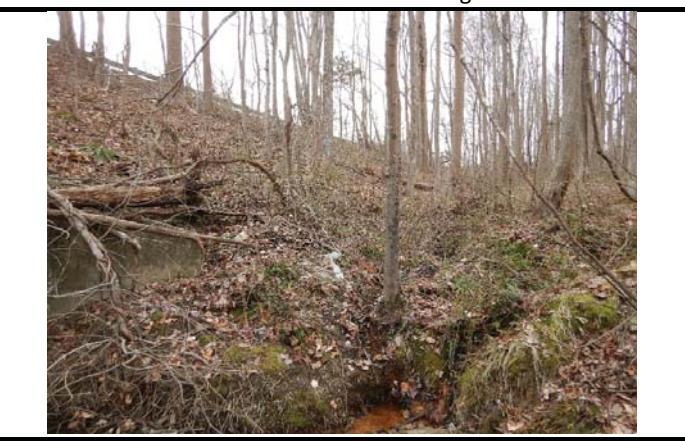
Access from road adjacent to culvert

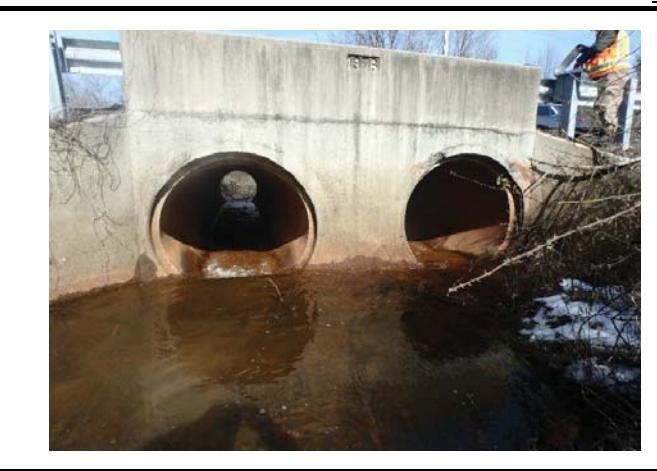
Culvert inlet - facing downstream

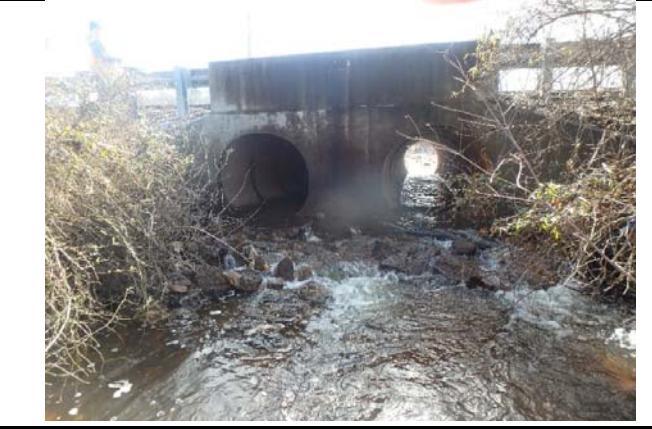
Culvert outfall/partial blockage - facing upstream

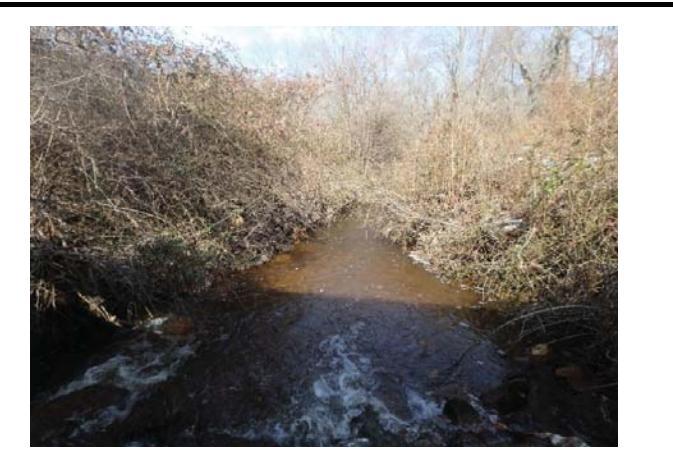
Channel overview downstream of culvert - facing downstream

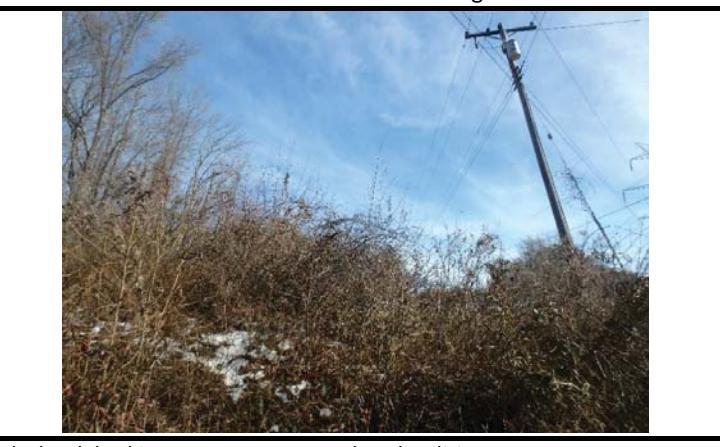
Right bank looking upstream at overhead utilities

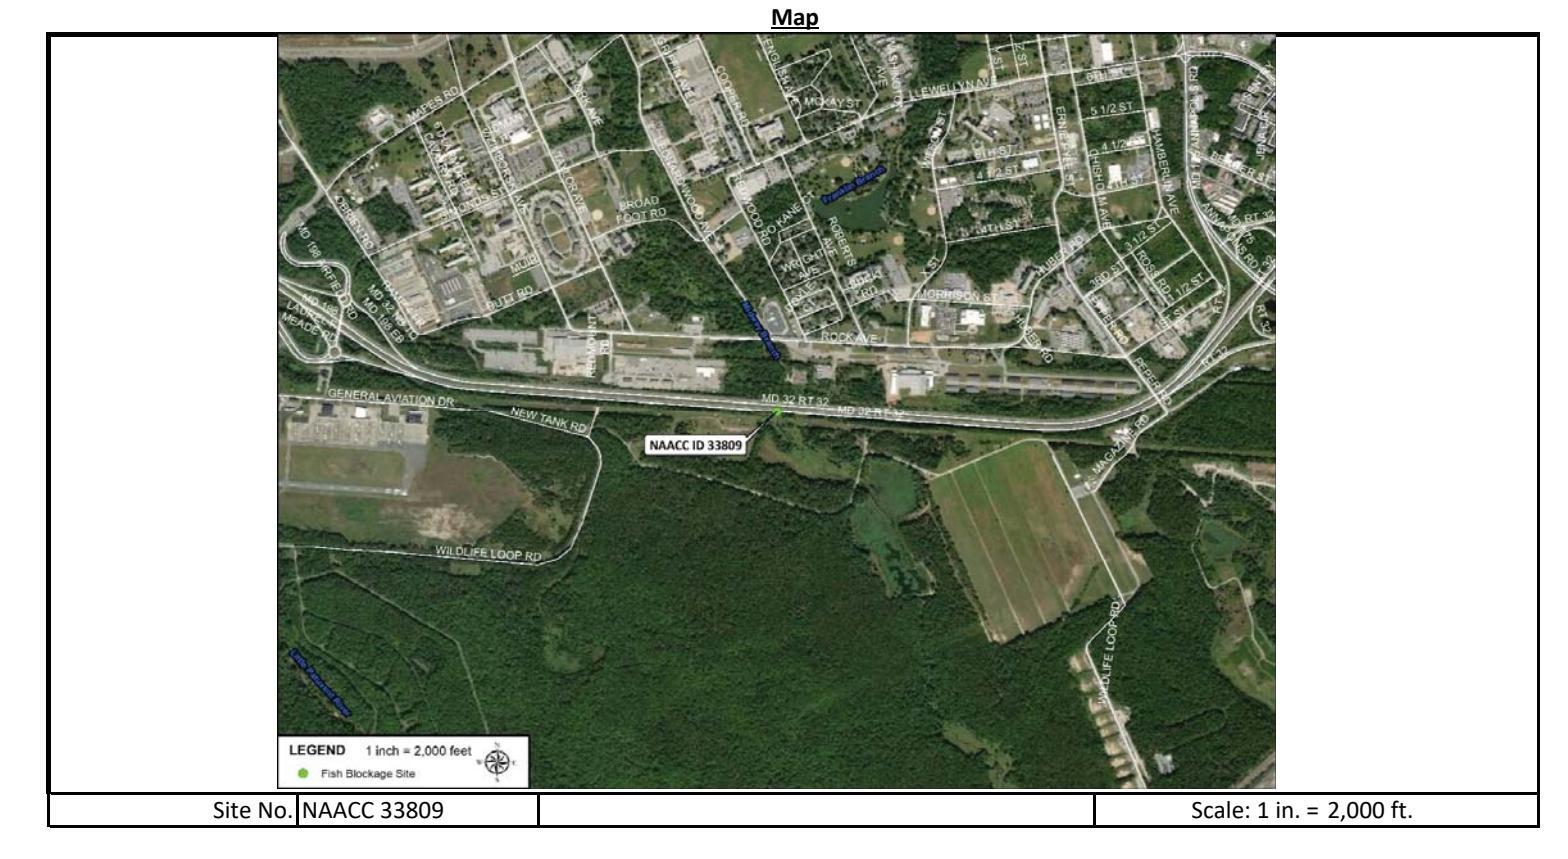
NSA force prohibiling site agent	Streen conditions US of read proving
NSA fence prohibiting site access	Stream conditions US of road crossing

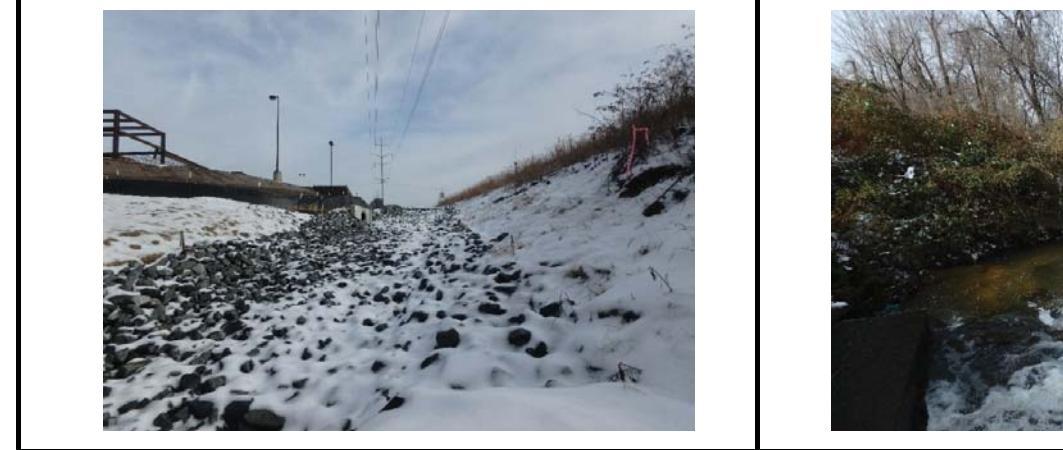
Righ Bank Riprap channel, overhead lines, and existing construction

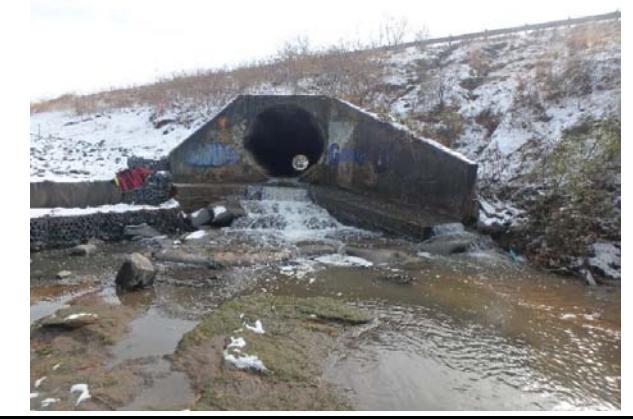
Downstream looking upstream at Culvert/complete blockage

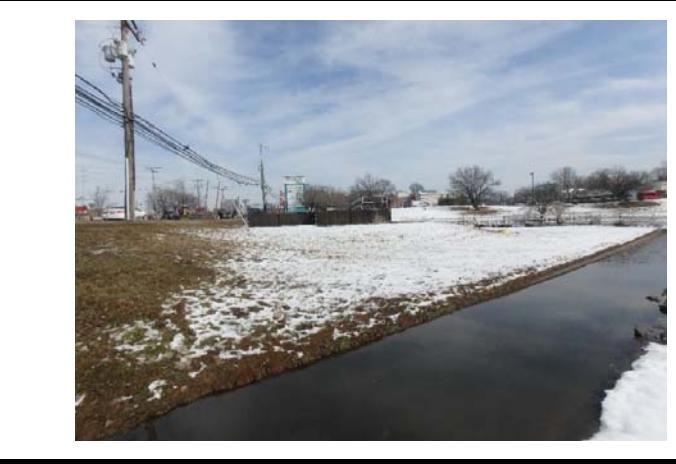
Right bank and County facility upstream of culvert

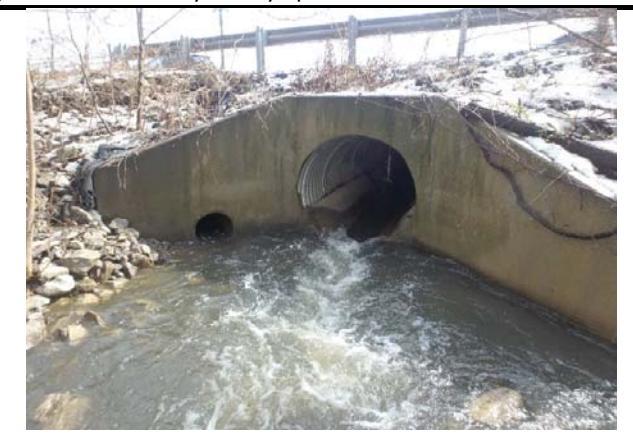
Downstream looking upstream at culvert/no blockage

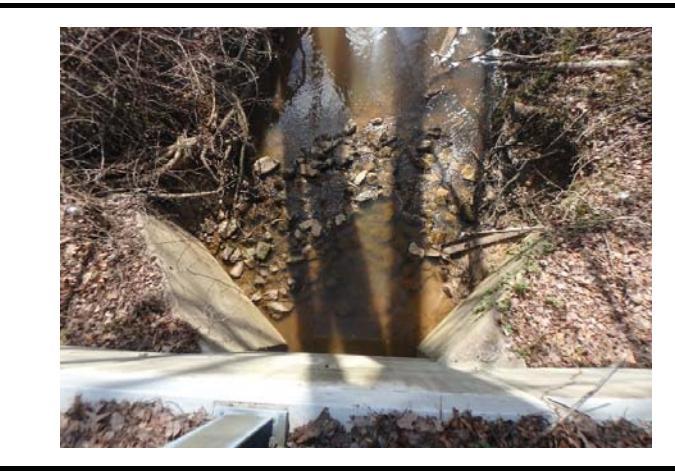
From roadway looking at downstream end of culvert

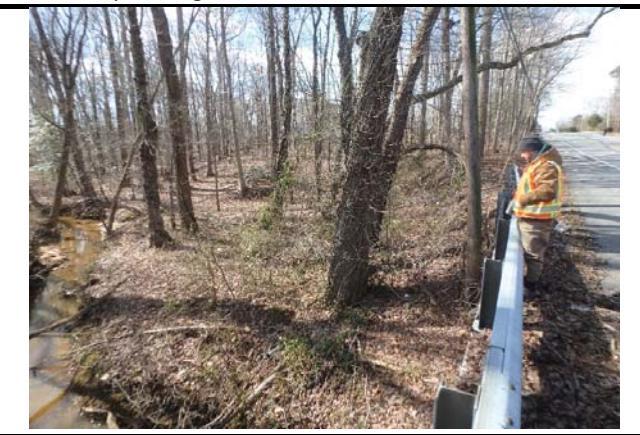
Right bank looking at riparian forest downstream

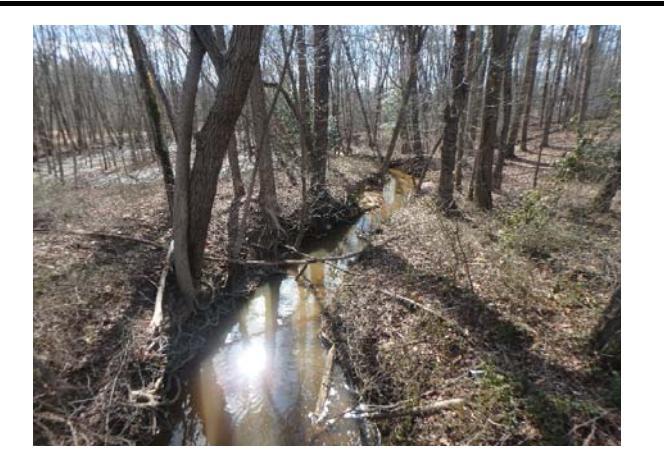
Downstream of culvert looking downstream

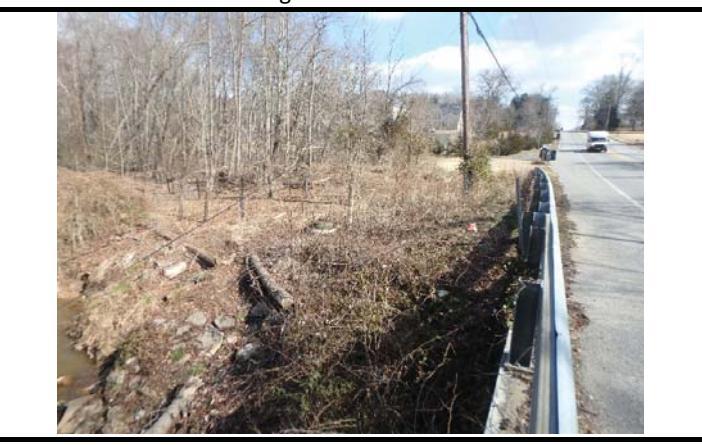
Left bank looking at sewer and powerlines upstream

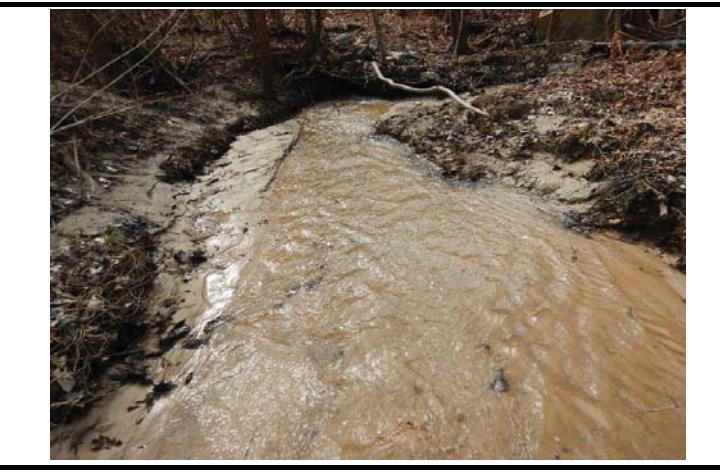
Channel overview downstream of culvert - facing downstream

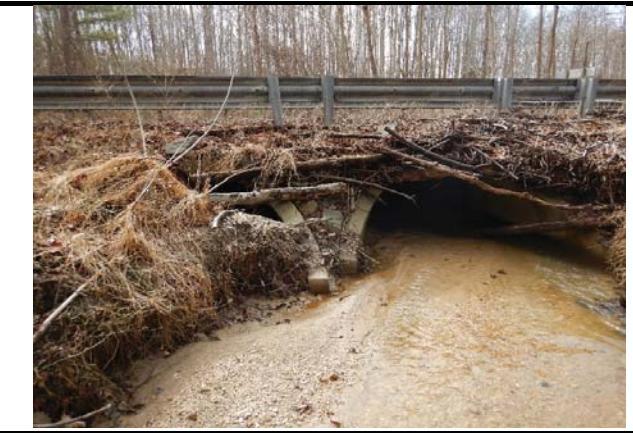
Culvert inlet - facing downstream

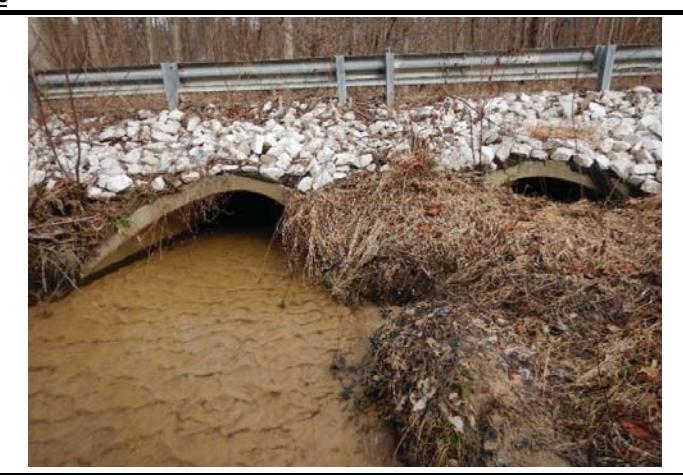
Culvert outfall - facing upstream

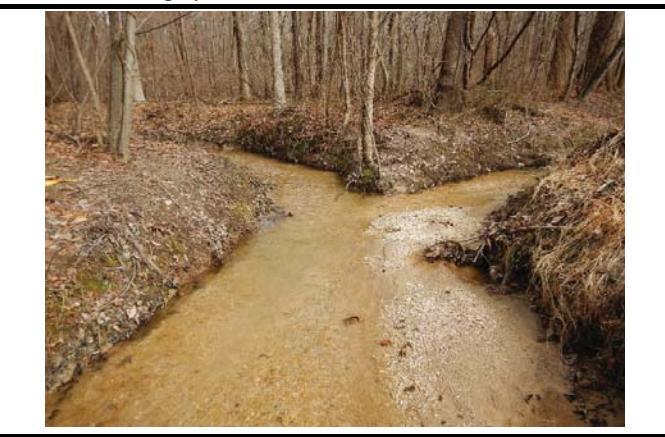
Channel overview upstream of culvert - facing upstream

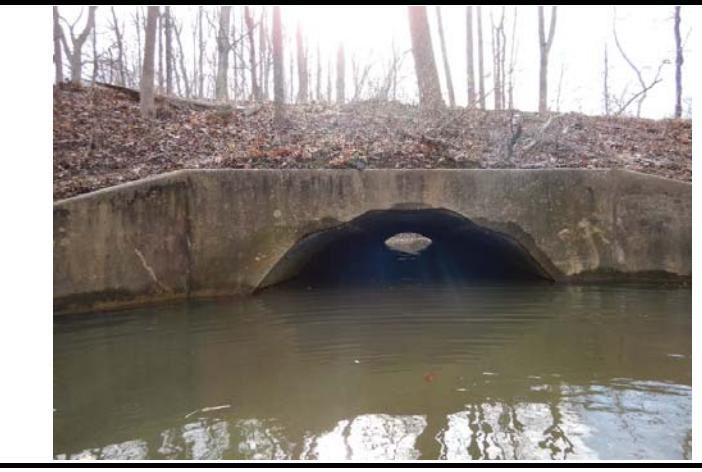
Culvert outfall - facing upstream

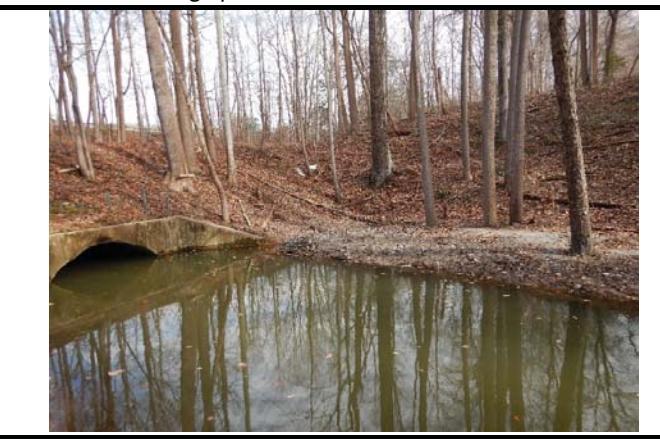
Culvert outfall - view of adjacent cover

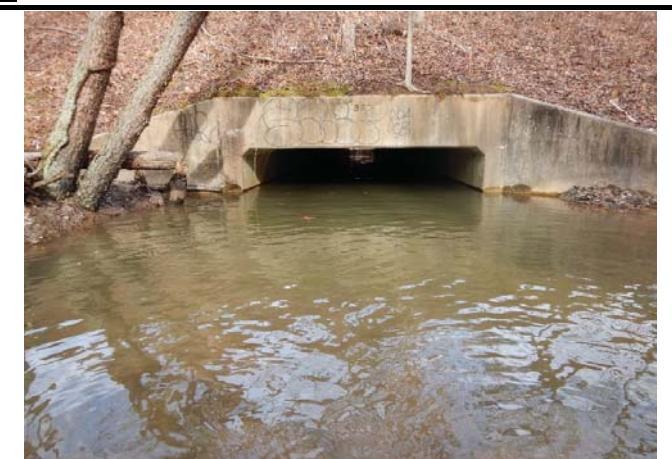
Culvert inlet - facing downstream

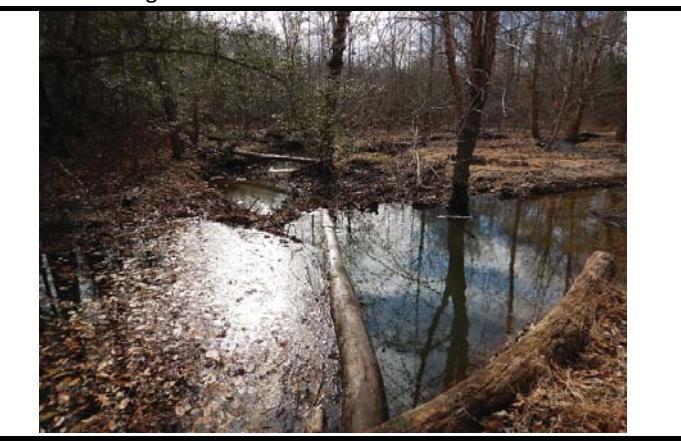
Channel overview downstream of culvert - facing downstream

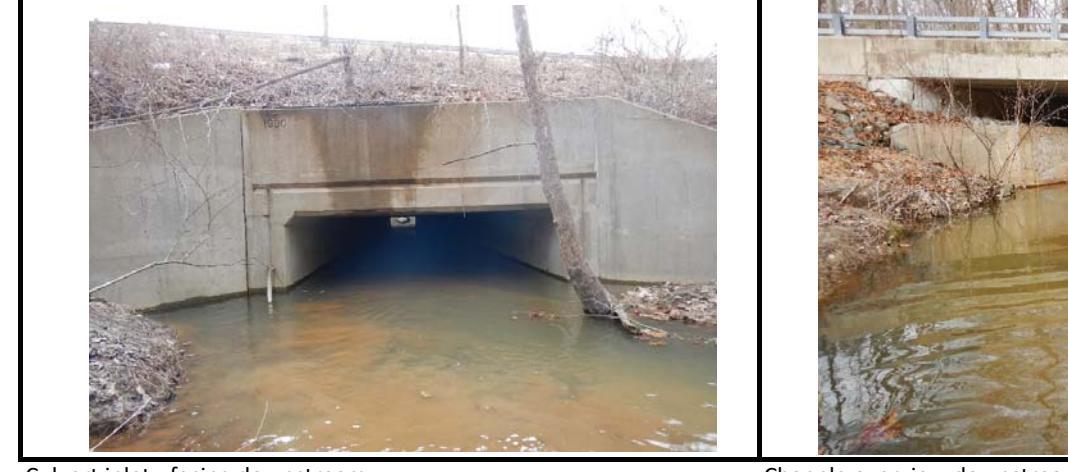
Culvert inlet - facing downstream

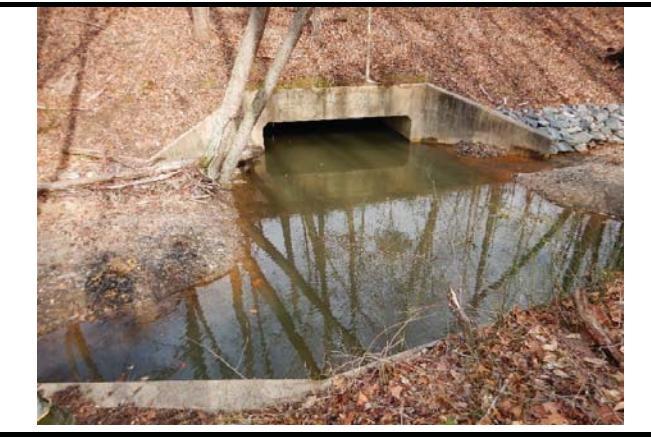
Culvert outfall - facing upstream

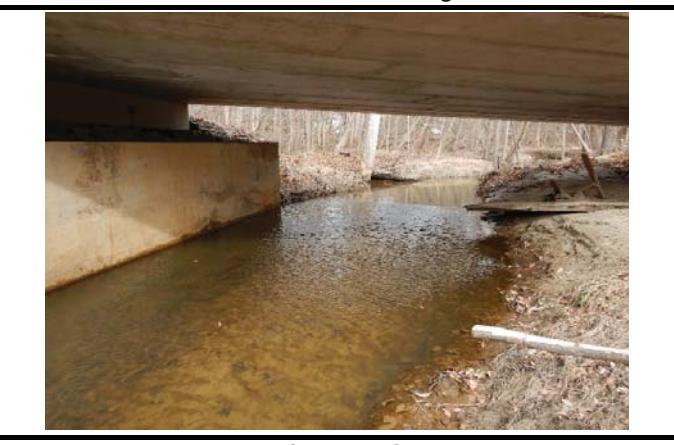
Channel overview downstream of culvert - facing downstream

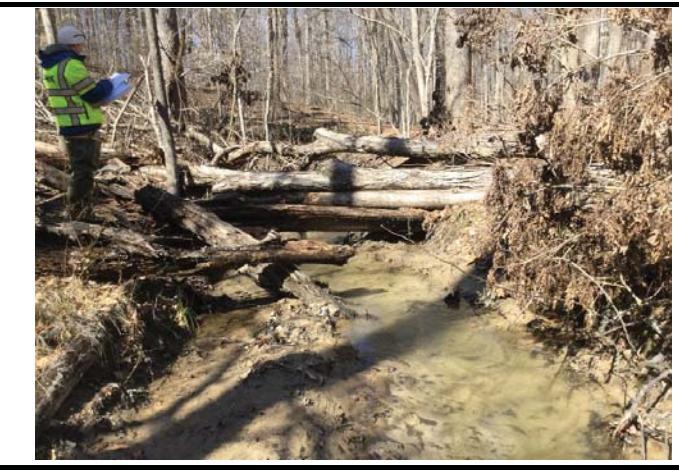
Channel overview upstream of culvert - facing upstream

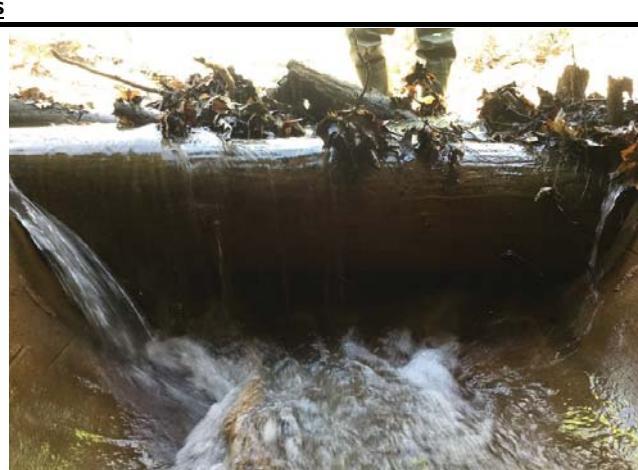
Within culvert - facing upstream, log blockage

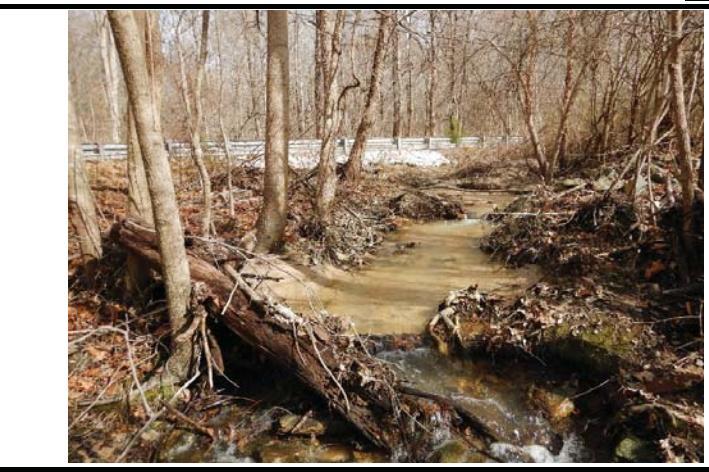
Channel overview upstream of culvert - facing upstream

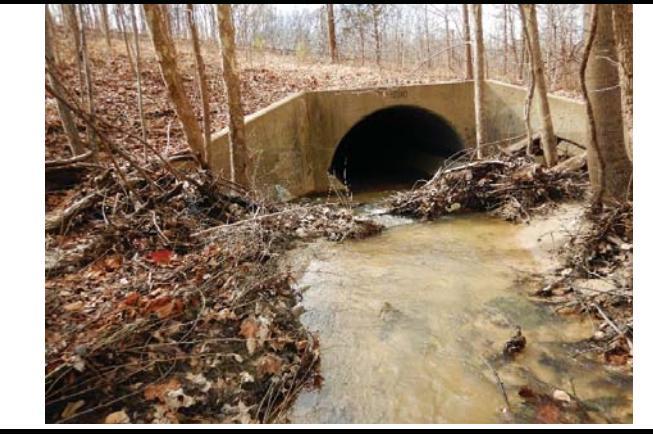
Culvert inlet - facing downstream

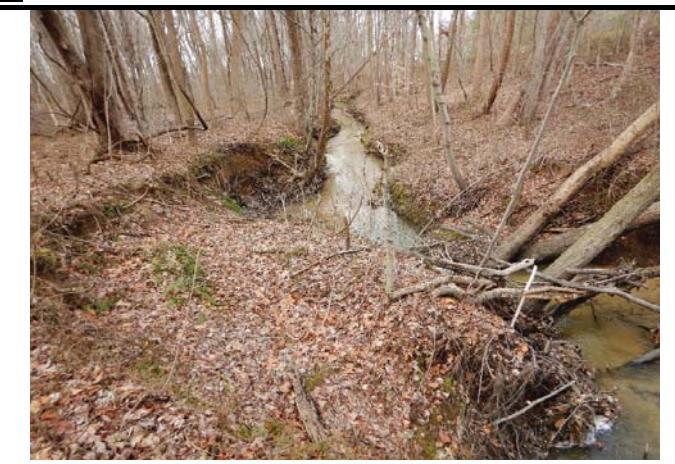
Channel overview downstream of culvert - facing downstream

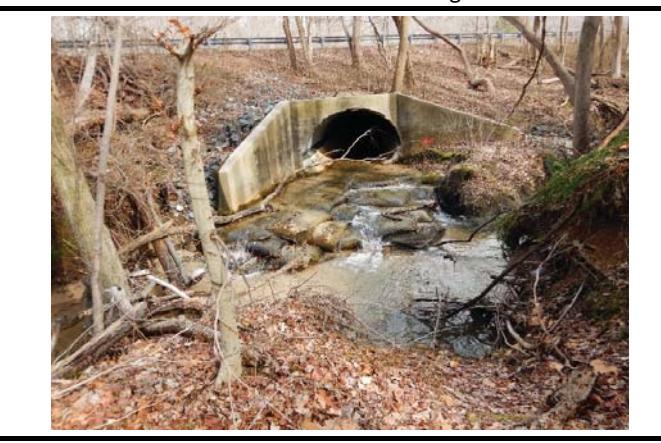
Culvert outfall - facing upstream

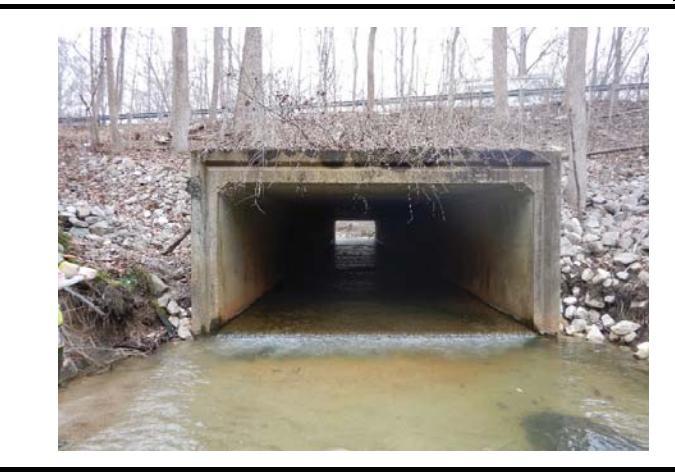
Culvert outfall/partial blockage - facing upstream

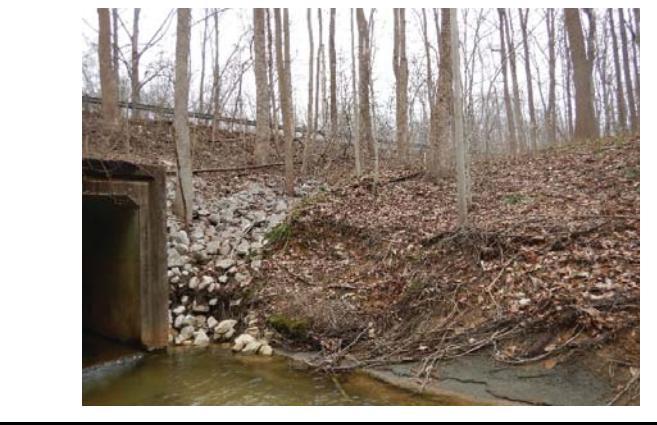
Potential access downstream of culvert - facing upstream

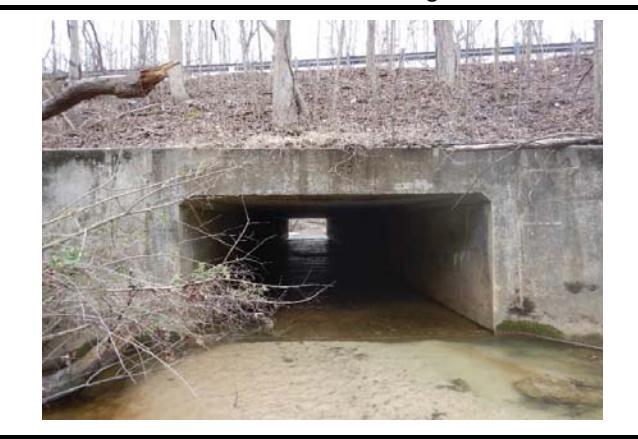
Culvert inlet - facing downstream

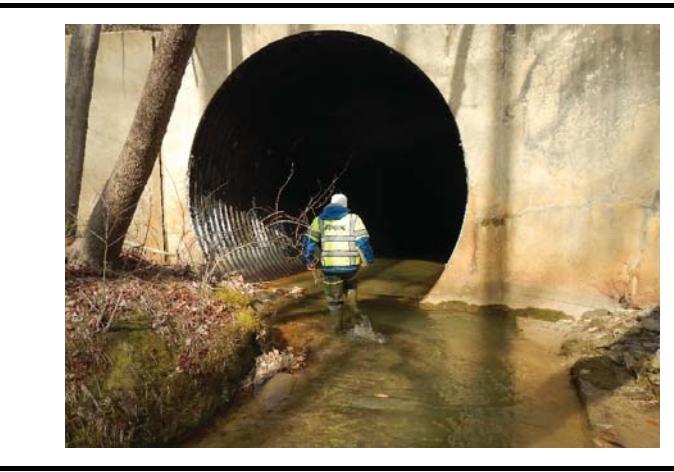
Culvert inlet - facing downstream

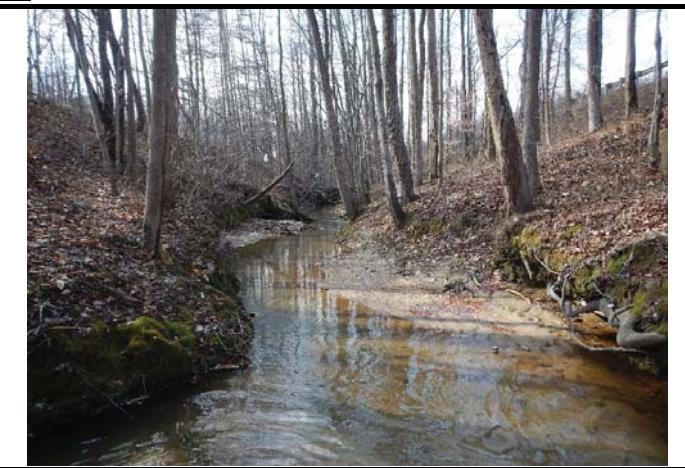
Channel overview upstream of culvert - facing upstream

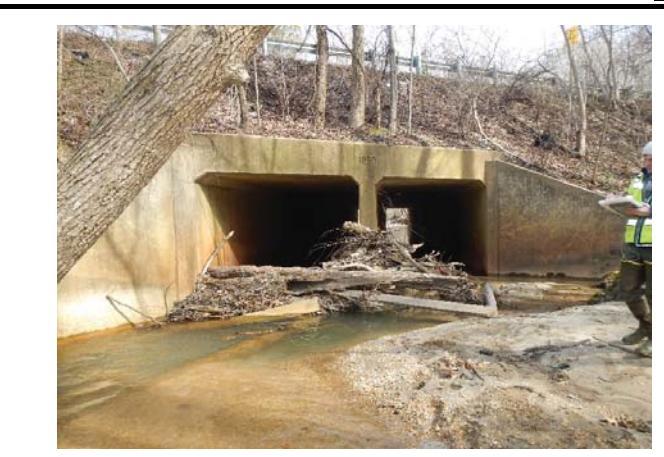
Culvert inlet - facing downstream

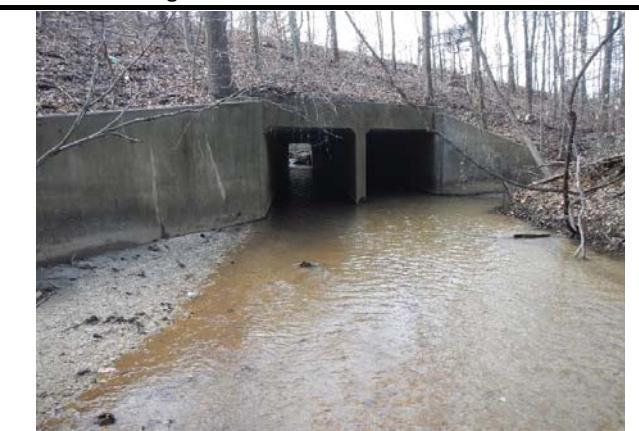
Culvert outfall - facing upstream

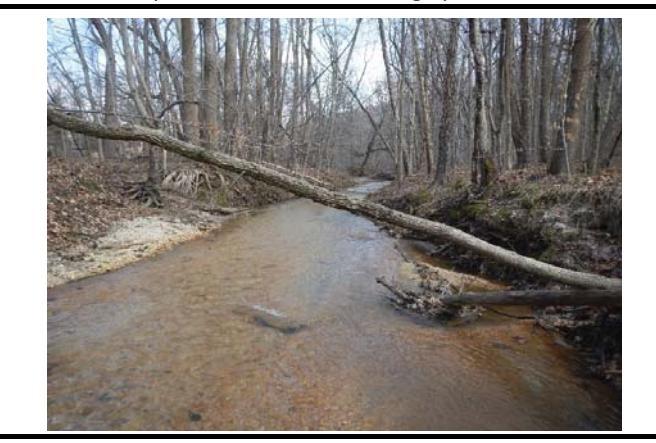
Channel overview downstream of culvert - facing downstream

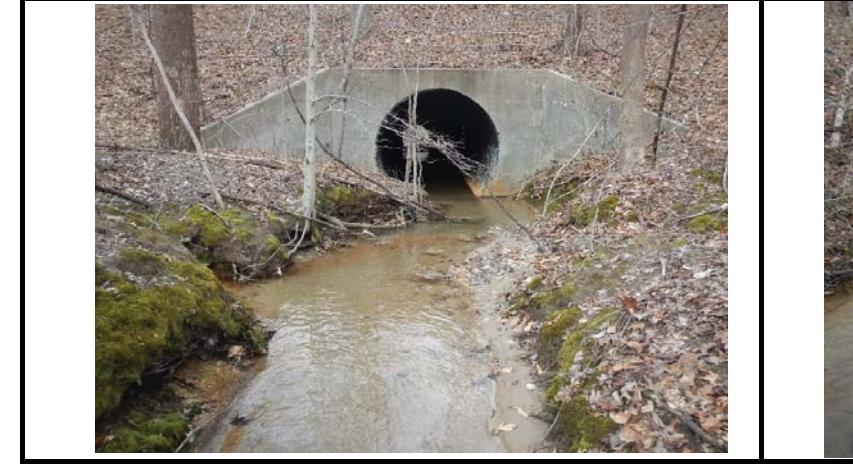
Culvert inlet - facing downstream

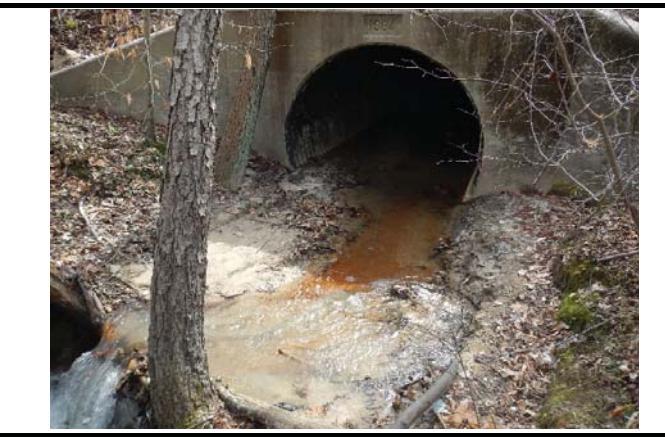
Culvert outfall - facing upstream

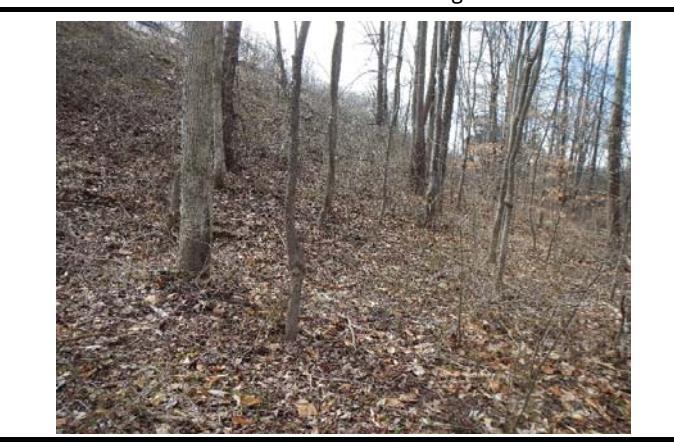
Slopes adjacent to culvert outfall, facing roadway

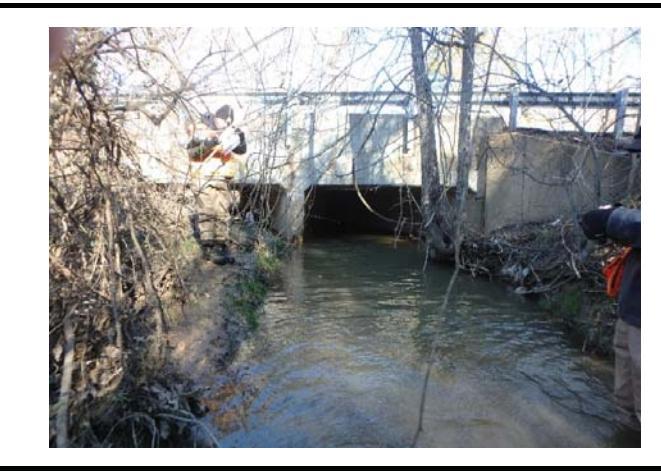
Downstream looking upstream at culvert/no blockage

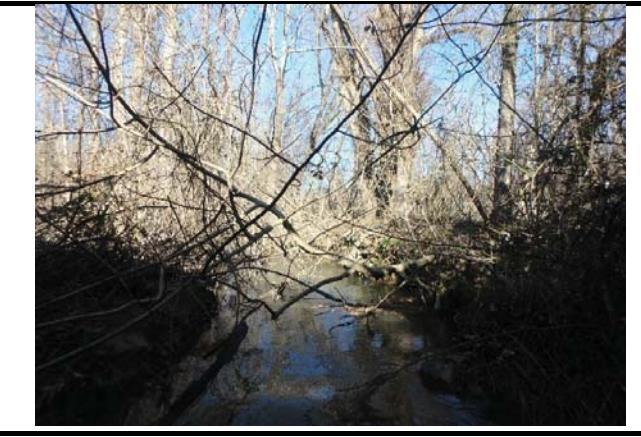
Upstream of culvert looking upstream

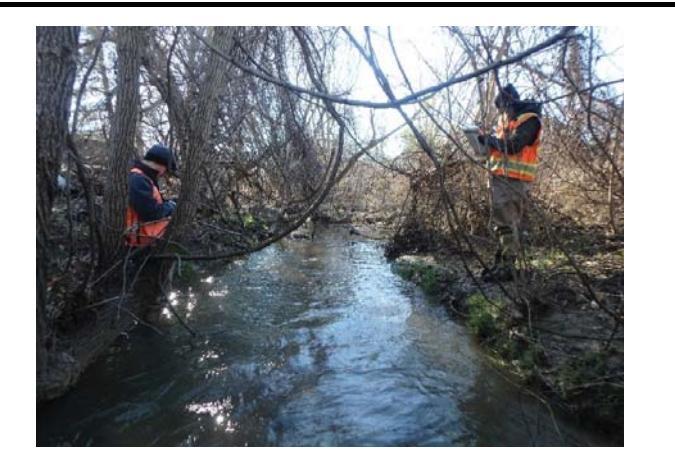
Downstream of culvert looking downstream

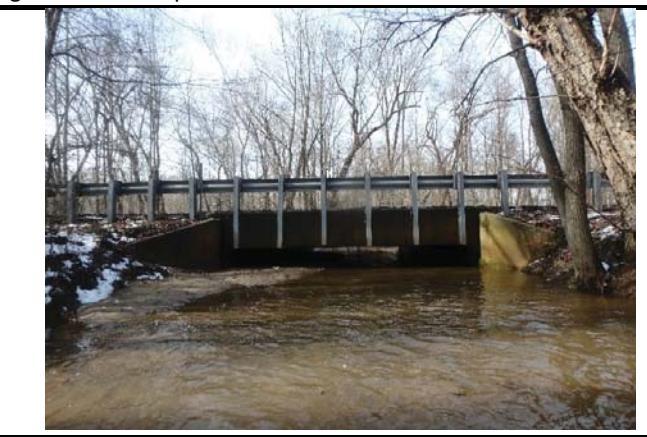
Downstream looking upstream at culvert/no blockage

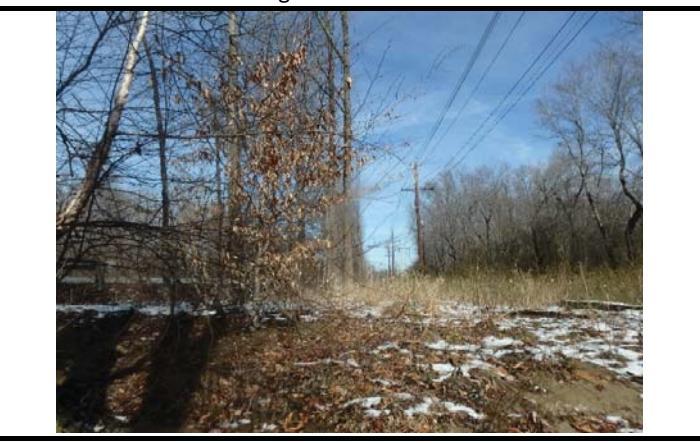
Left bank from downstream end of culvert, powerlines

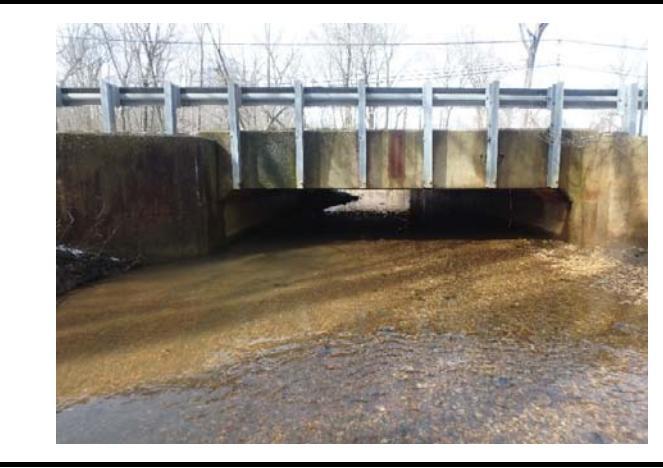
Downstream looking upstream at culvert/no blockage

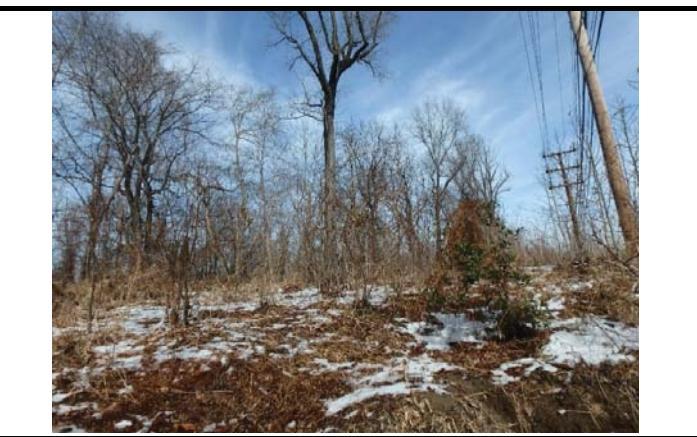
Left bank at upstream end looking at powerlines

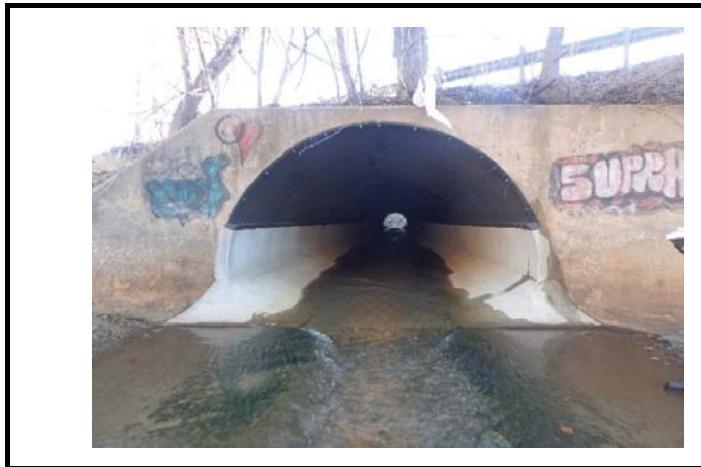
Downstream looking upstream at culvert/no blockage

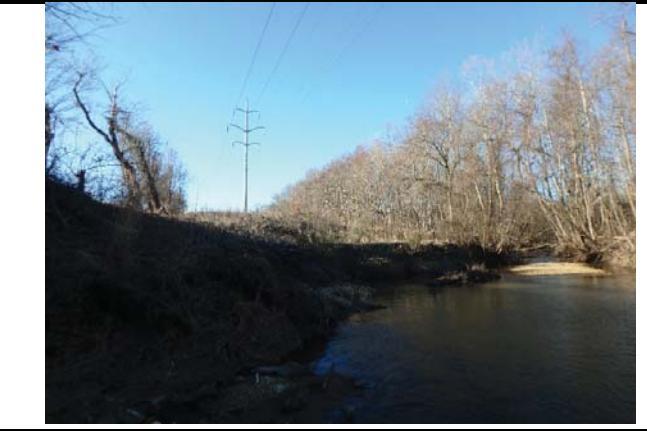
Left bank looking at ROW access and overhead lines

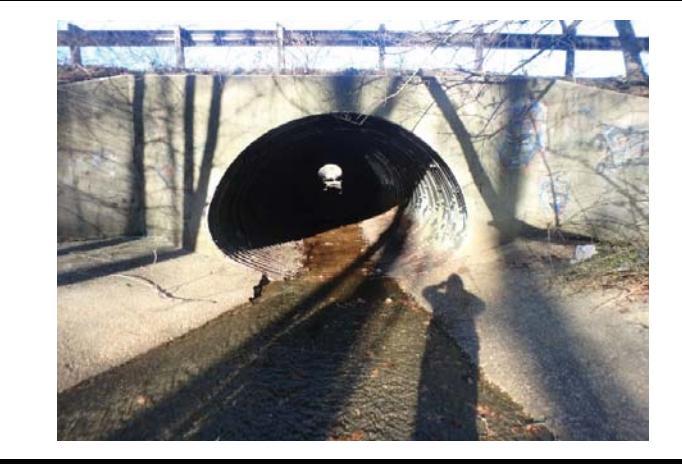
Upstream looking downstream at culvert/partial blockage

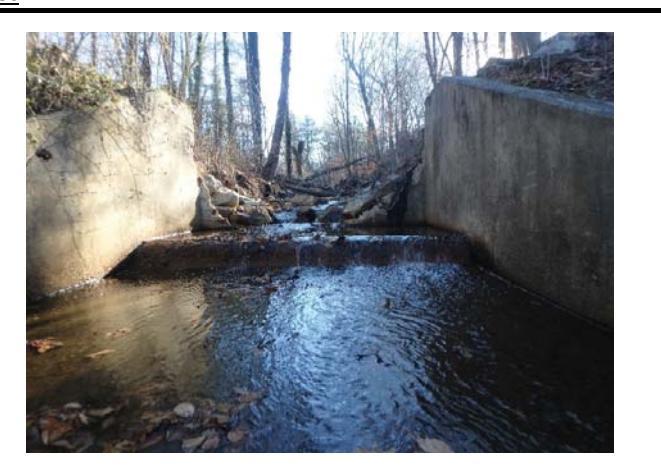
Upstream looking upstream at old cement structure outside of ROW

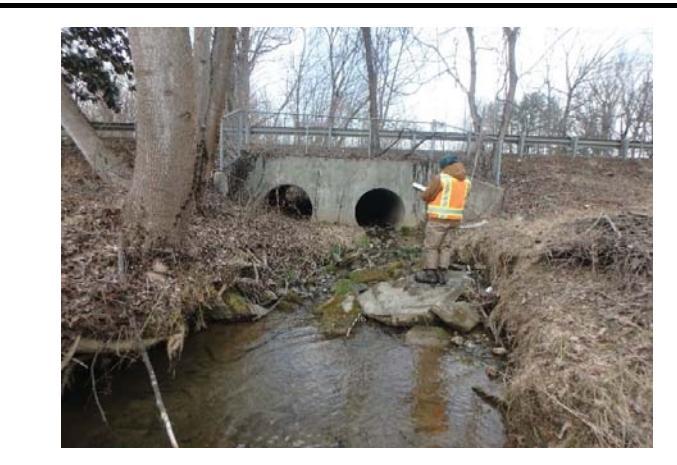
Downstream looking upstream at culvert/no blockage

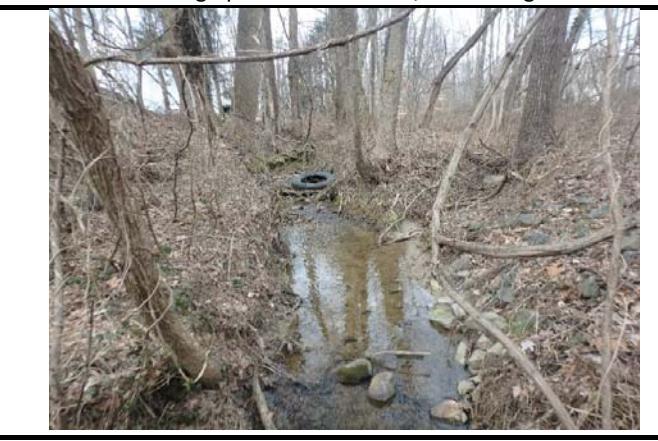
Upstream of culvert looking upstream

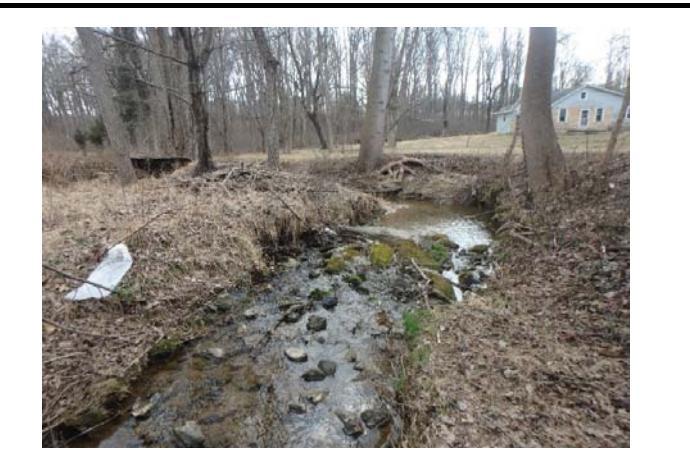
Downstream of culvert looking downstream

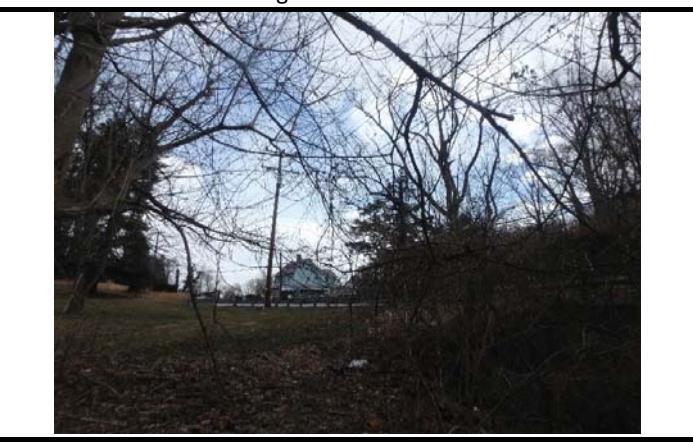
Left bank at upstream end of culvert looking at utilities

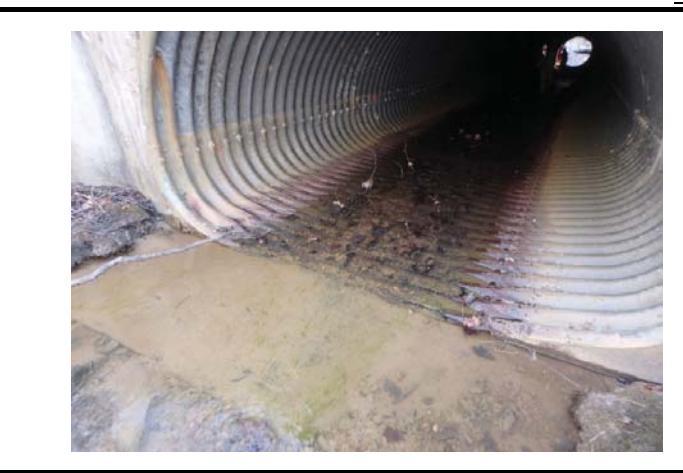
Closeup of inlet, upper end of gradient change

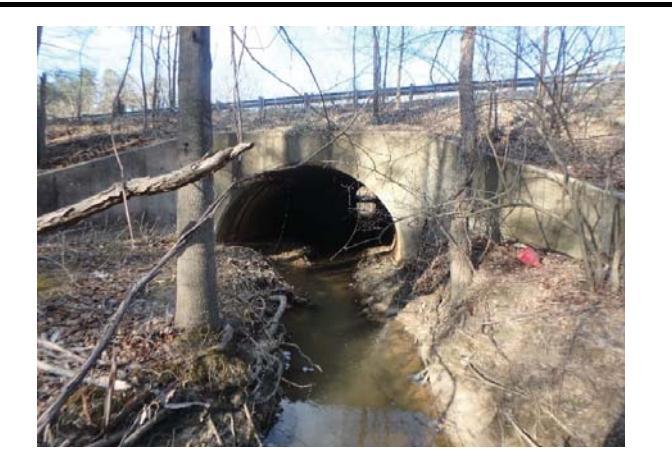
Downstream looking upstream at culvert

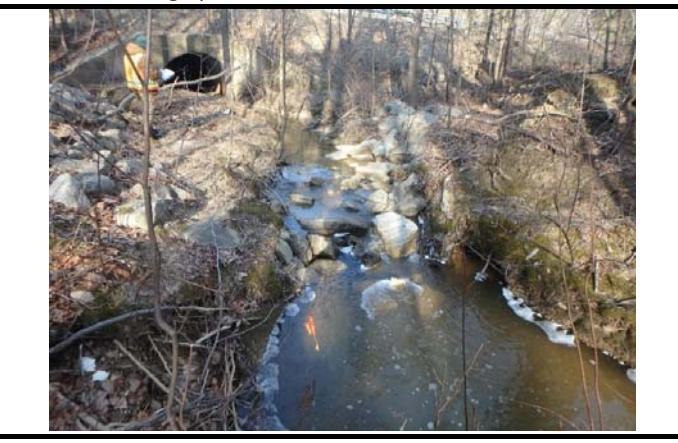
0.7 miles of 05 metwork			in CMP: 0.20 feet. Potential partial blockage during low	lows DS of culvert at
			rin civir. 0.20 feet. Potential partial blockage during low i	IOWS DS OF CUIVELL AL
Number of Downstream	n Fish Blockages	10	Adjacent Land Use	1
10 - 0 Blockages	in the brockages		10 - Commercial/Agriculture/Bare Ground	
5 - 1 Blockage			5- Field/Scrub-shrub	
1 - >1 Blockage			1 - Forest	
Describe:			Describe:	
0 blockages			Forest upstream and downstream	
NAACC Diadromous Fis	h HUC 12 Watershed Score	10	Ease of Construction	5
10 - 3 to 22			10 - Easy	
5 - 23 to 41			5- Average	
1 - 42 to 61			1 - Difficult/Complex	
Decesting.			U - NO BIOCKAGE	
Describe:			Describe:	
17			Large pipe, less than 1 loot	
Percentage of Upstream	n Impervious Surface	5	Ease of Access	1
10 - Less than 10%	· · ·		10 - Yes (with existing direct vehicular access to potentia	l site)
5 - 10 to 25%			5- Yes (open but no existing vehicular access)

Looking at potential partial blockage downstream of culvert
