I-495 & I-270 Managed Lanes Study

# **CA-5 (UNNAMED TRIBUTARY TO GREAT SENECA CREEK) STREAM RESTORATION MITIGATION**

**Semi-Final Design Report**

**April 2022**

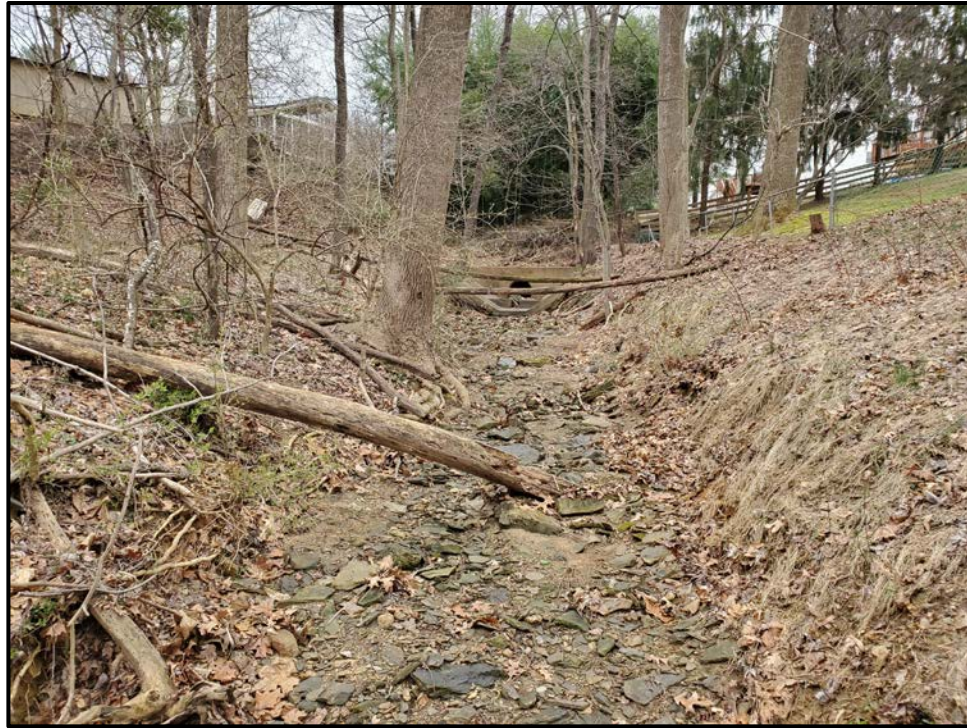
CA-5 Photo Point 101 36" Reinforced Concrete Pipe  
with Energy Dissipation into Tributary 1

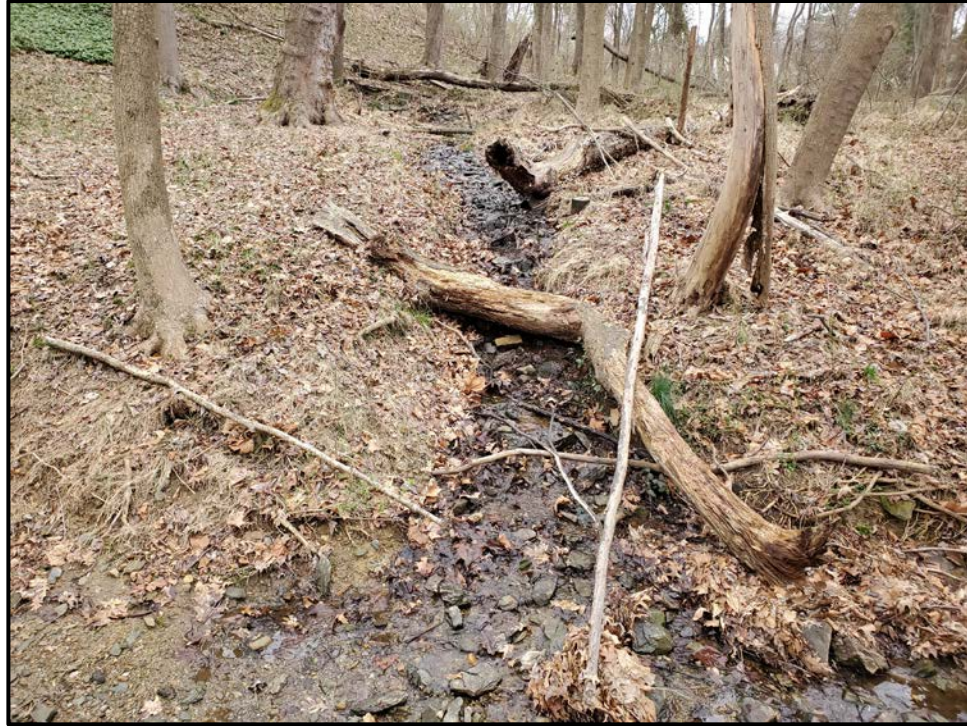
CA-5 Photo Point 103 Downstream at Groundwater  
Seep

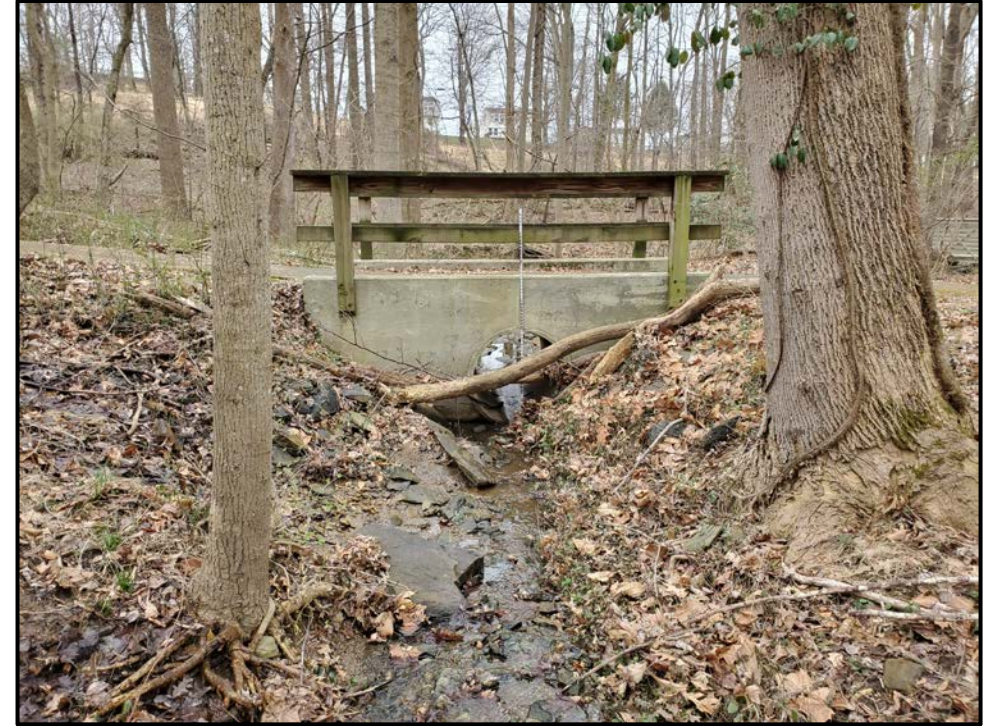
CA-5 Photo Point 104 Upstream at Groundwater Seep from Confluence

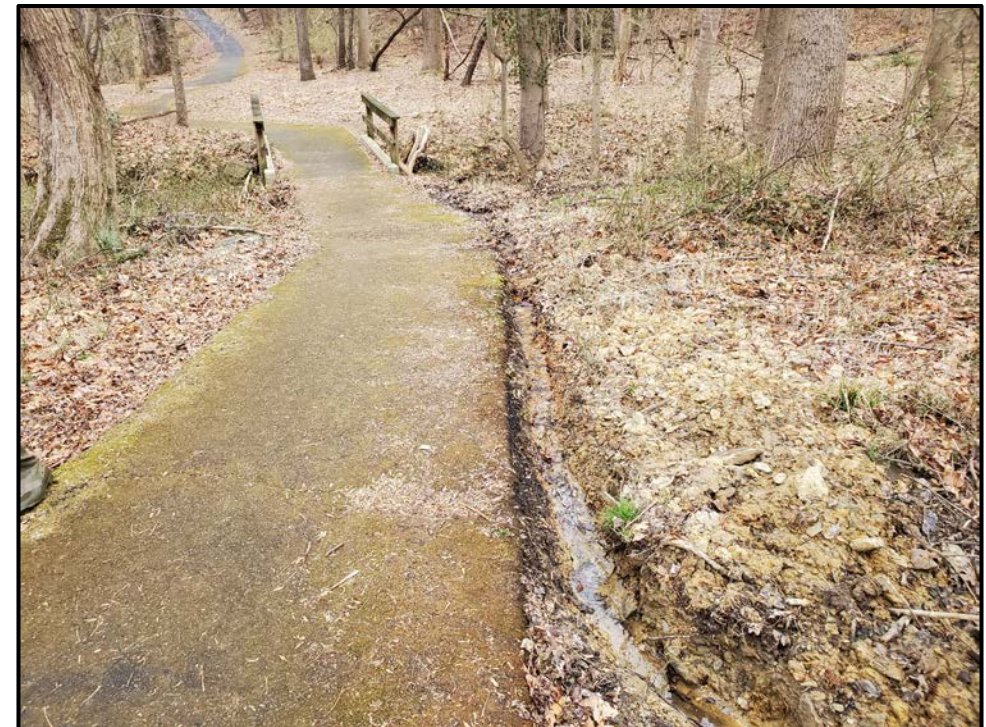
CA-5 Photo Point 105 at Groundwater seep adjacent to Trail

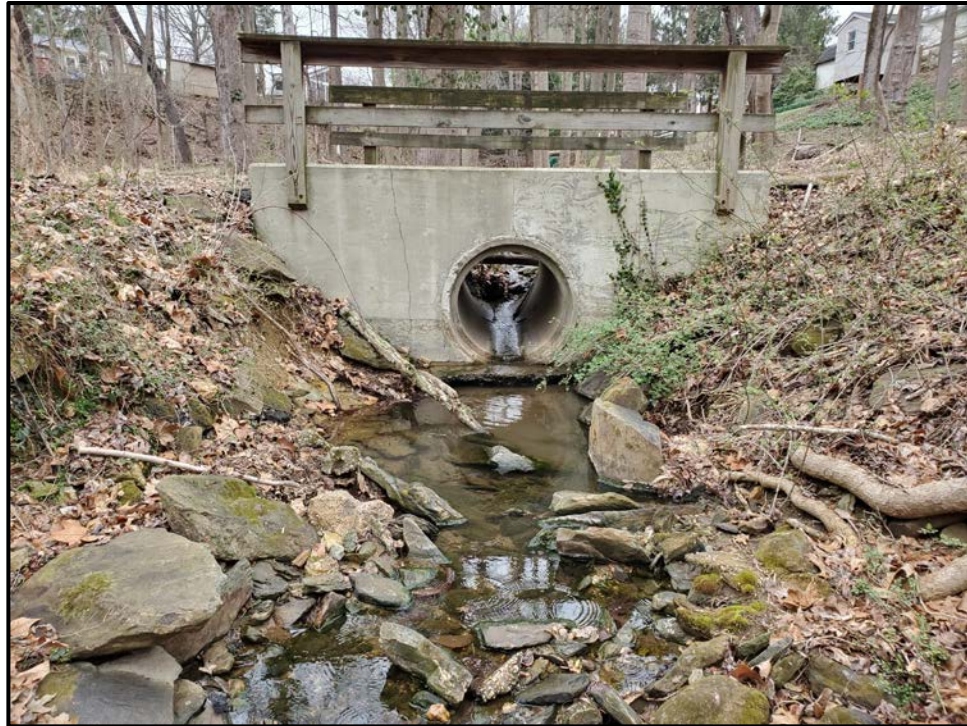
CA-5 Photo Point 105 at Groundwater seep adjacent to Trail

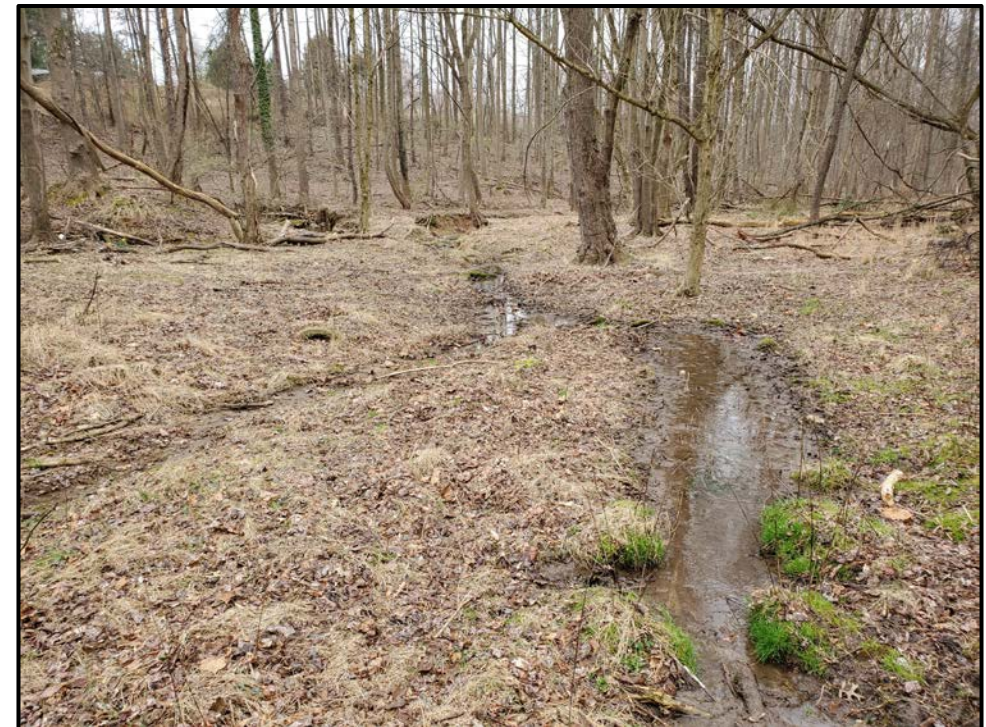
CA-5 Photo Point 201 Upstream at Groundwater  
Seep Headcut

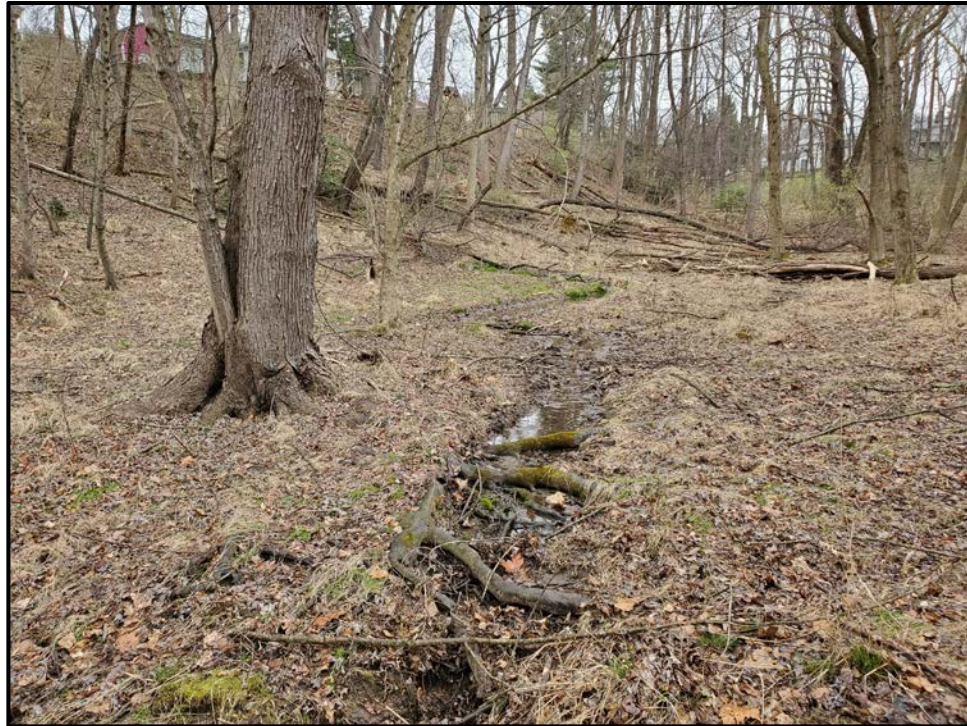
CA-5 Photo Point 201 Downstream at Groundwater  
Seep Headcut

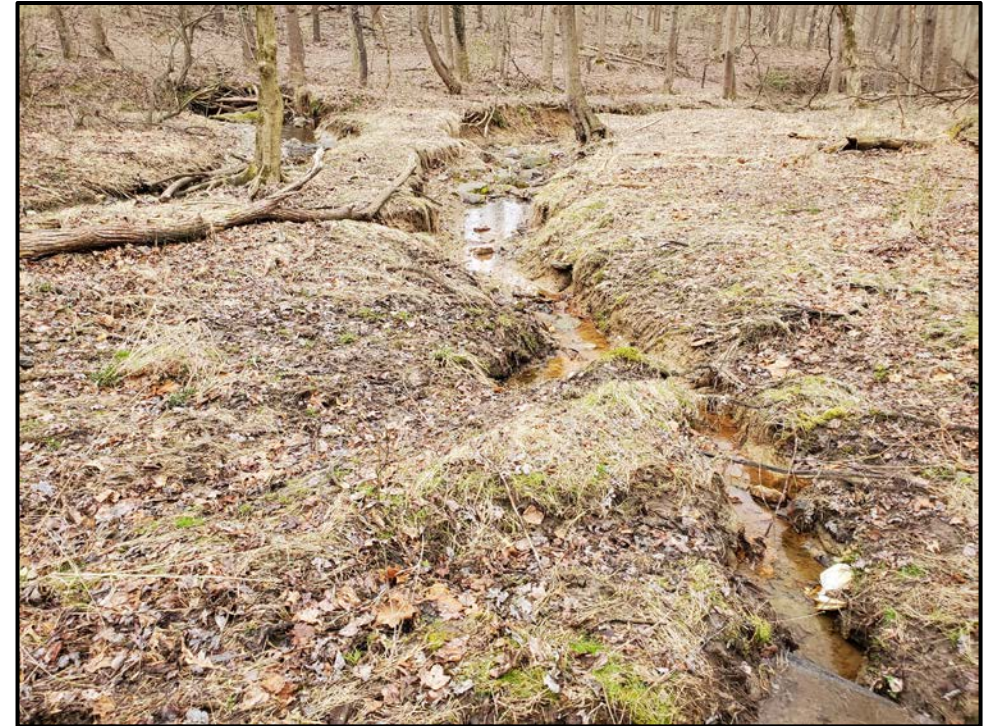
CA-5 Photo Point 202 Upstream Start of Headcut

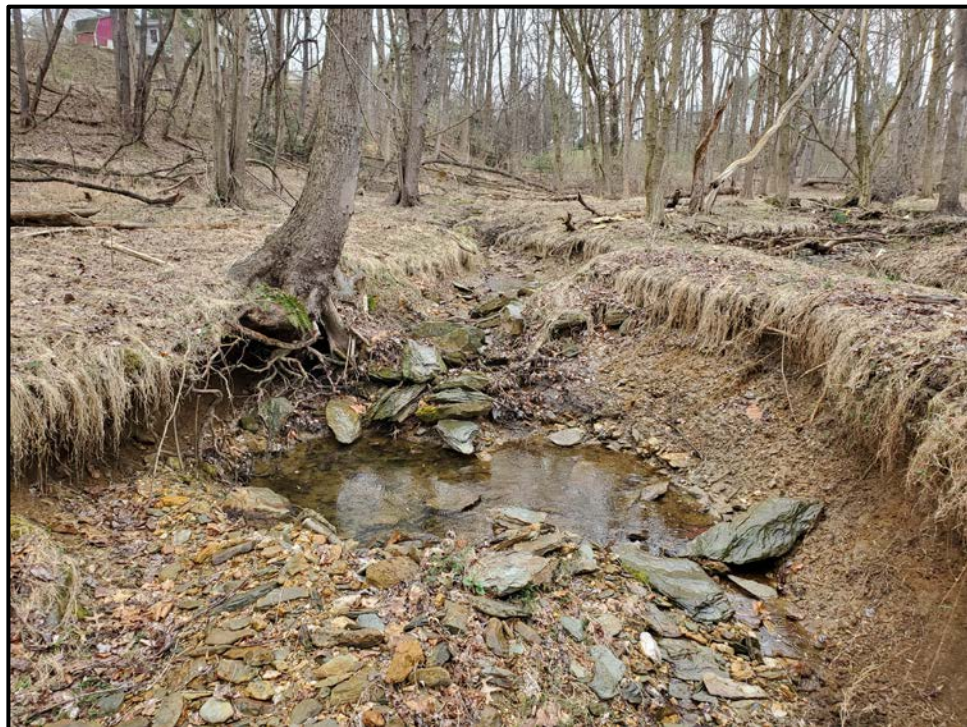
CA-5 Photo Point 202 Downstream Start of Headcut

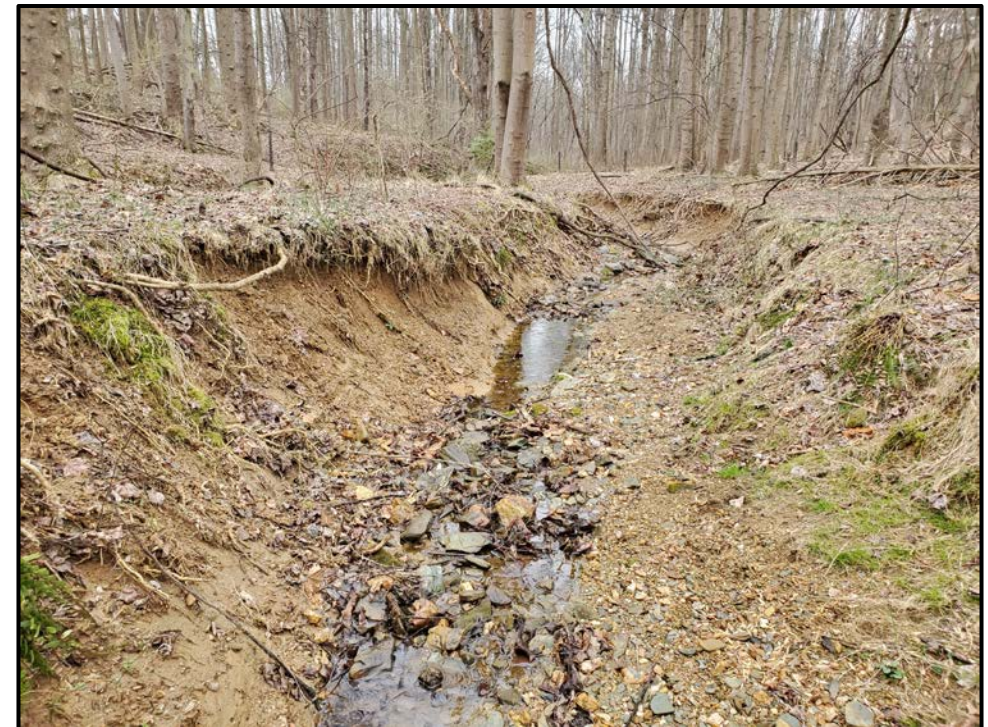
CA-5 Photo Point 203 Downstream

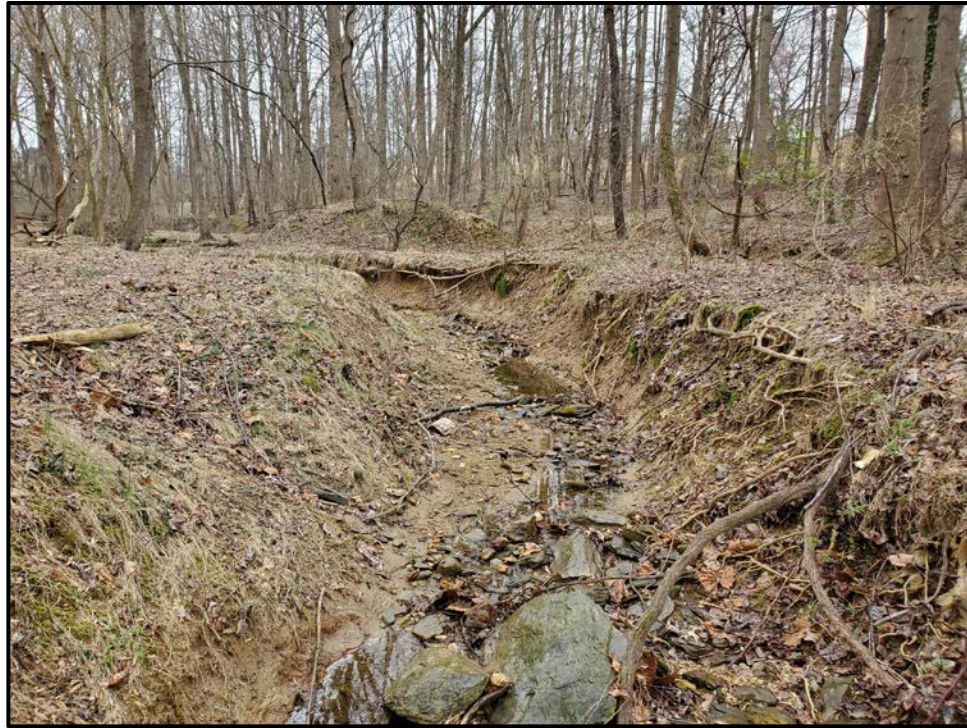
CA-5 Photo Point 204 Upstream

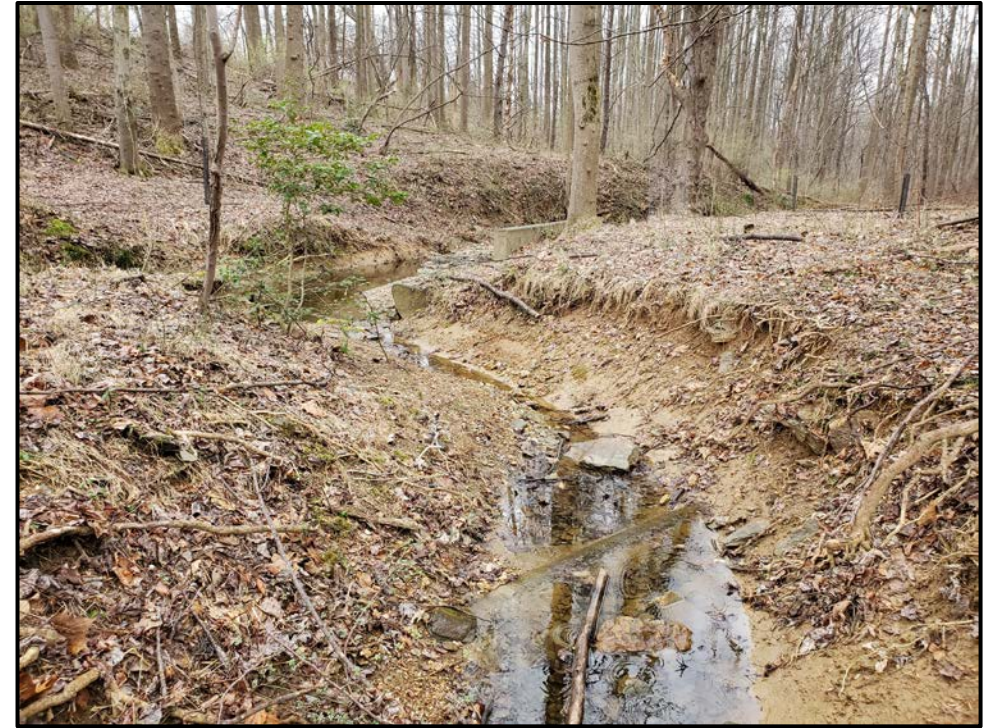
CA-5 Photo Point 204 Downstream

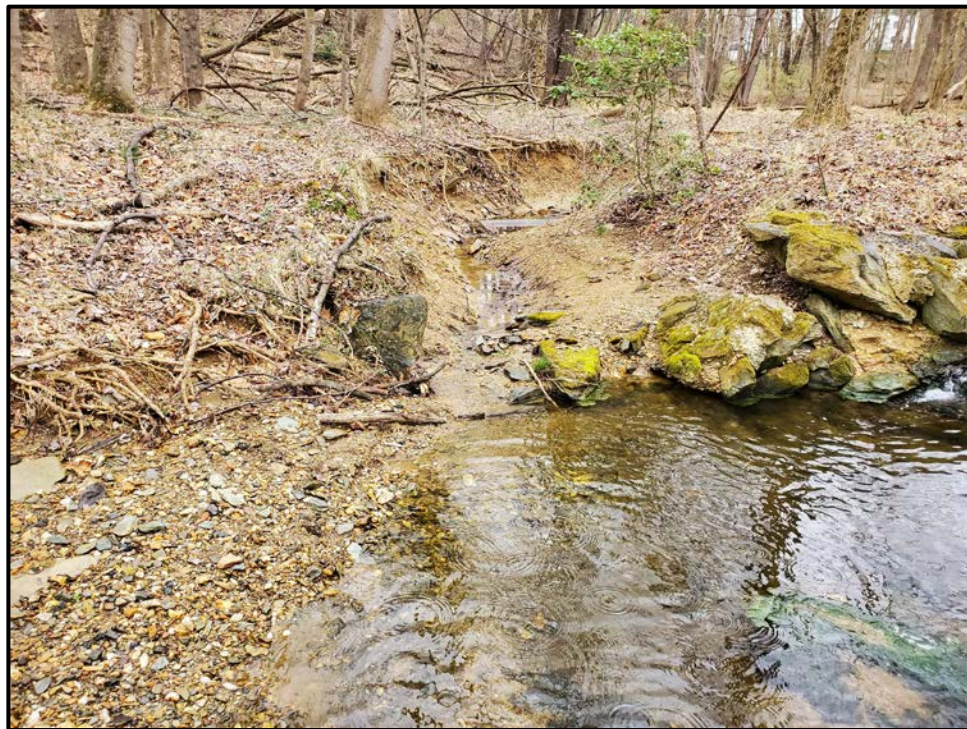
CA-5 Photo Point 205 Upstream at Confluence

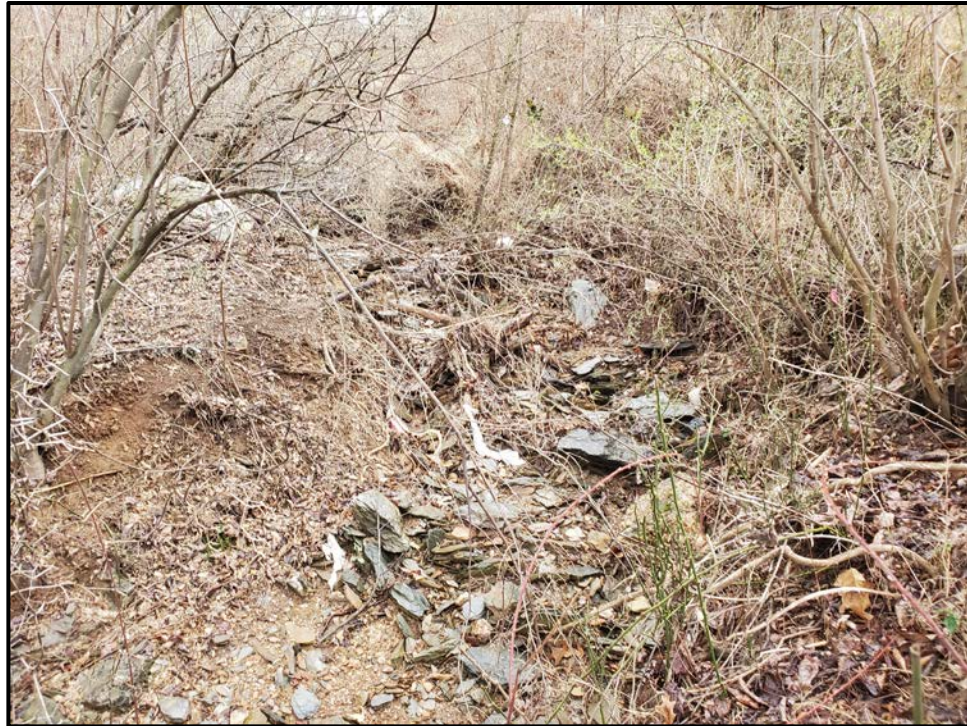
CA-5 Photo Point 301 Upstream at Top of Tributary 2

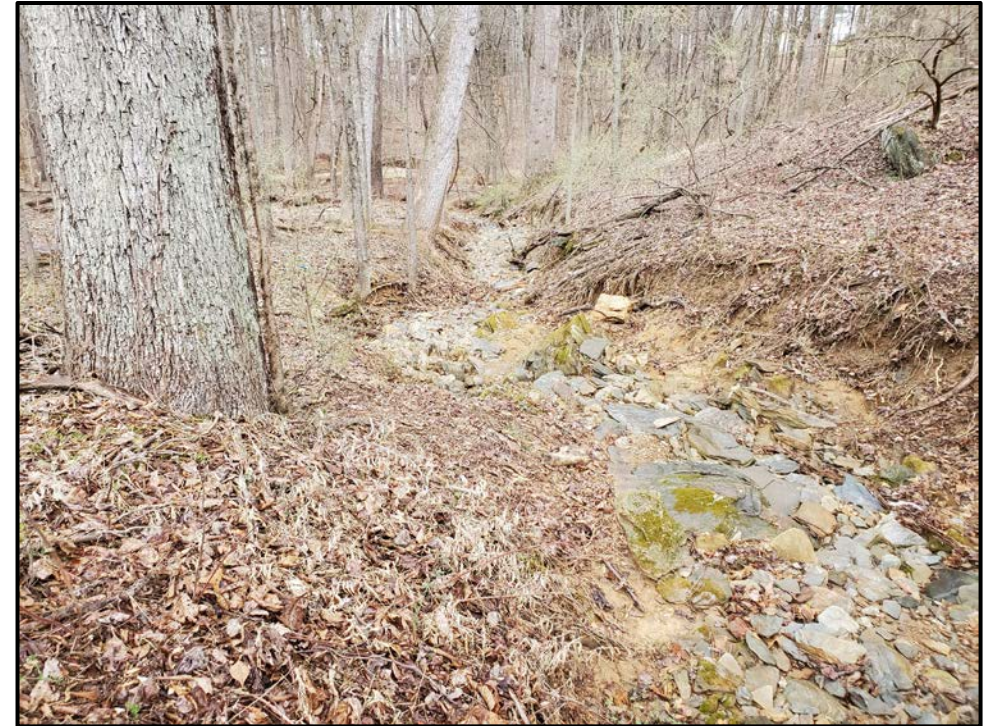
CA-5 Photo Point 301 Downstream at Top of  
Tributary 2

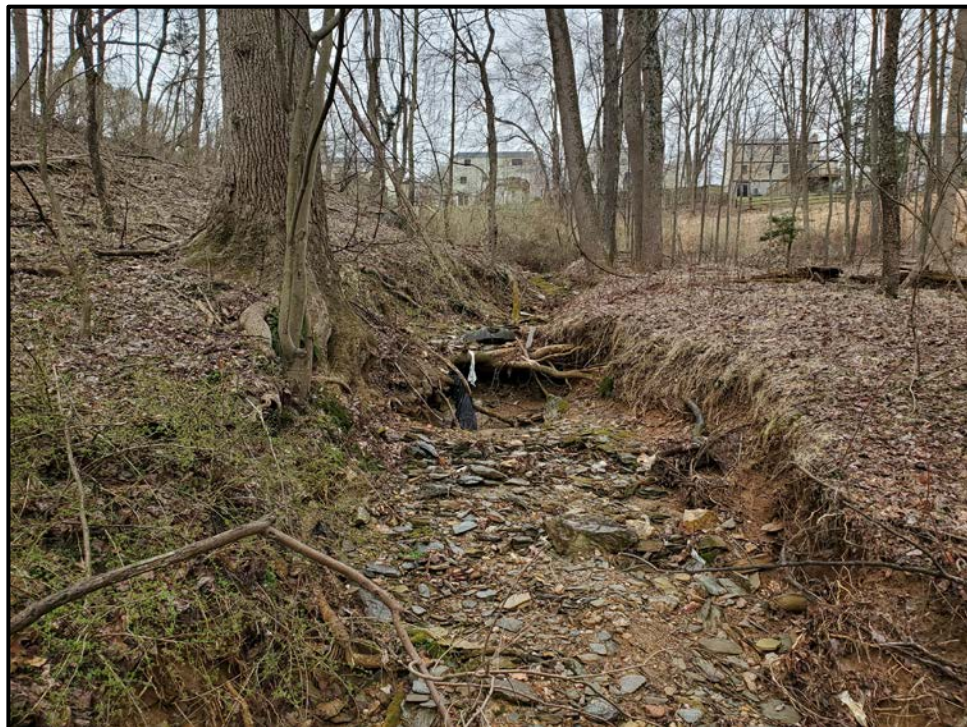
CA-5 Photo Point 302 Upstream Near Trail

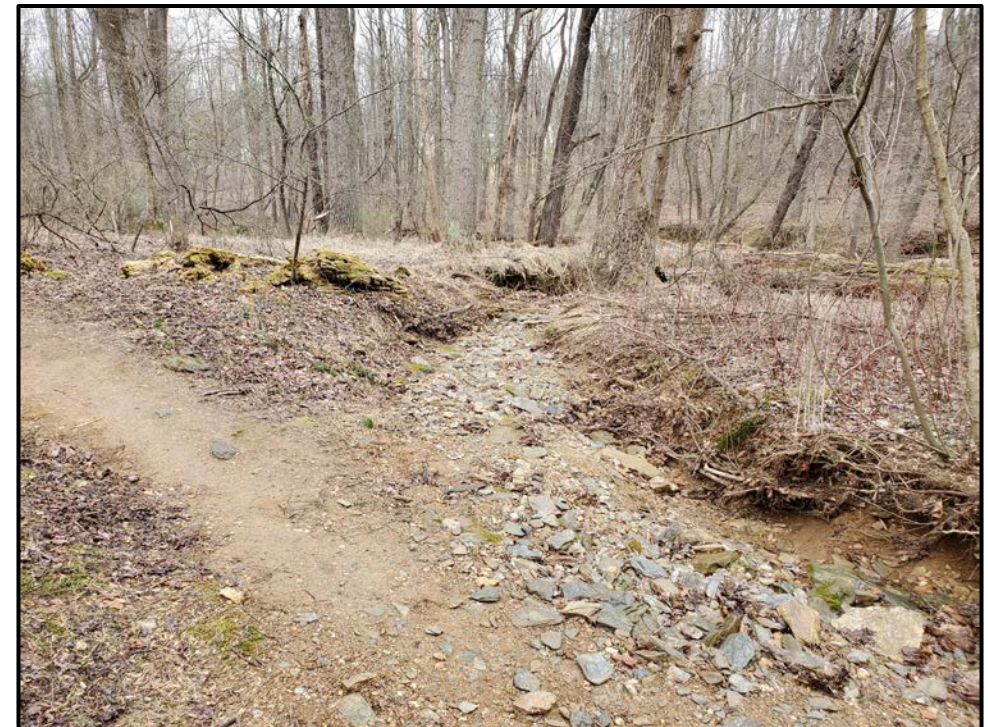
CA-5 Photo Point 302 Downstream Near Trail

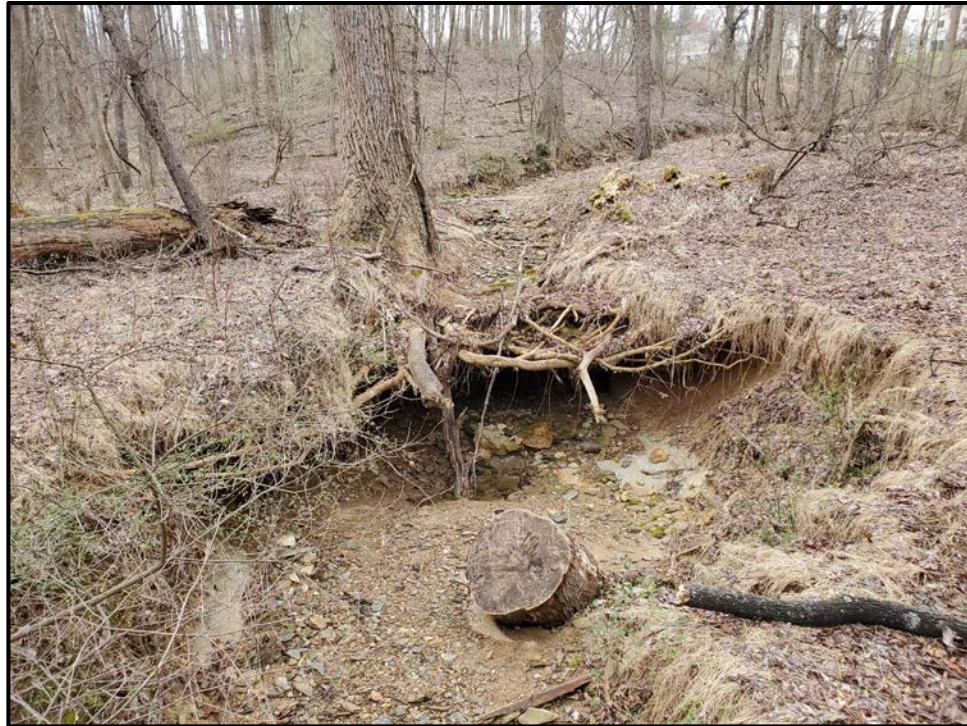
CA-5 Photo Point 303 Upstream at Headcut

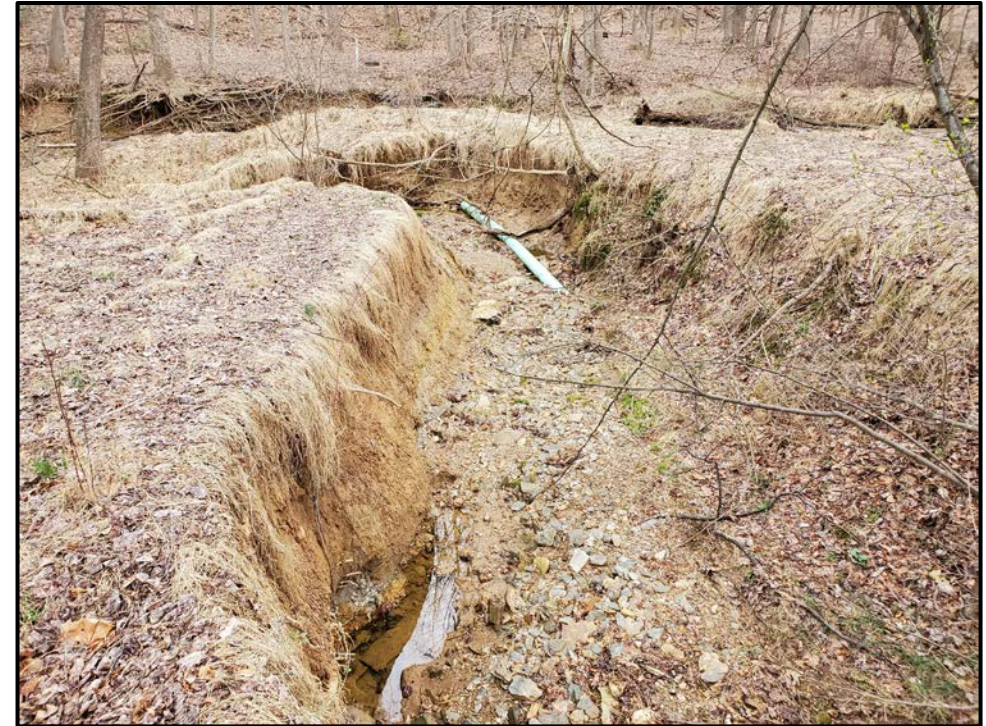
CA-5 Photo Point 303 Downstream

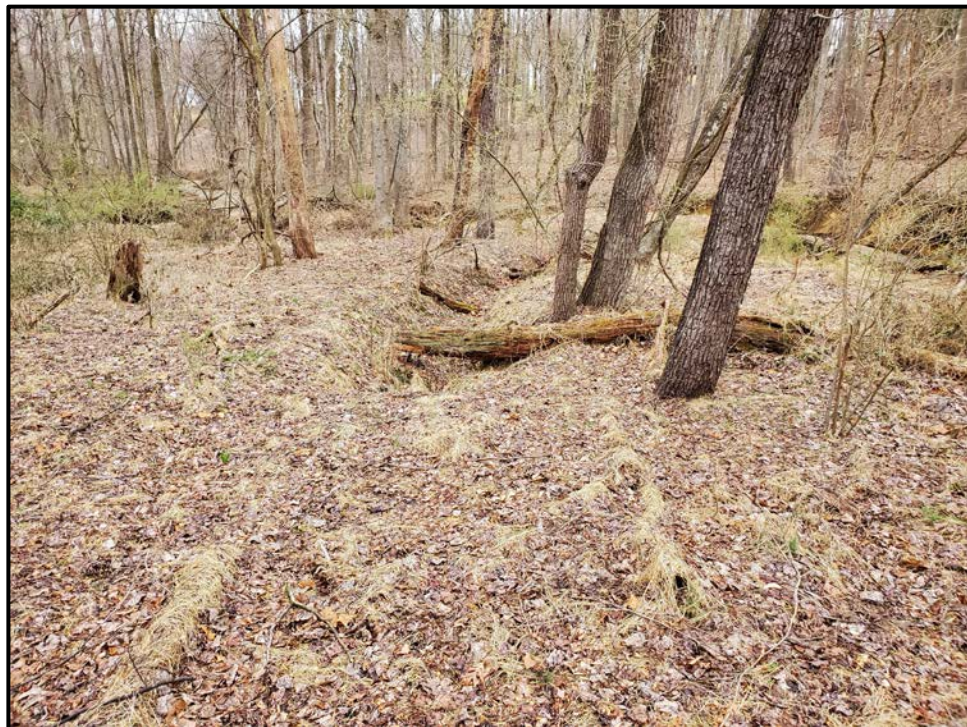
CA-5 Photo Point 303 at Abandoned Tributary

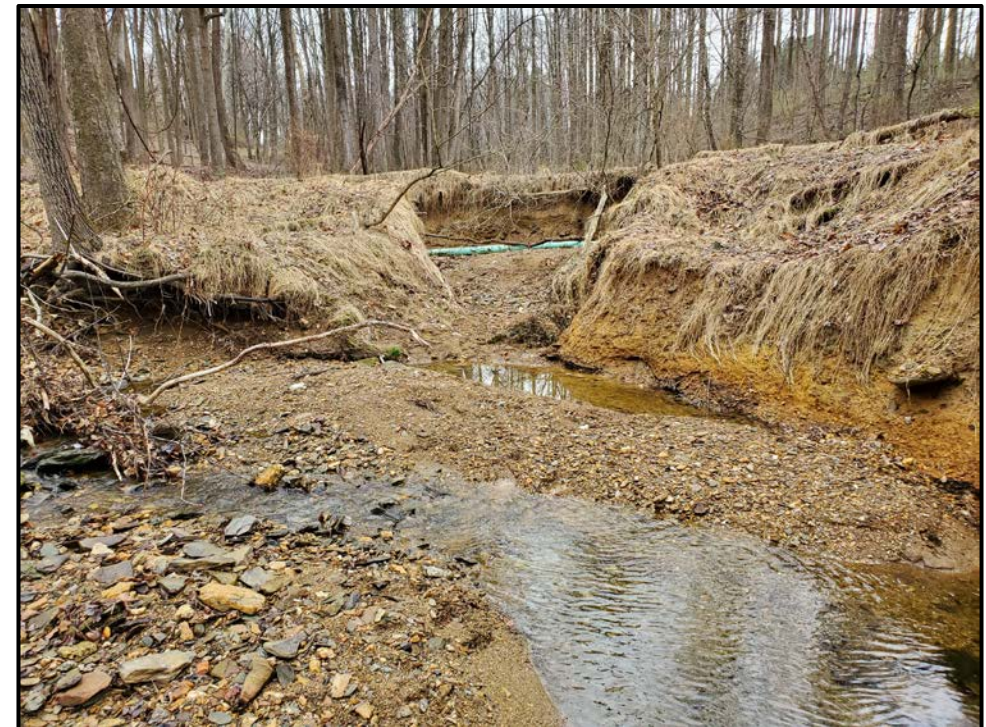
CA-5 Photo Point 304 Upstream at Confluence

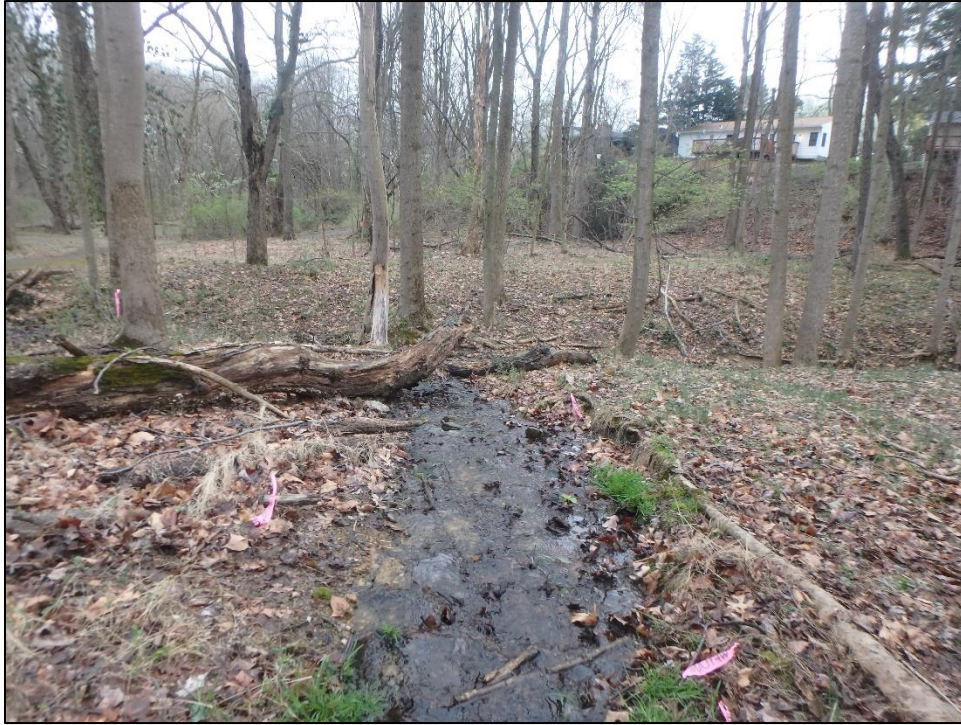
Photo 1: Looking downstream at WC1, a perennial stream.

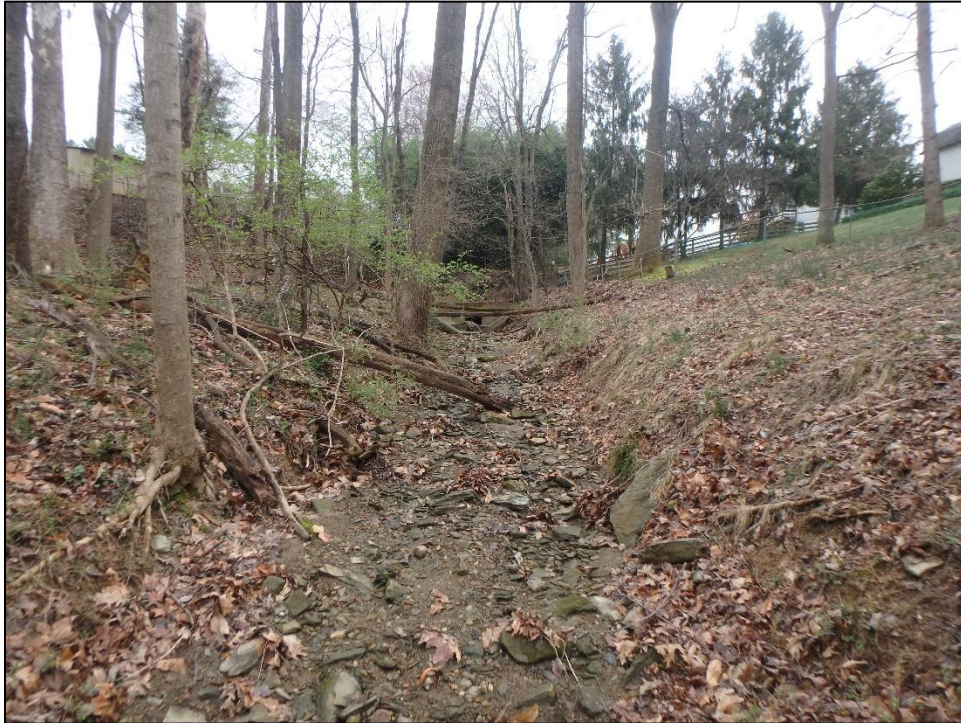
Photo 2: Looking upstream at the ephemeral portion of WC2.

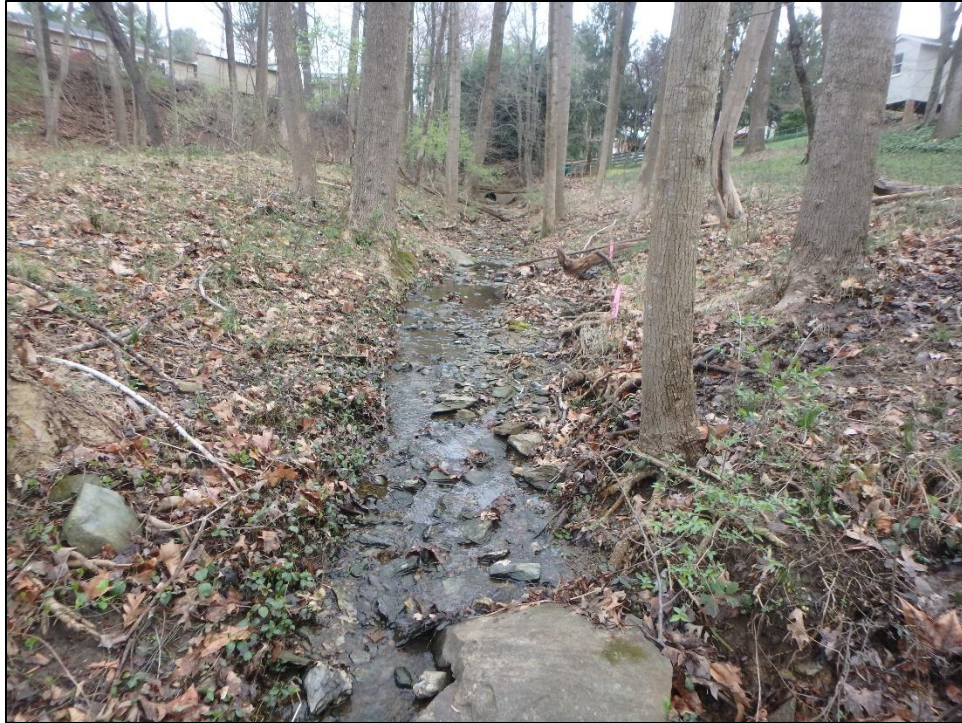
Photo 3: Looking upstream at the perennial portion of WC2.

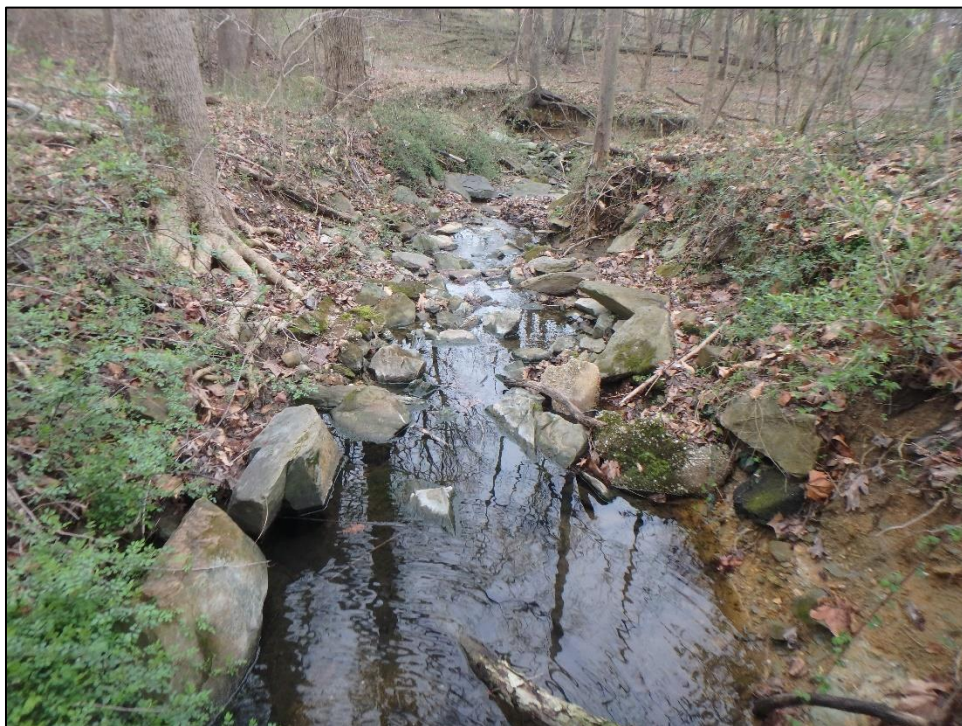
Photo 4: Looking downstream at the perennial portion of WC2.

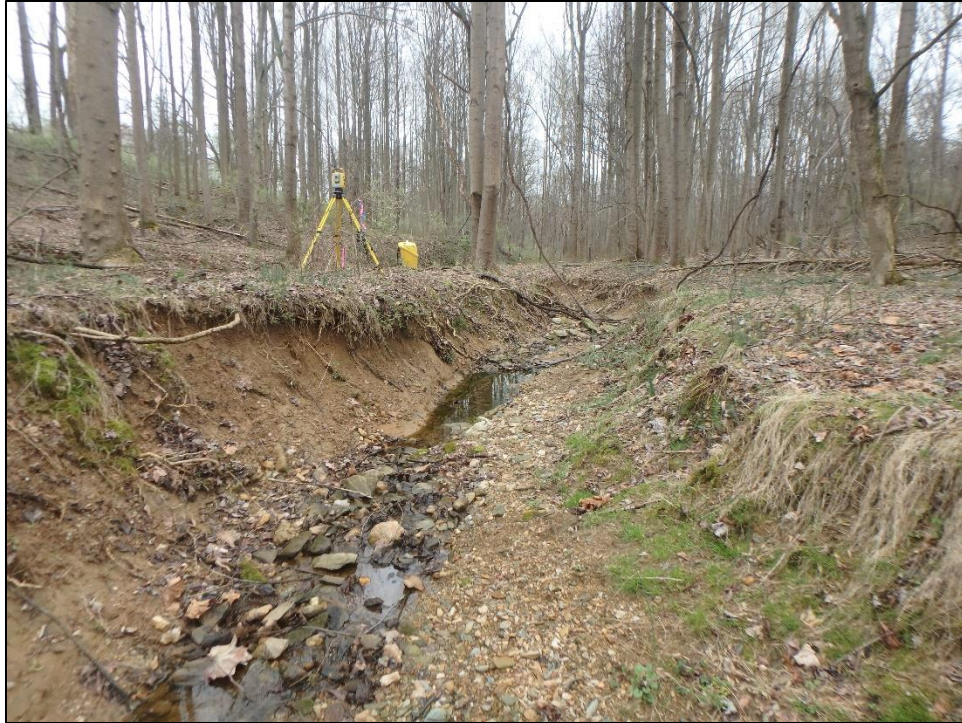
Photo 5: Looking downstream at WC3, an intermittent stream.

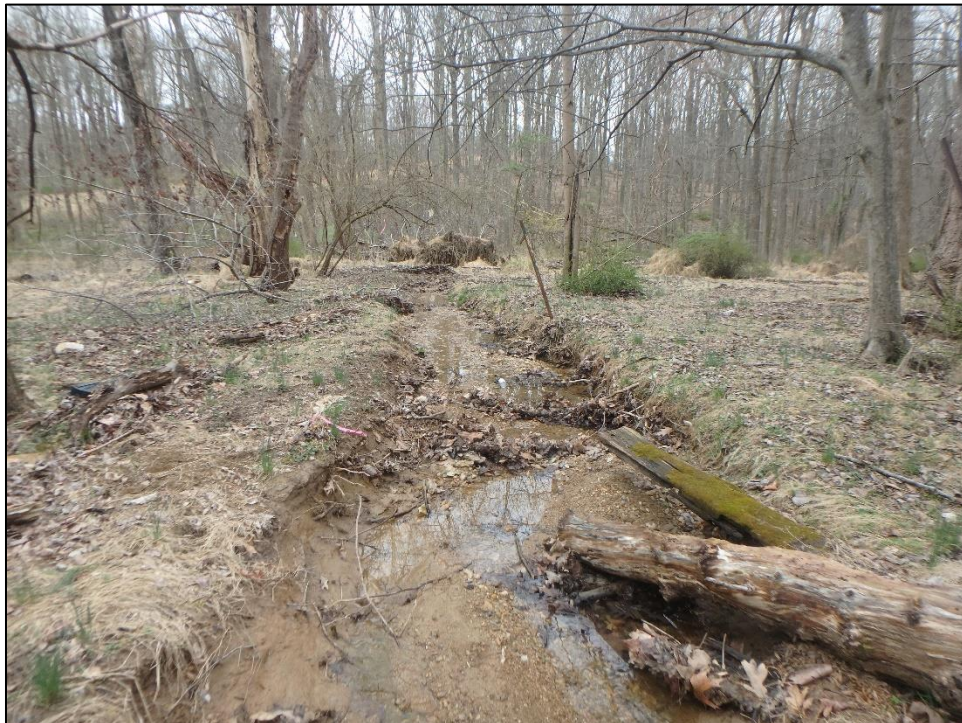
Photo 6: Looking downstream at WC5, an intermittent stream.

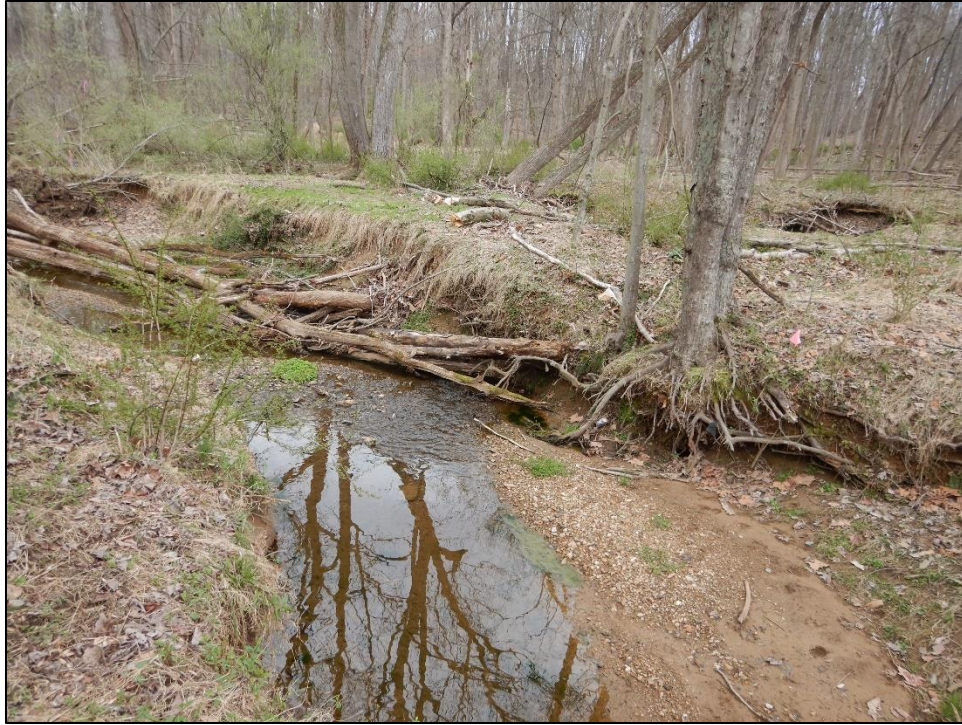
Photo 7: Looking downstream at WC6, a perennial stream.

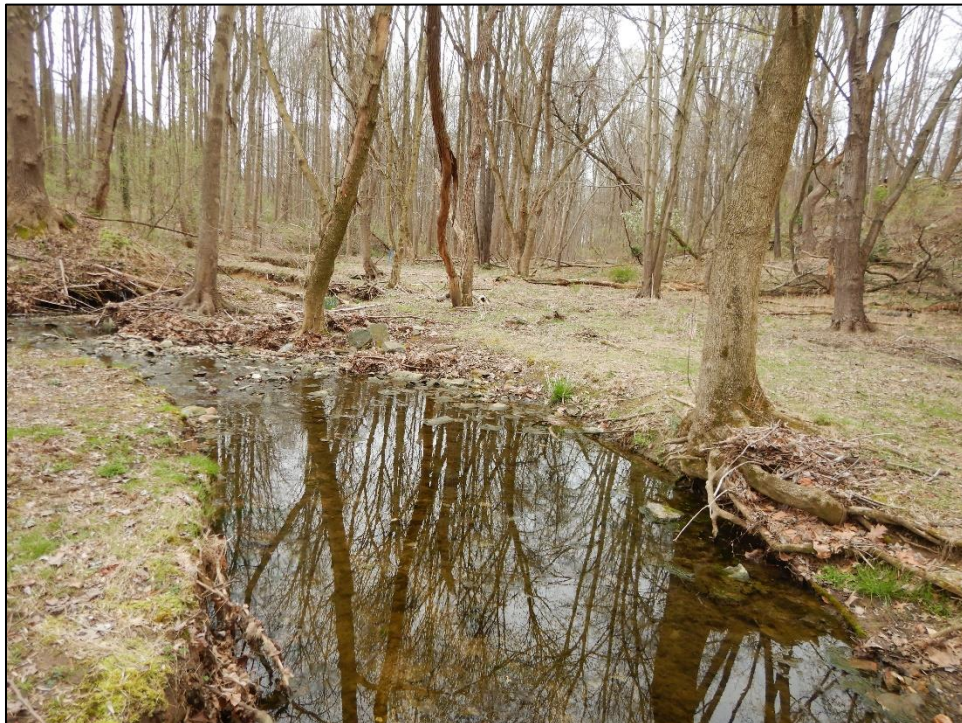
Photo 8: Looking downstream at the upstream end of WC7, a perennial stream.

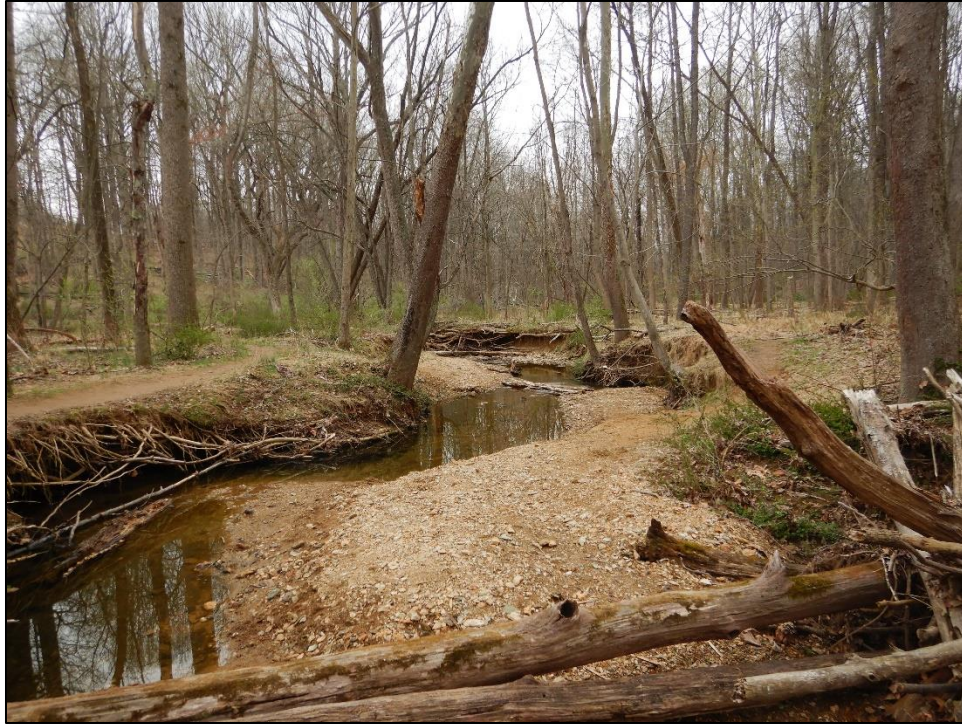
Photo 9: Looking downstream at the downstream end of WC7.
